- 1 **Q. [Data] – For each supplementary item of information obtained from operating**  
2 **personnel concerning practices, plans, policies, outlook, etc. as they relate to life or**  
3 **salvage characteristics, please provide the following:**  
4  
5 **a. a narrative identification of each separate practice, plan, policy, outlook, etc.;**  
6  
7 **b. the individual from whom each such practice, plan, etc. was obtained;**  
8  
9 **c. the inquiry made to elicit the input;**  
10  
11 **d. all underlying data, reports, documents, etc., that address each separate**  
12 **practice, plan, etc.; and**  
13  
14 **e. the impact each separate practice, plan, etc. had in the development of each**  
15 **depreciation parameter, by account.**  
16  
17 **A.** Attachment A includes the meeting notes from discussions with Newfoundland Power  
18 personnel. Attachment B includes the 2010 Property Inspection reports prepared by

**2010 Property Inspection Reports**

## **Depreciation Study 2010**

# **2010 DEPRECIATION STUDY**

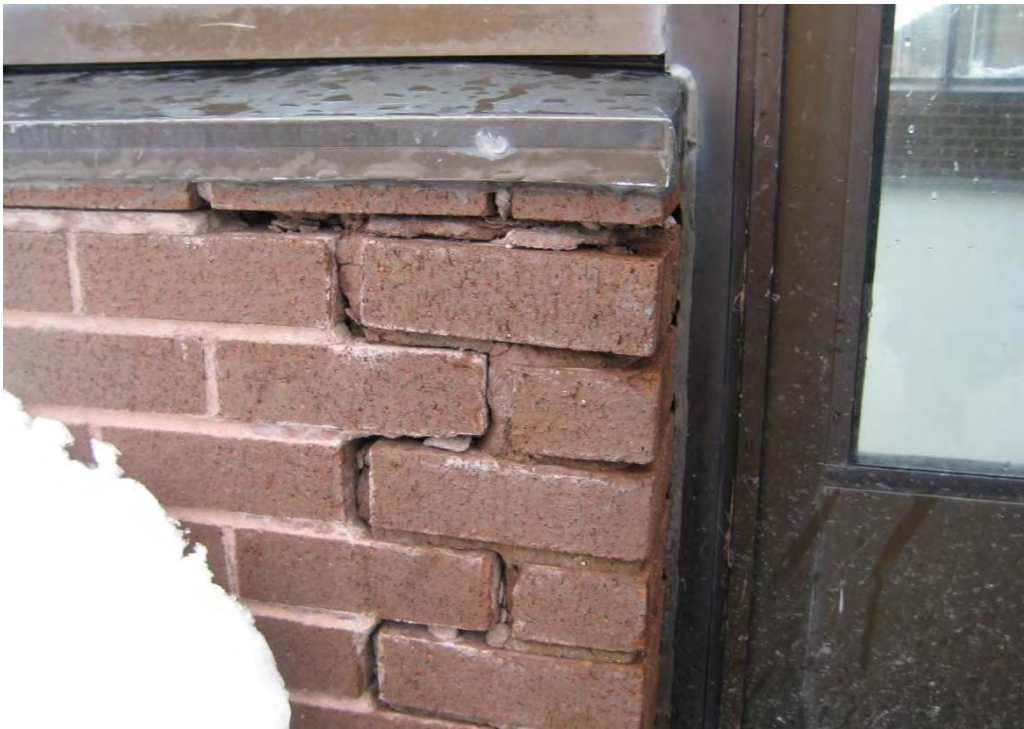
**Figure 5 - Cracked Exterior Block (2009)**

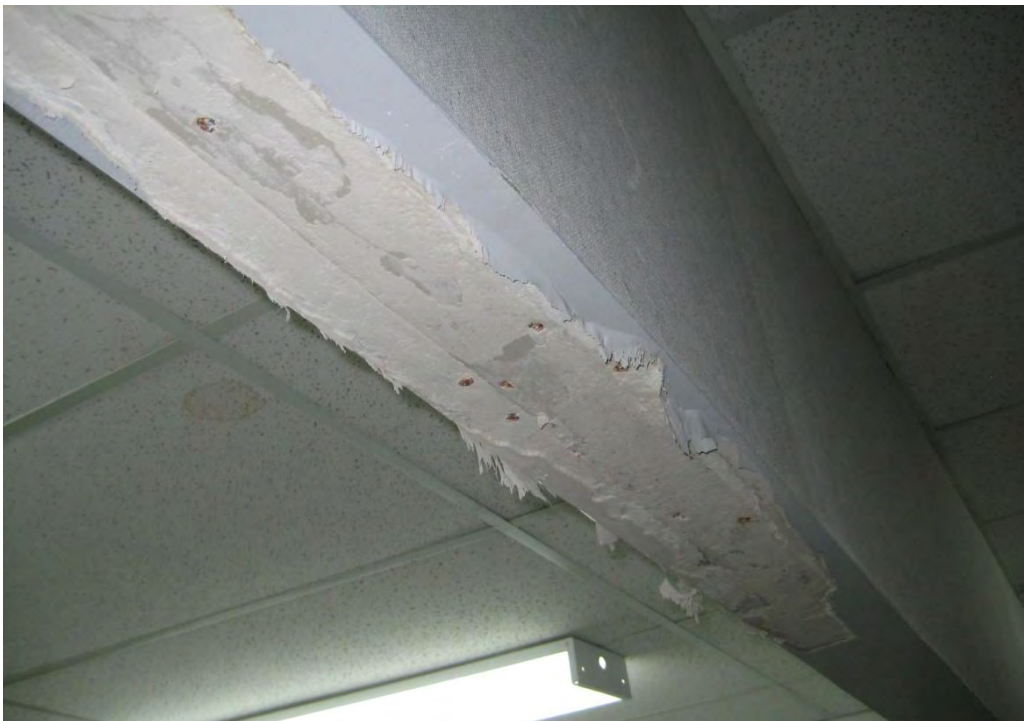
**Figure 6 - Water Damage (2009)**

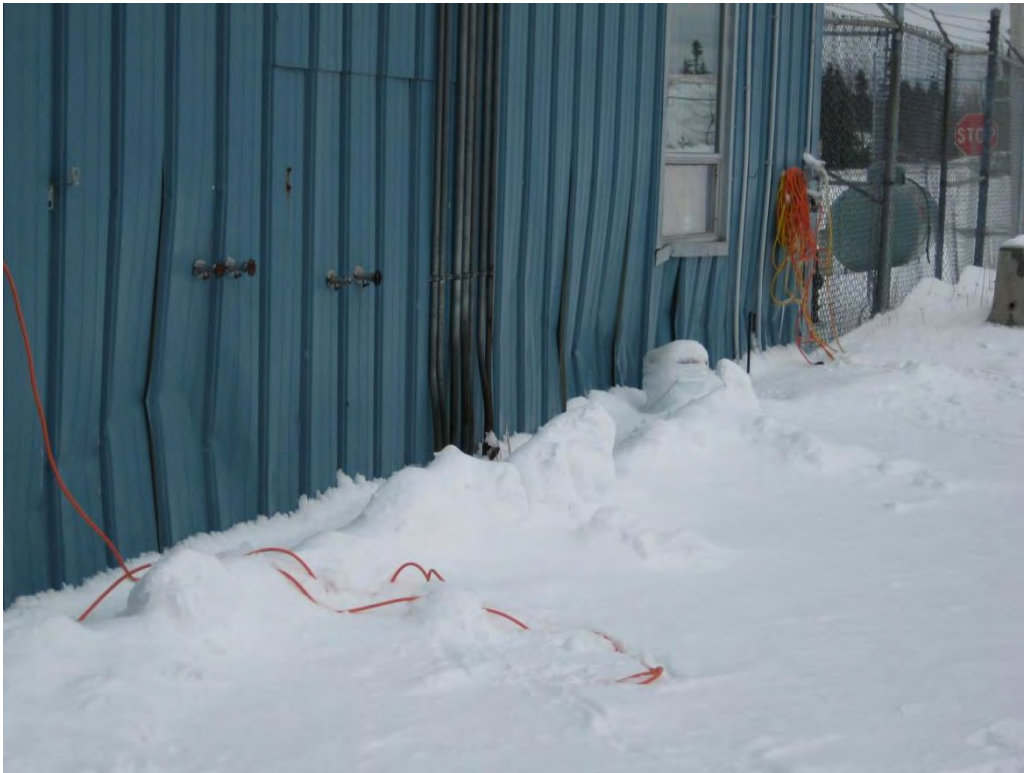
**Figure 11 - Damaged Siding (2009)**

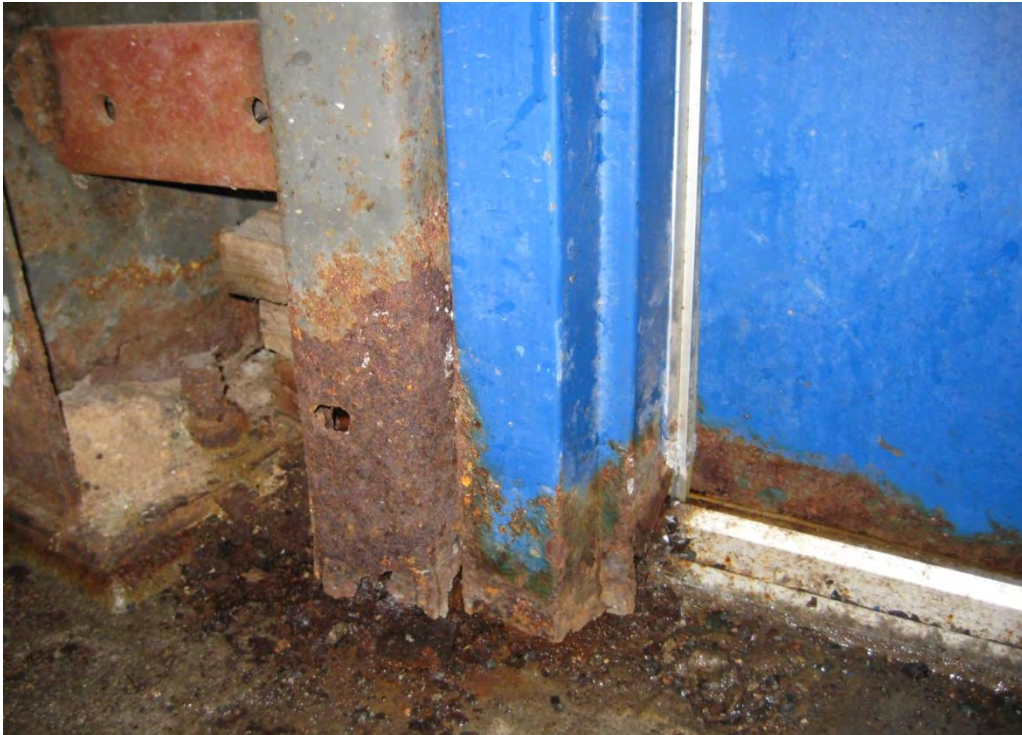
**Figure 14 - Door Corrosion (2009)**

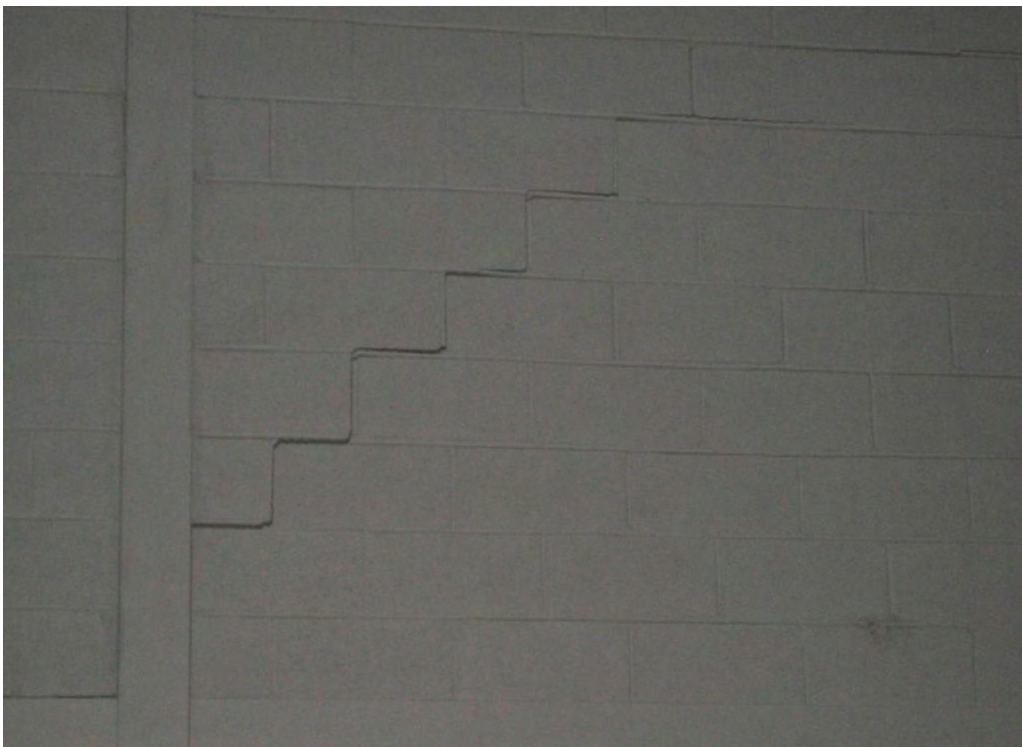
**Figure 15 – Crack in Masonry (2009)**

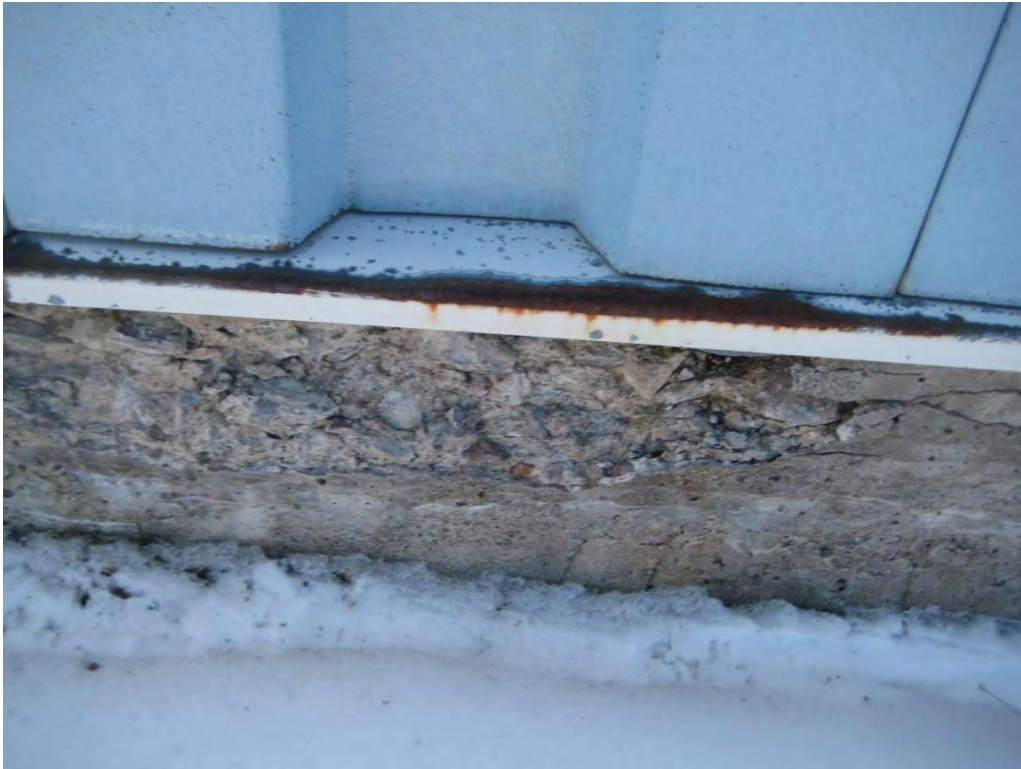
**Figure 17 - Damaged Foundation (2009)**

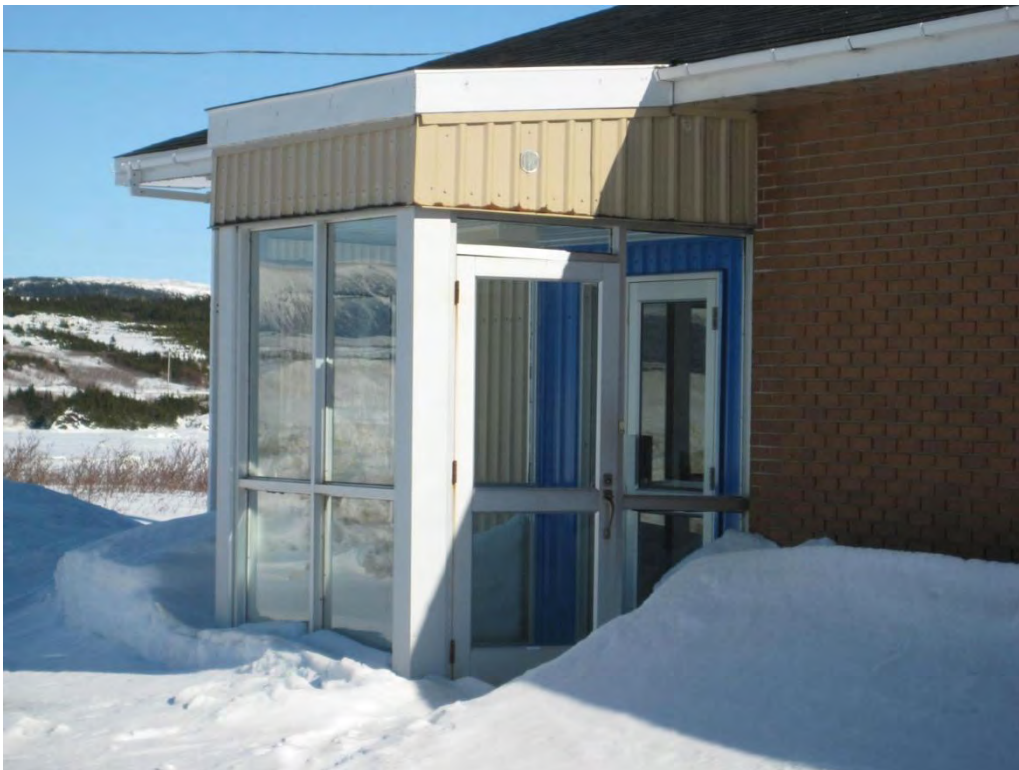
Figure 33 - Heaved Entrance (2009)
