Transmission Line Rebuild (June 2008)
and
Transmission Line Rebuild (June 2009)

Transmission Line Rebuild

June 2008

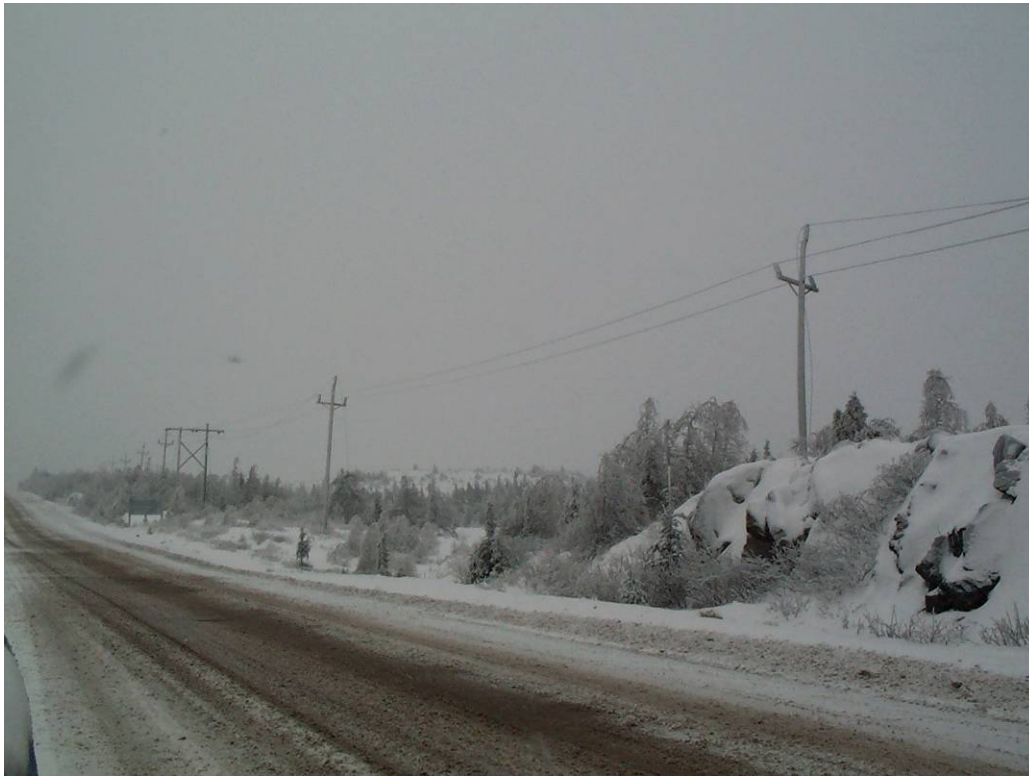
Since 2001, there have been several outages on this line due to wind and ice conditions causing conductors to slap together. This results in conductor damage and often conductor failure. The most recent occurrences happened in December 2003, April 2004, and December 2007 when ice build-up on overhead conductors caused the line to fail resulting in outages to customers.

Figure 1 - 110L Ice Storm Damage December 2003

Based on the condition of this line, it is recommended that another 4.9 km of 110L be rebuilt in 2009 at an estimated cost of \$627,000.

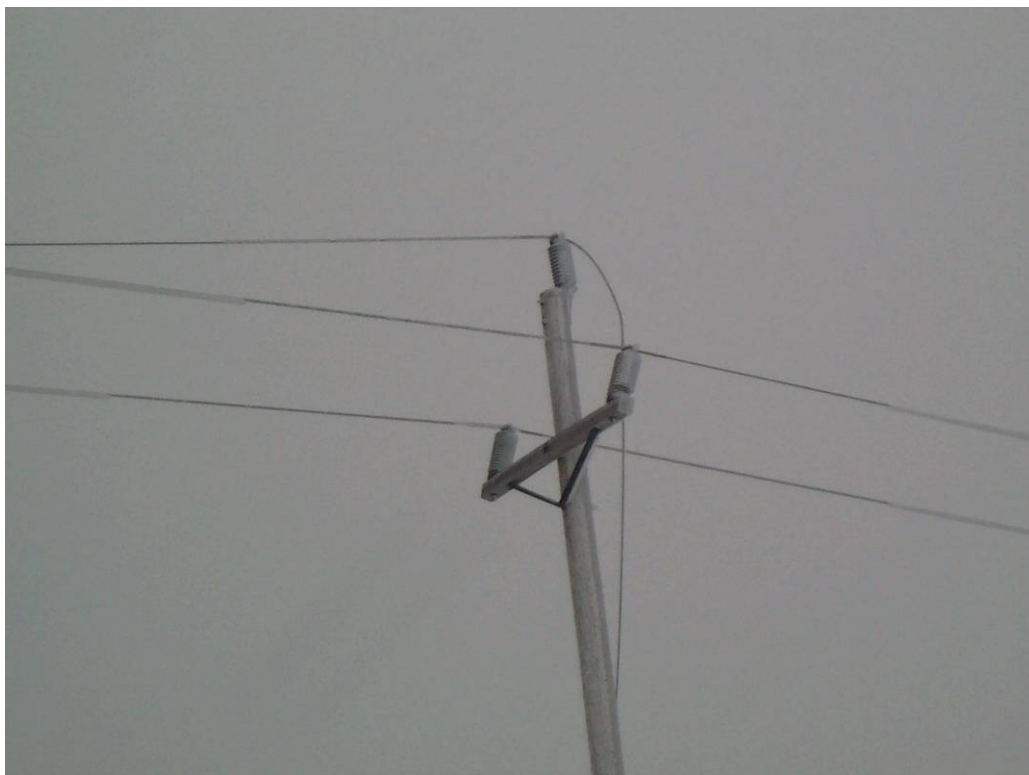
The conductor is damaged in many places and has been subjected to ice loading since its original installation. The steel core shows evidence of rust and the aluminum strands are corroded which reduces the physical strength and the current carrying capacity of the conductor. This conductor has deteriorated to the point that the line has been de-rated to about one-half of its original current carrying capacity out of concern that it will burn off and fall to the ground.

Figure 2 - 110L Broken conductor - ice build up December, 2003

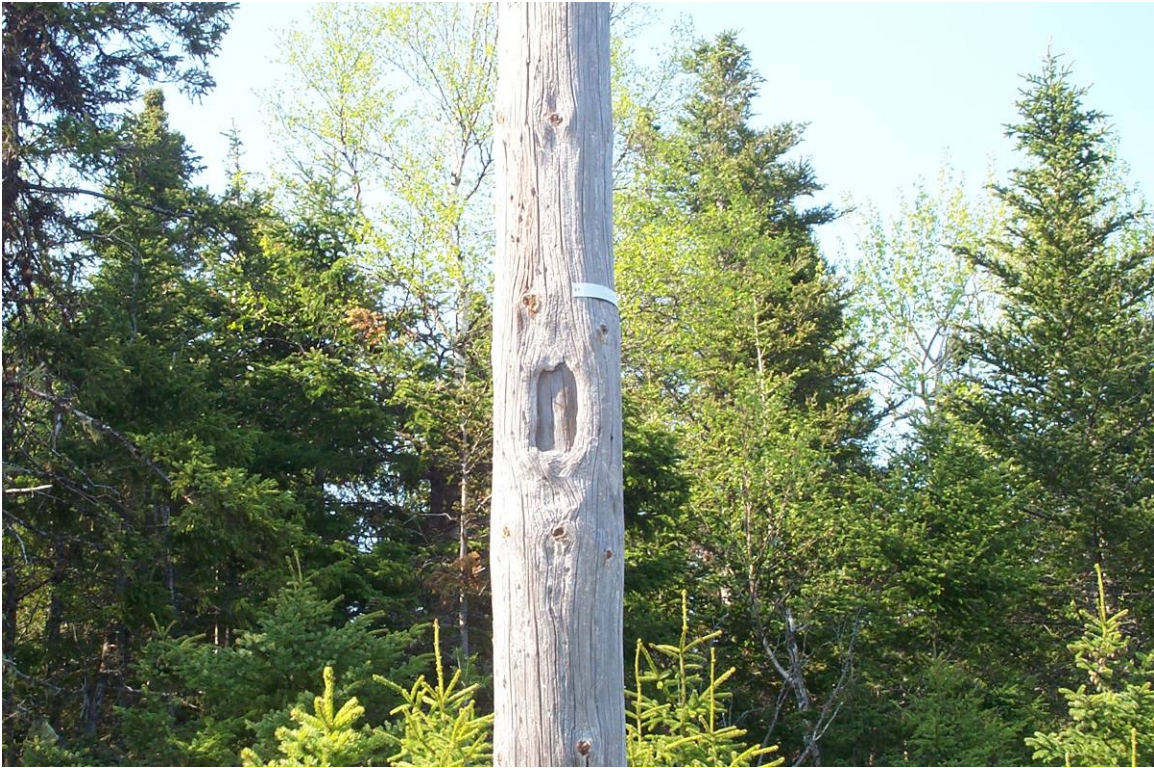
These lines are more than 50 years old and many of the original poles are deteriorated. Inspections have identified substantial evidence of external and/or internal rotting, insect and woodpecker damage, and cracks and splits in poles, crossarms, cross braces, and other hardware.

Figure 3 - Deteriorated pole 110L

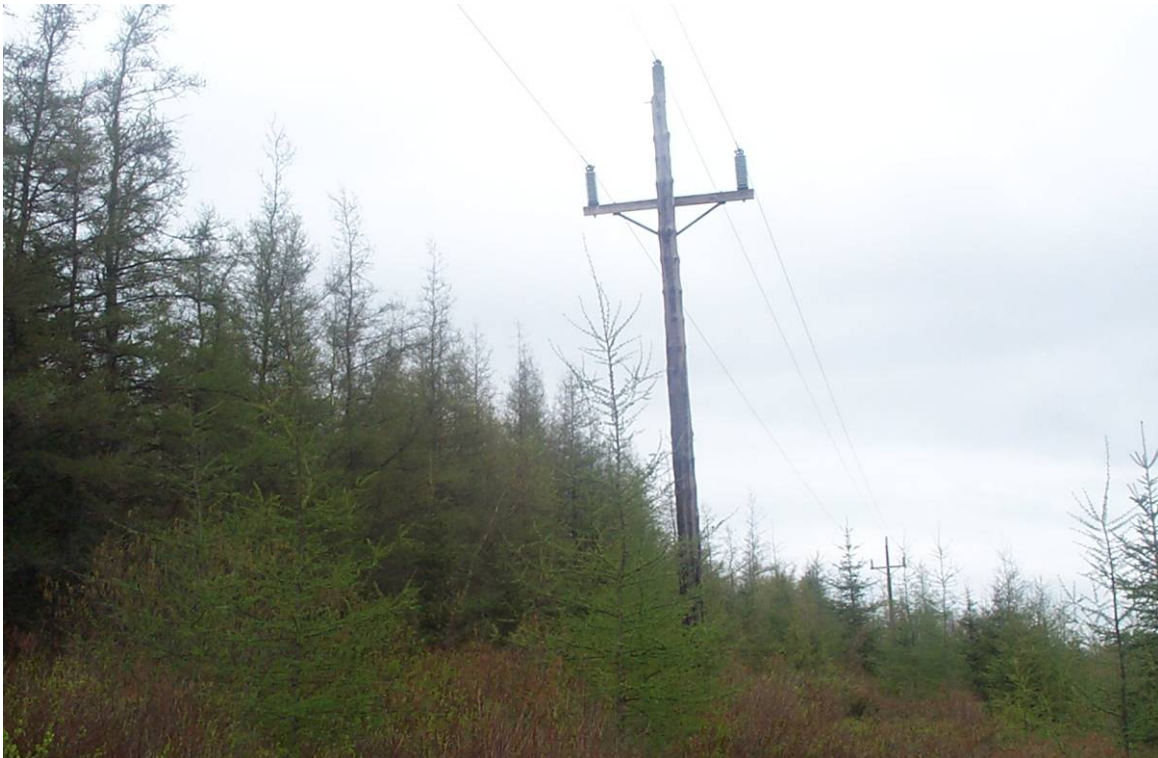
Figure 4 - Deteriorated pole 110L

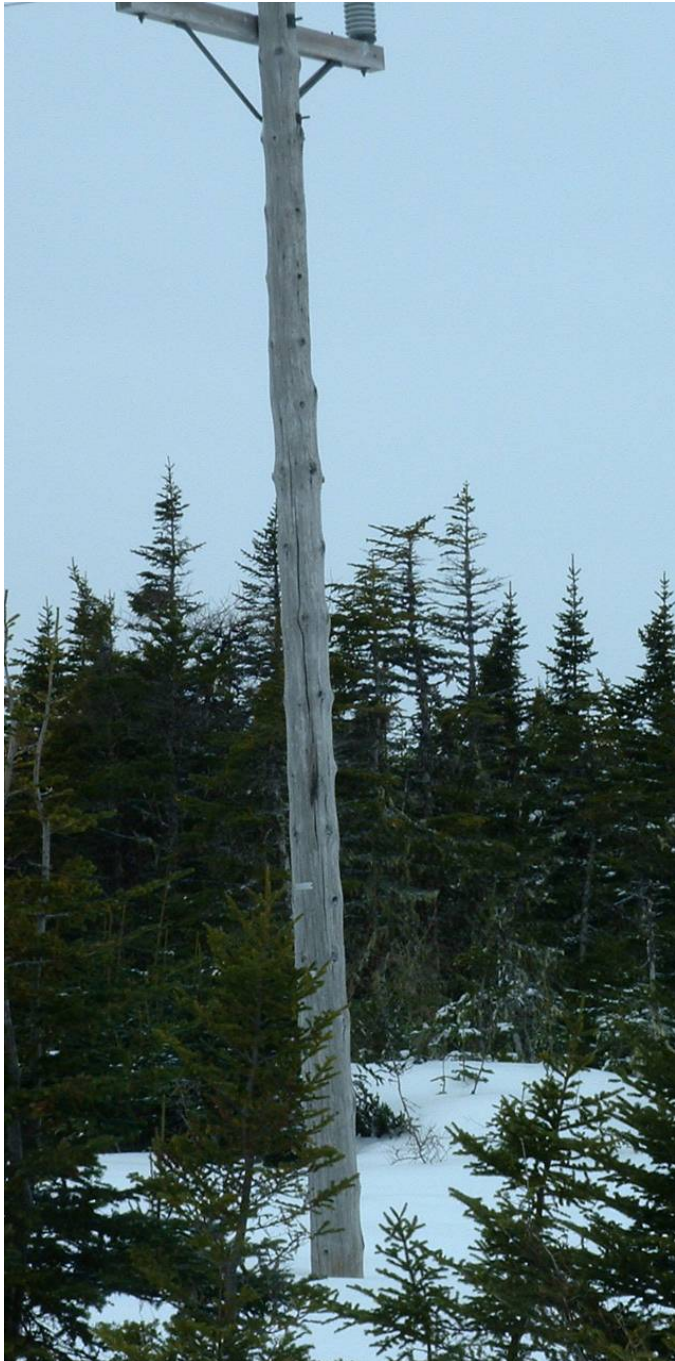
Many of the poles on this line are deteriorated and some are severely decayed. The guy wires are generally corroded and are nearing the point of failure.

Figure 5 - Deteriorated Pole 111L

A 13 kilometre section of this line was approved for reconstruction in the 2008 Capital Budget Application. Based on the overall deteriorated condition of the line, it is recommended that the remaining 17.7 km of the line be rebuilt in 2009. The estimated cost of this work is \$2,285,000.

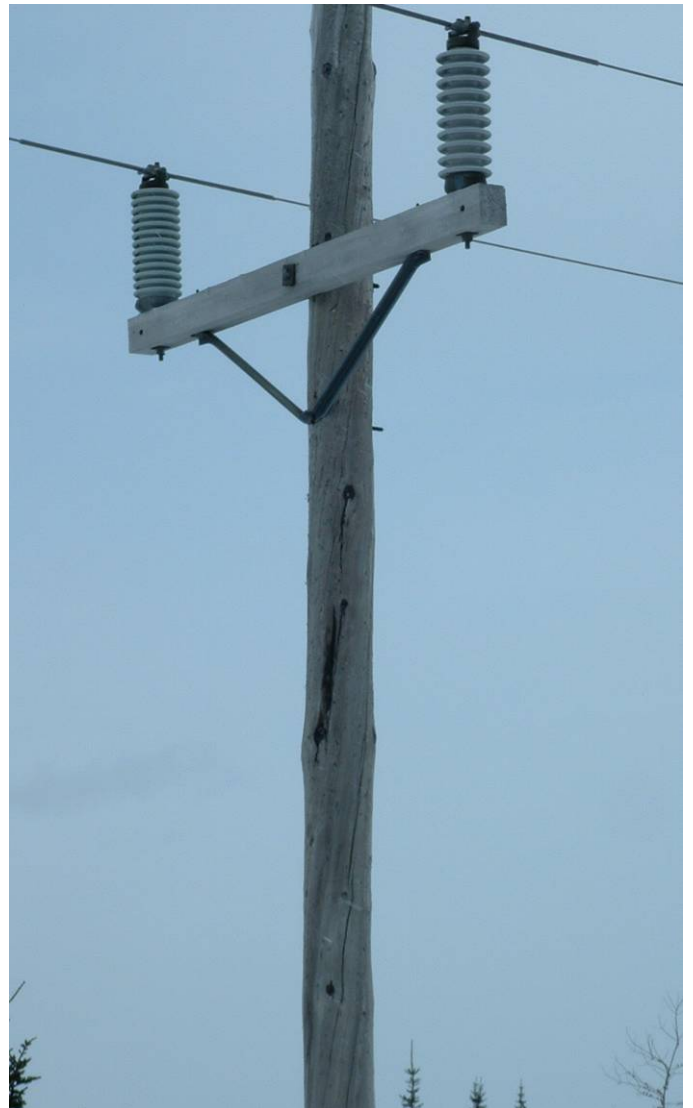
Figure 6 - Deteriorated Pole 111L

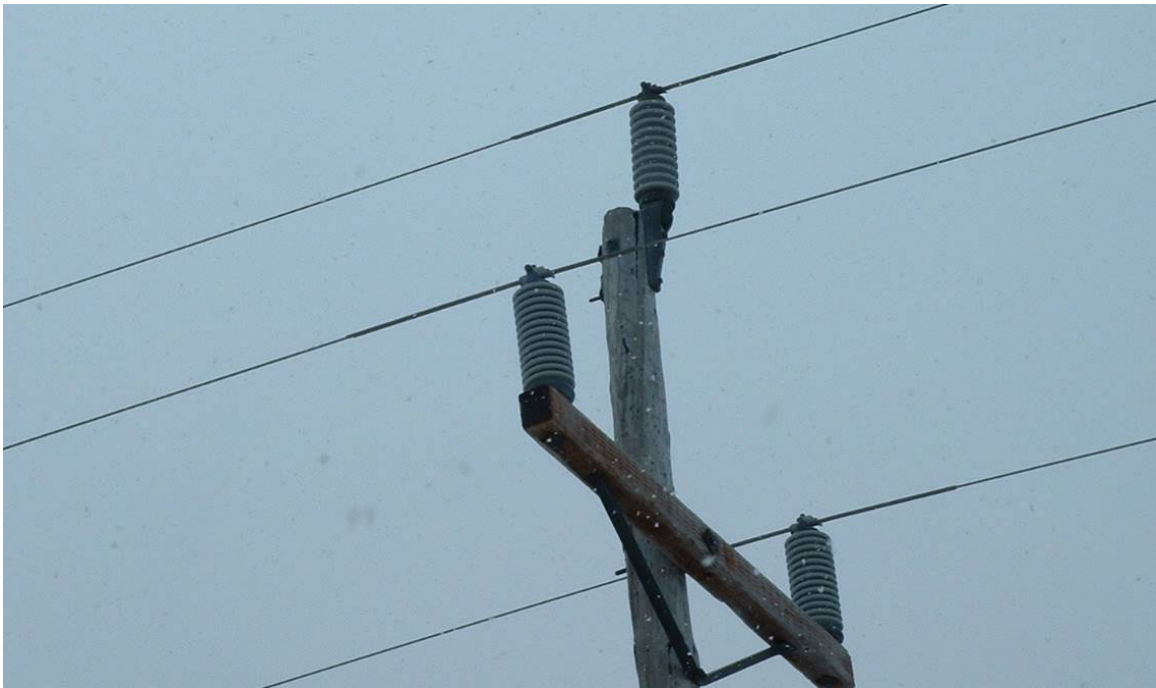
Figure 7 – Deteriorated Pole (Top Split) 111L

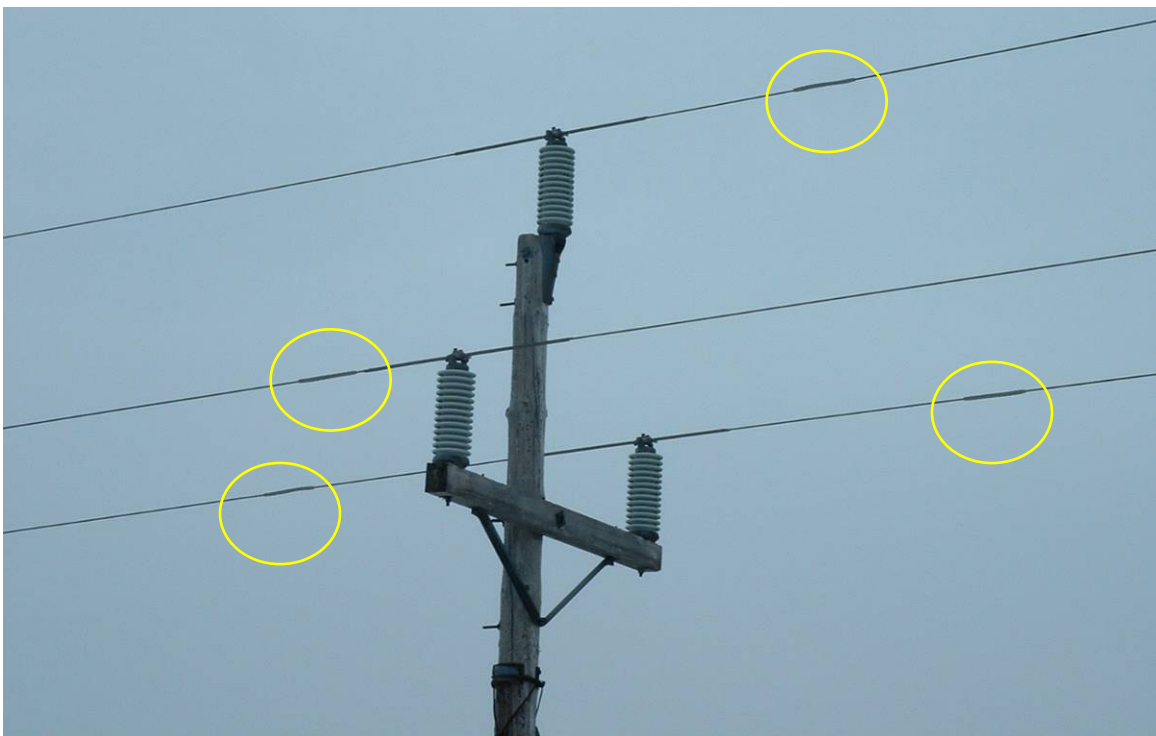
The non-standard conductor on this line is damaged in many places and its strands are broken in some locations. Over the years, many inline splices (sleeves) have been installed along the length of the conductor. These inline splices are evidence of repairs made after the conductor failed during various sleet storms in the area, most recently, during a severe ice storm in December 2007.

Figure 8 – Inline Splices Installed to Repair Conductor 111L

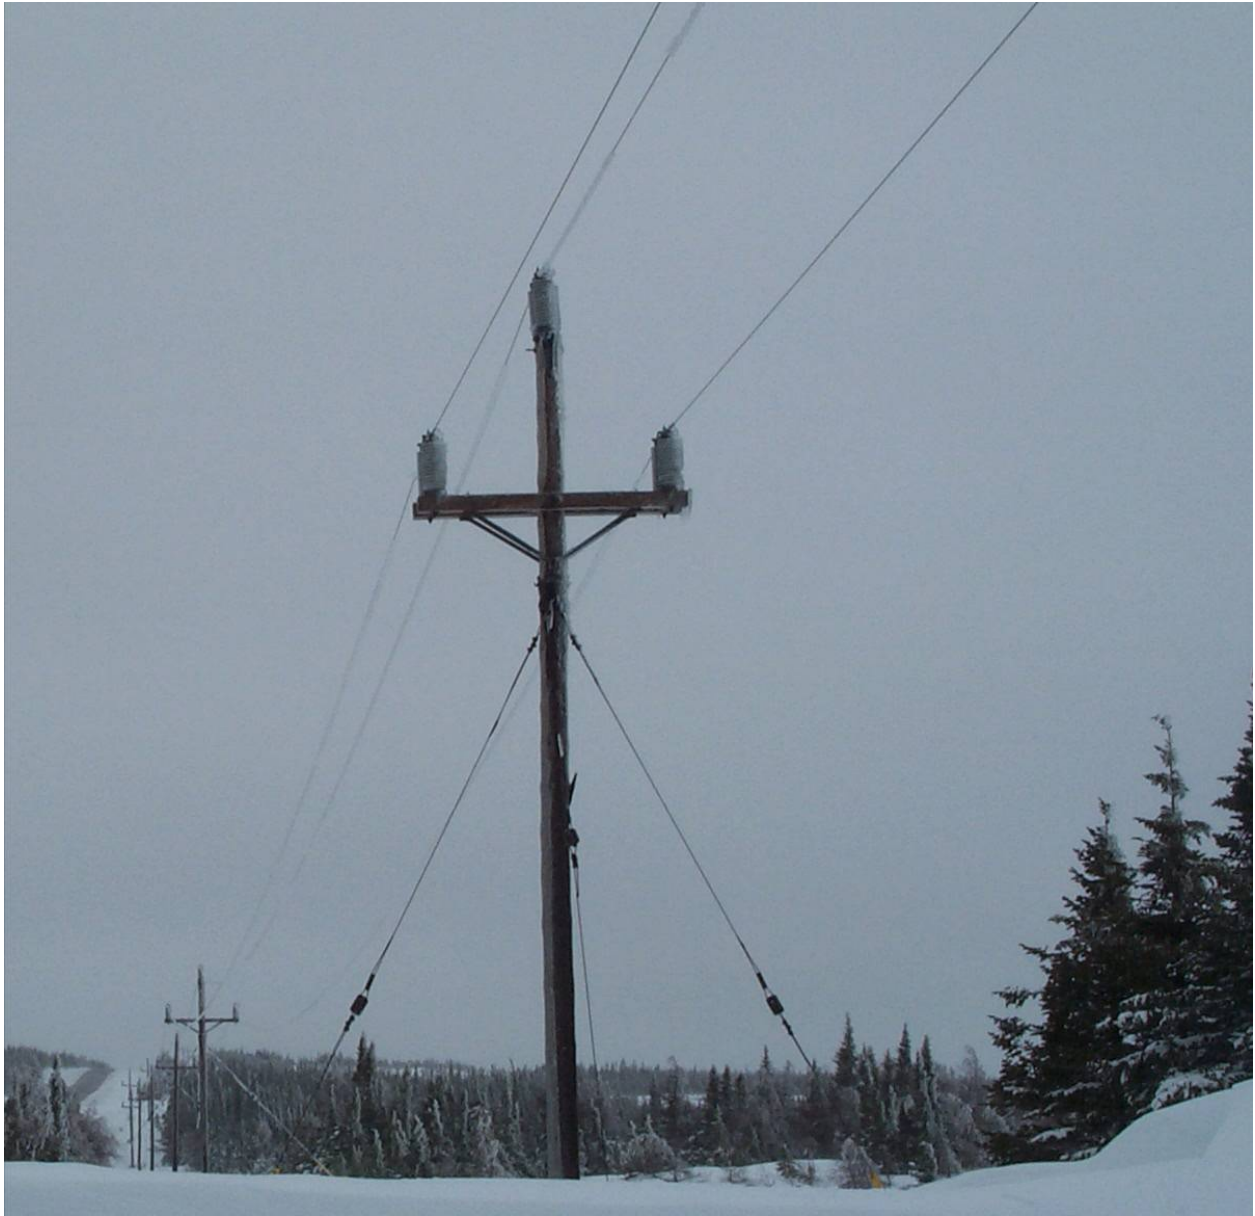
Figure 9 – Failed Guy Wire and Ice Loading on 111L

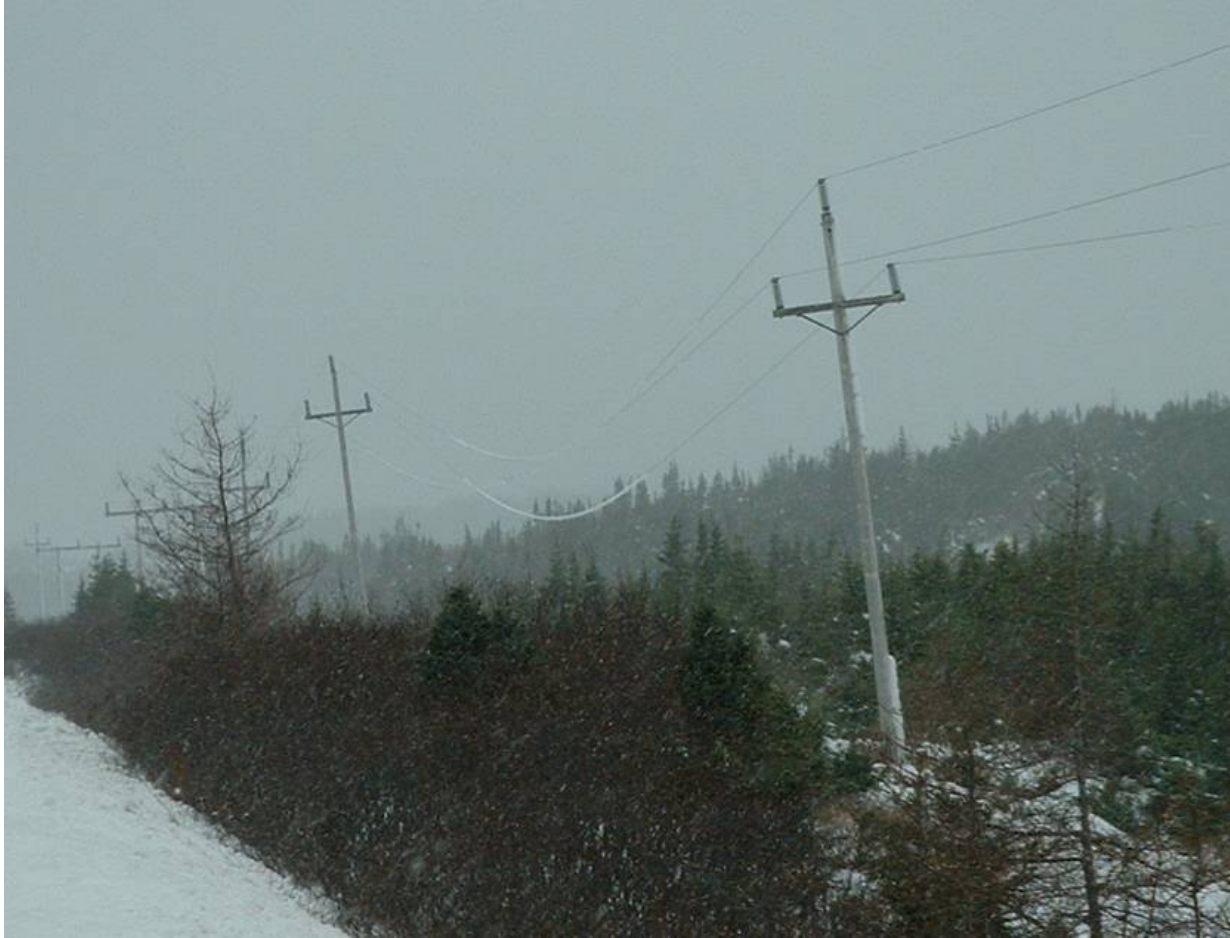
Figure 10 - 111L Ice Storm Damage December 2007

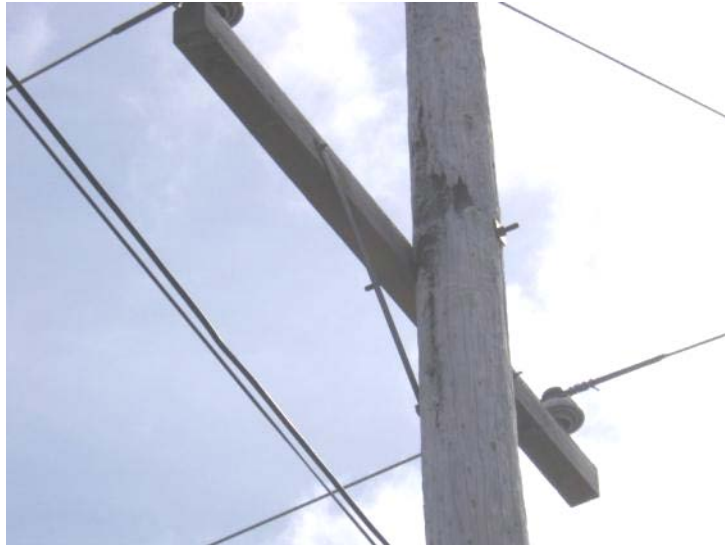
Burn Marks on Pole Caused by Flashover

Based on the overall deteriorated condition of the line, the associated safety and reliability concerns, and the energy efficiency benefits associated with this project, it is recommended that the line be rebuilt in 2010 at an estimated cost of \$826,000.

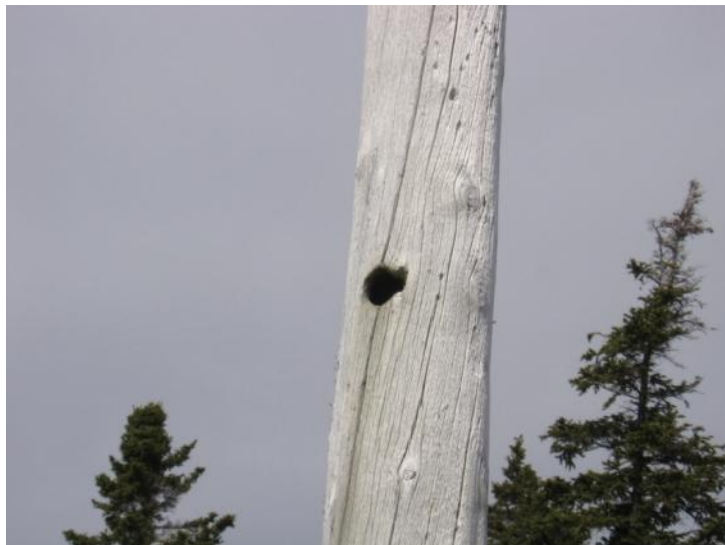
Inspections have identified deterioration to poles and crossarms due to decay, woodpecker holes, insect damage, splits and checks, as well as corrosion and wear to hardware. Many of these components are in advanced stages of deterioration and require replacement. A number of the wooden poles are original vintage (67 years old) and have surpassed their normal life expectancy.

Woodpecker Hole in Pole

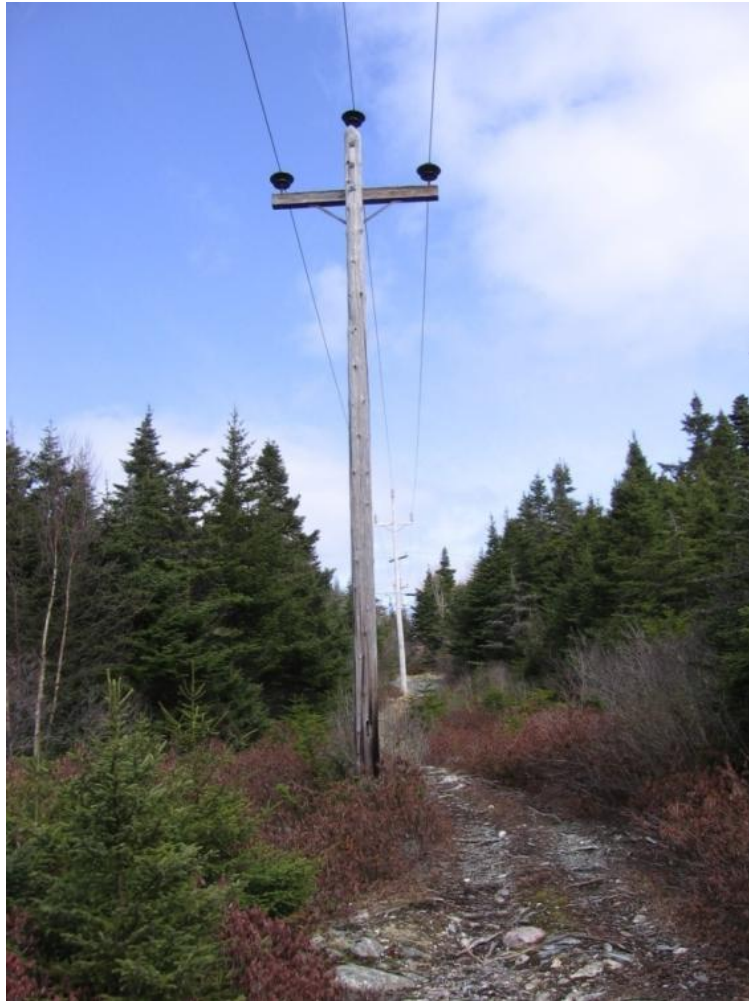
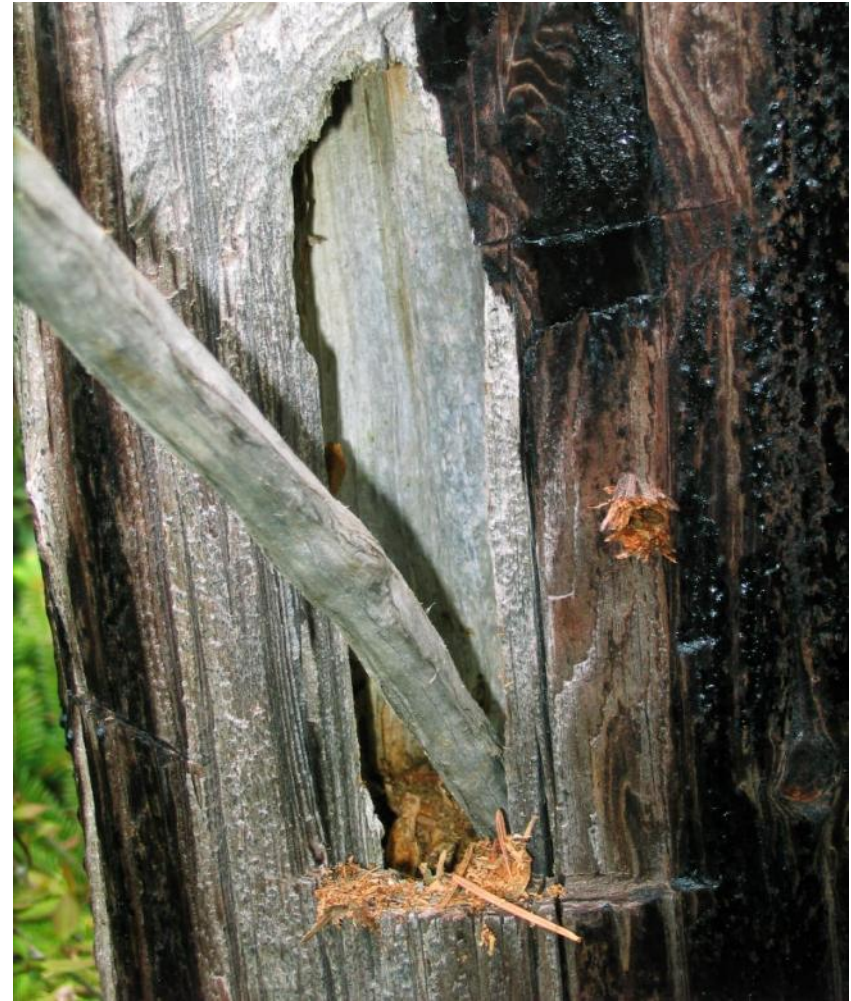
Hole and Rot in Pole

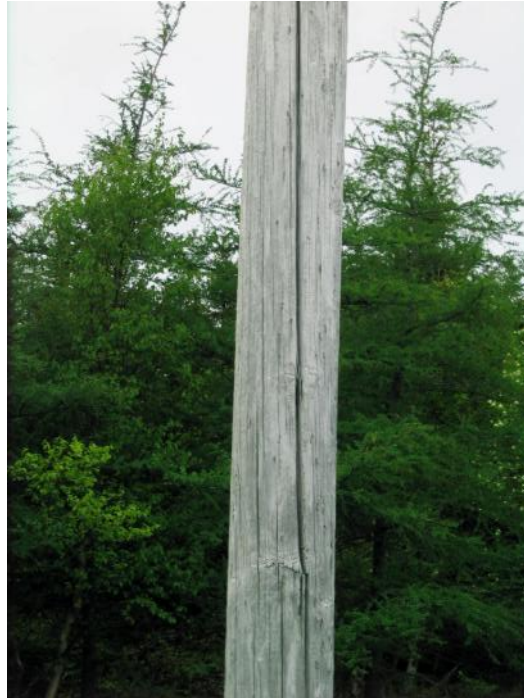
Inspections have identified deterioration due to decay, splits and checks in the poles and crossarms, and corrosion and wear to other hardware. Many of these components are in advanced stages of deterioration and require replacement.

Deteriorated Pole

Based on the overall condition of this section of 24L, it is recommended that the remaining 7.7 km be rebuilt in 2010 at an estimated cost of \$1,161,000.

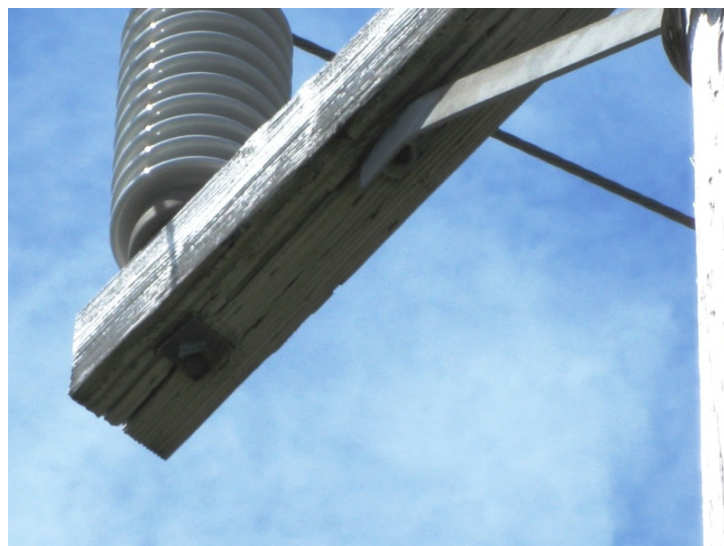
Deteriorated Crossarm

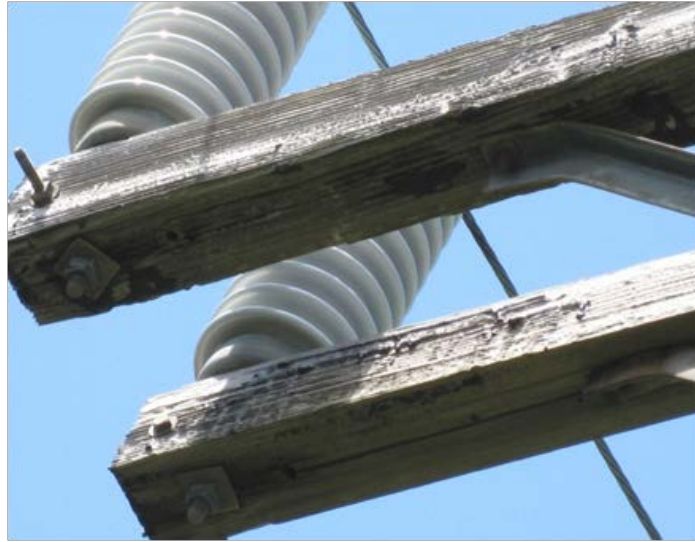
Deteriorated Crossarm

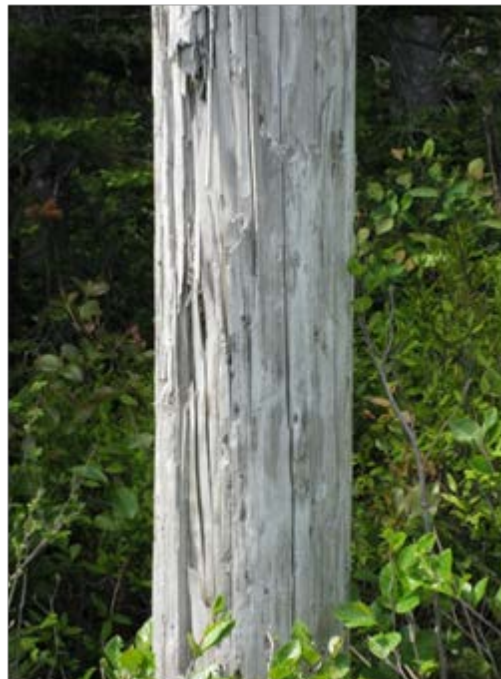
Deteriorated Pole

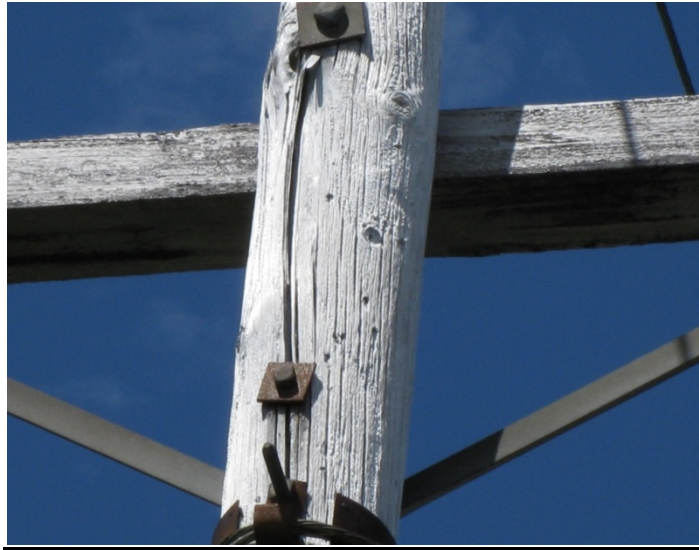
Pole Crack between Bolts

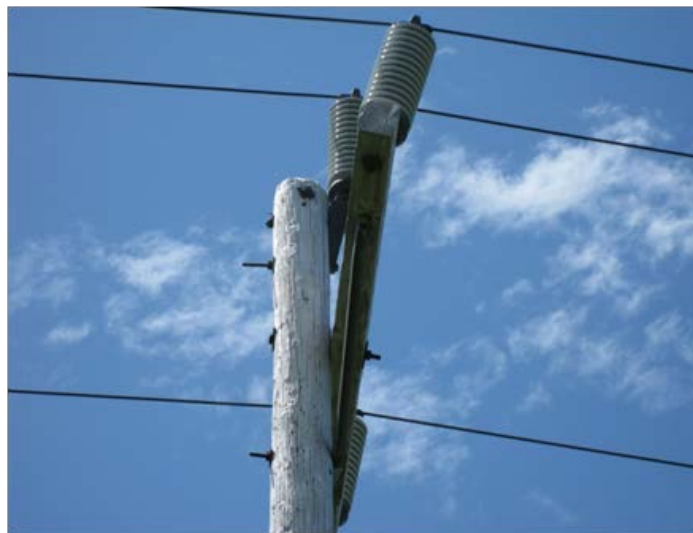
Leaning Insulator

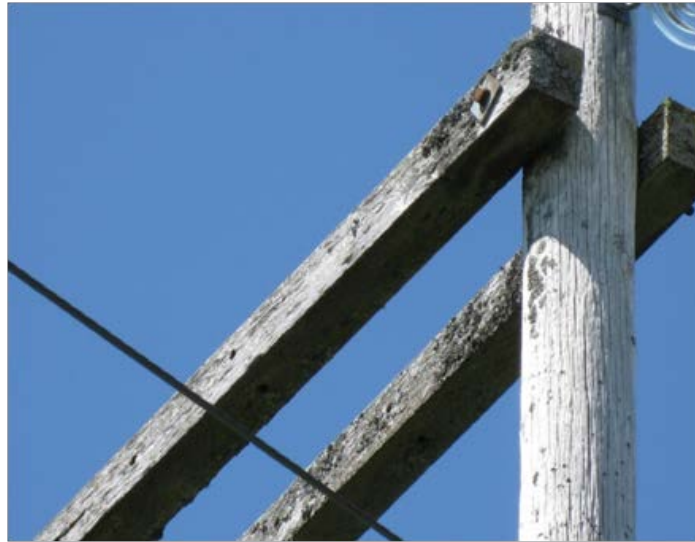
Deteriorated Crossarm

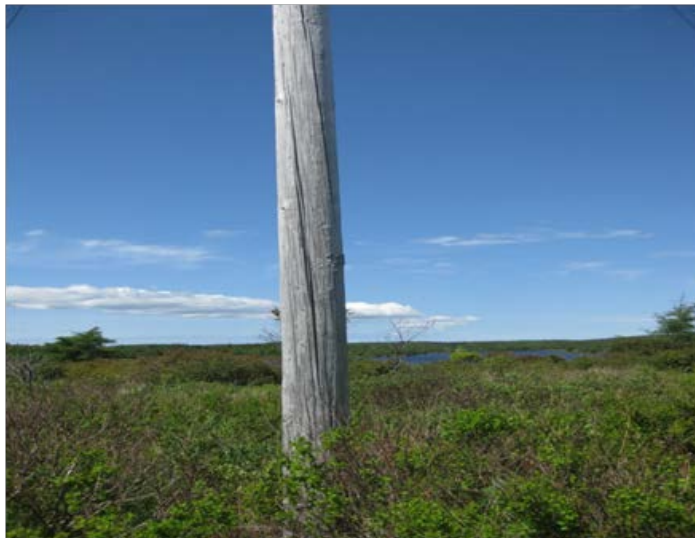
Split Pole

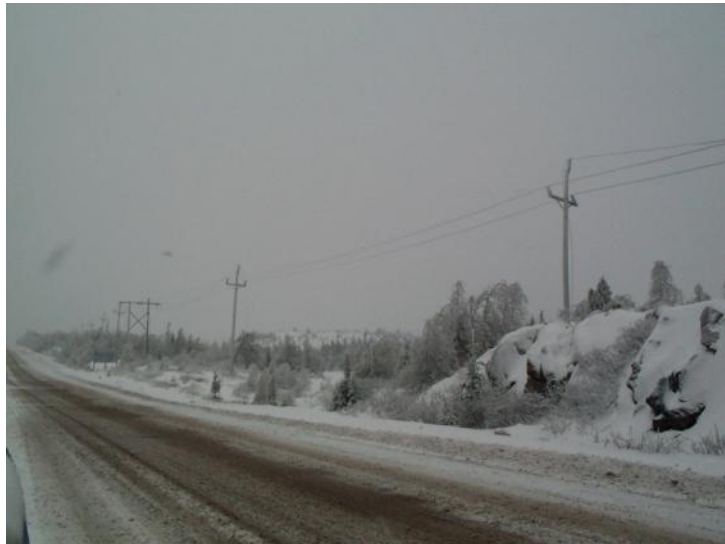
Since 2001, there have been several outages on this line due to wind and ice conditions which cause the conductors to slap together. This results in conductor damage and often conductor failure.

110L Ice Storm Damage December 2003

Based on the condition of the remaining sections of the line, it is recommended that another 14.5 km of 110L be rebuilt in 2010 at an estimated cost of \$2,178,000.

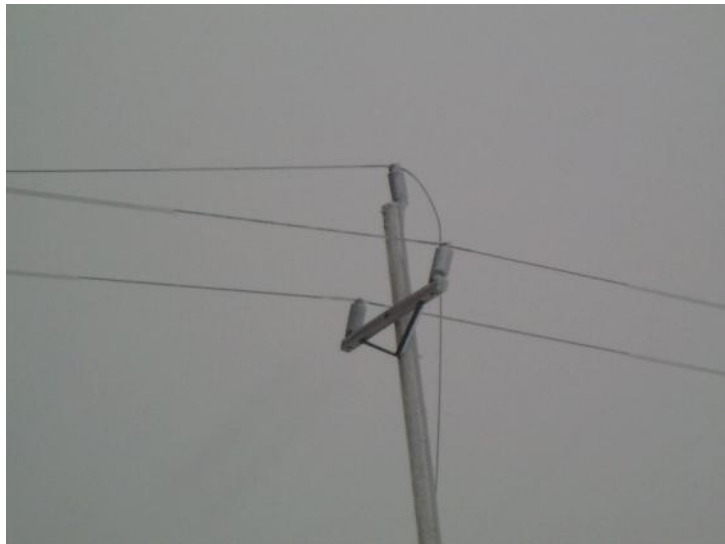
The conductor is damaged and deteriorated in many places and has been subjected to ice loading since its original installation. The steel core and the aluminum strands are corroded. This reduces the physical strength and the electrical capacity of the conductor. This deterioration is such that the line has been de-rated to about one-half of its original electrical current carrying capacity for safety reasons.

110L Broken Conductor - Ice Build Up December, 2003

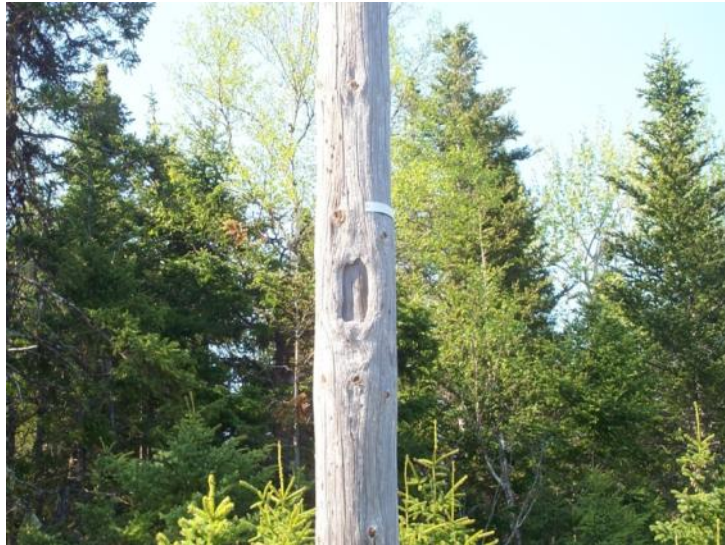
Deteriorated Pole 110L

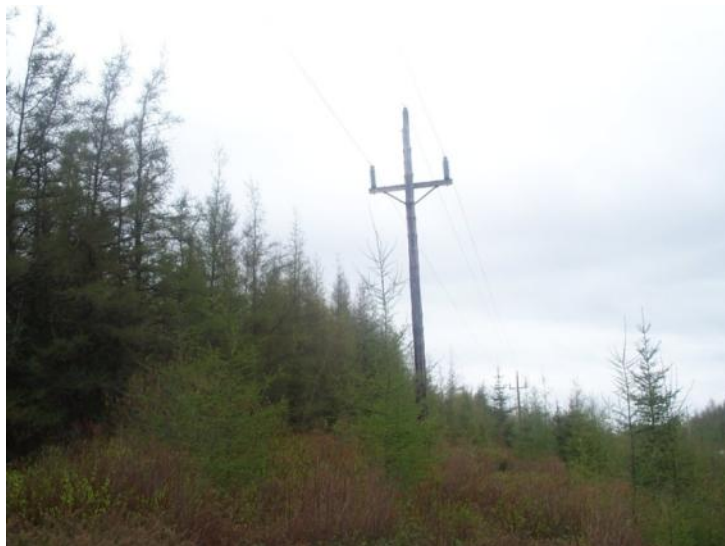
Deteriorated Pole 110L
