Re: Application for approval of a capital expenditure supplemental to Newfoundland Power Inc.'s (the "Company") 2014 Capital Budget

Table of Contents

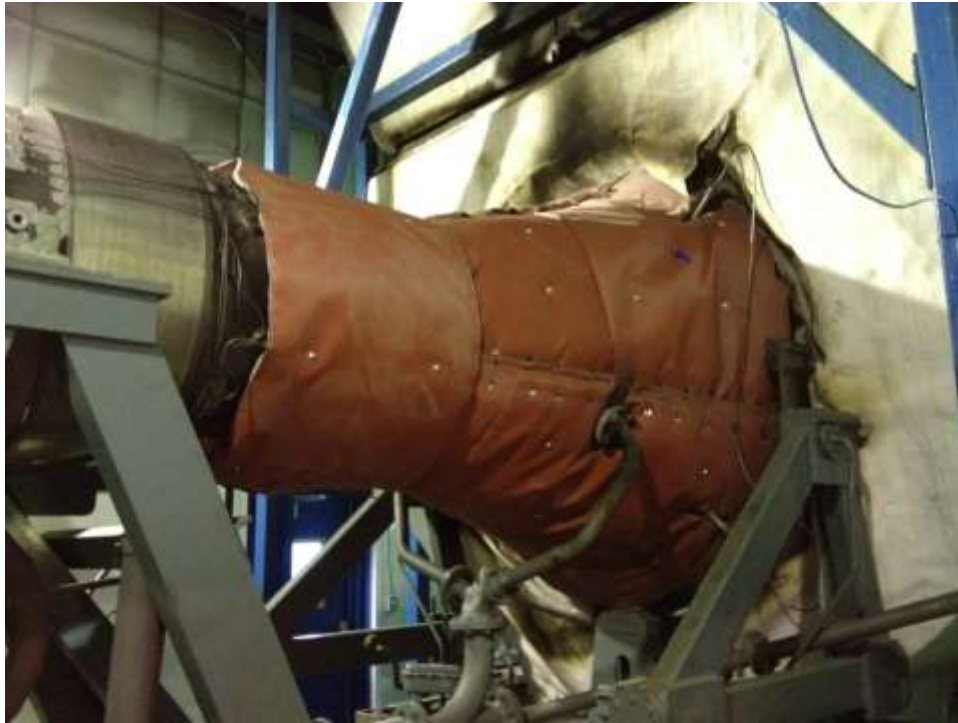
The power turbine inspection identified several cracks in the shrouds on the power turbine inlet duct. The power turbine inlet duct will have to be removed and weld-repaired. The power turbine insulating blankets require replacement as the cloth and refractory is broken away in several locations.¹⁷

Figure 1 – Power Turbine Exterior View

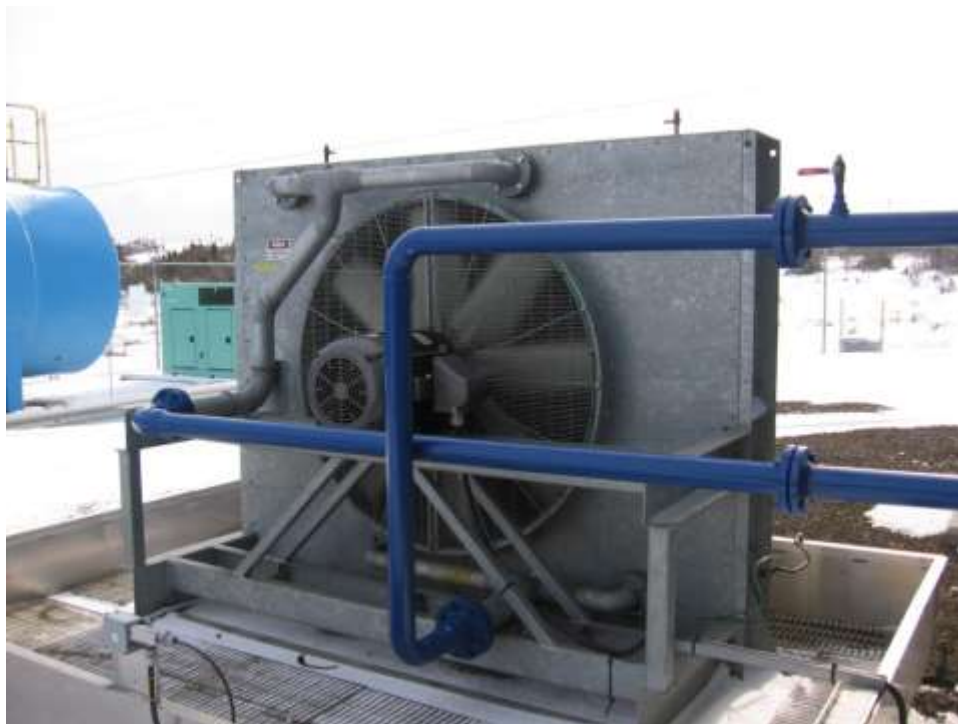
On January 5th, 2014 the lubricating oil cooler developed leaks in the junction between the core and the expansion tanks. Repairs were completed and the cooler returned to service on January 22nd, 2014. Since the cooler was returned to service, other leaks have developed. On that basis, it has been determined that the cooler must be replaced.

Figure 2 – Lubricating Oil Cooler

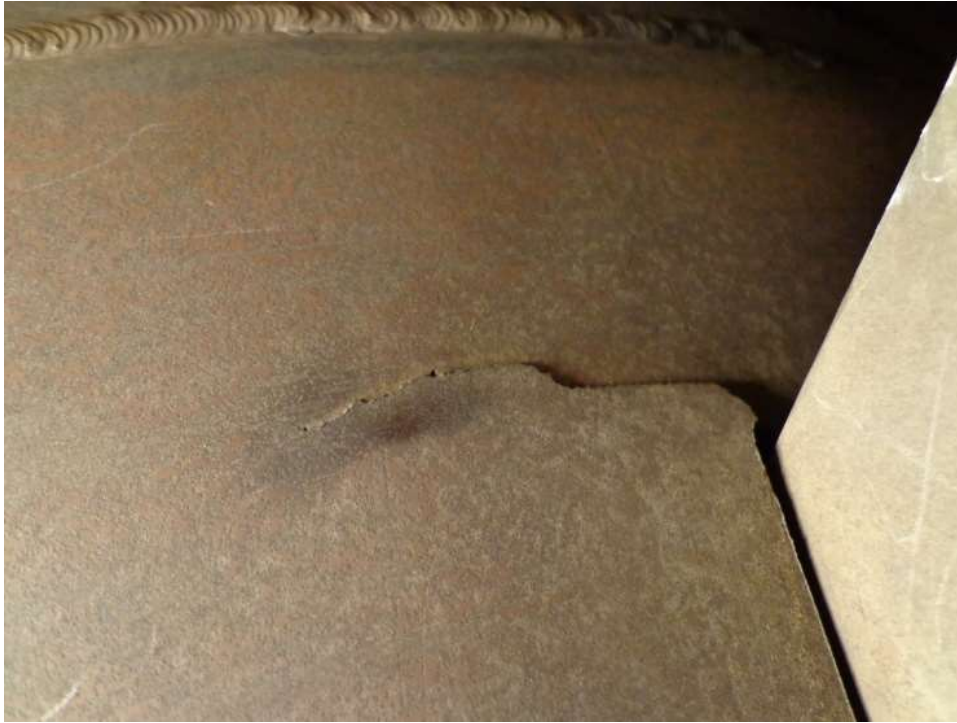
Figure 3 – Crack in Power Turbine Inlet Duct

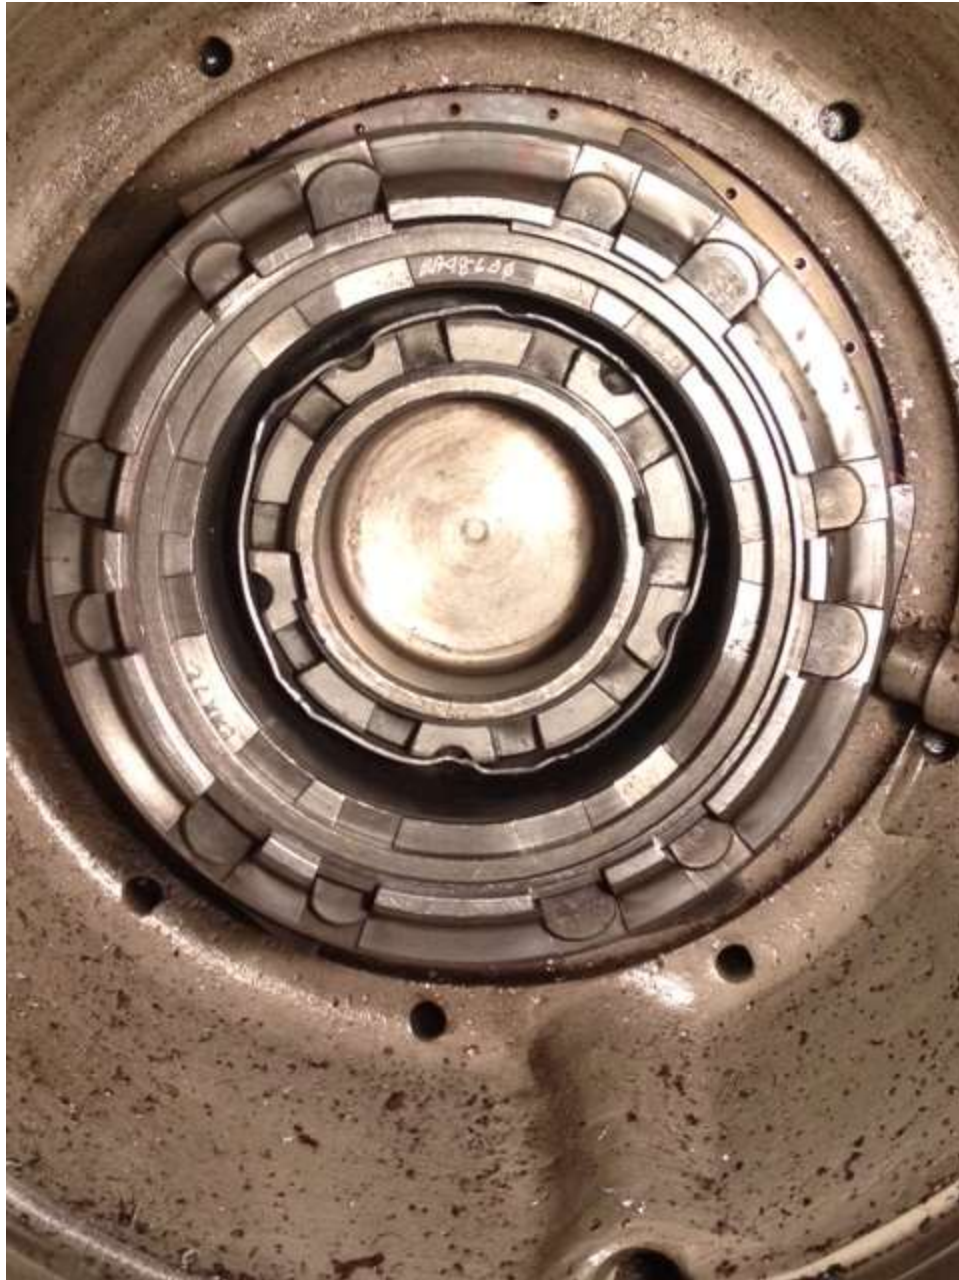
Figure 4 – Damaged Front Bearing

Is that the Avon gas turbine has suffered a catastrophic main line front bearing, causing the compressor to seize. The exact cause at this time is unknown and a detail strip of the gas turbine will need to be carried out within the Alba Power facility to determine the cause.

To remove the failed Avon gas turbine 37116 and ship to the Alba Power facility for a bulk strip, detailed strip, and an investigation as to the cause for the front bearing to fail. At this time Alba Power would strongly recommend a full overhaul of all coatings on blades, stators and turbine sections. Also to inspect the entire gas turbine concentrating on the compressor discs and pin locations as there is extensive wear noted, also on the turbine blades and discs. For the package the entire off gas turbine oil system will need to be removed and flushed out eradicating any possible chance of contaminants getting back into the gas turbine when the reinstatement and commissioning is carried out, this is a standard practice when there is any bearing failure. Alba Power can assist with the removal and shipment of the gas turbine.

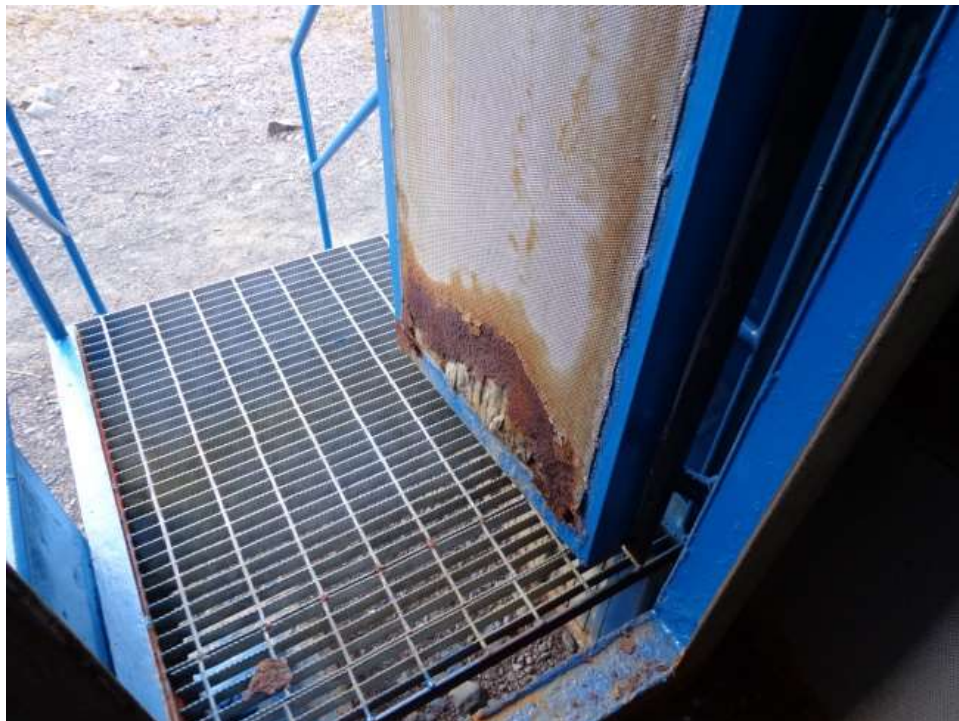
The building enclosure is original to the 1975 installation and has deteriorated from 40 years of normal use and exposure to the elements. The intake plenum door and frame need to be replaced. Some of the welds inside the intake plenum have cracked and need to be repaired.

Figure 2 – Corrosion Damage Intake Plenum Door

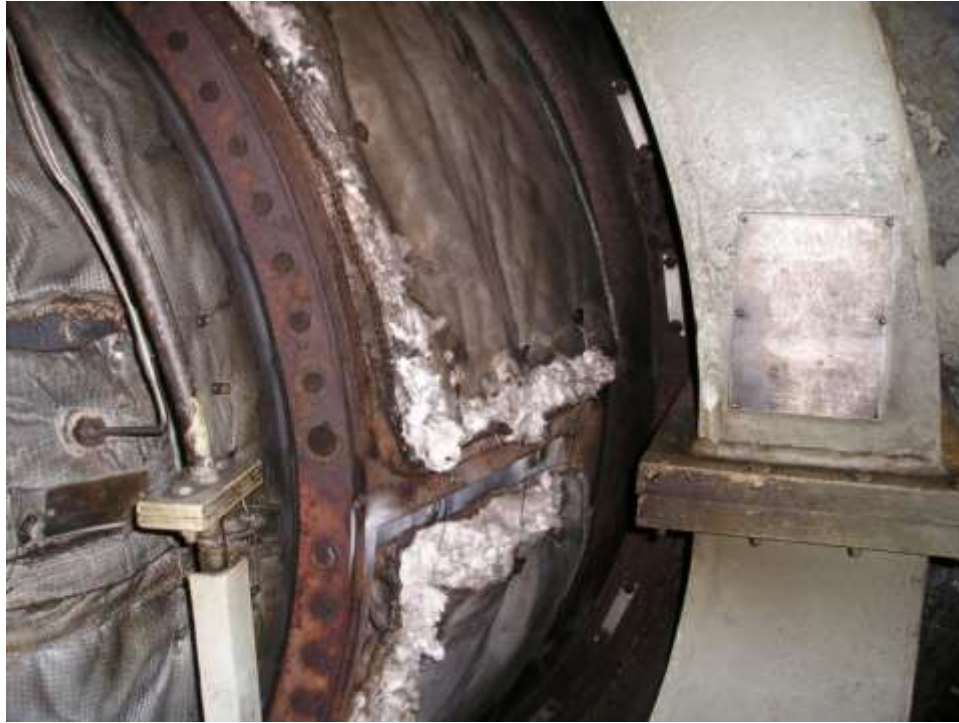
The power turbine insulating blankets require replacement as the cloth and refractory is broken away in several locations.

Figure 3 – Insulating Blanket Damage

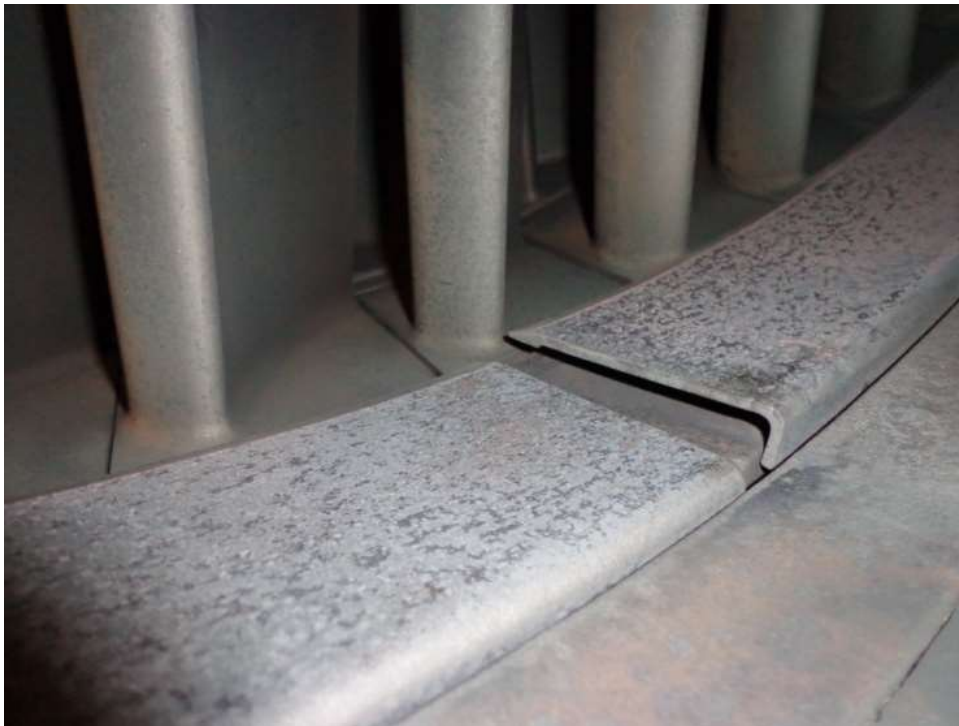
The power turbine inspection identified issues with the labyrinth seal and the inlet housing rear outer flange retaining ring. The front labyrinth seal clearance is outside the recommended tolerance and there is some material loss at the 6 o'clock position. The clearance needs to be re-established.¹⁸ The power turbine inlet housing rear outer flange retaining ring has suffered some heat distortion and has migrated into the hot gas path. To avoid further deterioration, oil leaks and failure of the seal, the inlet housing shroud that includes the retaining ring should be replaced.

Figure 4 – Retaining Ring Distortion

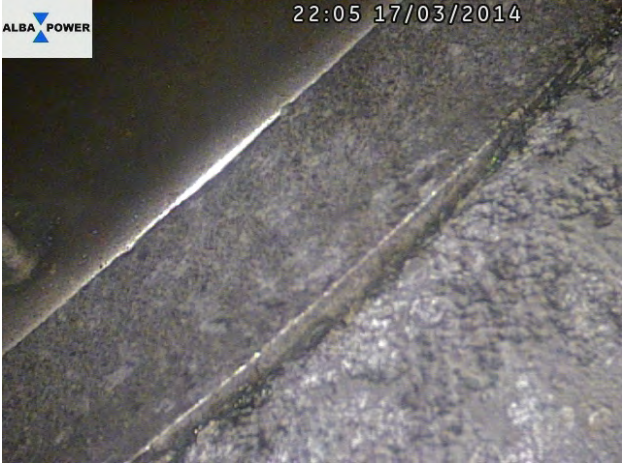
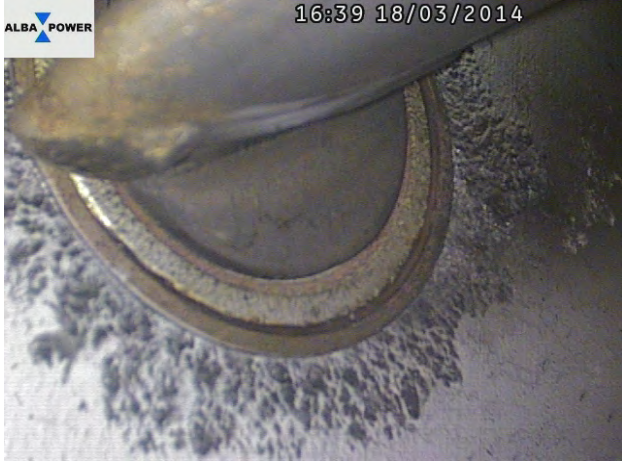
The front bearing housing is very pitted and heavily corroded especially around the VIGV bushes. The fuel nozzles were then removed from numbers 2 and 7 positions to inspect the combustion chamber areas and also the stage 15 compressor blades; and then the turbine section looking for any damage.

Air intake housing (Corrosion)	VIGV bush location (Corrosion)

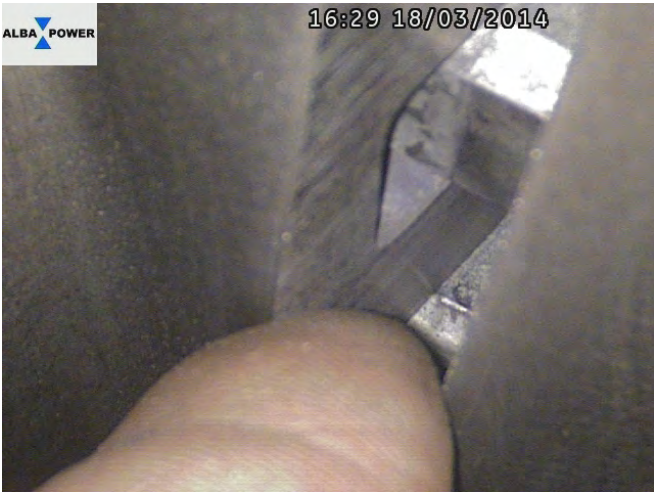
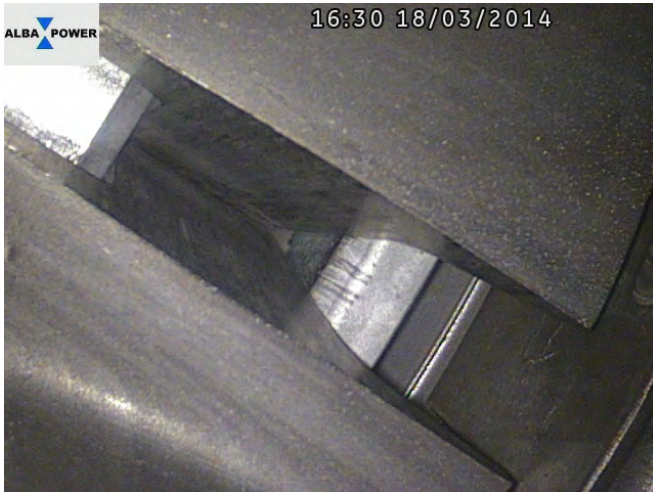
Stage 00 blades (worn)	Stage 00 blades (worn)

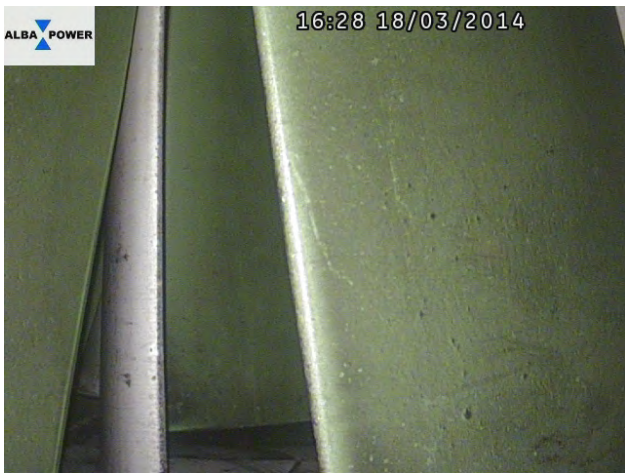
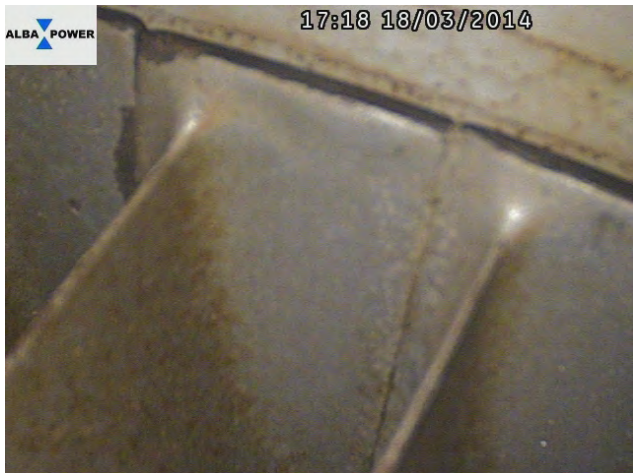
<p>17:18 18/03/2014</p>
Coating degradation	Corrosion on stage 15 stators

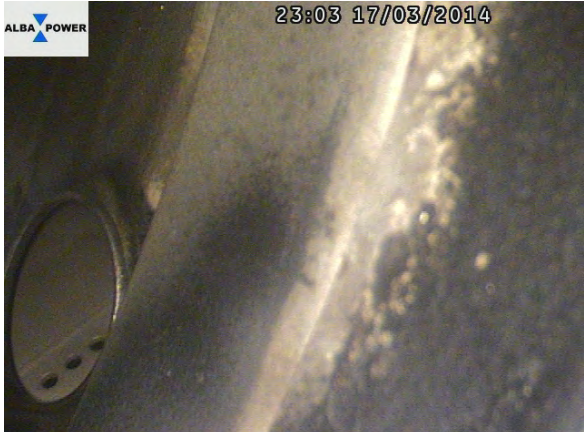
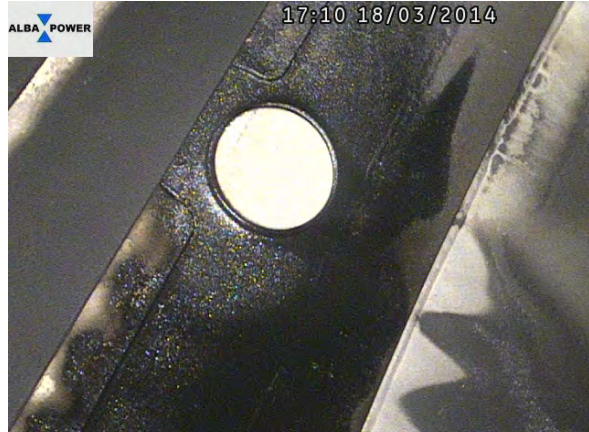
<p>17:10 18/03/2014</p>
Carbon build up on combustion chamber	Carbon build up on combustion chamber

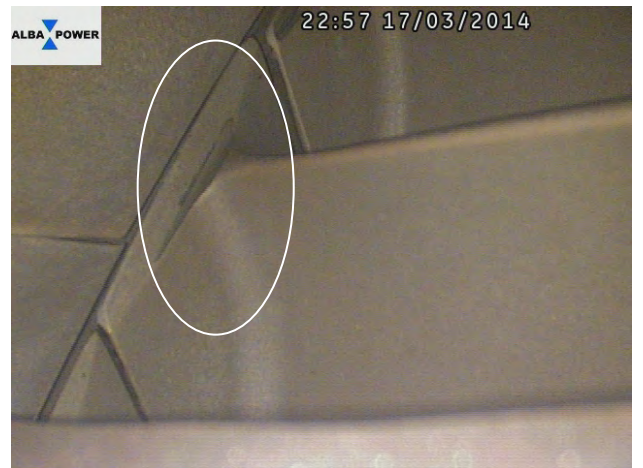
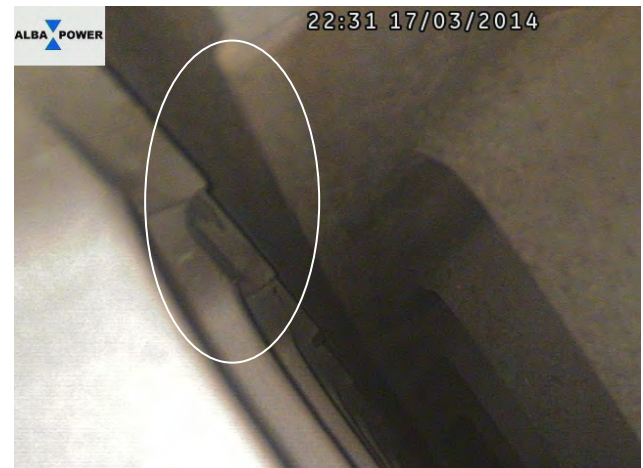
<p>22:31 17/03/2014</p>
Rub on HP turbine blade	Rub on HP turbine blade

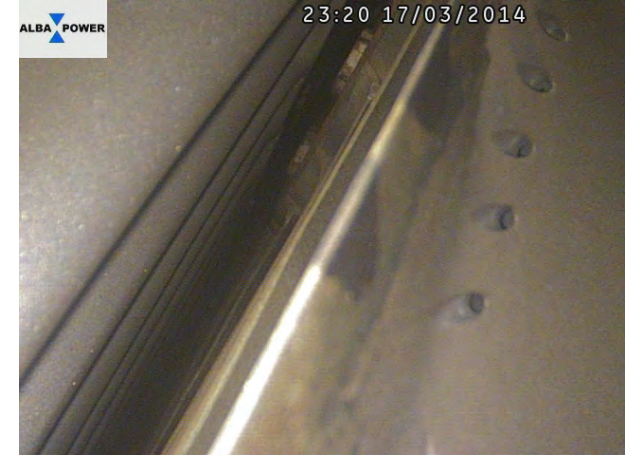
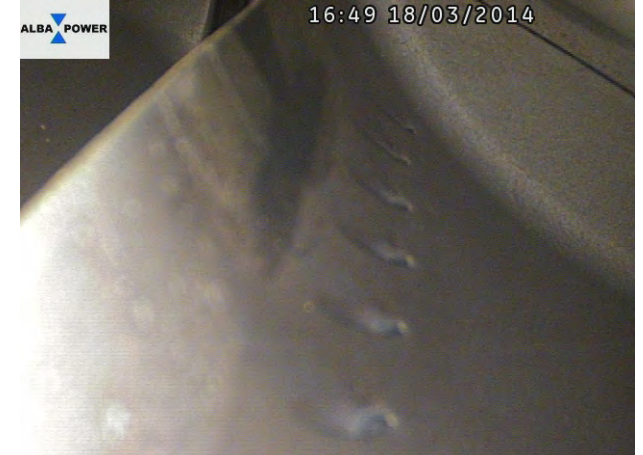
<p>16:49 18/03/2014</p>
LP NGV (old repair)	LP NGV (old repair)

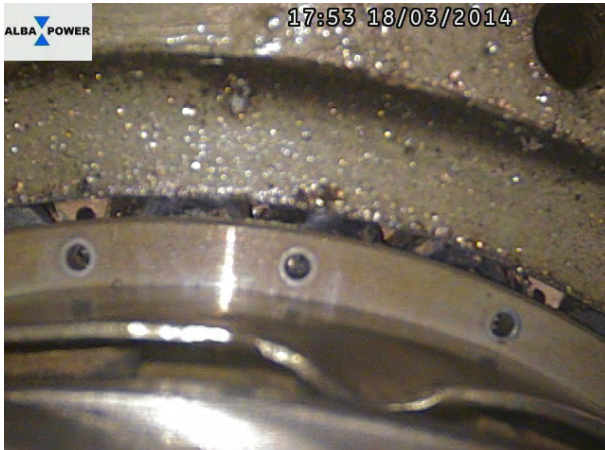
<p>17:53 18/03/2014</p>	  <p>17:54 18/03/2014</p>
<p>Front bearing failure</p>	<p>Front bearing failure</p>

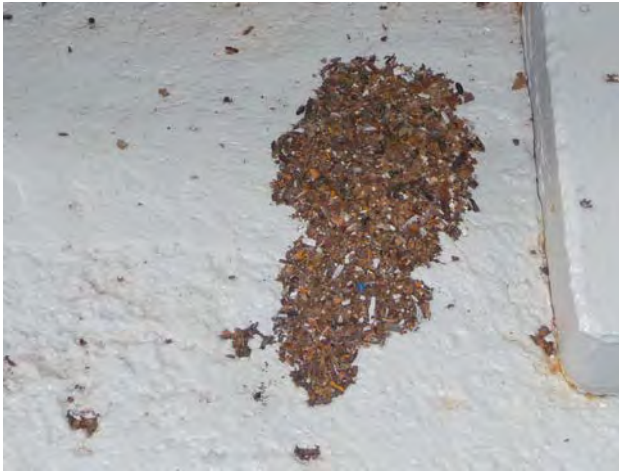
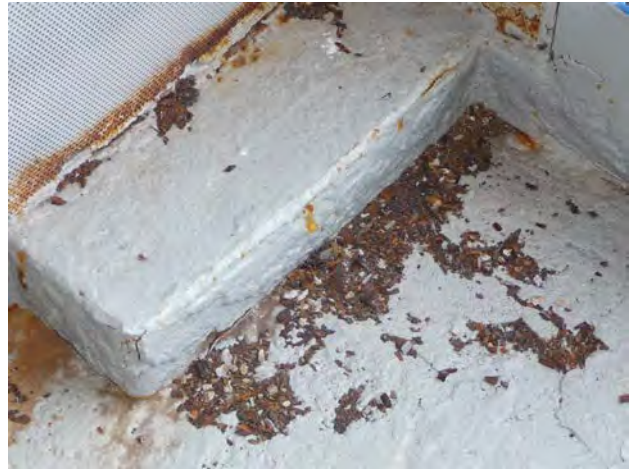
The intake plenum had a lot of rust debris in the corners; also the walls within the plenum chamber need repairing to stop the rust from falling.

Air intake plenum (rust debris)

The intake plenum needs work to eradicate the problem of rust falling from the walls which could be ingested into the gas turbine.

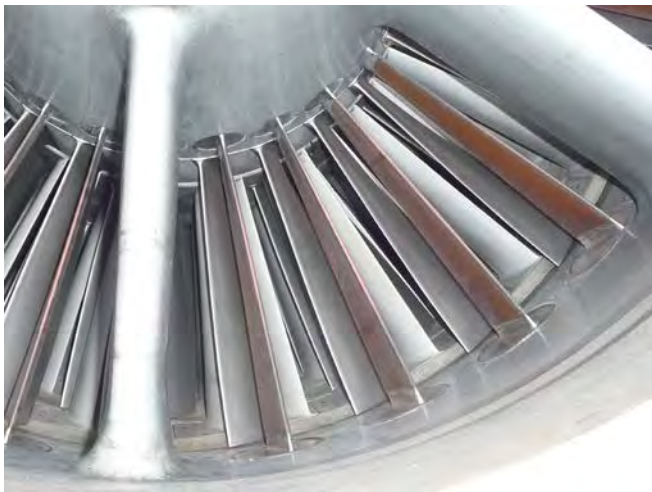
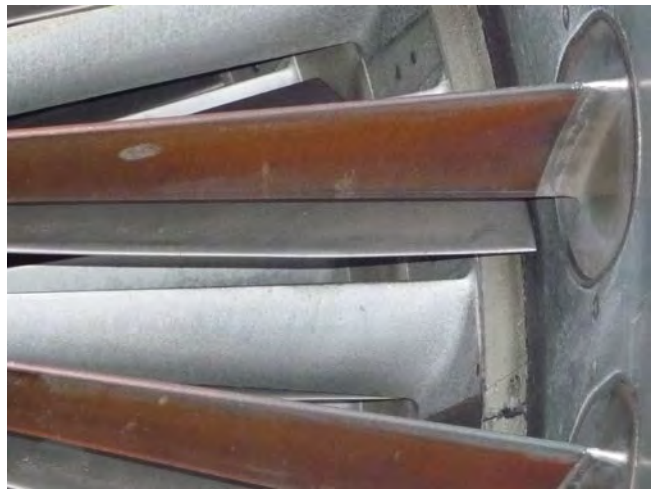
The air intake casing has coating loss on the struts leaving it exposed to the elements and salt air, IGV's and the compressor section are in a clean condition although with coating loss on the stators. The internal starter drive, and fuel pump bearings were found to be in a satisfactory condition, the HP compressor and stators are showing some signs of corrosion at this time, number 1&2 intermediate casing vane covers were removed to inspect the number seven bearing housing section. This was found to be in a good clean condition, all oil feed and scavenge pipes were also in a good clean order.

Air intake casing

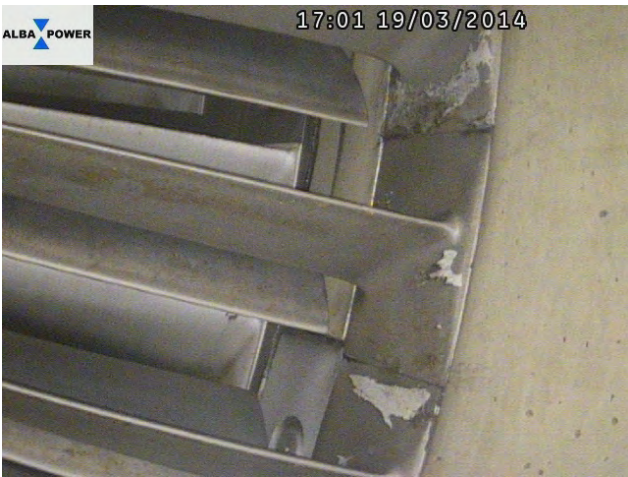
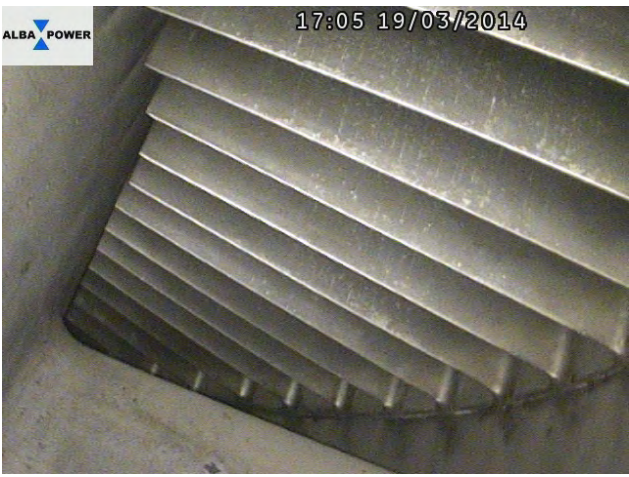
<p>17:05 19/03/2014</p>
<p>Coating degradation on LP stators</p>	<p>Coating loss on the leading edge LP stators</p>

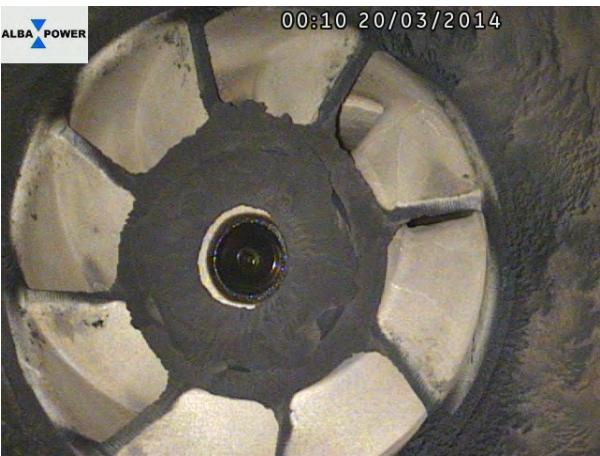
The fuel nozzles were removed to gain access to the turbine section, the combustion chambers were all showing carbon build up, but more importantly the chambers all look to be suffering from corrosion due to the length of time that they have been in service. It also looks like as some of the hard face coating on the air intake snouts is breaking up; images to follow in later section.

<p>00:10 20/03/2014</p>	  <p>20:43 19/03/2014</p>
<p>Carbon build up combustion chamber</p>	<p>Carbon build up combustion chamber</p>

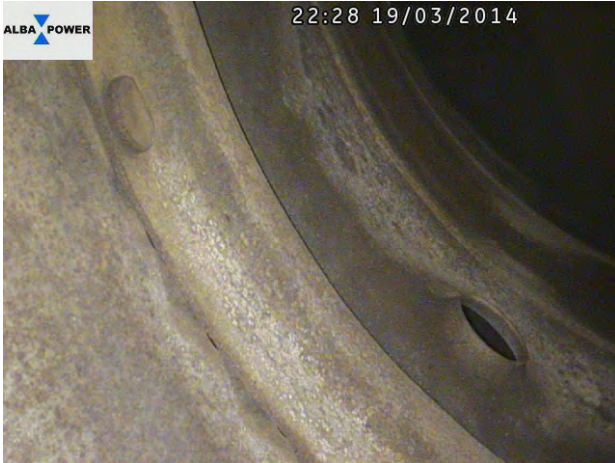
<p>22:28 19/03/2014</p>	  <p>00:11 20/03/2014</p>
<p>Combustion chamber corrosion</p>	<p>Combustion chamber corrosion</p>

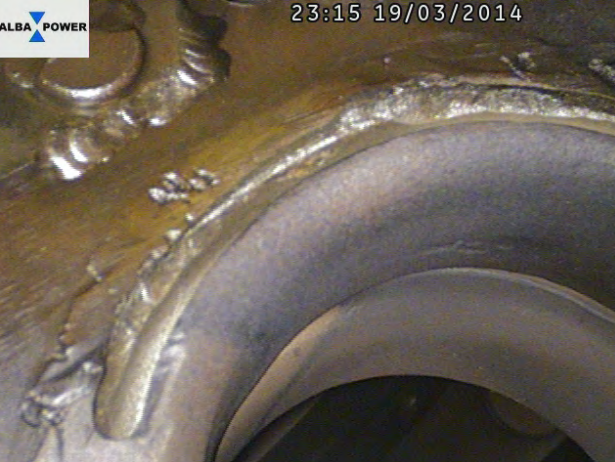
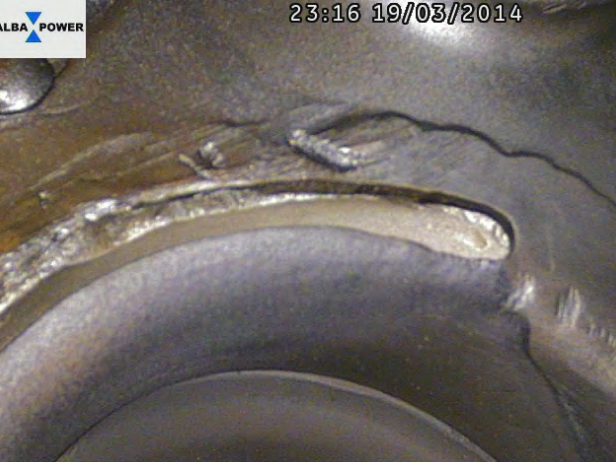
<p>23:16 19/03/2014</p>
<p>Old repair on No.5 combustion chamber</p>	<p>Old repair on No.5 interconnector</p>
  <p>23:17 19/03/2014</p>

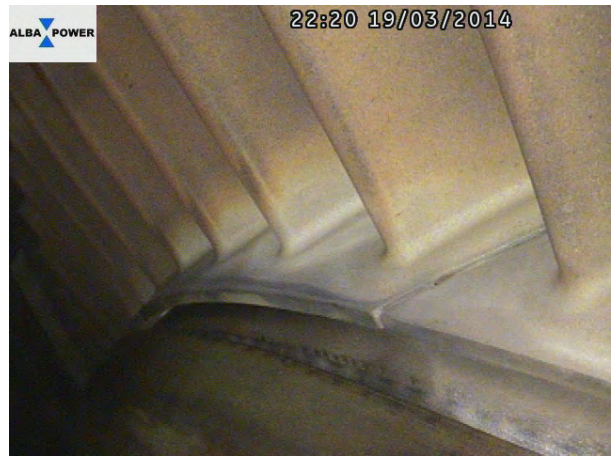
Continued the borescope inspection of the turbine section of the gas turbine. It was noted that the HP NGV's have total coating loss and the leading edges are showing signs of degradation. There was a blade pass carried out on the HP turbine blades and these were found to be in a serviceable condition. The LP NGV's have coating loss but at this time are also in a serviceable condition. A blade pass was carried out on the LP turbine blades and these are also in a serviceable condition.

<p>22:20 19/03/2014</p>
<p>Leading edge HP NGV</p>	<p>Leading edge HP NGV</p>

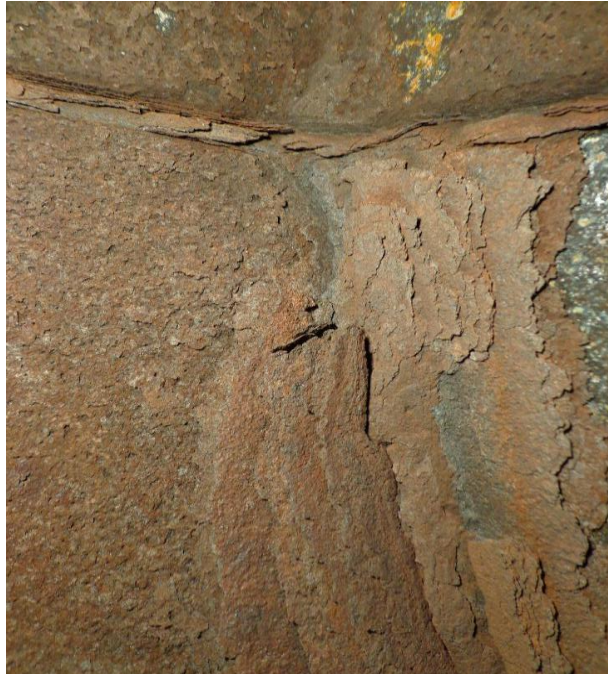
Exhaust Volute internals are in good condition with only surface corrosion being noted. The welded seams exhibited the heaviest corrosion and, although there was no cracking noted as being present, the corrosion may have weakened these areas and monitoring is recommended. There was no evidence of pooled fluids in the bottom of the volute.

Overall condition of the Exhaust System was good. See Fig 1 in appendices.

Fig 1 Corrosion in exhaust system.

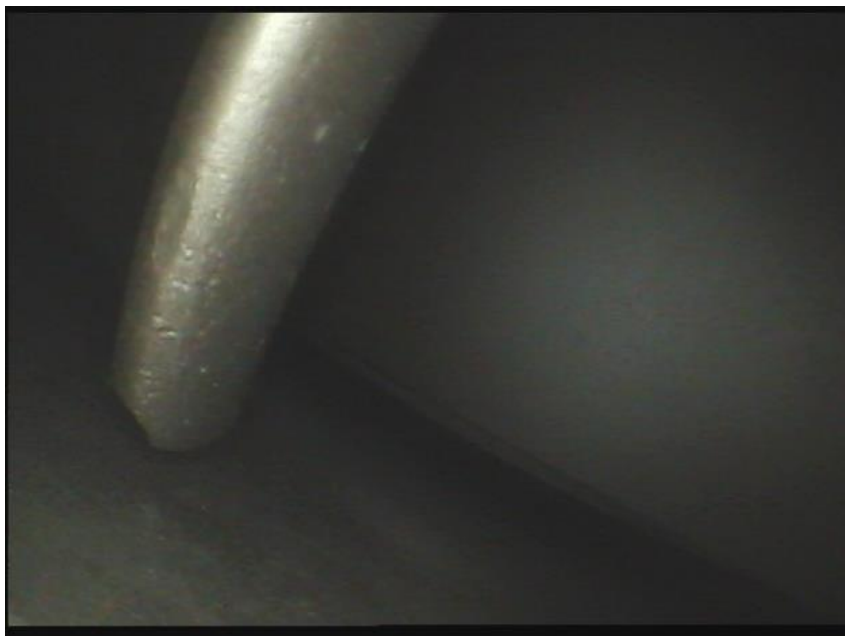
There were no signs of cracking to the blading however foreign object damage to the rotor and stator blades was evident. Due to the physical location, and access limitations, it is difficult to assess the full extent of the damage to the blading.

The rotor disc exhibits heavy pitting around the blade root areas and is assumed to be the condition of the disc faces. During operation disc/blade roots operate under high stress and pitting/corrosion in this area increases the risk of cracking. See recommendations and Fig 2/Fig 3 in appendices.

Fig 2 Blade impact damage and pitting

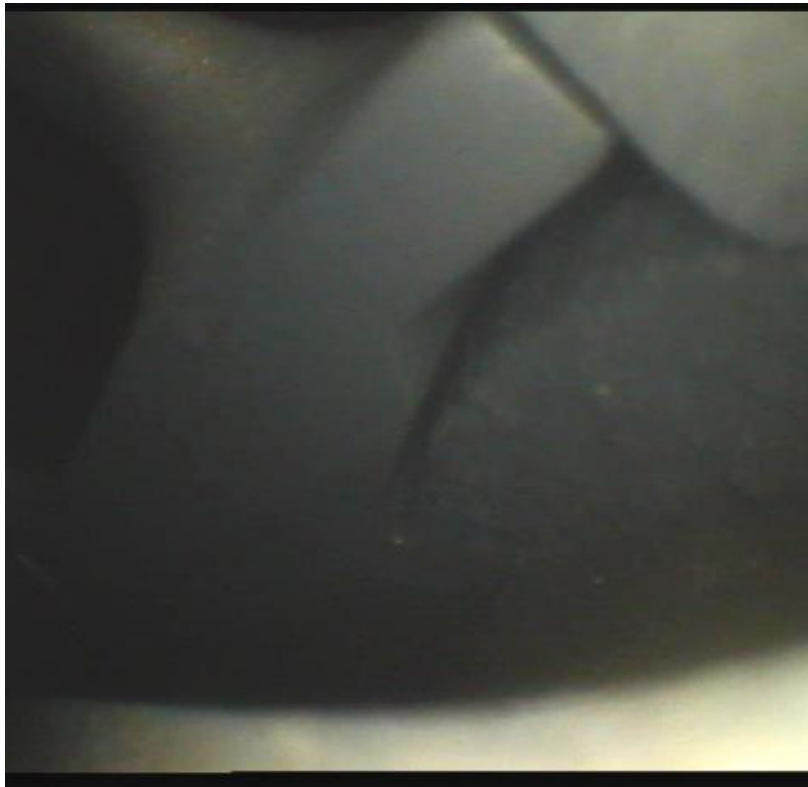
Fig 3 Blade and disc pitting at roots.

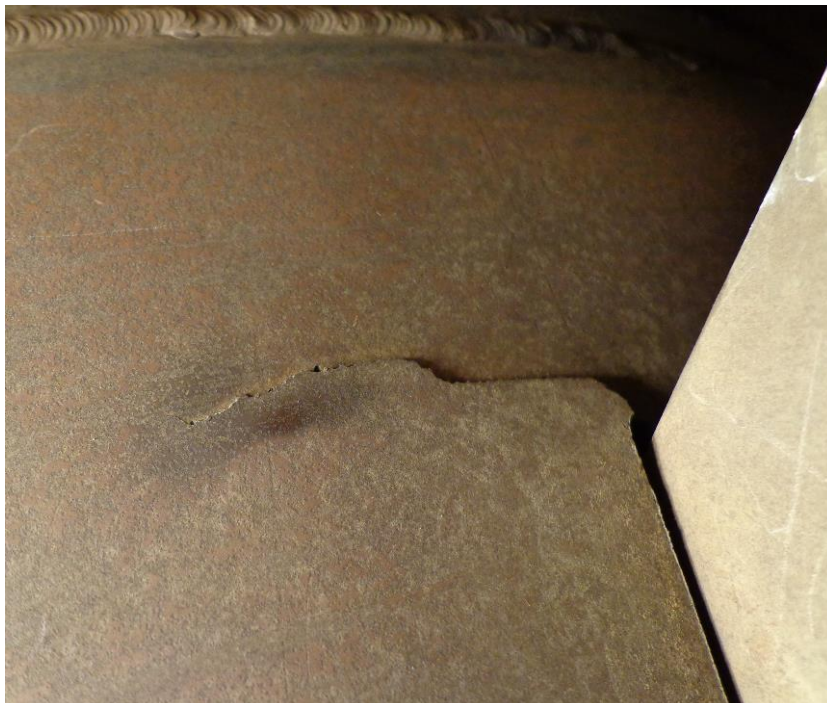
The transition piece, outer ring and outer duct were in a good condition however the inner duct (cone) has five cracks at the downstream side of where the support struts pass through the inner duct. These cracks varied between 1"- 3" in length. The cone was also distorted around the 10 o'clock position (air craft convention) See Fig 4 in appendices

Fig 4 Crack in inner duct

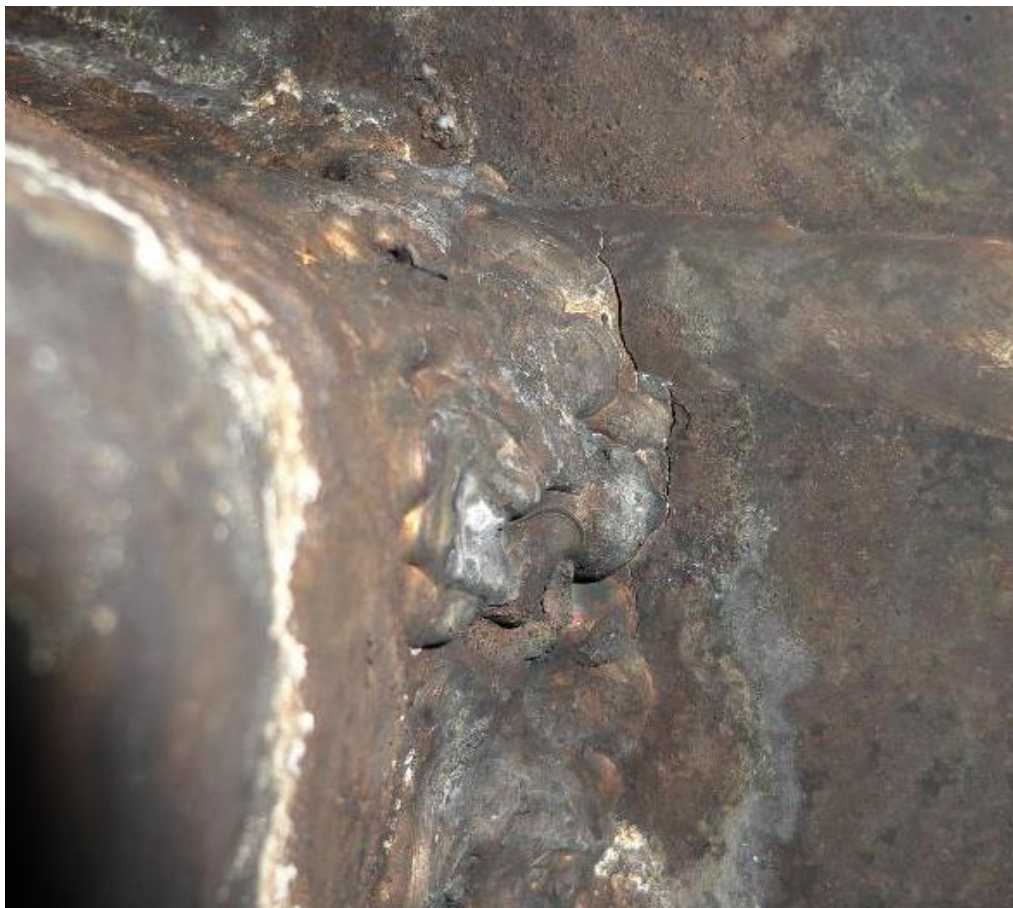
Fig 1 Crack on weld in exhaust.

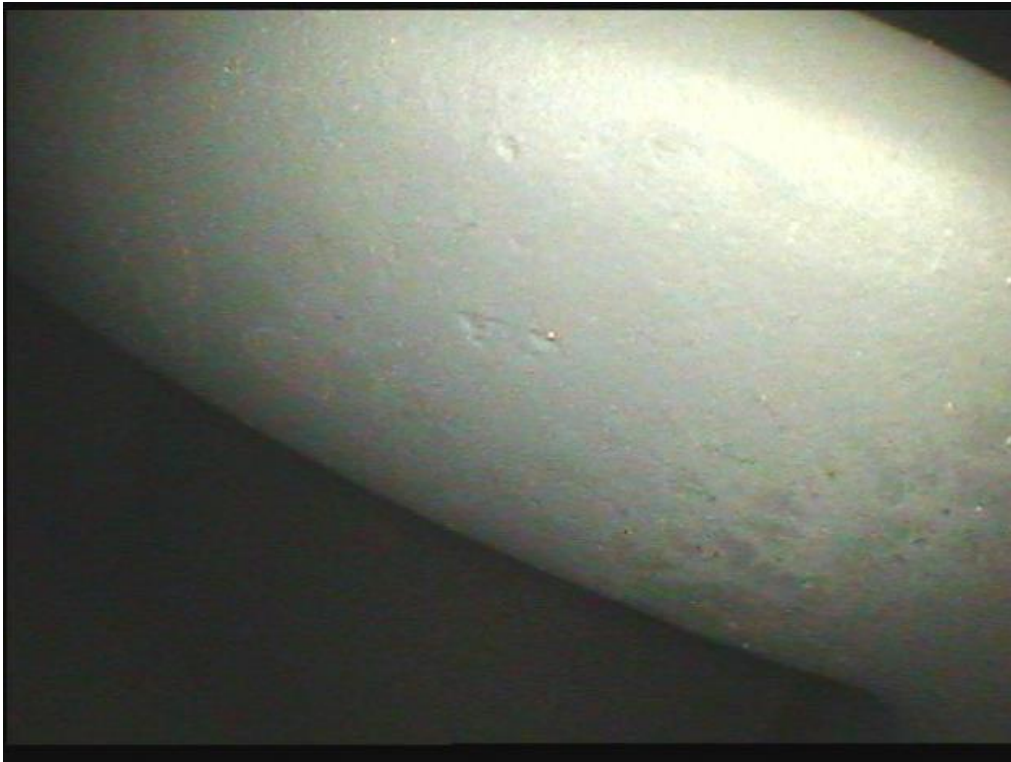
Fig 2 Typical Foreign Object Damage

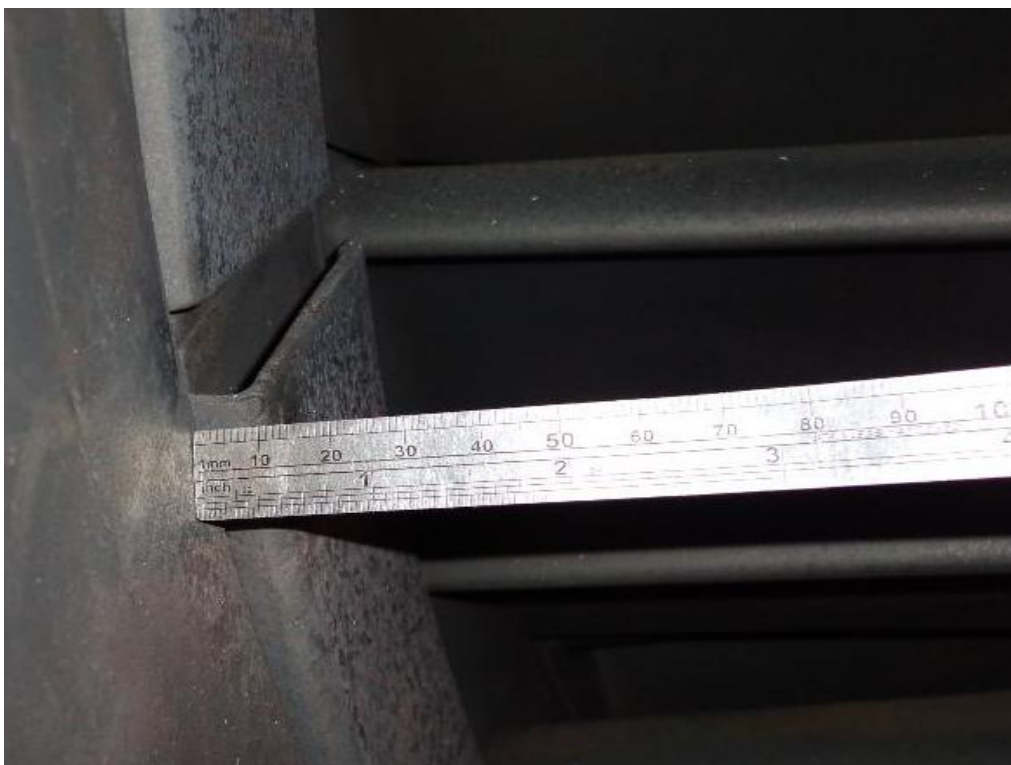
Fig 3 Protrusion of stator shroud

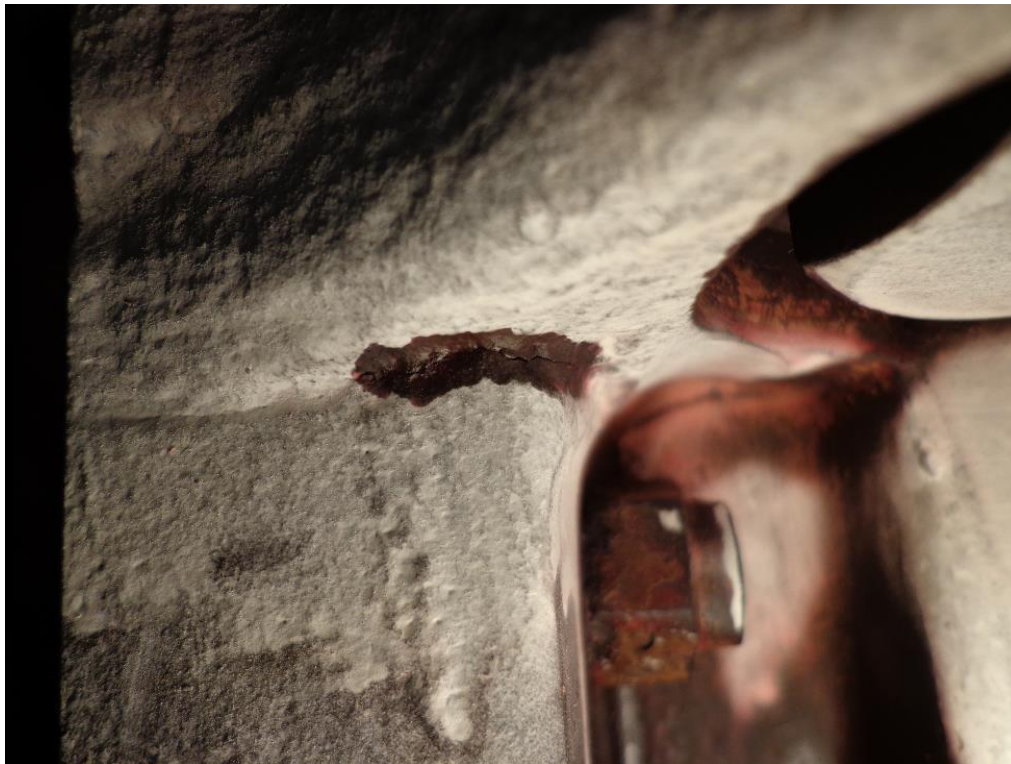
Fig 4 Crack in pressure casing
