**A REPORT TO  
THE BOARD OF COMMISSIONERS OF PUBLIC UTILITIES**

**Field Investigation for Holyrood Combustion Turbine  
Failed Start, March 4, 2015**

**July 20, 2015**

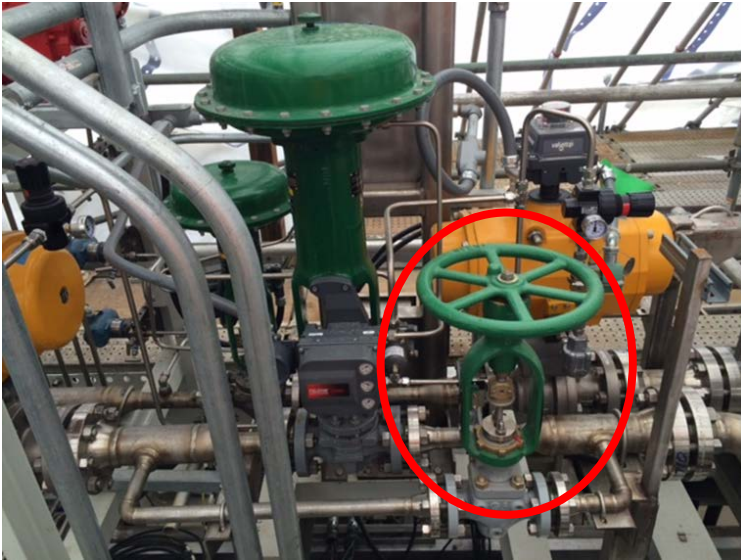
**Photo 1: Fuel bypass valve**

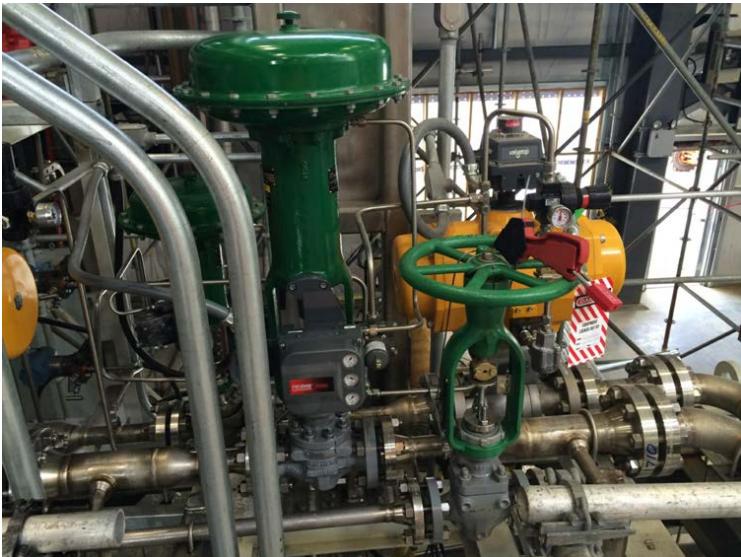
**Photo 2: Fuel bypass valve locked and tagged**

- The valve set position corresponding to the required flow rate was immediately marked on the valve so that if moved, the valve could be quickly returned to the proper position (Photo 3);
- The valve was locked in position so that it could not be easily moved (Photo 2);
- A pre-start up verification of the valve position was instituted; and
- The valve manufacturer was contacted to determine whether there was an engineered locking mechanism which could be affixed/applied to the valve.

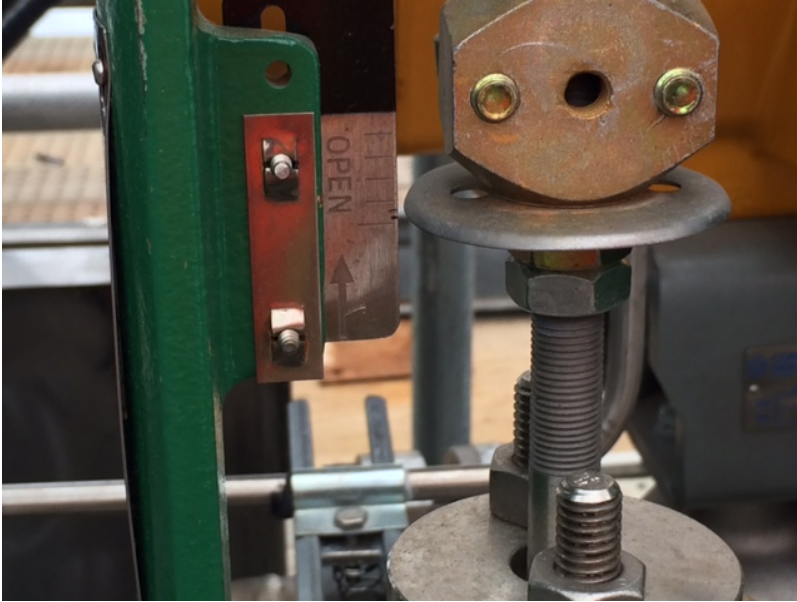
**Photo 3: Close up of fuel bypass valve position indicator**

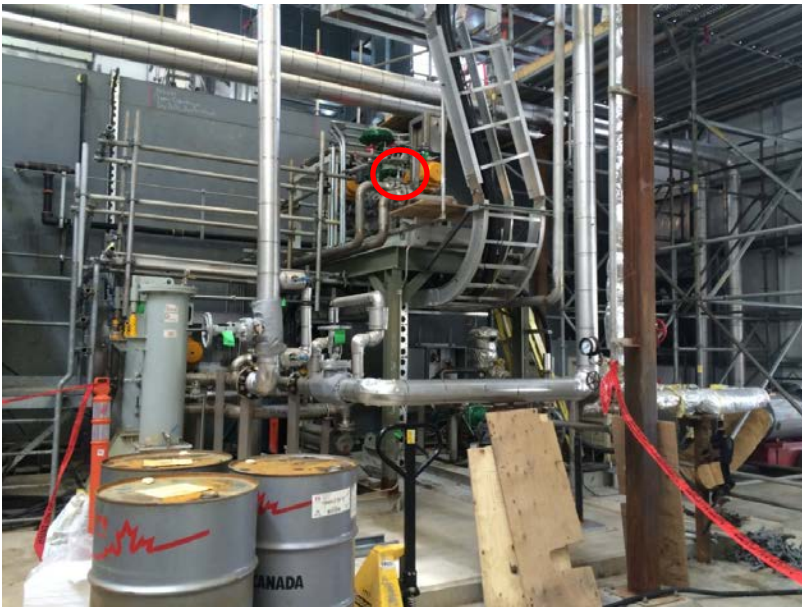
On Wednesday March 4, during start-up of the Holyrood CT, there were a series of failed starts due to an excessive fuel bypass valve flow rate. The bypass valve provides initial flow to the turbine fuel nozzles for starting the unit. The flow rate on this valve had been commissioned following installation to a flow rate in accordance with the original equipment manufacturer (OEM) specifications. This valve is not located on the turbine itself, but is part of the fuel supply system and is located on the fuel, oil, and water injection skid, on an elevated platform within the plant (Photo 4).

**Photo 4: Fuel bypass valve location within the plant**
