May 15, 2015

**Re: March 4, 2015 Power Outage Report (*Power Outage/Incident Advisory 2015-H-062*)**

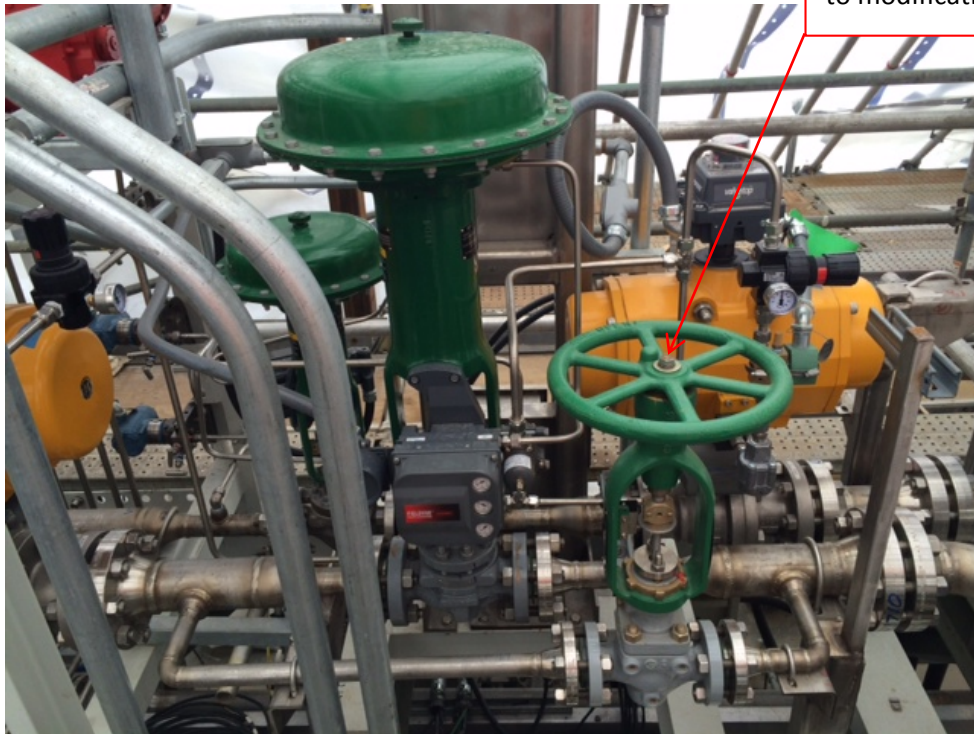
The Holyrood CT had operated successfully in the days leading up to March 4. There were no failures to start. The failure to start on March 4 was due to the incorrect flow rate of fuel from a fuel valve. When the unit was called to start, the flow rate was too high.

The original design of the fuel valve and its surroundings did not include protection from inadvertent bumping or protection from movement through vibration. It has been determined that no changes to the fuel valve position were made by the construction, commissioning, or operations staff. The possible reasons for the fuel valve coming out of proper adjustment include inadvertent contact with the valve or through a means such as vibration. (See Q6 answer for modifications to this valve.)

- a. Please see the photo below showing the fuel valve prior to any lock out modifications being affected.

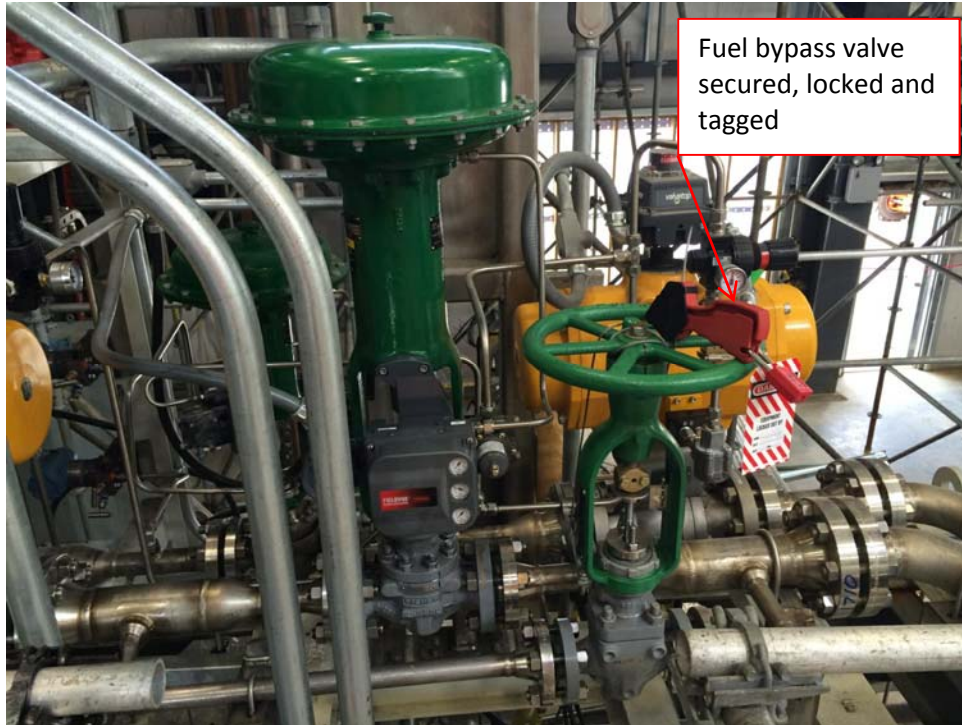
- b. Please see the photo below showing the valve following lock out modification. The valve has been secured, locked and tagged. While it is not visible in the photograph, the valve has also been marked to indicate the valve set position and a pre-start up verification of the valve position has been instituted.

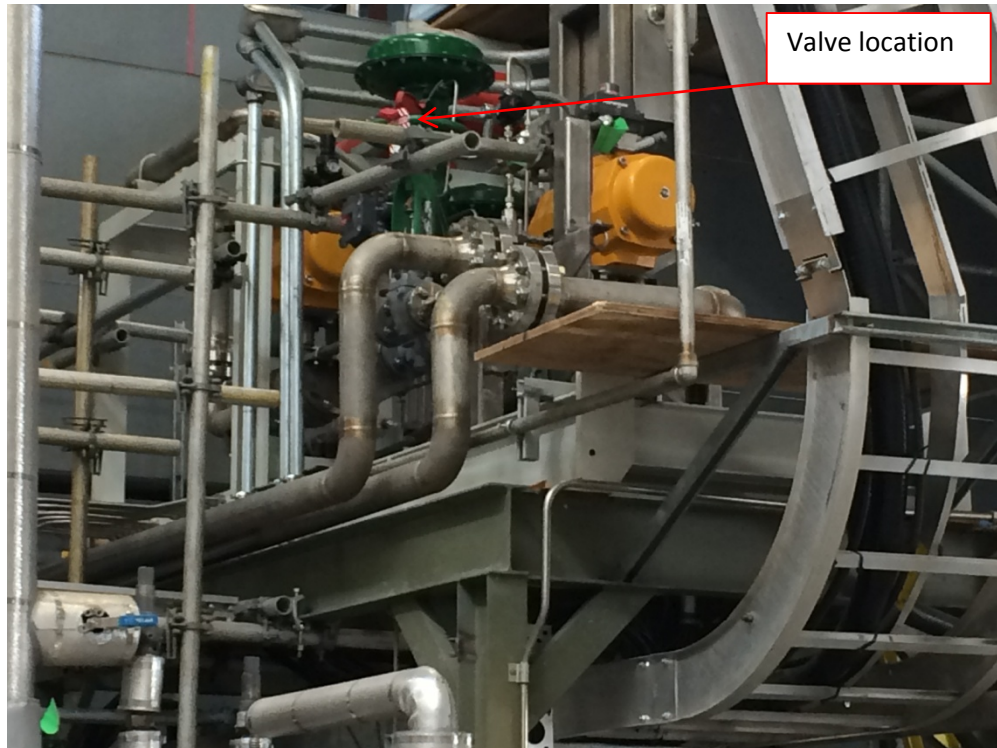
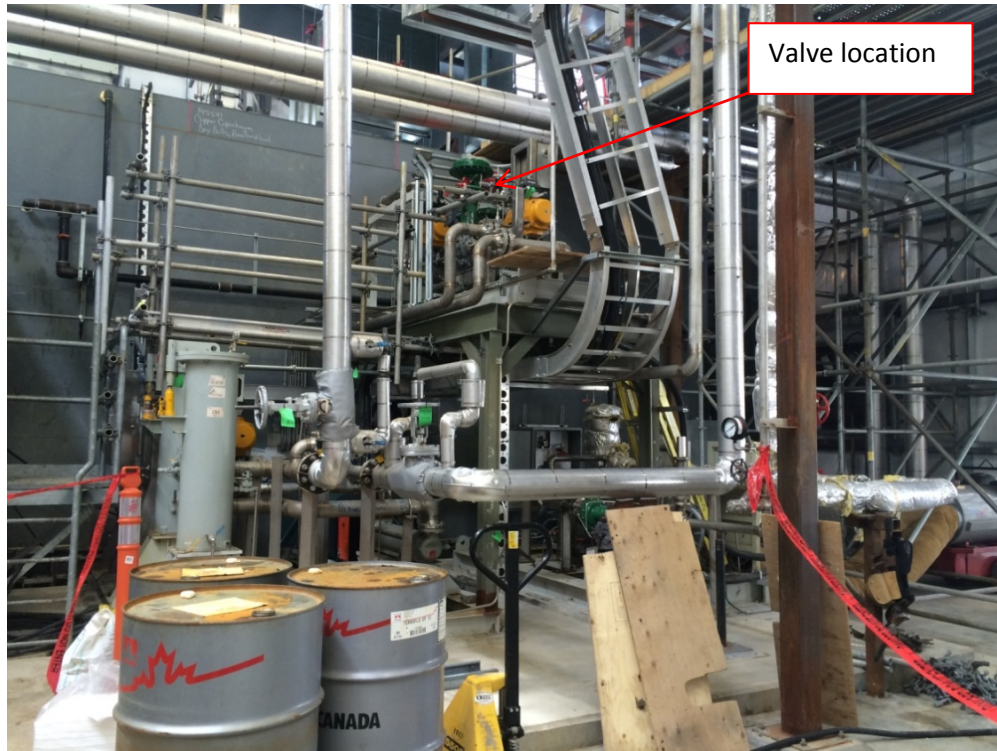
- c. Please see the photos below showing the location of the valve. The valve is not located on the turbine itself, it is located on the fuel, oil, and water injection skid, on an elevated platform within the plant. As can be seen in the photos, scaffolding is in place to facilitate access to the area.

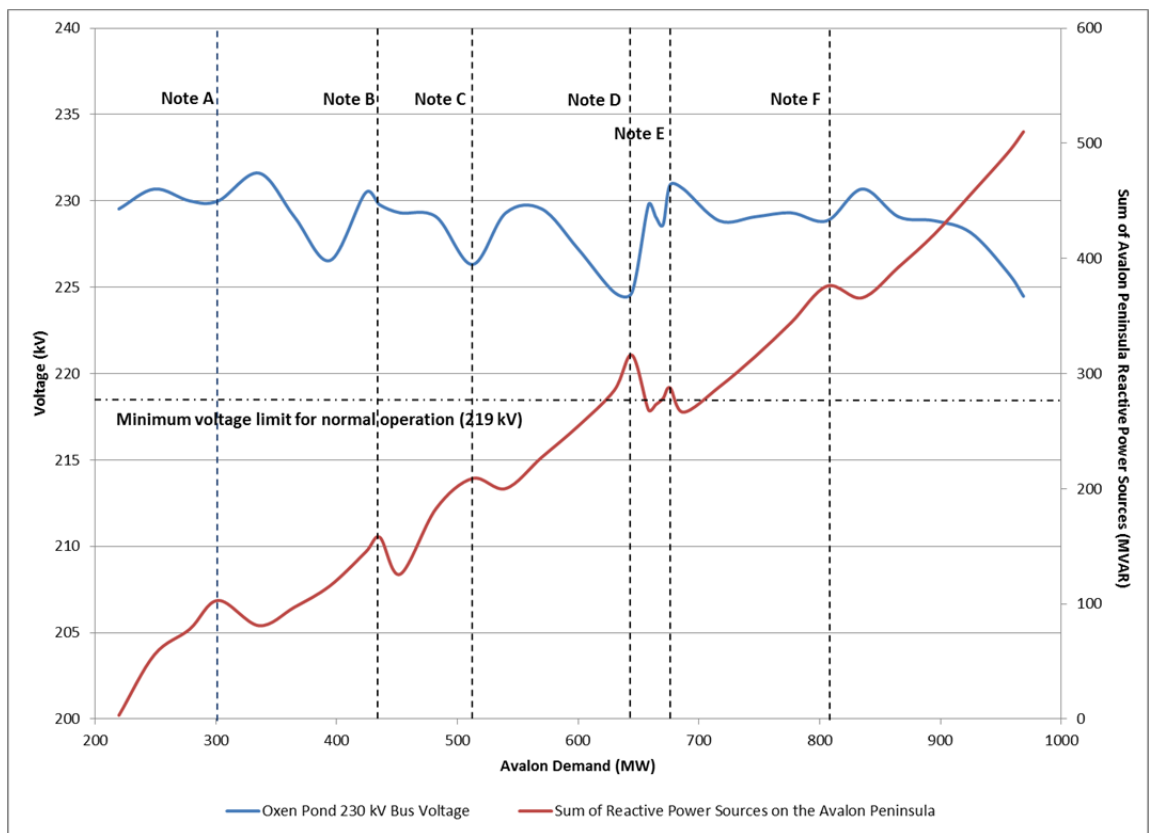
**Figure 1 – Avalon Peninsula Voltages and Reactive Power vs Gross Avalon Demand<sup>6</sup>**

As indicated, voltages are held above the minimum thresholds over the operating range. This is accomplished by increasing reactive support on the Avalon Peninsula through the operation of capacitor banks and by bringing additional generators online, as illustrated by the red line in the plot below.

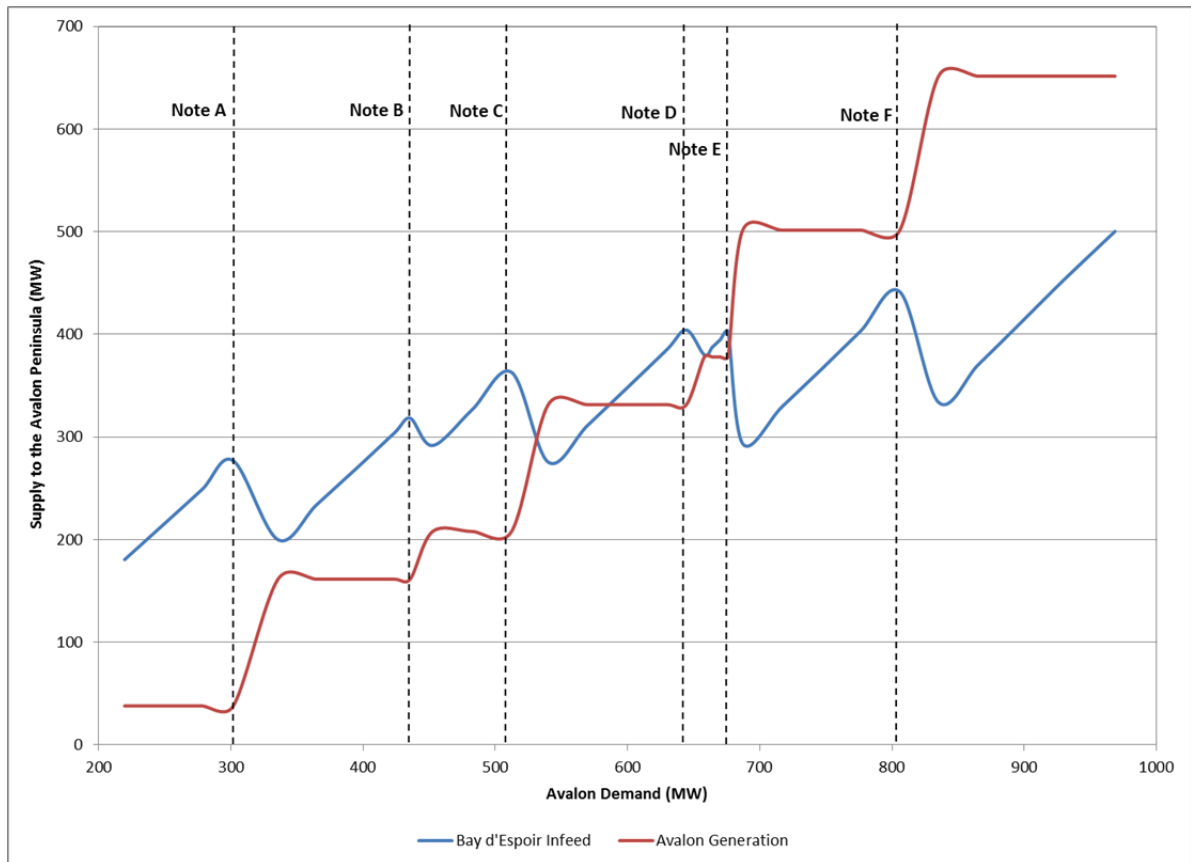
Figure 2 – Sources of Supply for the Avalon Peninsula<sup>7</sup>

Figure 2 includes illustrations of the sources of supply on the Avalon Peninsula versus Gross Avalon Demand associated with Figure 1. "Avalon Generation" includes the following sources of supply:

Power flows from Bay d'Espoir over transmission lines TL202 and TL206 are also provided, as requested.

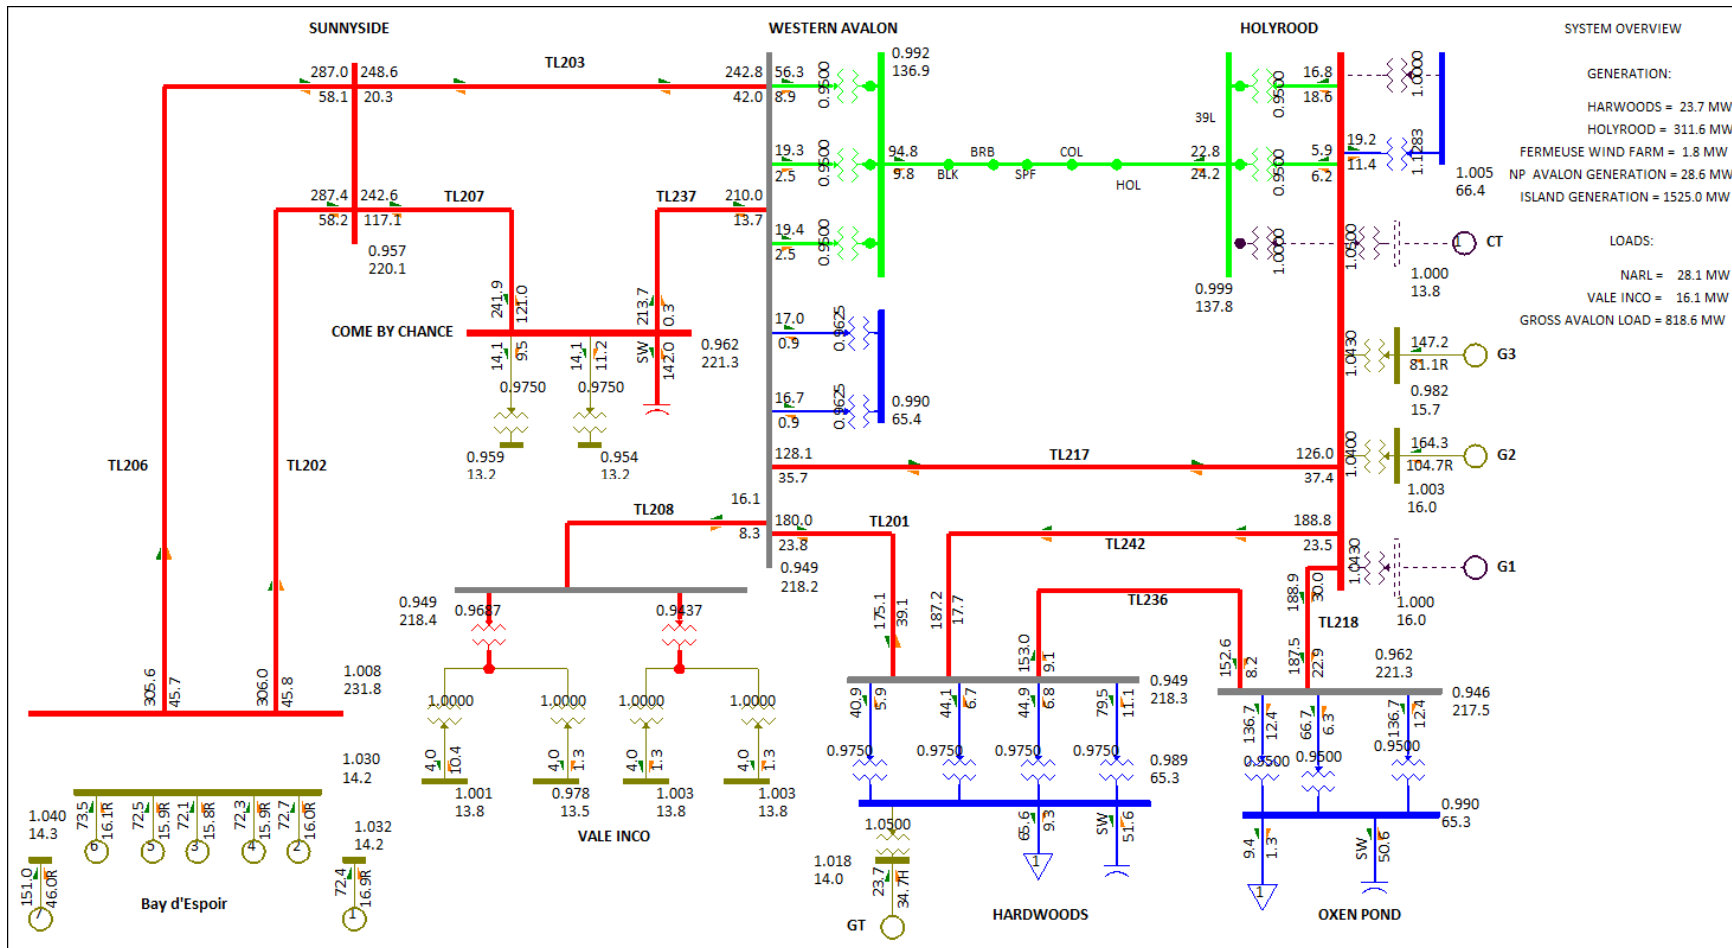
07:00:00 AM

prior to 07:00. At 07:00, low voltage conditions are noted at 230 kV buses at Western Avalon Terminal Station, Voisey's Bay Nickel (Vale Inco) Terminal Station, Hardwoods Terminal Station, and Oxen Pond Terminal Station. Extensive low voltage conditions are noted at 07:14.

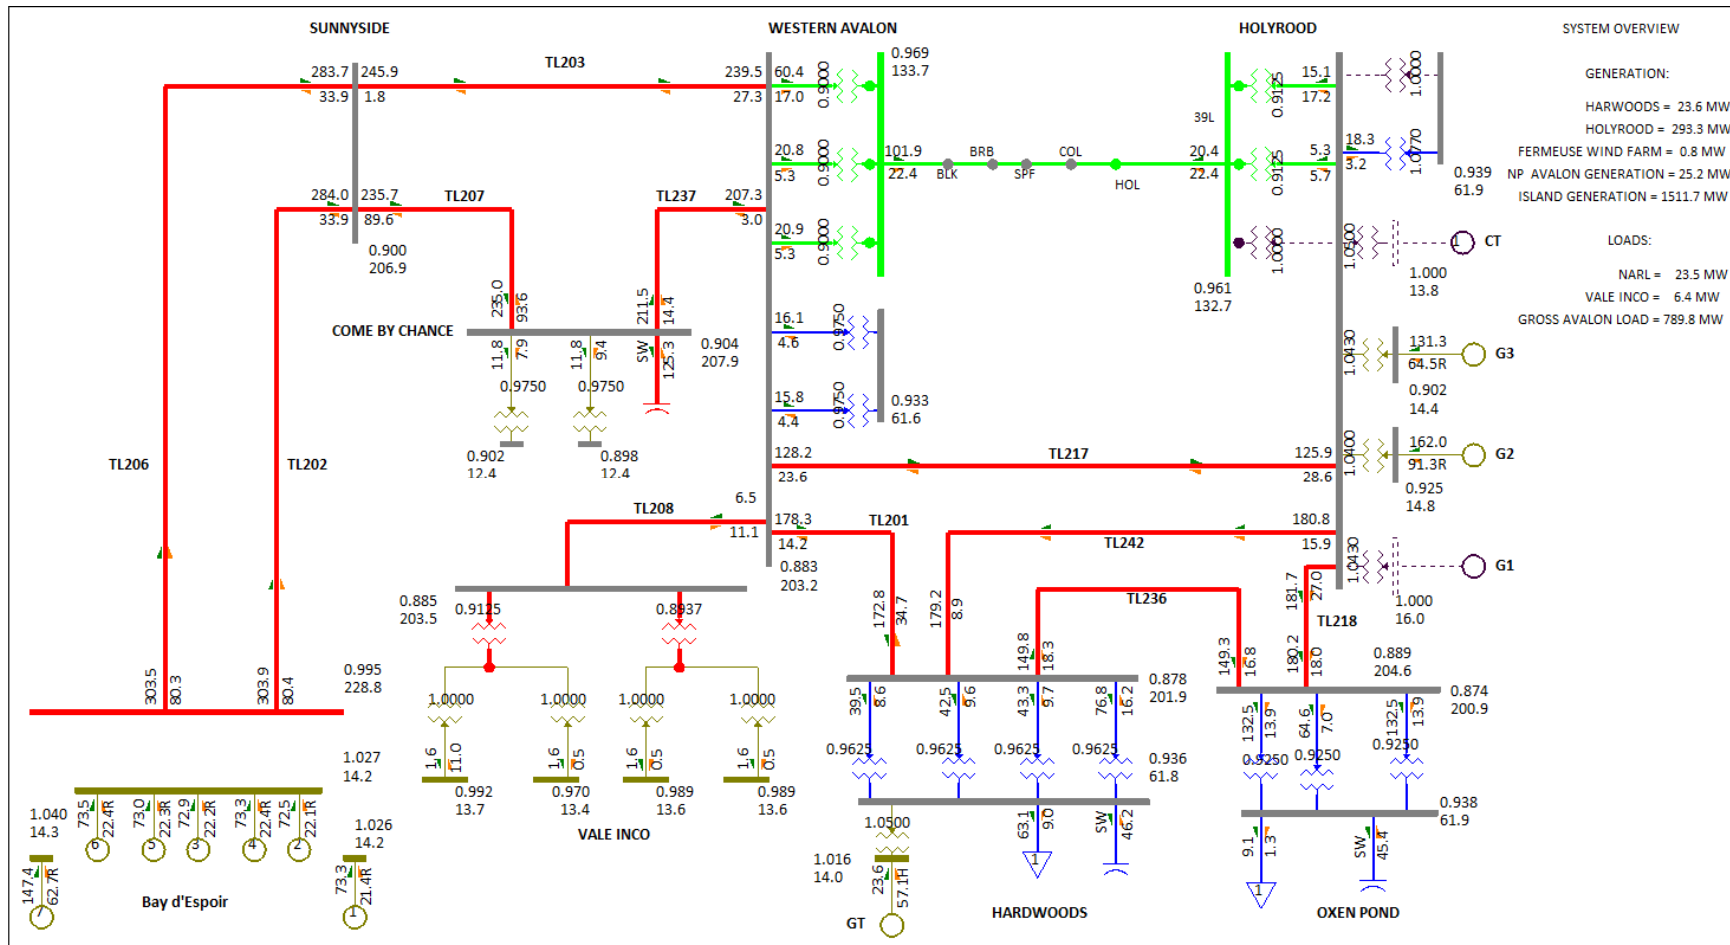
07:14:00 AM

If the voltage of a bus drops below 95% of nominal value, the colour is changed to grey. For example, the Oxen Pond 66 kV bus is coloured blue at 07:00 and grey at 07:14. As per the events described in the Power Outage Report, the plots contained in the appendix detail the system conditions over the specified timeframe. As indicated, system voltages are acceptable
