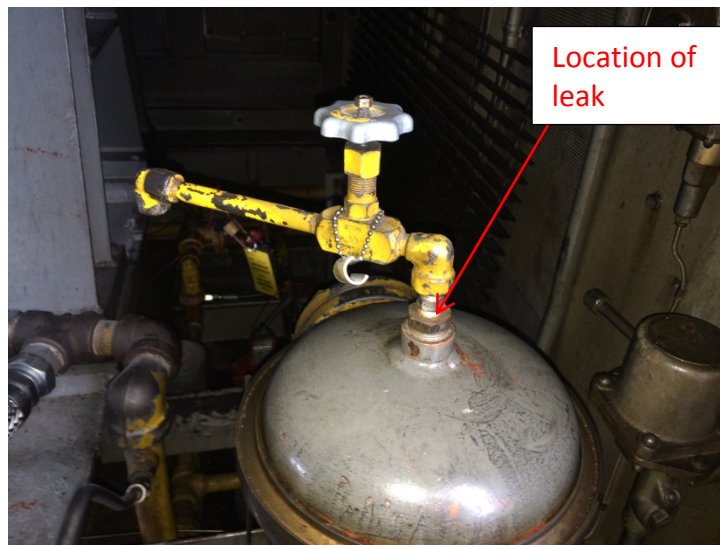
5 A. A visual inspection of the enclosure was completed when the fire was extinguished
6 on March 1, 2015. A fitting in the pressure relief line was found to be partially
7 cracked. This crack would have allowed pressurized diesel to spray onto hot
8 surfaces within the engine module while the unit was running, thereby igniting the
9 diesel. Please see the photo below of the pressure relief line after system isolation
10 showing the location of the leak associated with the cracked fitting.
11
