GTB Olympus serial number: 202224 Fire Investigation And Inspection

Customer: Newfoundland Hydro

Date: 23rd March 2015

Project Number: Alba 4636

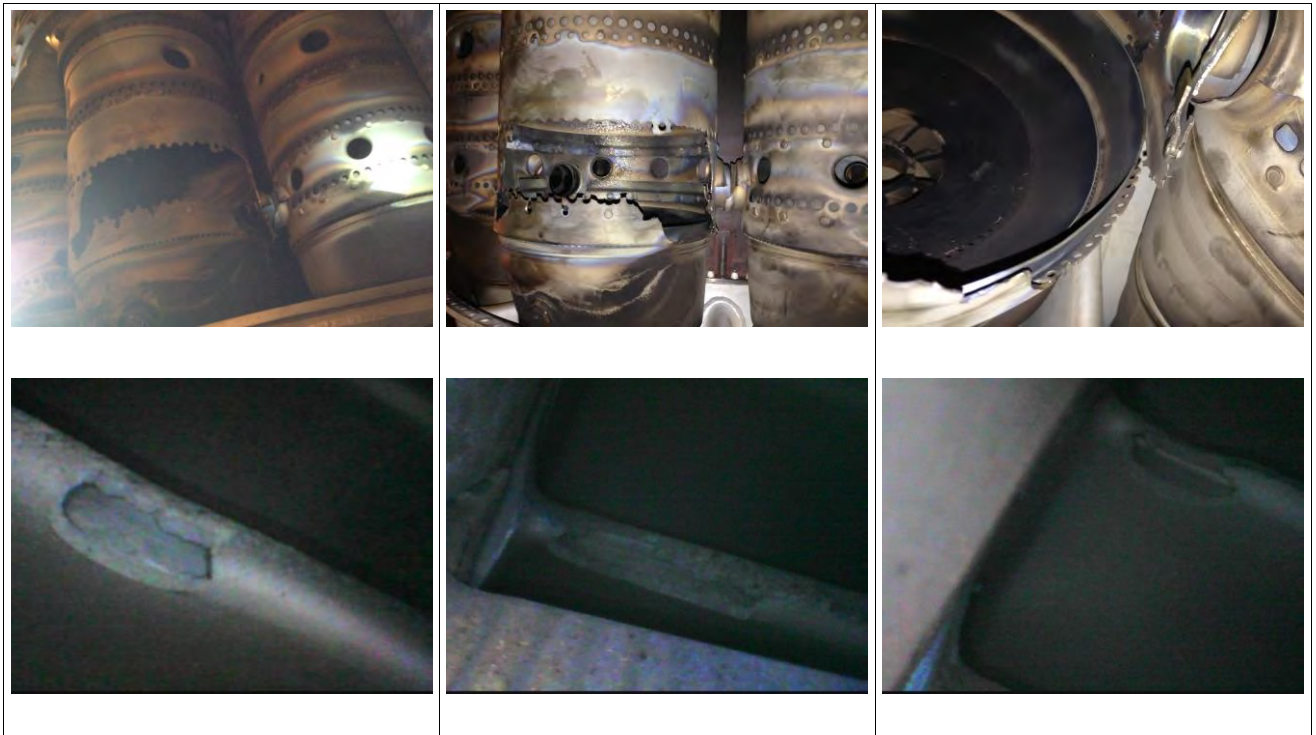
6.1 Digital Images

It was confirmed that combustion can number 8 had been blown outwards and pieces were lodged in the HP turbine section. An inspection of the HP turbine blades confirmed that there was sufficient damage to make the turbine unfit for a site repair.

Pictures below show HP Turbine rotor blade damage and combustion can damage. The combustion cans were damaged from the inside and blown outwards.

On inspection of the combustion section of the GTB Olympus it was confirmed that combustion cans 5, 6 and 8 had broken up sending large pieces through the Turbine section. This meant the engine was unfit for an onsite repair as there was significant damage to the HP Turbine rotor blades caused by pieces of combustion cans passing through.
