Snook's Arm Wood Stave Penstock

Evaluation, Recommendation and Estimated Cost for Replacement

Newfoundland and Labrador Hydro
Generation Engineering

January 26, 2004

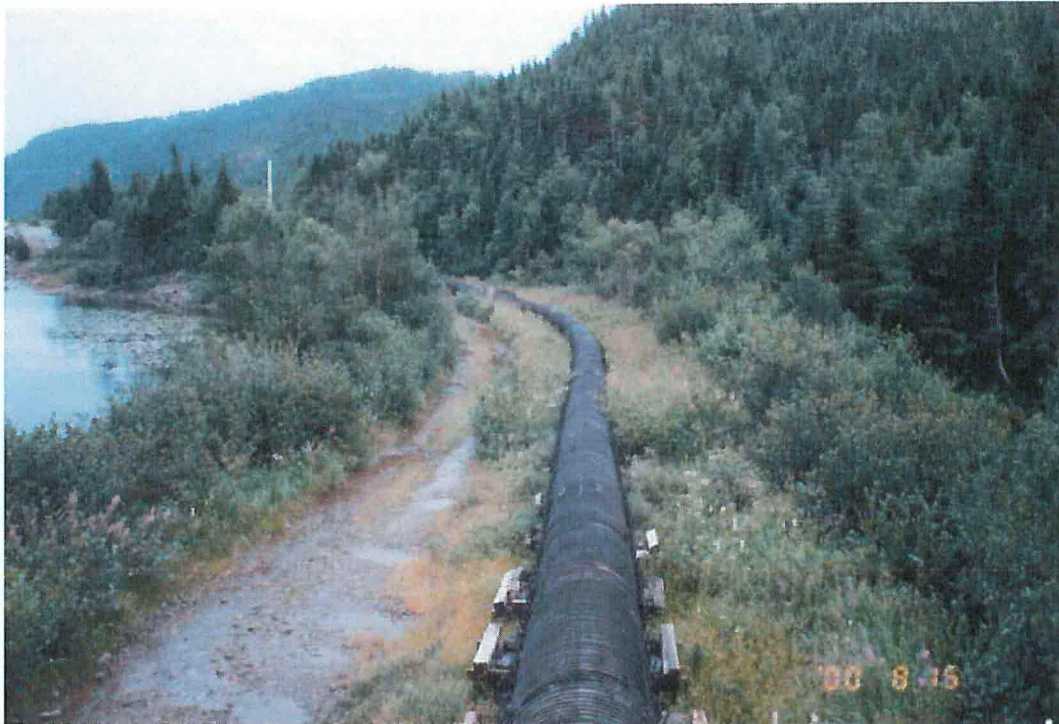
The penstock profile has several flat sections and one reverse section in the mid to upper half of the penstock, see photos #1 & #2. The reverse grade increases the probability of the penstock collapse during operation, when the Plant is fully loaded. The only protection from collapse is a vacuum breaker valve located at the mid-point of the line. This valve is designed to break any vacuum that may cause a collapse. It is critical that this valve is kept in good working condition to ensure that it will operate as required. Recent problems experienced include a fire in the valve enclosure and a malfunction of the valve.

Photo #1: View of penstock, August 2000.

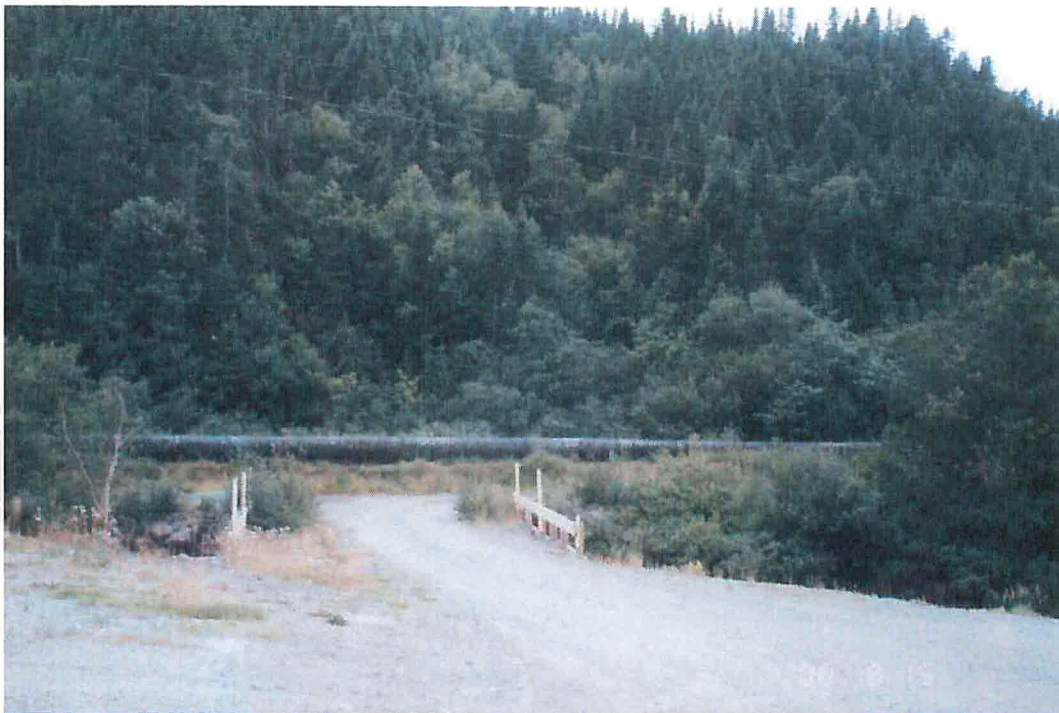
Photo #2: View of flat and reverse section of penstock, August 2000.

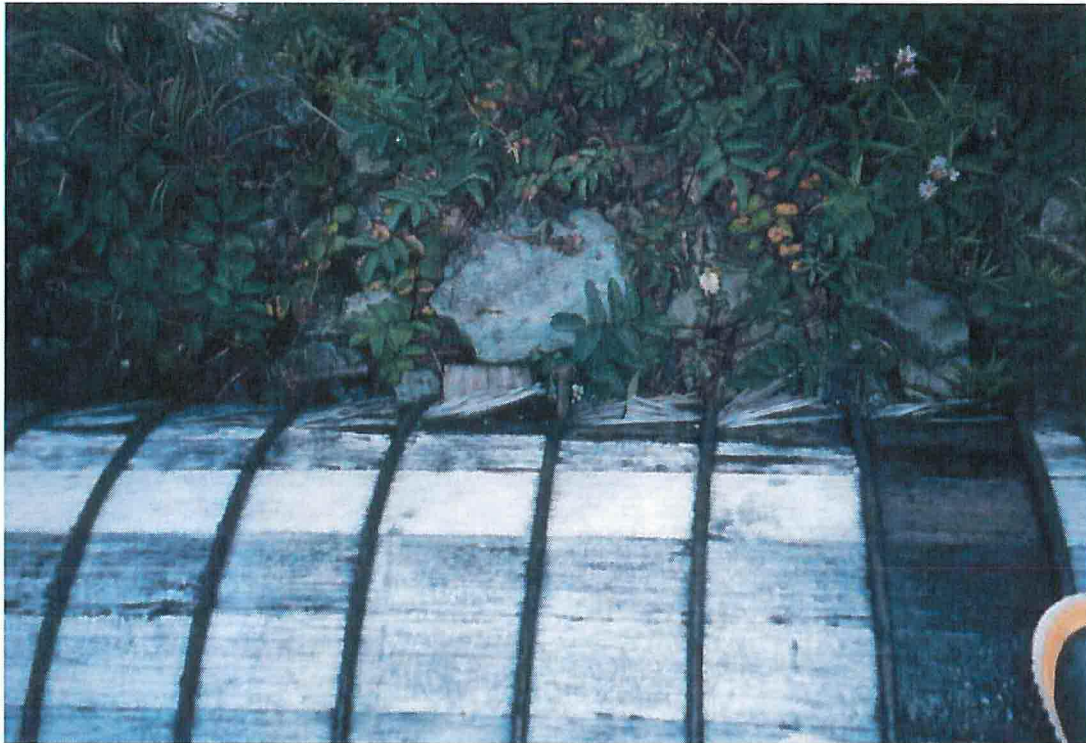
Various inspections of the penstock have indicated that there is joint leakage between the staves, brooming at stave ends and between steel bands and crushing of the staves along the spring line or top of the penstock. The brooming and crushing is worse at the lower end of the penstock, which is subject to higher pressures. The crushing and brooming indicates delamination between the wood fibers and deterioration of wood, see photos #3 & #4. The rate and areas of deterioration continues to grow with the age of the structures.

Photo #3: View of brooming between metal bands, August 2000.

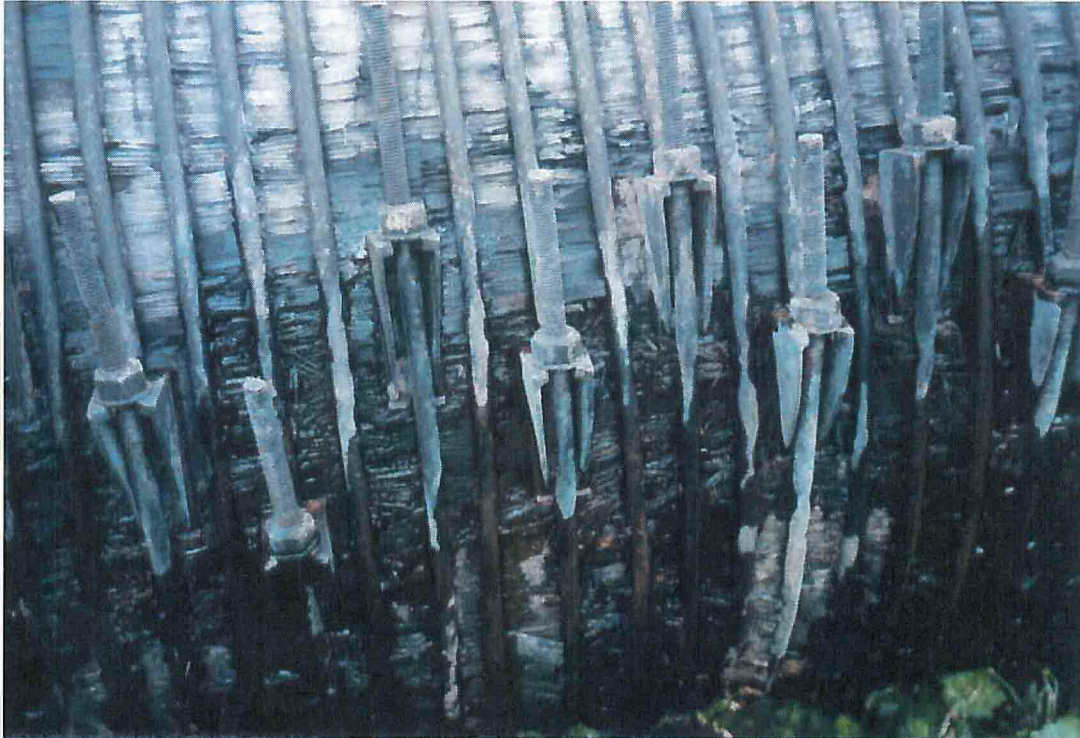
Photo #4: View of crushing and brooming of wooden staves, August 2000.

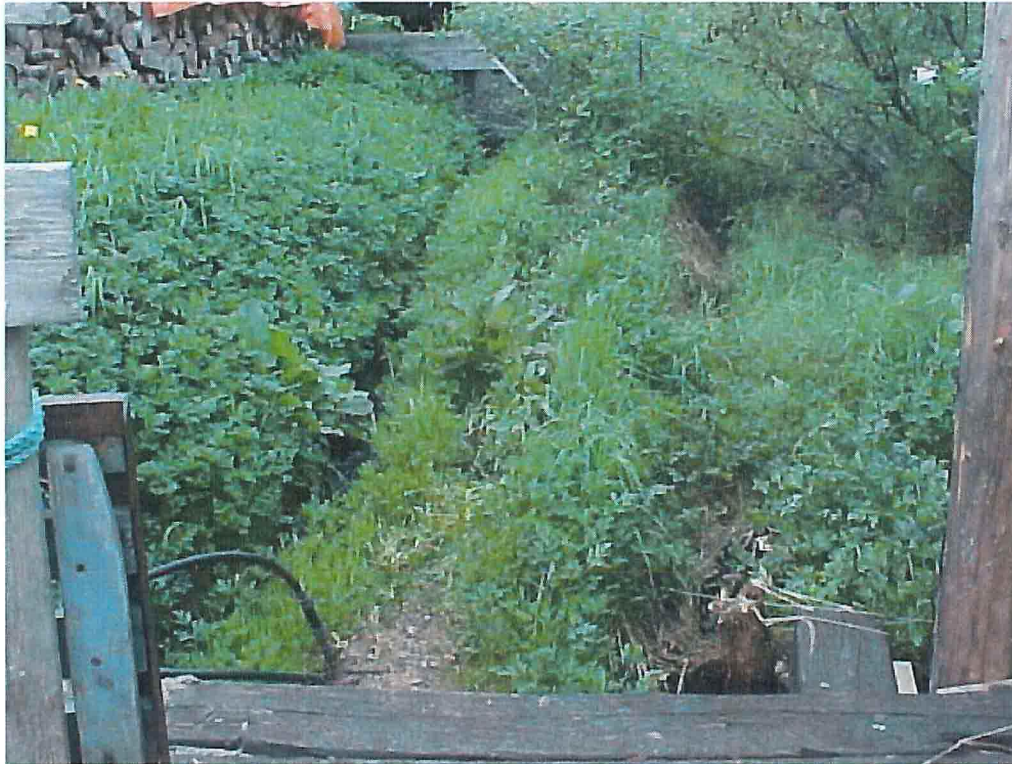
Also along the length of the penstock, areas of moss and other vegetation are growing directly on the penstock; see photos #5 & #6. Vegetation growth typically retains moisture and cause stave deterioration. In some cases the vegetation can be parasitic to the wood stave. Vegetation thrives because of continuous water supply leaking from the penstock. The cost of removing the vegetation continues to increase.

Photo #5: Vegetation growth around and on penstock, June 2001.

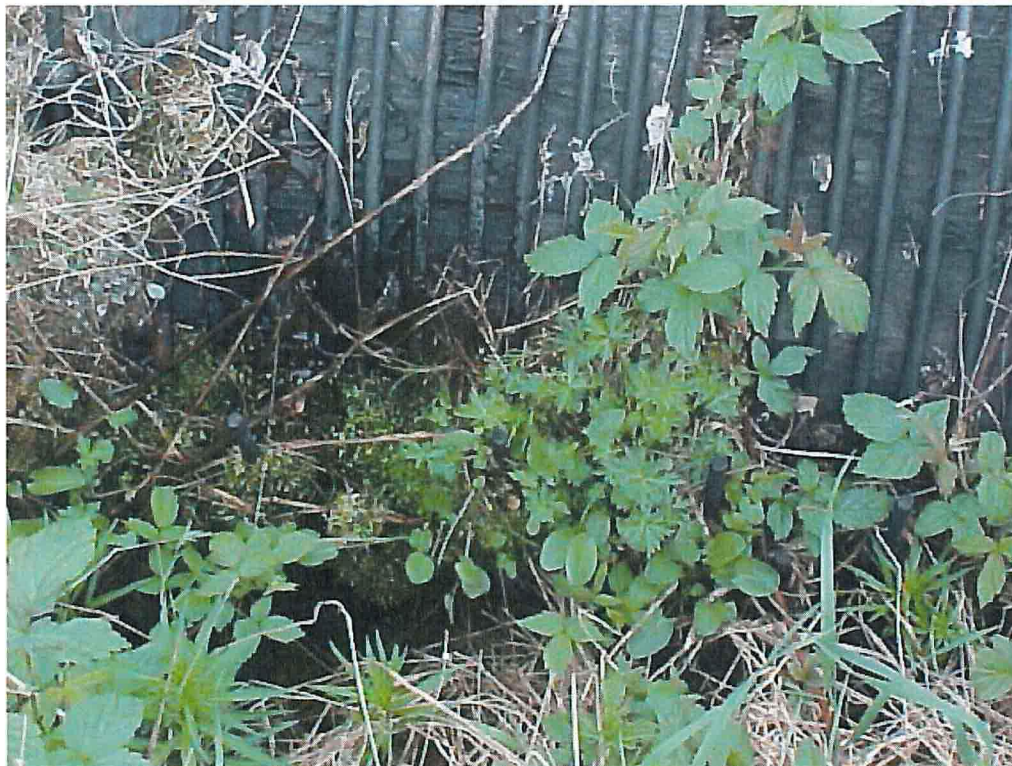
Photo #6: Moss and other vegetation growing directly on penstock, June 2001.

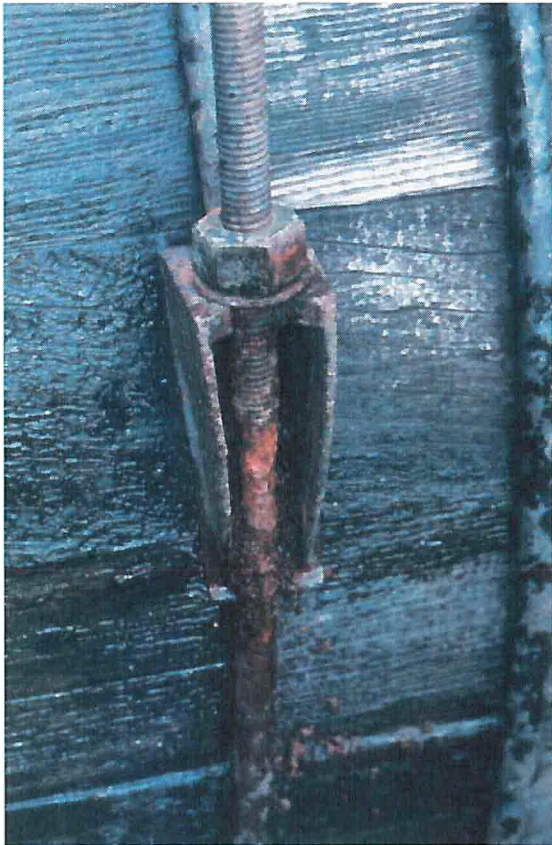
There are approximately 12,000 steel bands used to maintain the shape and integrity of the penstock. All of the bands show various signs of rusting, corrosion and deterioration. Also, in recent years some bands have been observed with significant corrosion below the threads on the band, see photos #7 & #8. These bands are required to be replaced or new ones installed adjacent to the old ones (where possible). In addition, there is bright, visible corrosion on the majority of the steel bands that do not receive direct sunlight. These areas include the penstock enclosure, buried section of the penstock and at the road crossings. In these same areas it is difficult if not impossible to replace the steel bands because of the limited access. Also, in several locations it is impossible to replace the bands unless the penstock is dewatered, because of the decreased band spacing and the higher pressure on the lower half of the penstock. However, frequent dewatering of the penstock is not recommended because of its aged and deteriorated condition.

Photo #7: View of corrosion below threads, August 2000.

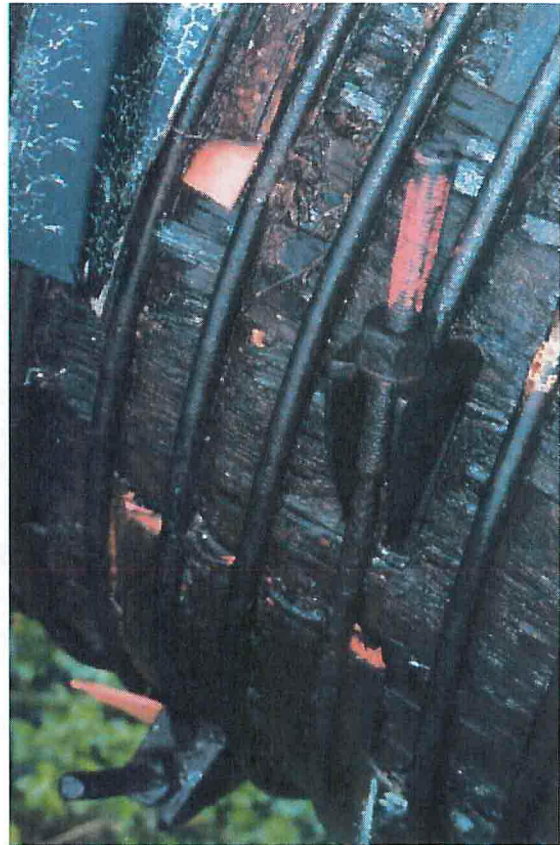
Photo #8: View of corrosion on metal bands, August 2000.

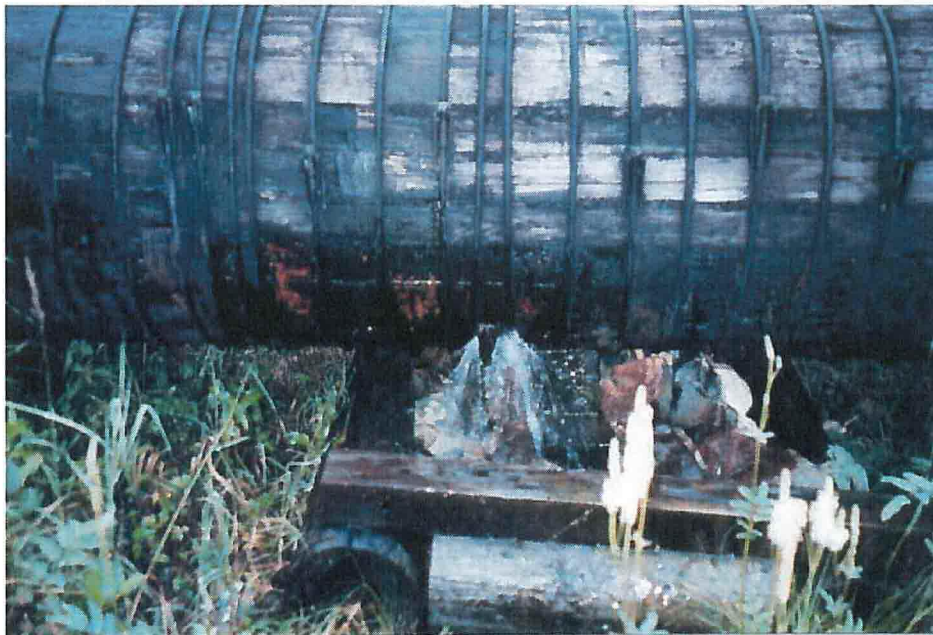
Leaking of the penstock joints have been observed since at least 1968, see photos #9, #10 & #11. The leaks were sometimes repaired by driving nails into the leaking area, this method however tends to promote deterioration of the wooden staves, see photo #12. The more common method of sealing the leaks involved the installation of small steel plates under the existing steel bands or by adding new bands between the existing ones in the area of the leak, see photo #13. The penstock has been dewatered approximately 4-5 times since 1989 to repair the leaks. During one event, the penstock was dewatered for approximately 5-6 days, which allowed the wood staves to dry out and shrink in size. When the penstock was watered up there were a significant number of additional leaks of various sizes, which required lengthy time and effort spent to correct and seal the new leaks. Based on this experience, the penstock has been dewatered and watered up during the same day to repair any leaks in the penstock. However, each time the penstock is dewatered, additional leaks appear when the penstock is watered up again. Overall, the dewatering of the penstock is a significant activity that creates just as many or more leaks than those that are repaired.

Photo #9: Water leaking from penstock, August 2000.

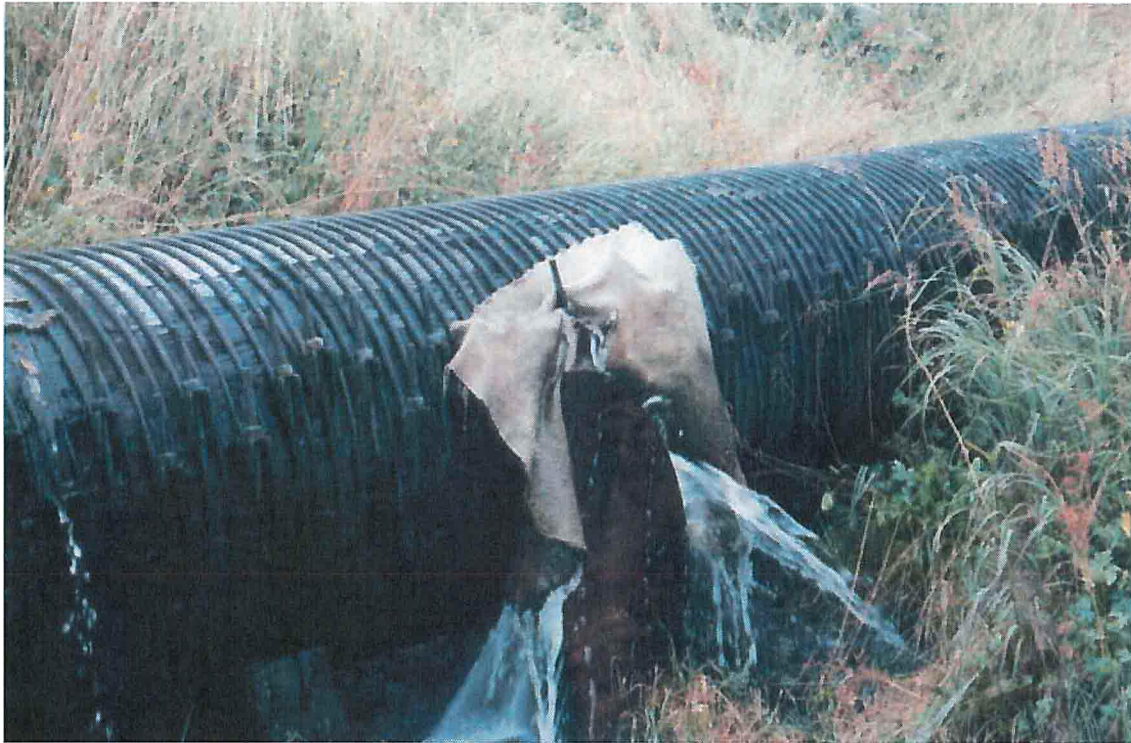
Photo #10: Water leaking from penstock, August 2000.

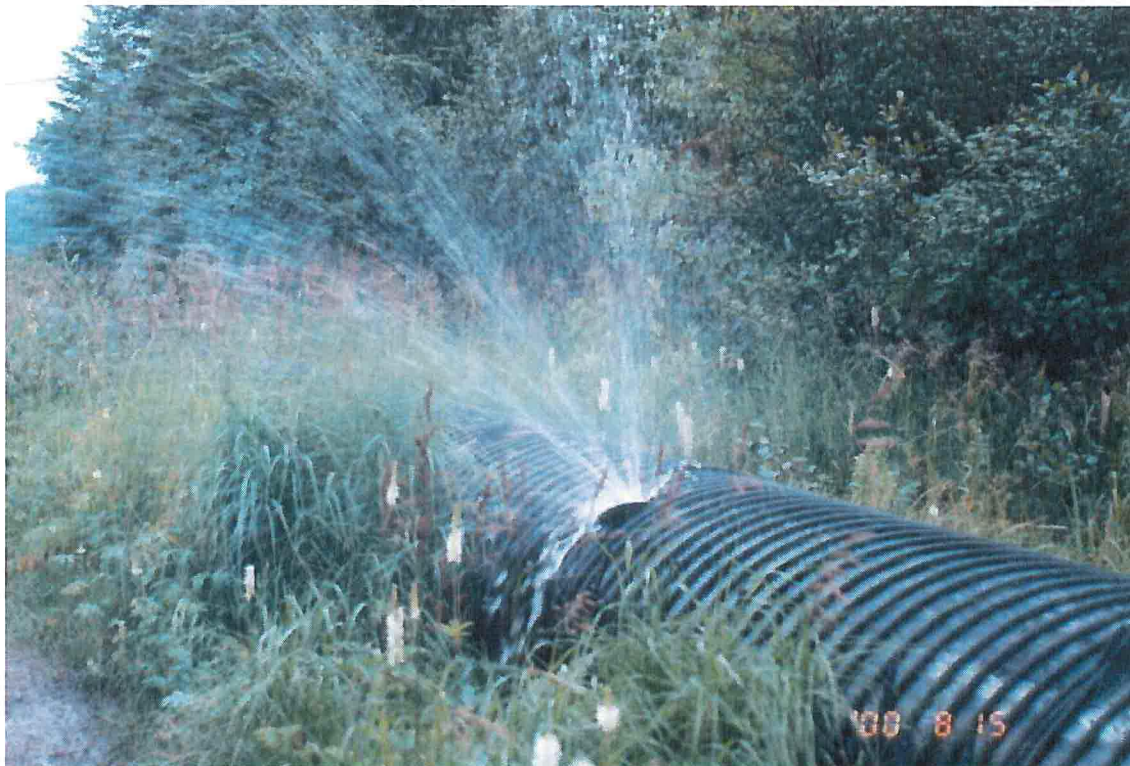
Photo 11: View of water leaking from penstock, August 2000.

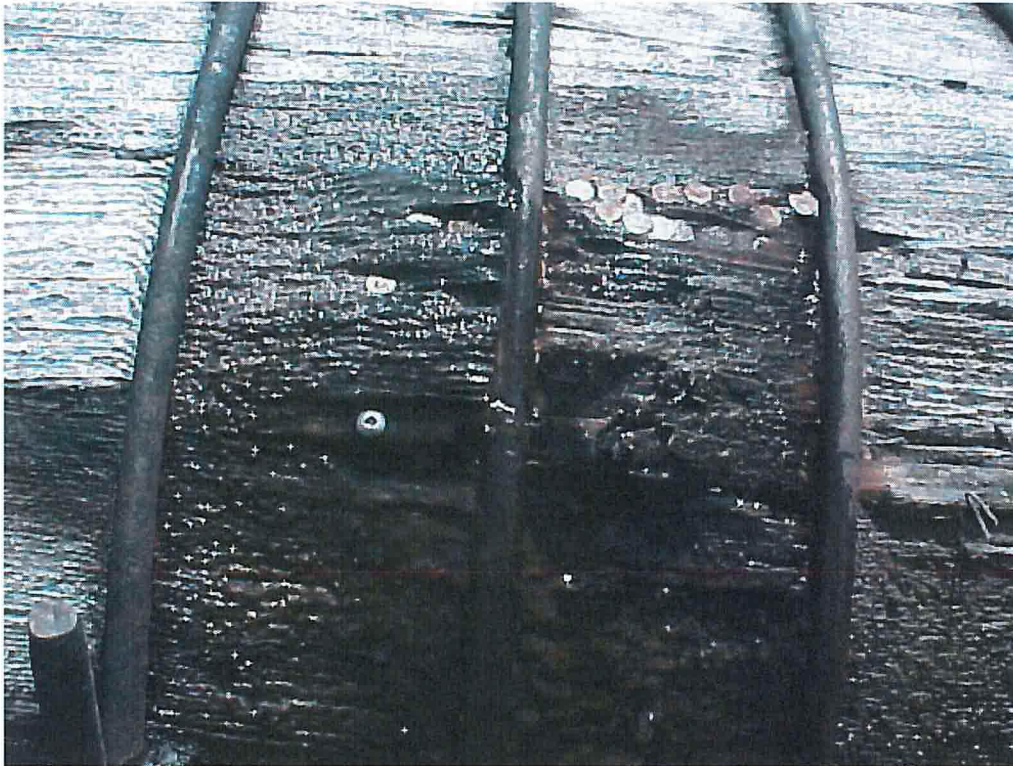
Photo #12: Nails driven into penstock to stop leaks, June 2001.

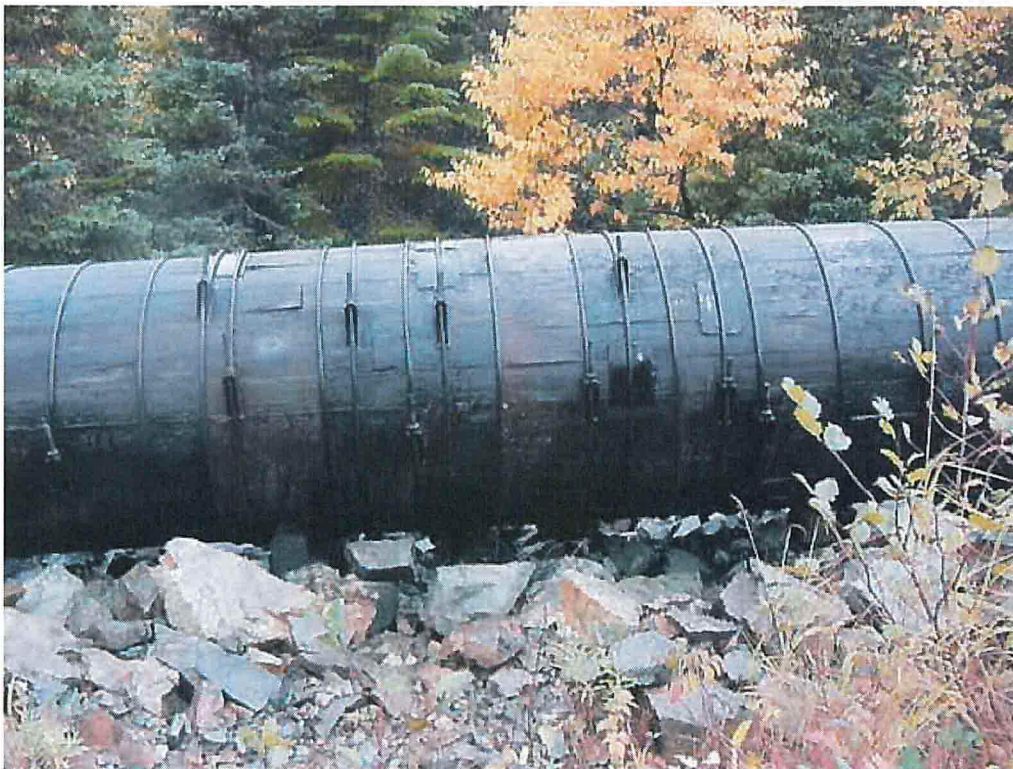
Photo #13: Metal patches placed under new bands to stop leaks, October 2003.

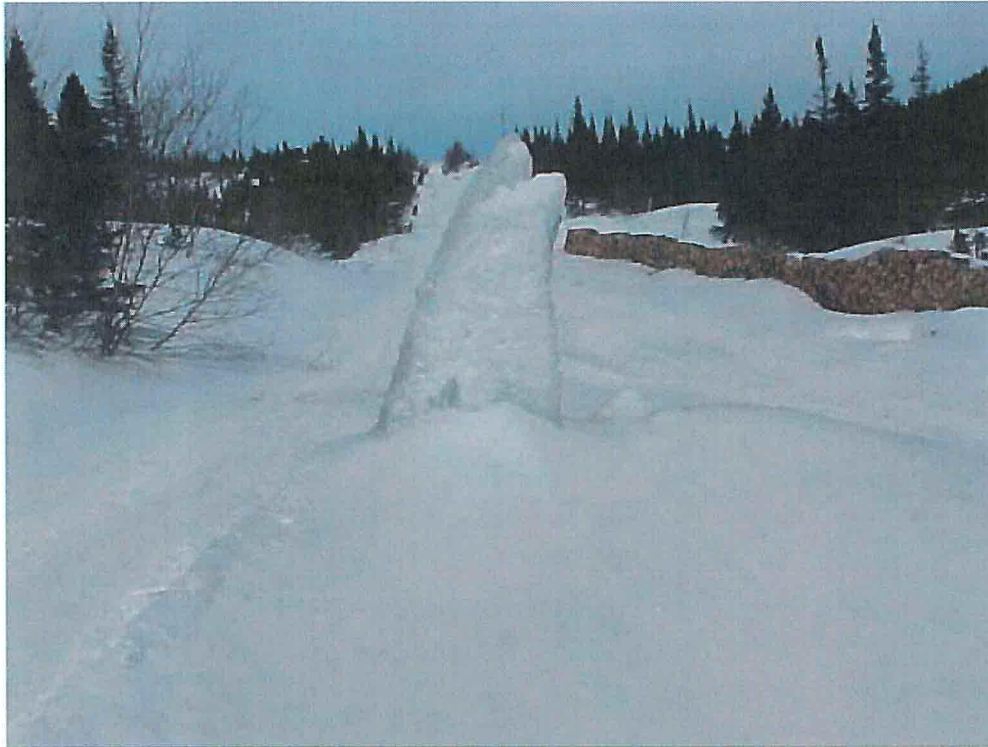
All leaks from the penstock result in significant ice formation during the winter. The ice formations are becoming an increasing problem for Hydro because of its danger/risk to local residents.

Photo 14: Ice formation above penstock, April 2001.

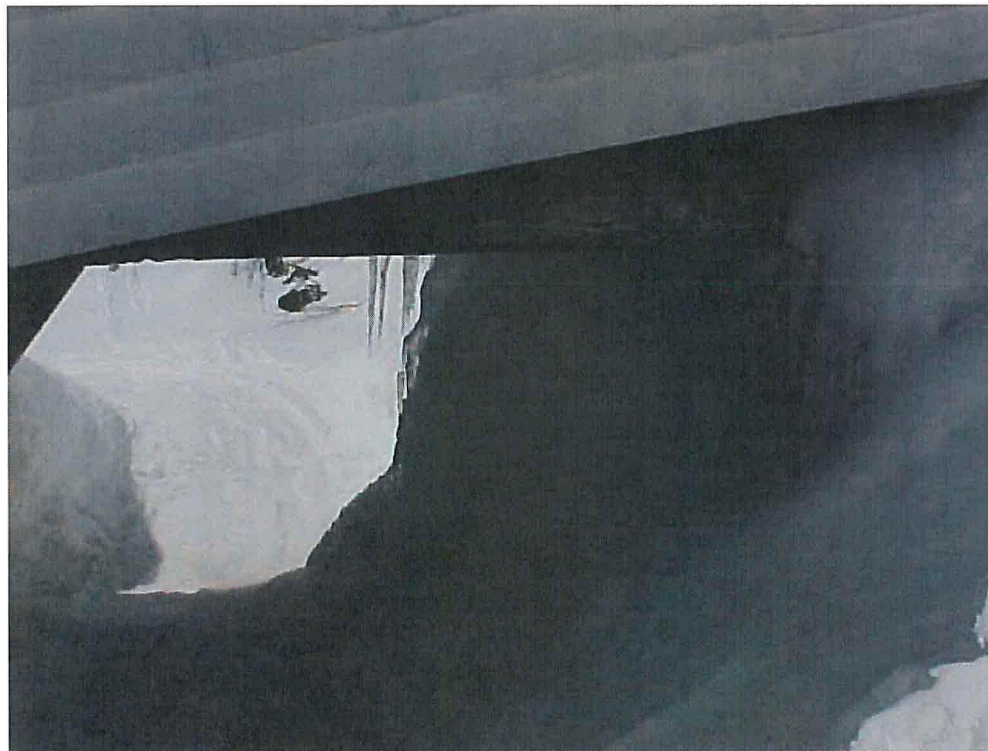
Photo 15: Ice formations under penstock enclosure, April 2001. For location of ice formation refer to Photo #18.

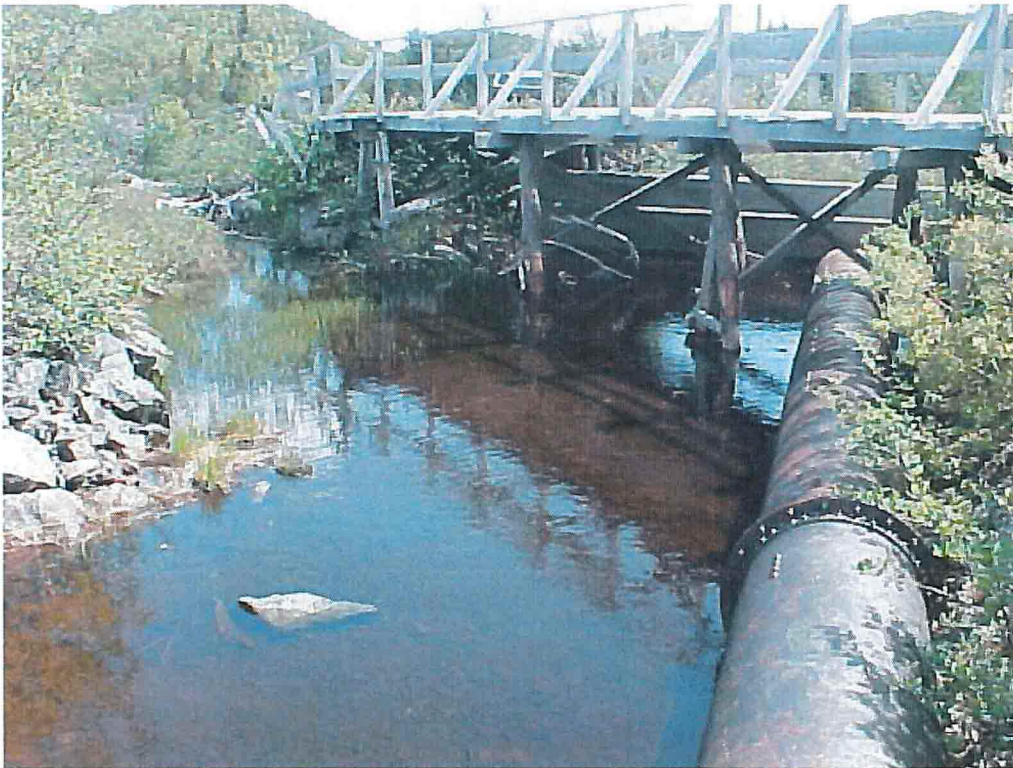
The first section of the penstock, from the intake to approximately 80 ft downstream, is fabricated from riveted steel plate; refer to location #1 on map SA-1 and photos #16 & #17. Because of the age of this steel section of penstock plus the fact that it has been partially or totally submerged for years, it continues to deteriorate. In addition, the concrete saddles for this section are also damaged. This section of penstock will likely be required to be replaced at the same time as the adjacent wooden penstock.

Photo #16: Accumulation of water behind concrete cut-off dam, June 2001.

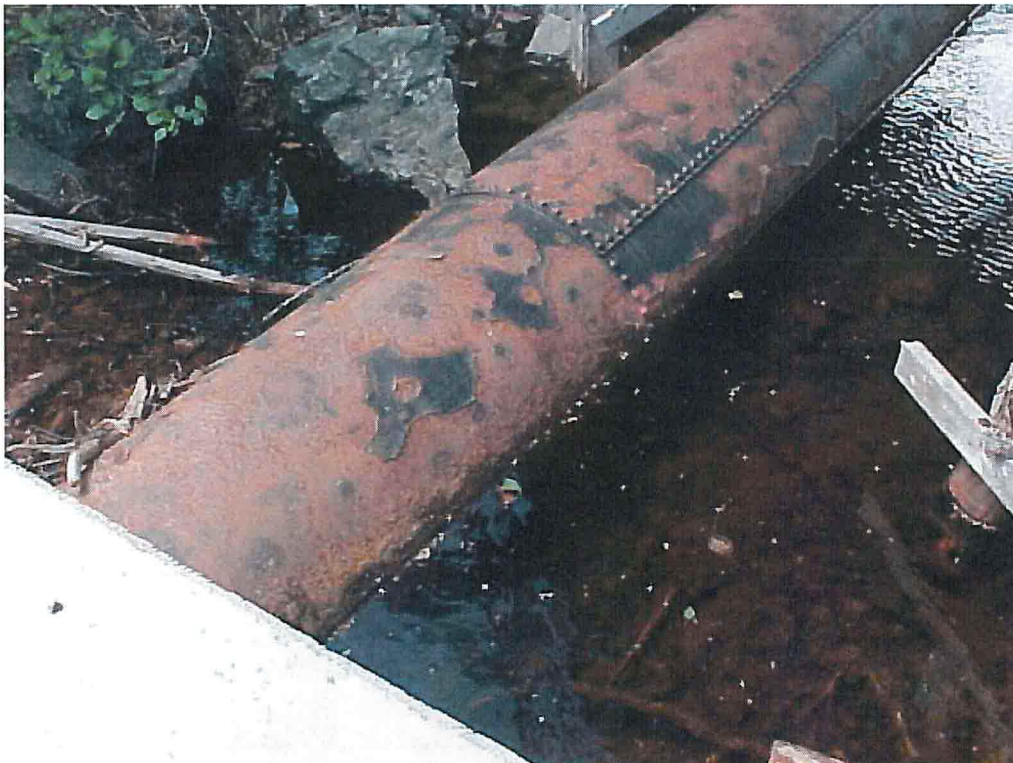
Photo #17: Steel section of penstock, partially submerged in water, June 2001.

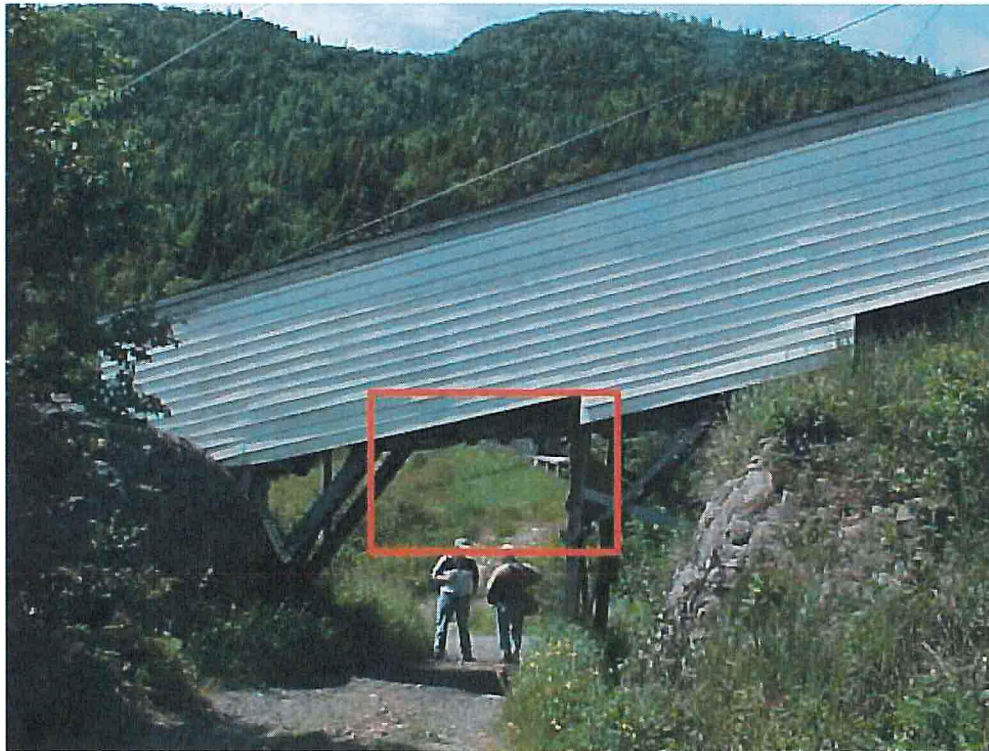
The penstock is enclosed for a length of 75 ft in the vicinity of the access road; the enclosure was built to reduce ice formation during the winter. The penstock invert was heat traced to reduce ice buildup inside of the structure; however, ice buildup inside and outside of the enclosure is still an ongoing problem. There are several concerns associated with this structure including the old and deteriorated condition of the enclosure, reliability of the heat tracing, and the limited access for inspection and maintenance of the penstock inside the enclosure. In general, the structure is becoming more of a safety concern as it ages.

Photo 18: Penstock enclosure over access road, July 2002. Highlighted area indicates location of ice formation shown in Photo #15.

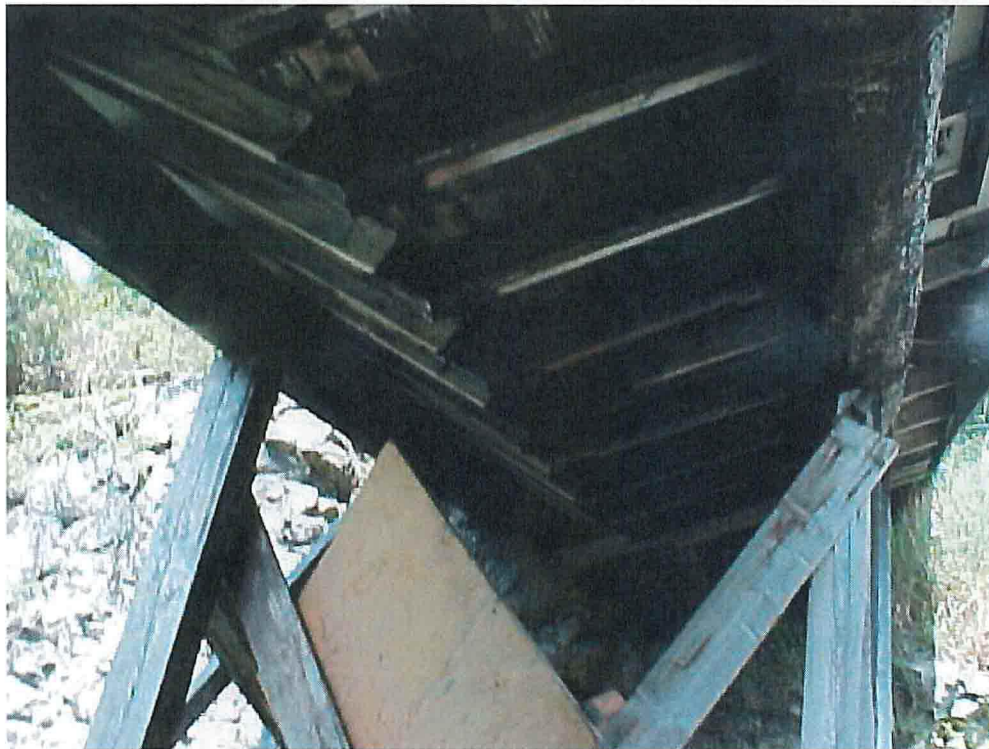
Photo 19: Support structure for penstock enclosure, July 2002.

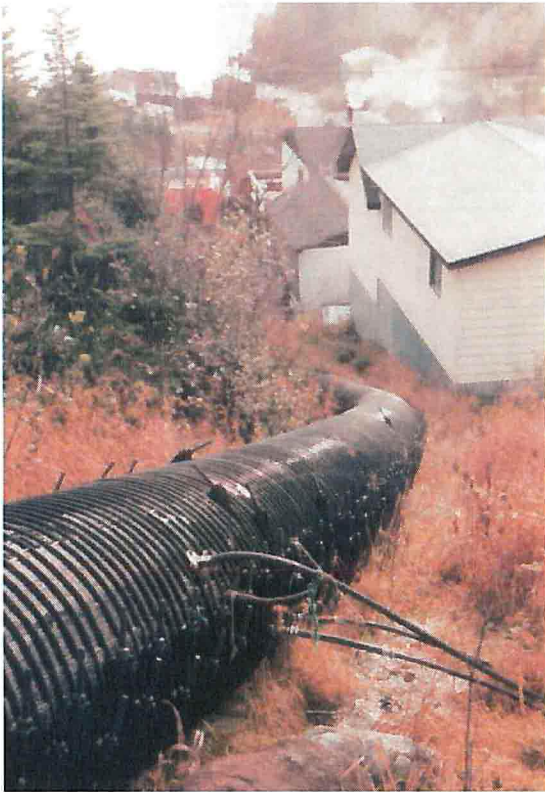
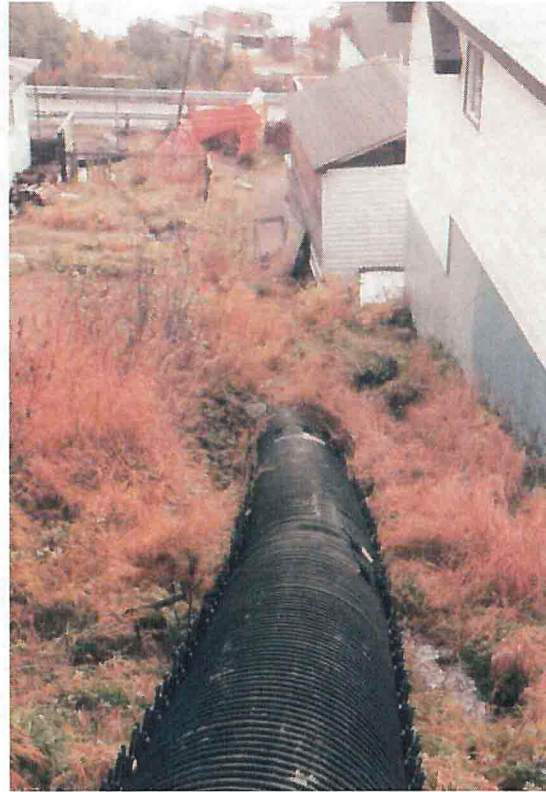
The penstock passes through the middle of the community and at times, is within a few feet of the adjacent houses; see photos #20 & #21. Also a considerable length of the penstock, approx. 200 ft is buried, refer to location #3 on map SA-2 and see photo #22. In 1998, a section of the buried penstock was excavated and it was observed that the penstock is supported on cradles, similar to the rest of the penstock. Buried penstocks are designed to be fully supported along their length, the discovery of cradles supporting the penstock in the buried section, suggests that the penstock was not designed to be buried. The burial of the penstock subjects it to additional loads from the overburden soil and live loads from vehicles, skidoos, woodpiles, etc. In addition, there is very poor drainage around the penstock causing the penstock to be submerged in water. The risk associated with this section of penstock is high because of additional loading, moist conditions and lack of maintenance; there is a high probability of failure of this section of the penstock.

Photos #20 & #21: View of penstock passing through community, October 1992.

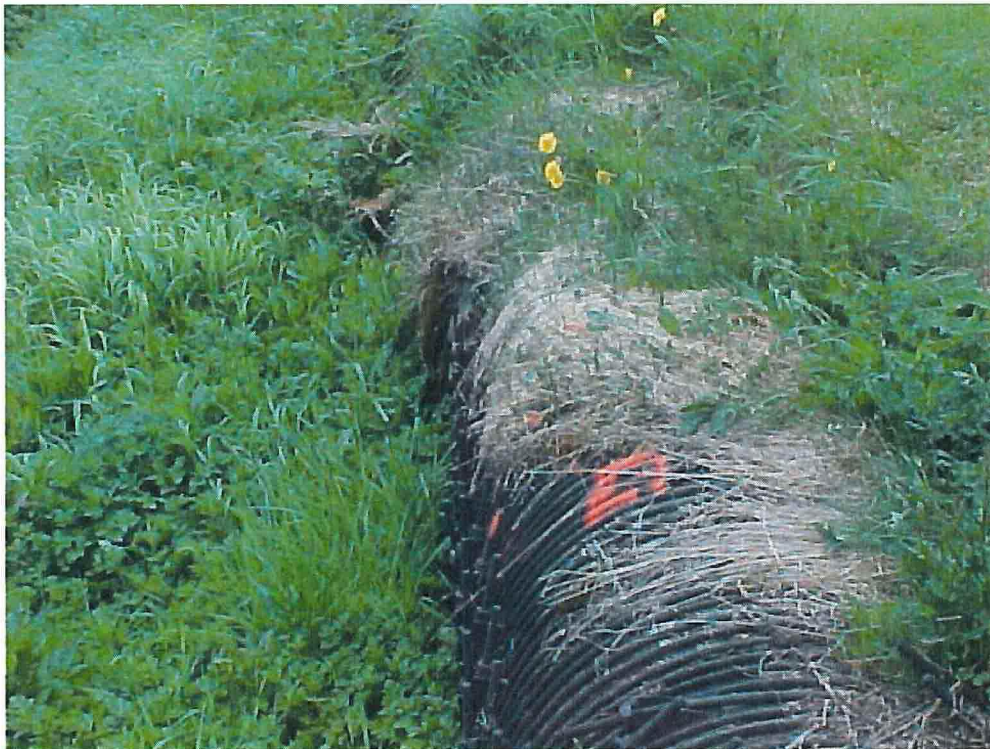
Photo #22 Buried section of penstock in community, June 2001.

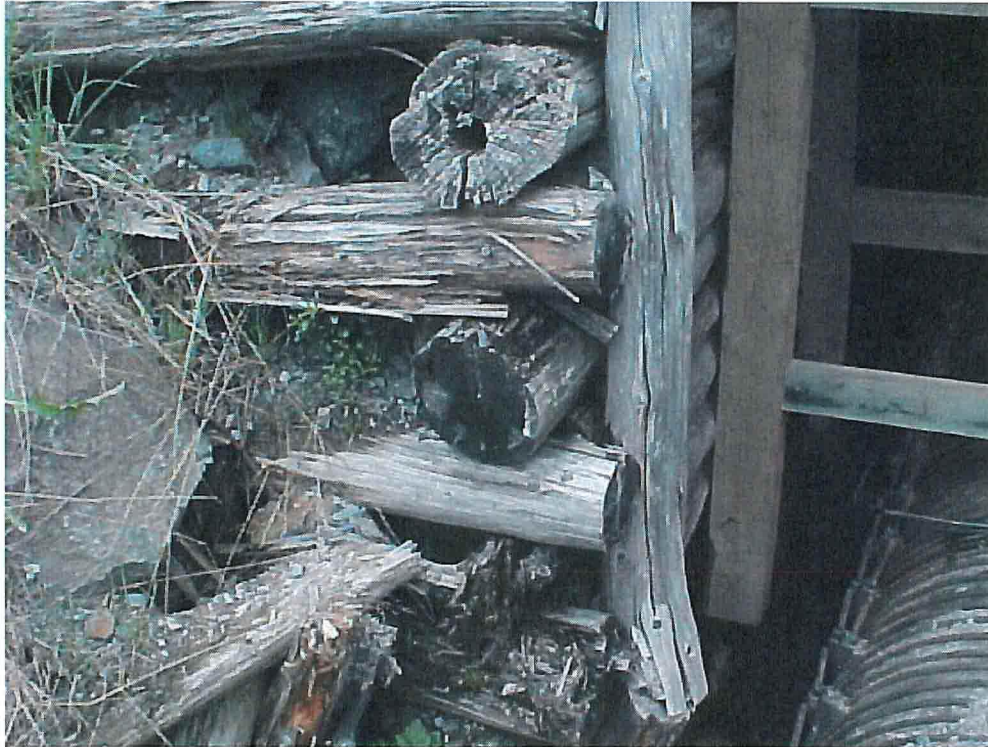
Some of the existing bridge components were constructed in 1971 and they are showing obvious signs of deterioration. The bottom section (approx. lower $\frac{3}{4}$) of the bridge abutments are constructed from local untreated timbers and they are deteriorating, see photo #23. It appears that the only thing keeping the abutments from collapsing is a framework of pressure treated timber braced between the existing abutments, which were installed several years ago, see photo #24. The department of Works, Services and Transportation have indicated that they have no plans to replace this structure in the near future.

Photo 23: View of bottom portion of bridge abutment, June 2001.

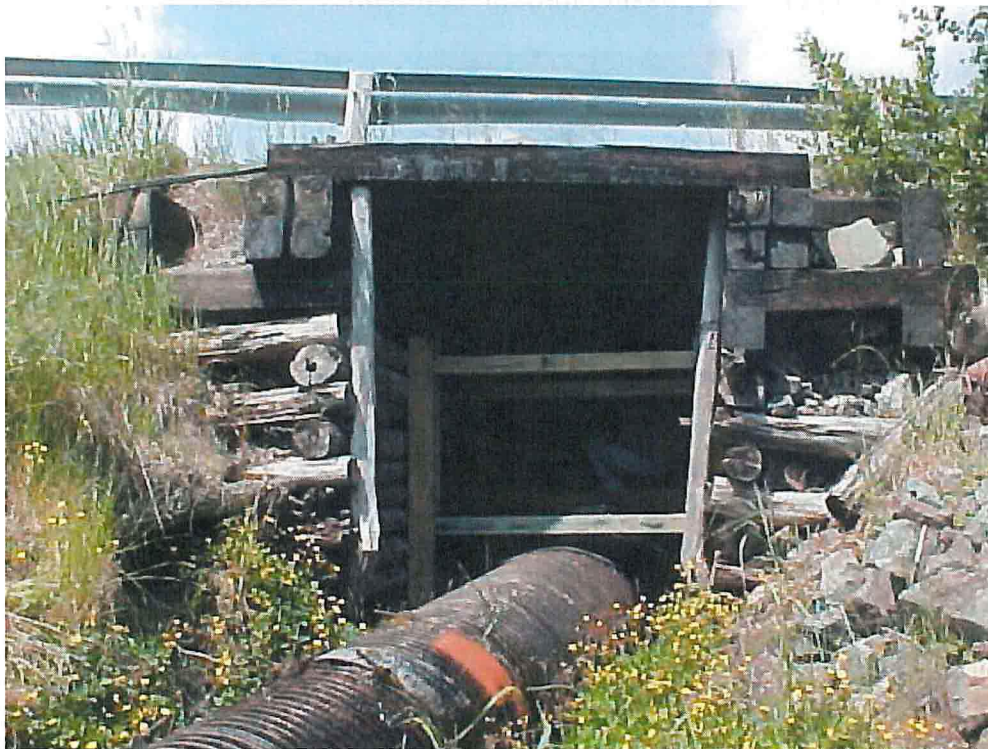
Photo 24: Road bridge over penstock, note timber reinforcement between abutments, July 2002.

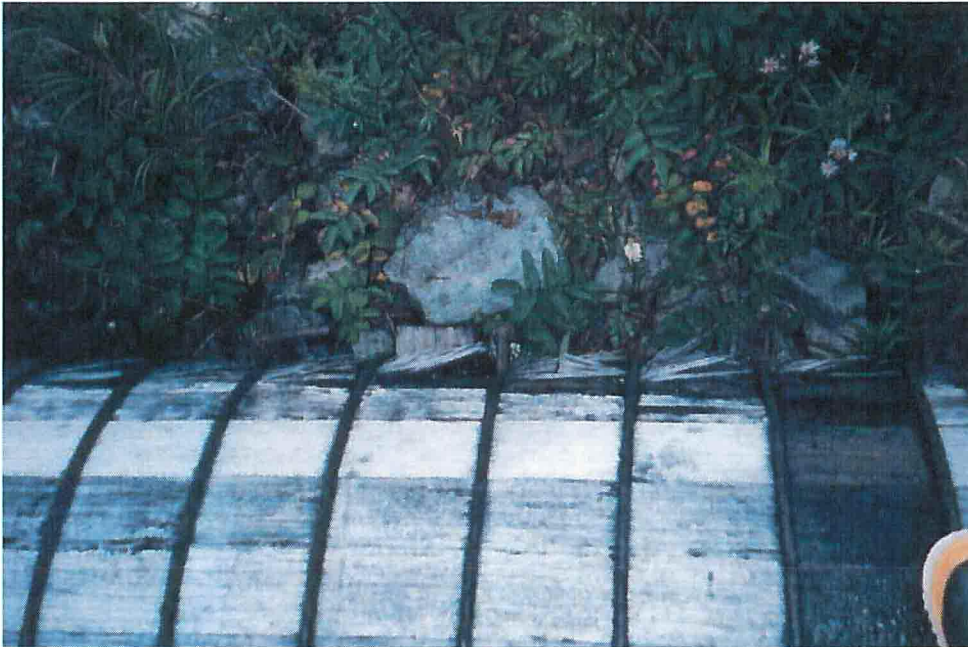
The original wooden penstock components were coated with creosote to provide protection from deterioration and sunlight. Typically a wood penstock would be recoated with creosote every 5-10 years to maintain the protective coating. This penstock has not been coated for at least 15 years (due to environmental restrictions on the use of creosote) and as a result the majority of the wooden penstock has no protection coating, especially along the top, see photo #25. The lack of protective coating has accelerated the deterioration of the wooden staves.

Photo #25: Loss of protective coating on penstock and bleaching of the wood, August 2000.

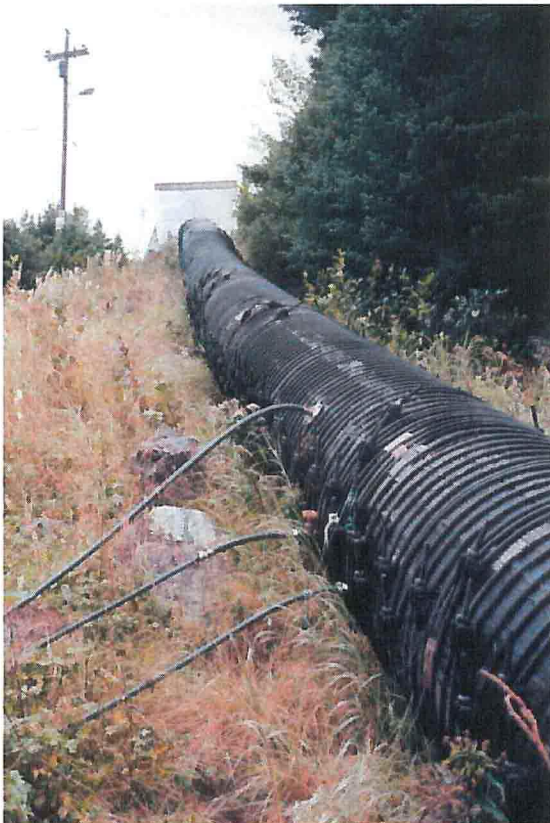
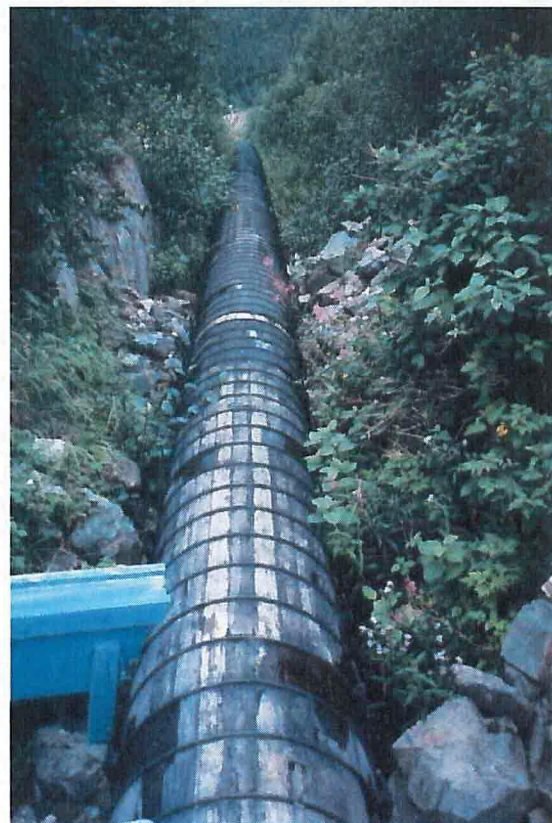
As indicated earlier, the penstock passes through the community and in several locations the penstock is within a few feet from homes and roadways. The proximity of the penstock to the homes has encouraged many residents to tap into the penstock for a source of water, see photos #26 & #27. These taps were constructed without any permission from Hydro and in several locations have been abandoned and leaking water, see photo #28. In addition, all terrain vehicles and skidoos travel over and under the penstock, which imposes additional loads and stresses on the penstock. In the upper half of the penstock, there is firewood stacked adjacent to the penstock, see photo #29, and in several places there are cuts in the penstock from chainsaws. The use

Photos #26 & #27: Water take-offs to adjacent homes (left) and Nugget Pond gold mine security building (right), August 2000.

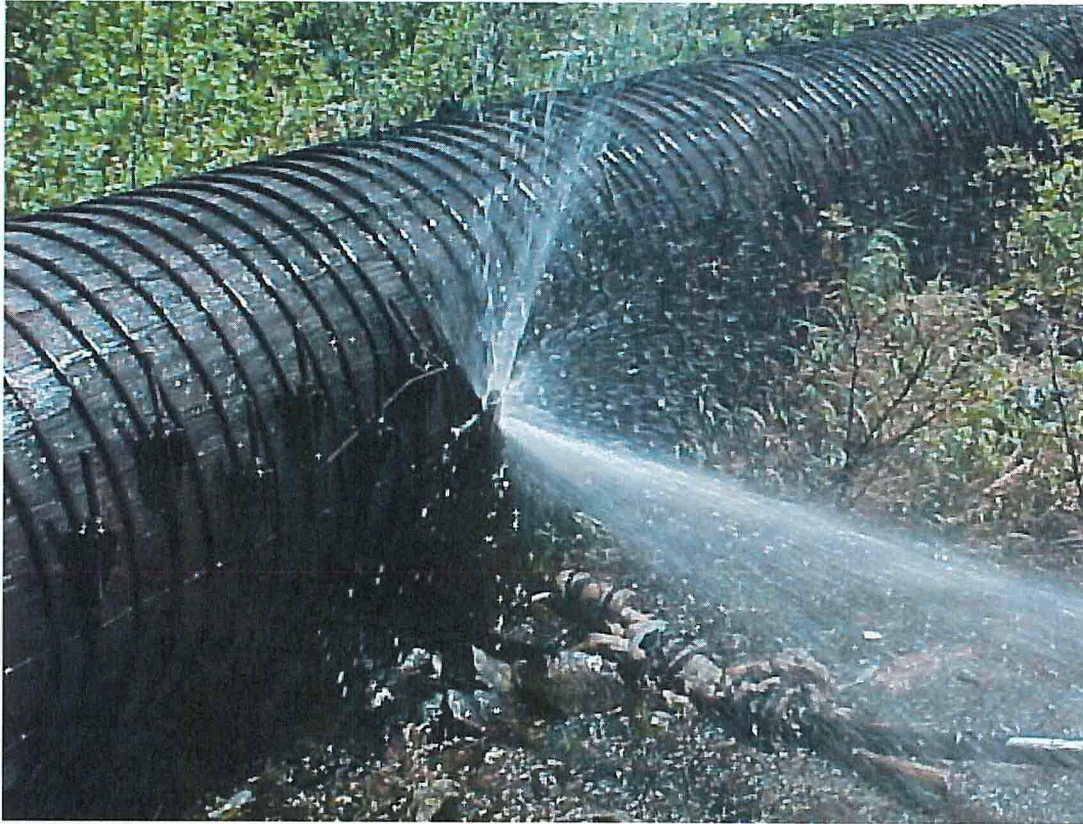
Photo #28: Location of abandoned water tap in penstock, June 2001.
