Snook's Arm Wood Stave Penstock

Evaluation, Recommendation and Estimated Cost for Replacement

Newfoundland and Labrador Hydro
Generation Engineering

January 26, 2004

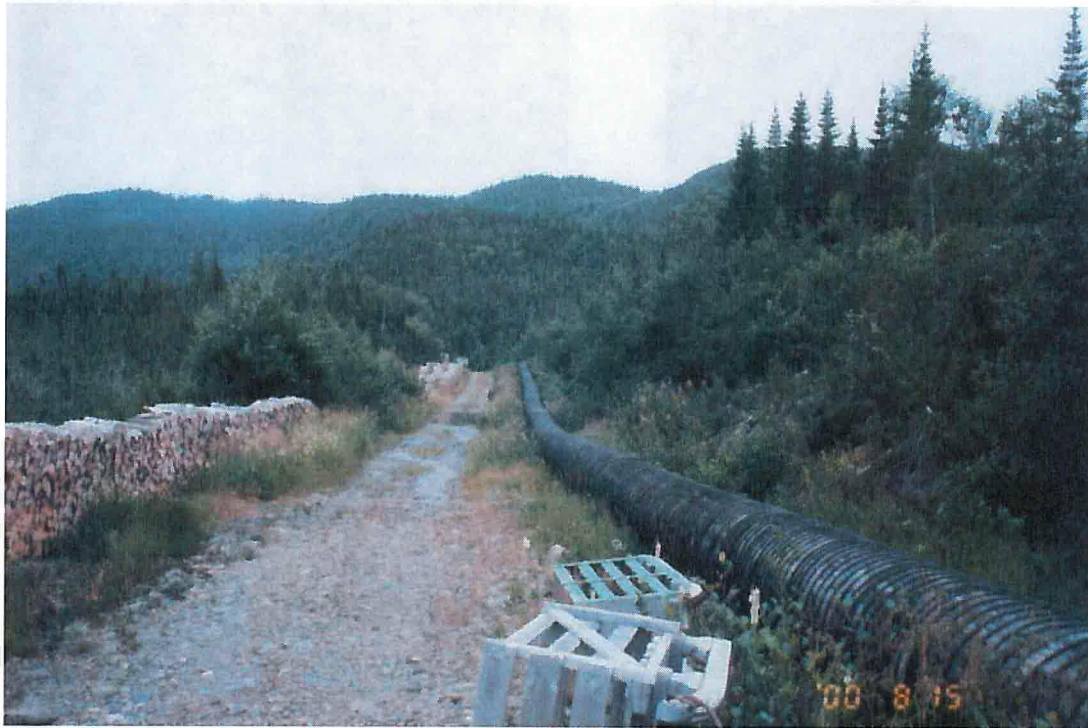
Photo #29: View of access road and firewood adjacent to penstock, August 2000.

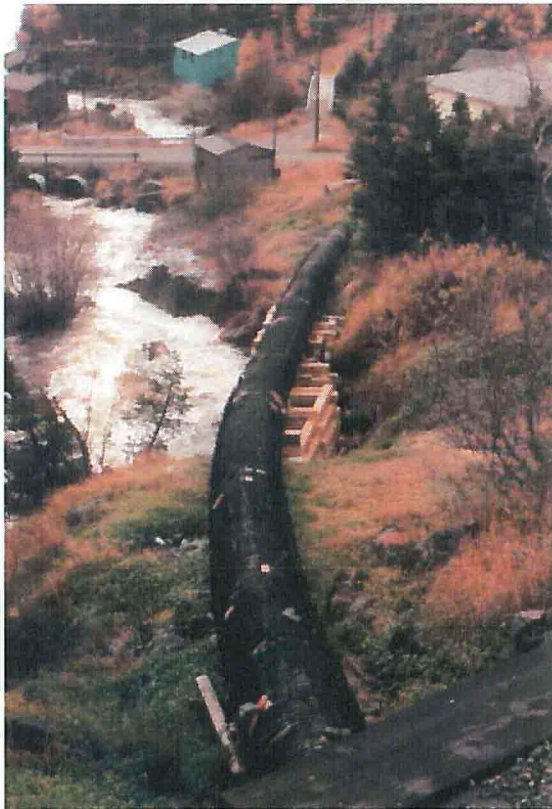
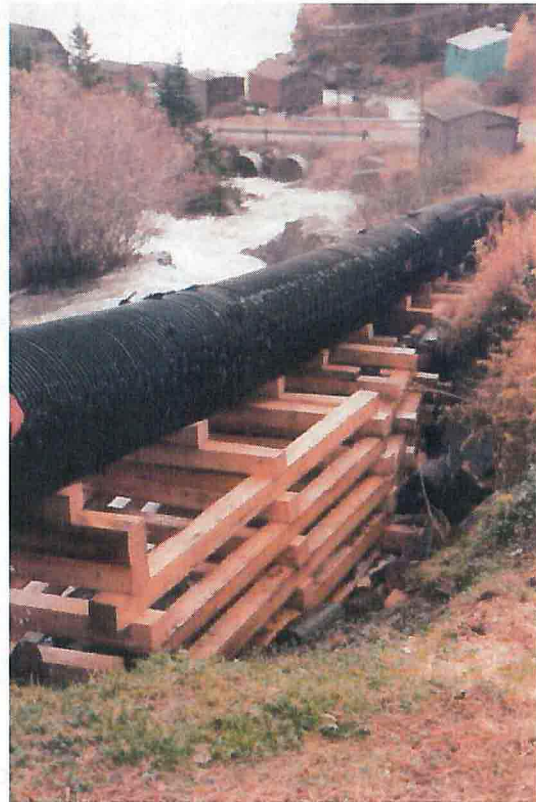
The lower section of the penstock passes under the main access road to the community and then proceeds along the side of a brook towards the powerhouse, refer to location #5 on map SA-2. In 1992 high water levels in the brook caused a section of the embankment under the penstock to erode. Untreated timber cribbing was installed along side of the brook to support the penstock, see photos #30 & #31. The timber support is 15 years old and is still subject to brook damage. The penstock has also developed a noticeable dip in elevation at this location resulting in more leaks.

Photos #30 & #31: Timber support added under penstock after erosion of embankment, October 1992.

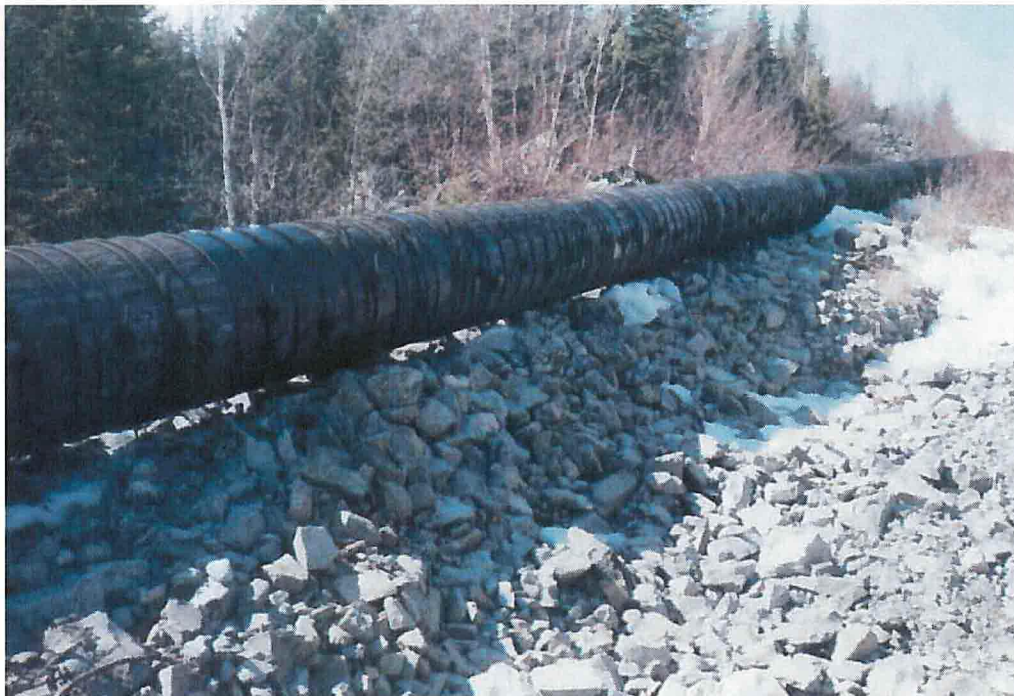
In 1996 water overtopped Snook's Arm main dam and caused flooding downstream. The flooding caused a 200 ft section of the access road to the Nugget Pond gold mine to be washed away. The flooding caused a significant amount of rock and debris to move downstream and adjacent to the penstock. Though, the majority of the rock debris was removed, however some of the rocks remain next to the penstock, see photos #32 & #33. This rock debris probably has and will continue to impose stresses on the penstock and, which over time, may displace the penstock transversely. Another similar event would likely have a major impact on this section of the aged and weakened penstock.

Photo #32: View of rocks and gravel washed up against penstock, April 1996.

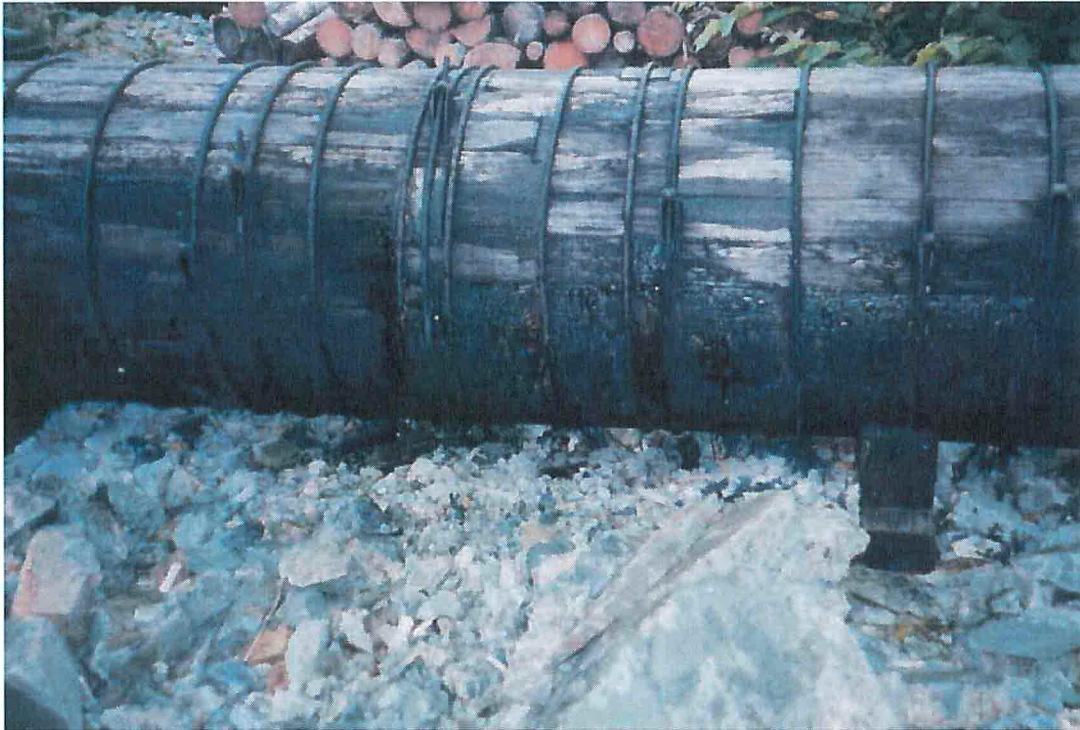
Photo #33: View of rocks and gravel under penstock, August 2000.

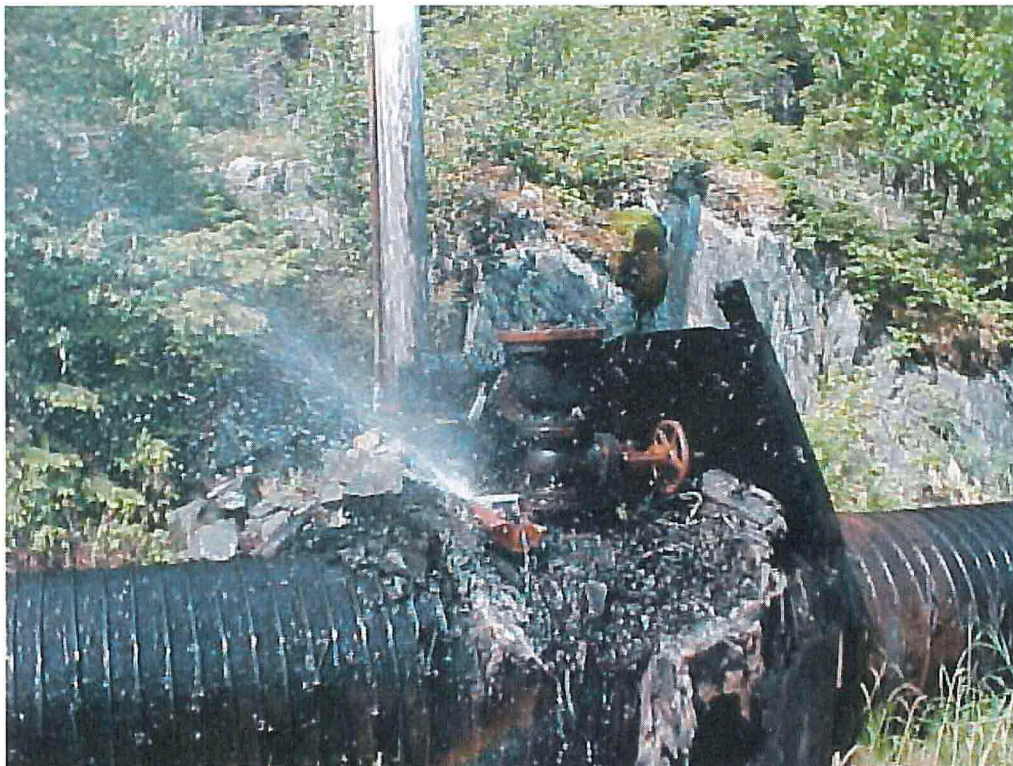
In 2002 a fire occurred in the valve enclosure around the vacuum breaker valve, see photos #34 & #35. The fire was caused by a malfunction of the heat tracing and caused the destruction of the valve enclosure and damage to the valve. Luckily, there was no apparent damage to the penstock. However, the vacuum breaker valve did require repair. And, as stated earlier, if this valve fails to operate when required, the penstock may collapse.

Photo 34: Fire damage to vacuum breaker valve enclosure, July 2002.

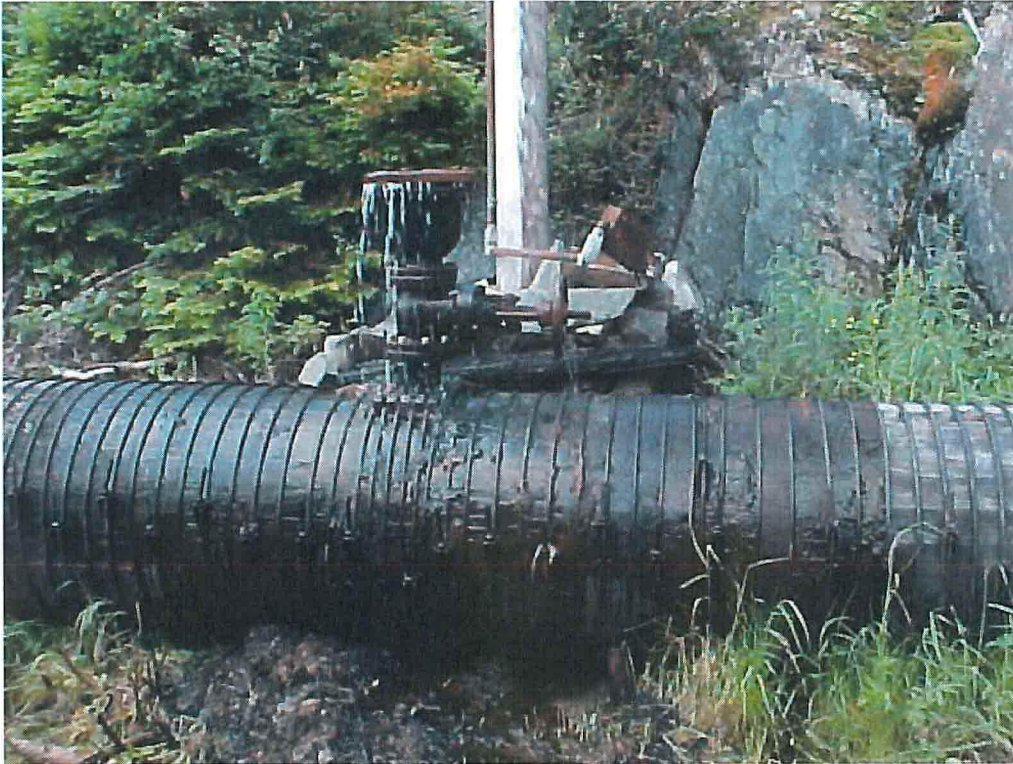
Photo 35: Vacuum breaker valve after fire, July 2002.
