Re: Newfoundland Power's 2015 Capital Budget Application

**Pierre's Brook Hydro Plant
Penstock Replacement and Surge Tank Refurbishment**

June 2014

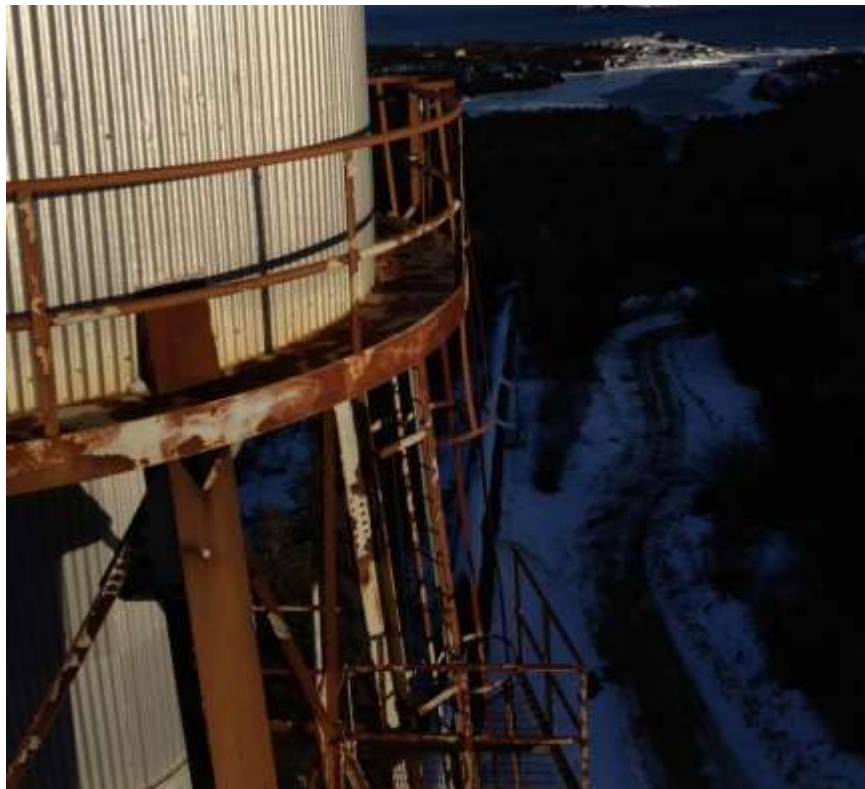
Figure 29: Deteriorated Coating – Deck

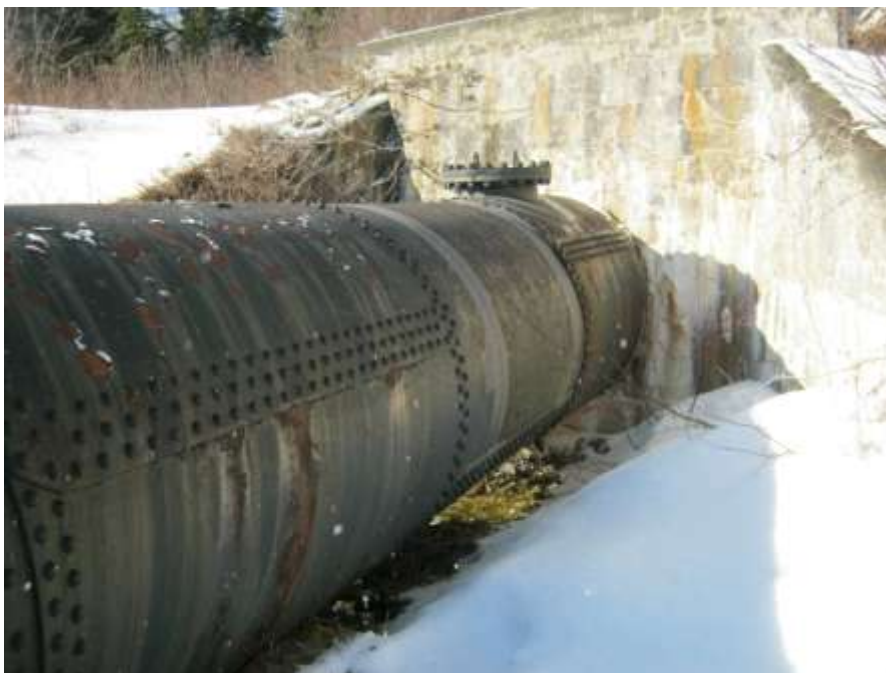
Photo C-6: General condition of steel penstock shell

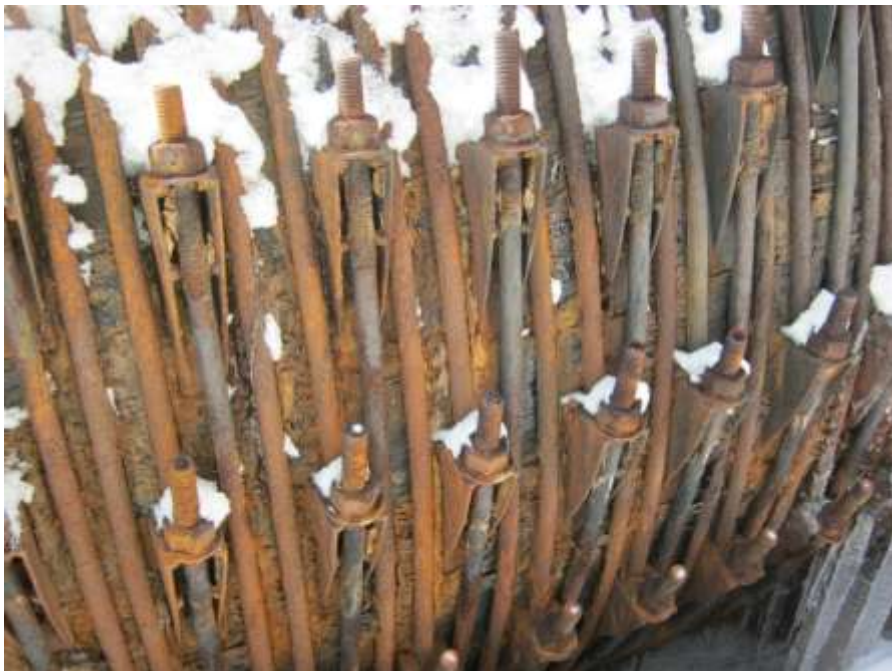
Photo C-17: Deteriorated wood staves near downstream end of penstock

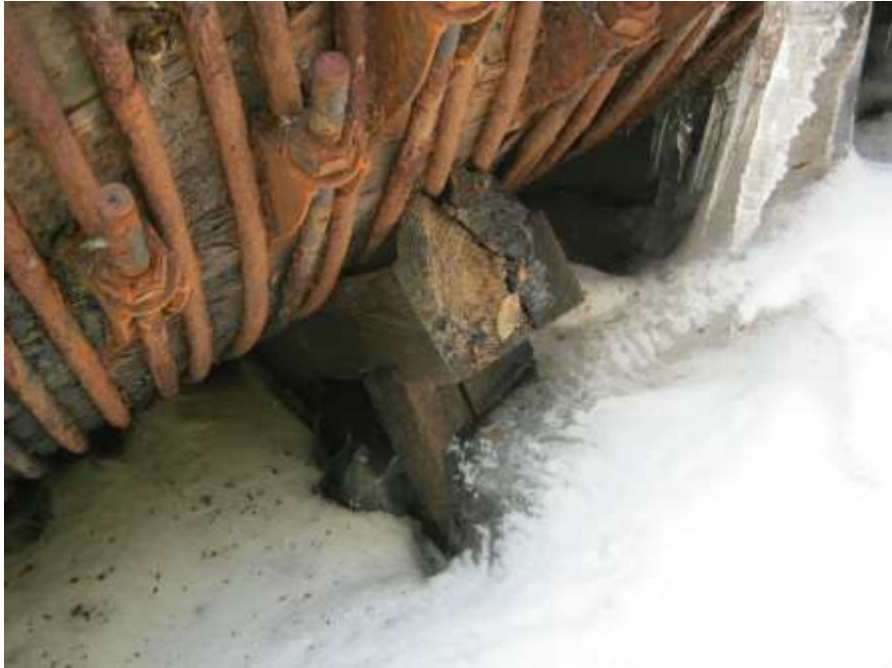
Photo C-18: Deteriorated cradle

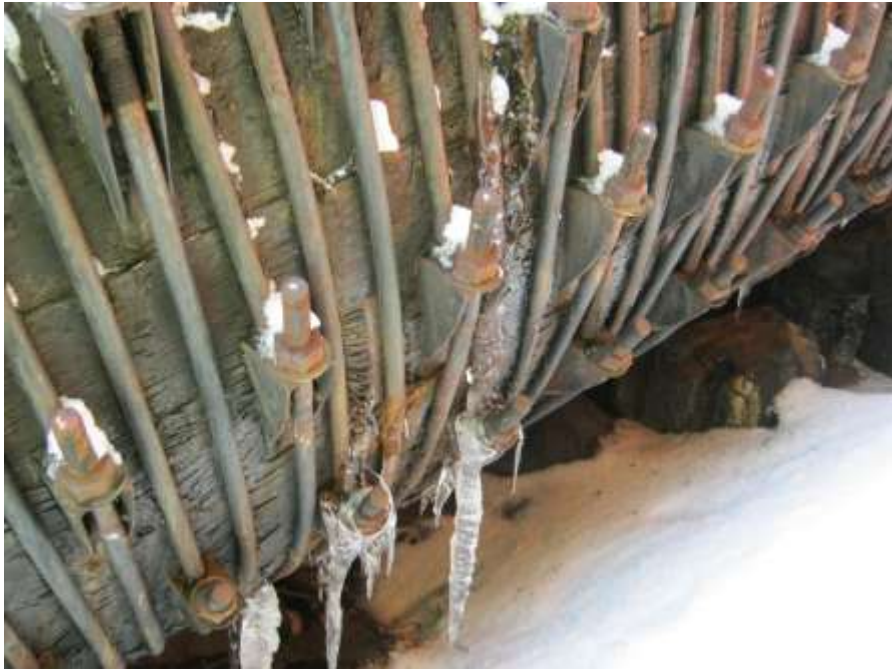
Photo C-20: Crushed staves, and broomed ends of staves

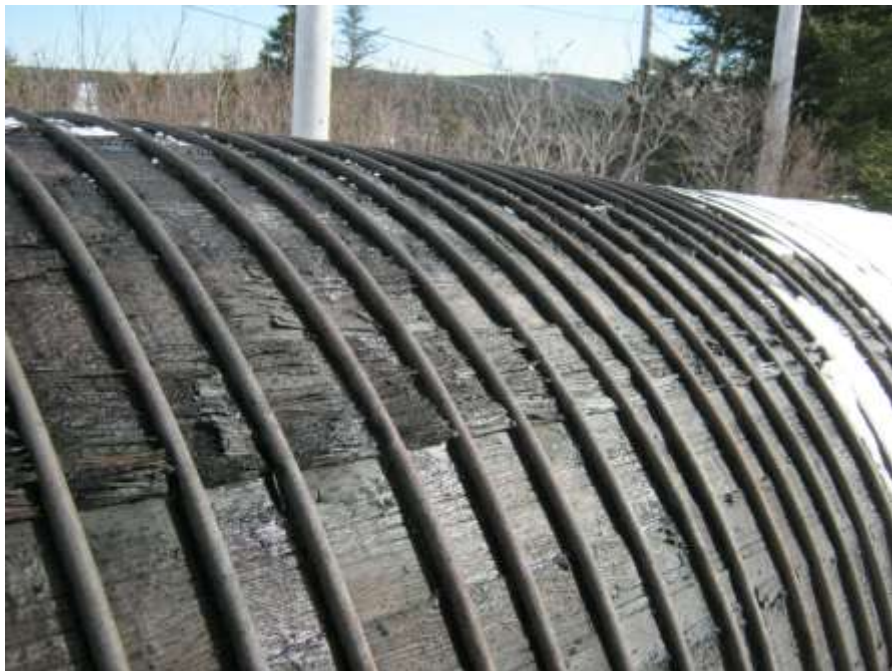
Photo C-23: Example of delaminated stave and crushing under the bands

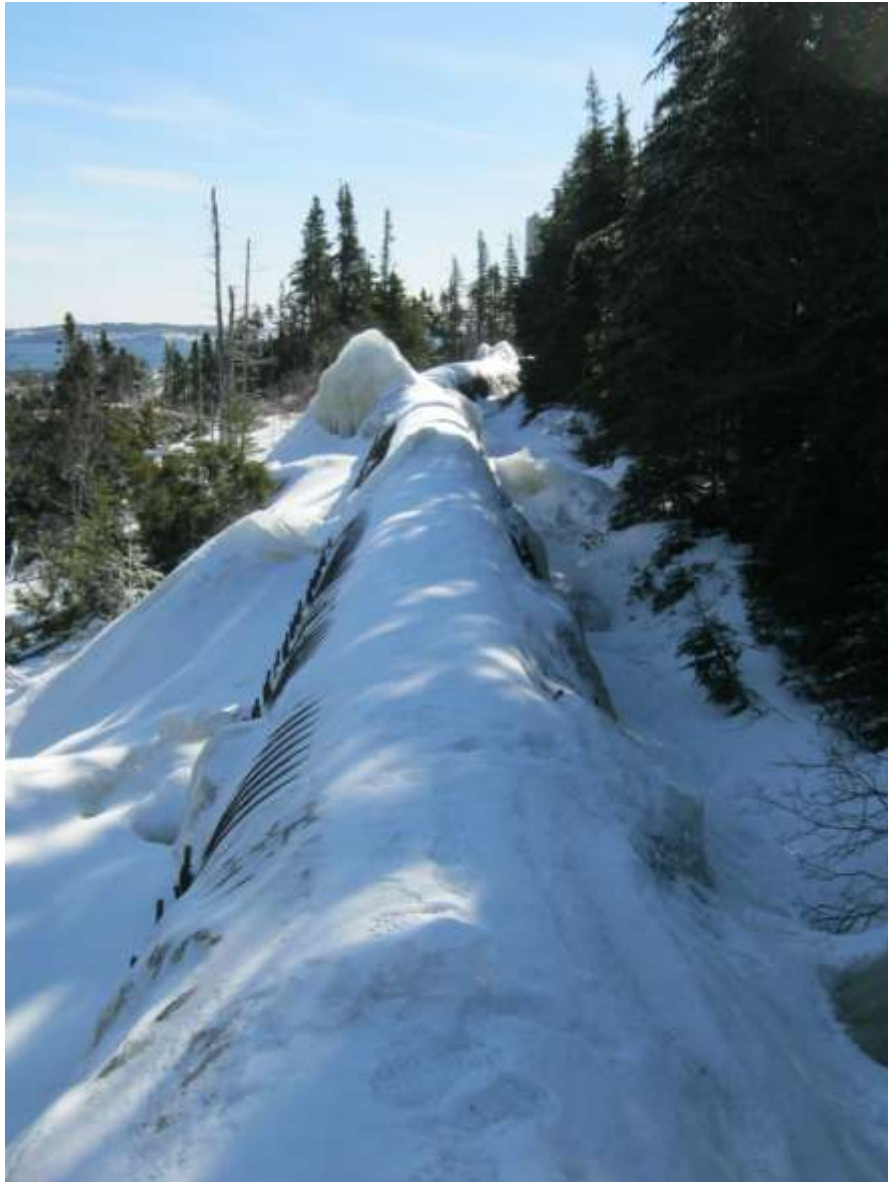
Photo C-37: General view of penstock upstream of surge tank showing leakage

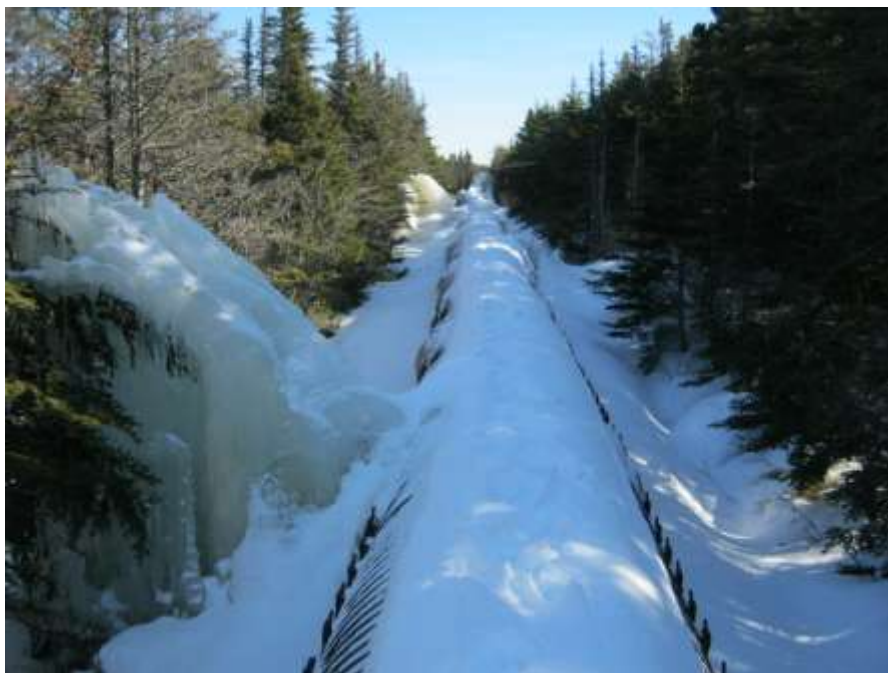
Photo C-41: General view of penstock showing leakage

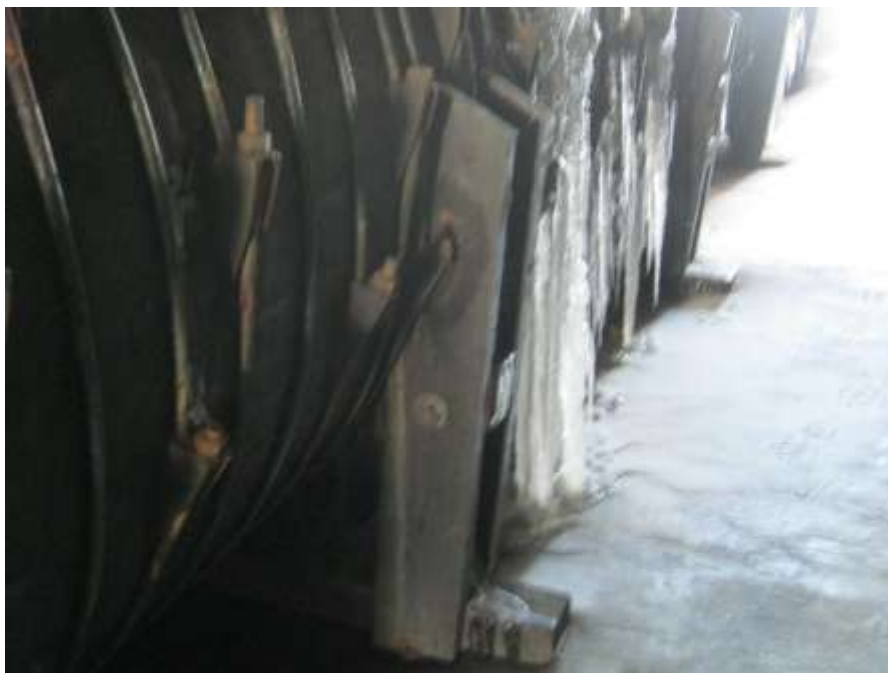
Photo C-45 Change in cradle design at location of highway crossing

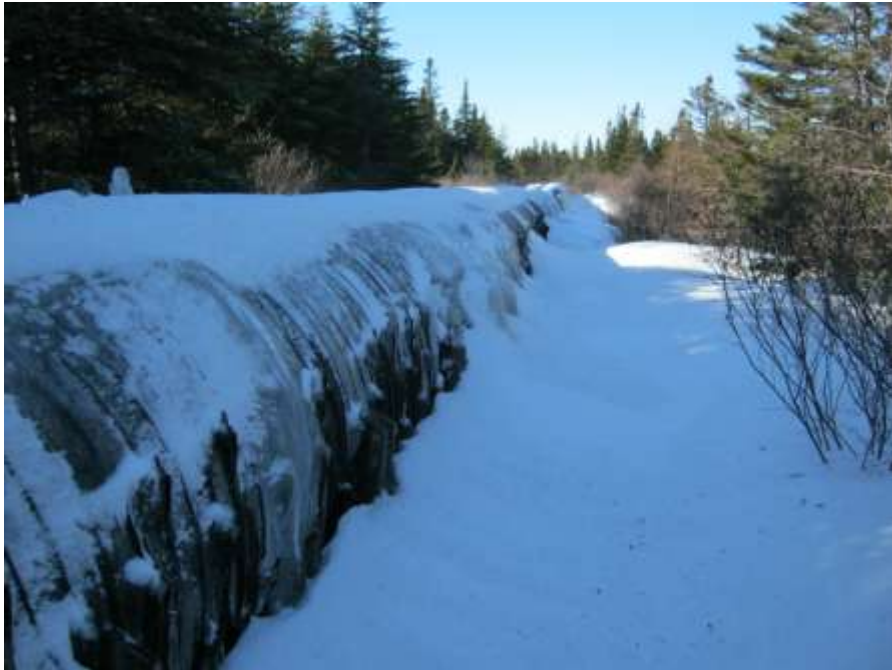
Photo C-52: Widespread leakage at springline

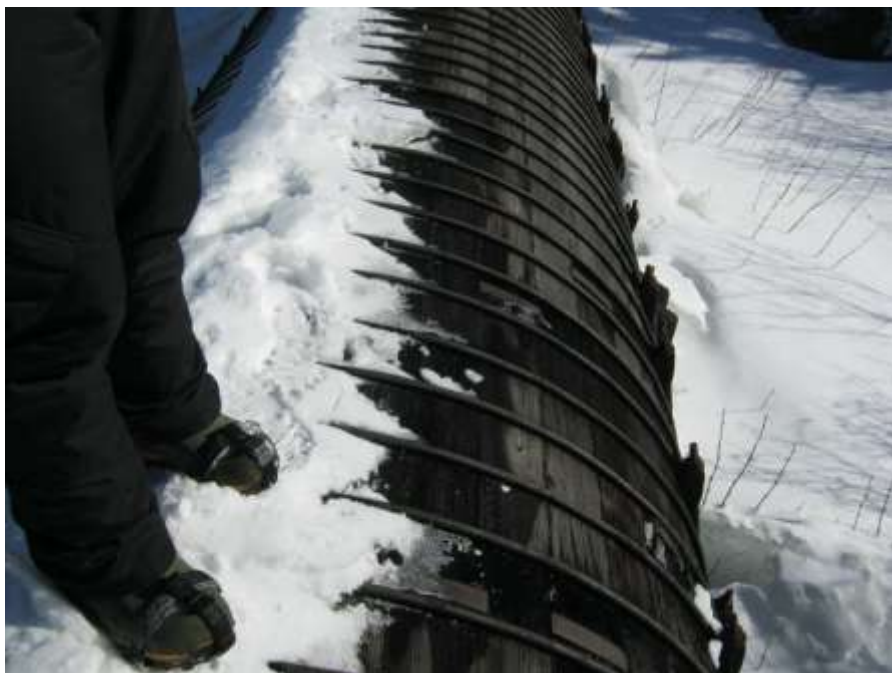
Photo C-55: Typical condition of wood stave preservative treatment

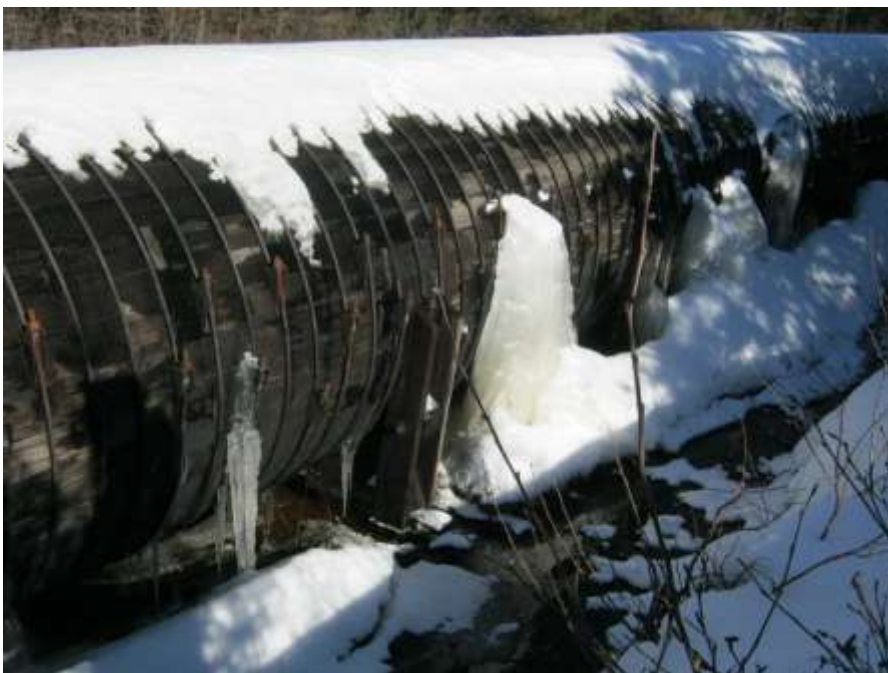
Photo C-57: Poor drainage of penstock bed

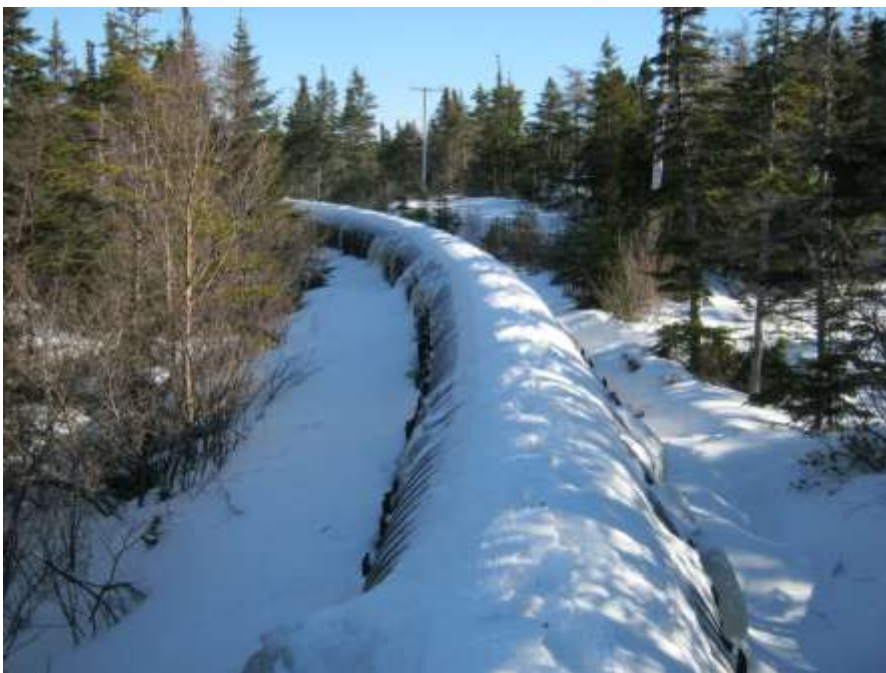
Photo C-59: Leakage along springline of penstock

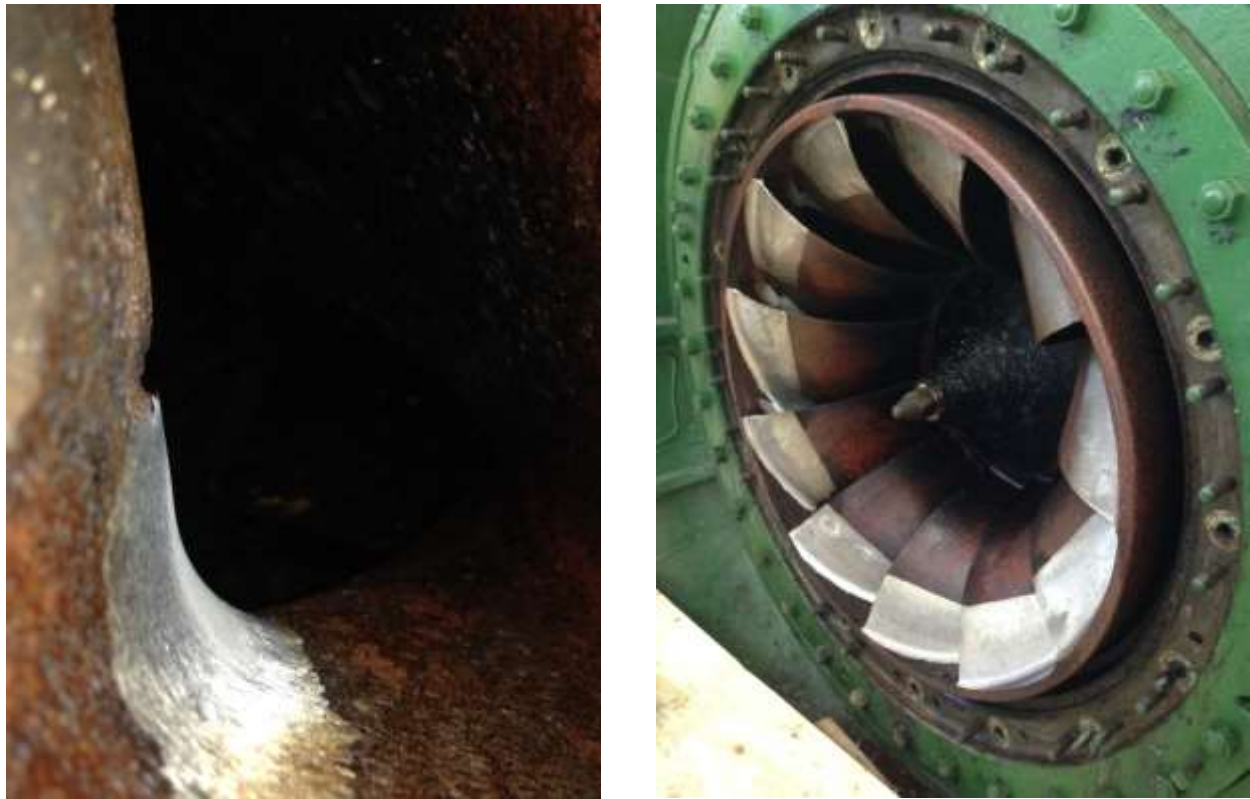
A recent inspection of the turbine runner showed some erosion on the low and high pressure side of the turbine blades.⁸ The heaviest erosion is on the high pressure side where the blade is welded to the runner band. There were also isolated areas of heavier erosion on the inside of the runner band.

**Figure 2 – 2014 Photos of the G2 Turbine Runner
Showing High Pressure and Low Pressure Erosion Respectively**

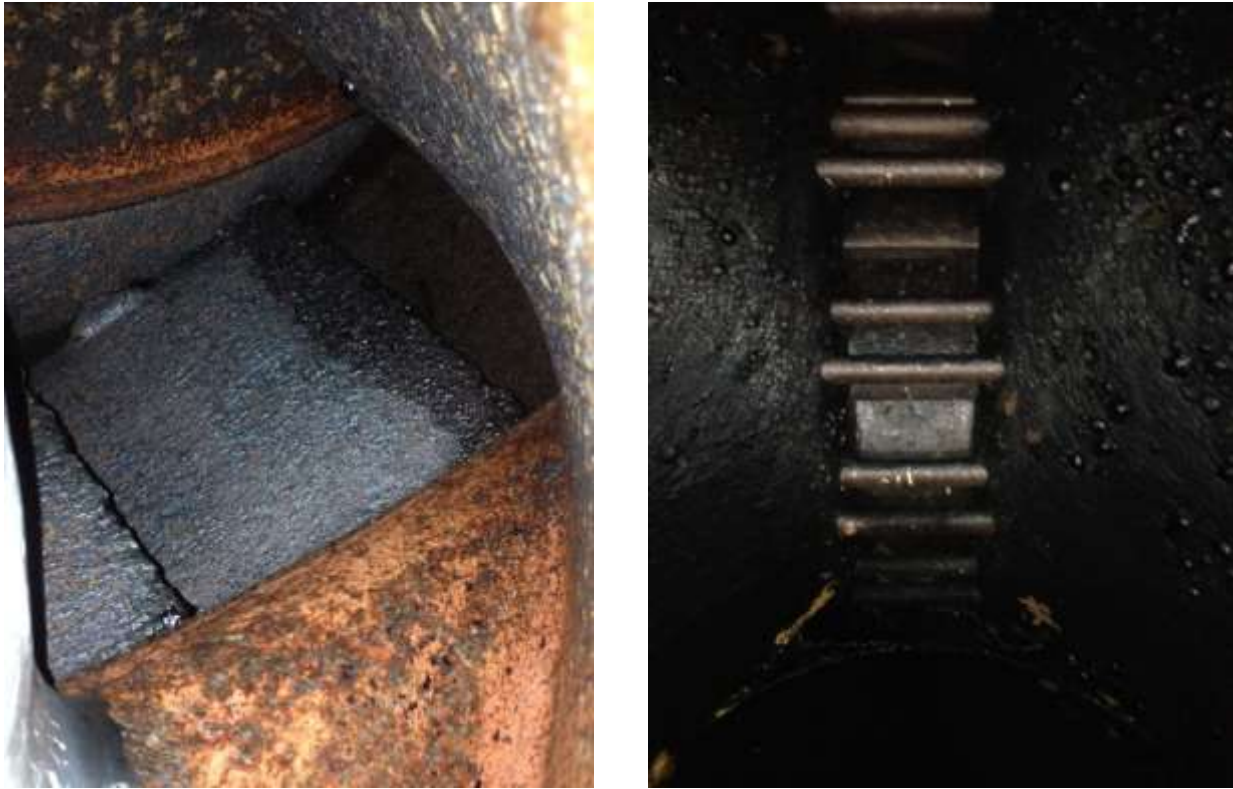
The turbine stay vanes in the scroll case were found to be in good condition. The original 1941 wicket gates were found to have considerable erosion on the toe of the gates (see Figure 3). Considerable leakage was also observed between all gate stems and the gland followers. Stainless steel wicket gates and links will be installed to minimize erosion and ensure continued reliability. Self-lubricating bushings, which require no maintenance and have less environmental risk, will be installed with the new wicket gates.

Figure 3 - 2014 Inspection of the G2 Wicket Gates and Scroll Case

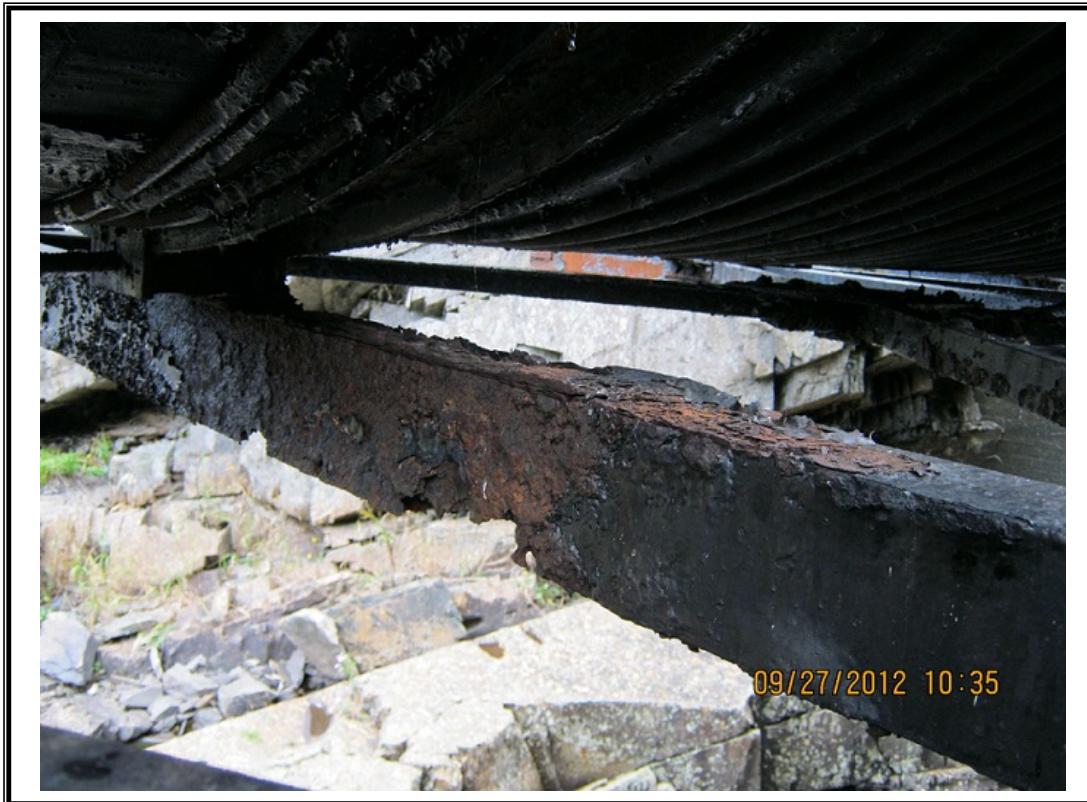
Photo No. 1 – Severely Deteriorated Bottom Truss Transverse Member

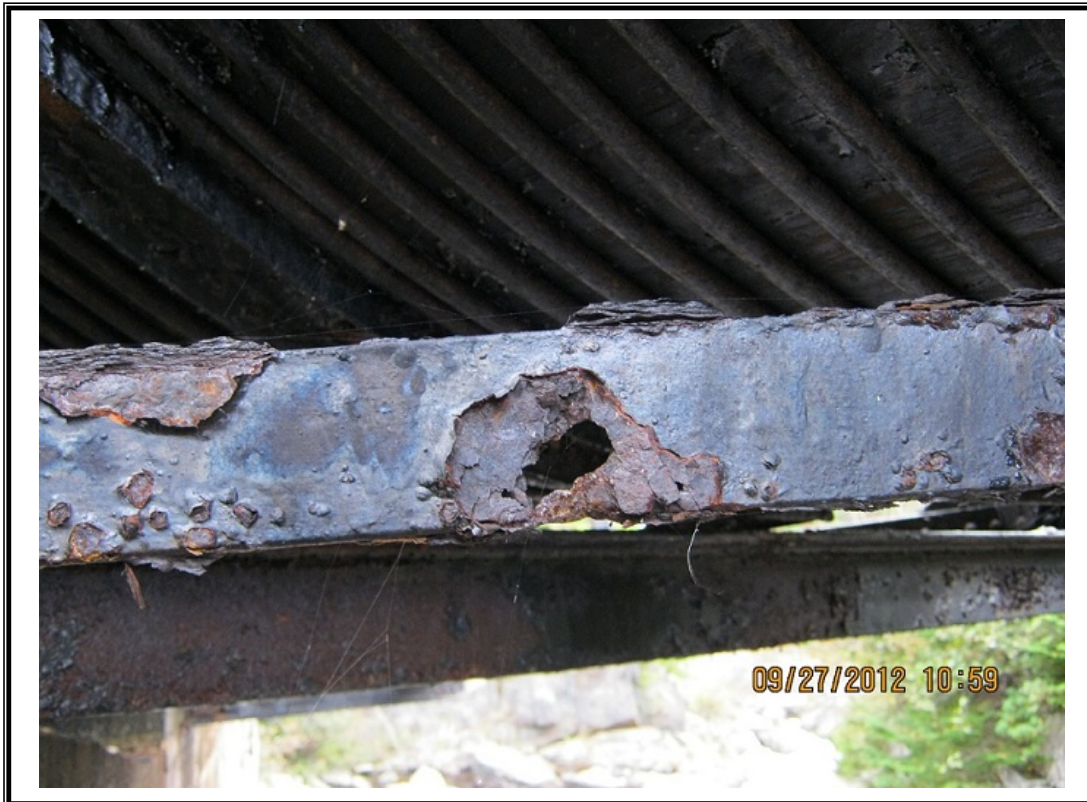
Photo No. 3 – Deteriorated Bottom Truss Horizontal Cross Brace

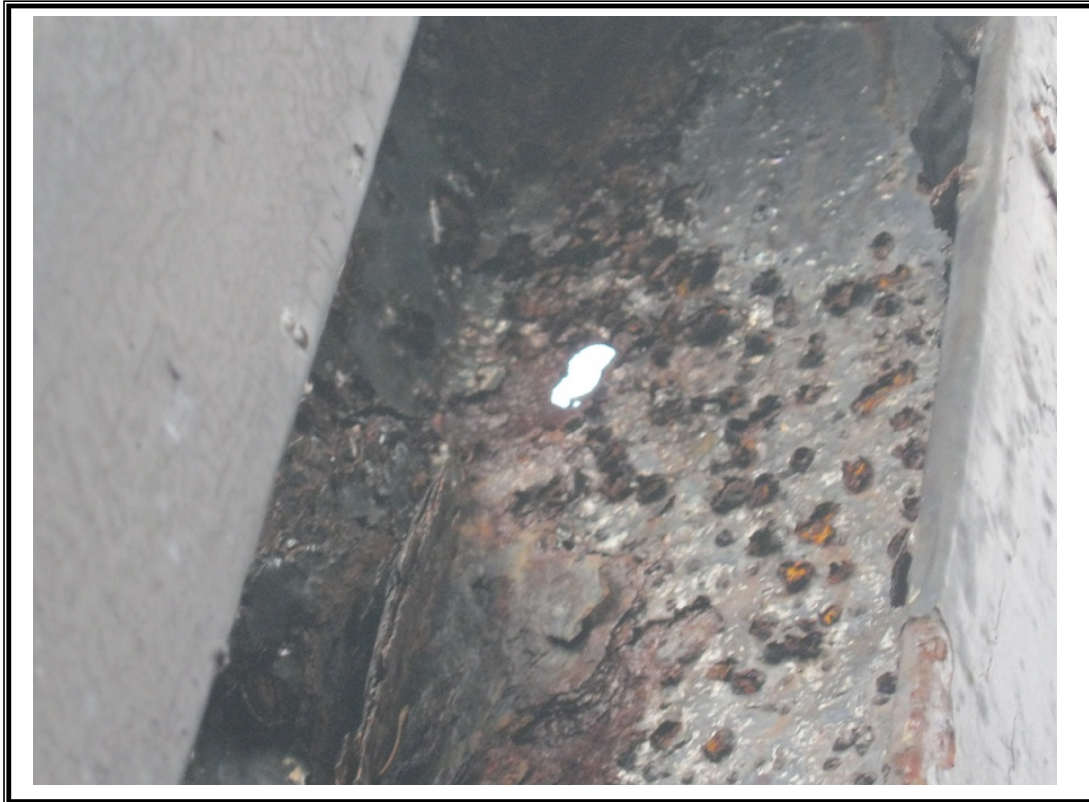
Photo No. 5 – Deteriorated Hanging Support

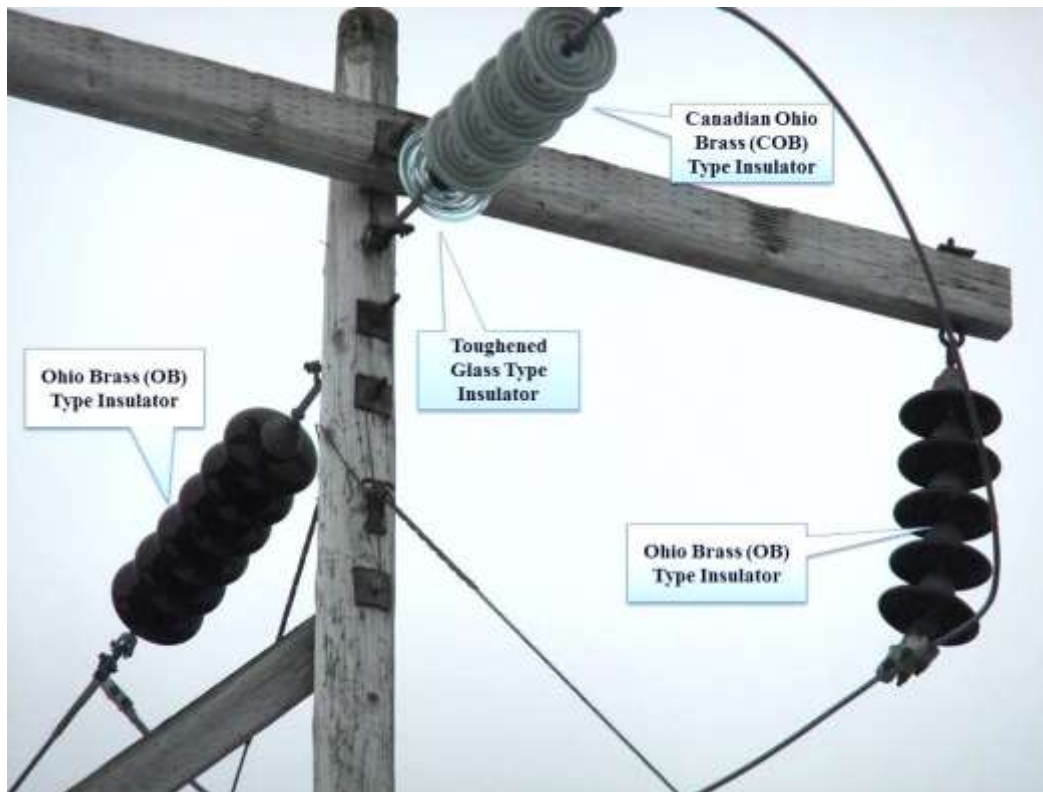
Figure 2 – Insulators

The dark colored Ohio Brass (“OB”) type insulator is original to the 1967 construction. The grey colored COB type insulators were used to replace some of the OB insulators on 400L in the 1980s. There is one toughened glass disc on the COB string of insulators. This type of replacement was typically undertaken in the 1990s.

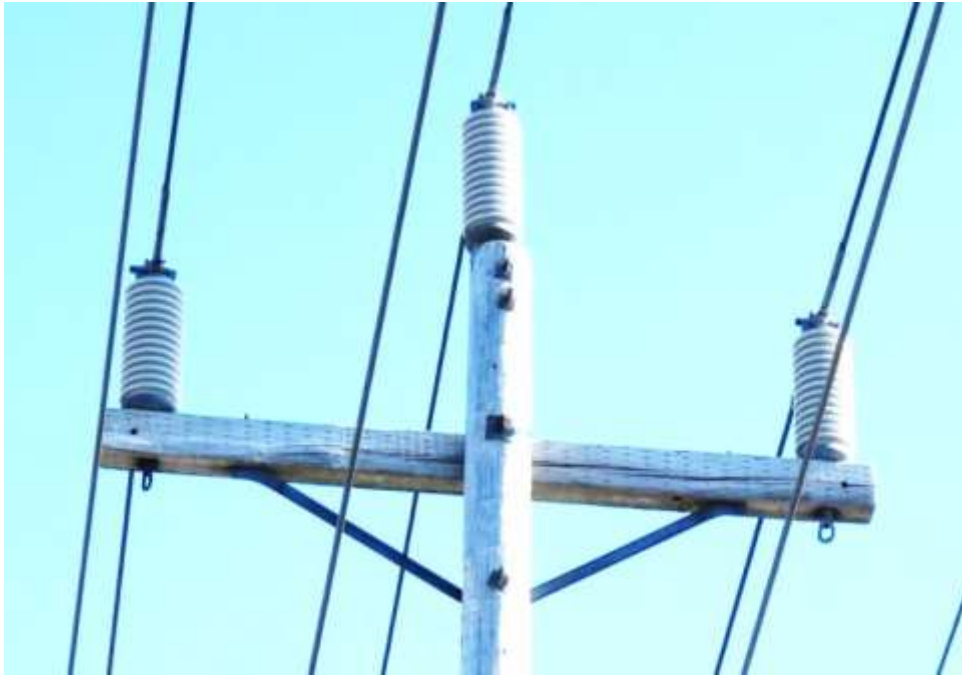
Figure 13 – Split Crossarm

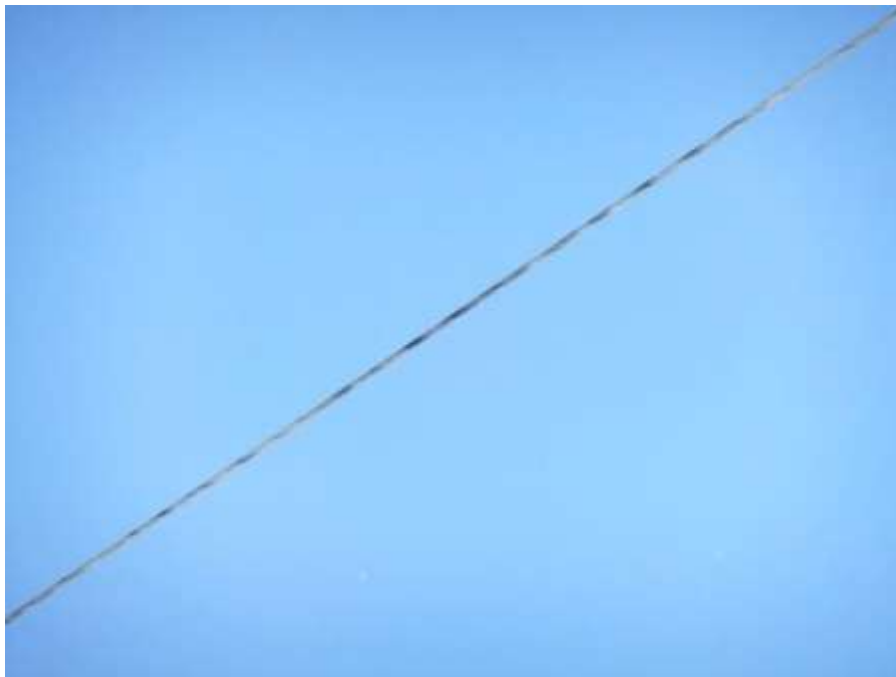
Figure 16 – Conductor Corrosion

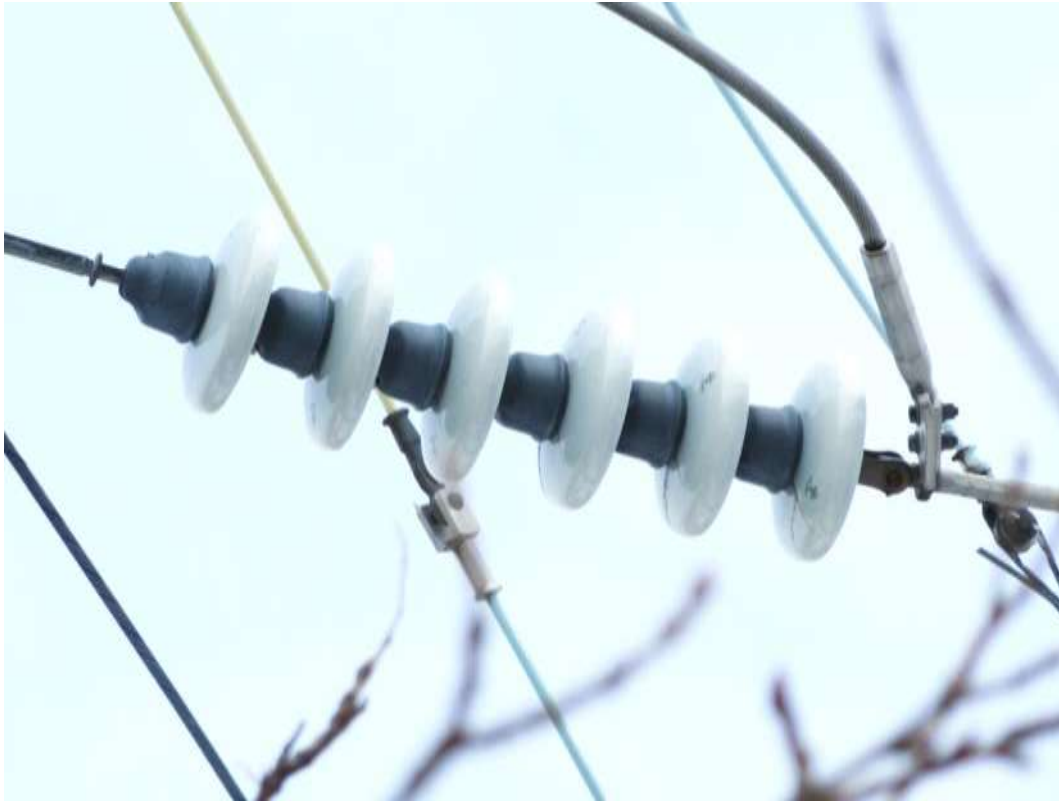
Figure 19 – Hairline Cracks in Insulators

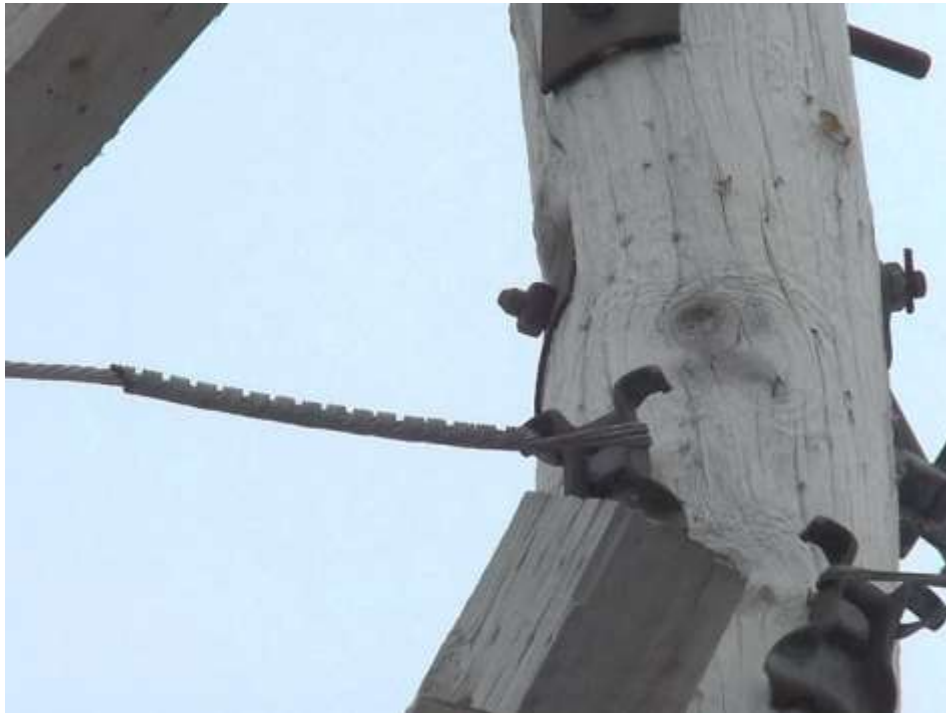
Figure 21 – Pole and Hardware Damage at Guy Wire Attachment

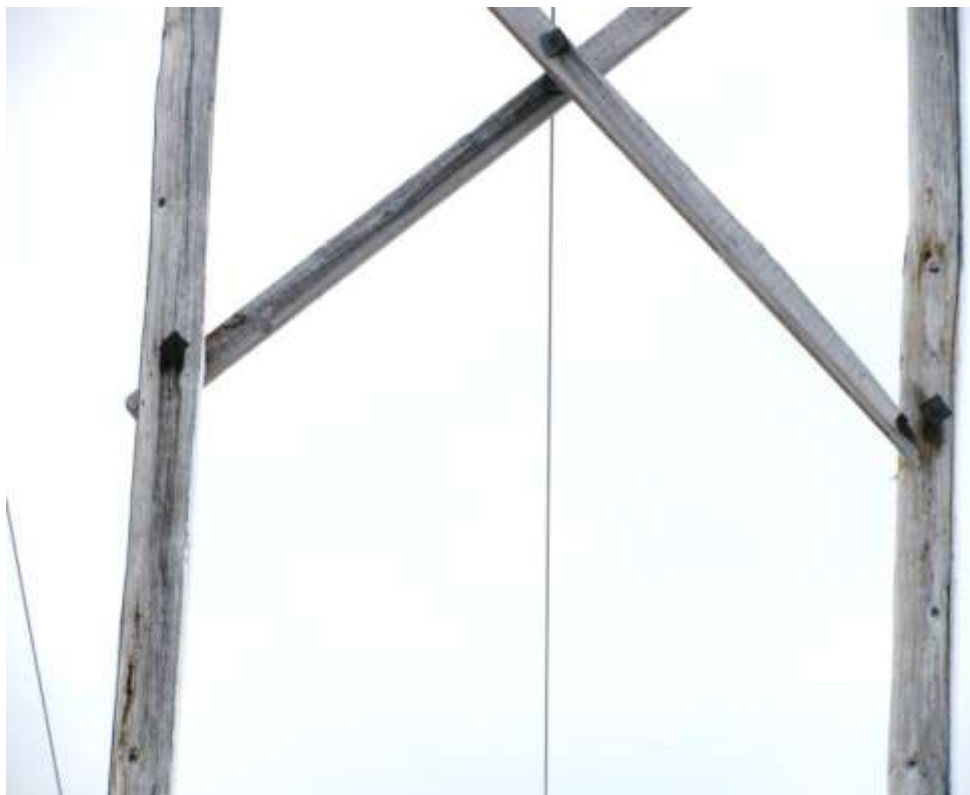
Figure 24 – Crossbrace Damage

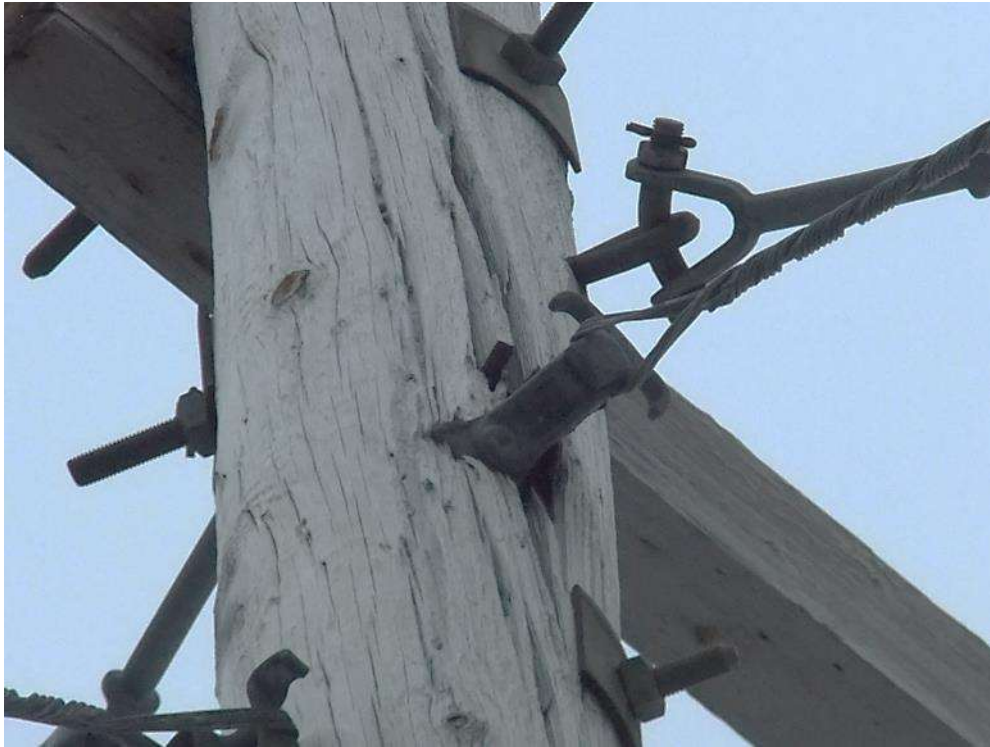
Figure 25 – Severe Pole Checking Due to Shell Separation

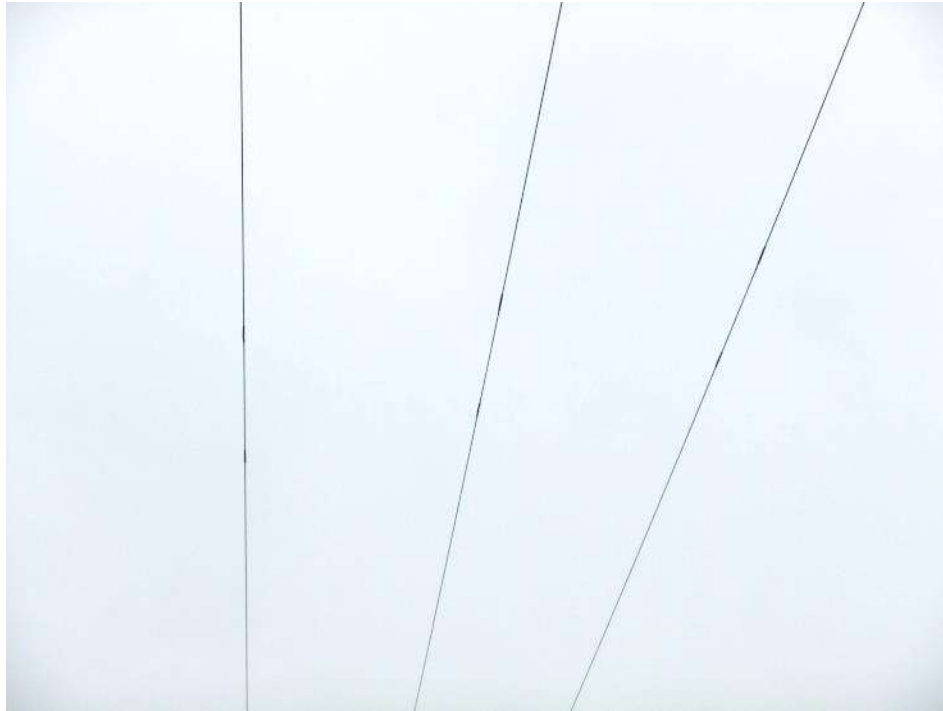
Figure 27 – Repairs to Conductor Due to Phase Contact Damage

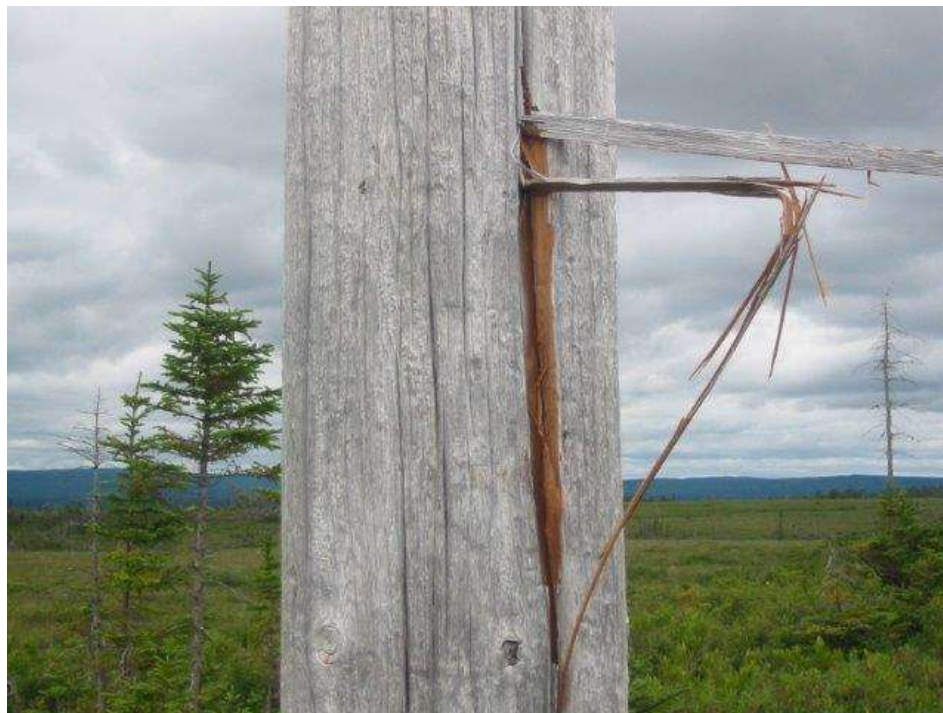
Figure 28 – Pole Shell Separation Showing Exposed Inner Wood

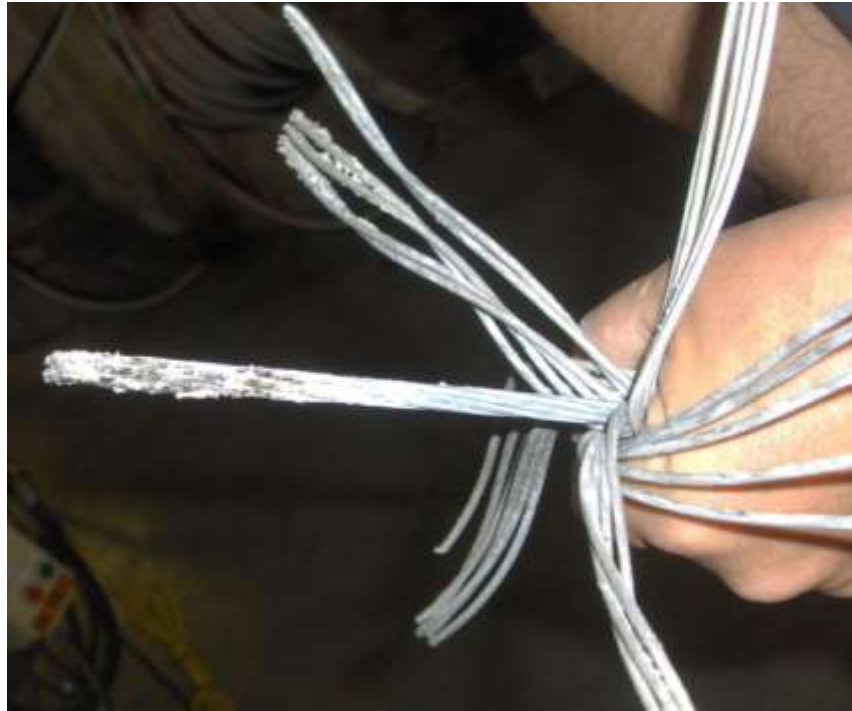
Figure 33 – Oxidization and Corrosion of 266.8 ACSR Steel Core

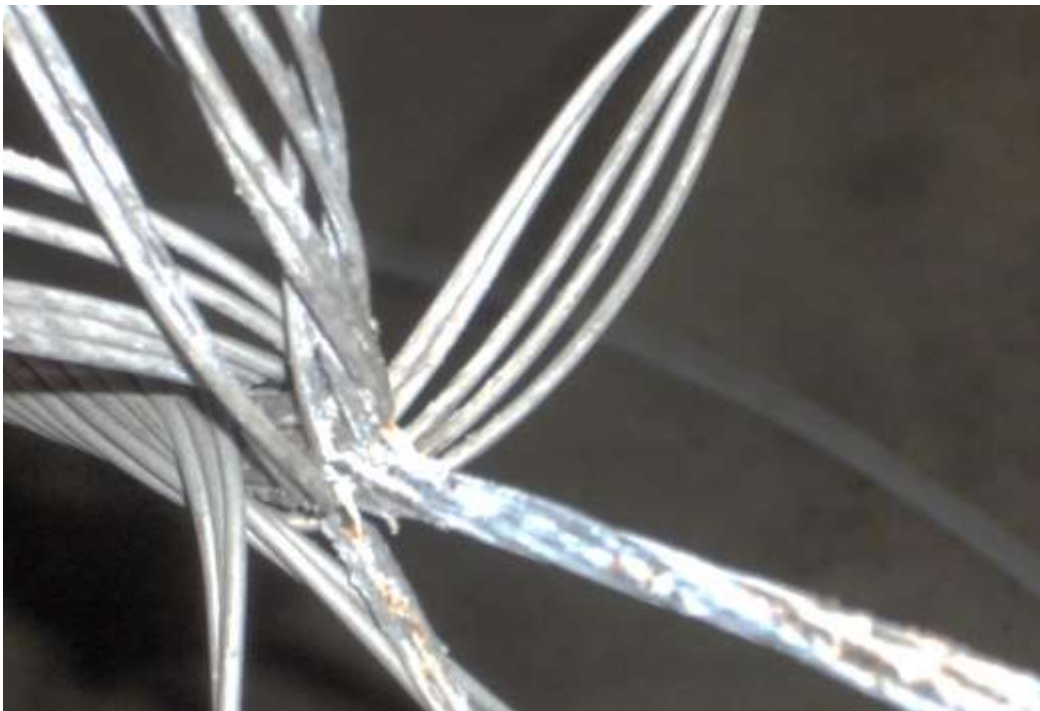
Figure 34 – Oxidization and Corrosion of 266.8 ACSR Conductor

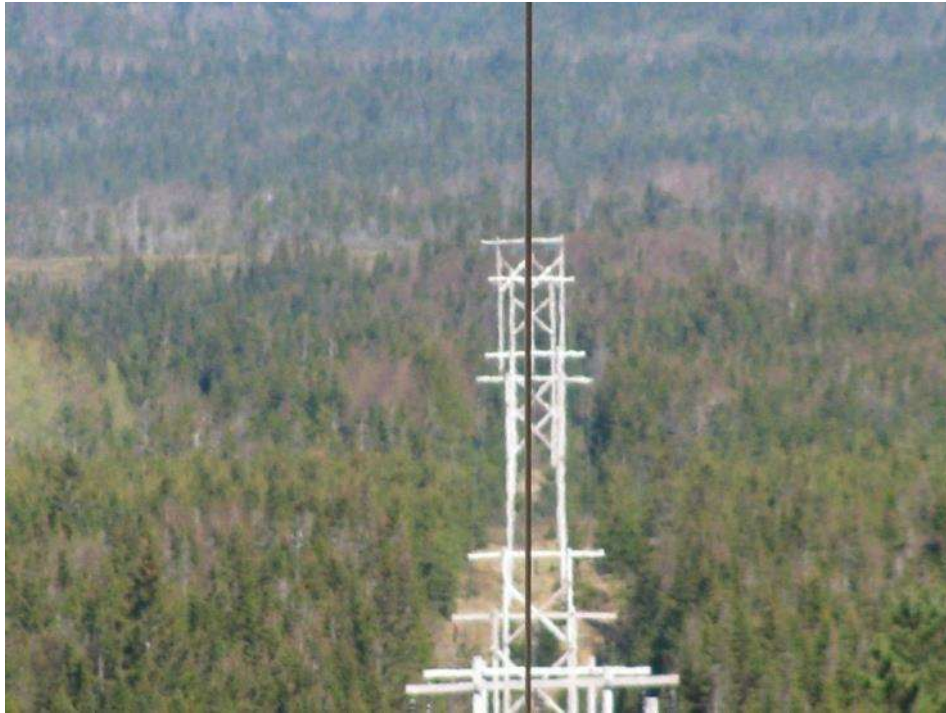
Figure 35 – Corroded Conductor in Foreground

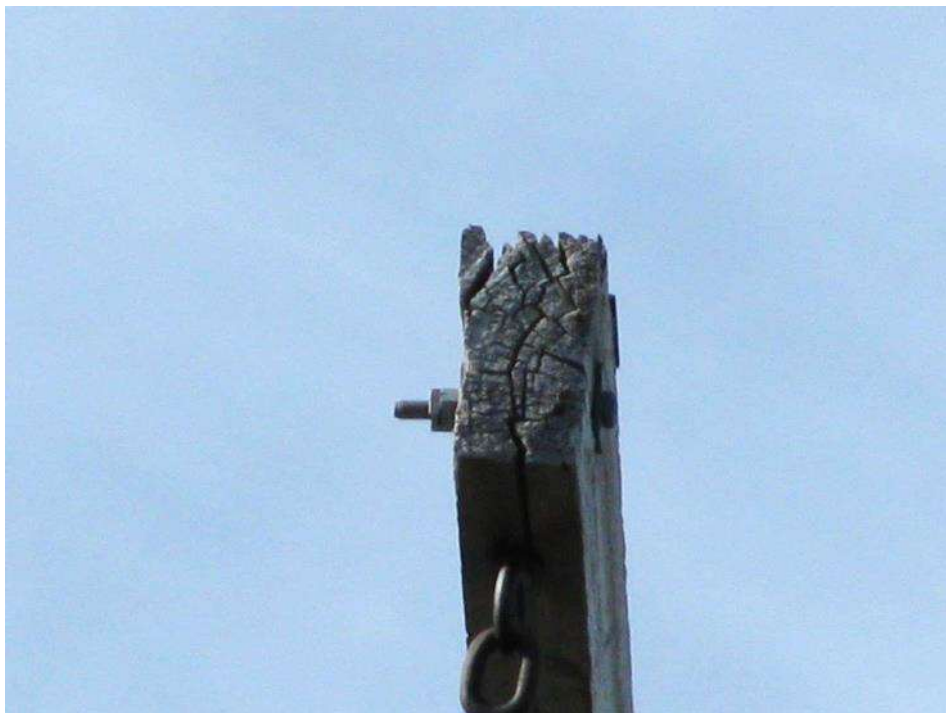
Figure 36 – Deteriorated Crossarm
