Re: Newfoundland Power's 2015 Capital Budget Application

**Pierre's Brook Hydro Plant
Penstock Replacement and Surge Tank Refurbishment**

June 2014

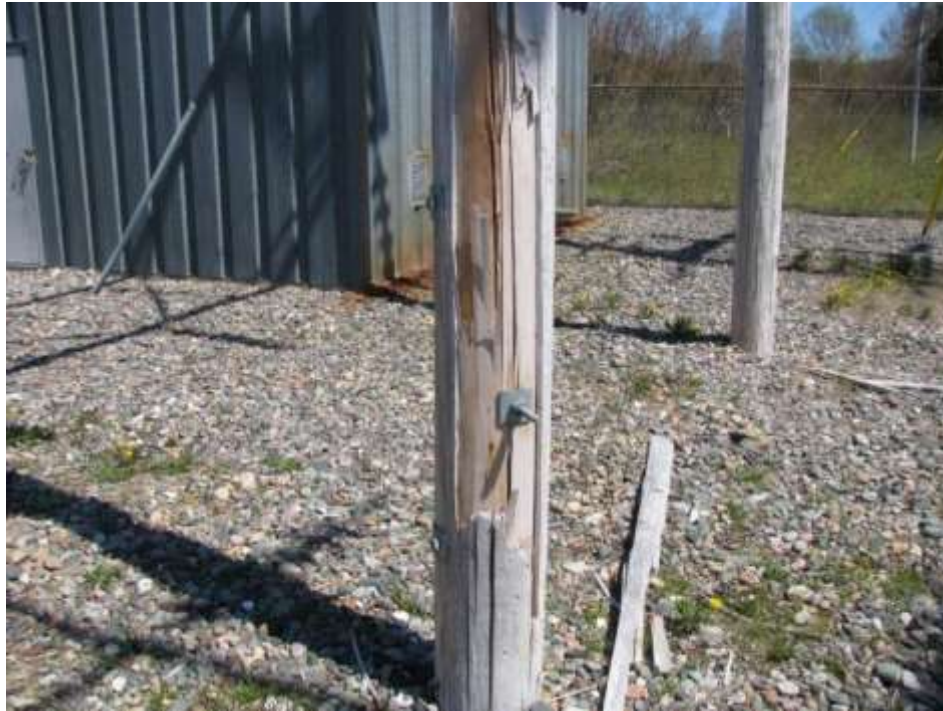
Figure 37 – Bolts Keeping Broken Pole Together

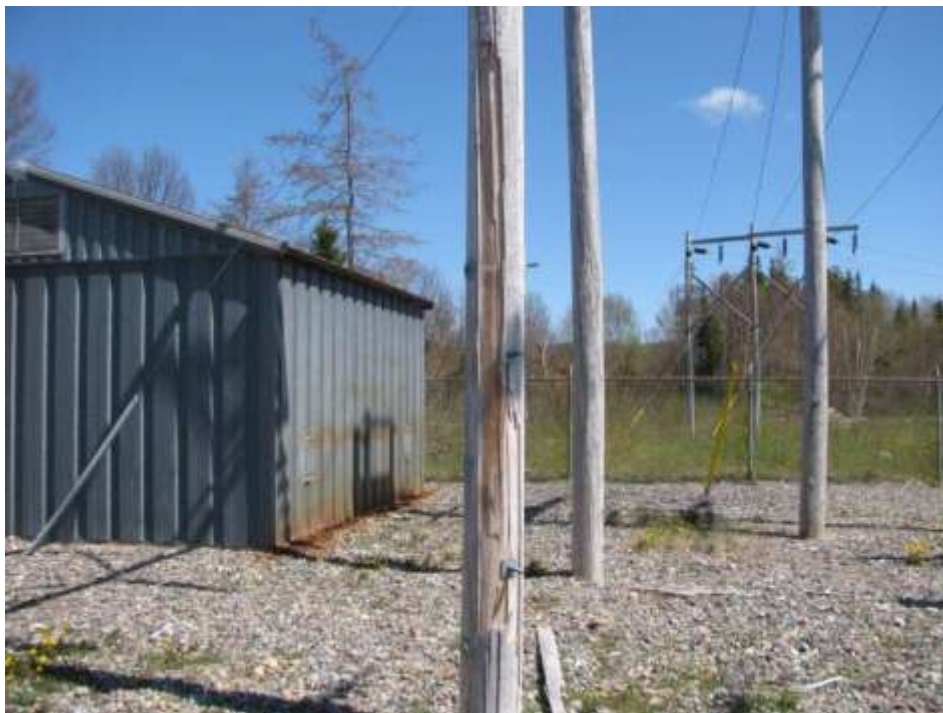
Figure 38 - Bolts Keeping Broken Pole Together

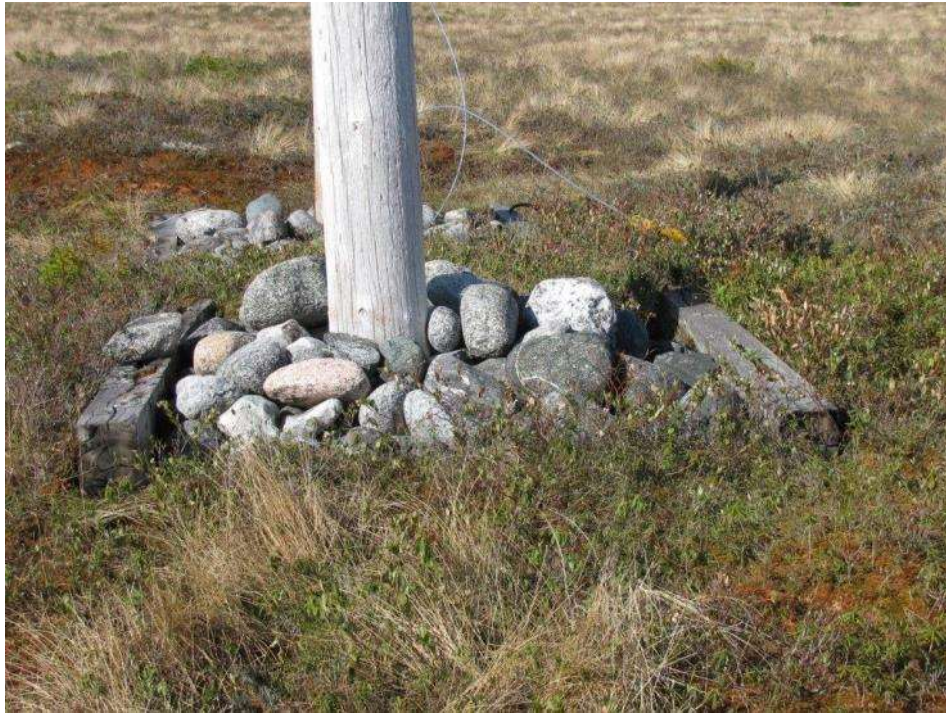
Figure 39 – Deteriorated Pole Crib

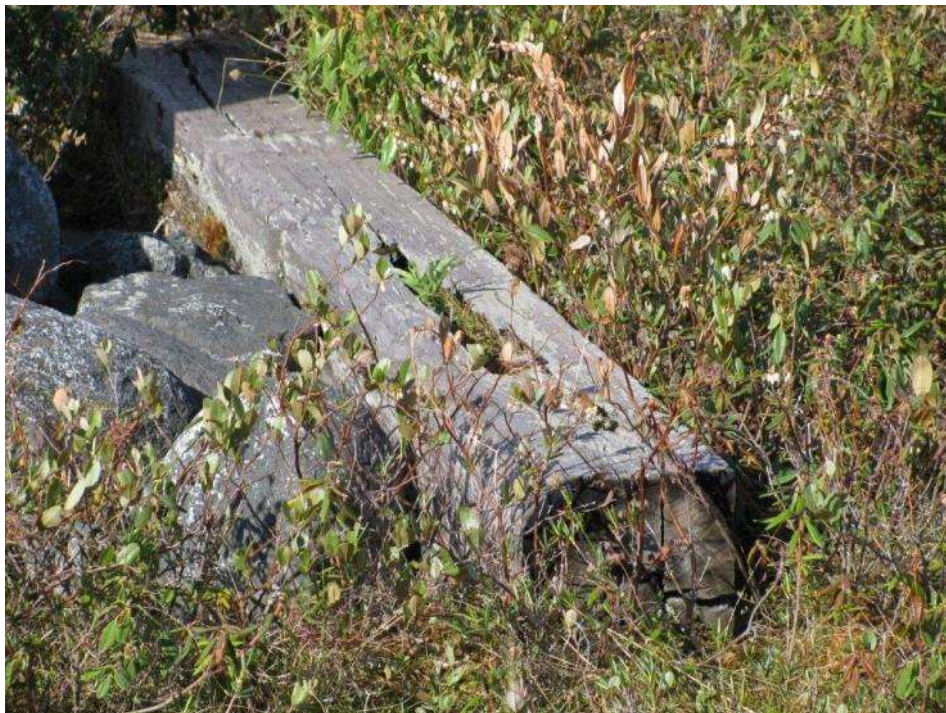
Figure 40 – Deteriorated Pole Crib Timber

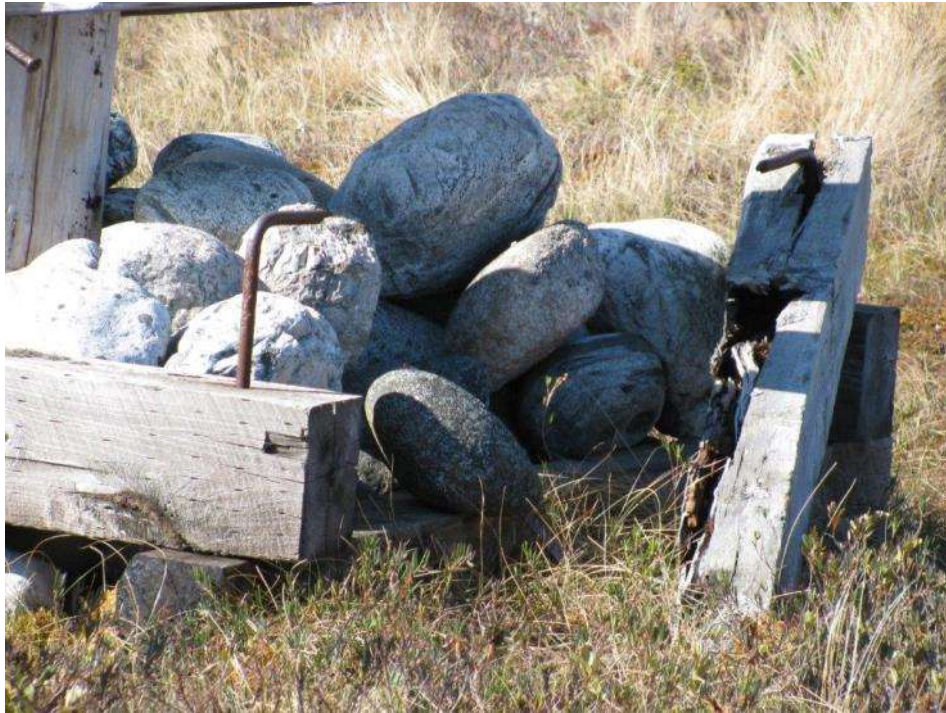
Figure 41 – Rock Ballast No Longer Contained

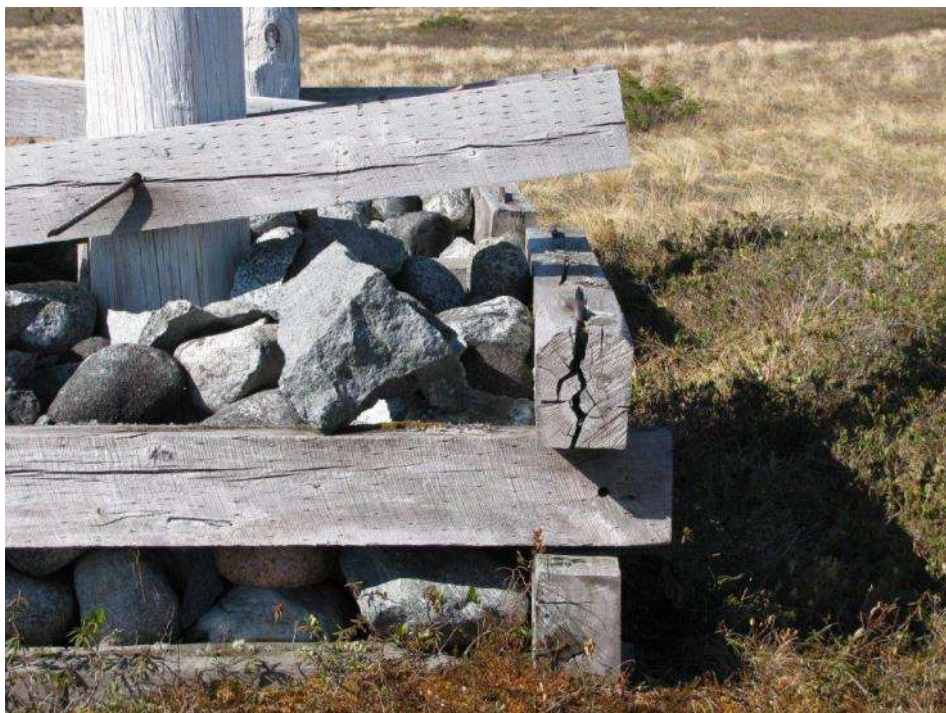
Figure 42 – Deteriorated Pole Crib Timber

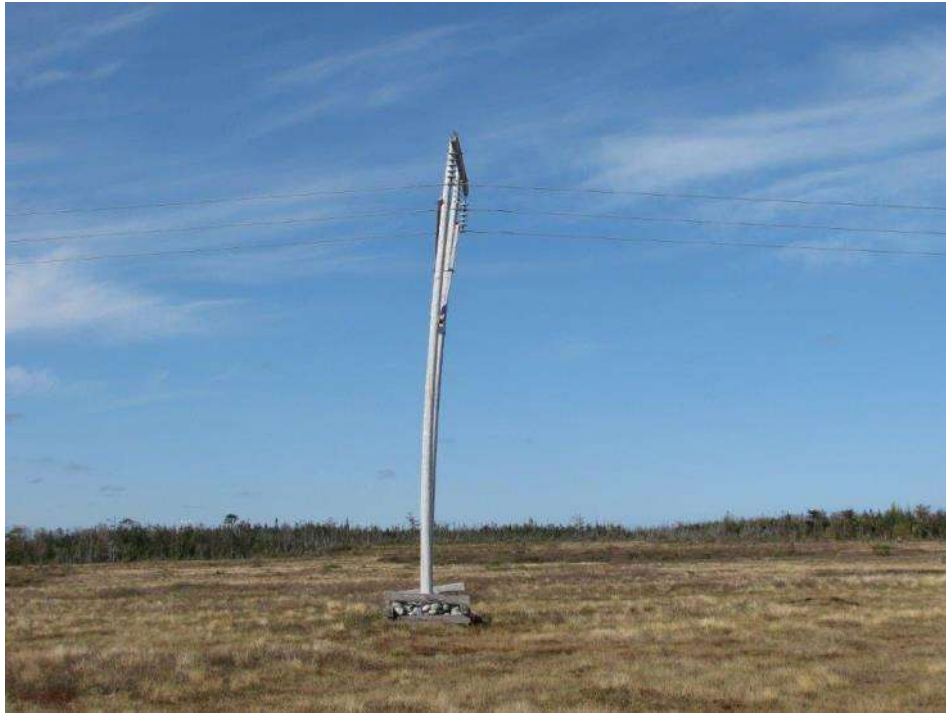
Figure 43 – Bent Structure

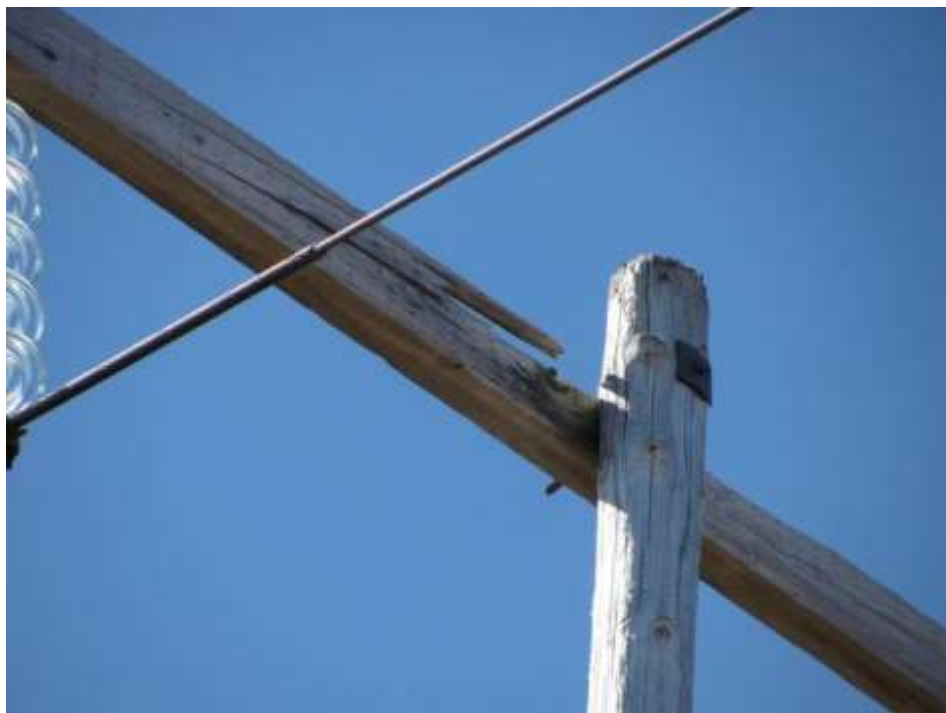
Figure 44 – Broken Crossarm

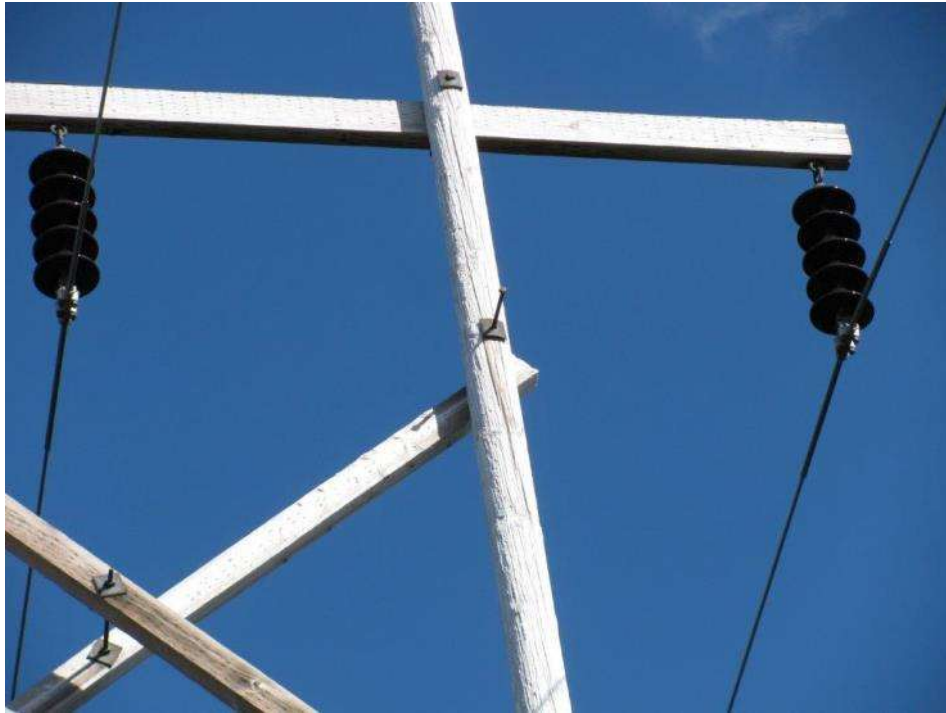
Figure 45 – Bolt No Longer Securing Cross Brace

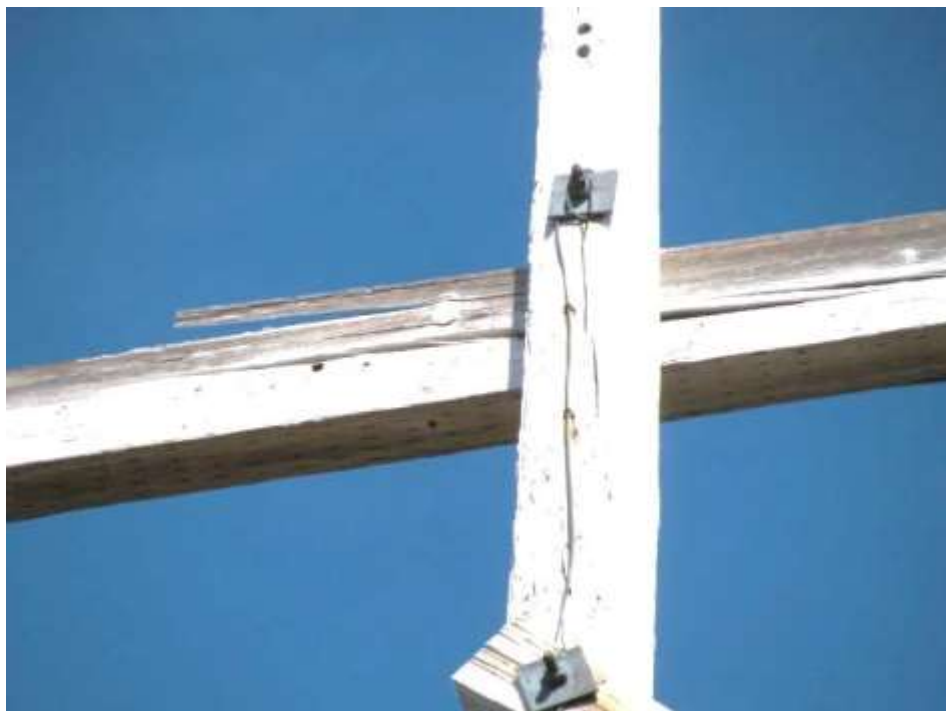
Figure 46 – Broken Crossarm

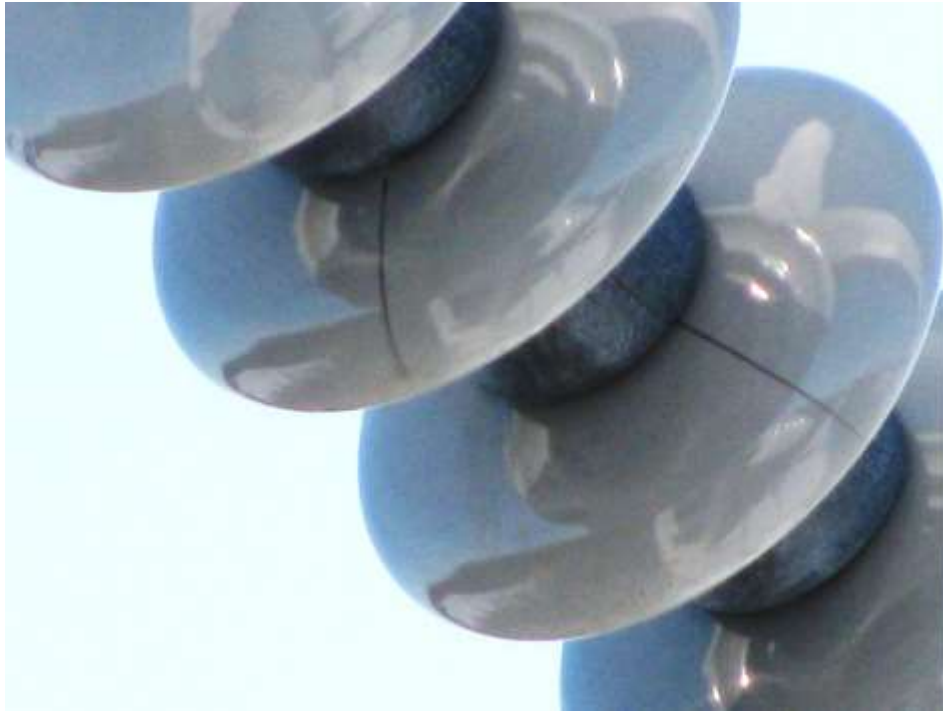
Figure 47 – Cracks in COB Type Insulator

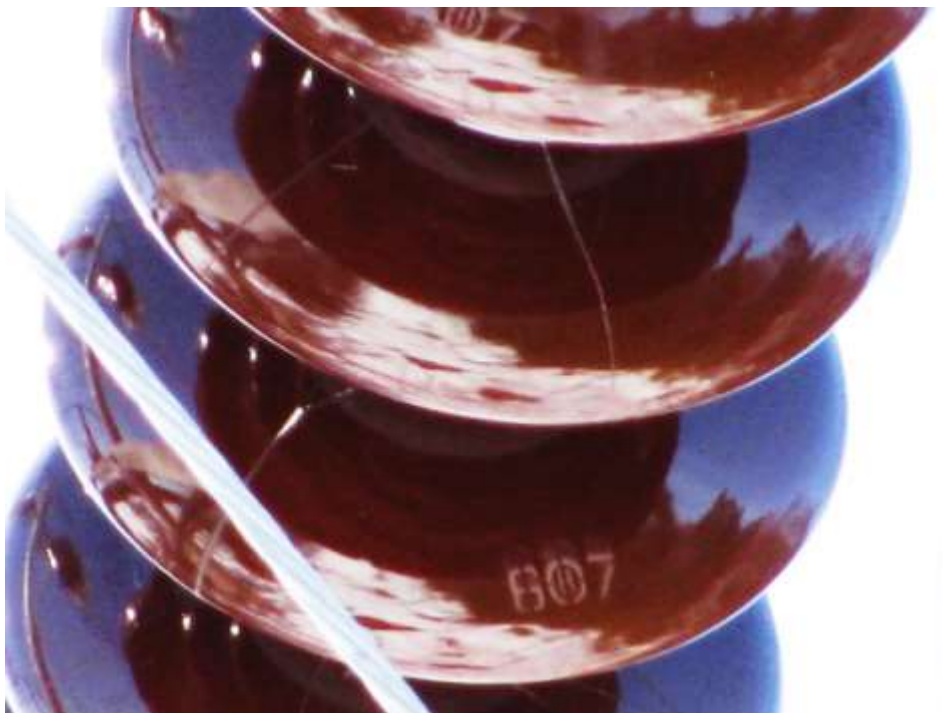
Figure 48 – Cracks in OB Type Insulator

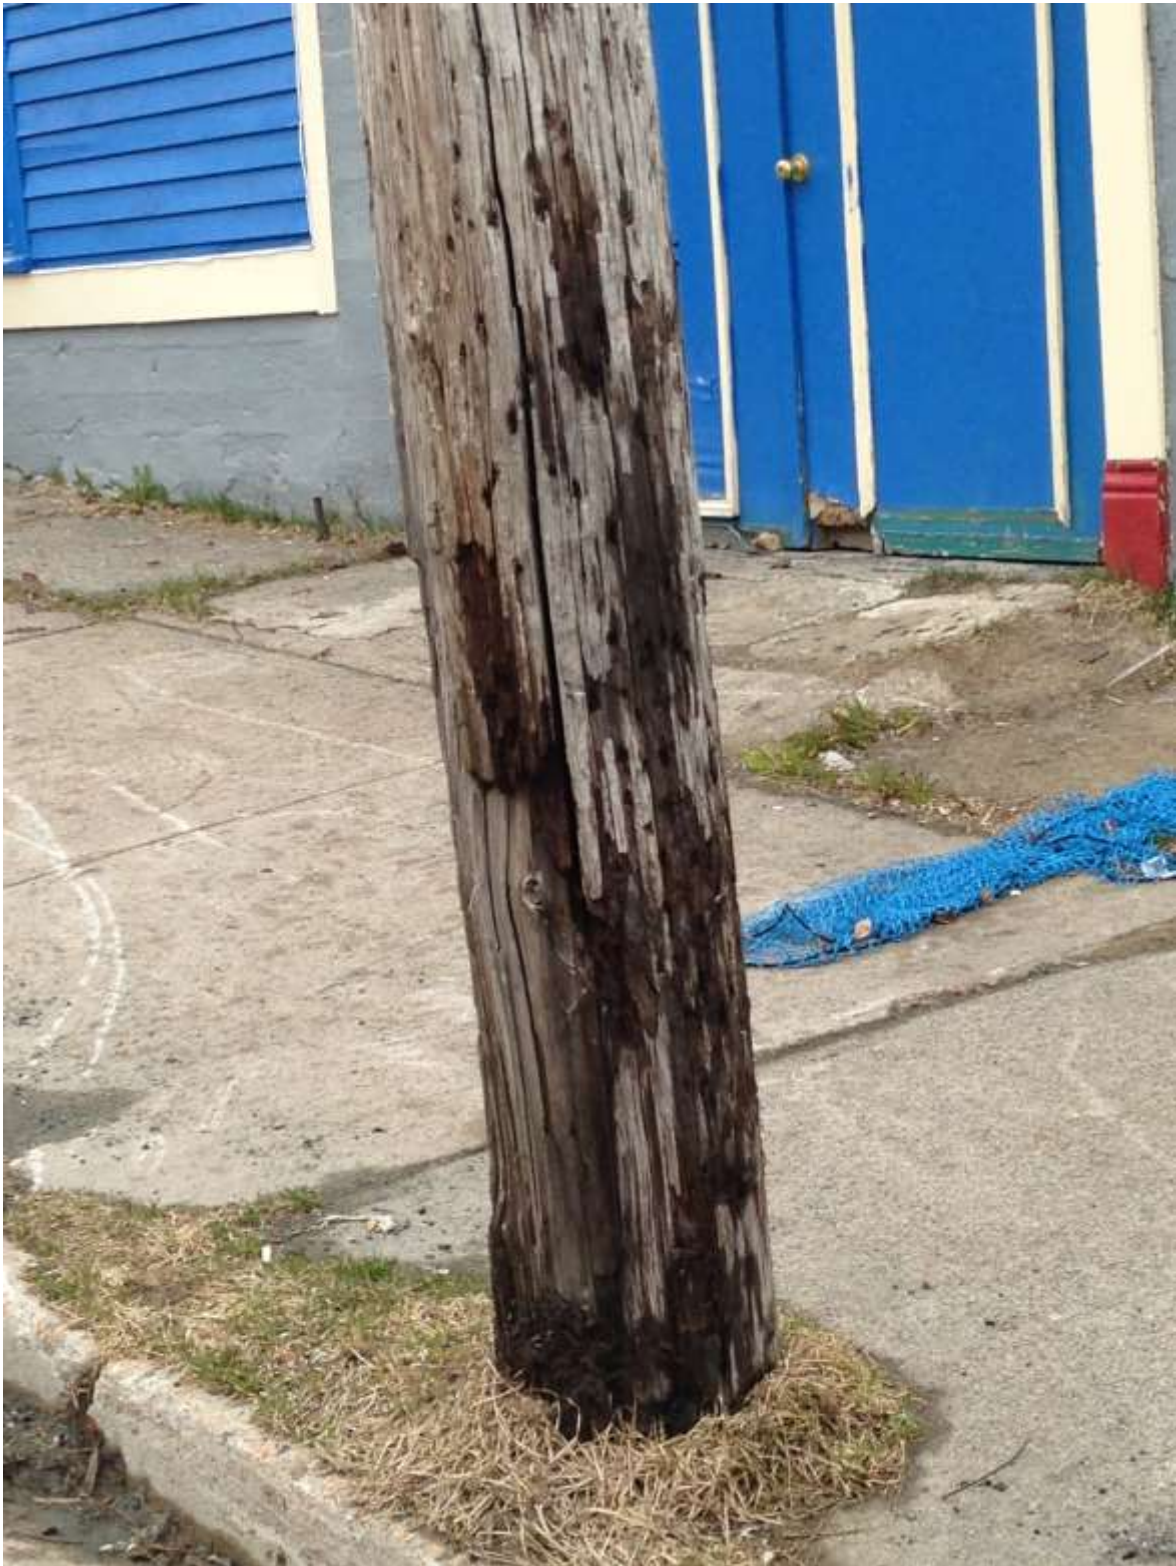
Figure 6 - Deteriorated Pole

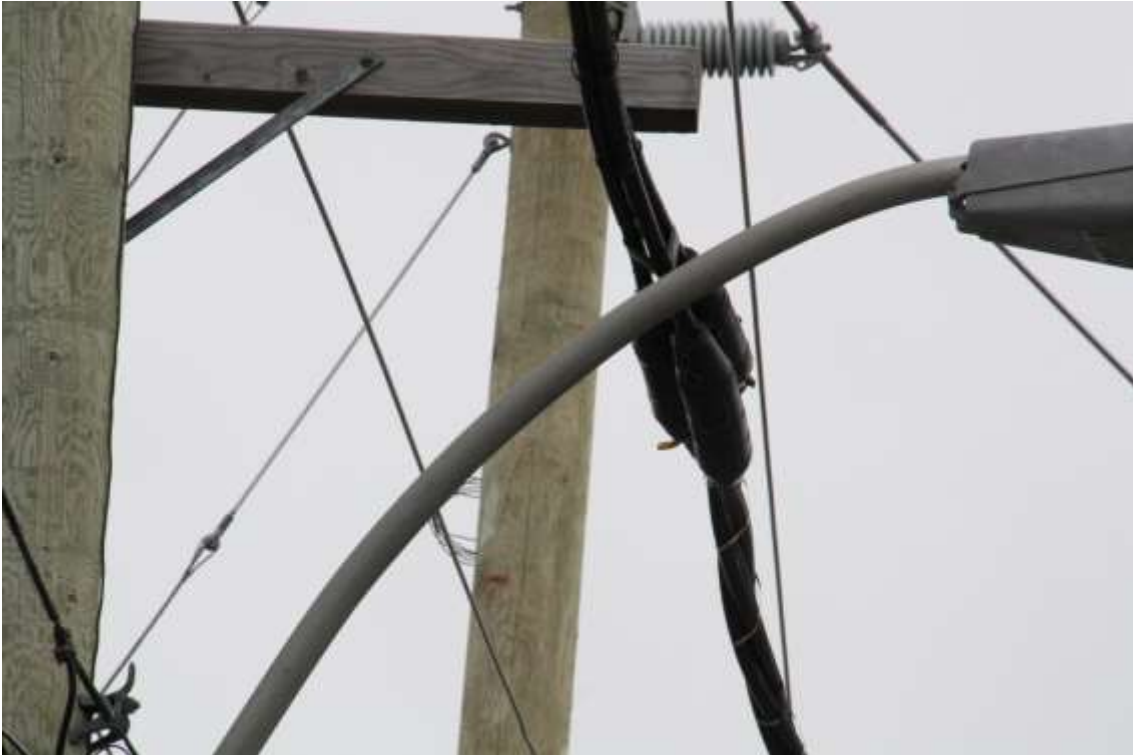
Figure 7 – Aerial Cable Splice

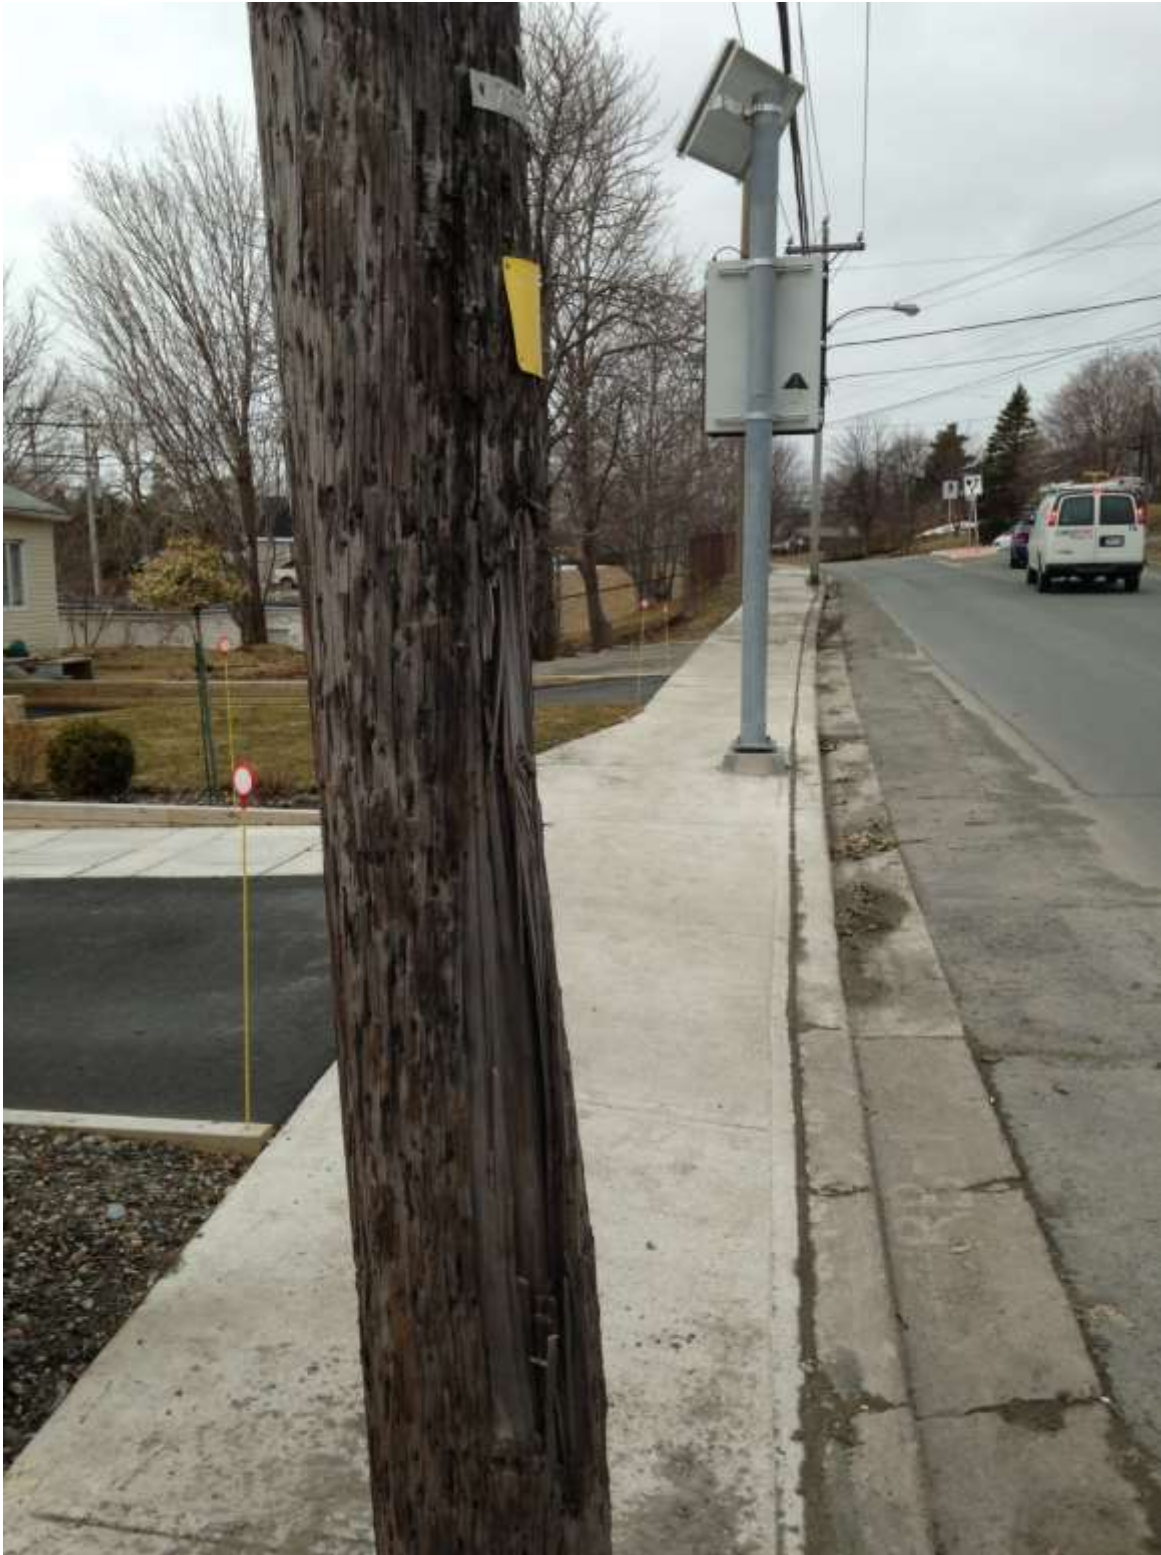
Figure 1 – MOL-09 Pole Damage

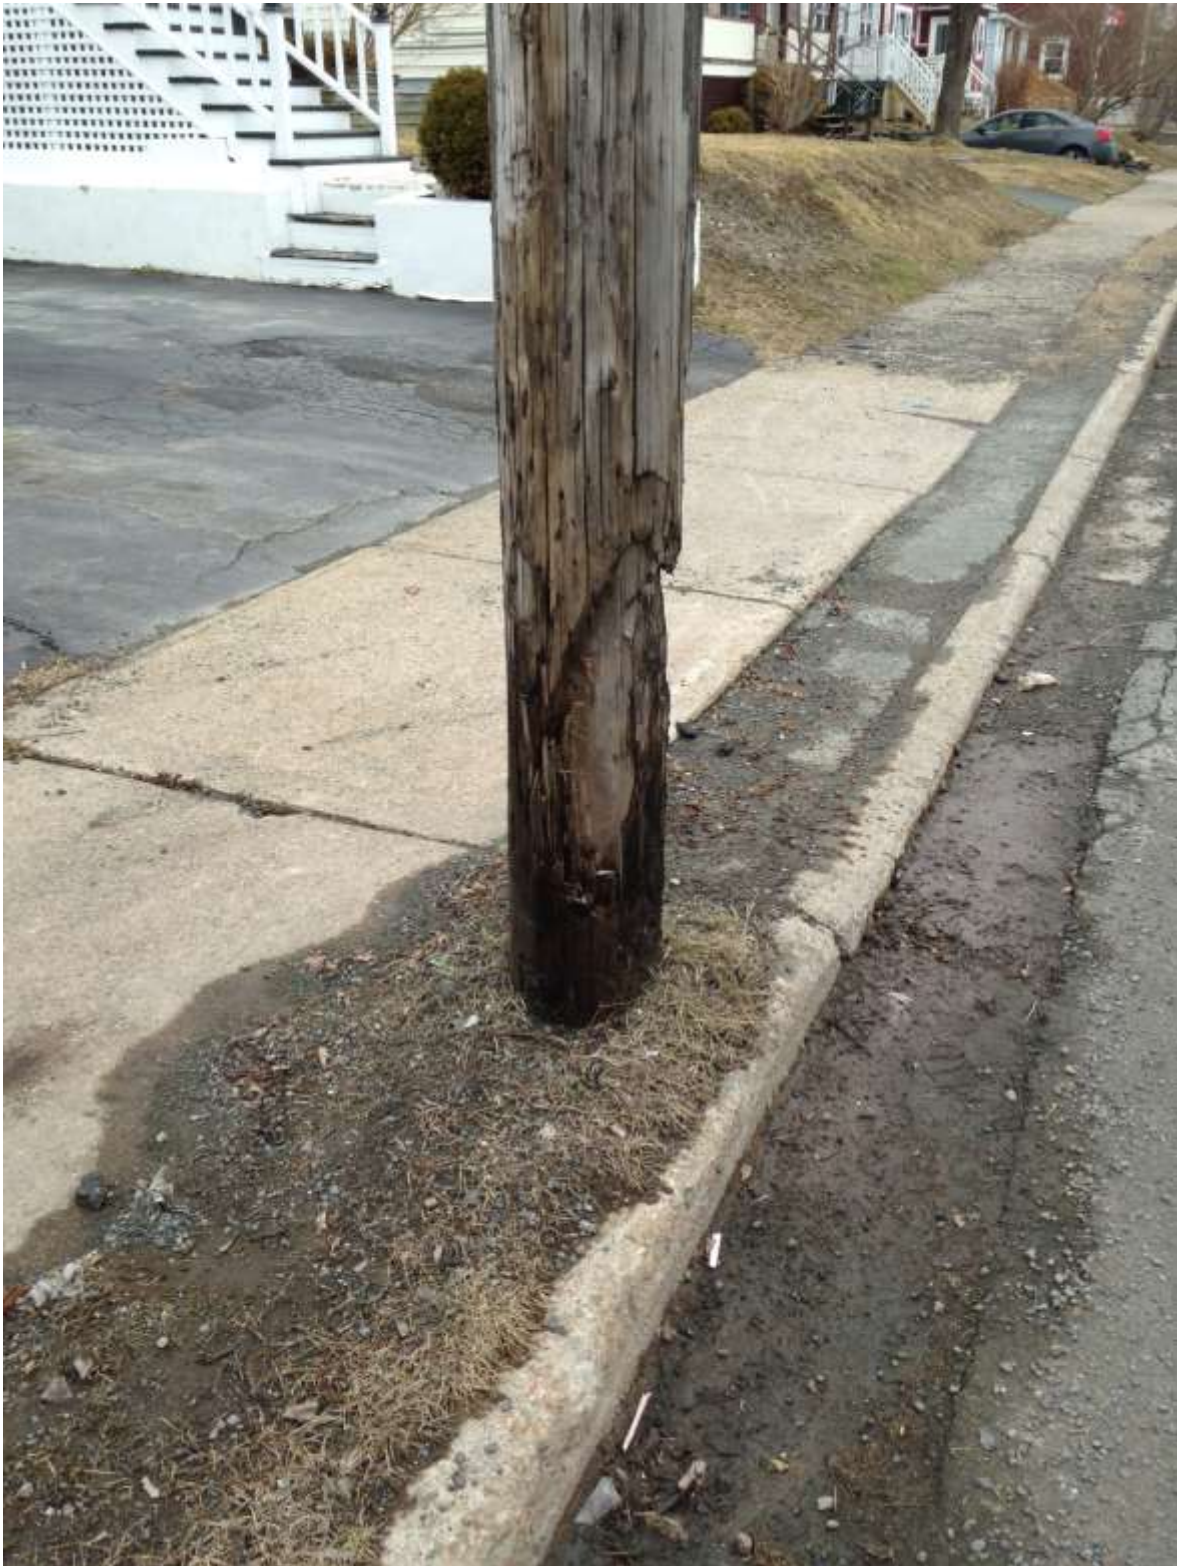
Figure 2 - Pole Damage at Base

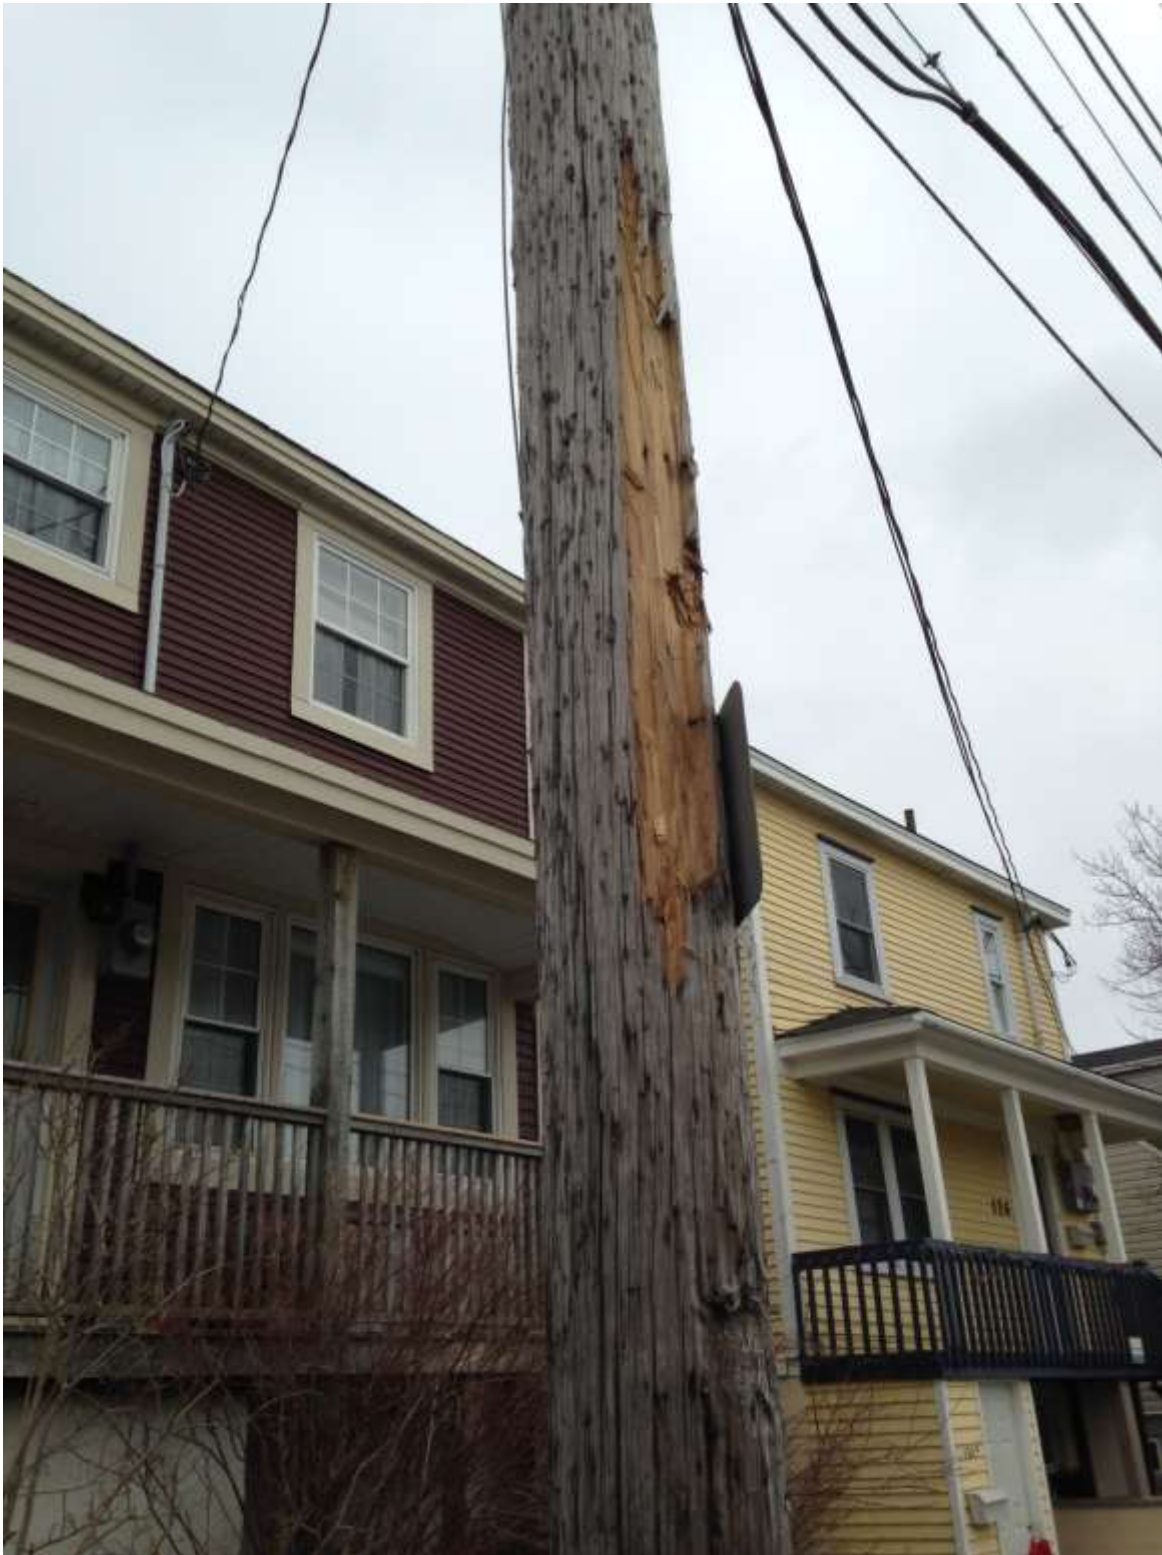
Figure 3 - Pole Damage

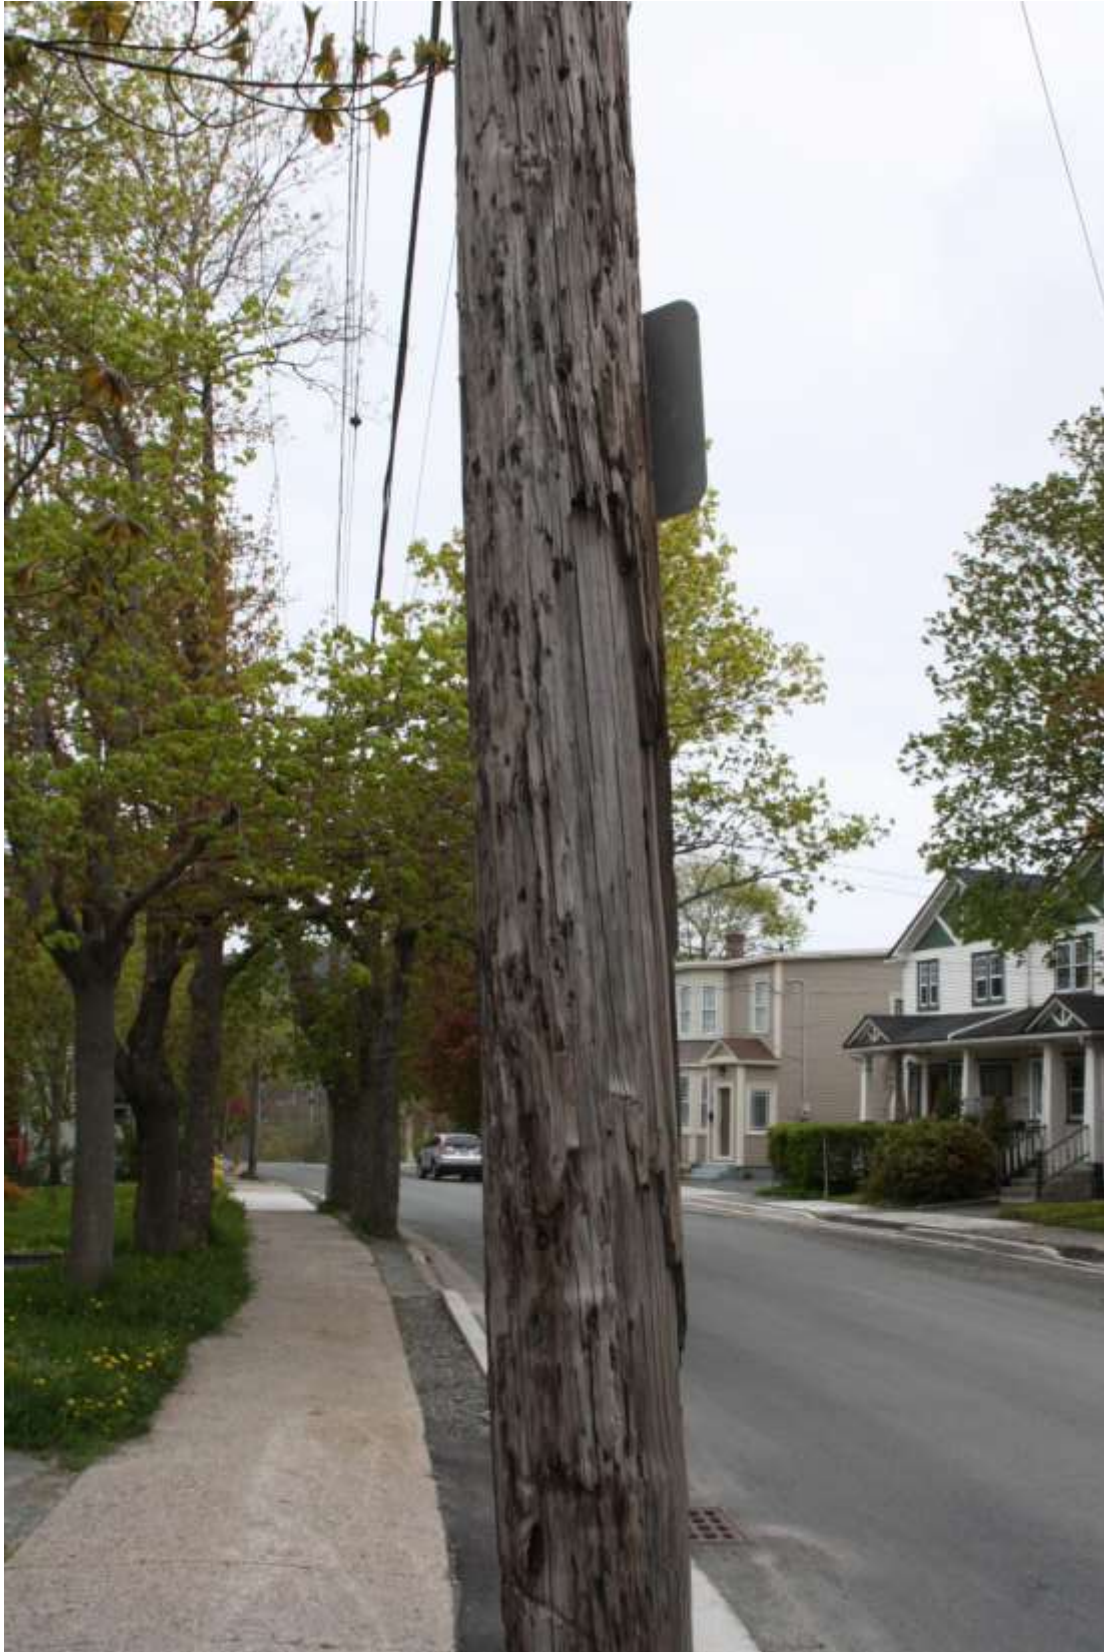
Figure 4 - Outer Shell Damage

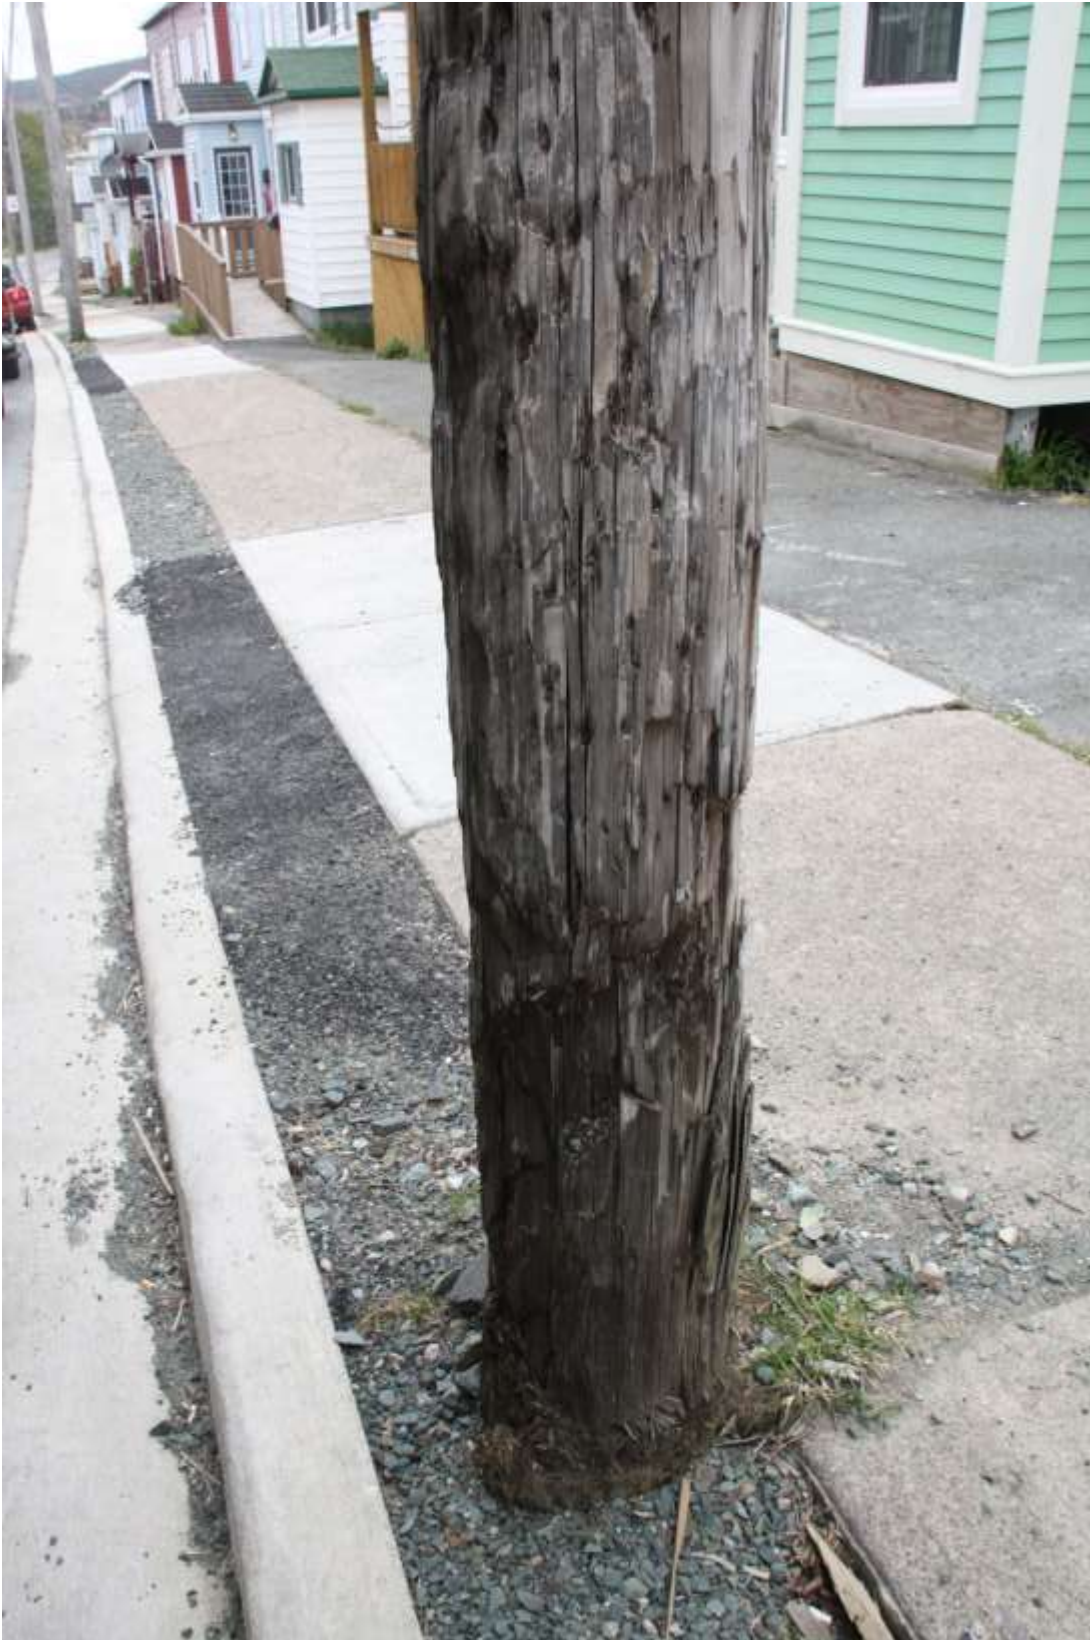
Figure 5 – Pole Damaged by Vehicles

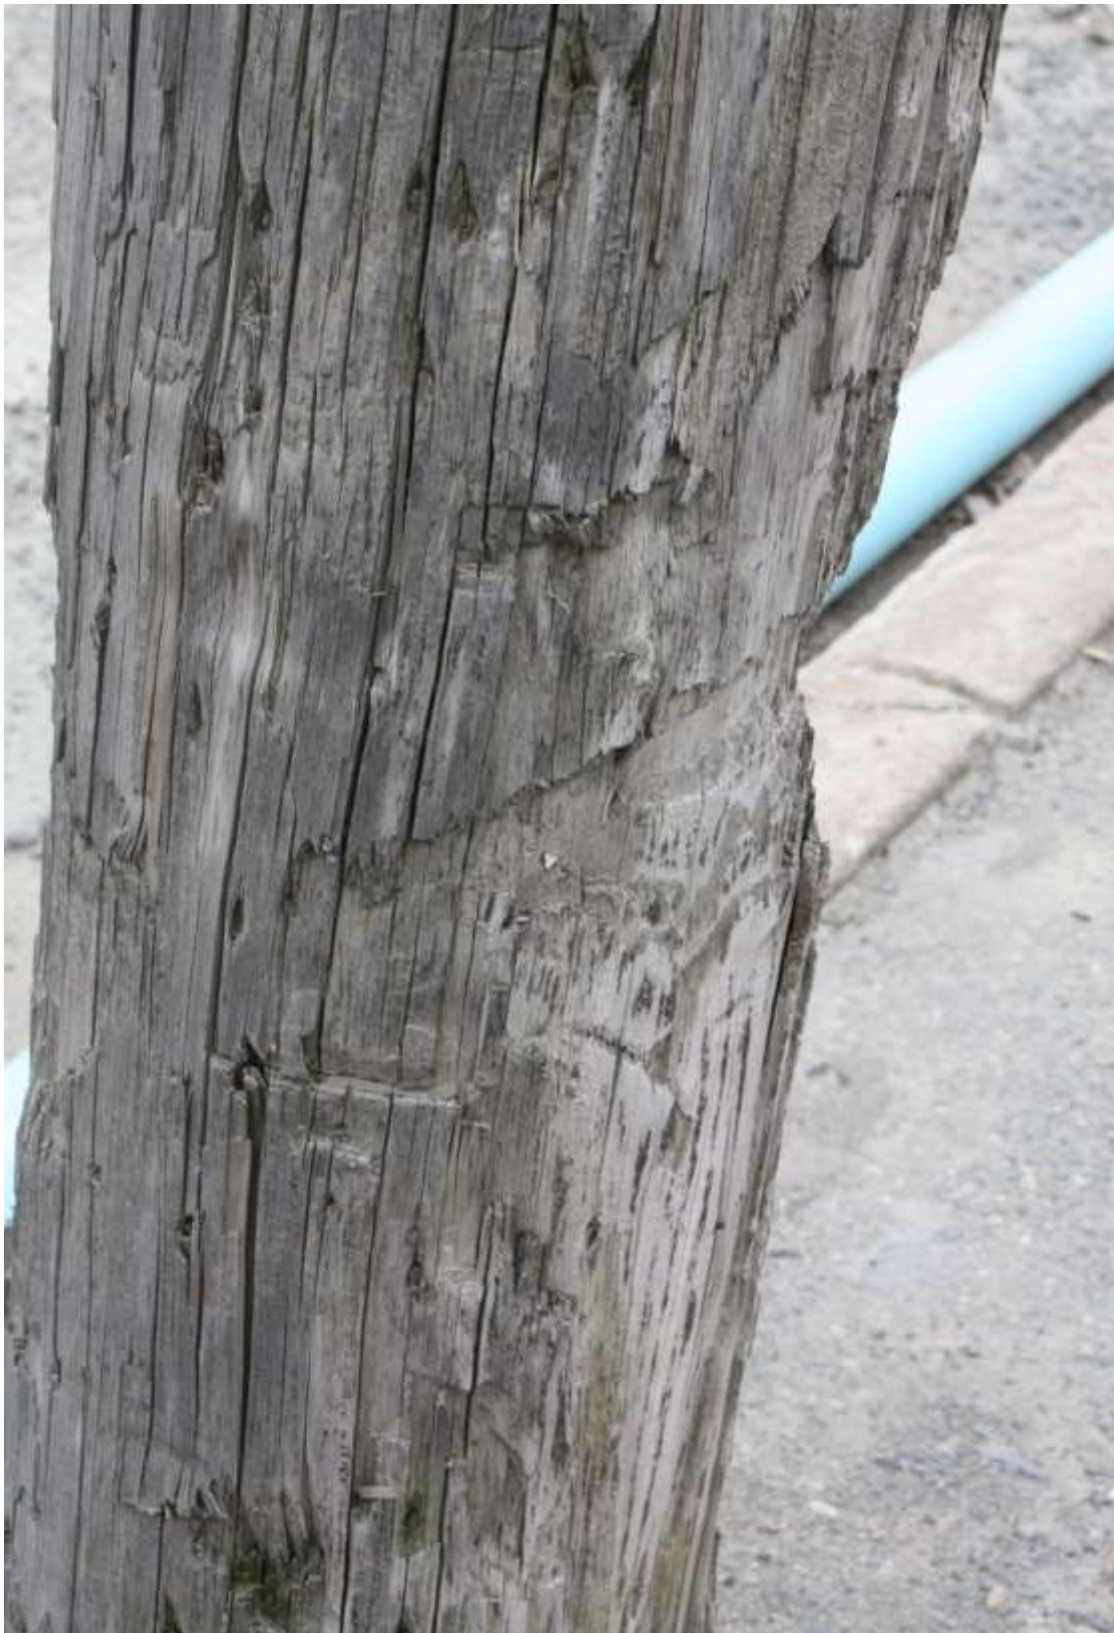
Figure 6 – Pole Damage near Base

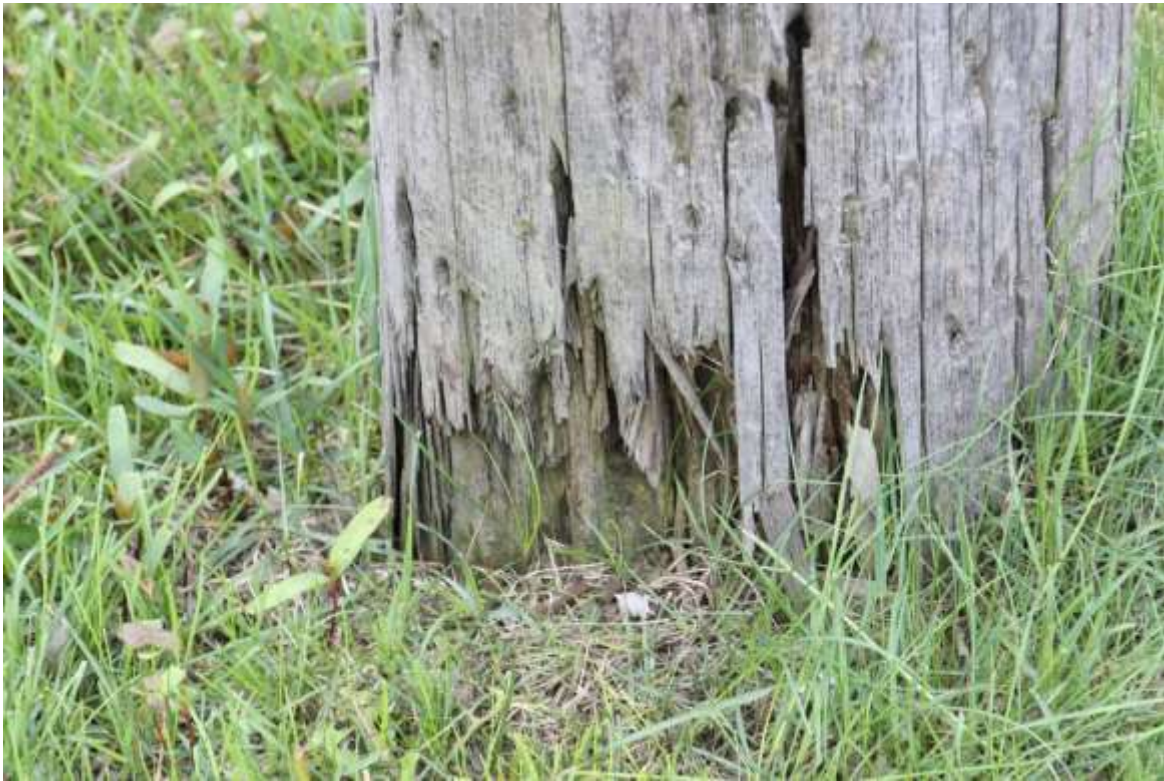
Figure 7 – Pole Deteriorated at ground line
