Re: Newfoundland Power's 2015 Capital Budget Application

**Pierre's Brook Hydro Plant
Penstock Replacement and Surge Tank Refurbishment**

June 2014

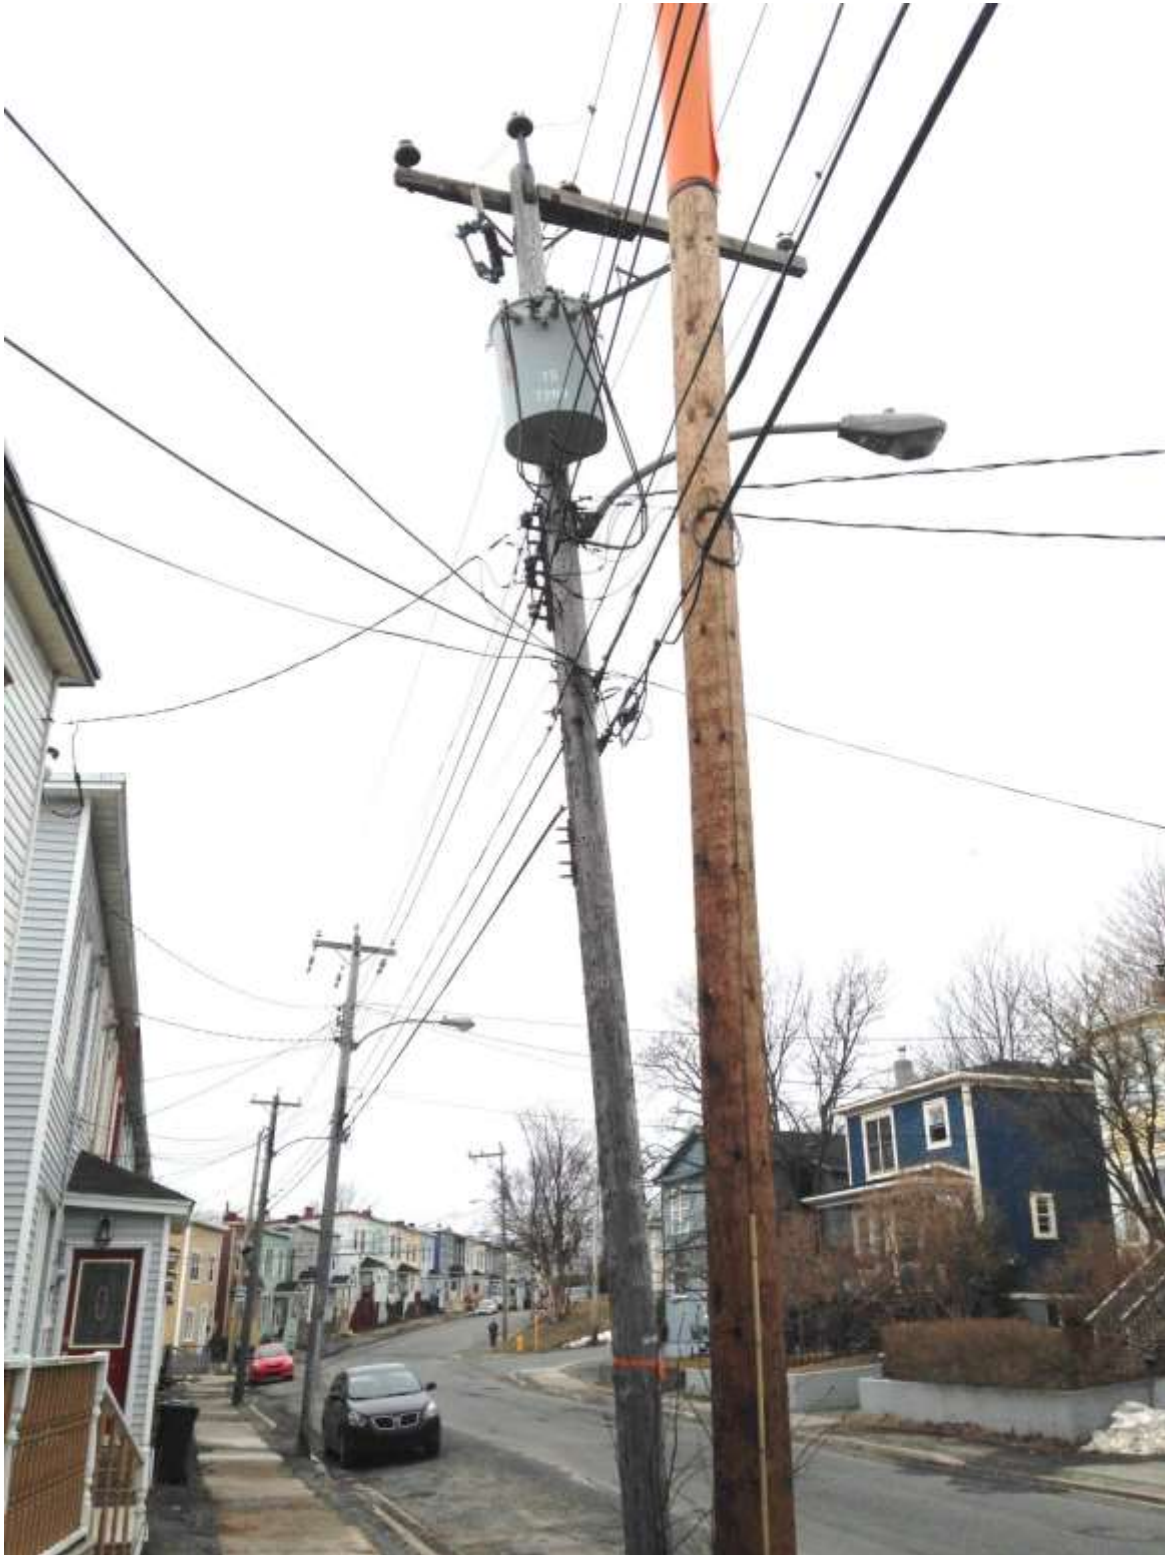
Figure 8 - Broken Crossarm, Leaning Pole, and Pole Replacement in Progress
