1 Q. Reference: *Gas Generator Engine Refurbishments Hardwoods and Stephenville*,
2 Page 8, line 5 to Page 9, line 10.

Field Service Report For Removal of Serial No: 202205 Installation of Alba Lease Serial No: 202040

Customer: Newfoundland Hydro Hardwoods

Field Service Report For Investigation of High Vibration Olympus Serial No: 202204

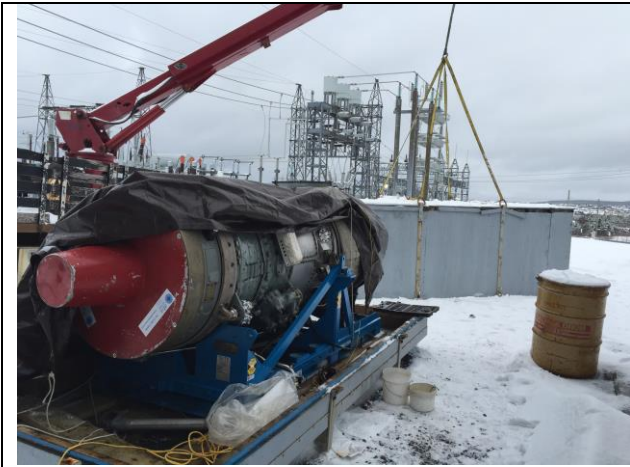
202205 removal of fuel pumps for Stephenville

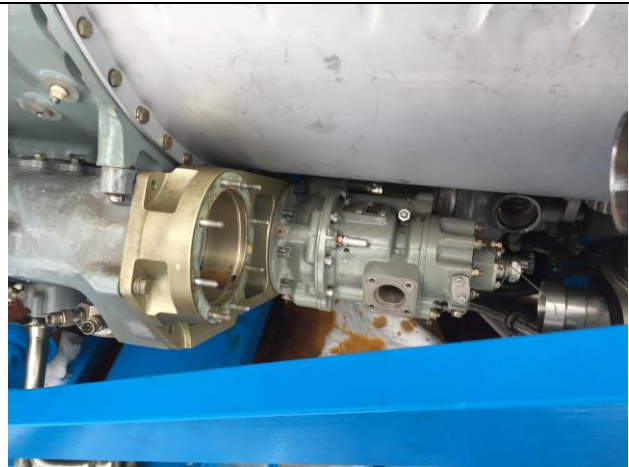
202205 removal of pumps

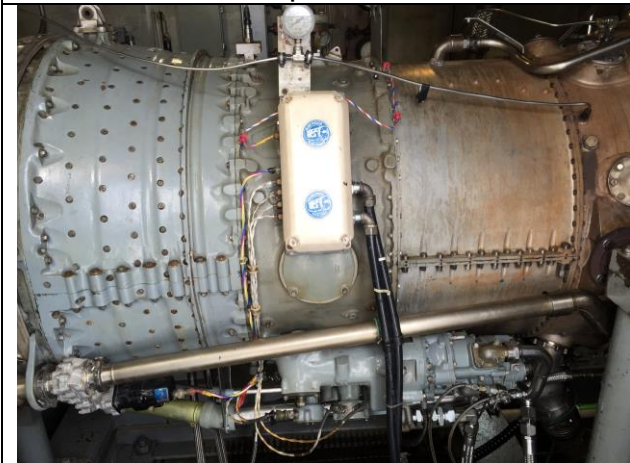
Installation of 202040

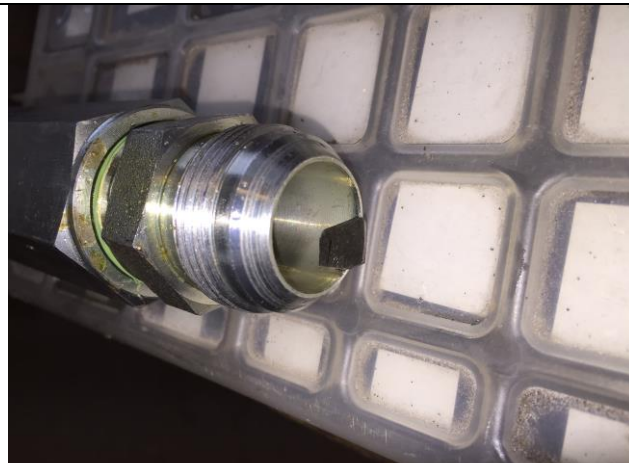
It was then decided to remove the NRV. This was found to be sticking open caused by a particle found emanating from the CCC valve. The CCC valve was replaced, and the NRV checked, found to be functioning satisfactorily, and then refitted.

Part from CCC valve found inside NRV

The CCC valve was replaced and NRV removed, cleaned, function checked then re installed. Tee – piece connection blanked from LP fuel pump to CCC valve.
Alba lease Olympus Gas Turbine s/n: 202040 was installed and commissioned successfully in accordance with Alba Power Ltd procedures.

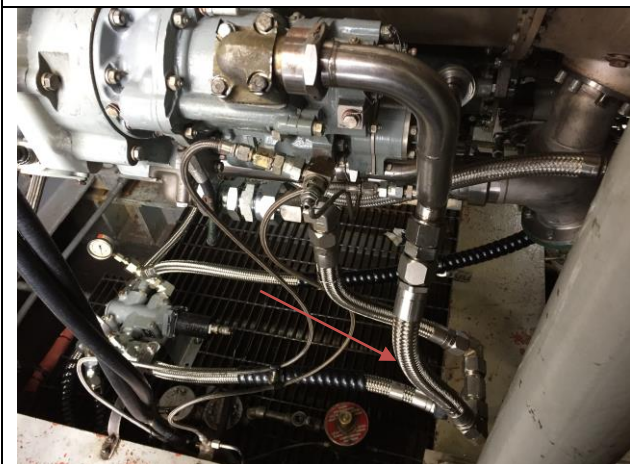
It was then noted that an extra pipe was installed at the fuel pumps to CCC valve connected by a tee piece, this pipe had been installed on the lease engine when installed on engine in B berth. This appeared to be back pressure to the valve.

202040 extra pipe removed and blanked

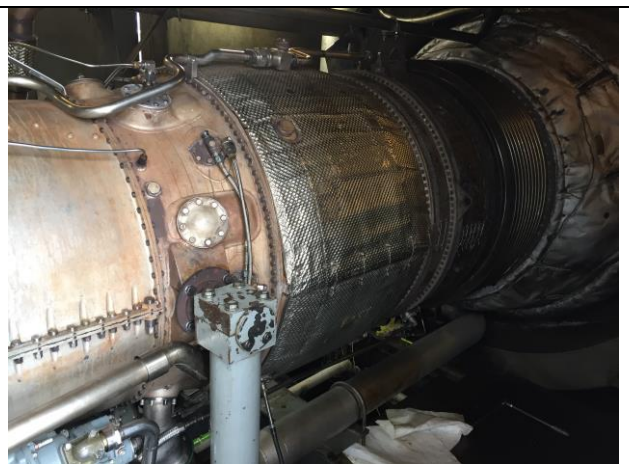
Gas Turbine 202040 installed

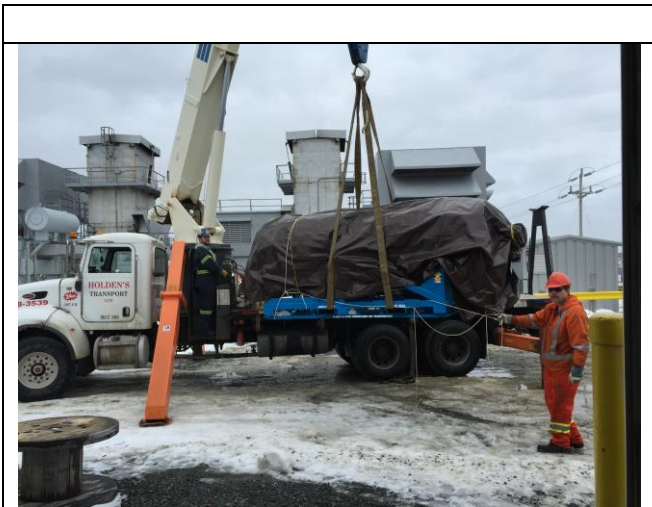
Moving 202205 to workshop

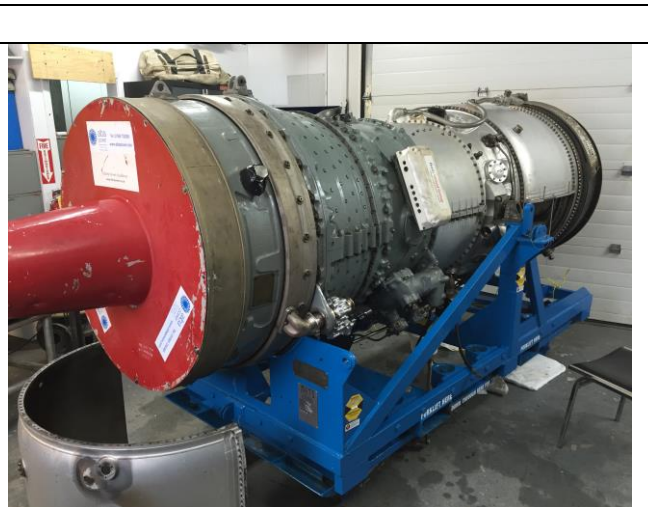
Gas Turbine 202205 in workshop

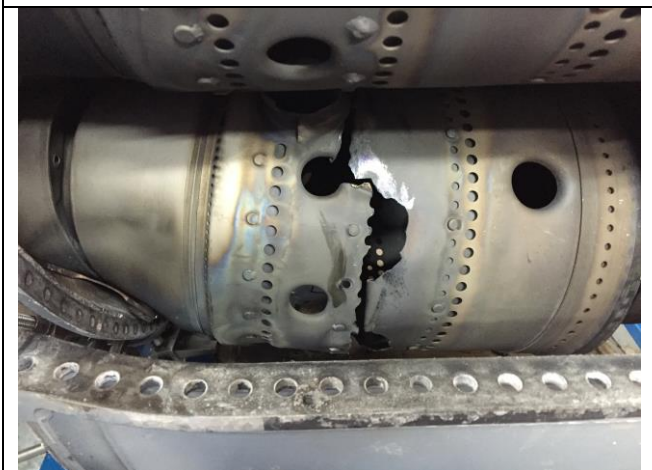
The heat shields, the combustion casings, and the damaged combustion chamber were removed. The gas turbine had sustained extensive damage to the turbine section and could not be repaired on site and would have to be shipped back to Alba Power for investigation and detail strip of the turbine section.

Combustion can failure. Rivets missing

Gas Turbine s/n 202205 failed to trip when the combustion casing failed and had to be manually shut down by site personnel at the main fuel valve.
Inspect function test of Alarm / Trip on Exhaust gas temperature thermocouples should be carried out.

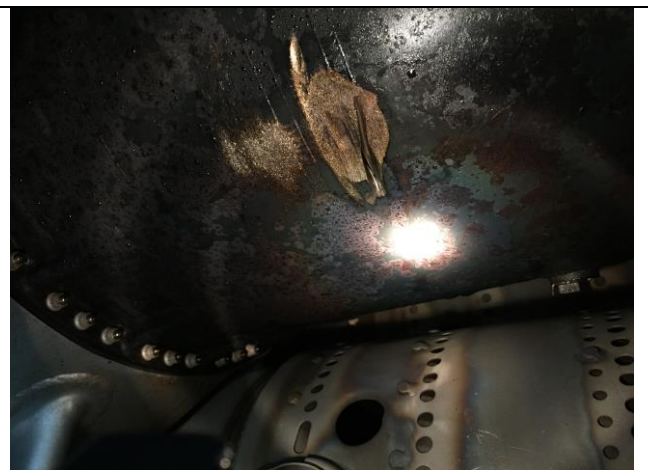
Turbine support housing holed & fretted

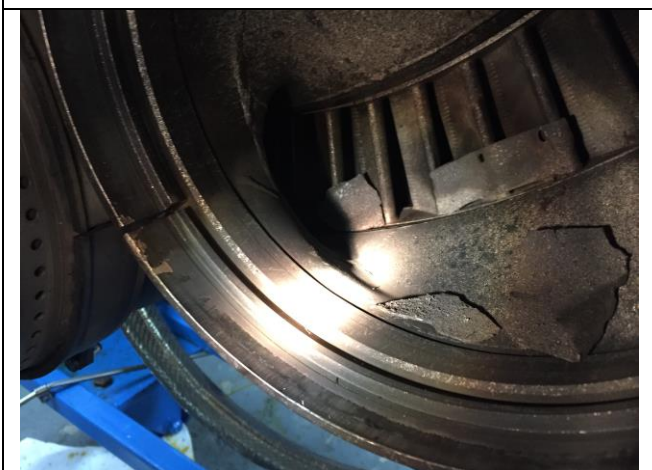
Pieces of combustion can in HP NGVs

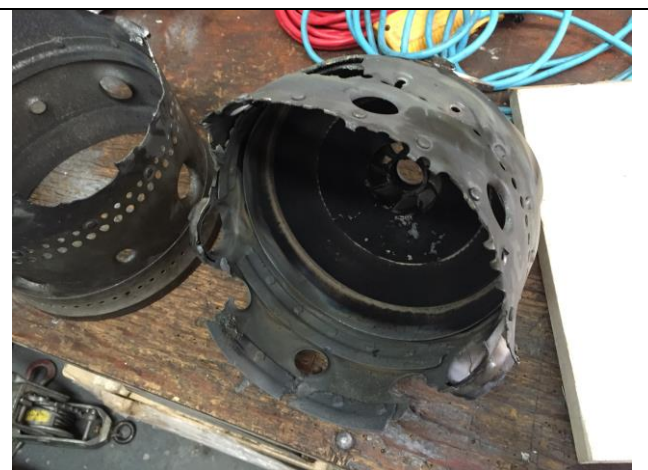
Combustion can in two parts
