1 Q. Reference: Newfoundland and Labrador Hydro's 2009 Capital Budget Application,
2 Volume II, Tab 21, *Hardwoods Gas Turbine Plant Life Extension Upgrades*.

**FINAL REPORT
CONDITION ASSESSMENT AND LIFE
CYCLE COST ANALYSIS
HARDWOODS AND STEPHENVILLE
GAS TURBINE FACILITIES**

Stantec Job #: 21061
Ref. #: 2007-35410-OQ
December 18, 2007

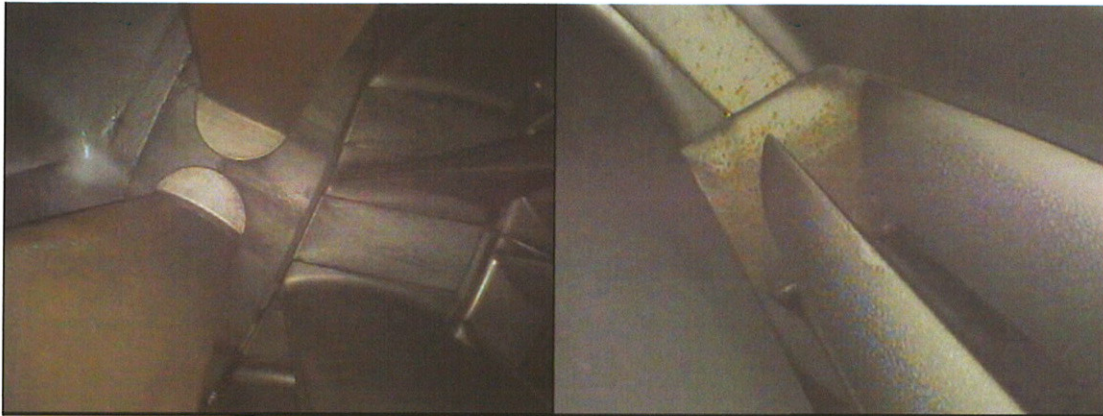
In general the unit shows signs of corrosion, coating loss and staining due to location. This should be monitored and repaired prior to component degradation.

Inlet Guide vane corrosion

Stage 1 shroud corrosion

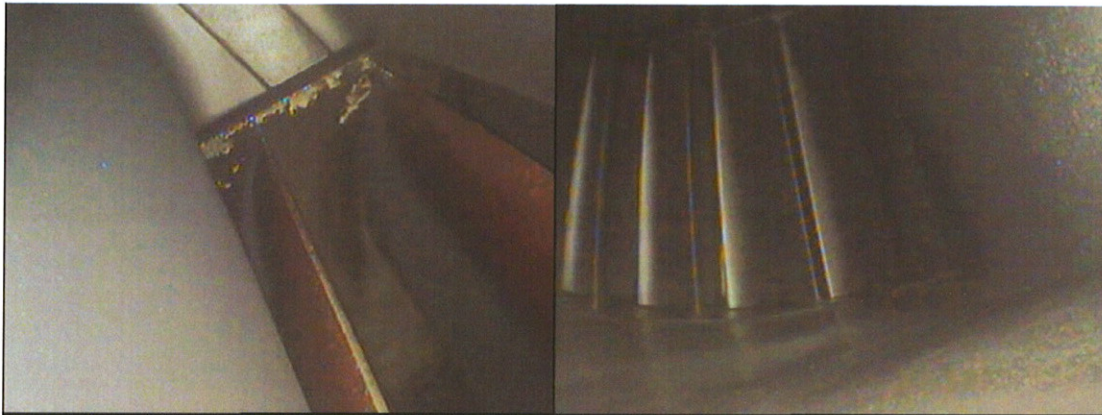
Stage 5 OGV coating loss HP Compressor entries

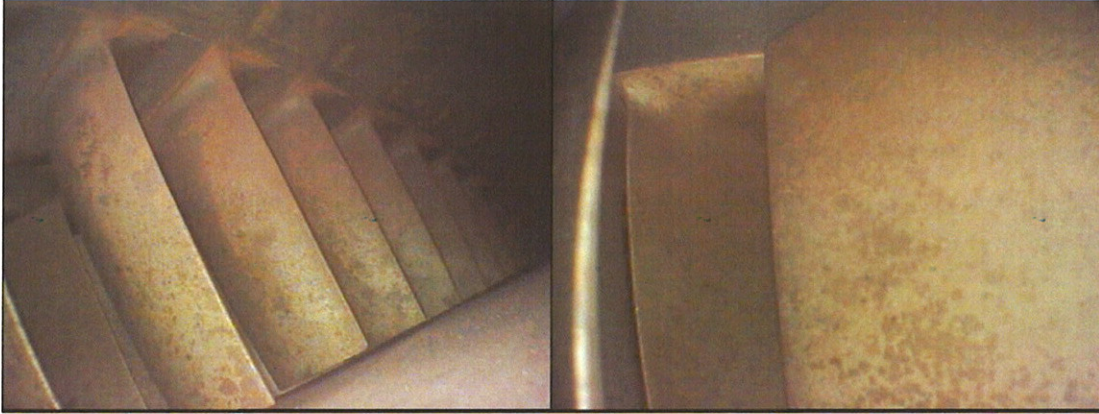
HP Compressor corrosion

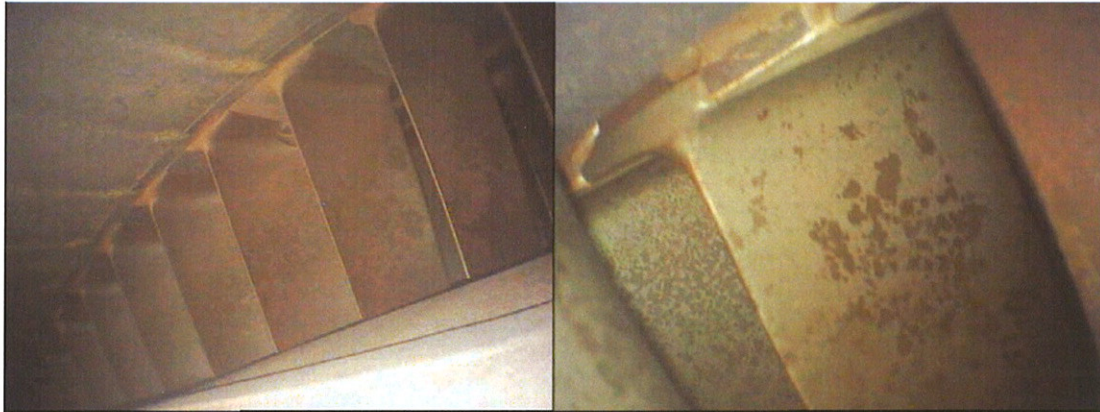
HP Compressor corrosion

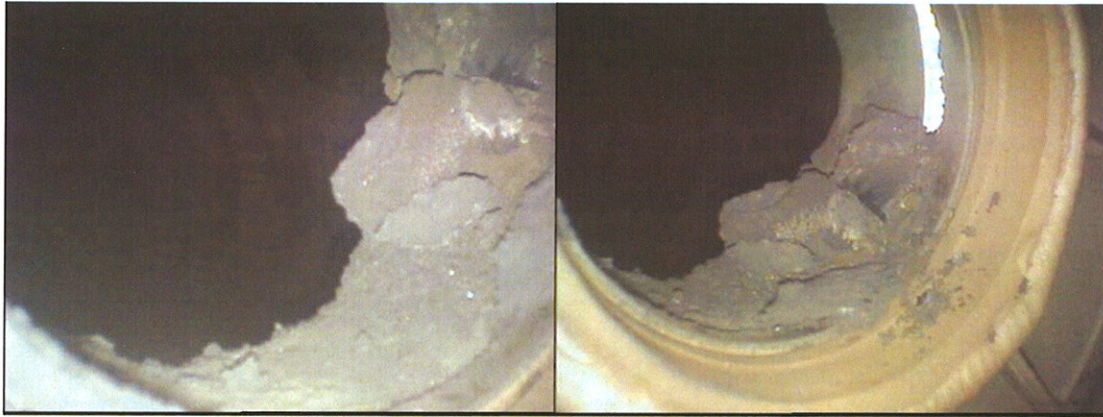
The combustion cans are badly effected by carbon and have suffered material loss and cracking throughout. These cans should be changed at the earlier opportunity and a regime of waterwash and burner cleaning implemented every 6 months. This would prolong the life of the burners and cans.

Typically found carbon deposits

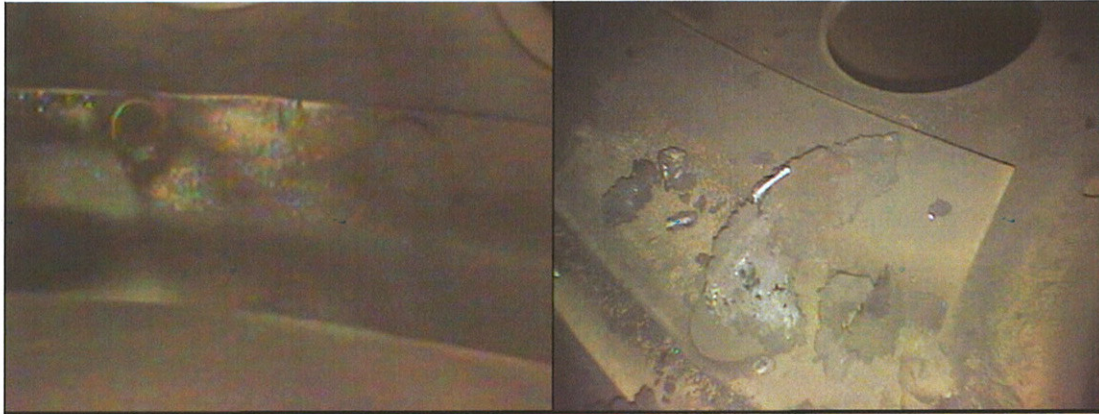
Cracking on No 3 Can

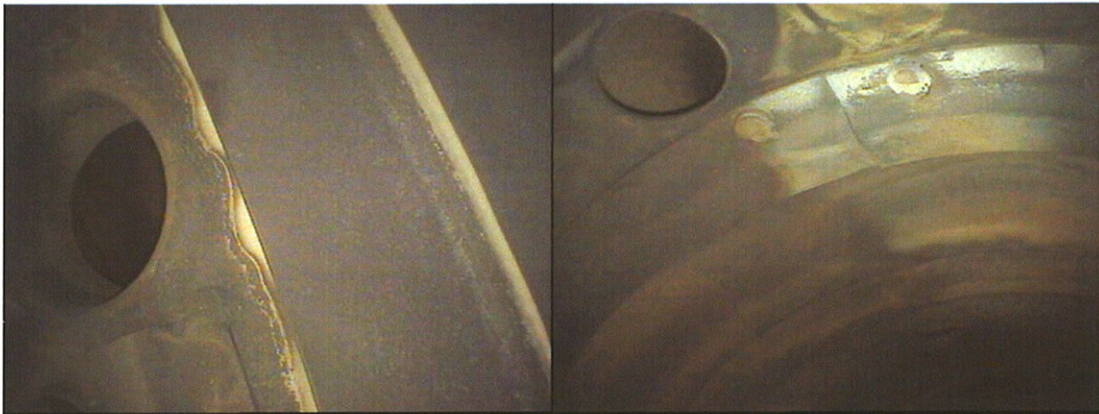
Material loss on combustion cans

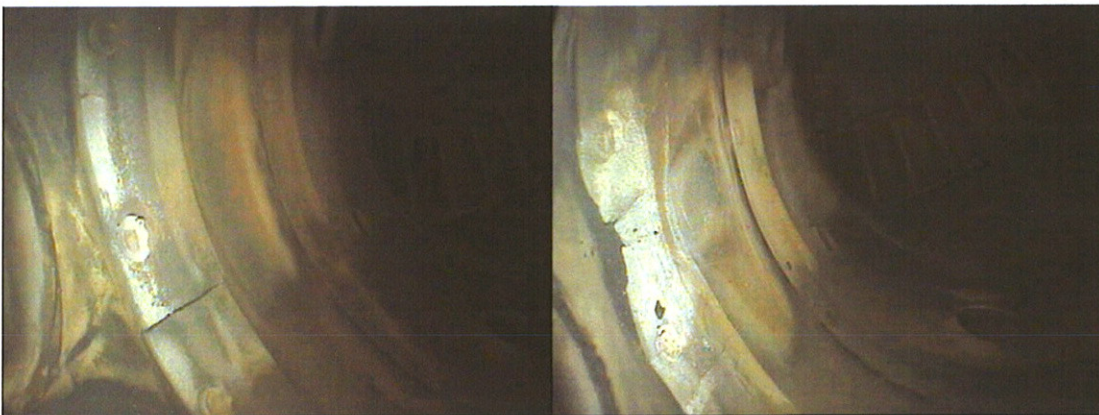
Cracking of No5 Can

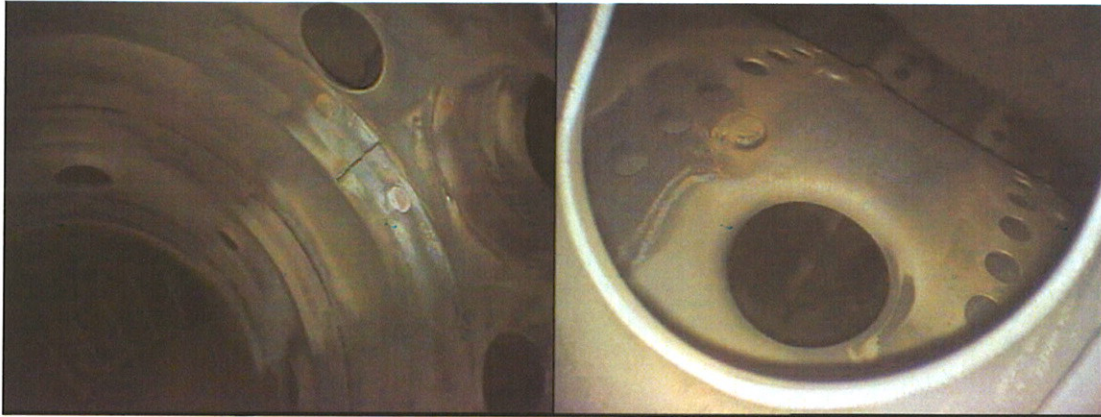
Cracking in No7 Can

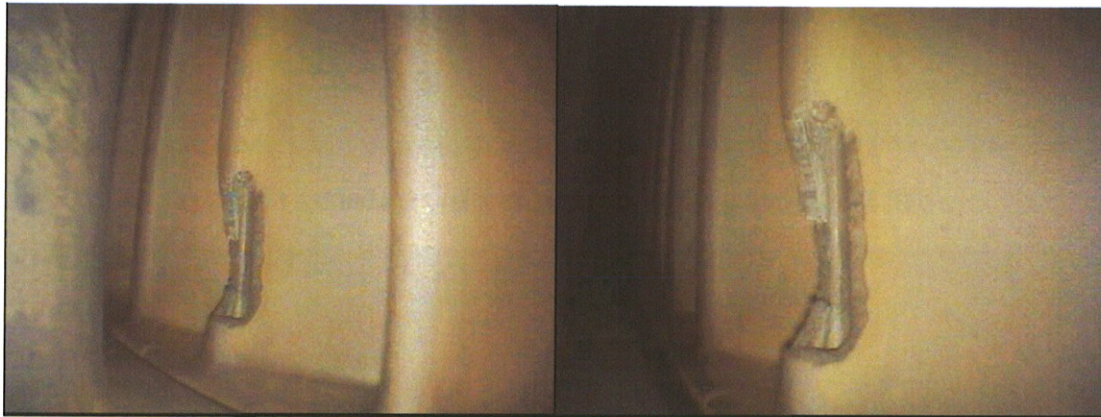
As can be seen a sizeable portion of 2 blades has been removed through collision or erosion. The remaining blades show sign of coating loss and pitting. Consideration should be given to removing the unit immediately for remedial works. This is currently a safety risk, and at risk of further damaging the unit should the blade fail entirely. (See Alba Power options for repair, overhaul and exchange)

HP Blade damage, blade found no 1

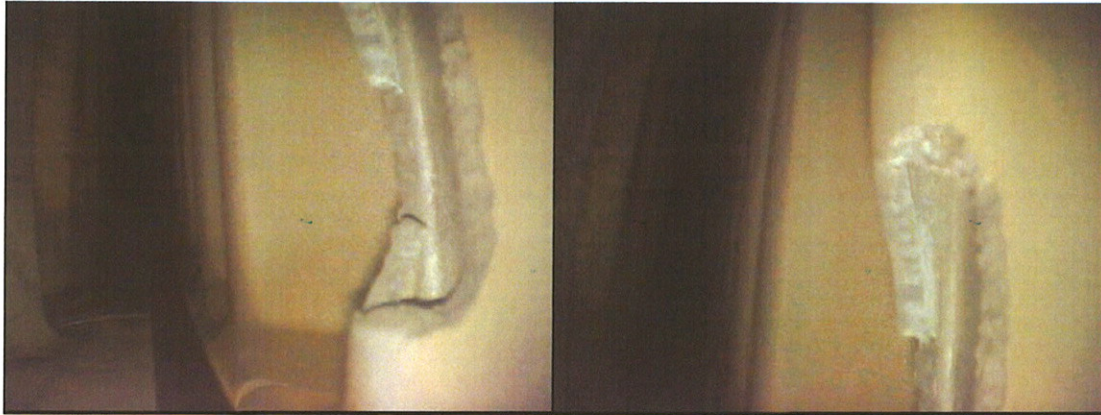
HP Blade damage, blade found no 1

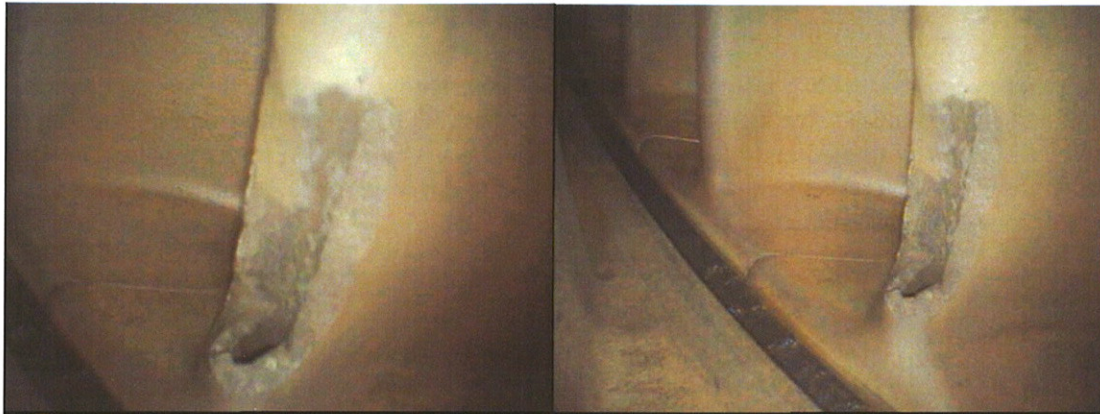
HP Blade damage, blade found no 2 (separated by 4 blades)

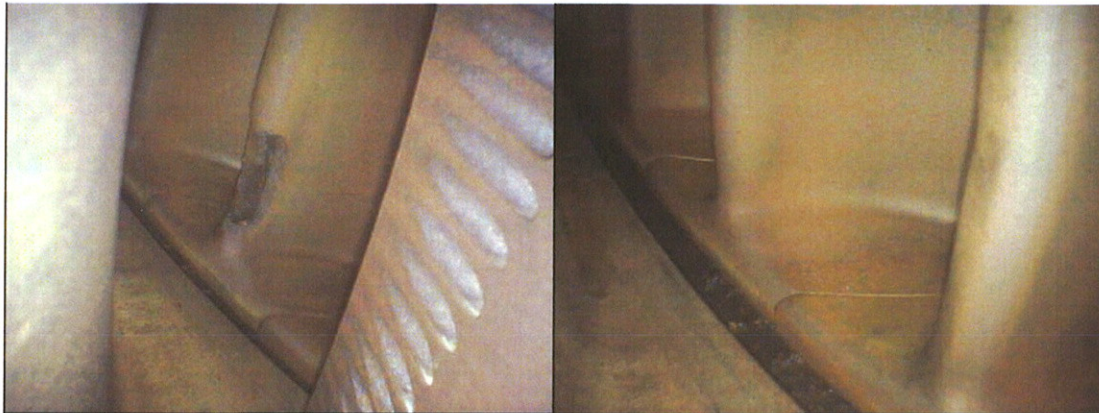
HP blade damage, No2

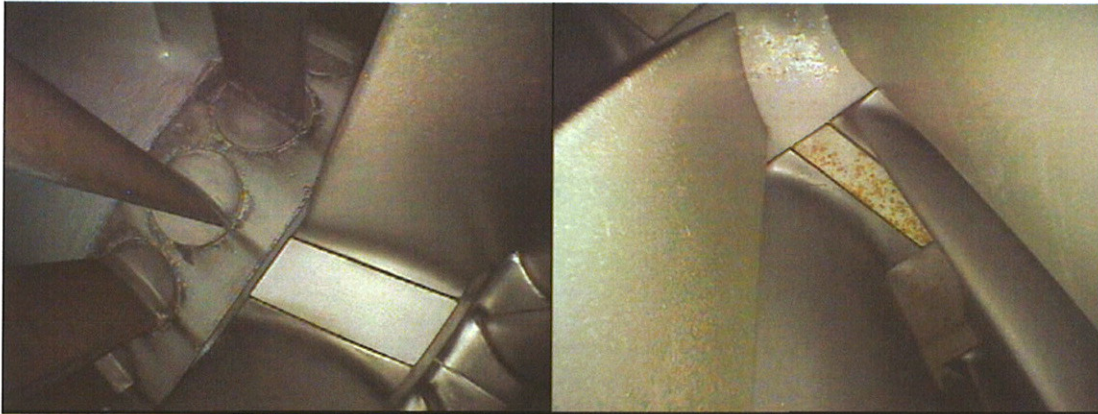
The compressor section on this unit is extremely corroded with extensive coating loss and pitting. It was found that one of the HP compressor stator spacer was missing, this has led to creeping of the remaining stators. These blades are now in an unsafe position, if they move slightly through operation further spacers and blades will be allowed to move, release and cause major damage to the unit. (Please see Alba Power proposal for onsite repair)

IGV Corrosion and pitting

Stage 1 spacer corrosion

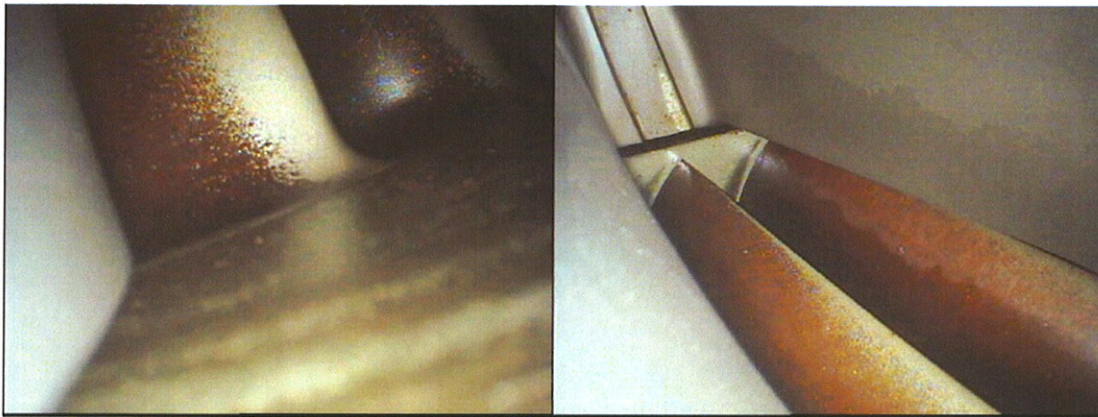
Coating loss Stage 5

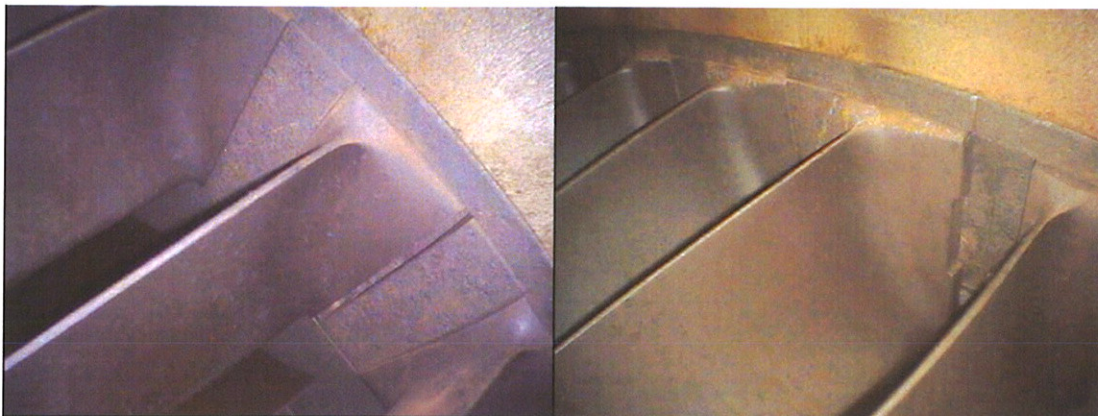
OGV Stator gap

missing spacer plate

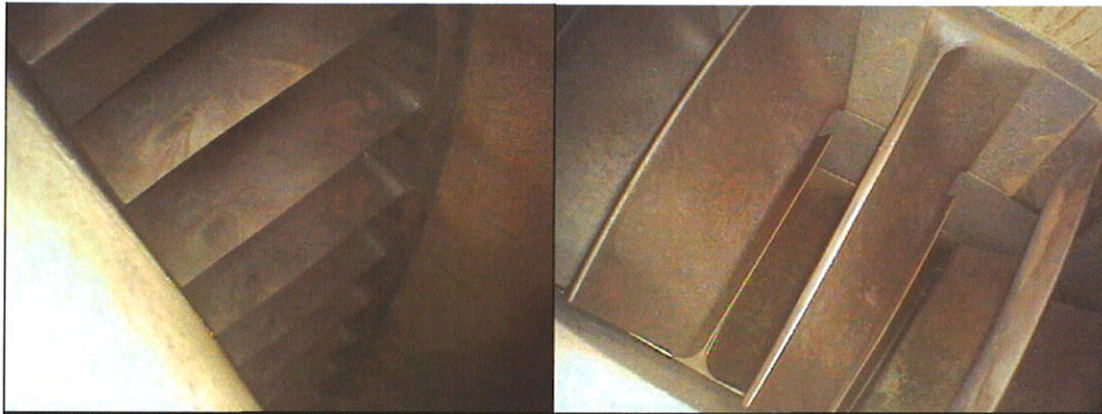
General condition of HP compressor

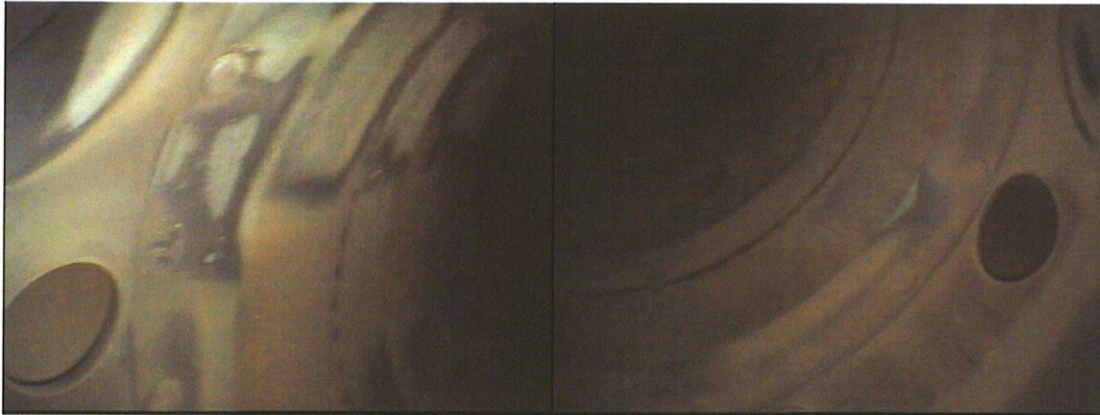
The combustion second, although heavily affected by carbon, was in good condition and should be monitored yearly through borescope.

General combustion chamber condition

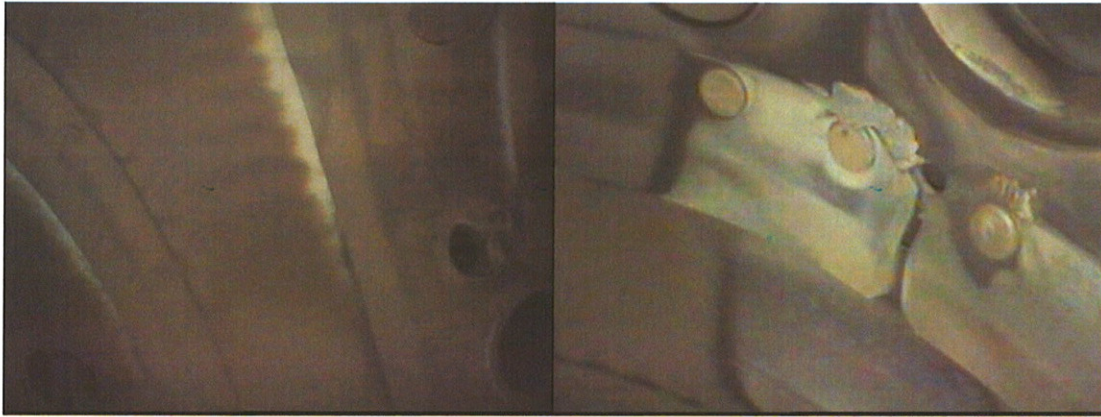
Combustion cracking and material loss

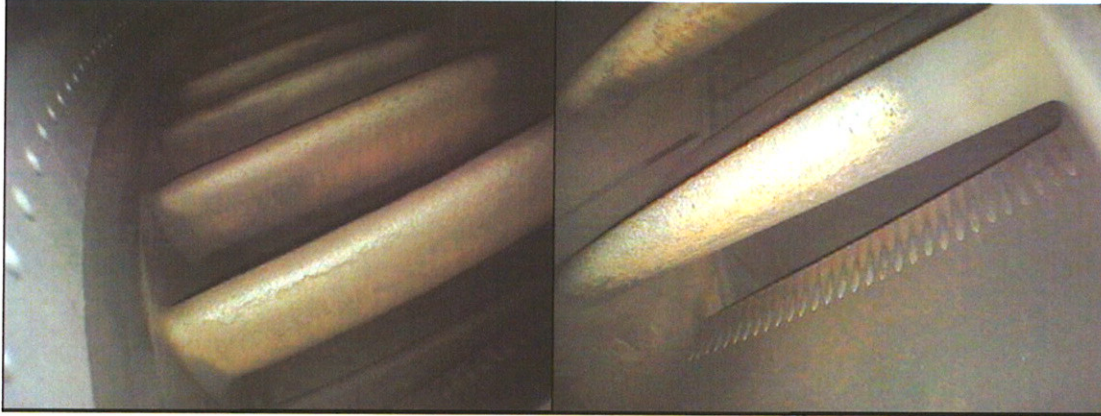
The turbine section was found to have heavy deposits of carbon, perhaps evidence of fuel pump issues. In the main the unit has coating loss and pitting on the HP NGV's, however this would continue in service through regular yearly monitoring.

HP NGV coating loss and staining

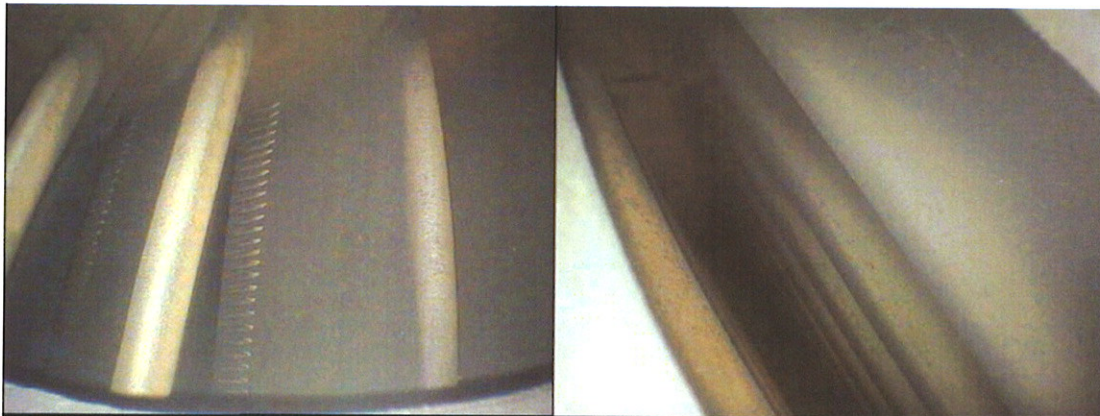
HP NGV Pitting

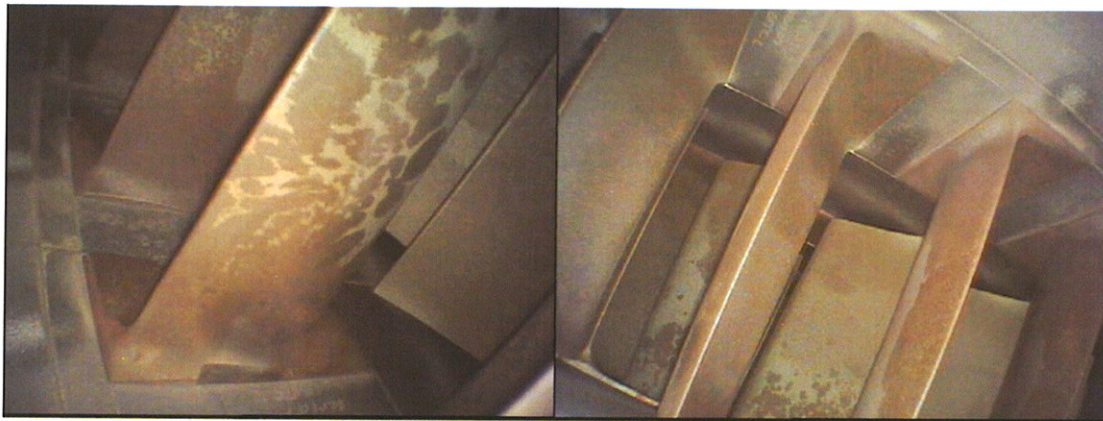
The unit was generally in clean condition with some minor corrosion and pitting. The rear of the HP compressor does show signs of corrosion.

HP compressor corrosion

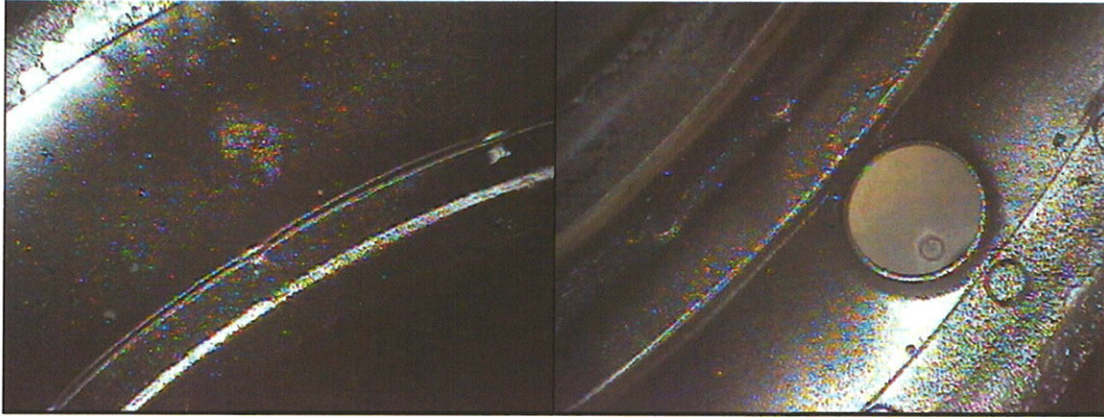
The unit showed signs of coating loss with No5 can show excessive liquid staining. This could be a sign of burner wear or fuel pump issues.

No 5 Staining

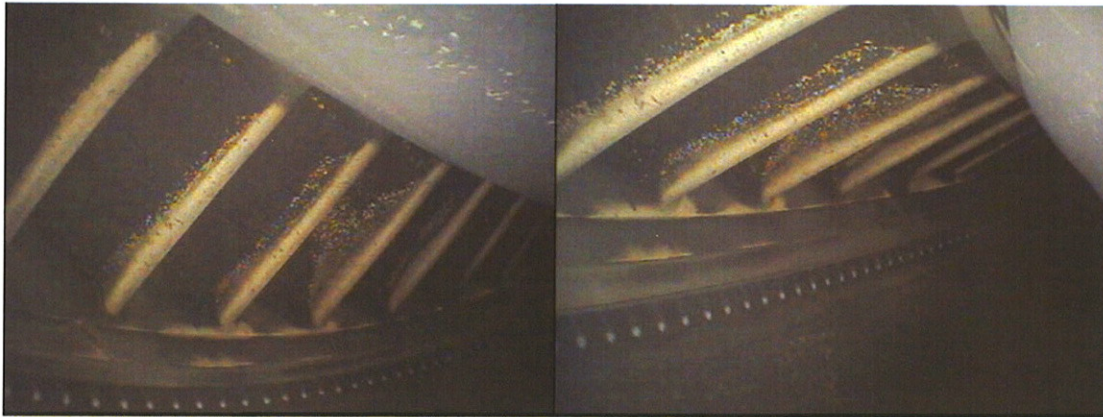
The turbine section showed signs of excessive pitting and coking, again a sign of incorrect fuel flows. It would be advisable to plan for full inspection and recoating of the NGV's and blades before the capital equipment is beyond repair.

HP NGV,s with pitting and coking

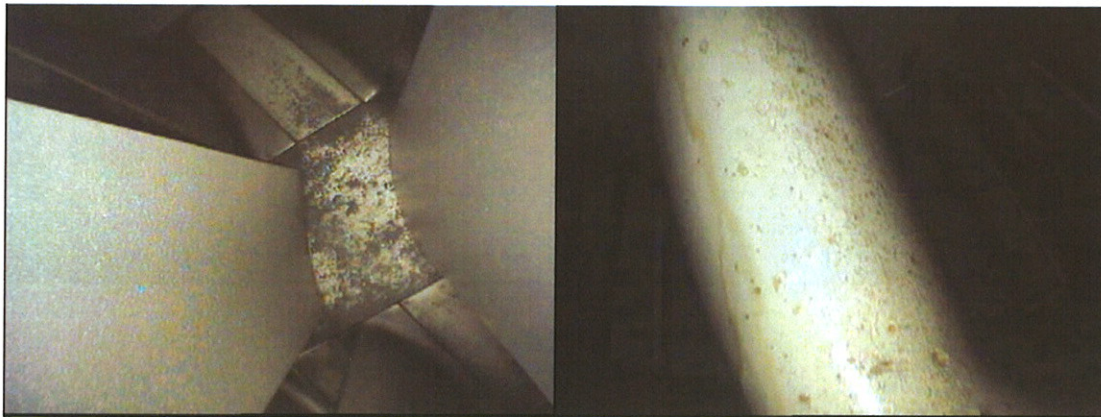
Stage 1 corrosion

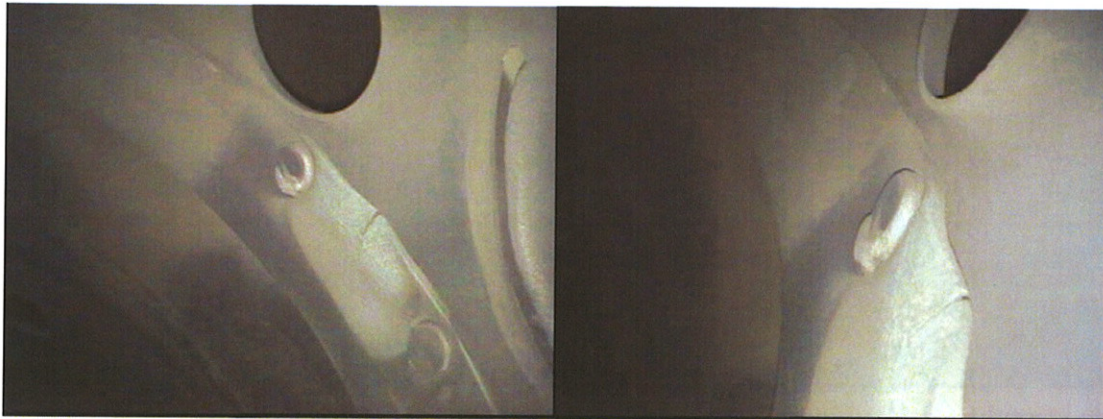
The combustion area was generally in good condition with the exception of the No5 position, which has a large crack and material loss.

No 5 cracking

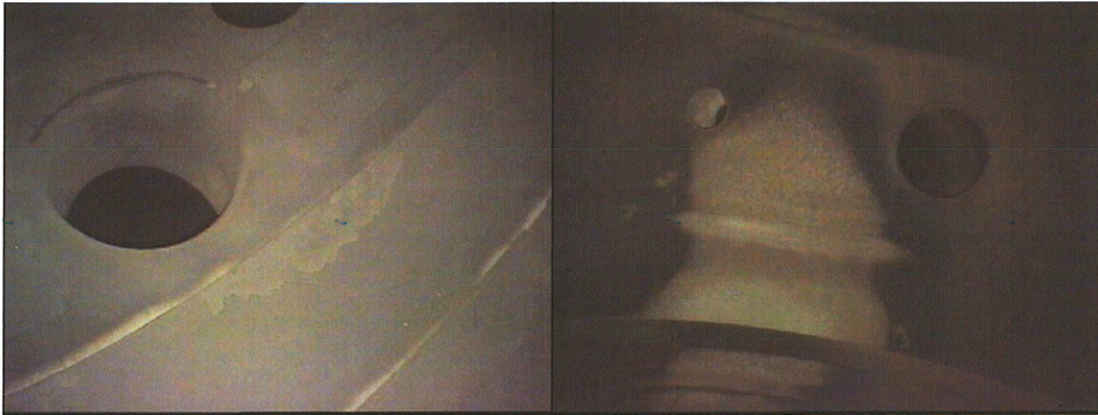
Coating loss and staining

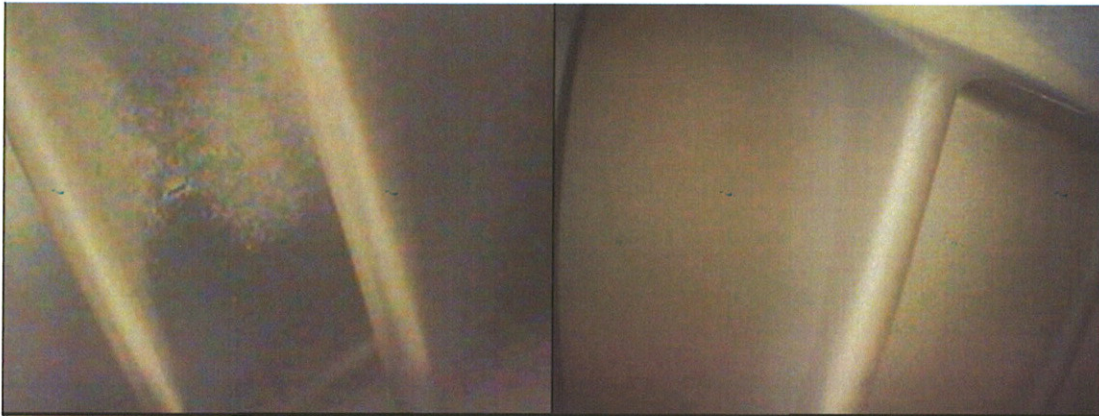
The turbine section was inspected and heavy coking and light cracking of the HP NGV's were found. This should be monitored for growth at next inspection period.

HP NGV damage
