1 **Q. Project C-14: Upgrade Work – Cat Arm**

Projet / Project : Servomotor - CAT ARM - PO4501166807Rapport / Report # : RC 3.0Client/Customer: Andritz Hydro Ltée# Contrat/contract: 1262Qtée/Qty: 1Produit/Product: Cylinder #1 (big diameter) (oil side)Index: item: Type rapport / report: Visual at receivingDessin/Dwg: 1262-001Rev.: 0

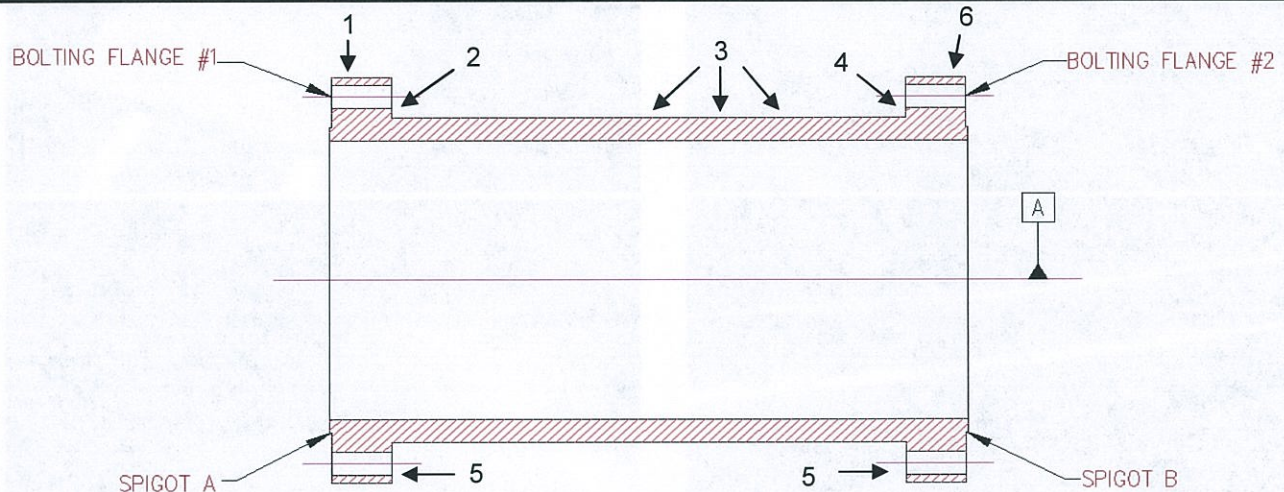
1- 3 punch marks, scratches and dents all around the flange, up to .010" deep.

2- Rust and blackened welded joint all around flange.

3- Scratches and marks all around & 1" wide machined surface by .010" deep for run out purposes.

4- Lightly rusted diameter and blackened welded joint all around.

5- Lightly damaged holes on back of both flanges.

6- 2 punch marks, scratches and dents all around flange up to .010" deep. (Punch marks are inline on both end)

7- Light scratches all around the inside diameter, no depth.

LEAVE AS IS

HONE THE CYLINDER TO RESTORE
THE SURFACE FINISH TO N6- SAND BLAST AND PAINT.

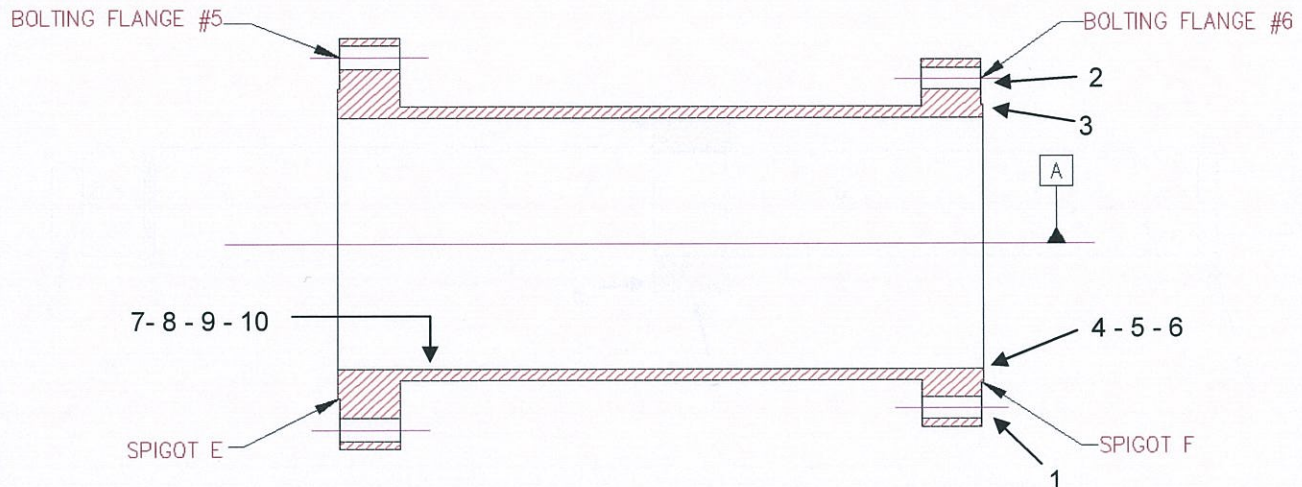
1- Bump on bolting flange #6 about 1/4" long x .003" height.

2- Bump on bolting flange #6 about 3/8" long x .010" height.

3- Puck on bolting flange #6, 3/4" x 1/8" x .010" deep.

4- 5- 6- Pucks on spigot F, up to 3/16" x 3/32" x .005" deep.

7- 8- 9- 10- Heavy wear on inside diameter at 4 places spaced by 90° on 80% of the length.

REPLACE CYLINDER BY A NEW CYLINDER MADE
OF STAINLESS STEEL.

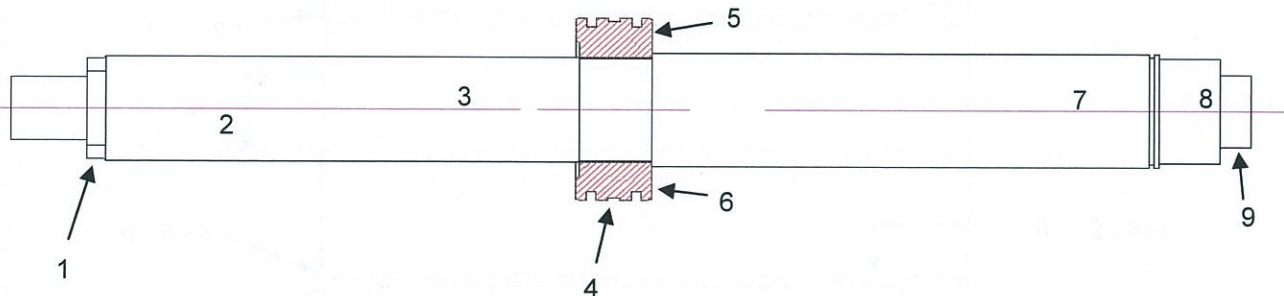
1- Damaged flat 5/8" long x .030" deep. SLIGHTLY GRIND TO REMOVE BURRS.2- 6 hollow spots up to .003" deep x Ø .040". LEAVE AS IS3- Linear scratches all around 17" long up to .001" deep. POLISH TO RESTORE NO SURFACE FINISH

4- Damaged outside diameter on piston up to .180" deep 4 places : 0° - 90° - 180° - 270°.

5- 2 holes Ø 3/8", 180° appart.

6- 1 holes Ø .080" x .040" deepé

7- Black marks and scratches, no depth.

} MAKE NEW PISTON
MADE OF STAINLESS

LEAVE AS ISSTEEL.8- 3/4" long threads used to lock piston on rear end. REFRESH USING A DIE9- Scratches and marks all around the diameter, up to .005" deep. LEAVE AS IS10- Damaged seal. REPLACE BY A NEW SEAL

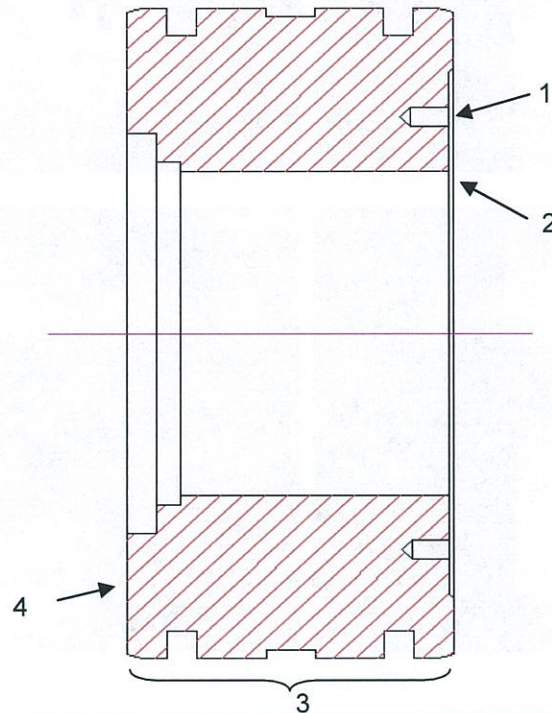
1- One $\varnothing 3/8$ " damaged hole.

2- 3/4" long locking threads for piston rear end.

3- Rust all around the diameter.

4- Rust and minor scratches all over face. Scratches are up to .002" deep.

LEAVE AS IS

CLEAN UP USING STEEL WIRE BRUSH AND SOLVENT WITH RAG

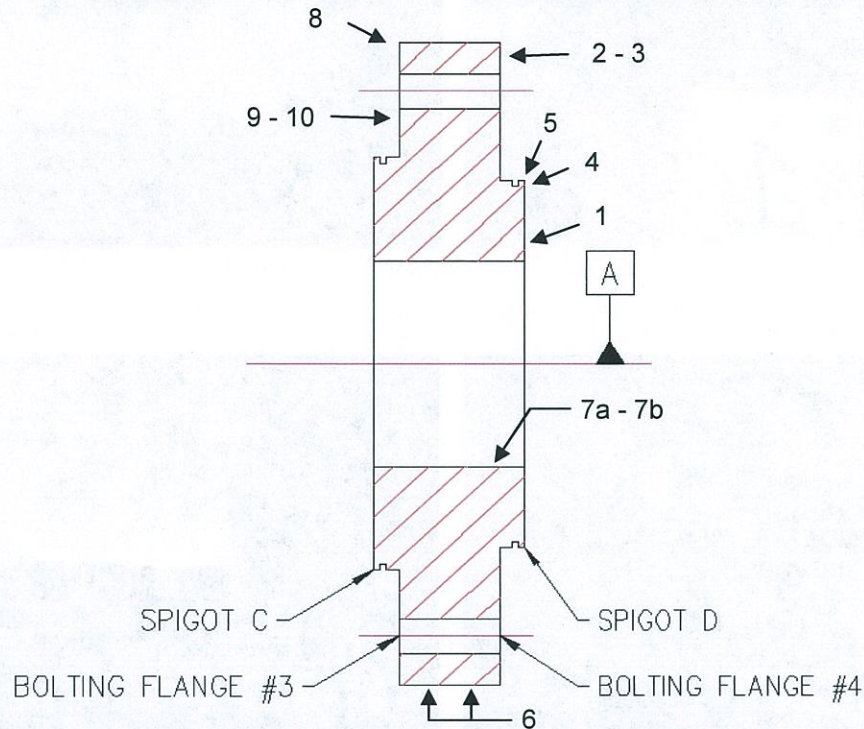
1- Dirt on this side & wear about $\varnothing 5 \frac{1}{2}$ " x $\frac{3}{16}$ " width x .015" deep. **LIGHT SANDING TO REMOVE BURRS ONLY.**2 & 3- Scratches about $\frac{3}{4}$ " x $\frac{1}{16}$ " x .010" deep. **LIGHT SANDING TO REMOVE BURRS ONLY.**4- Pits up to $\frac{1}{4}$ " x $\frac{3}{16}$ " x .020" deep. **REBUILD SPIGOT WITH STAINLESS STEEL WELDING MAT'L**5- Puck on spigot "D" about .020" deep. **AND REMACHINE TO ORIGINAL DIAMETER. DO A NEW 'O' RING GROOVE.**6- One of the two threaded holes have dirt and rust in. **→ REFRESH WITH A TAP**7a & 7b - Good condition of inside diameter. **→ OK**8- Grinder marks up to $\frac{1}{32}$ " deep. **GRIND SMOOTH TO REMOVE BURRS**9 & 10- Many light scratches and tool marks up to .002" deep. **LIGHT SANDING TO REMOVE BURRS ONLY**Good condition of spigot "C". **→ OK**

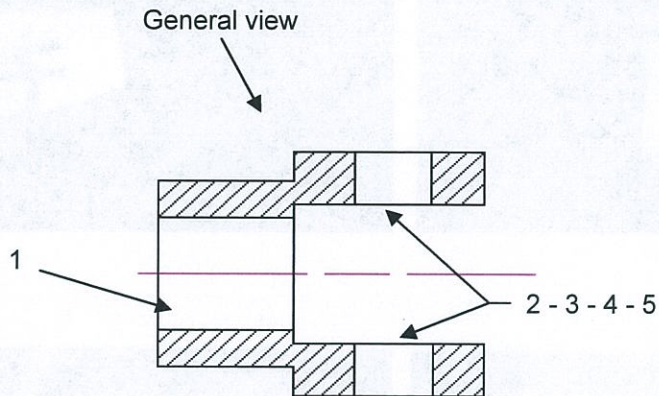
1- Good condition of threads → OK.

2 - 3 - 4 - 5 - Rust inside diameter. → LEAVE AS IS.

General view : Paint peeling → SAND BLAST AND PAINT

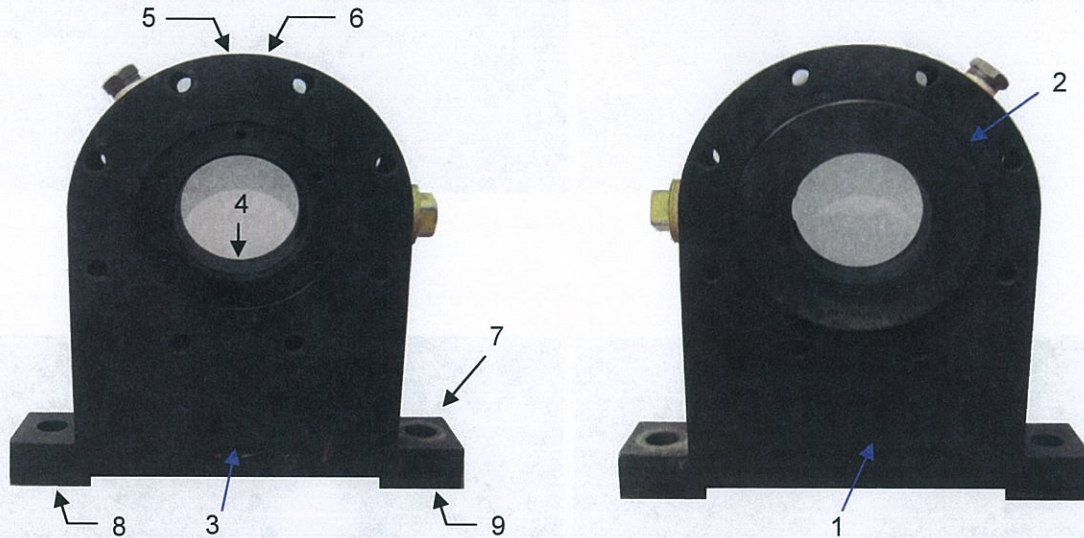
- 1- Good condition of all surface of this side.
- 2- Good condition of o-ring and groove.
- 3- Good condition of all surface of this side.
- 4- Good condition of inside diameter.
- 5- Punch mark.
- 6- Many pits about .002" deep on 2" x 1" area.
- 7- Puck 1/4" x 1/4" x 1/8" deep.
- 8 - 9 - Good condition of face.
- Good condition of all holes and threaded holes.

LEAVE AS IS

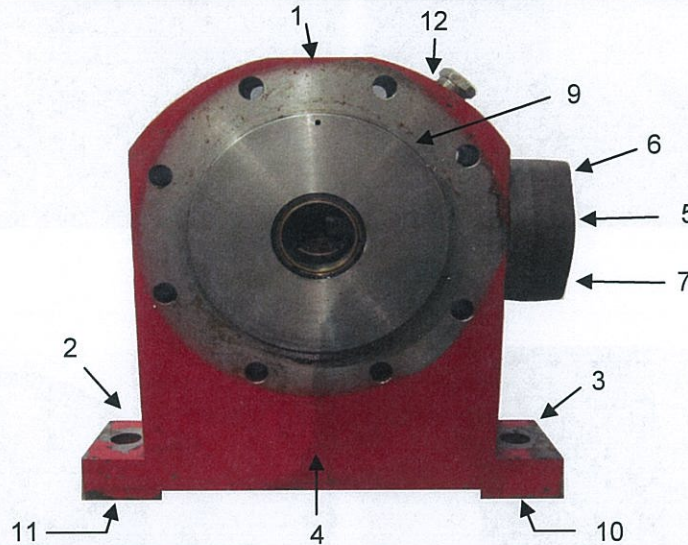
1- Punch mark

2 - 3 - Paint peeling

6- Light rust on face.

7- Dirt in threads.

12- Dirt in NPT threads and on thread of plug.

LEAVE AS IS

SAND BLAST AND PAINT

LIGHT SANDING TO CLEAN SURFACE

→ REFRESH USING A TAP

→ OK. REPLACE "O" RING ONLY

→ REFRESH THREADS USING A TAP
