THE **Lower Churchill** PROJECT

March 2010

**MF1271 - Evaluation of Existing Wells,
Pumps and Related Infrastructure in the
Muskrat Falls Pumpwell System**

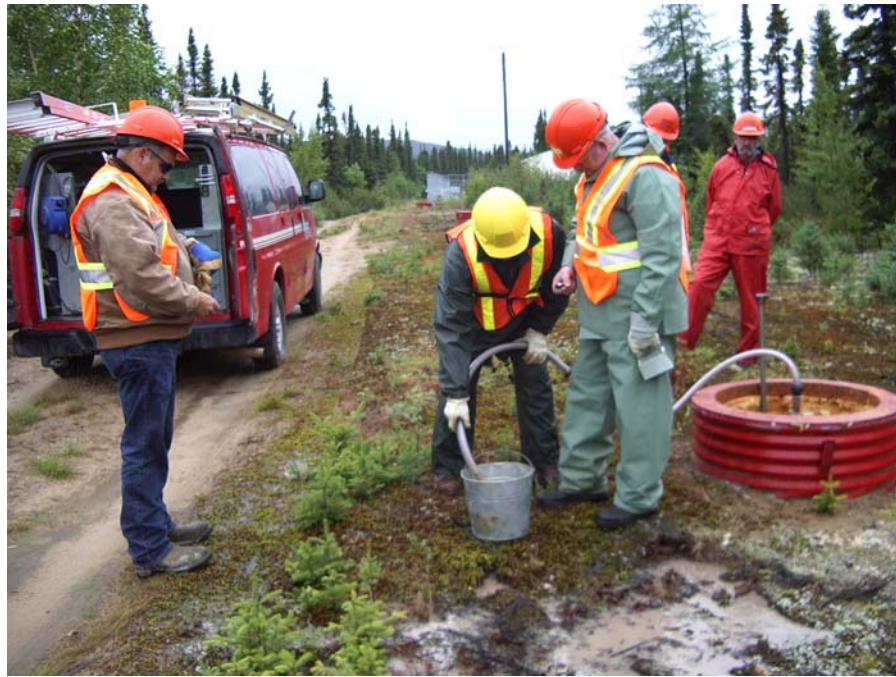
Photograph 1: A flow test was conducted at each well prior to inspection and cleaning.

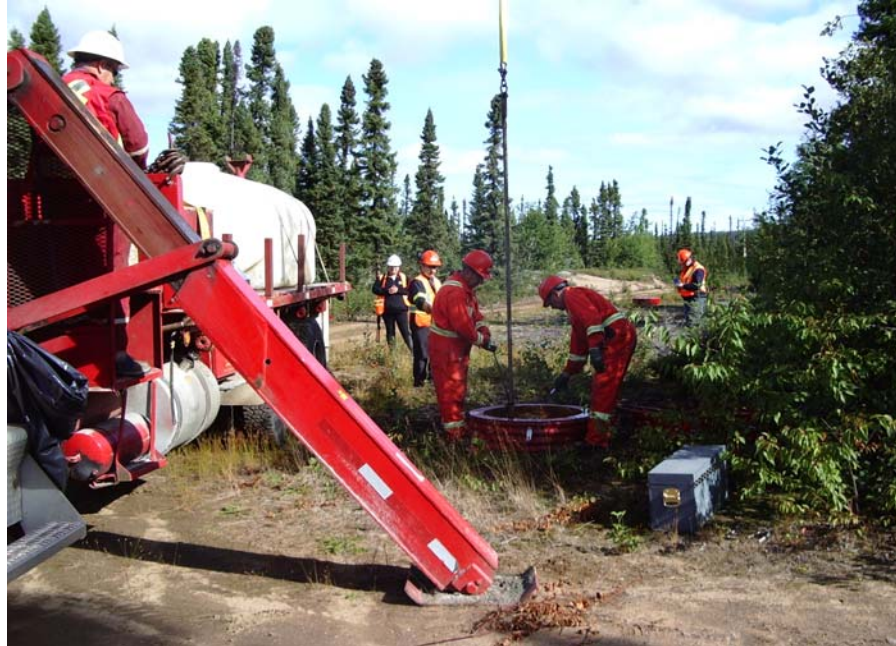
Photograph 2: The risers, wiring and pump were removed from each well.

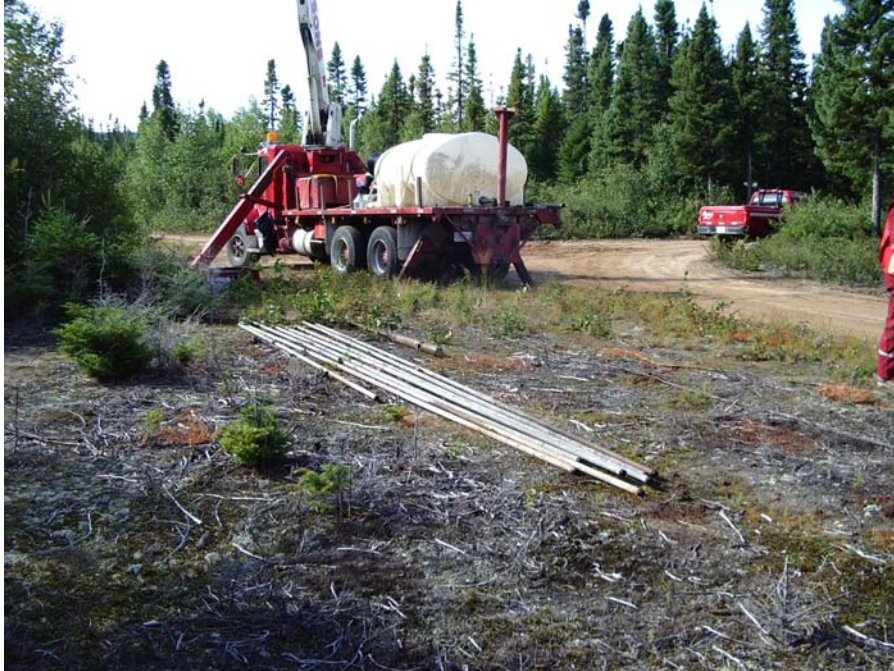
Photograph 3: The risers and pump were laid down on the ground for inspection.

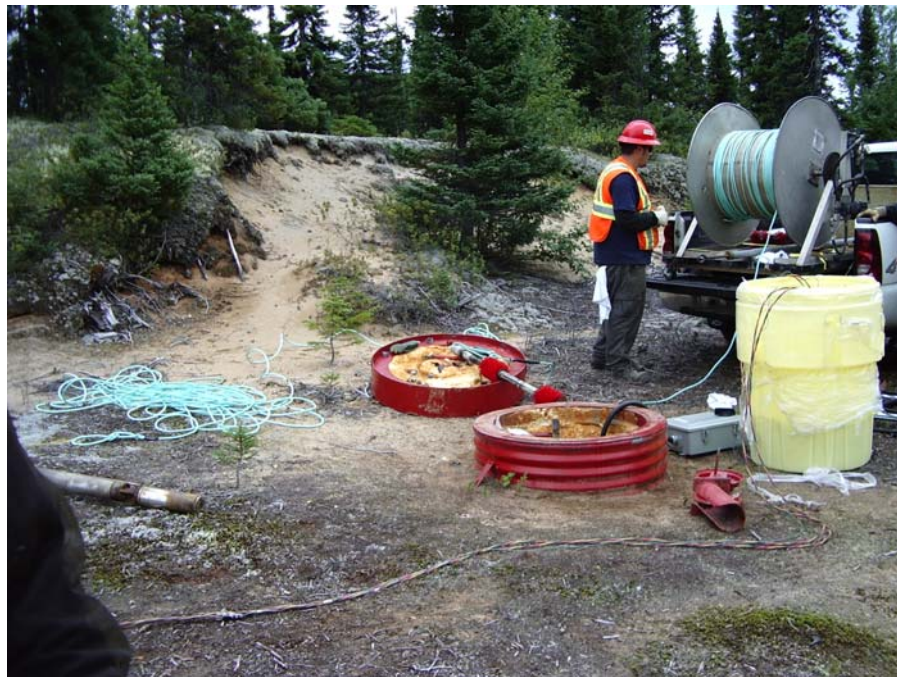
Photograph 8: An acid solution was added to the well and allowed to stand for 2 hours. Then a wellbore brush was used to clean the casing and screen.

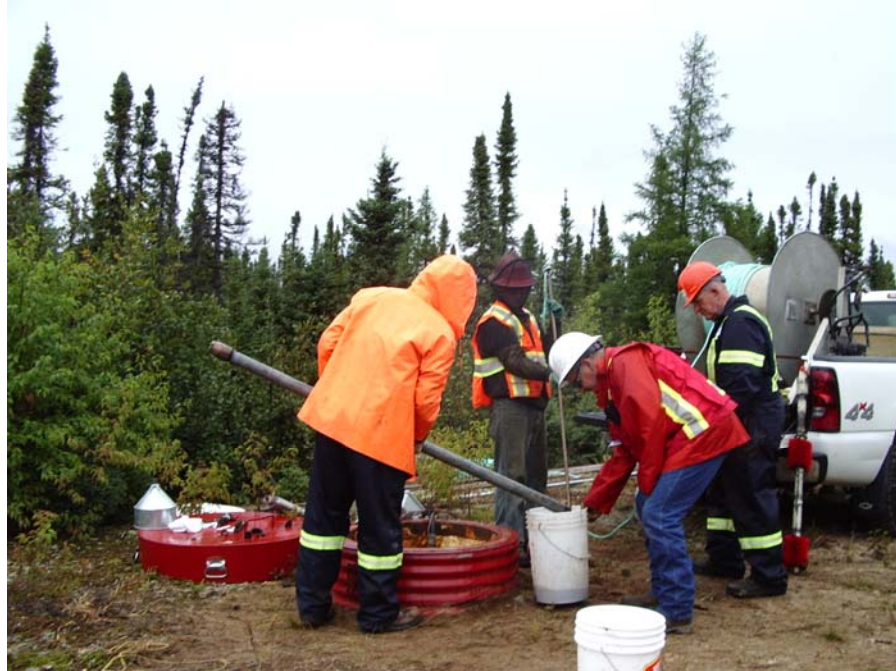
Photograph 9: A sand pump was placed down into the well, water and sediments were suctioned into the sand pump. The sand pump was brought to the surface and the sediments collected in a pail for examination.

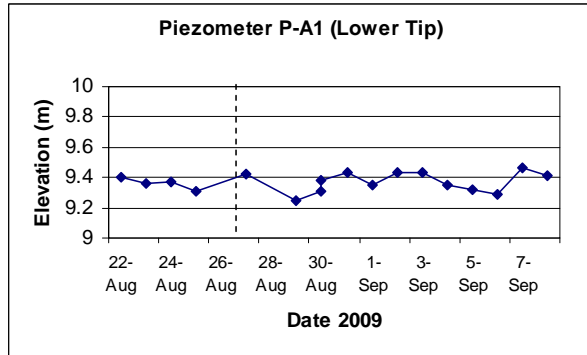
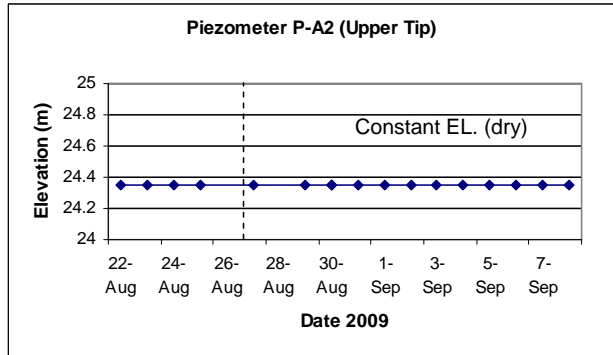
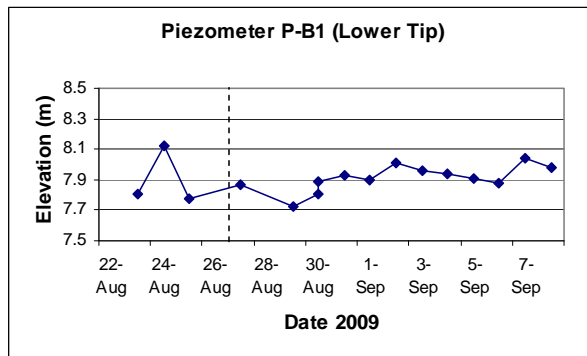
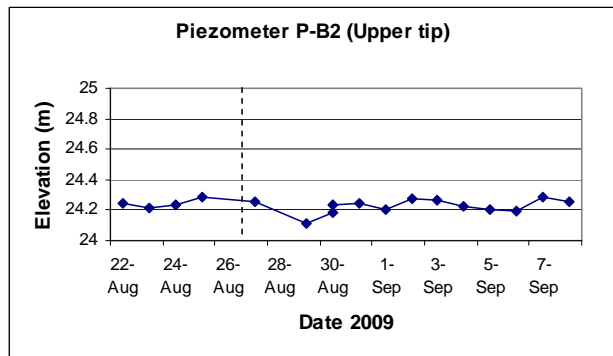
Figure 3 – Piezometer water level variations prior to and during the well inspection program:

(a) P-A1 lower tip, (b) P-A2 upper tip, (c) P-B1 lower tip and (d) P-B2 upper tip. Note: Daily shutdown of pump system commenced on August 27, 2009, shown as vertical dashed line.

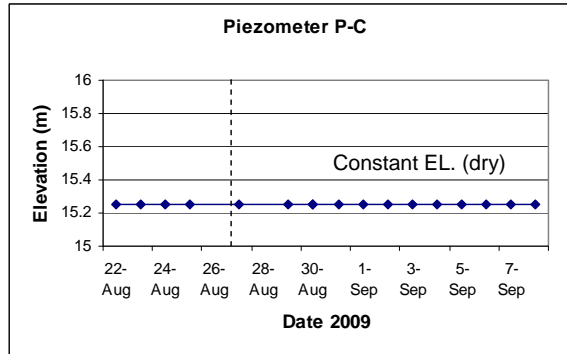
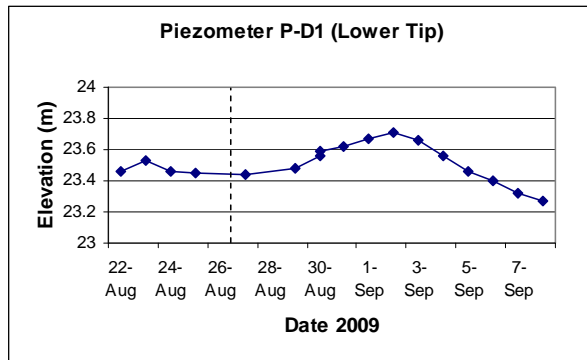
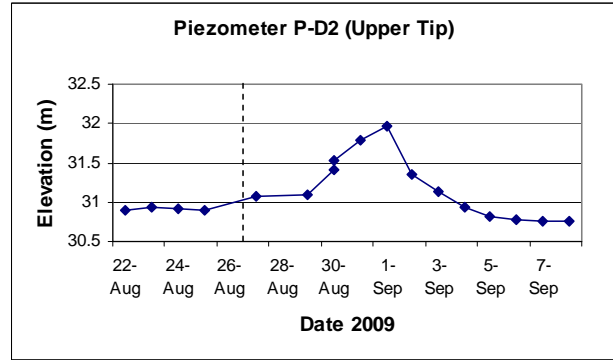
Figure 4 – Piezometer water level variations prior to and during the well inspection program:

(a) P-C, (b) P-D1 lower tip, (c) P-D2 upper tip. Note: Daily shutdown of pump system commenced on August 27, 2009, shown as vertical dashed line.

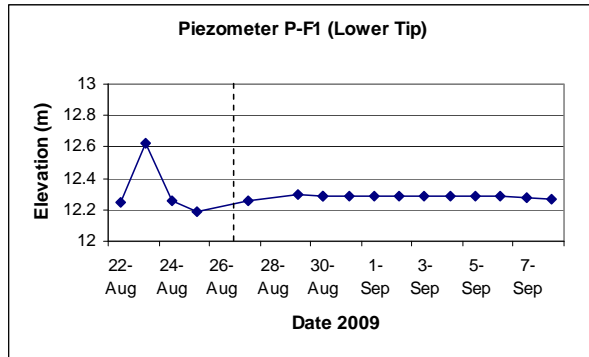
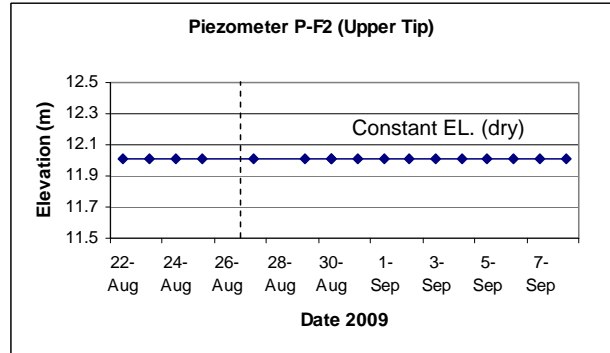
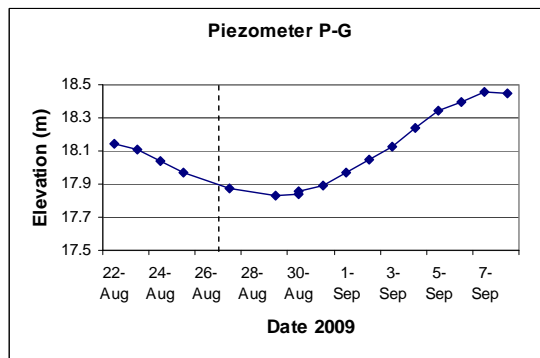
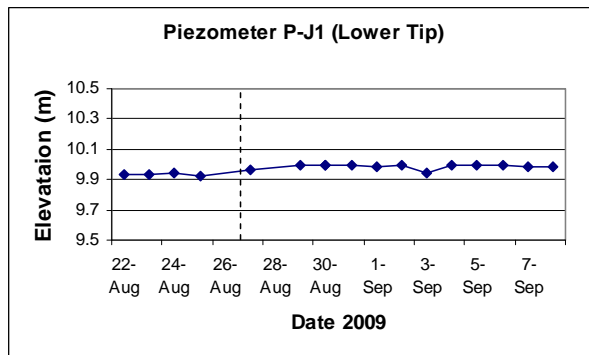
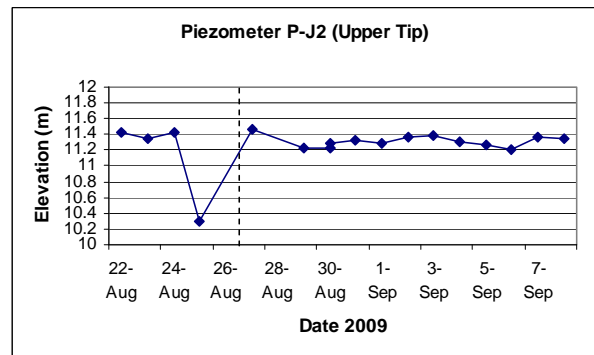
Figure 5 – Piezometer water level variations prior to and during the well inspection program:

(a) P-F1 lower tip, (b) P-F2 upper tip, (c) P-G , (d) P-J1 lower tip, (e) P-J2 upper tip. Note: Daily shutdown of pump system commenced on August 27, 2009, shown as vertical dashed line.
