**LOWER CHURCHILL PROJECT**

**MUSKRAT FALLS NORTH SPUR**

**Technical Note**

**Muskrat Falls North Spur - 1999 to 2011**

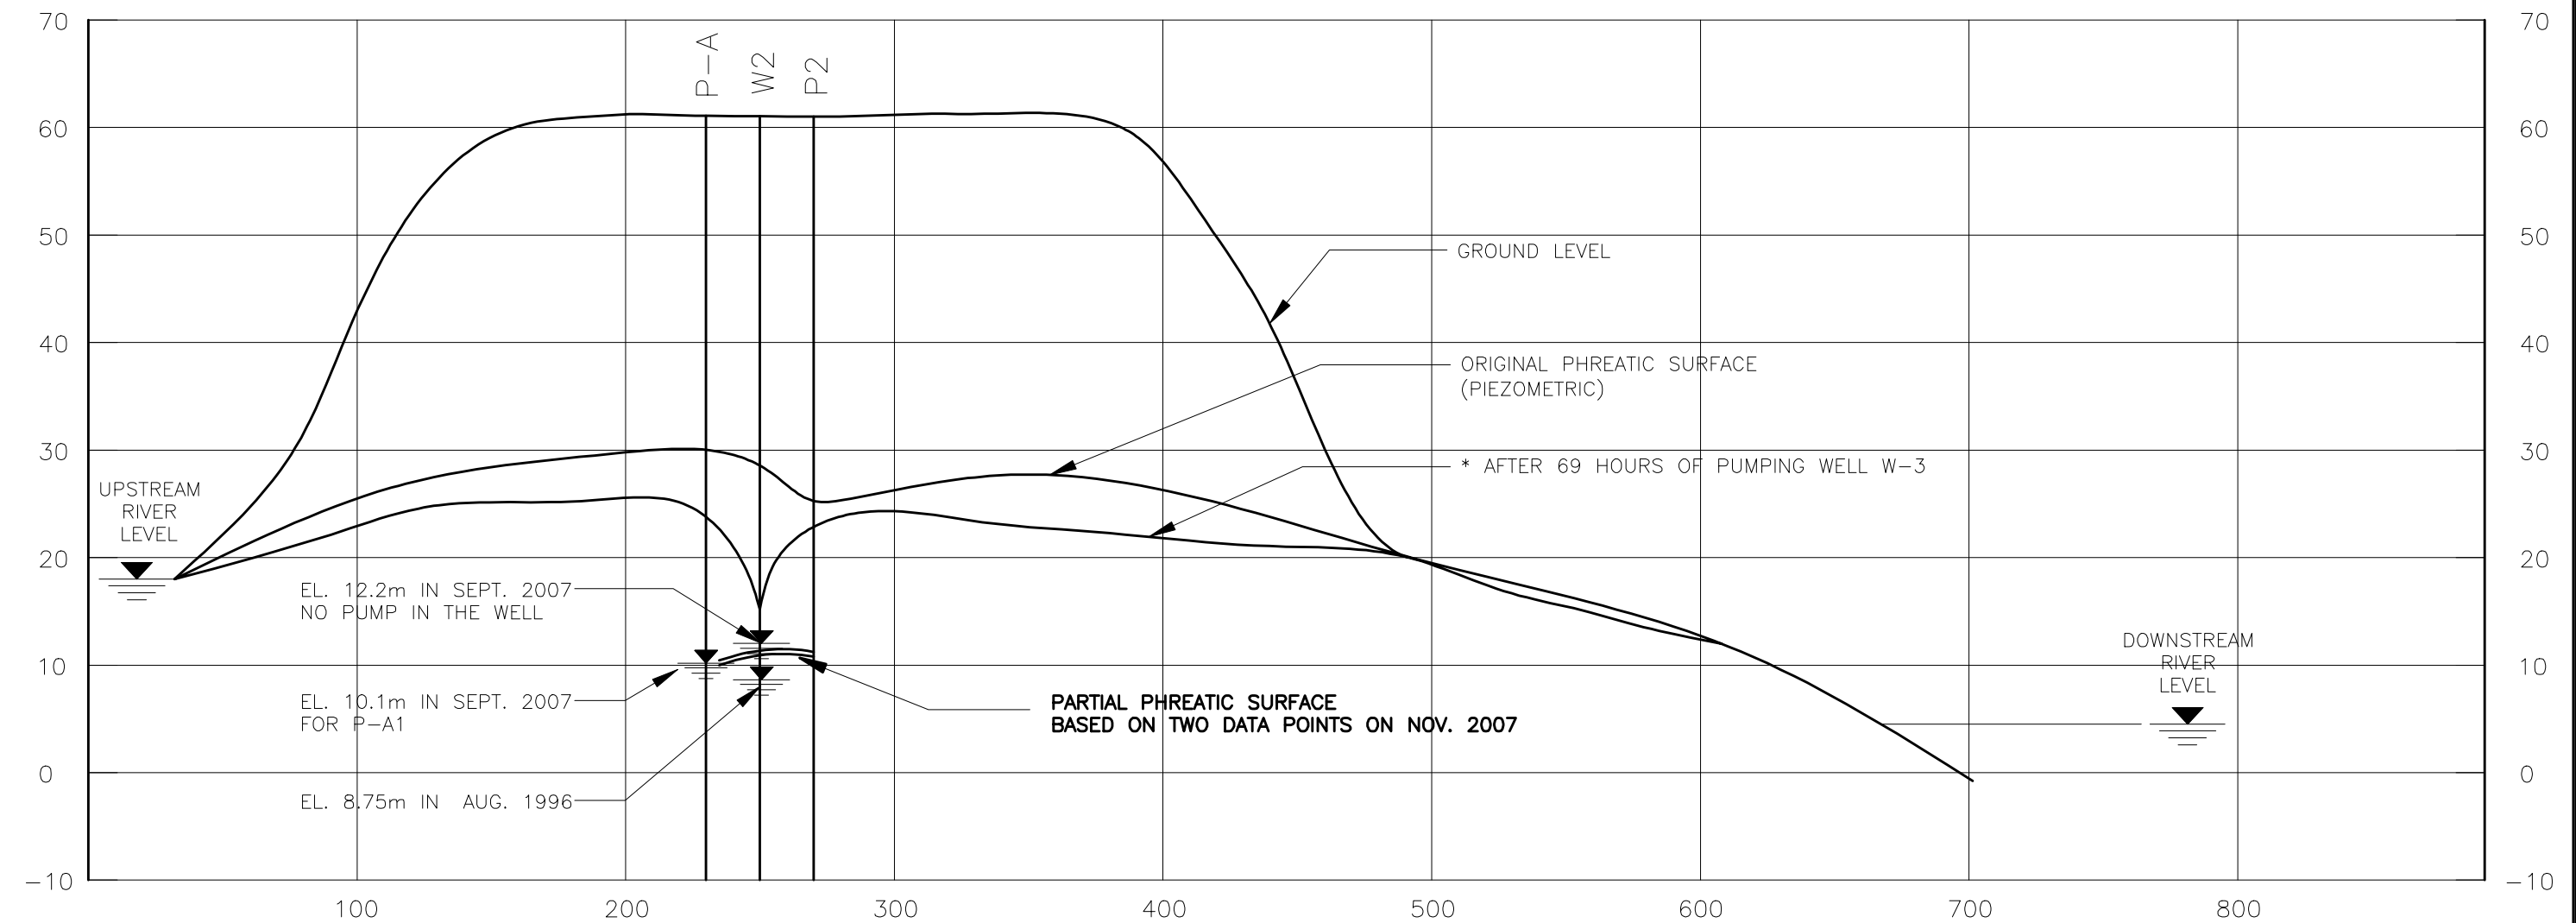
SECTION B1-B1

NOTE:  
DRAWING THE CURRENT PHREATIC SURFACE  
IS NOT PRACTICAL WITH ONLY TWO DATA  
POINTS.

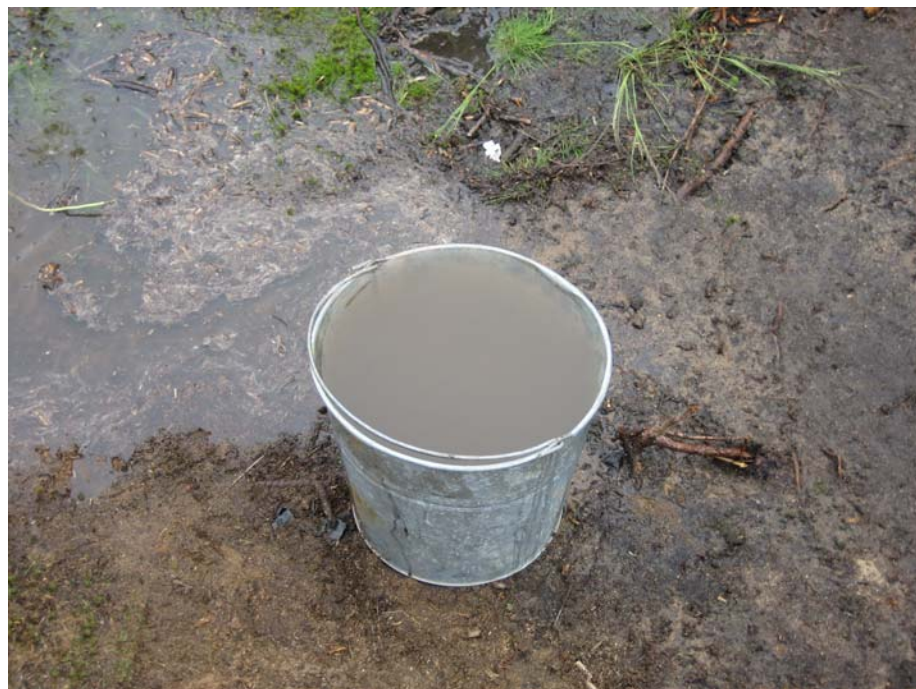
**Silt and fines in W4 riser pipe (Site Visit -1)**
