1 Q. Please provide the inspection report and any other report authorized by
2 Alstom (*sic*) in relation to this matter.

EVALUATION OF A WATERWALL TUBE

**NEWFOUNDLAND & LABRADOR HYDRO
HOLYROOD GENERATING STATION
UNIT NUMBER 2
CONTRACT NO. 04968
PSA -85800/LN-05J656
MTC-05-376**

Technical Services Report
Newfoundland & Labrador Hydro
Holyrood Unit 2
January 2006 - East Waterwall Tube Failures

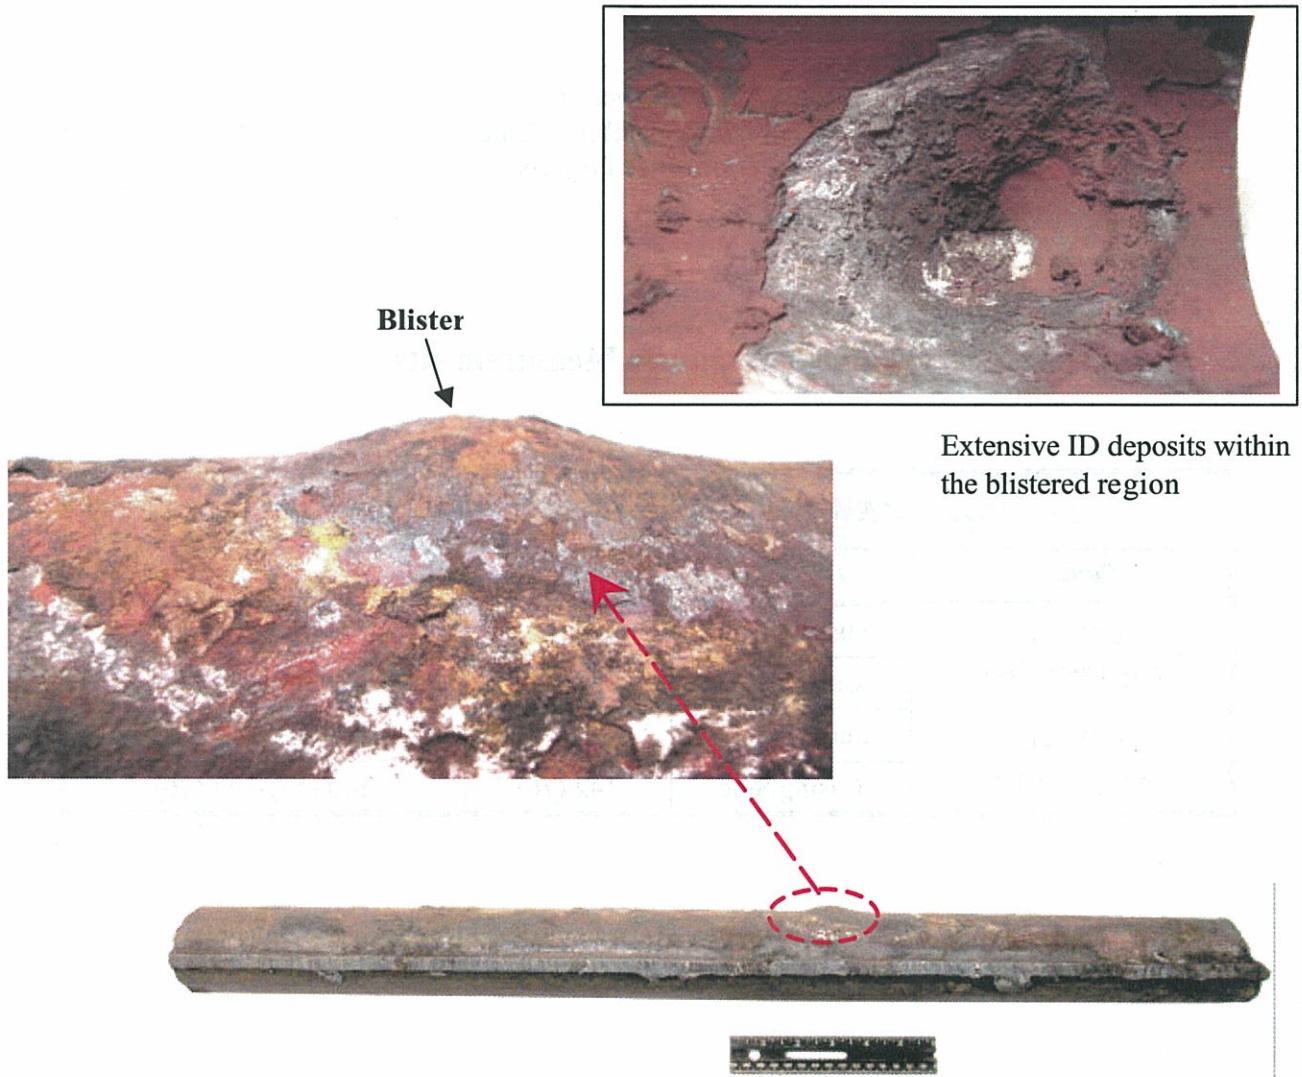
A section of waterwall tubing removed from Unit 2 at Newfoundland & Labrador Hydro's Holyrood Generating Station was submitted to the Materials Technology Center (MTC) for destructive analysis. The sample, shown in Figure 1 as it appeared when received from the field, was taken from east furnace waterwall tube 41 from D corner at the top burner elevation (approximately 55'). According to information provided by the customer, the sample was selected for evaluation because it was considered representative of the condition of a number of blistered tubes discovered in this same area of the unit during a recent outage. Reportedly, three similar furnace wall tube leaks had been identified previously in this unit in April 2005.

Figure 1. Documenting the Section of Waterwall Tubing Removed from Unit 2 at Newfoundland & Labrador Hydro's Holyrood Steam Station, As It Appeared When Received from the Field.

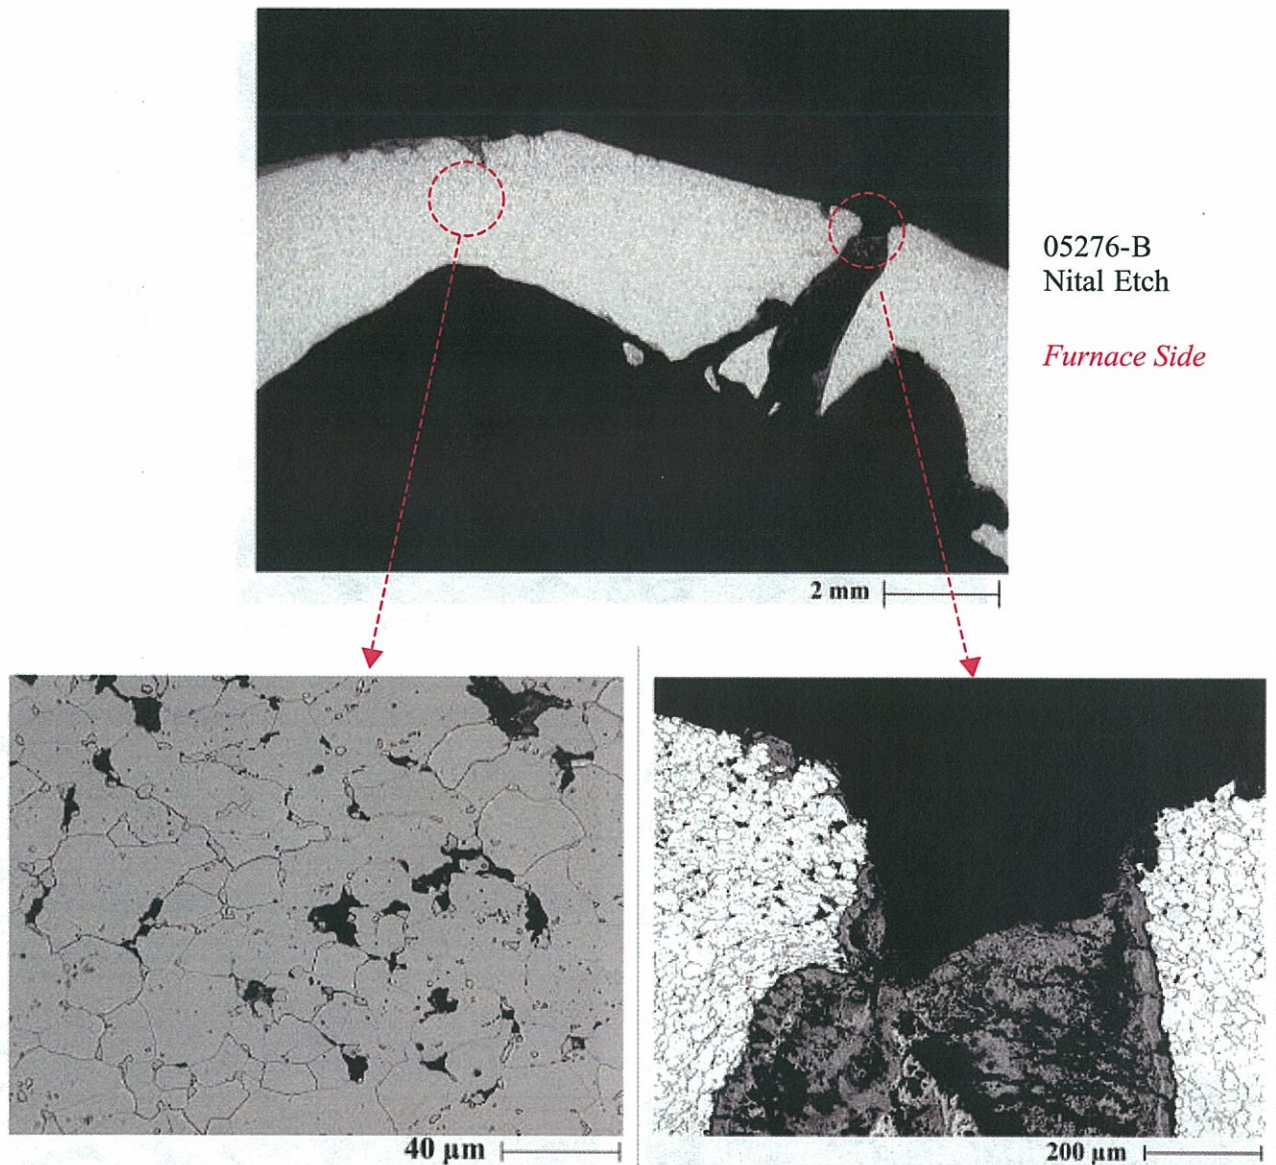
The condition of the furnace side of the tubing in the blister area is documented in Figure 2. Examination of the microstructure in this area revealed the presence of extensive creep cavitation and large, blocky carbides along the grain boundaries. However, in the absence of any evidence of phase transformation, it was evident that tube metal temperatures within the rupture zone had *not* exceeded the lower critical transformation temperature for carbon steel tubing, which is ~1350°F. In contrast, the casing side of the tube at the blister elevation (Figure 3) and both the furnace and casing sides of the tube away from the blistered area (Figure 4) exhibited no evidence of overheating.

The micrographs on the top and bottom right of Figure 2 showed an area of corrosion attack that had propagated completely through the tube wall to form a leak path. The through-wall penetration was located within the blistered area but obviously away from the area where the swelling was greatest. Because there was no evidence of any widespread corrosion activity noted in other areas of the sample, it was believed that the penetration originated at a tube defect and that it grew slowly by preferential corrosion over the course of many operating cycles. Once the penetration had progressed to a critical size, the tube leaked.

Figure 2. Documenting the Condition of the Macrostructure and Microstructure at the Blister Location. Showing The Extensive Creep Cavitation And Large, Blocky Carbides That Were Observed Along Grain Boundaries (bottom, left). Also Showing a Crack-like Penetration that had Propagated Completely Through the Tube Wall by Preferential Corrosion at What was Believed to be a Defect Area (bottom, right).

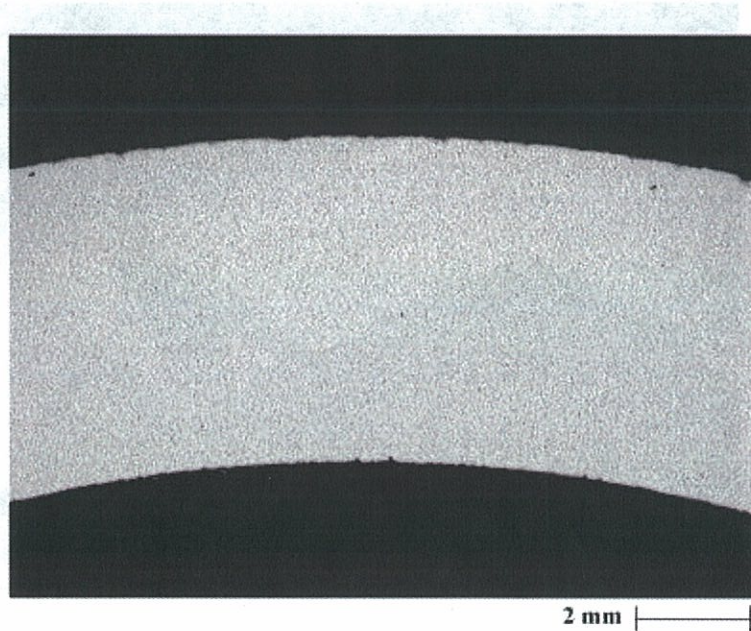
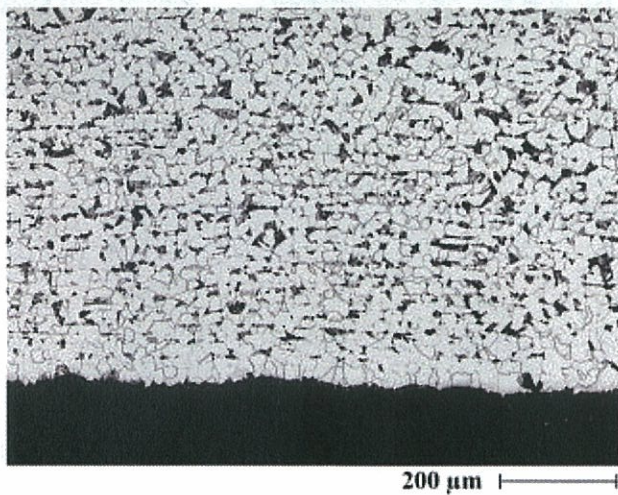
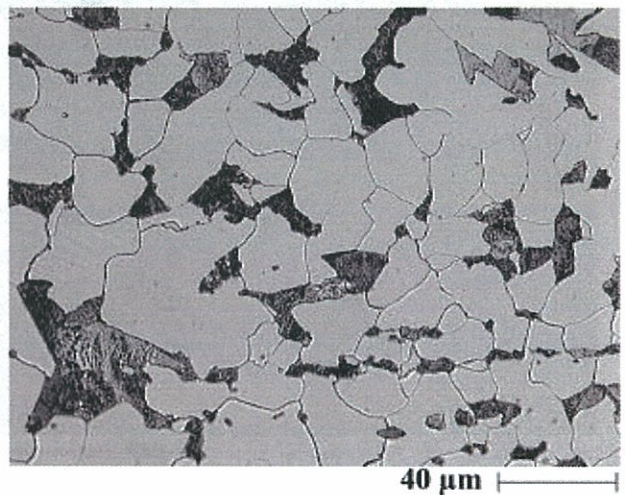
Figure 3. Documenting the Typical Condition of the Macrostructure and Microstructure on the Casing Side of the Tube at the Blister Elevation.

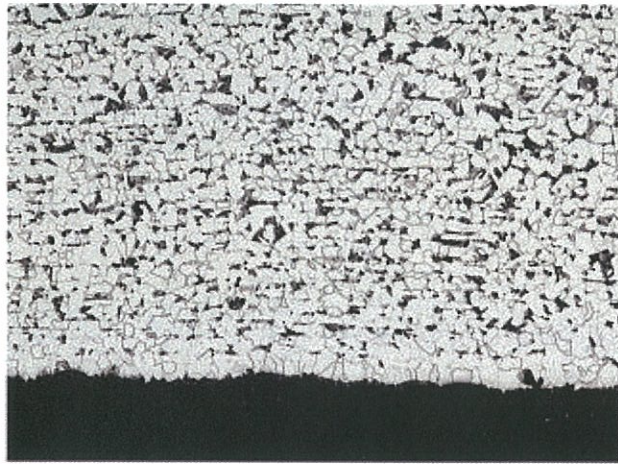
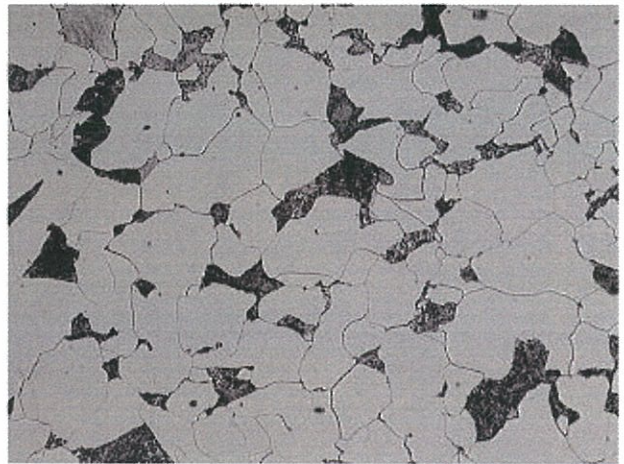
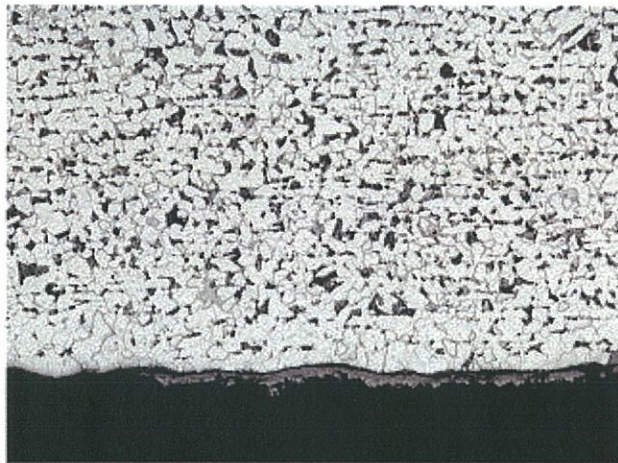
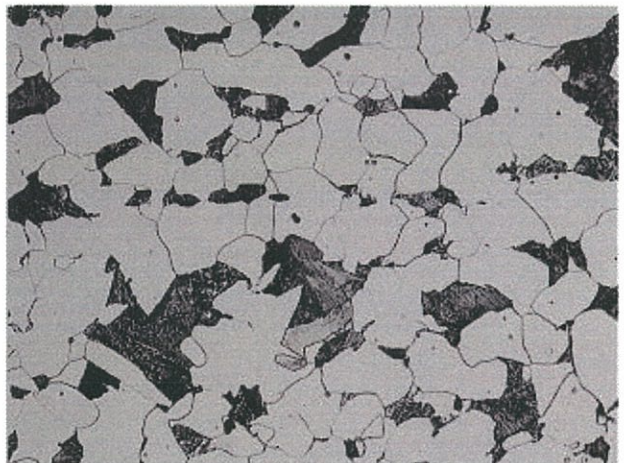
Figure 4. Documenting the Typical Condition of the Microstructure on the Furnace and Casing Sides of the Tube at a Location away from the Blister.

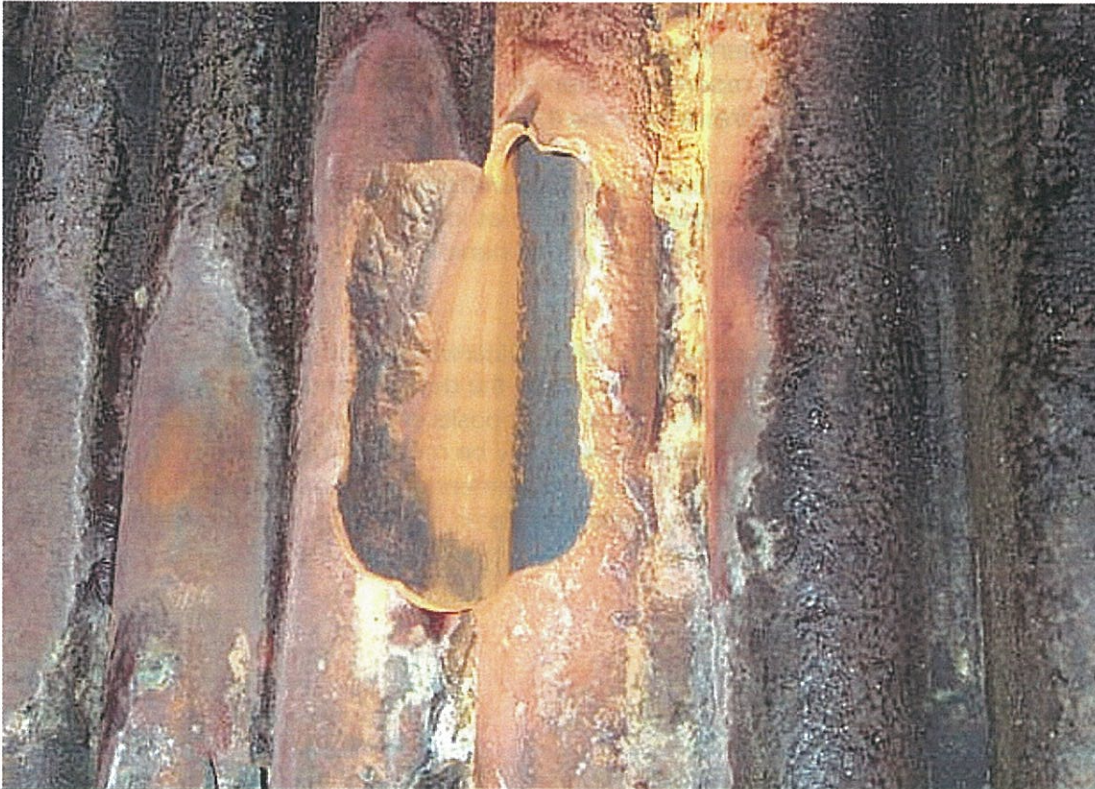
A tube failure occurred on January 6, 2006. The failure was on tube #56 from D corner on the east wall at 53' elevation. It was a window-type failure as can be seen in the photograph in Section 8 of this report. This tube was removed and replaced with new material.

Figure 1. Original tube failure - Tube 56 from D corner 53' elevation

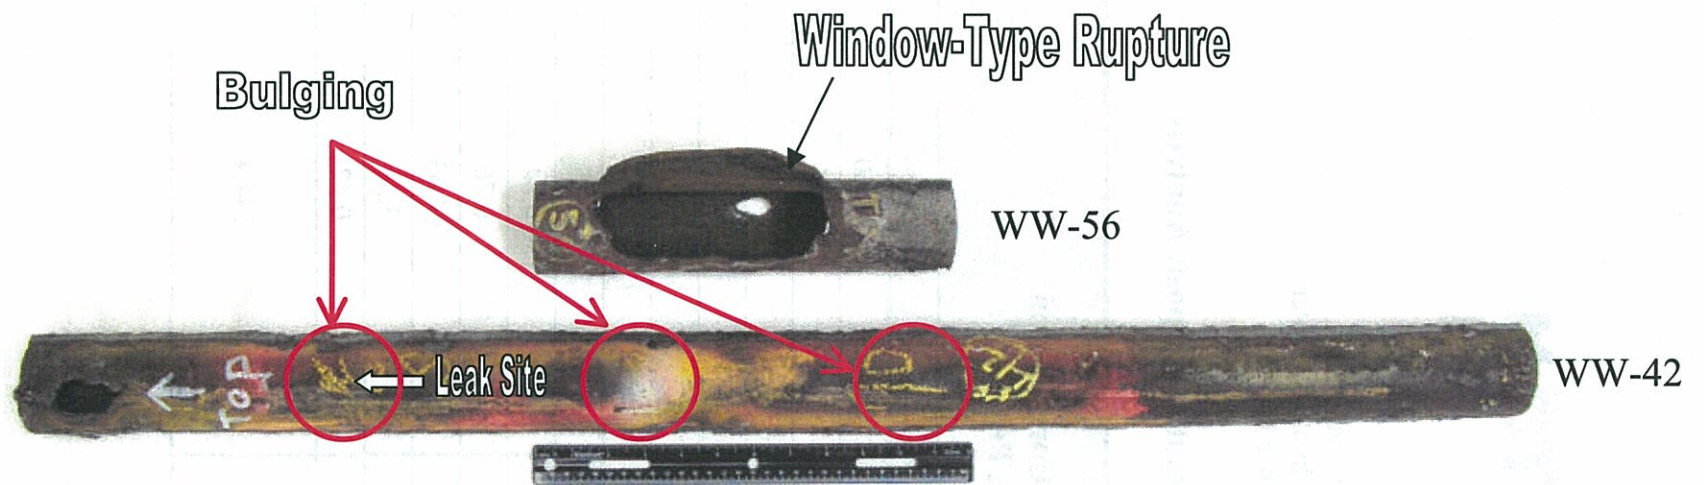
Figure 1. Documenting The Waterwall Tubes As They Appeared When Received From Unit 2 at Newfoundland and Labrador Hydro's Holyrood Generating Station. Also Indicating the Approximate Locations of the Failures and Bulging.

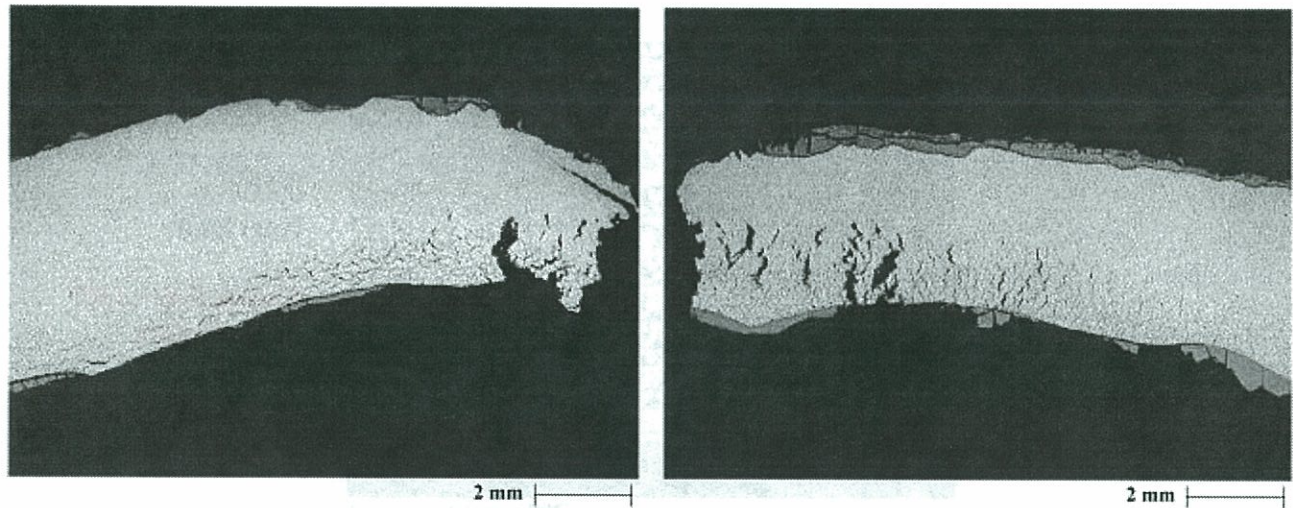
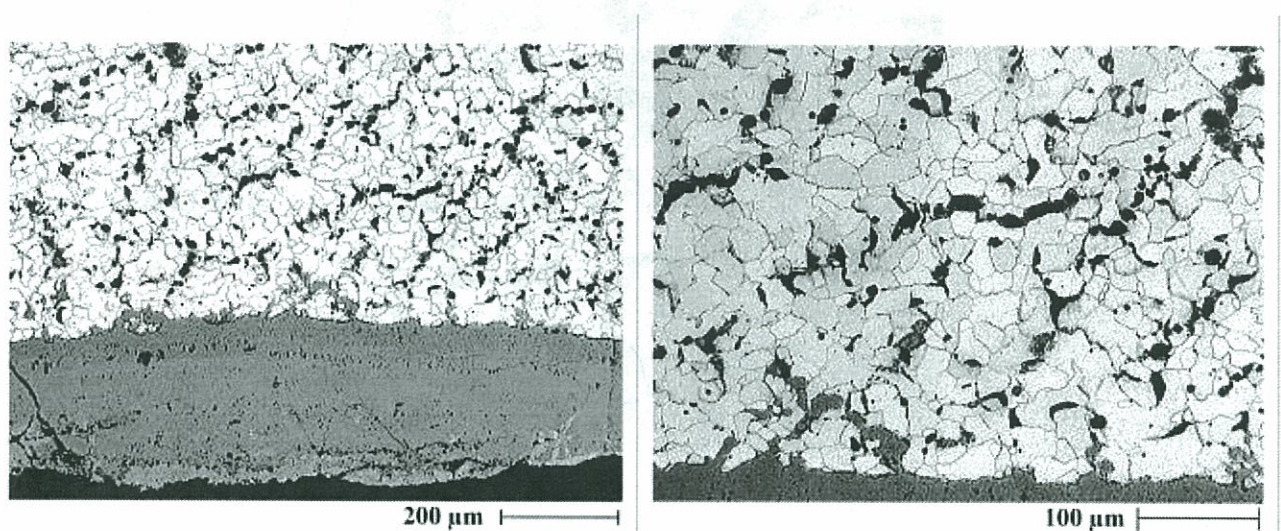
Figure 2. Documenting the Condition of the Macrostructure and Microstructure at the Failure Site on Tube 56.

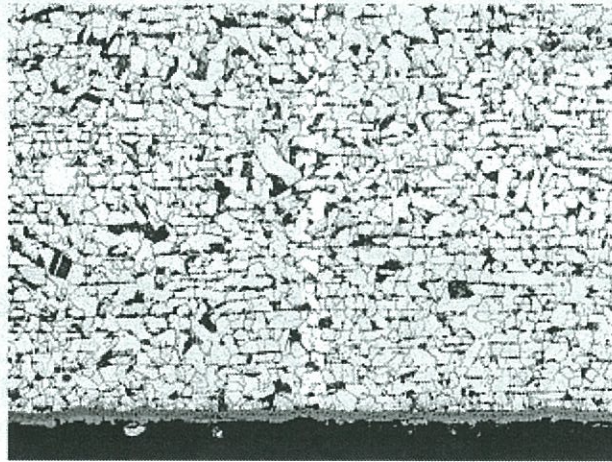
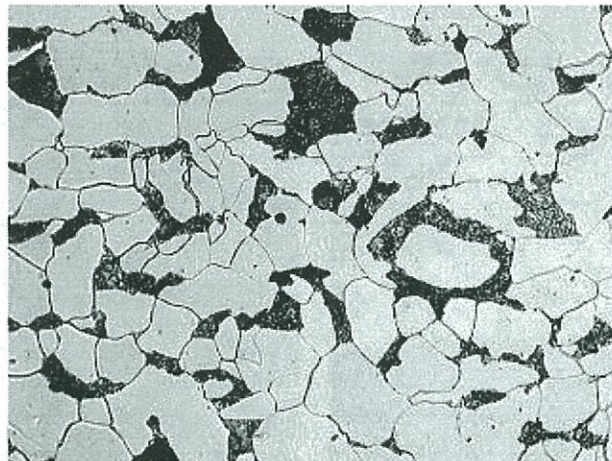
Figure 3. Documenting the Typical Condition of the Microstructure in Areas Away From the Failure on Tube 56.

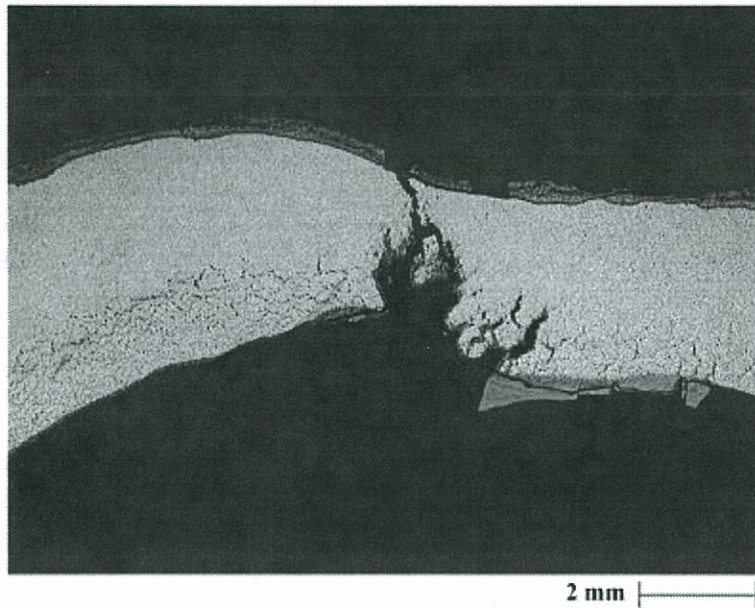
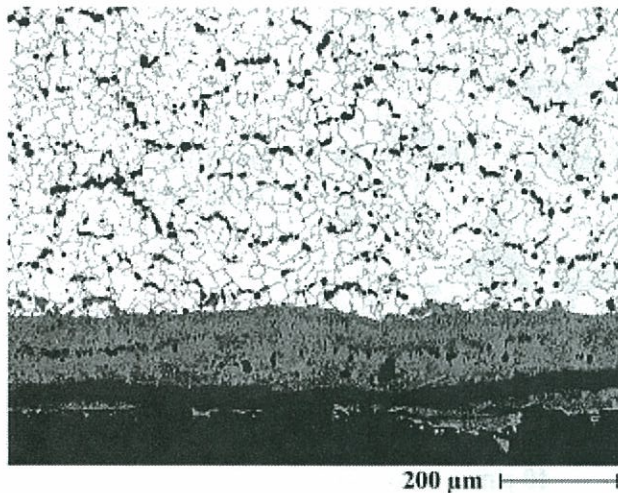
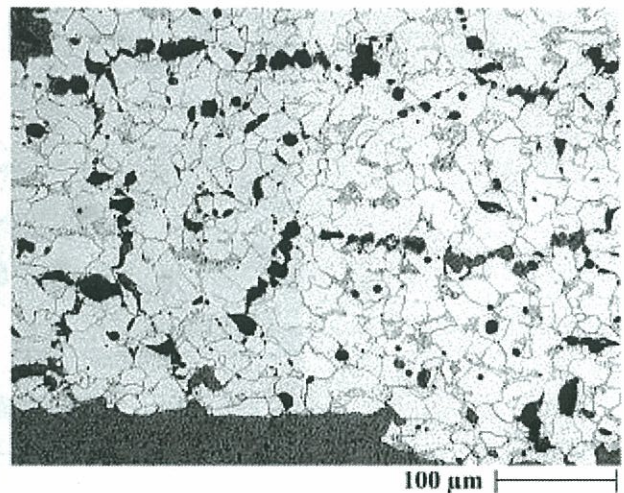
Figure 4. Documenting the Condition of the Macrostructure and Microstructure at the Failure Site on Tube-42.

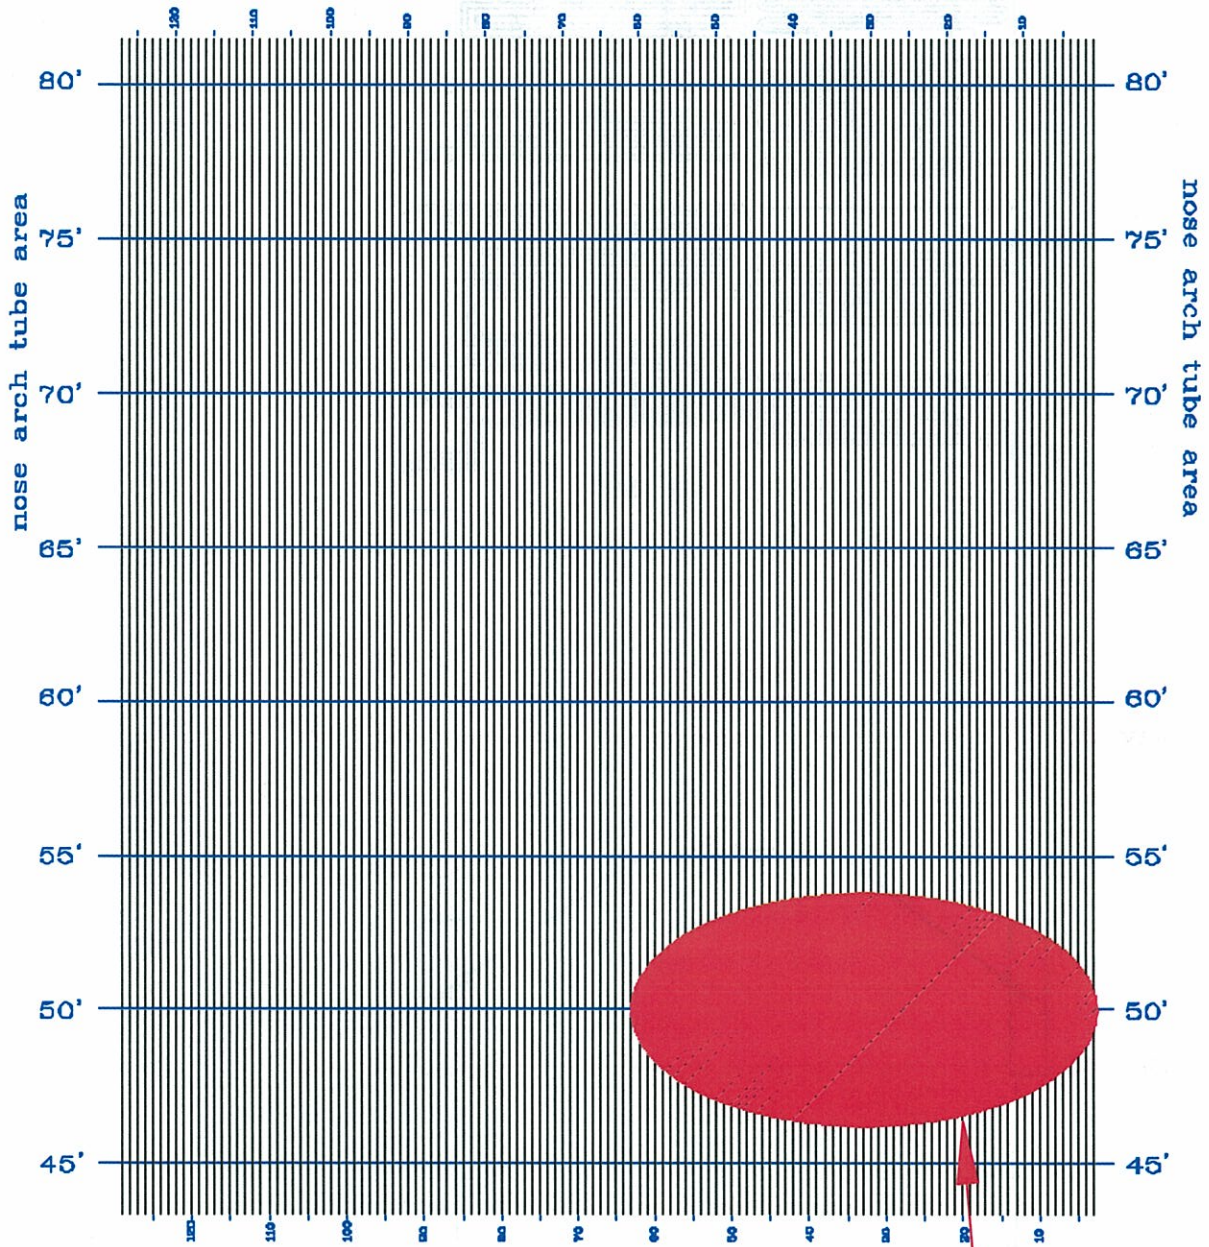
Rear Waterwall

Approximate
area of damage

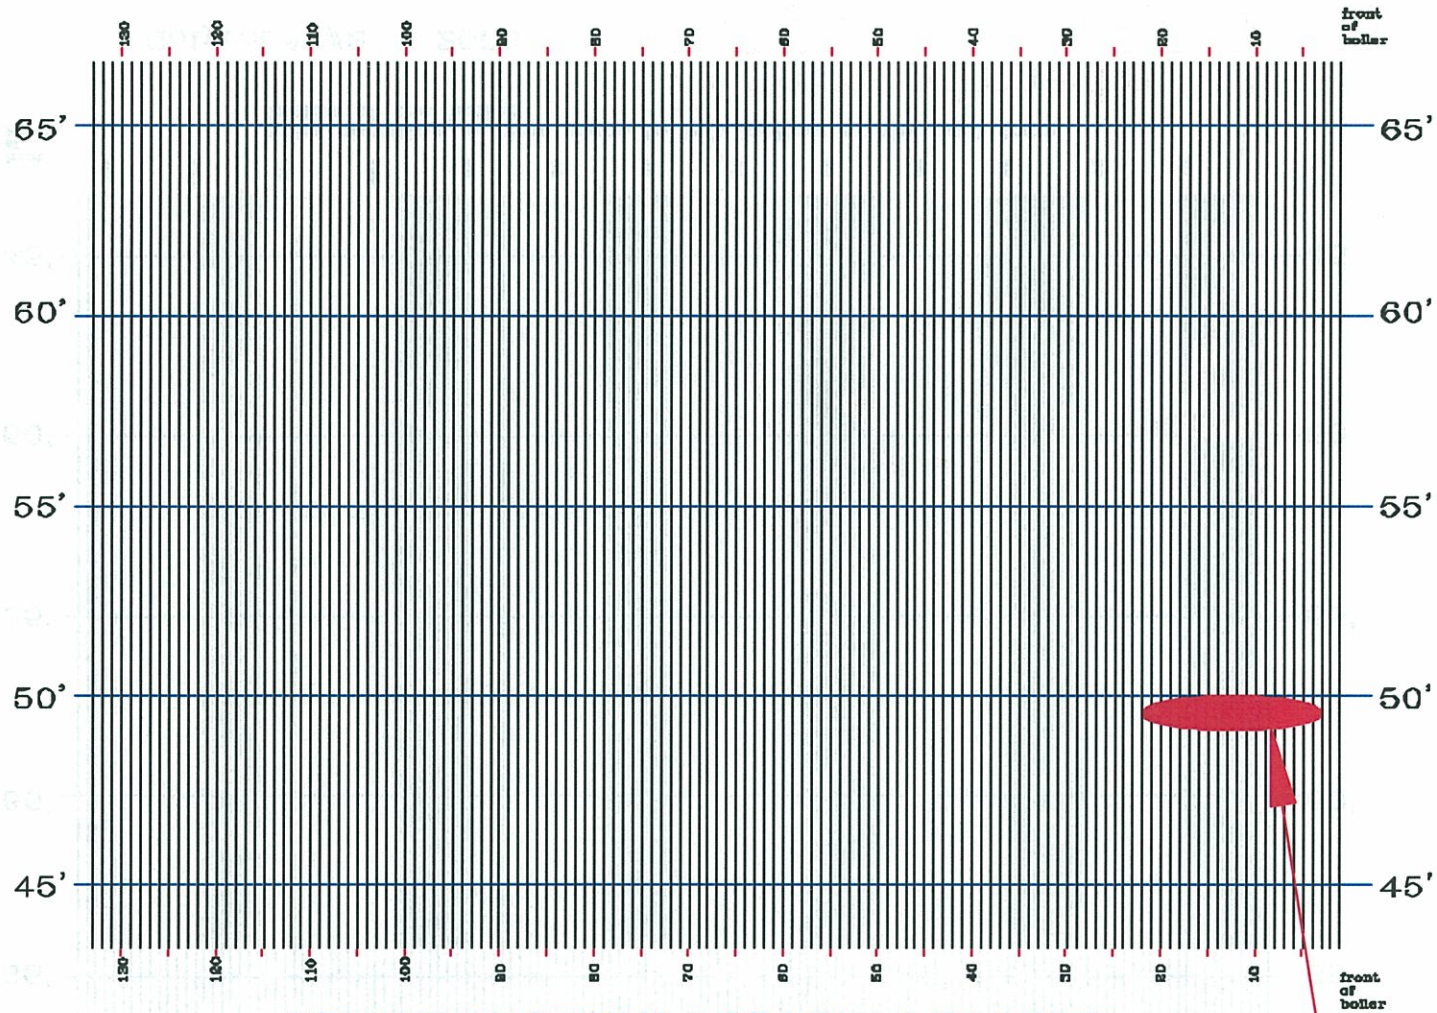
Front Waterwall

Approximate area of damage

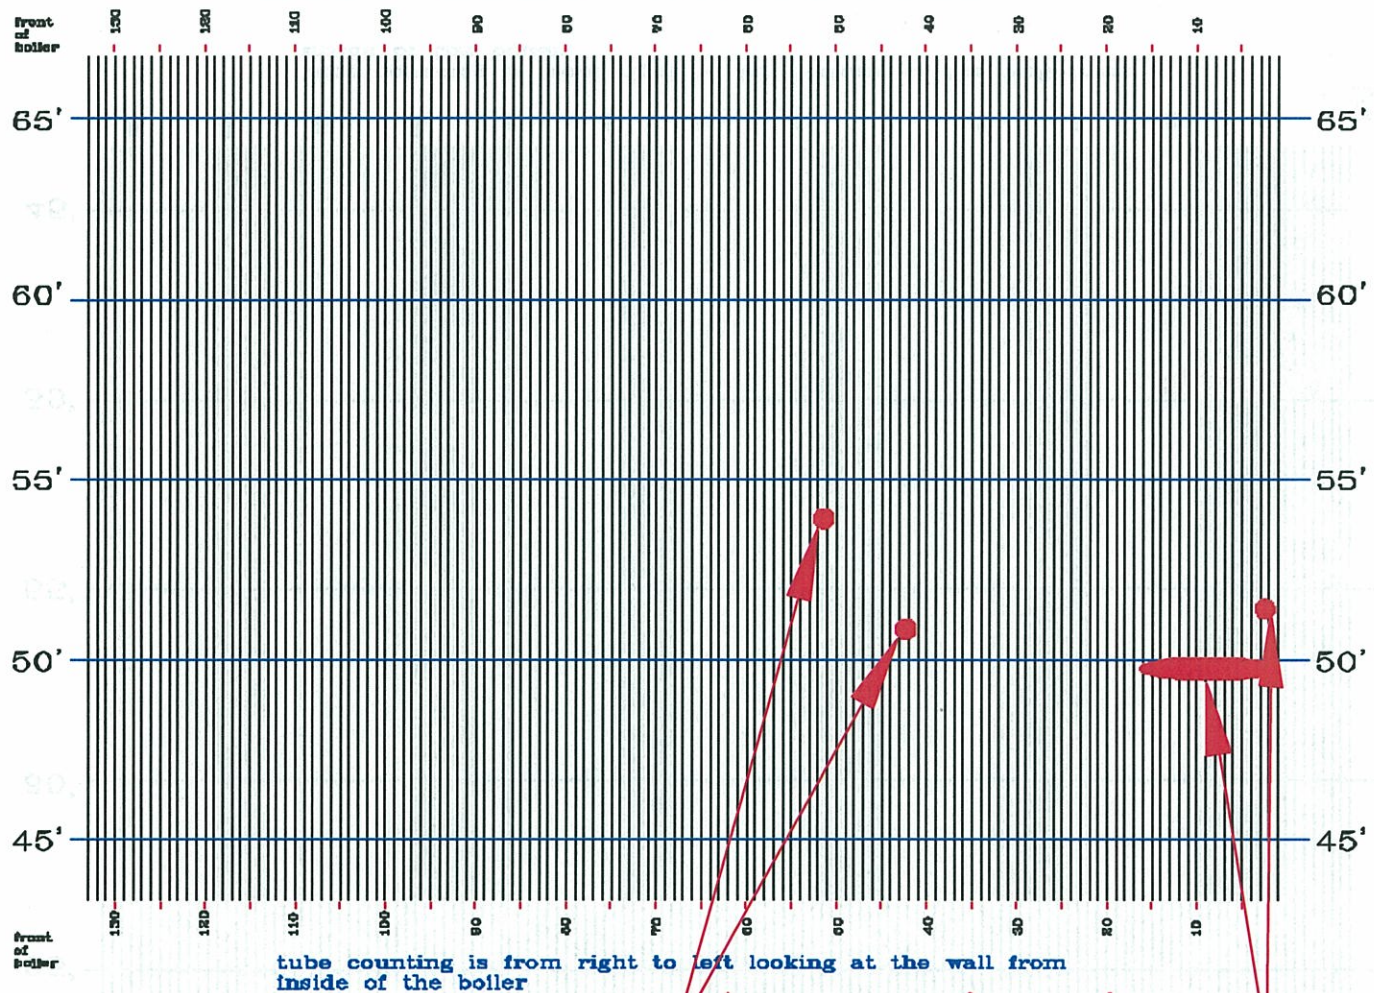
Left Side Waterwall

Approximate
area of damage
