1 **Re: Page B-199, Refurbish Microwave Site, \$202,200**

ORIGINAL 1979 WEST COAST TOWER SITE

DEFICIENCY SUMMARY AND SITE REPORT

Gull Pond Hill Repeater, NL
280 ft (85 m)

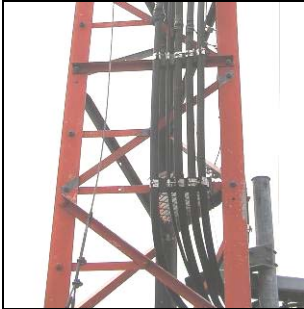
High	\$ 25 k	The rung spacing is outside of CSA S37-01 and presents a very difficult climb.
3	Replace guys and guy hardware.	High	\$ 40 k	Requires Engineering input
4	Install cathodic protection at Anchor 3.	Moderate	\$ 5 k

High	\$ 5 k	
2	Install new ladder.

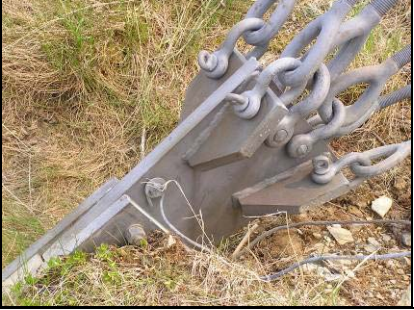
High	\$ 10 k	Requires Engineering input
2	<p>Replace the used bolts in the new tower reinforcing with new A-325 bolts.</p>

Item	Description	Priority	Cost	Comment
1	<p>Perform a sub-surface investigation on the anchors to determine their condition.</p>

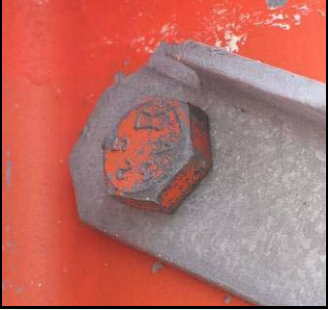
High	\$ 3 k	
3	<p>Clean and cold galvanize the ice guard guys and hardware for the HP 6 ice guard.</p>

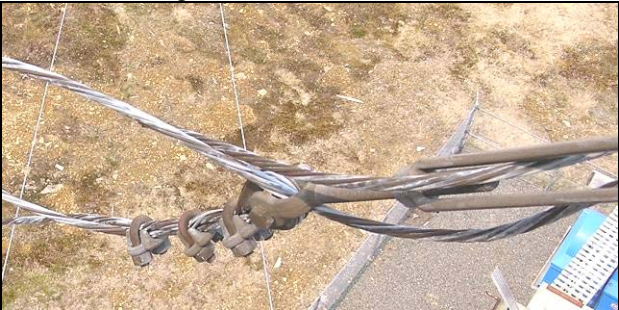
Moderate	\$ 5 k	
4	<p>Replace the braided copper and mechanical connector ground kit at 50' on transmission line 4.</p>

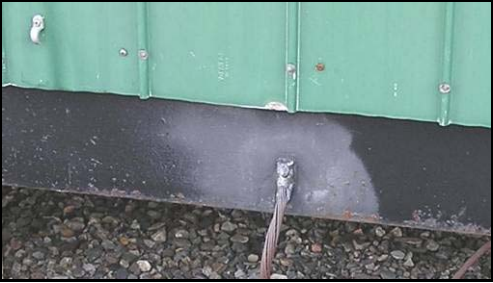
Moderate	\$ 1 k	
4	Re-Caulk all protrusions through the buildings' siding.

Moderate	\$ 3 k	
2	Replace caulking on the siding where the porch meets the building and around the door frame.	Moderate	\$ 1 k	
3	Replace the corroded and missing siding screws with proper siding fasteners.
