1 **Re: Page B-23, Salmon Spillway Stoplog Handling System, \$140,600**

To: Darren Moore/NLHydro@NLHydro
cc: Leveson Kearley/NLHydro@NLHydro
Subject: Salmon River Spillway -Stop log storage system

ACCIDENT/INCIDENT INVESTIGATION SUMMARY REPORT

ACCIDENT/INCIDENT NO.
97609

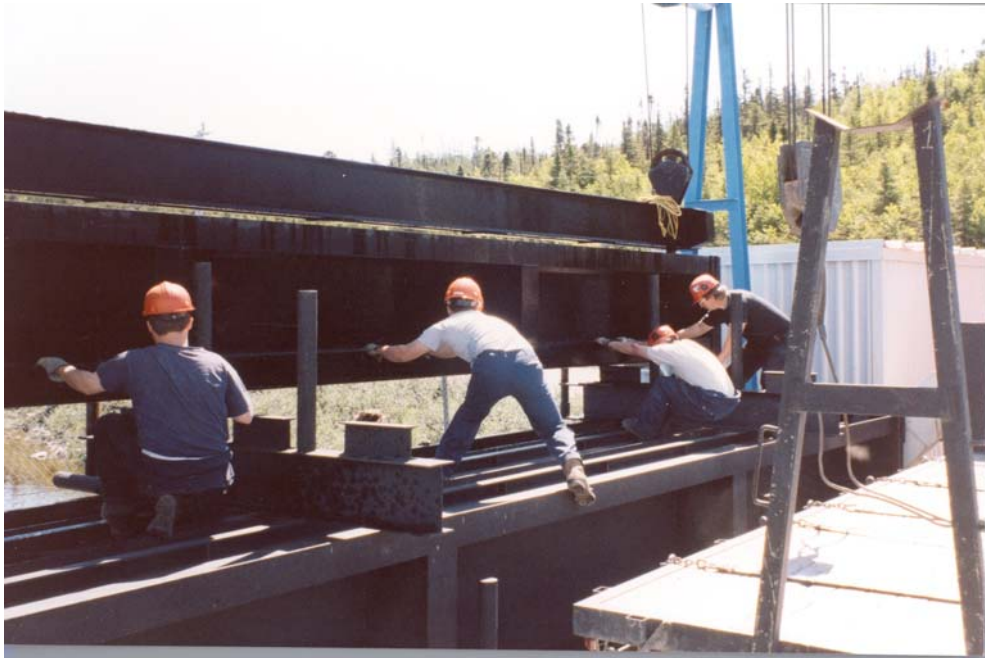
Picture # 1: Workers Guiding Log

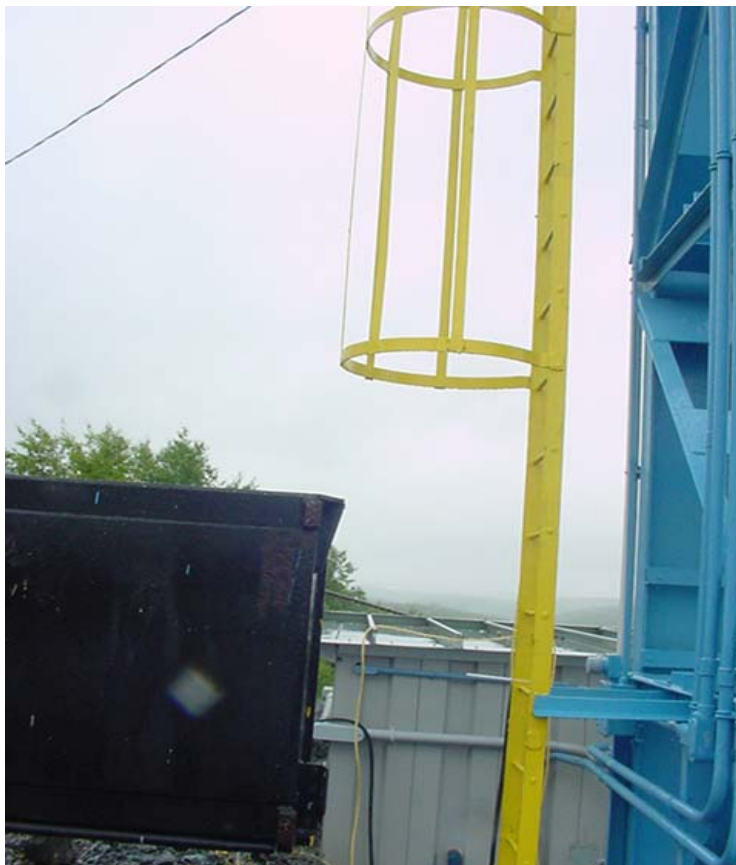
2. There is not enough room to properly handle the logs while placing in the rack. I have attached a few pictures here that indicates the amount of room between the truck, the mono rail support and the log on one end, as well as between the ladder, the gabion and the log on the other end. Because these areas are very small, workers must work partially under the suspended stoplog while positioning the log at the final point of travel.

Picture # 2: Area between Log and Ladder

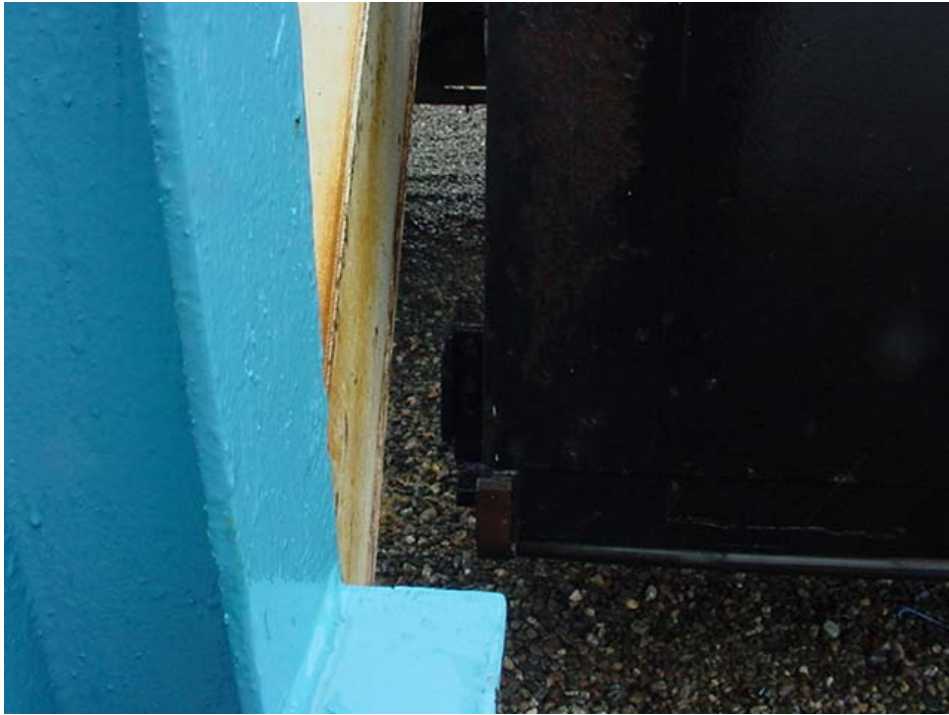
Picture # 3: Available Space at Monorail Support and Outrigger

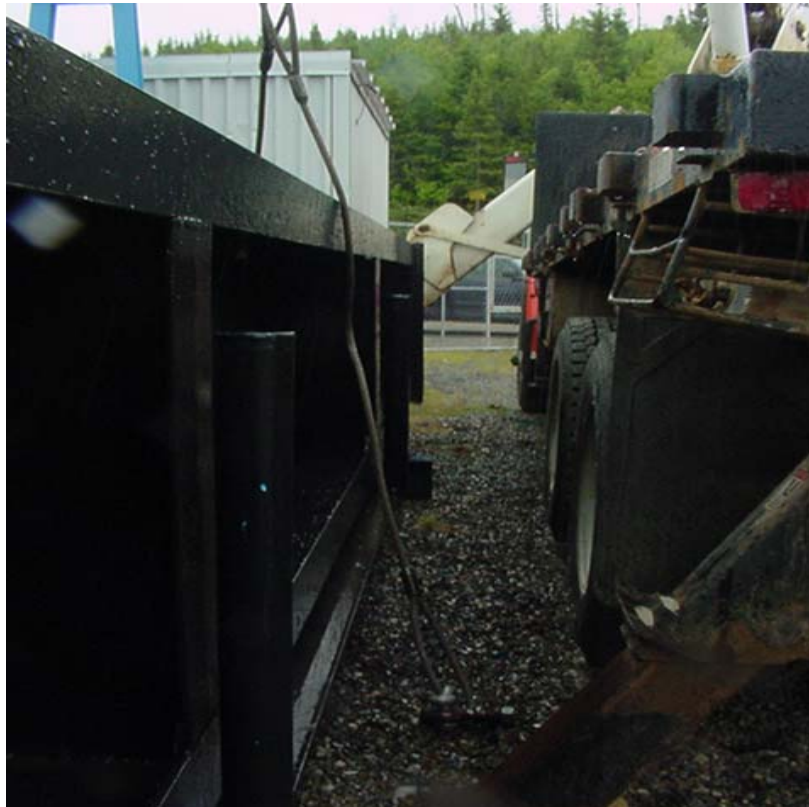
Picture # 4: Available Space between Truck and Storage System

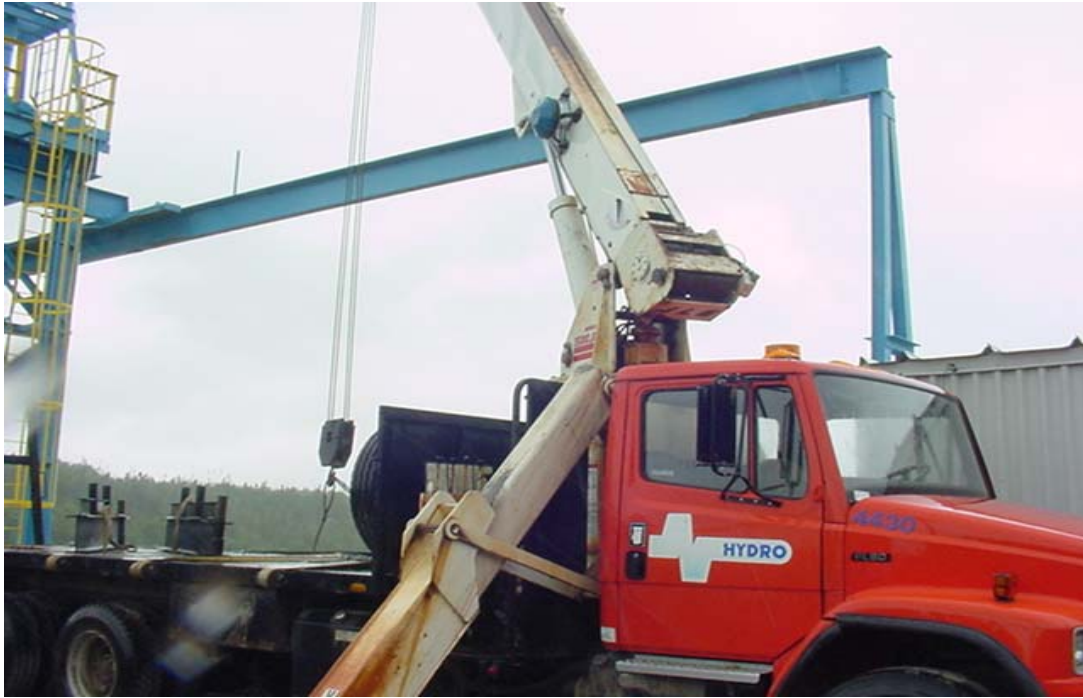
5. The limits on the boom truck are overridden during the operation.
6. The cable on the boom truck is in contact with the monorail beam when the log is first lifted.

Picture # 5: Boom Truck Cable in Contact with Monorail

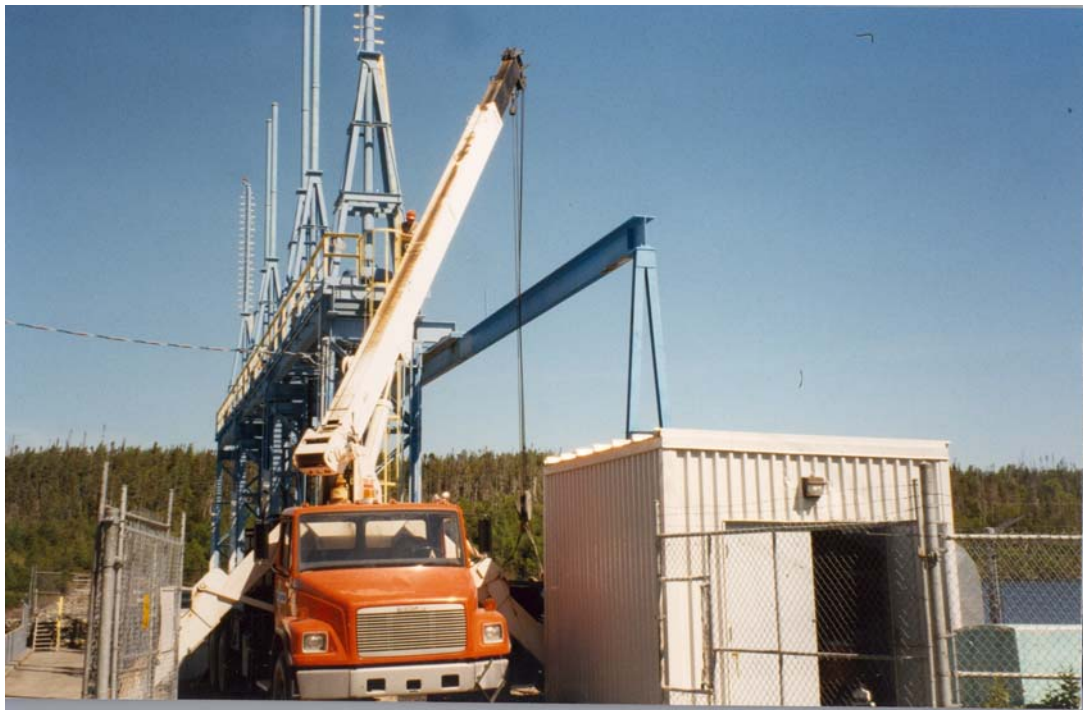
Picture # 6: Boom Truck Cable

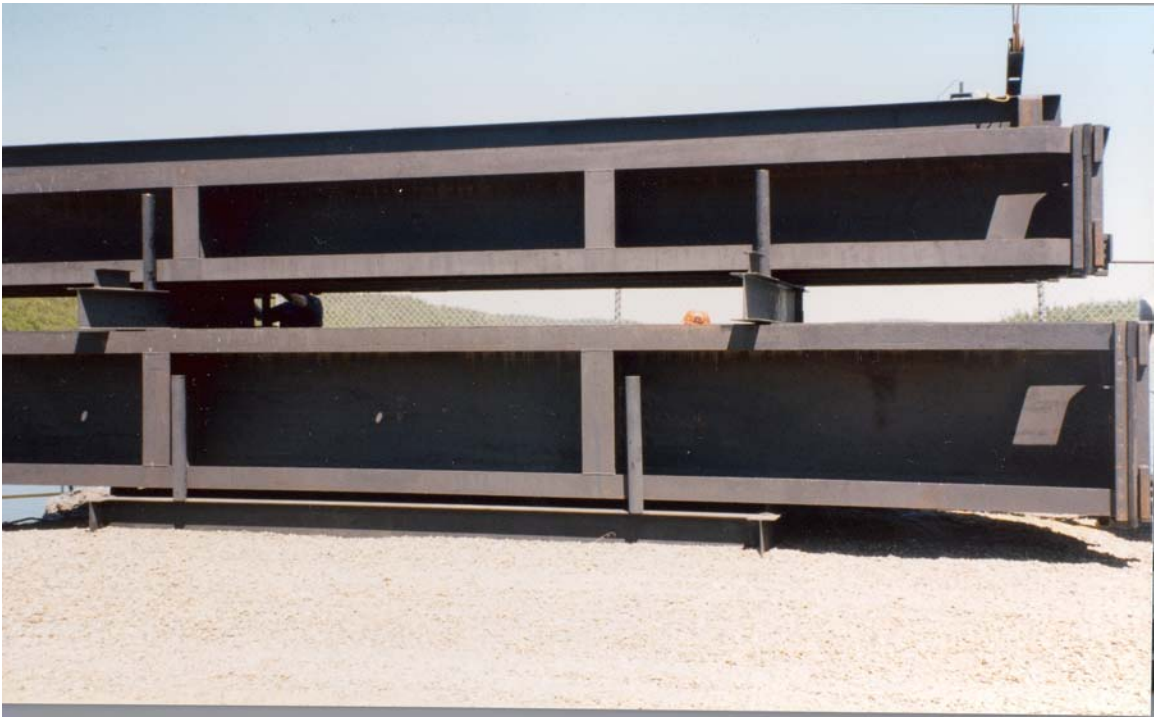
3. The logs are stacked two on top of three. The second tier of two logs is supported by two independent beams that rest on the top of the three bottom logs. Once the logs are in place, there is no real concern with stability but workers have to stand on the loose beams while positioning the second tier. Because the whole system is not level, and because the beams are not fixed, and because the logs are not perfectly even, this can present a fall hazard.

4. The bottom three logs, and the top two logs are stored very close to each other. In order to remove the eye bolts workers must climb onto the log and reach between to remove the nuts.

Picture # 7: Stop Logs Stored

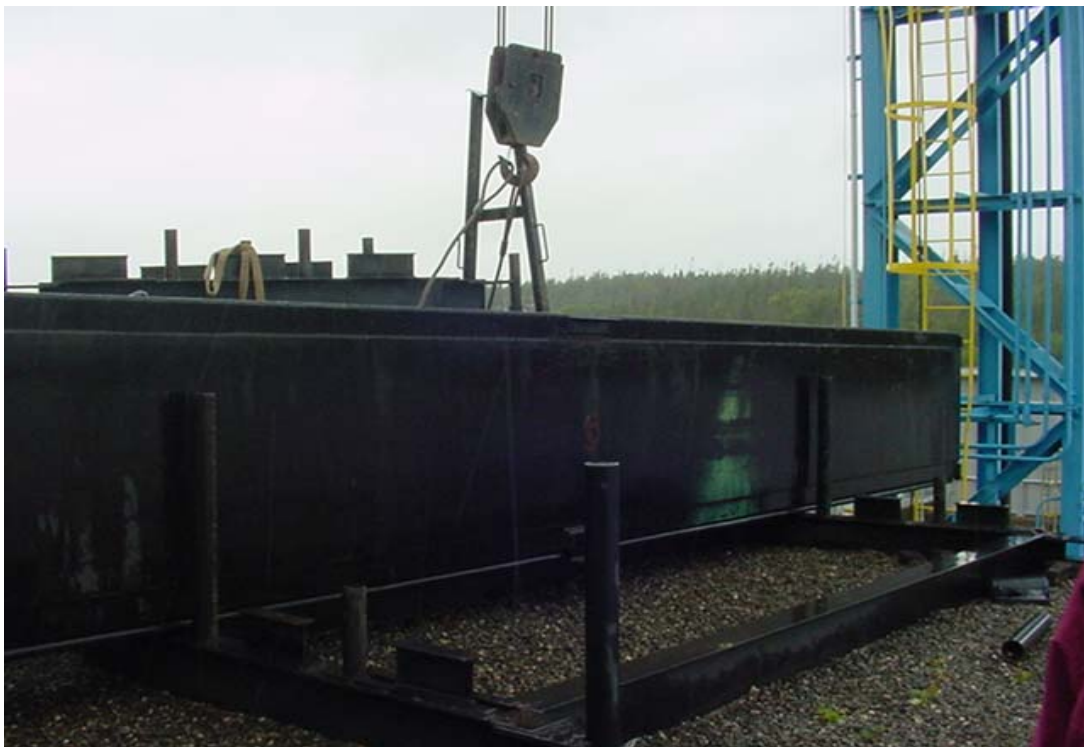
Picture # 8: Stop Log Transfer to Boom Truck

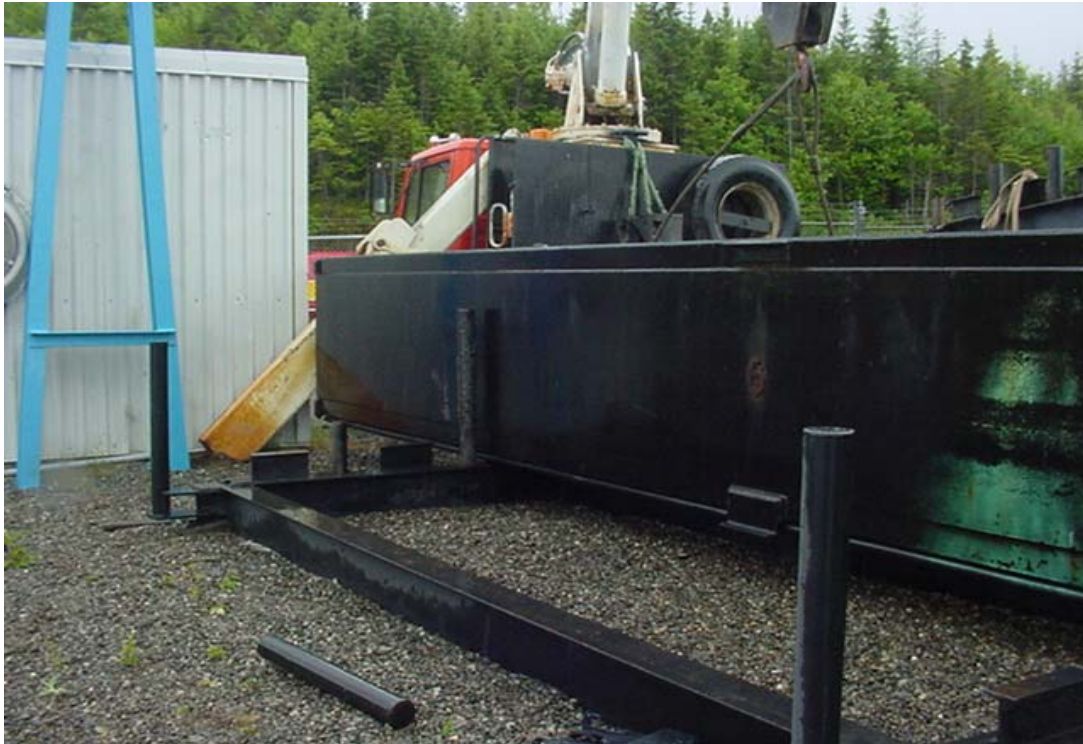
Picture # 9: Truck Outrigger – Available Space
