Re: Page B-25, Upgrade Intake #4 Gate Controls, \$115,500

Q. Please provide documentation outlining the problems encountered during the two major incidents that occurred during penstock filling.

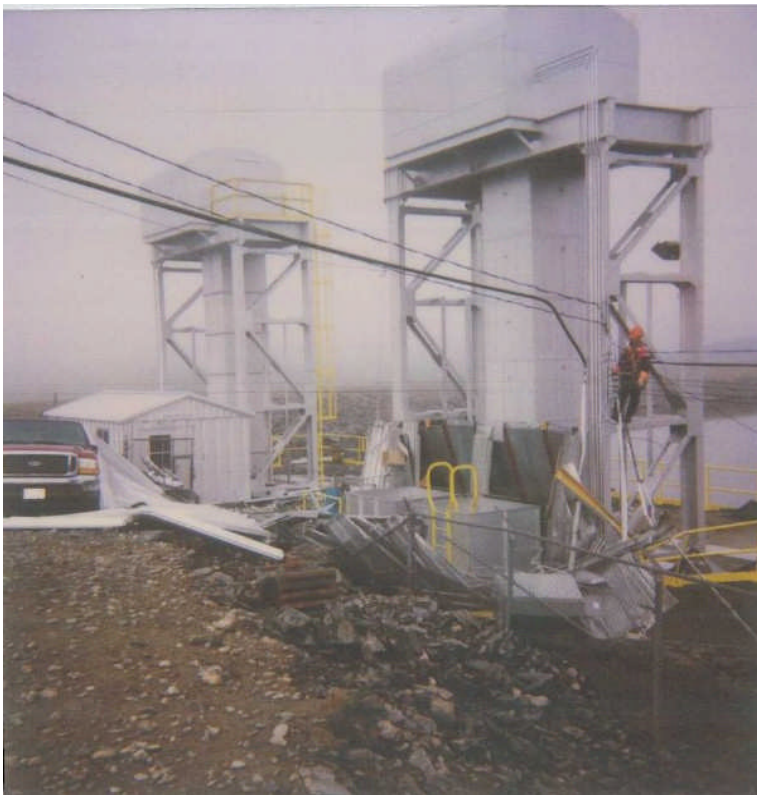
14 intake reached a level of about 12 feet above the sill, the hoist house, where
15 the operator was standing, started to shake violently and flooded with water
16 coming from the penstock. After the flooding stopped, the vent house and
17 most of the electrical equipment previously located inside the vent house
18 were completely destroyed. There was also severe damage to a Hydro
19 vehicle that was parked close by as well as damage to security fencing and
20 the intake guard rail. Sections of the roadway to the intake were also washed
21 out and electrical power and water level indications were lost to all four intake
22 structures. This incident was also classified as a near miss as it once again
23 presented major opportunity for personnel injury.

Bay D'Espoir Intake #1 (shown on left) and Intake #2 (shown on right) after the failure in 2000. Notice that the vent house structure has been completely destroyed as it previously resembled that of

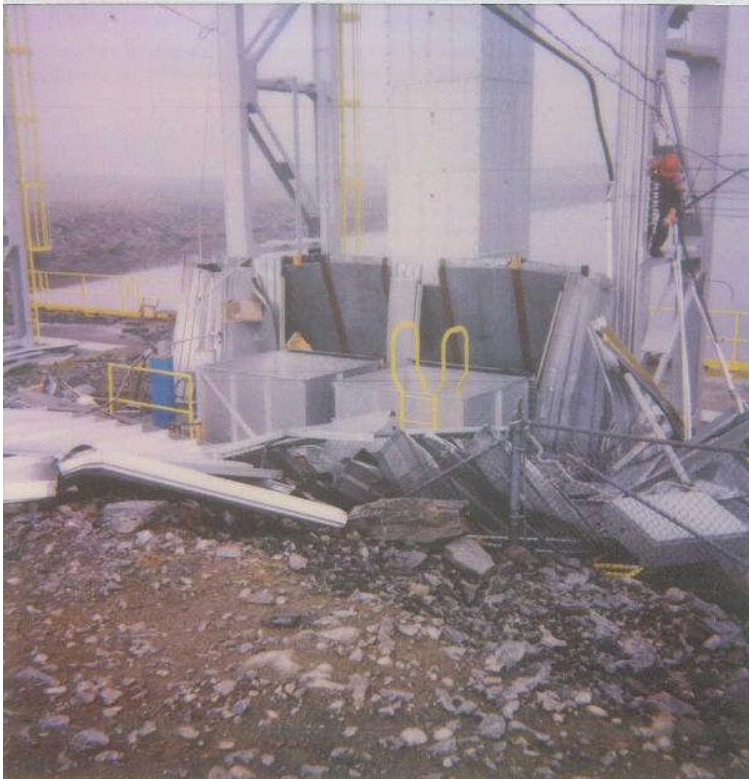
Bay D'Espoir Intake #2 after
the failure in 2000.

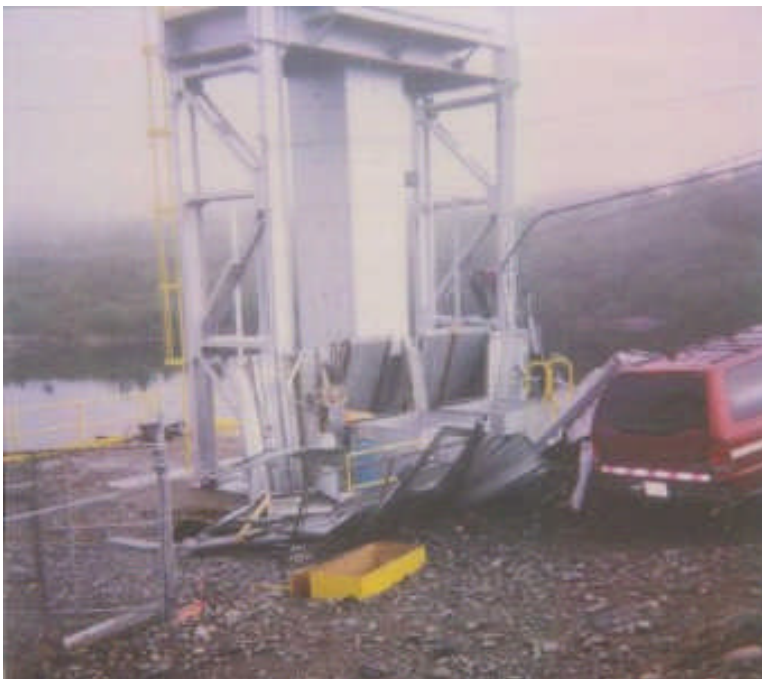
Bay D'Espoir Intake #2 after
the failure in 2000.
