**A REPORT TO  
THE BOARD OF COMMISSIONERS OF PUBLIC UTILITIES**

## **UPGRADE UNIT 1 STACK BREECHING**

### **Holyrood Thermal Generating Station**

**Revision 1, October 26, 2010**

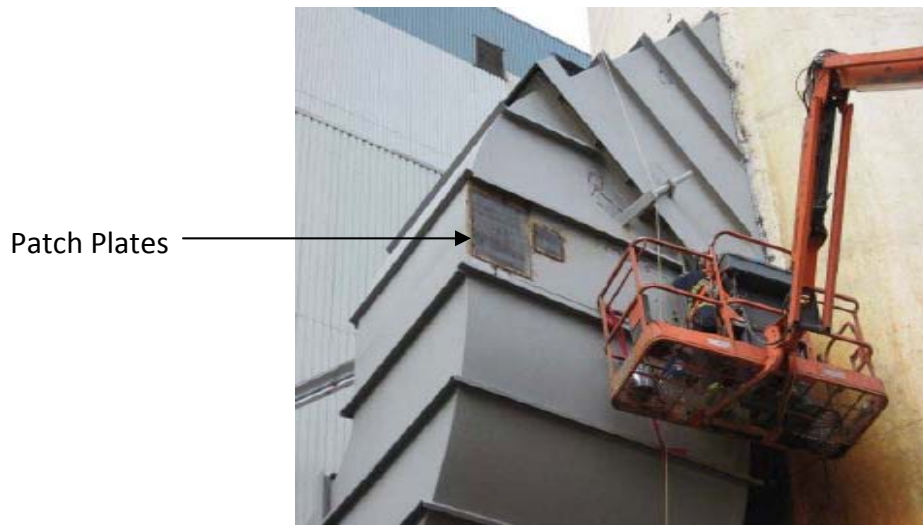
In addition to the erosion of the borosilicate insulation, cracks in the internal insulating liner and concrete floor have developed. Cracks in the concrete floor and insulation blocks falling away from the walls and ceiling allow flue gas to contact the steel plates underneath the insulation and concrete. The flue gas condenses to form sulfuric acid which causes localized corrosion that necessitates steel plate repairs. The internal insulation liner and steel plates underneath have required repairs on an annual basis that have resulted in high maintenance costs (see Table 1) during scheduled annual outages. Typical steel plate and insulating block repairs are illustrated below in Figures 4 and 5 respectively. Concrete floor cracking is illustrated in Figure 6.

**Figure 4 – Unit 1 Breeching Plate Repairs**

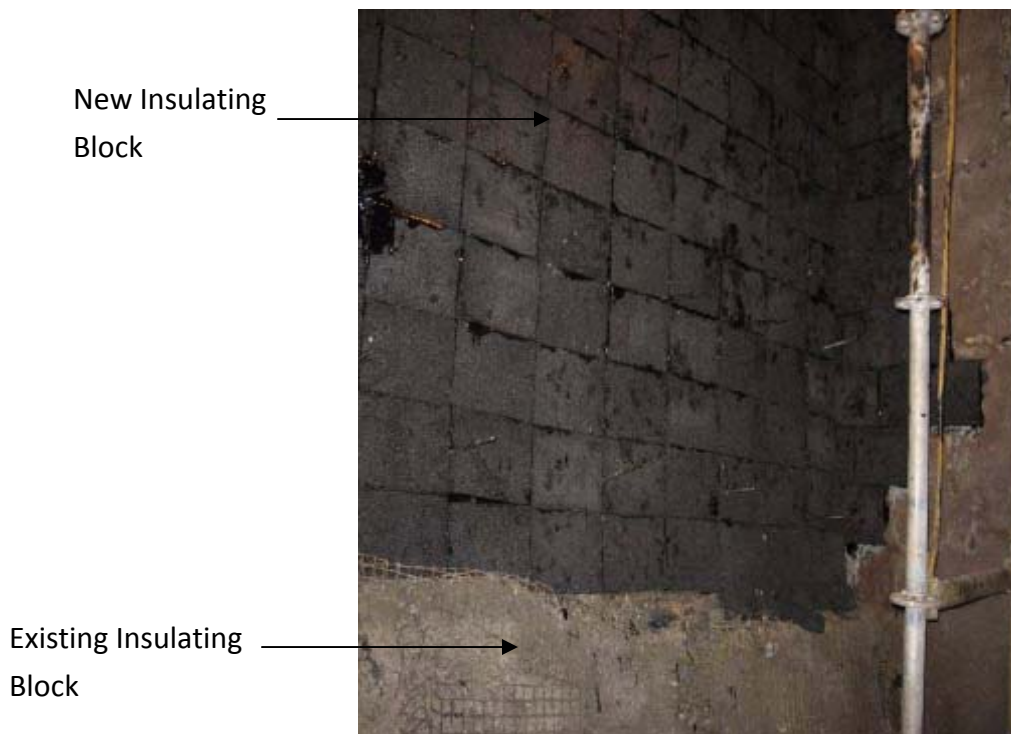
**Figure 5 – Unit 1 Insulating Block Replacement**

Also, failure of the internal insulation blocks is caused by the breakdown of the adhesive membrane that bonds the blocks to the breeching plate. The temperature limit of the membrane is 200 degrees Fahrenheit. This limit is exceeded by the actual flue gas outlet temperature which is approximately 311 degrees Fahrenheit when Unit 1 is operated at full load.

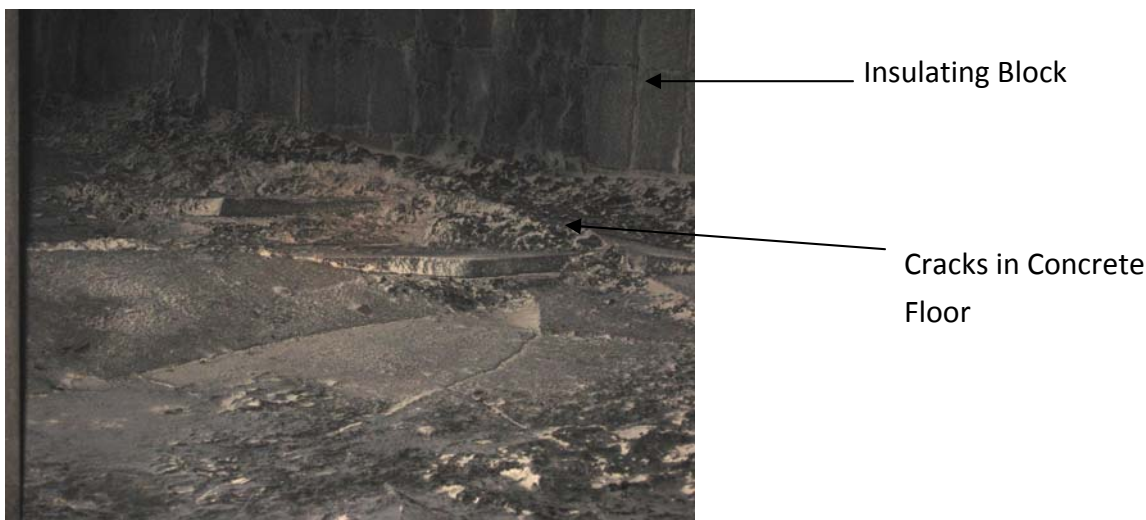
**Figure 6 – Unit 1 Breeching Concrete Floor**

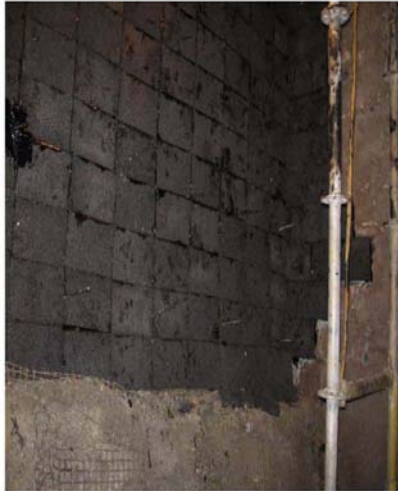
**Fig. 8: Unit 1 – Insulating block replacement**

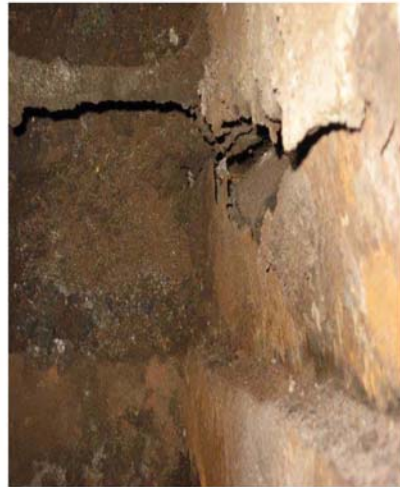
**Fig. 9: Unit 1 – Duct corroded through**

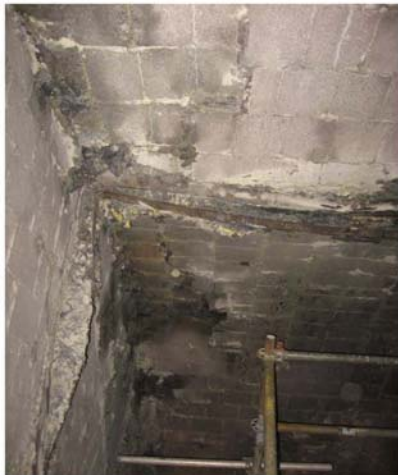
**Fig. 10: Unit 1 – Sloped section as found**

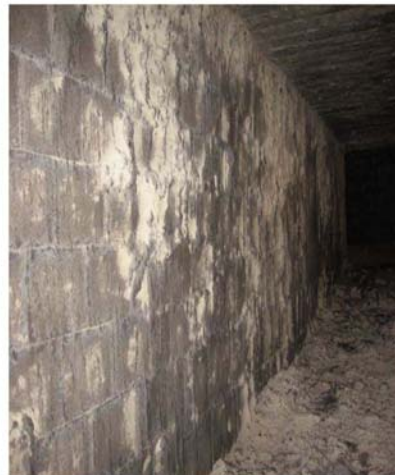
**Fig. 11: Unit 1 – Sidewall and floor**

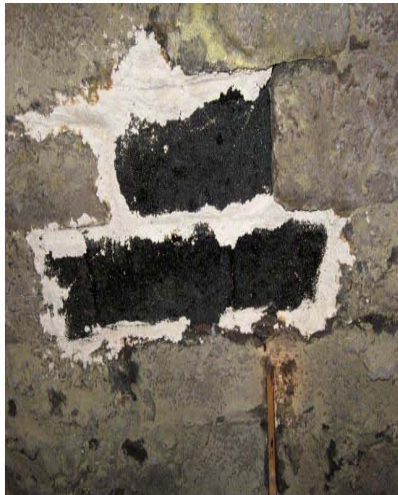
**Fig. 12: Unit 1 – Replaced blocks**

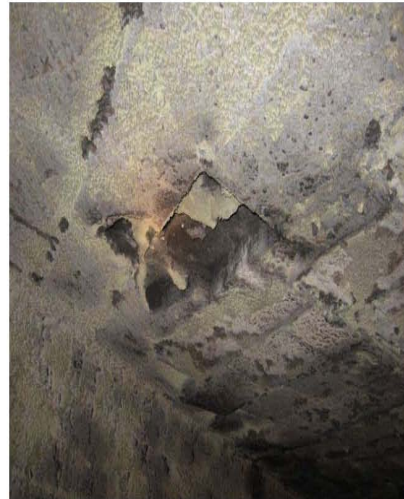
**Fig. 13: Unit 1 – Missing block overhead**

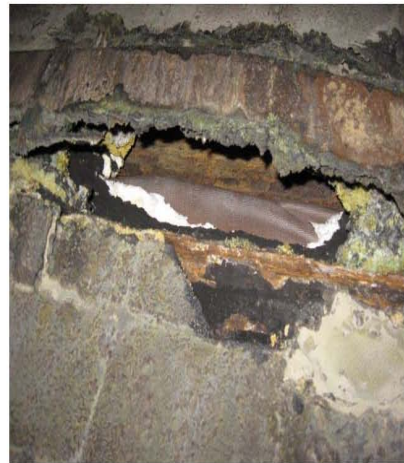
**Fig. 15: Unit 1 – Damaged expansion joint**

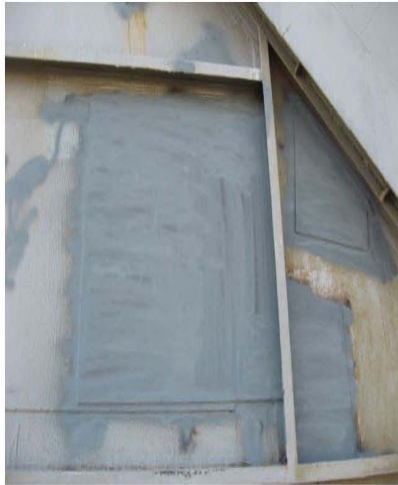
**Fig. 16: Unit 1 – External duct repairs**

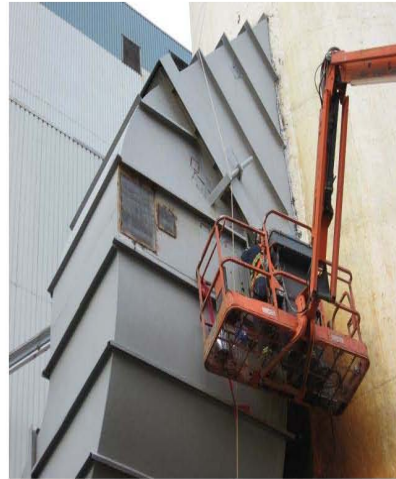
**Fig. 17: Unit 1 – External duct repairs**

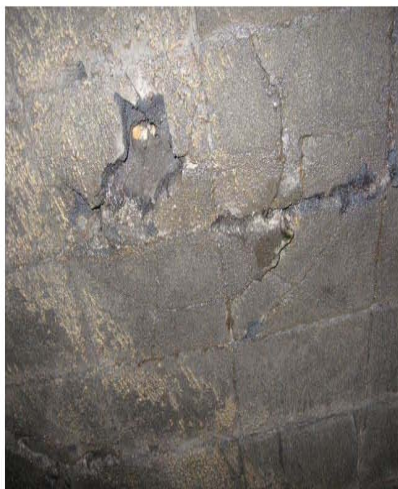
**Fig. 18: Unit 2 – Missing insulation blocks**

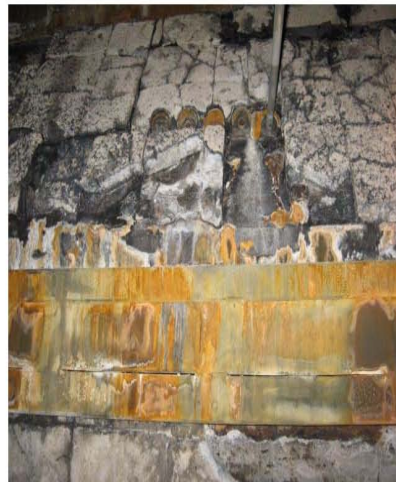
**Fig. 19: Unit 2 – Missing insulation blocks**

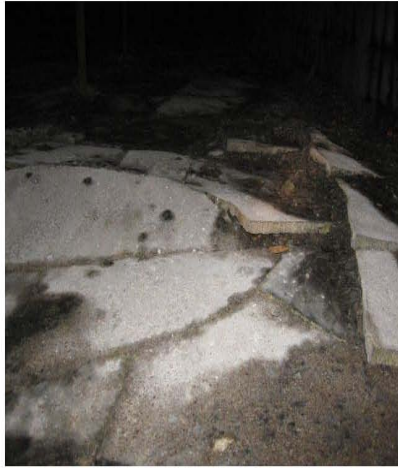
**Fig. 20: Unit 2 – Cracked cement floor**

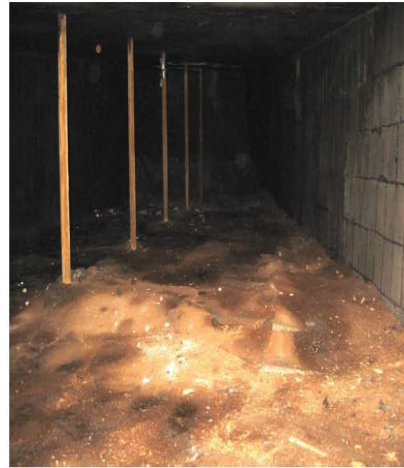
**Fig. 21: Unit 2 – Cracked cement floor**

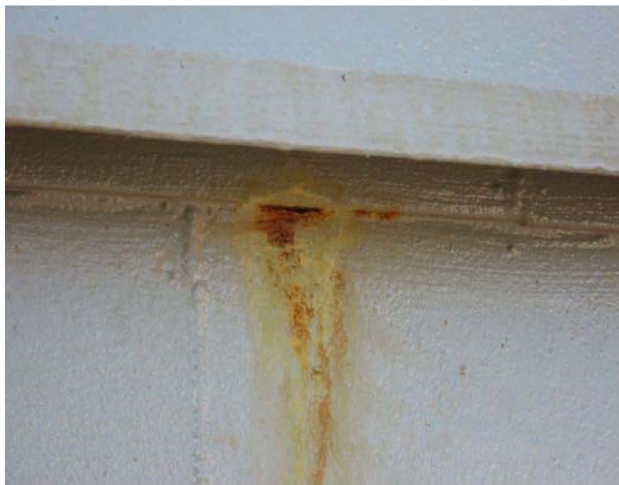
**Fig.22: Unit 2 – External coating break down**

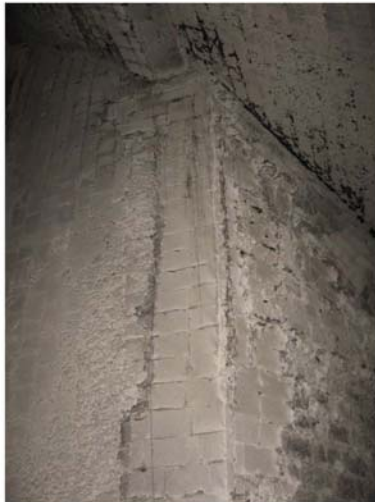
**Fig. 23: Unit 3 – Repairs 2007**

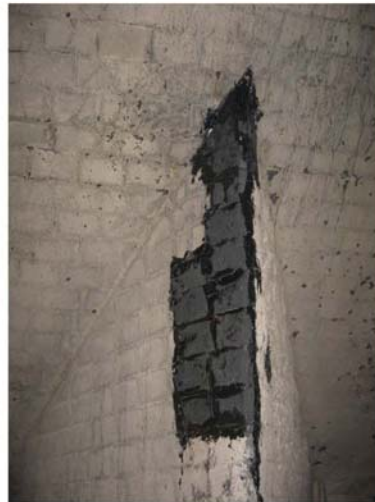
**Fig. 24: Unit 3 – Crotch repairs**
