Newfoundland and Labrador Hydro

Condition Assessment Final Report

Condition Assessment of Ten Diesel Plants

H333005-0000-10-236-0001

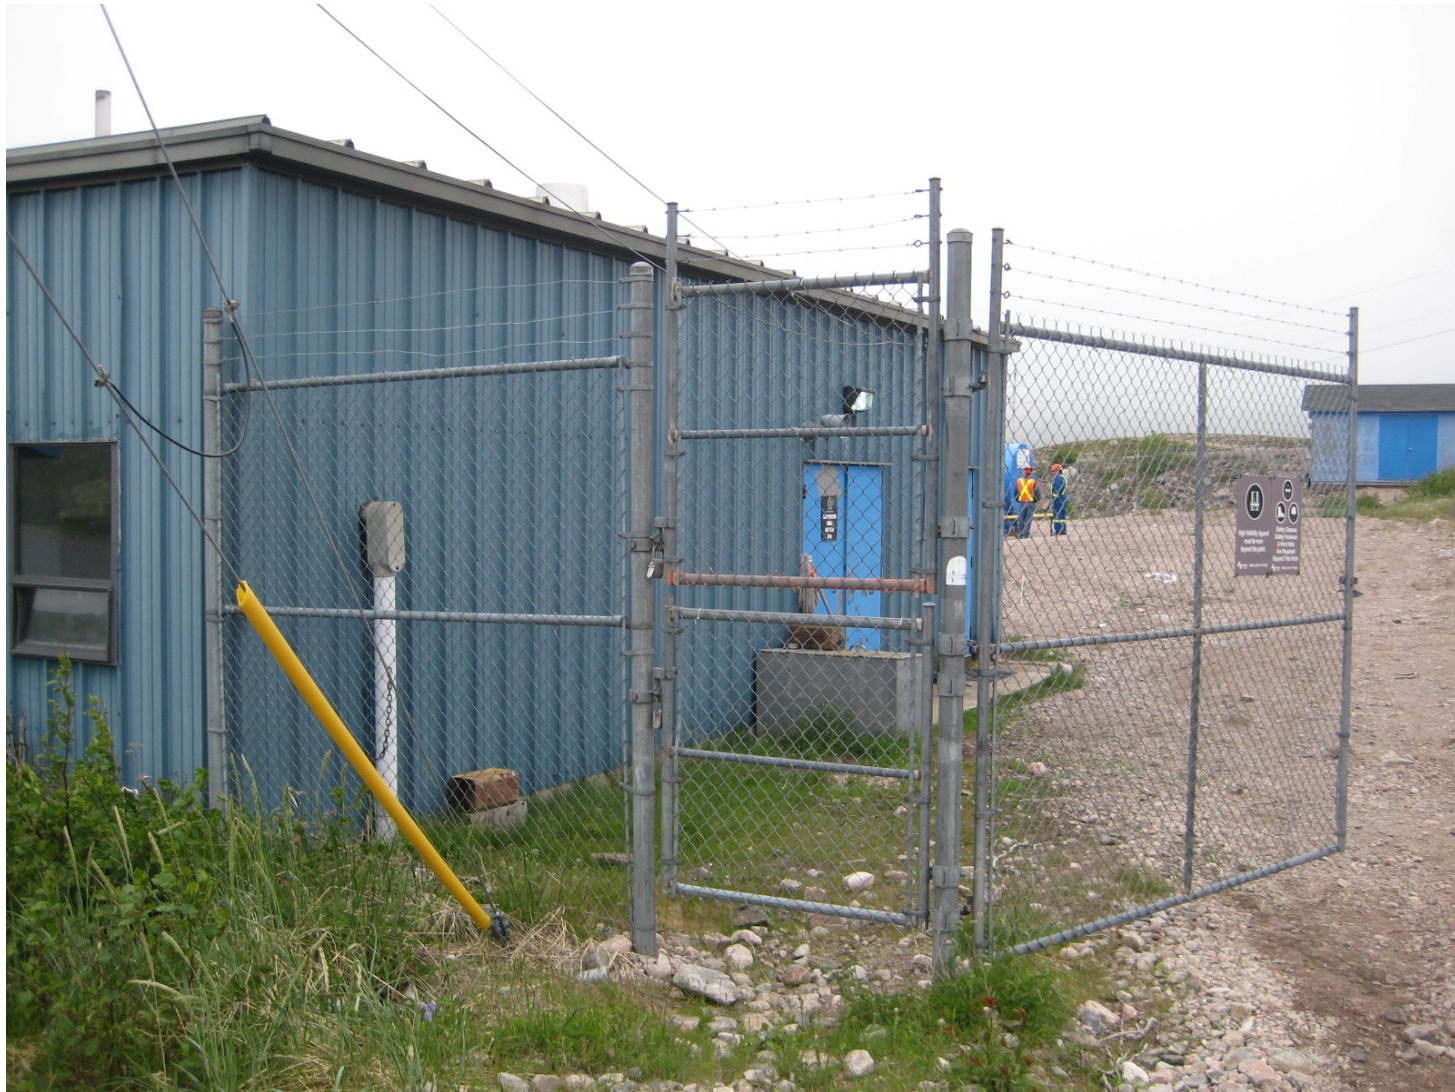
Williams Harbour, Labrador

- Lighting type/levels – Lighting fixtures are generally fluorescent with fluorescent and incandescent in the generator hall; some incandescent fixtures are missing globe lenses and new globes need to be installed, or fixtures replaced with fluorescent type.

- Availability/condition of washroom facilities – Washroom was located next to office and was also being used as a storage area.
- Building height – Minimal clearance above lifting device beam.

- Lifting devices – Chain hoist (manual) monorails above generators.
- Conduit, cable and cable tray – one junction box near exit door is missing a cover; replace cover to comply with CEC.

- Building envelope – Corner flashing missing, siding faded and dented (weathered) (fair to good condition).

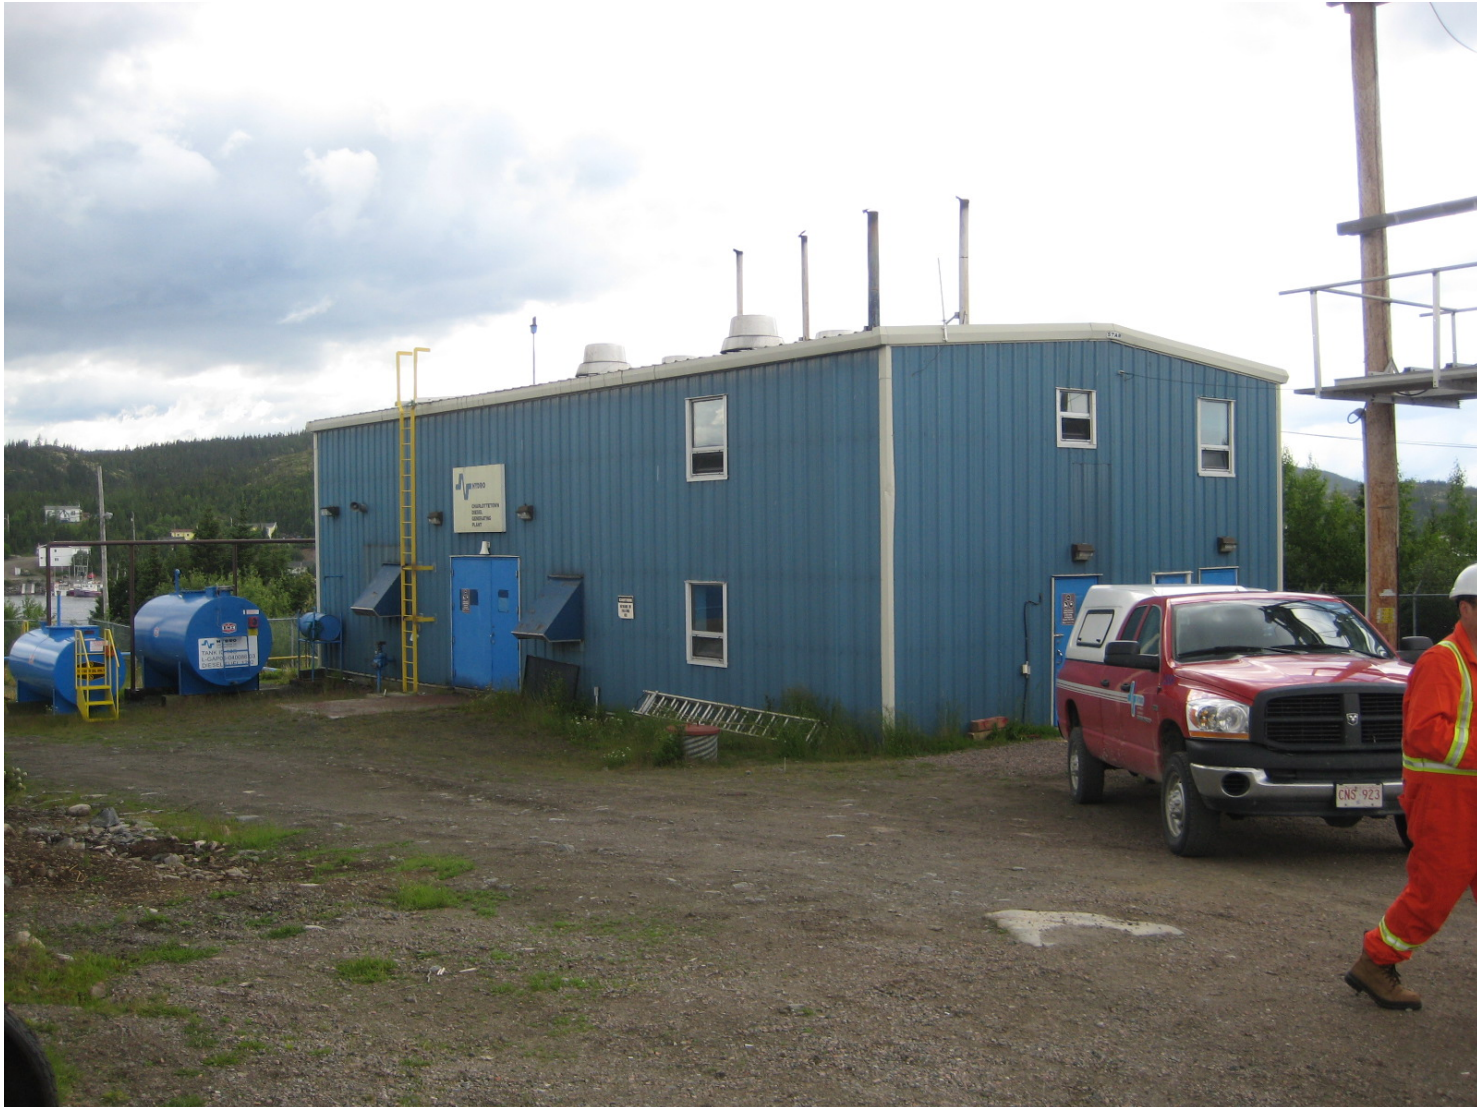
Charlottetown, Labrador

- Clearance around equipment – Space around switchgear and three of four generators does not meet CEC requirements.
- Adequate work areas – Work area appeared inadequate for size of gensets.
- Available wall space – Little to no available wall space.
- Lighting type/levels – Acceptable, no issues found.
- General plant noise – Noise levels in plant and general work areas were excessive and appeared to moderate in the office and lunch areas.

- Storage – Plant is running above designed capacity. All gensets in plant were running, plus using an external portable genset trailer. Storage capacity is inadequate.

- Availability/condition of office – Office space was less than the office space in St. Lewis, but generally adequate.
- Availability/condition of lunchroom – Lunchroom was small and very warm due to being located on the second level.

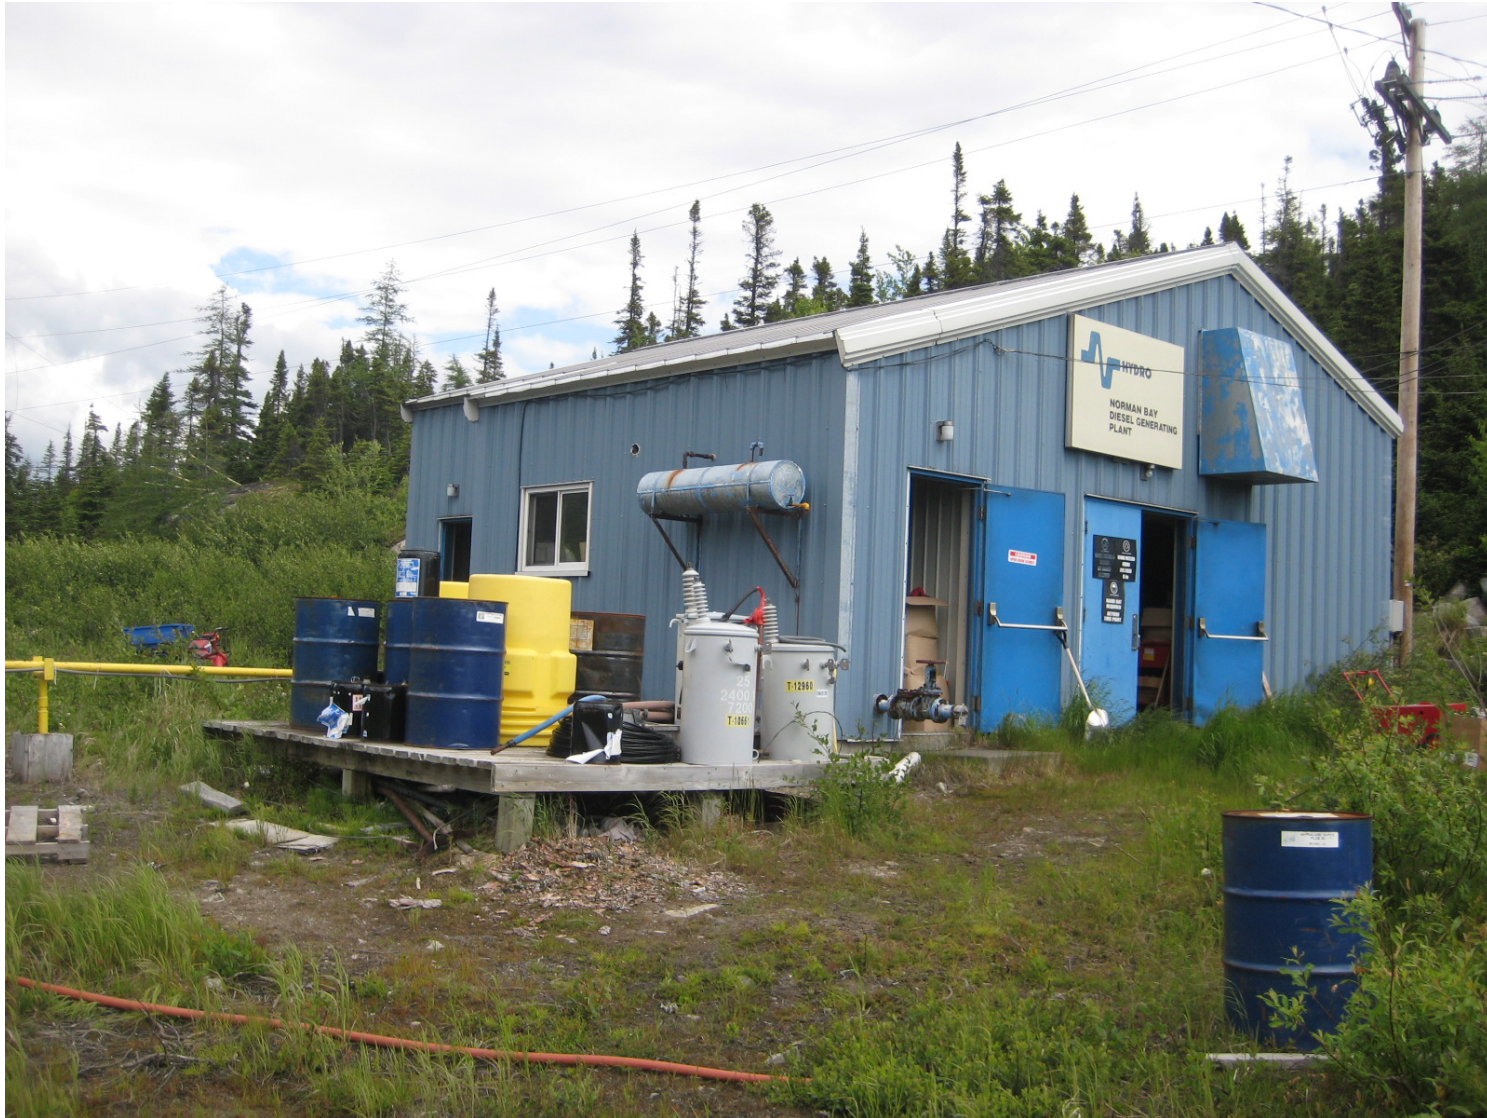
Normans Bay, Labrador

- Clearance around equipment – Clearance between generator and secondary exit does not meet CEC requirements.
- Adequate work areas – Work area was very small, almost non-existent.
- Available wall space – Some available wall space.
- Lighting type/levels – two incandescent fixtures in generator hall have failed lamps, replace lamps or replace fixtures with fluorescent fixtures; outdoor fixture is missing lens and needs replacement.
- General plant noise – Noise level in plant was moderate. However, office is virtually in the plant with no noticeable means of separation/isolation, producing unacceptable noise levels.
- Ventilation – Temperature in plant was moderate to high; however temperature in office was too warm.

- Storage – Virtually no storage in plant and no detached sheds. Small work area was extremely cluttered.
- Availability/condition of office – Office was extremely small and located in the plant. Operator would find it very difficult to do office work due to the noise and heat.

- Exit and emergency lighting – Exit signs need servicing, either wiring problem of all lamps have failed (all breakers “on”, but signs are not illuminated); by NBC all signs must be illuminated.

- Building envelope – Torn insulation, dented siding, paint peeling (fair to good condition).

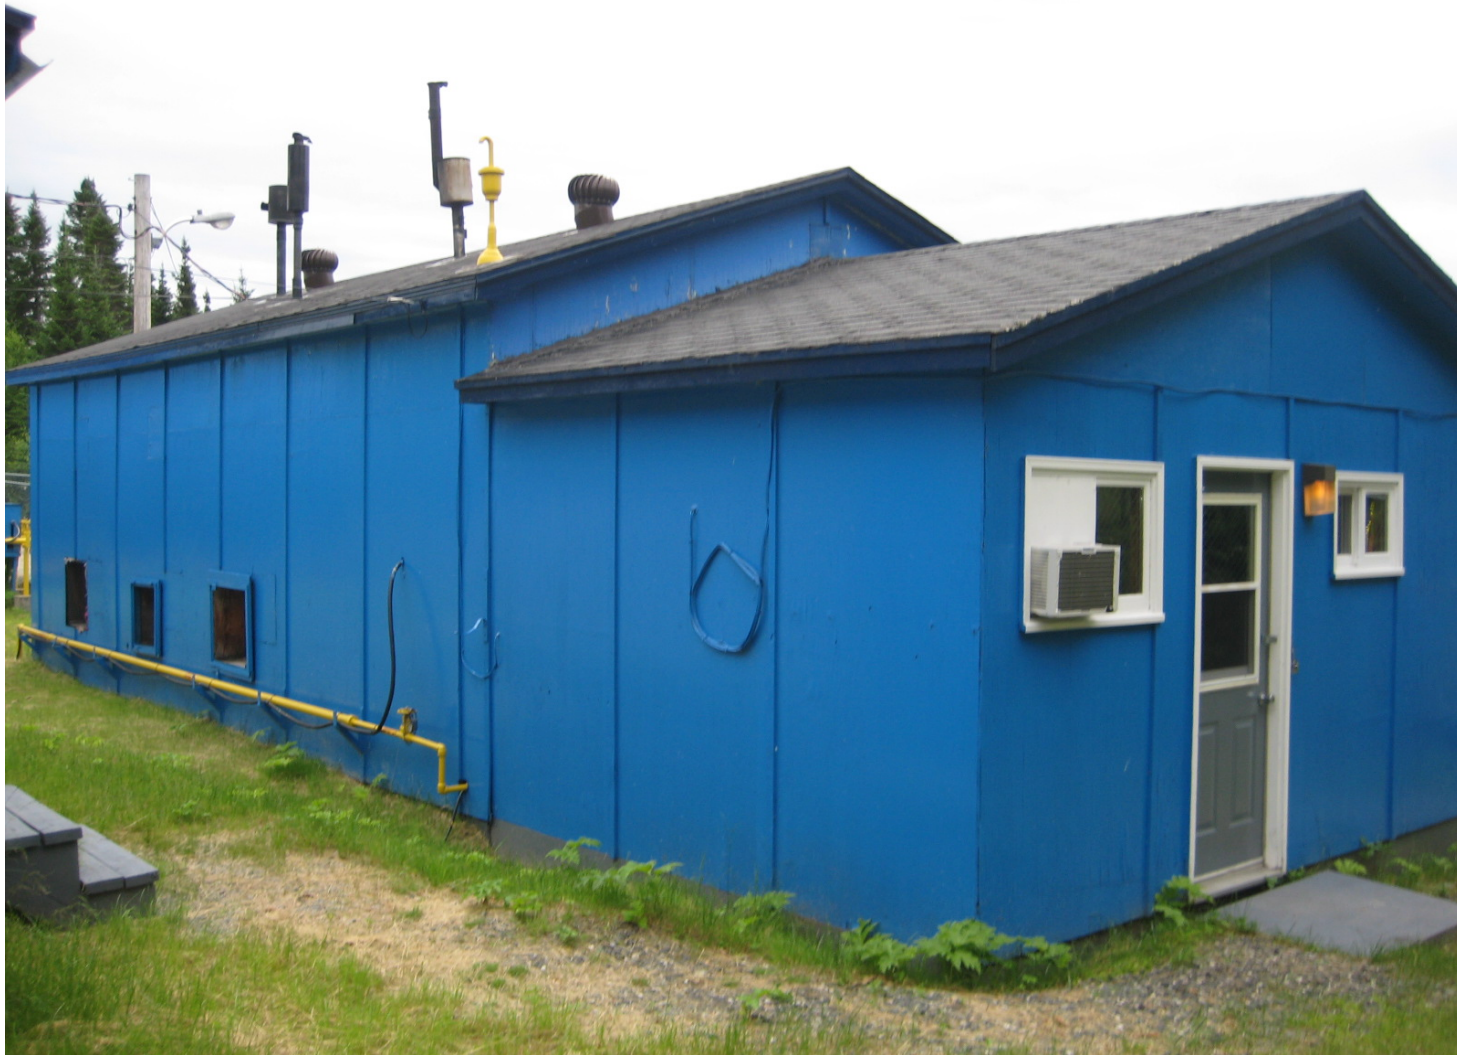
Paradise River, Labrador

- Building envelope – Wooded structure, asbestos sheeting, cracked foundation. Ice damming is a problem due to open trusses (bad to fair condition). Recommend further structural analysis to determine adequacy of building envelope.

Paradise River is ranked second in the suggested for replacement category. It is suggested for replacement due to one main issue: the integrity of the building envelope. The plant appears to be one of the oldest that was assessed. The plant had no mechanical ventilation. There is also the issue of asbestos sheathing on the interior of the plant. The operators noted severe frost heave of the foundation in the winter months that would indicate a potential structural concern. Again, to rectify these issues, a new building is recommended.

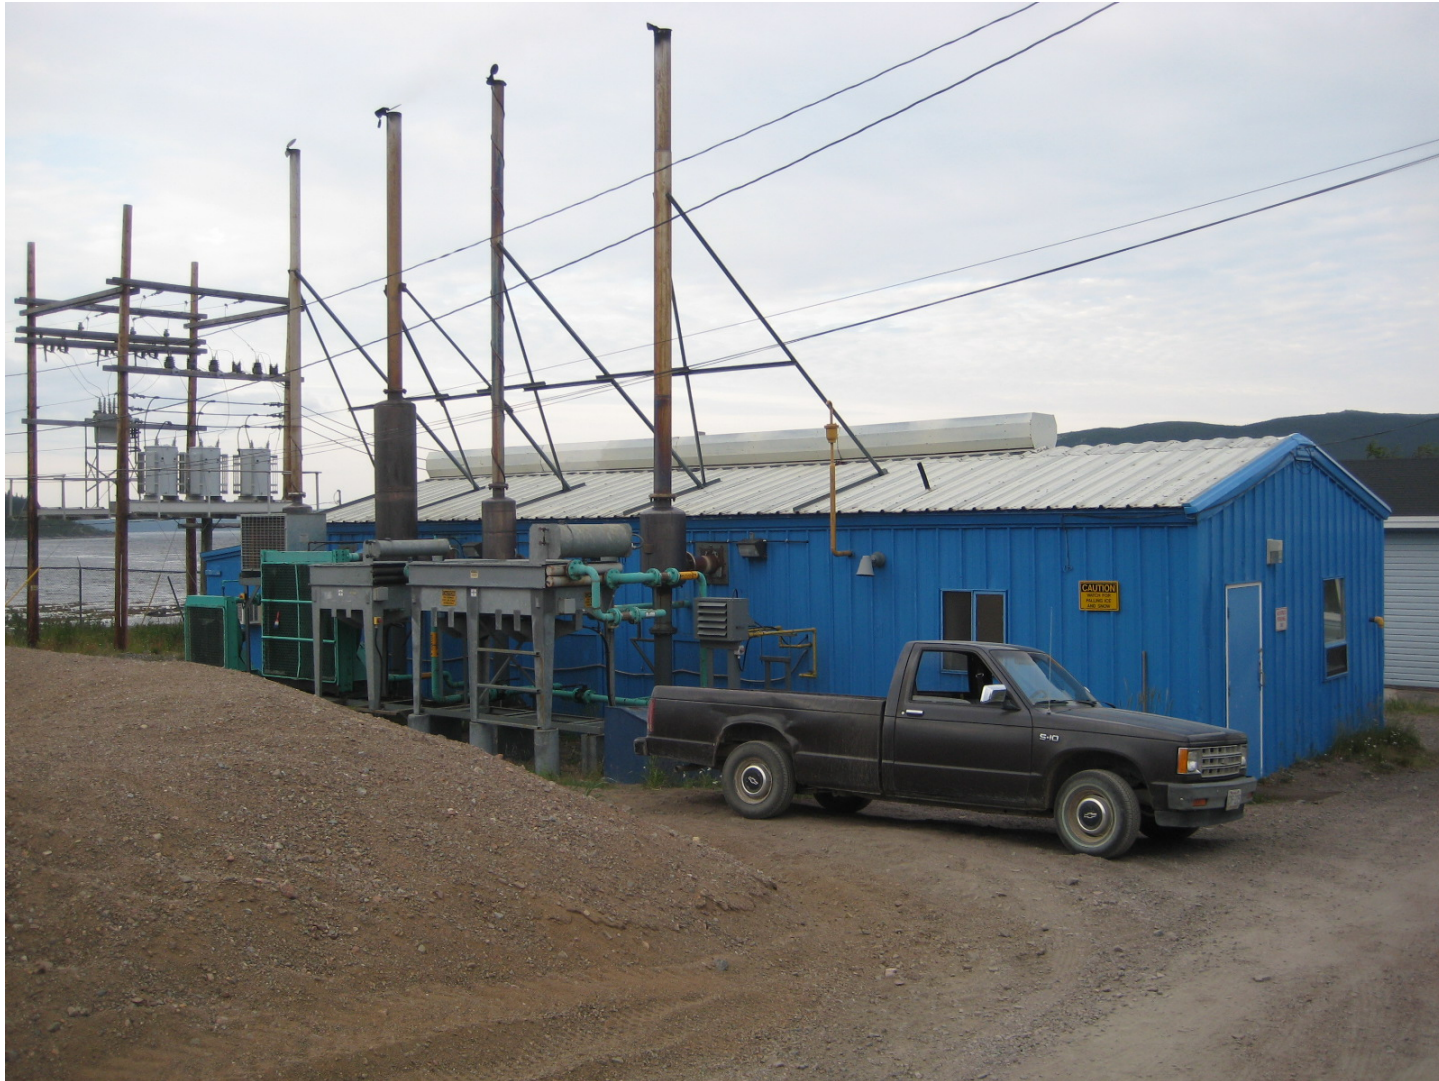
Rigolet, Labrador

Rigolet is ranked first although it appears to have recently undergone some upgrading. This plant is severely overcrowded and congested, resulting in serious egress issues. To rectify this issue, a new building is recommended.
