Upgrade Unit 1 Stack Breeching

Holyrood Thermal Generating Station

UNIT #1 AIRHEATER TO STACK DUCTING

ULTRASONIC EXAMINATION REPORT

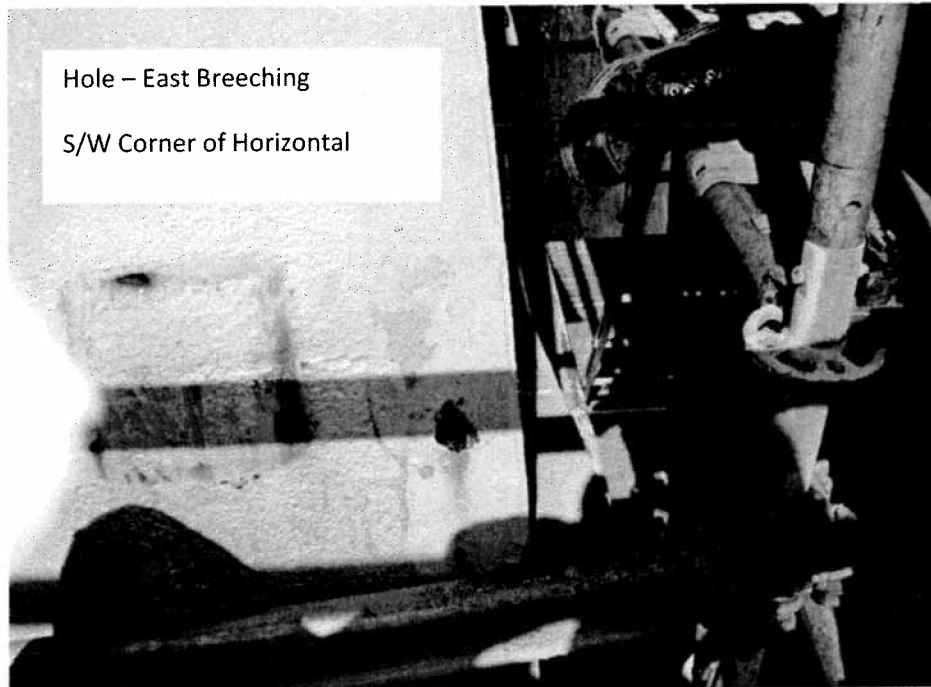
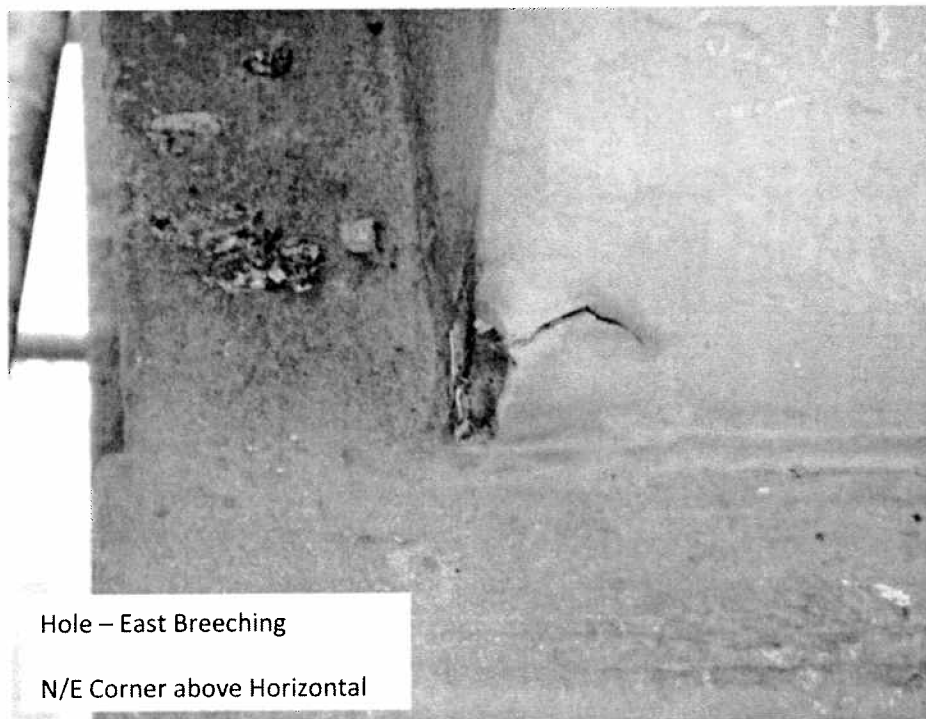
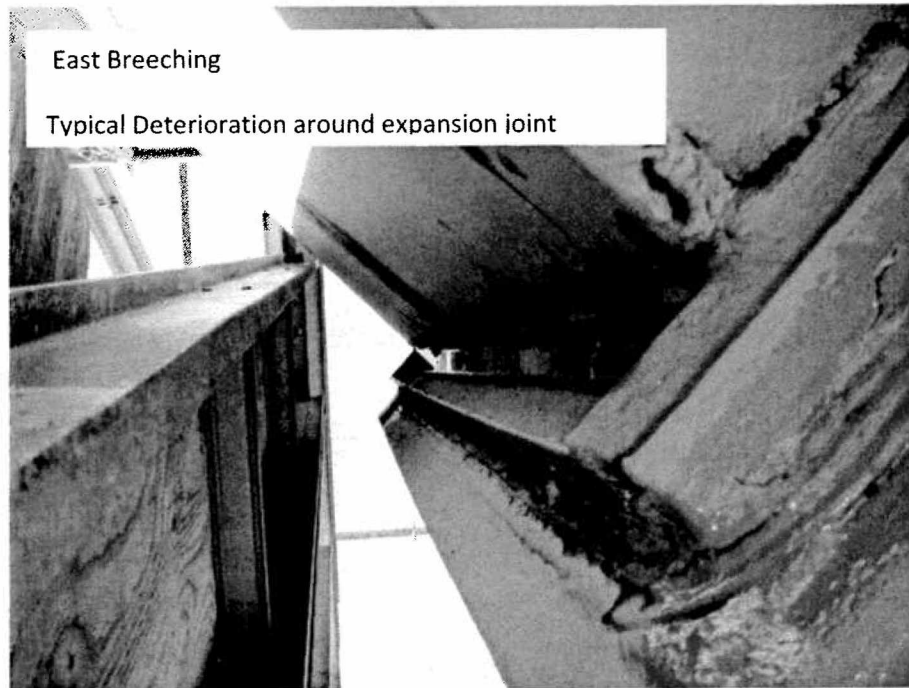
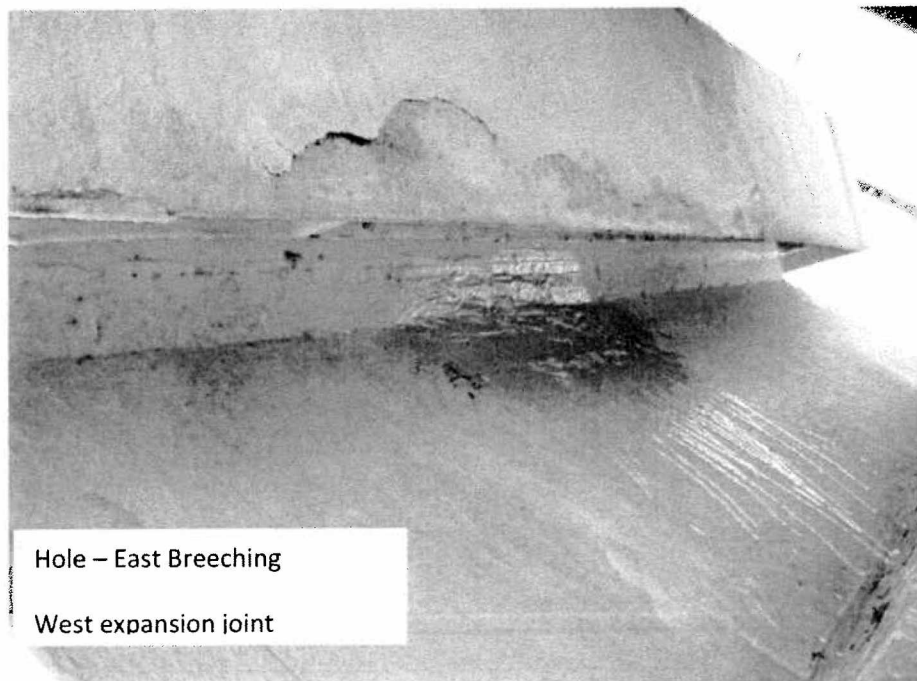
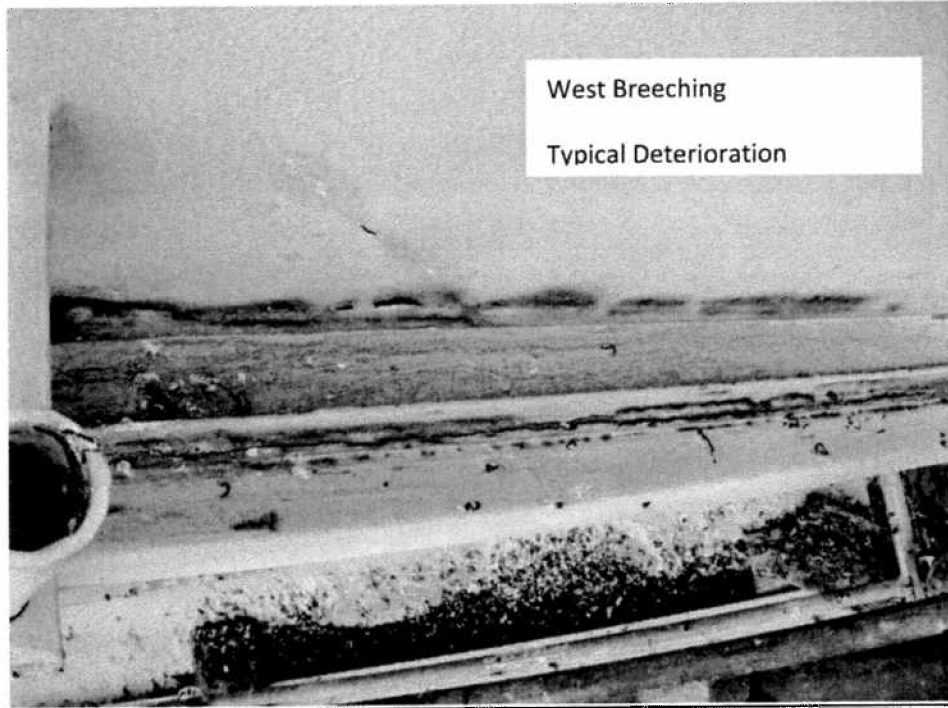
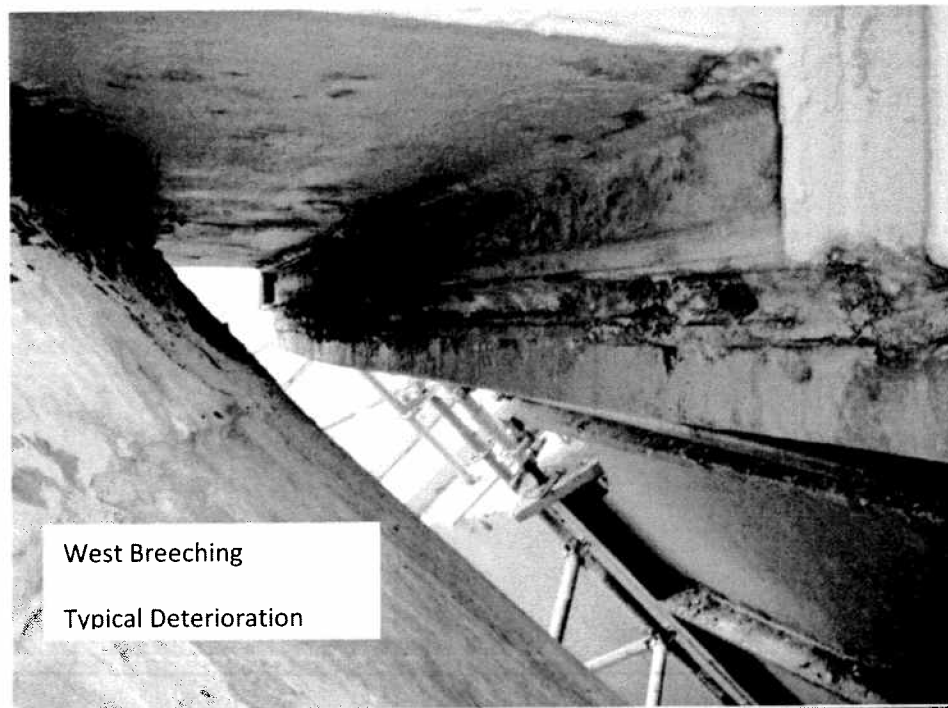
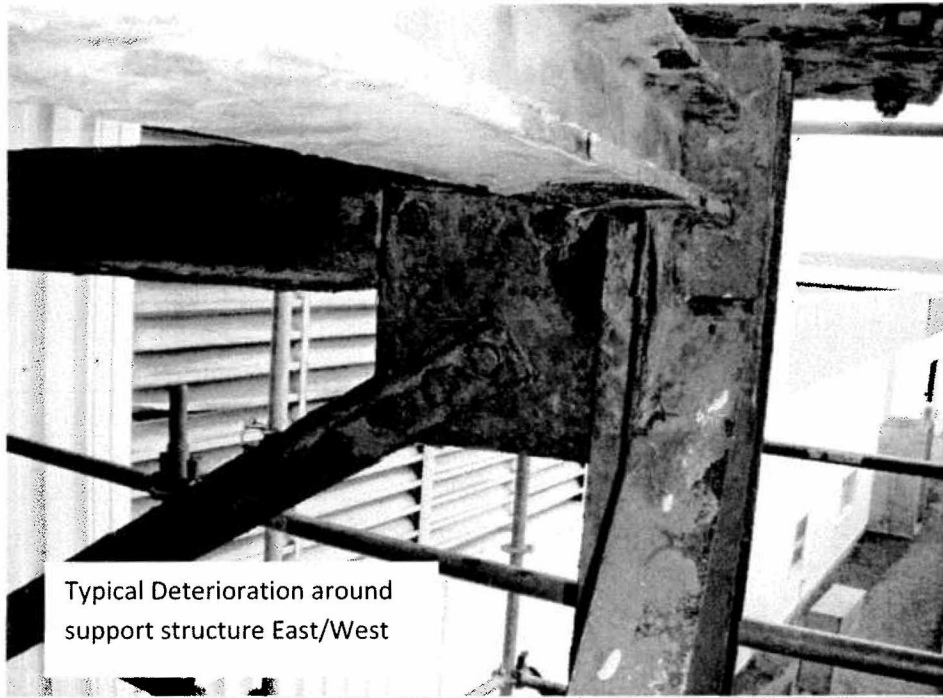
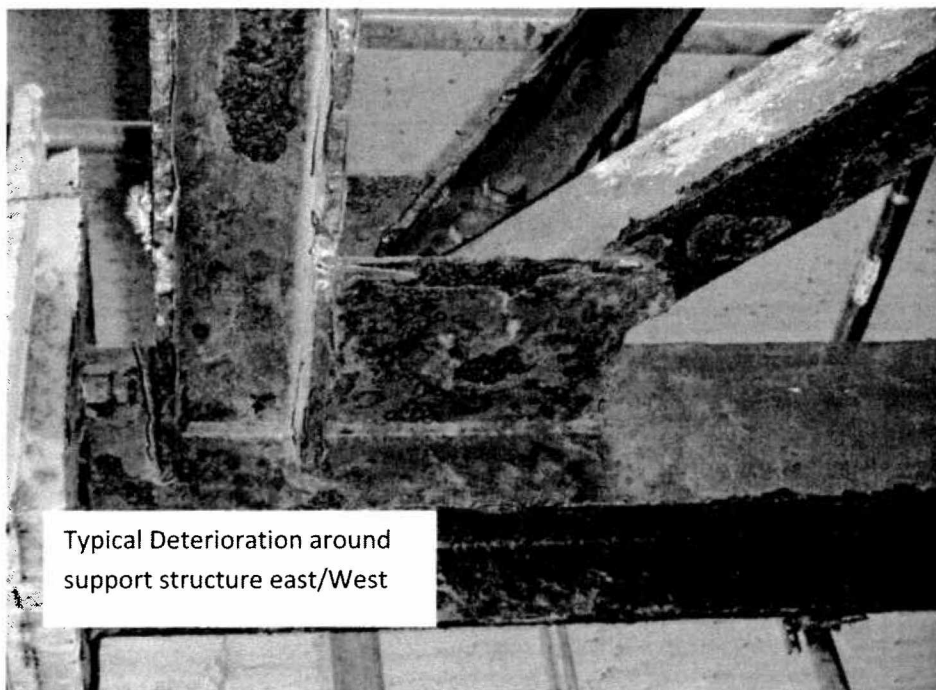
3.0 Photographs:

The ultrasonic thickness survey was completed on all accessible areas of both the east and west breeching. Several thickness measurements were taken at each location with the lowest recorded. There are isolated areas that have wall loss less than .200 inches. It appears that the nominal wall thickness was .250 inches. The overall paint condition is fair to good with deterioration noted around the stiffeners. All observed holes were covered with Devon and painted. There is a lot of deterioration around both expansion joints.
