BAY D'ESPOIR GENERATING STATION

POWERHOUSE NO. 1

UNIT GENERATORS #1, #3 AND #4

CONDITION ASSESSMENT REPORT

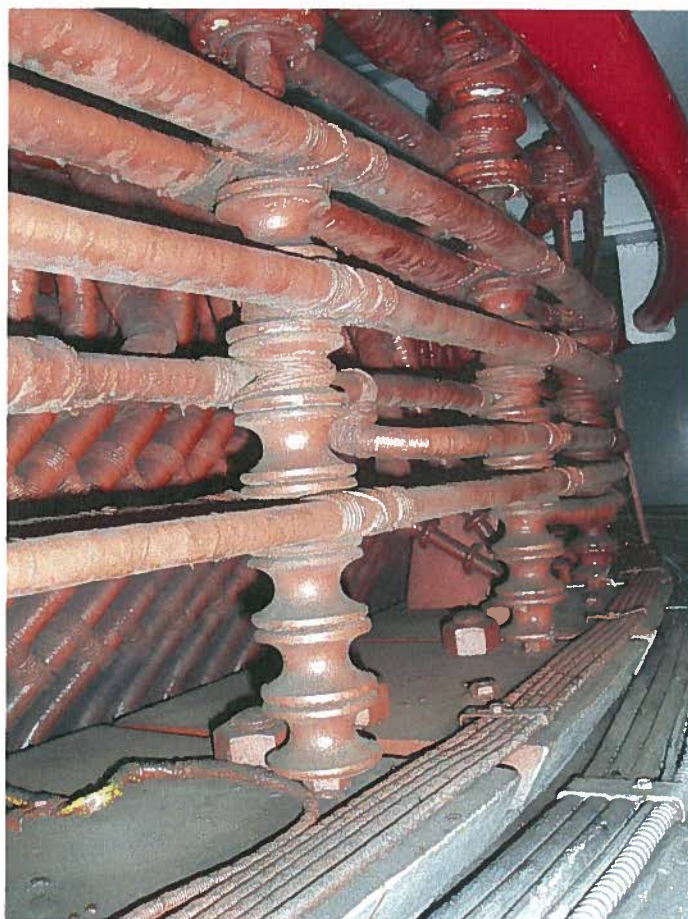
Photograph 013 – Stator top windings showing dusty conditions.

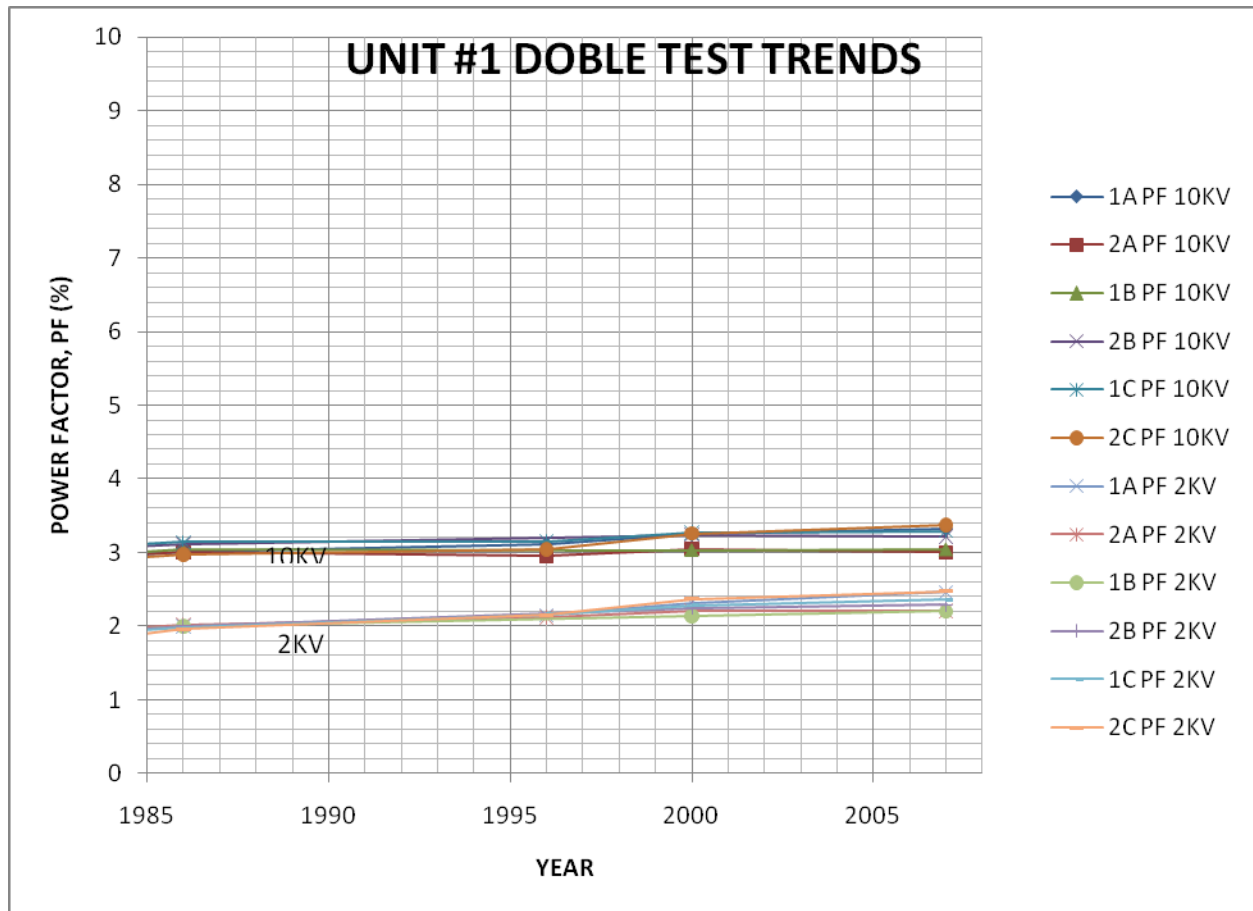
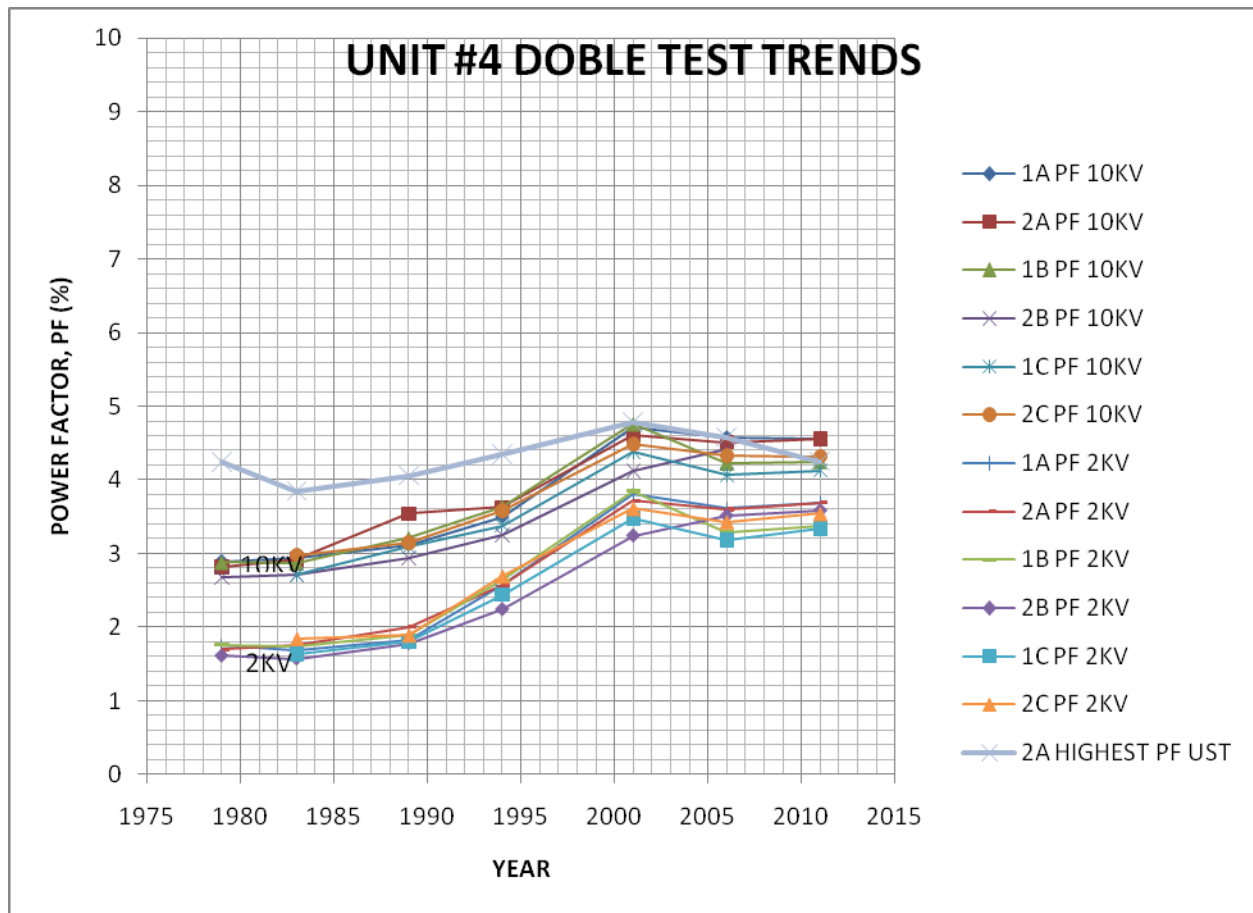
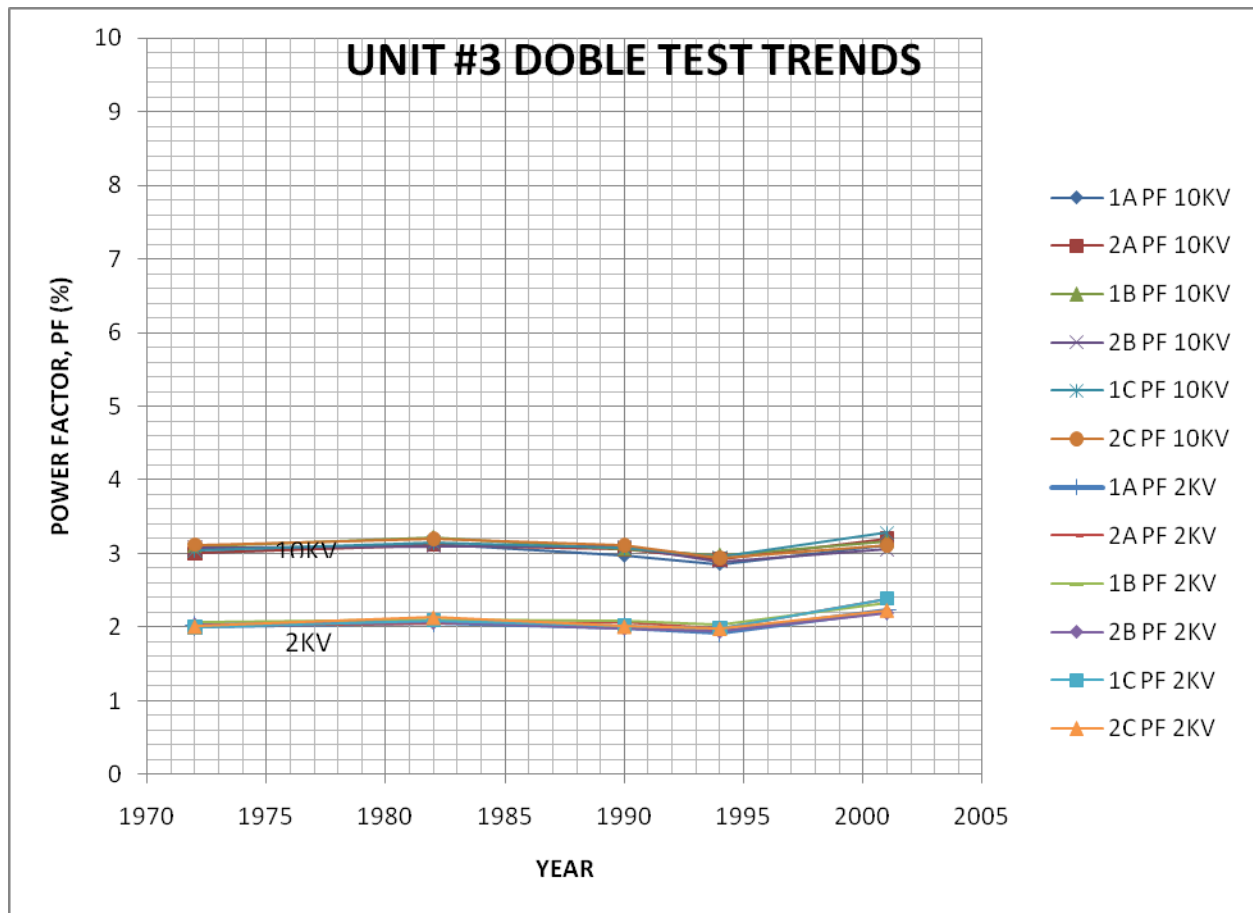
Unit #4 follows consistently linear trends until 1989 when all three phases had similar power factors of 2 and 3 percent at their respective test voltages of 2kV and 10kV. From the most current tests the second coil in Phase A reaches a power factor of 4.6% at a test voltage of 10kV and a power factor of 3.7% at 2kV. The power factor varies from zero to six percent between coils within a single year of tests; this is a sign of deterioration within the winding insulation.

According to these Doble tests, Unit #4 continues to have the worst trends between the three units. Units #1 and #3 have significantly better trends and follow the same power factors at both test voltages throughout the entire period of testing.

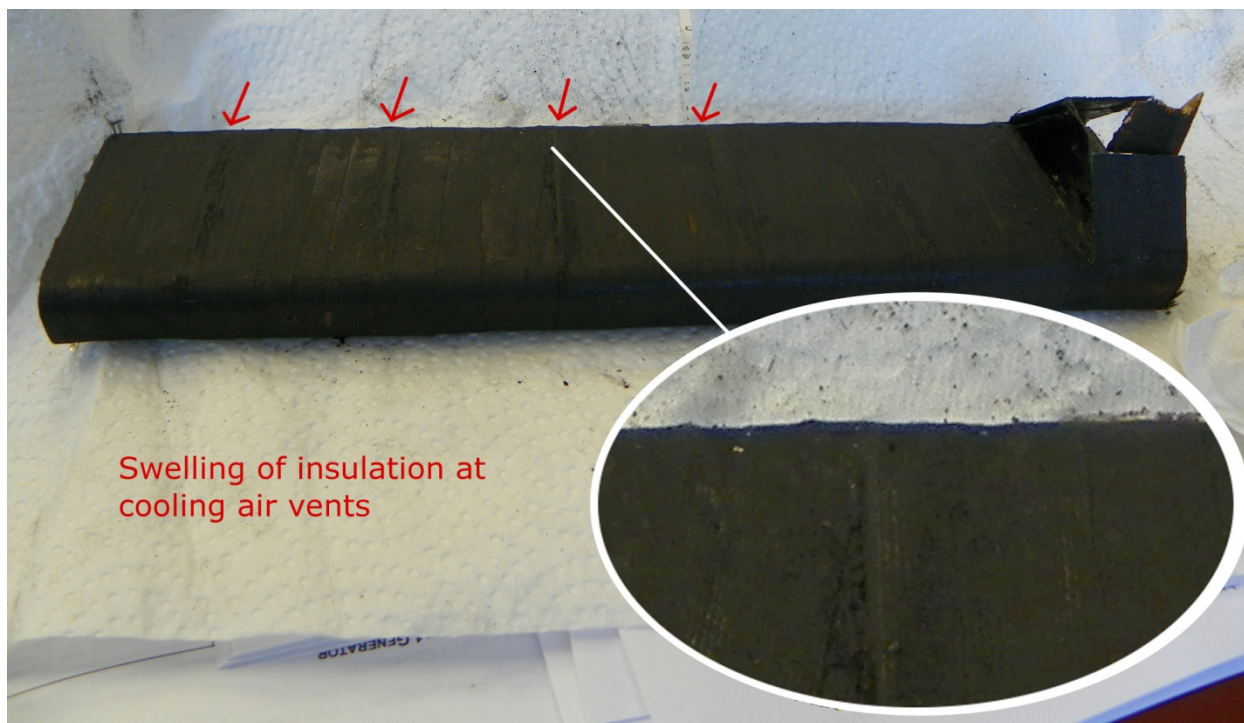
- Oil mixed with black dirt is soaked into the outside overall tape of the coil. It is evident that the oil leaking problem that entered the stator slot from the top of the core is very serious.
- The insulation swell is observed at the core vent hole.
- Asphalt has migrated downward and the mica tape has a lack of asphalt on many layers.
- Mica tape delamination is evident.
- Turn insulation is not examined.

Swelling of insulation at
cooling air vents

Air vent swell

All of the observations above support the PDA monitoring in the past, indicating high activities of PD in the slots and delamination of the insulation. Over the long term, the common problem of oil leakage must be corrected for all units. The common long term oil leak problems for all units must be fixed.

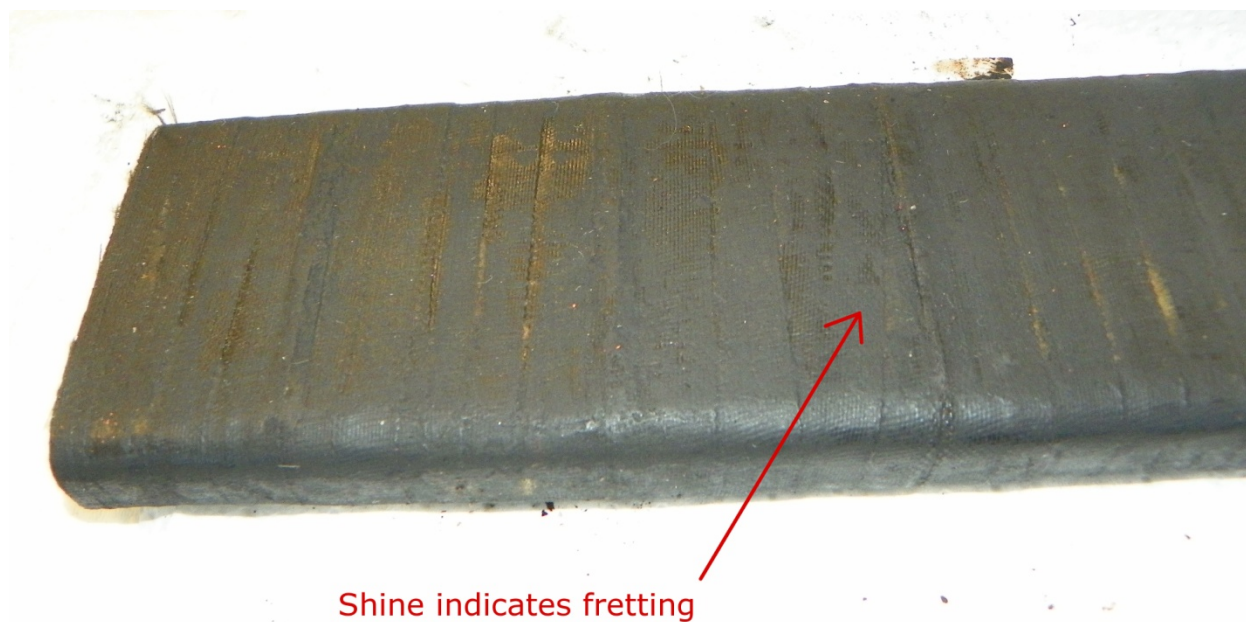
Fretting
