1 Q. **Re: Refurbishment of Marine Terminal at the Holyrood Thermal Generating**  
2 **Station (Tab 3)**

**Laboratory #:** 498237-08

**Specimen:** Marine Fender Support Arm

## TEST REPORT

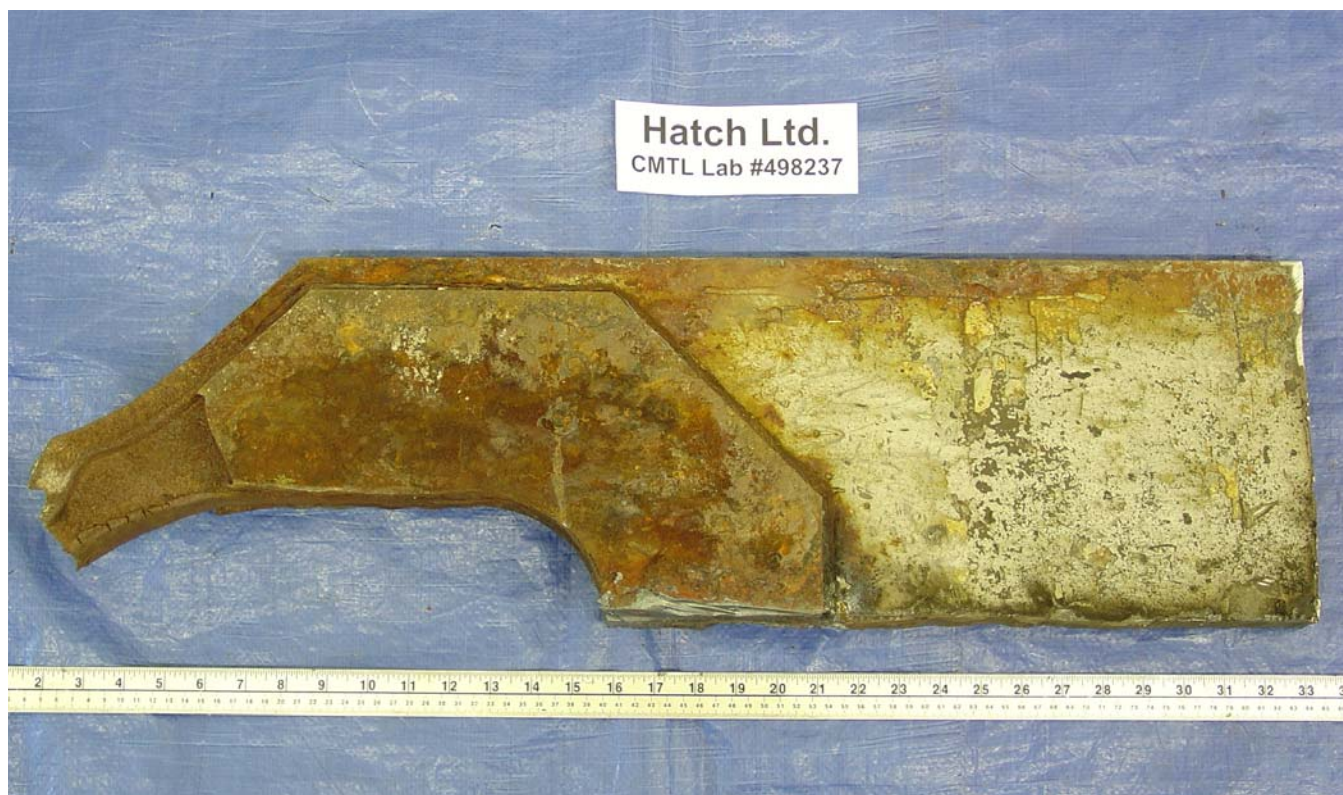
A section of a failed support arm for a marine fender was submitted for evaluation (refer to Figure 1). The purpose of the evaluation was to document the condition of the marine fender support arm remains, approximate the cross sectional area of the fracture surface and determine the tensile properties of the main plate of the support arm. Hatch has indicated that the support arm was manufactured from an 18" wide x 1.375" thick plate and had 0.688" thick support plates welded on either side. A 6.0625" hole in the support arm was used to hold a 6" hardened pin that was attached to a 65 ton concrete fender. The marine fender had been in service for 30+ years prior to the failure. A dimensional drawing of the support arm was also provided by Hatch (refer to Figure 2).

Figure 1: Photograph of the as received section of the marine fender support arm. Top scale on scale marker is in inches and the bottom scale is in centimetres.

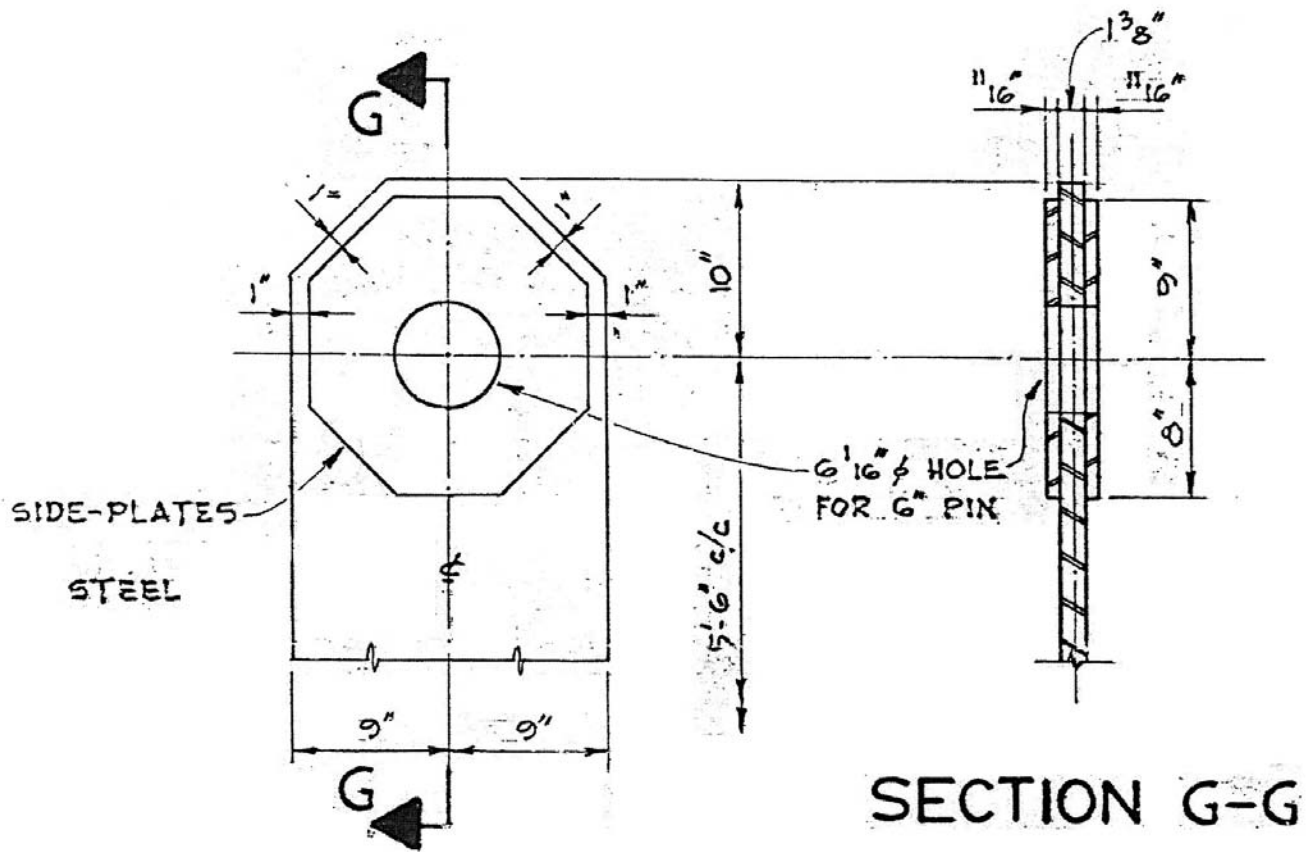
Figure 2: Copy of the Hatch submitted drawing showing the dimensions of the marine fender support arm.

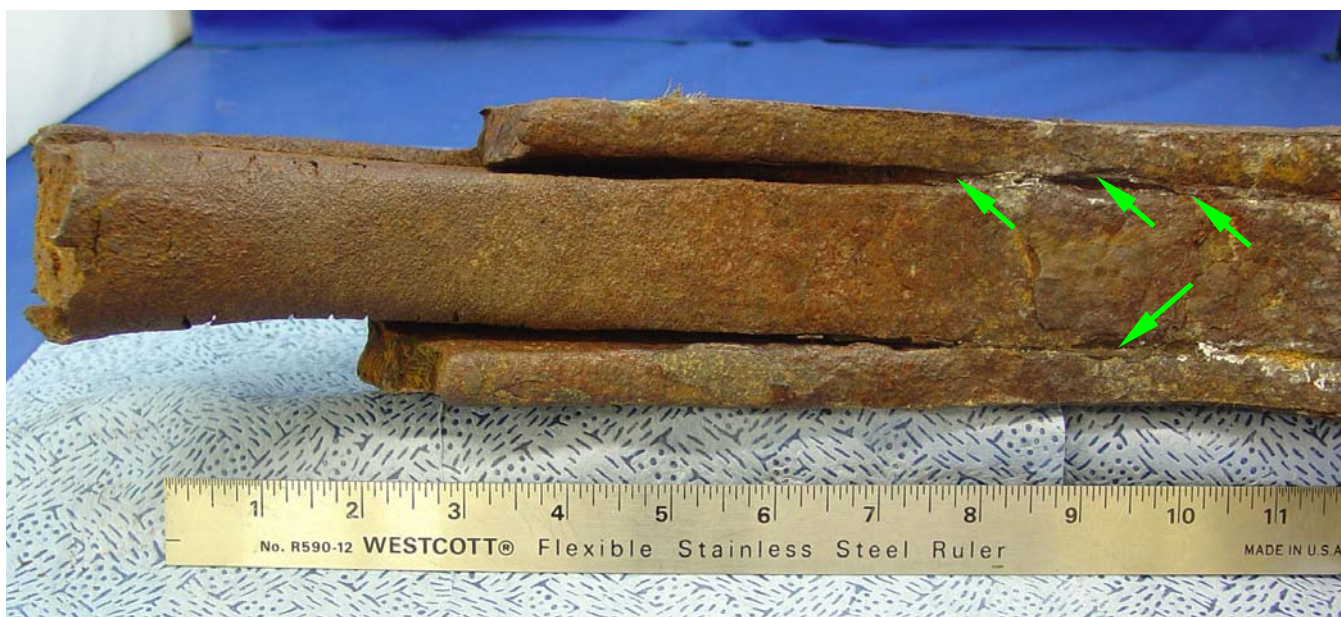
With the exception of two flame cut edges all of the surfaces of the specimen were heavily corroded. Examination of the marine fender support arm section suggests that the submitted section represents only half of the original width. The submitted section of the marine fender support arm was approximately 9" wide and 31" long. The main plate had an approximate thickness of  $1\frac{3}{8}$ " and the support plates were approximately  $\frac{9}{16}$ " thick. The corrosion product was observed between the main plate and supports plates and the support plates appeared to be separating from the main plates as a gap was observed between the plates (refer to Figure 3). The fracture of the main plate appears to have occurred along the bottom of the hole in an area of minimal cross section, with support plates each fracturing in different locations above the main plate fracture location (refer to Figure 4). The two support plates were welded to the main plate around their outside edges. Between the support plate fracture locations and the main plate fracture location there does appear to be some remnant weld metal still on the main plate (refer to Figure 5).

Figure 3: Photograph showing the corrosion between the support plates and the main plate (refer to the arrows) and the gaps that were present between the main plate and the support plates. Scale is in inches.

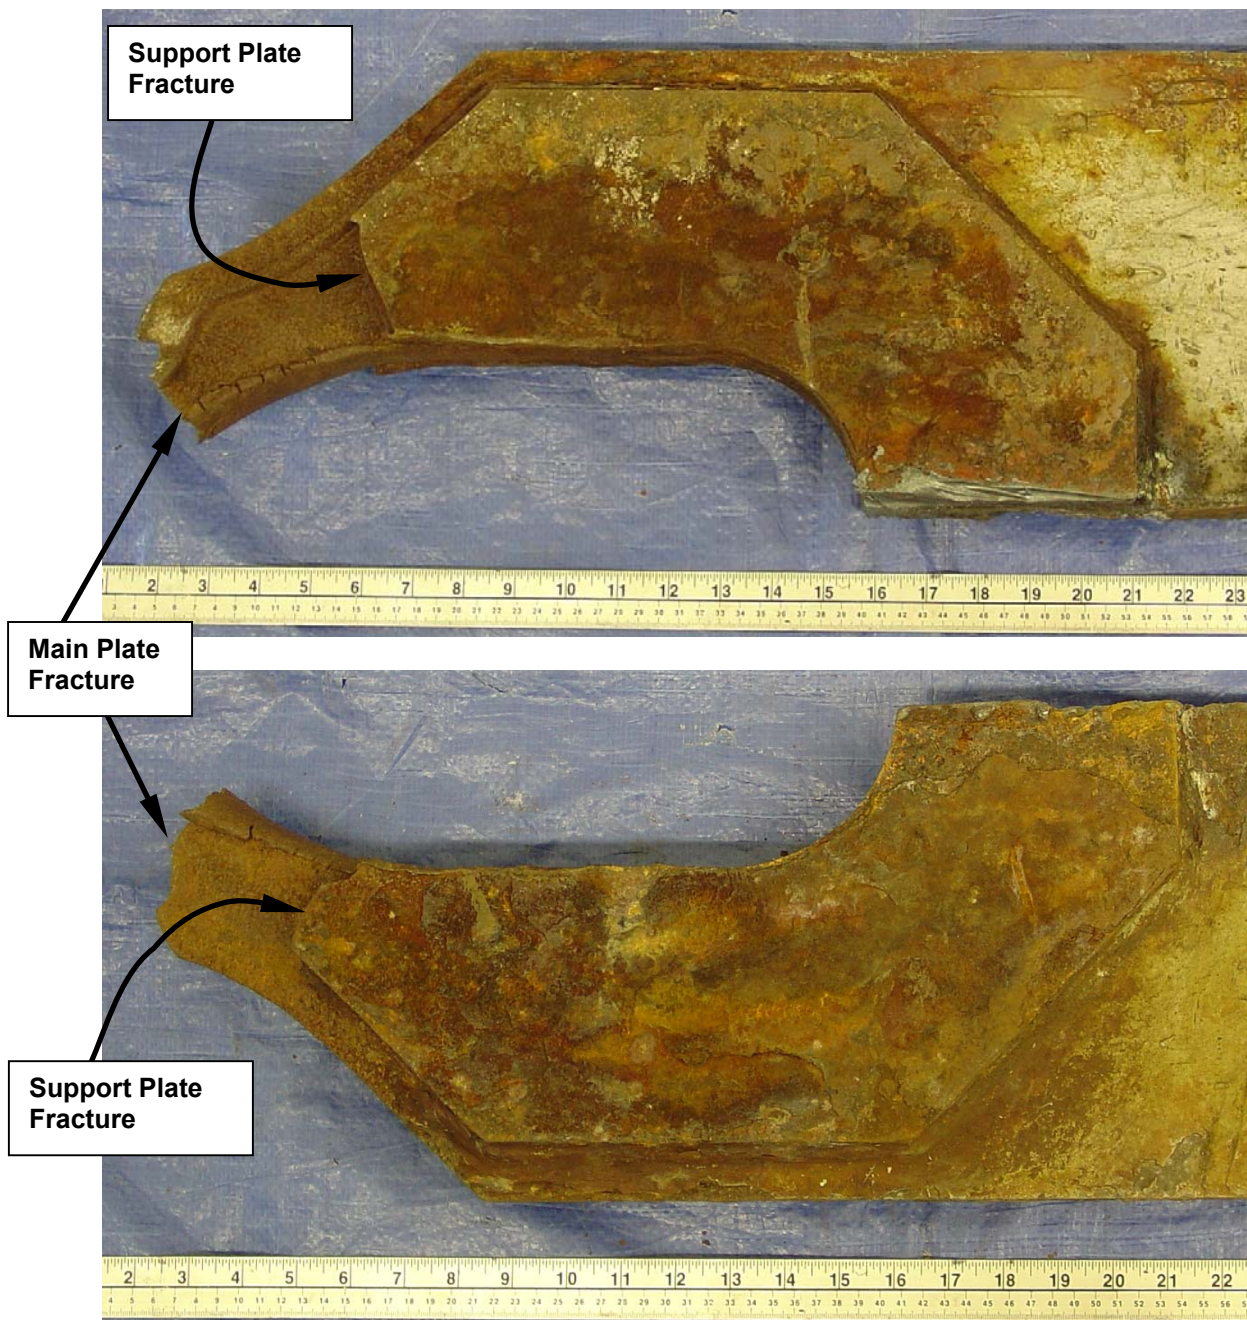
Figure 4: Photographs of each side of the submitted specimen showing the fracture location of the main plate and of both support plates. Top scale on scale marker is in inches and the bottom scale is in centimetres.

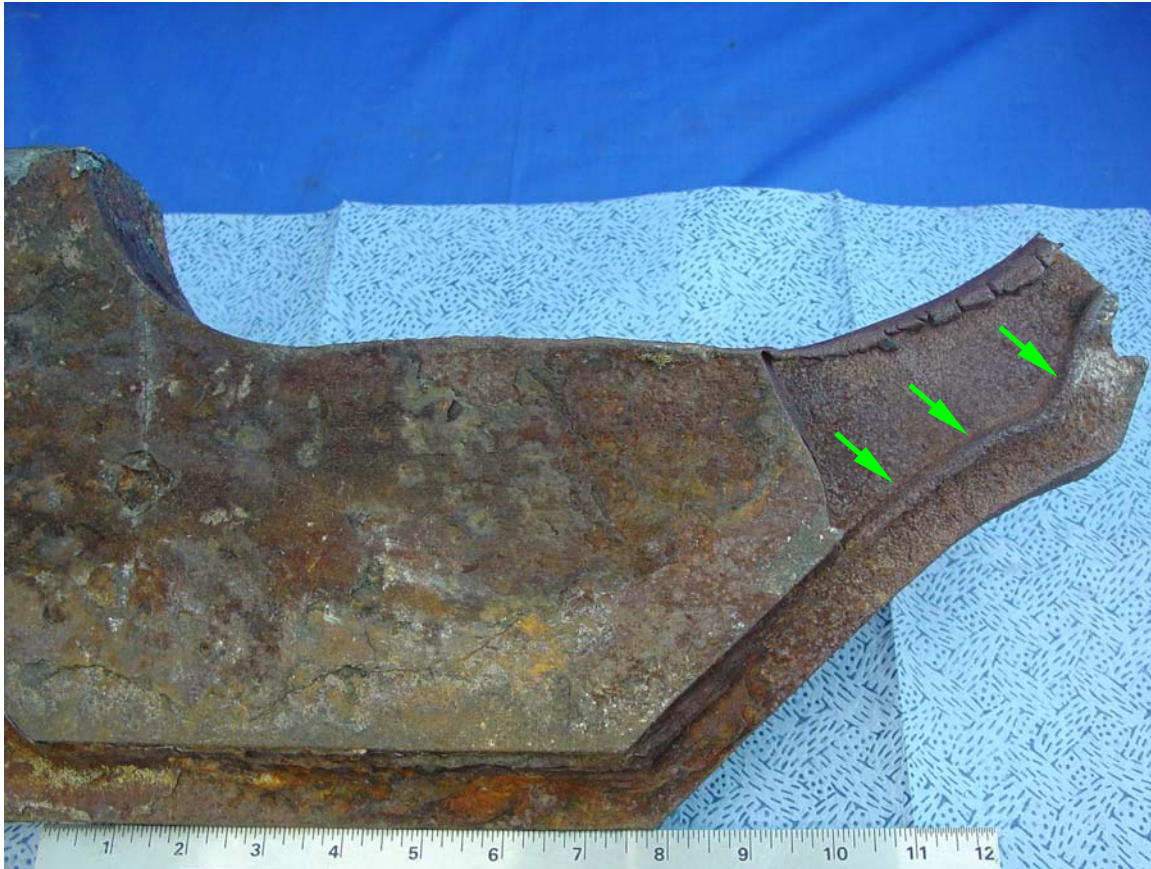
Examination of the main plate around the fracture location showed a slight curve to the material indicating some deformation (bending) of the material at this location during fracture when compared to the dimensional drawing (refer to Figure 2 and Figure 5). Examination of the main plate fracture surface revealed no fine detail was visible due to the corrosion of the fracture surface, however a chevron pattern observed on the surface indicates the fracture originated along the inside diameter of the hole (refer to Figure 6). Examination of the hole showed that it appeared to be severely elongated due to wear. The hole surface revealed evidence of material deformation as the main plate appeared to be 'mushrooming' at both edges of the hole (refer to Figure 7).

Figure 5: Photograph showing the remnant weld metal on the surface of the main plate (refer to the arrows). Also visible in the photograph is the slight curvature to the diagonal edge of the support arm. Scale is in inches.

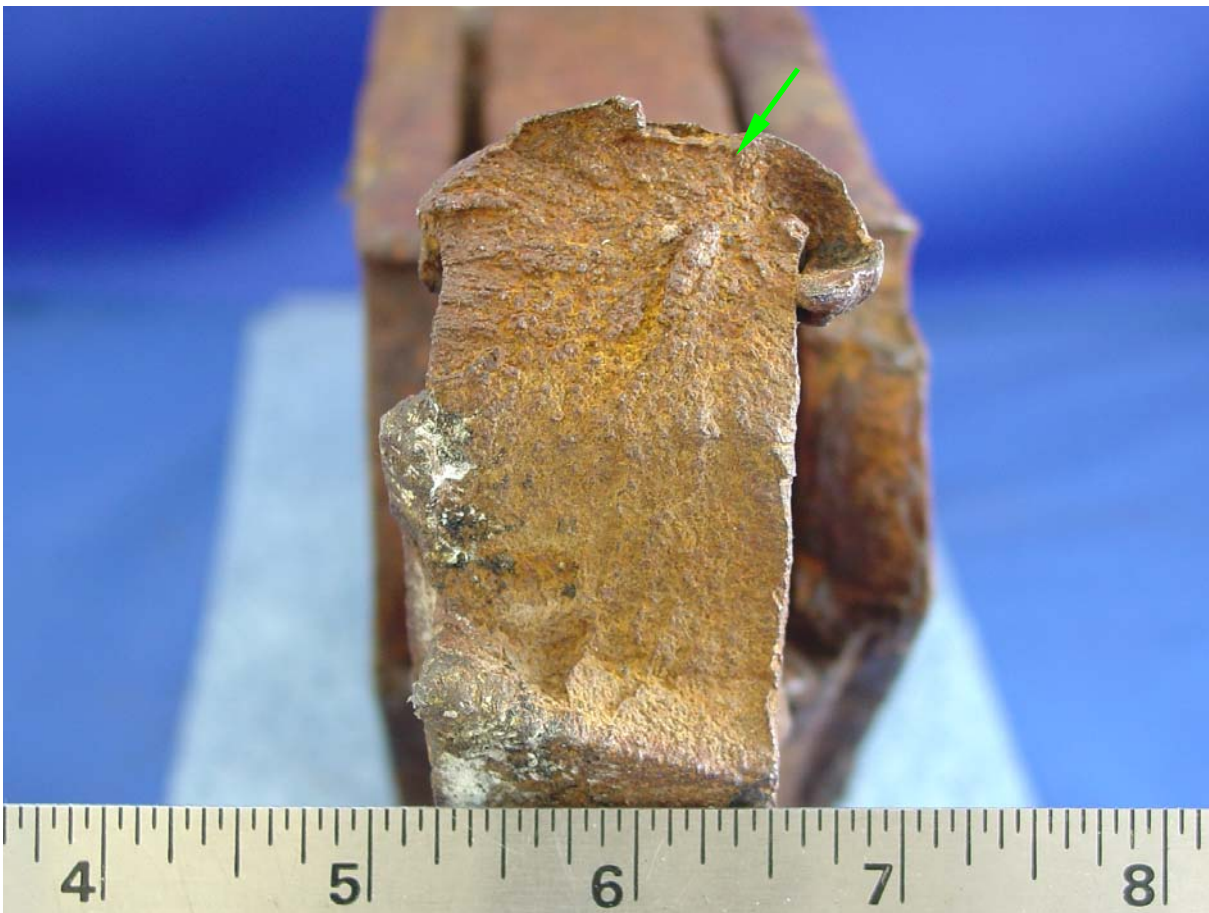
Figure 6: Photograph of the main plate fracture surface. The arrow indicates the likely origin location of the fracture. Scale is in inches.

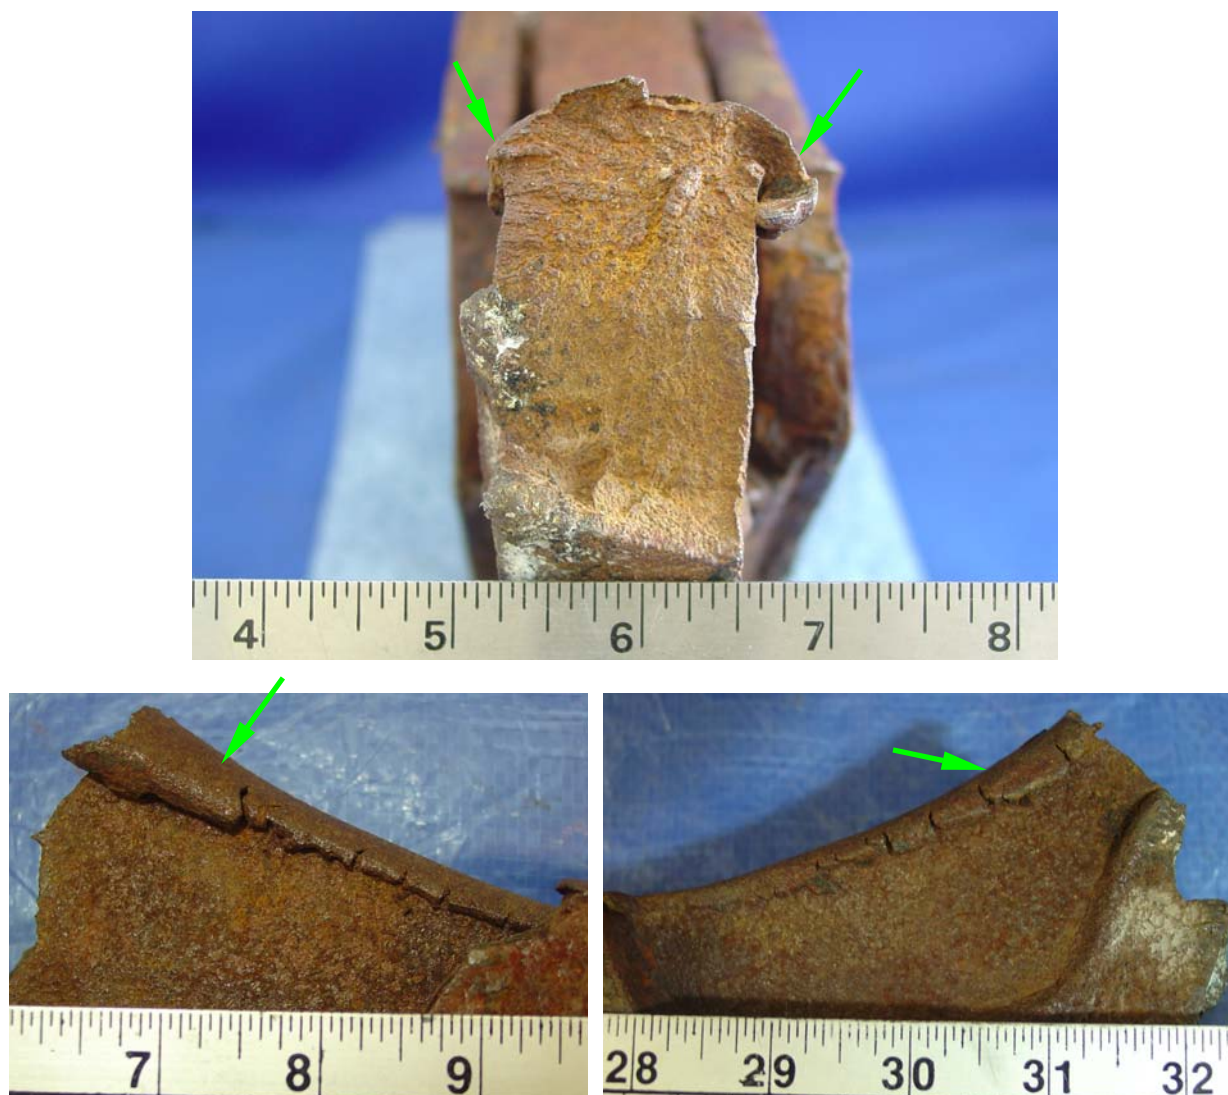
Figure 7: Photographs showing the 'mushroomed' material that was observed along the bottom half of the hole (refer to the arrows). Scale is in inches.

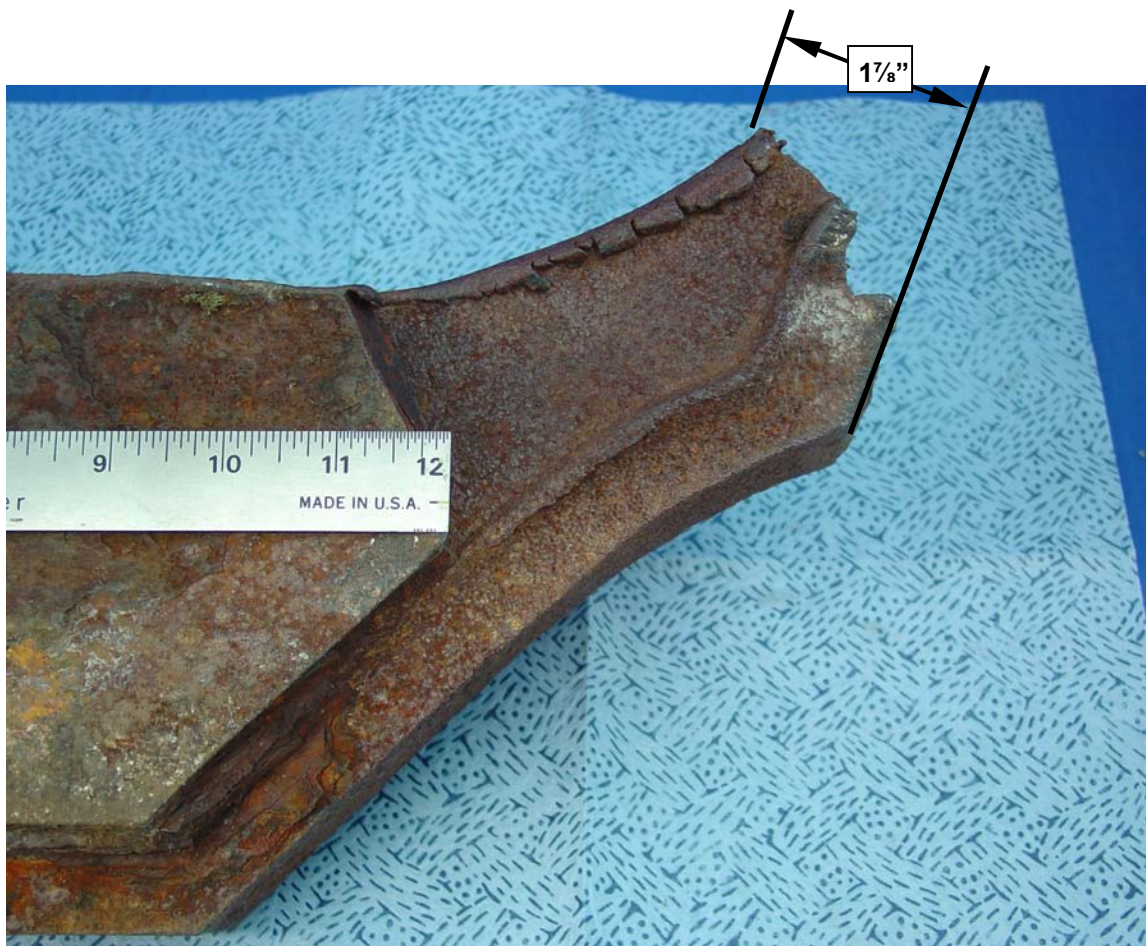
At the fracture location dimensions of the remaining material of the main plate were approximately  $1\frac{3}{8}$ " thick x  $1\frac{7}{8}$ " long (refer to Figure 8). Based on these measured dimensions an approximate cross section area of the main plate at the fracture location was calculated to be 2.578 in<sup>2</sup>. Also, based on the dimensions of the support arm indicated in the supplied drawing and the measured  $1\frac{7}{8}$ " length on main plate material remaining along the bottom of the hole at the time of fracture it was estimated that  $5\frac{3}{32}$ " of material were worn away along the bottom of the hole. A full-scale cardboard pattern was constructed using the supplied dimensions of the support arm and the submitted section of the support arm was placed on top of the pattern by aligning the outer edges to help convey the amount of wear experienced by the hole in the support arm (refer to Figure 9).

Figure 8: Photograph showing the bottom portion of the hole with dimension lines to indicate how the length of the remaining material was approximated. Scale is in inches.

The cross sectional area at fracture was calculated as approximately 2.578 sq in. and the material yield at 33,800 psi. Load at yield would have been 87136 lbs or 43.5 tons. This does not account for the load intensification due to a circular hole in the plate. For a perfect circle the stress concentration at the bottom of the hole is 3 times the applied tensile load. At the measured UTS of the material, 68,000 psi, the ultimate load for the cross section is 175,304 lbs or 87.6 tons. If you divide by 3 the actual capacity is approximately 29 tons. Assuming both arms are similar in remaining cross section and tensile strength then we would have an approximate capacity of 58 tons. The fender weight is 65 tons and the majority of this is supported on the front two arms.

Based on this quick review of the report we can reasonable assume the failure was caused by the reduction in cross sectional area due to wear caused by nearly 40 years of small movements due to wind and wave action and some corrosion of the unprotected surfaces.

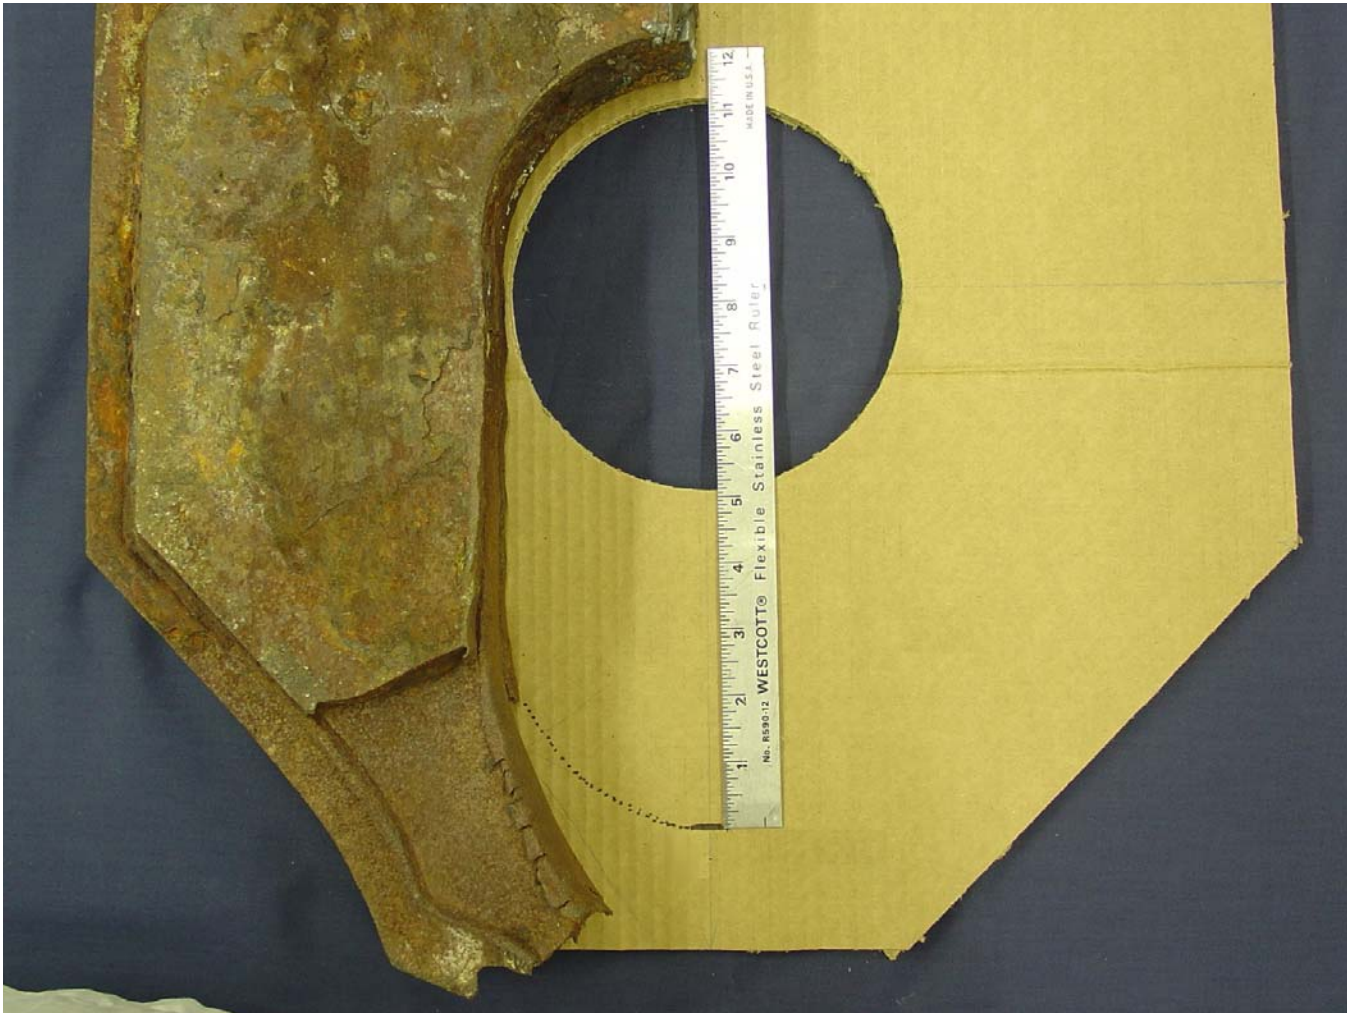
Figure 9: Photograph showing the lower section of the submitted support arm placed on a full-scale cardboard constructed using the supplied dimensions of the support arm. The black line on the pattern indicates the suspected location of the main plate prior to fracture. Scale is in inches.
