1    Q.    **Re: Project B-12 Upgrade Unit 2 Stack Breeching**

**Condition Assessment of Stack Breeching**

**Holyrood G.S.**

**Alstom Canada Inc.**

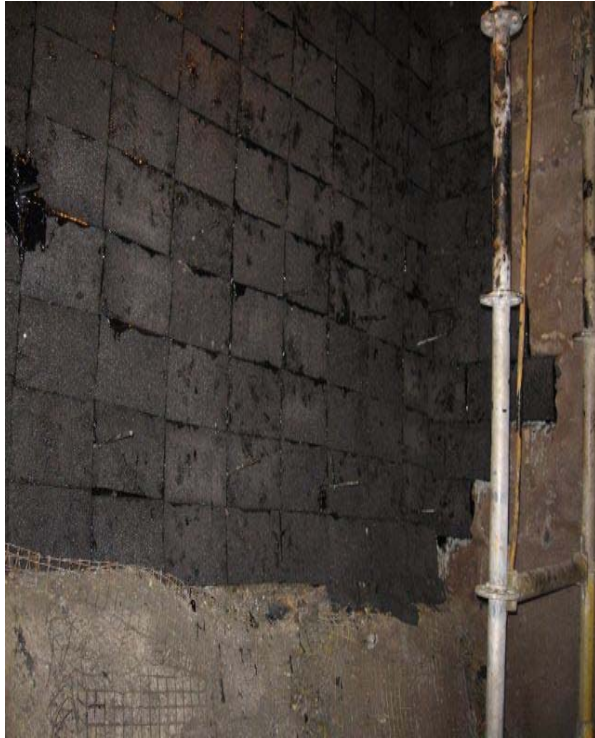
**Fig. 8: Unit 1 – Insulating block replacement**

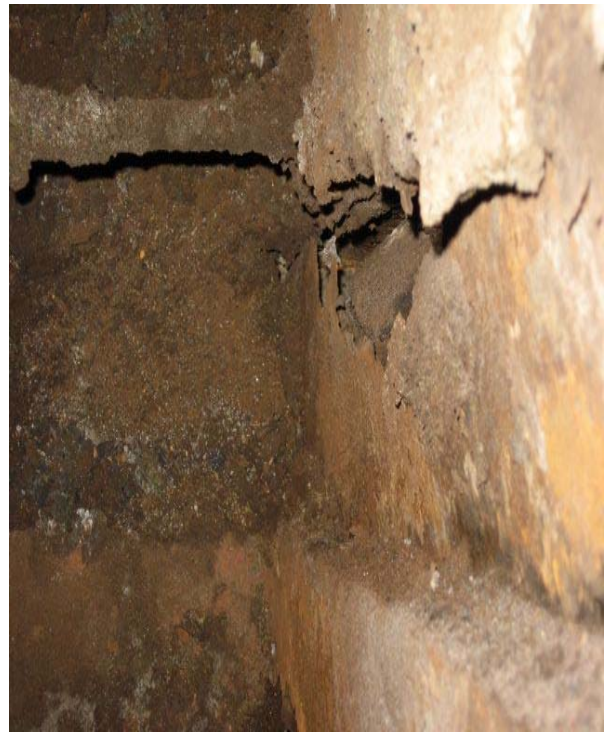
**Fig. 9: Unit 1 – Duct corroded through**

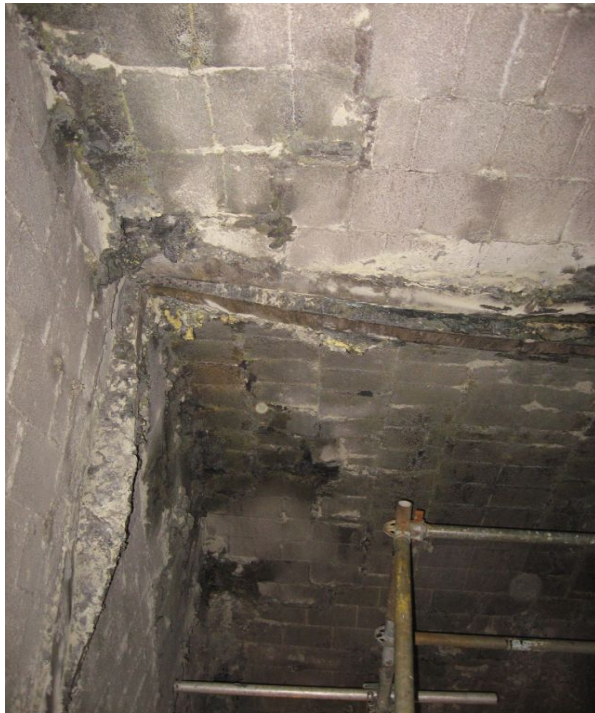
**Fig. 10: Unit 1 – Sloped section as found**

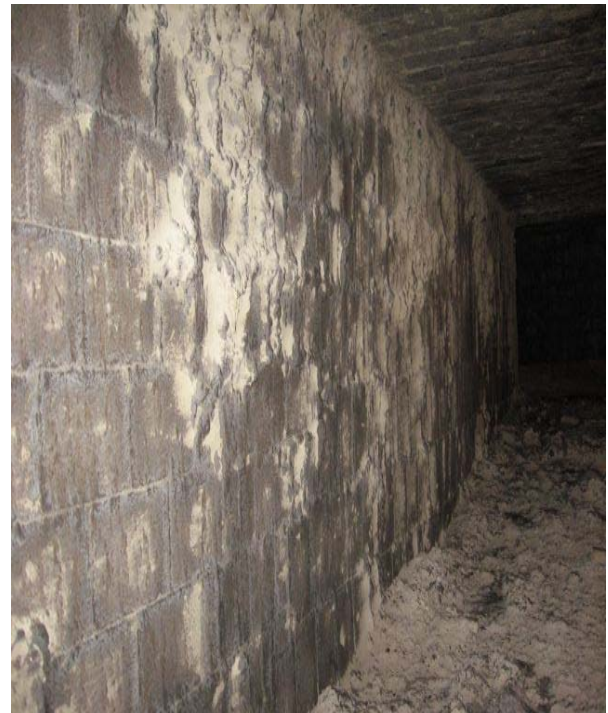
**Fig. 11: Unit 1 – Sidewall and floor**

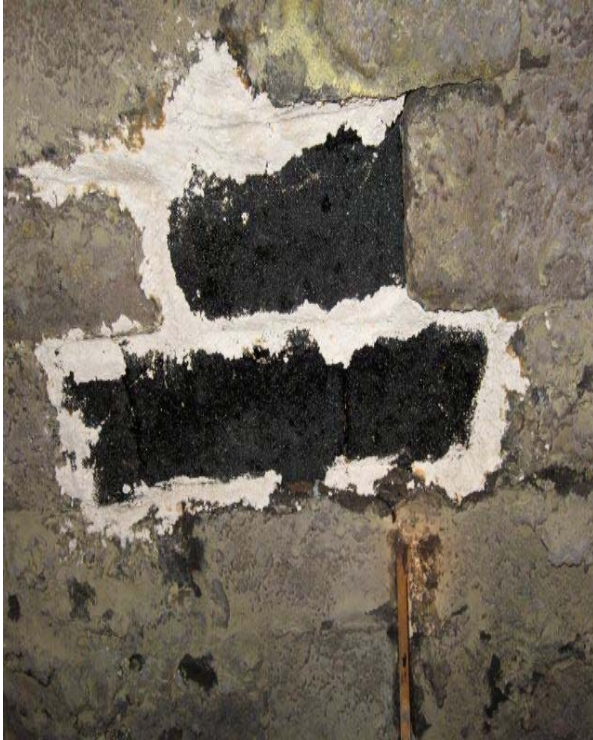
**Fig. 12: Unit 1 – Replaced blocks**

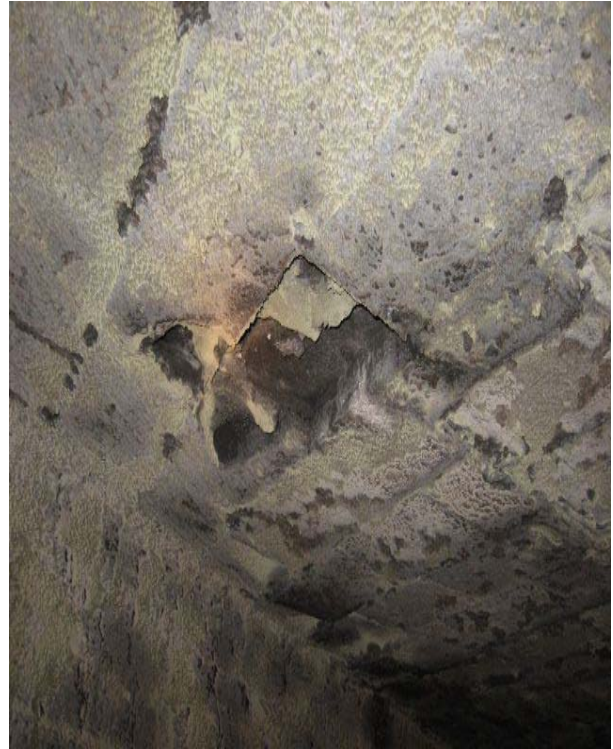
**Fig. 13: Unit 1 – Missing block overhead**

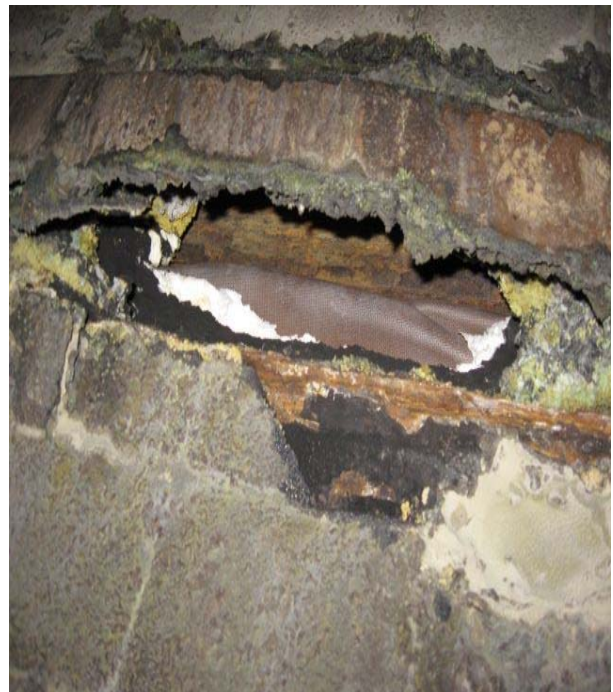
**Fig. 15: Unit 1 – Damaged expansion joint**

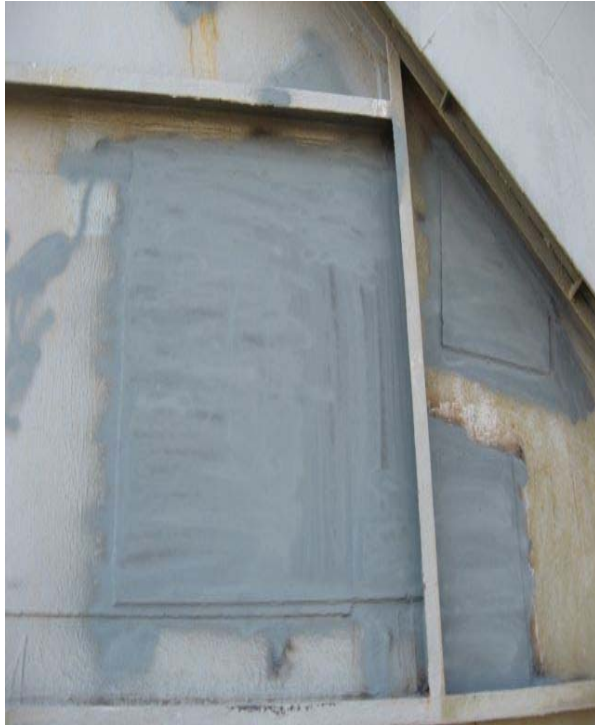
**Fig. 16: Unit 1 – External duct repairs**

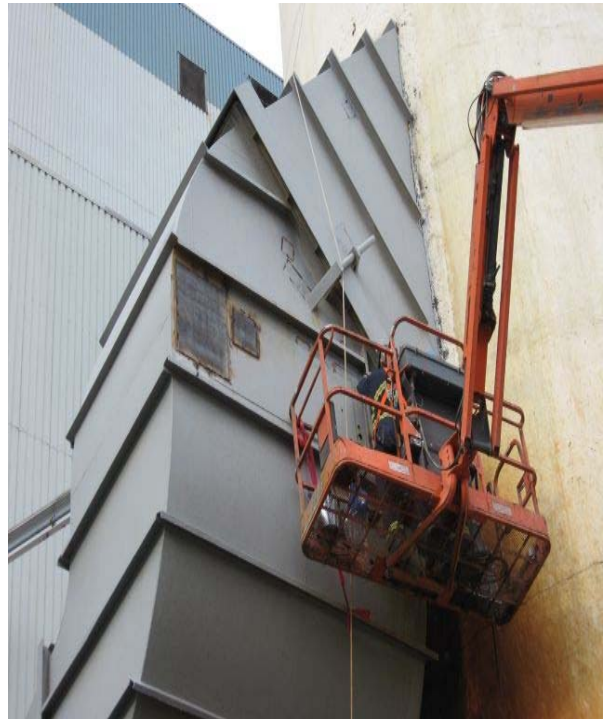
**Fig. 17: Unit 1 – External duct repairs**

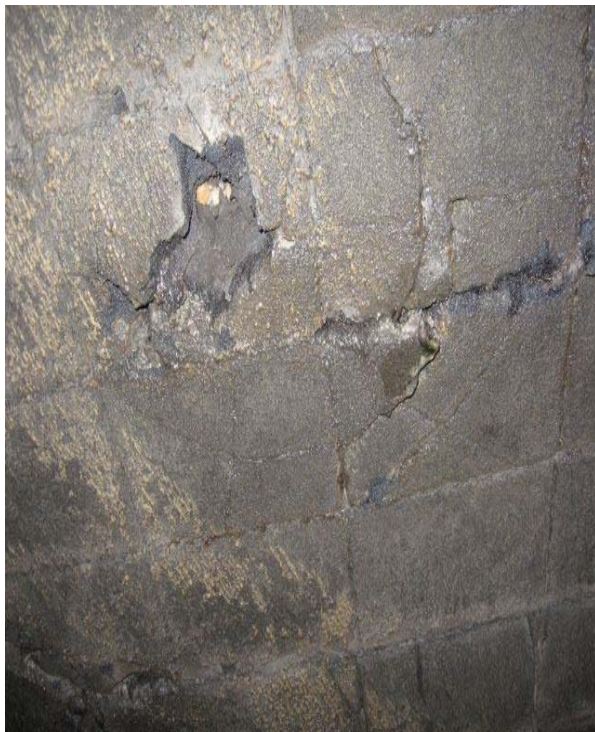
**Fig. 18: Unit 2 – Missing insulation blocks**

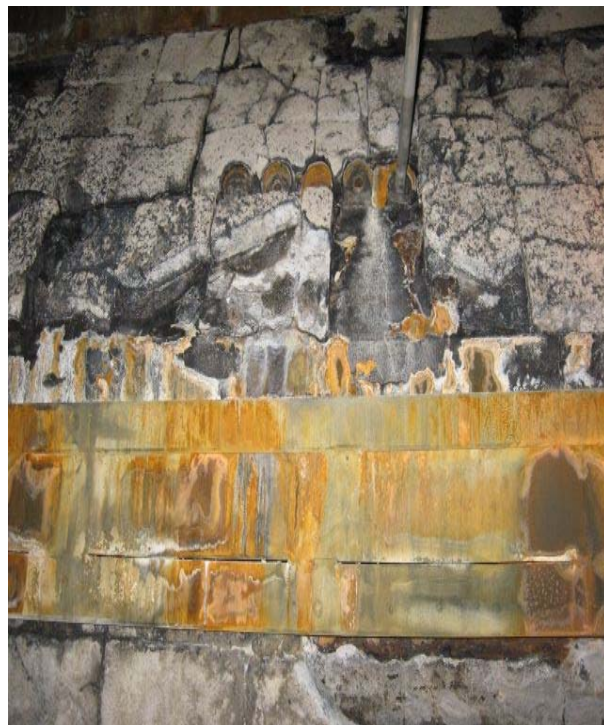
**Fig. 19: Unit 2 – Missing insulation blocks**

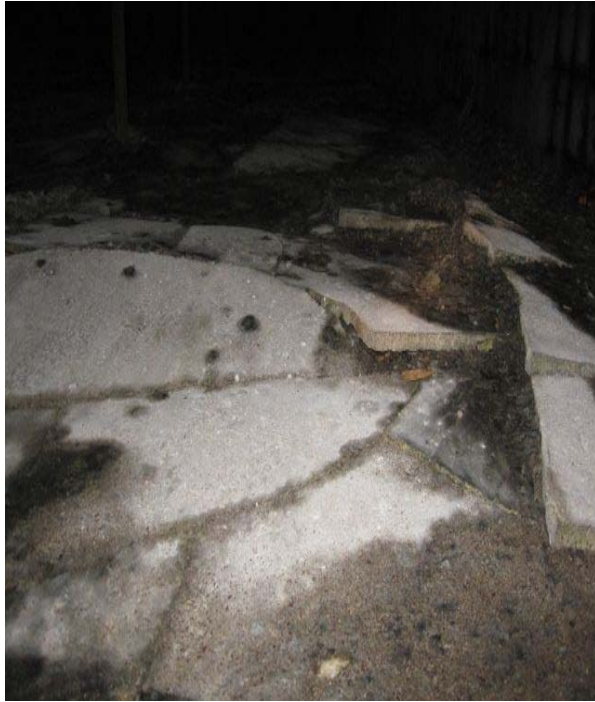
**Fig. 20: Unit 2 – Cracked cement floor**

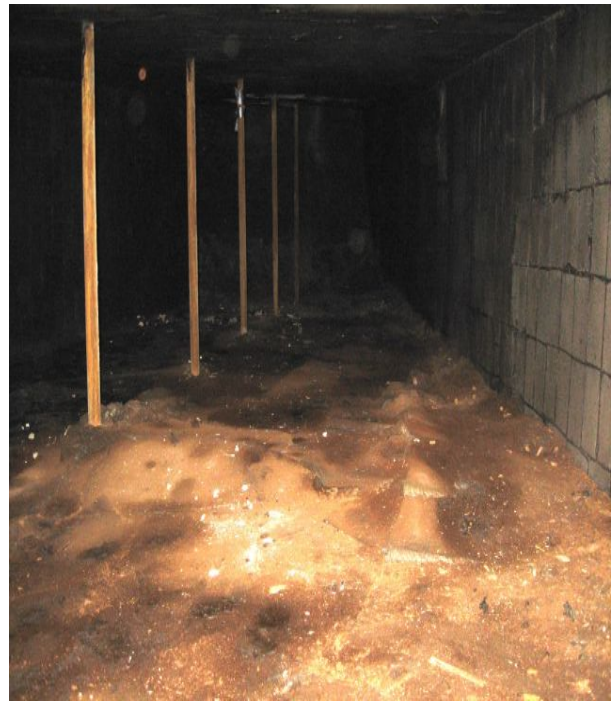
**Fig. 21: Unit 2 – Cracked cement floor**

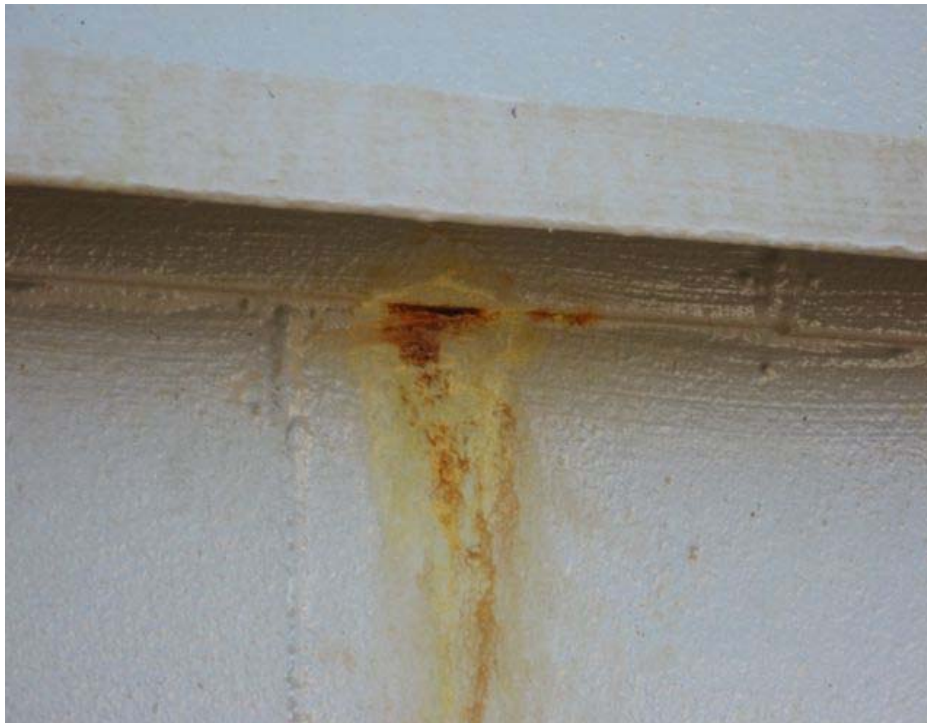
**Fig.22: Unit 2 – External coating break down**

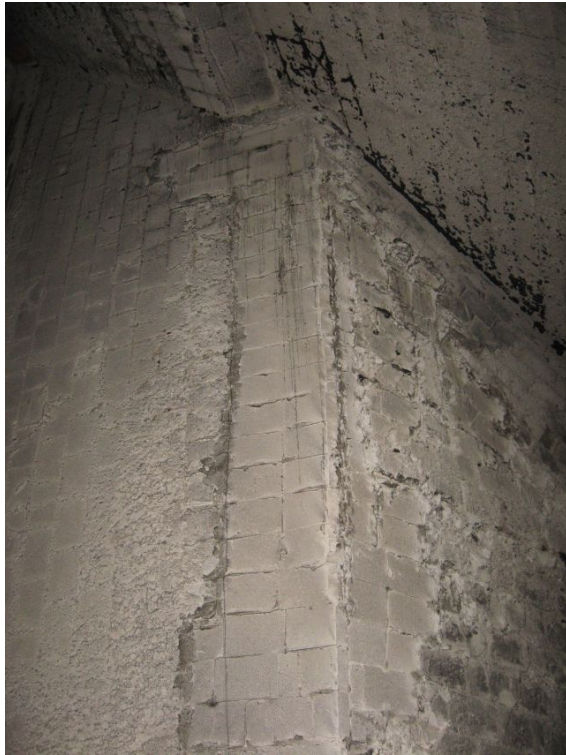
**Fig. 23: Unit 3 – Repairs 2007**

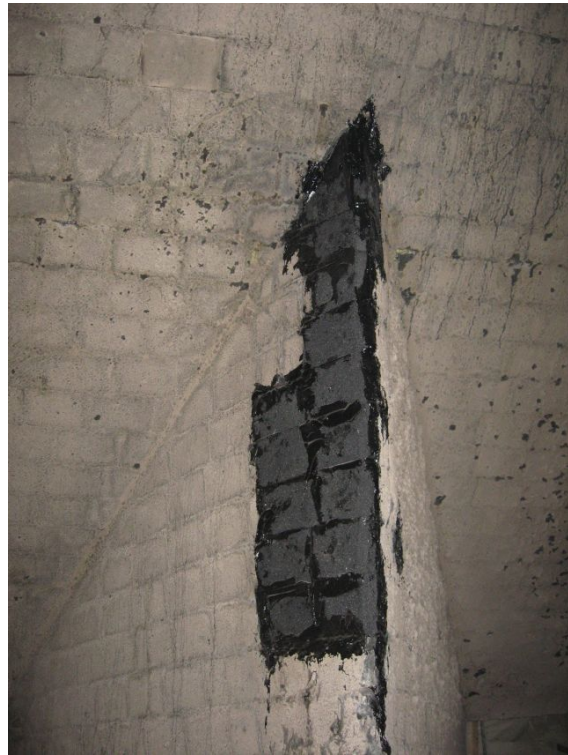
**Fig. 24: Unit 3 – Crotch repairs**
