A REPORT TO  
THE BOARD OF COMMISSIONERS OF PUBLIC UTILITIES

## REFURBISHMENT OF THE FUEL OIL STORAGE FACILITY

Holyrood Thermal Generating Station

July 2011

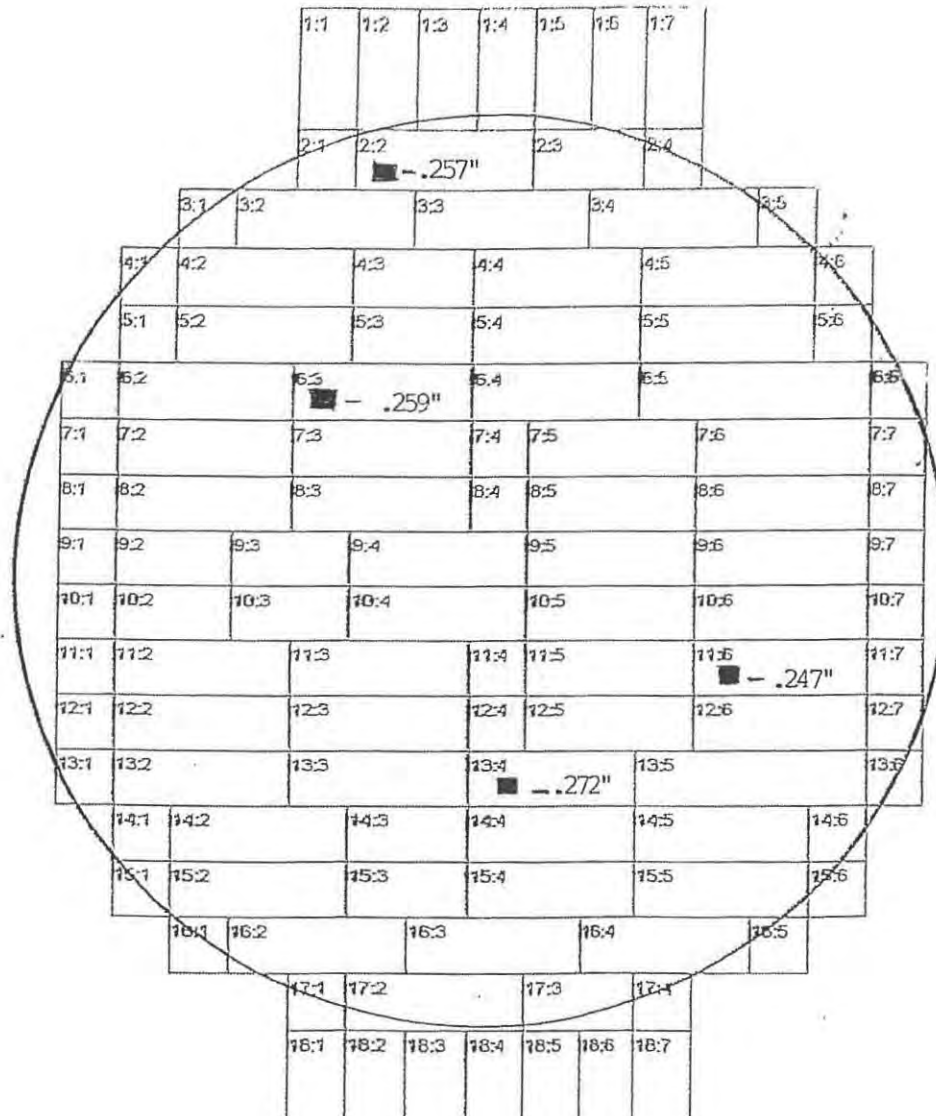
TANK #3 BUNKER "C"

$\blacksquare$  — DENOTES AREA ON THE FLOOR PLATE WHICH WAS UNTRASONIC  
SCANNED IN ORDER TO ESTABLISH A SHORT TERM CORROSION  
RATE.
