A REPORT TO THE BOARD OF COMMISSIONERS OF PUBLIC UTILITIES

UPGRADE UNIT 1 STACK BREECHING

Holyrood Thermal Generating Station

July 2011

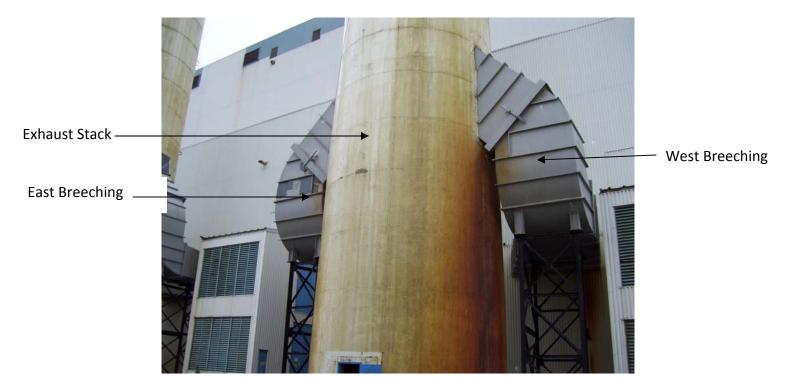
Figure 2: Unit 1 Stack Breeching

The general arrangement of the existing Unit 1 stack breeching is illustrated above in Figure 2. The breeching has a rectangular cross section that is constructed from carbon steel plate and is insulated internally on the sides and top with borosilicate (glass) block. The breeching sections are coated externally with a protective film to inhibit corrosion. In addition, the breeching sections have a silicate concrete floor. A typical cross section of the Unit 1 stack breeching is illustrated in Figure 3.

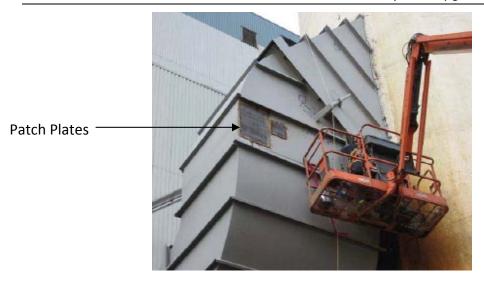
Figure 4 – Unit 1 Breeching Plate Repairs

In addition to the erosion of the borosilicate insulation, cracks in the internal insulating liner and concrete floor have developed. Cracks in the concrete floor and insulation blocks falling away from the walls and ceiling allow flue gas to contact the steel plates underneath the insulation and concrete. The flue gas condenses to form sulfuric acid which causes localized corrosion that necessitates steel plate repairs. The internal insulation liner and steel plates underneath have required repairs on an annual basis that have resulted in high maintenance costs (see Table 1) during scheduled annual outages. Typical steel plate and insulating block repairs are illustrated below in Figures 4 and 5, respectively. Concrete floor cracking is illustrated in Figure 6.

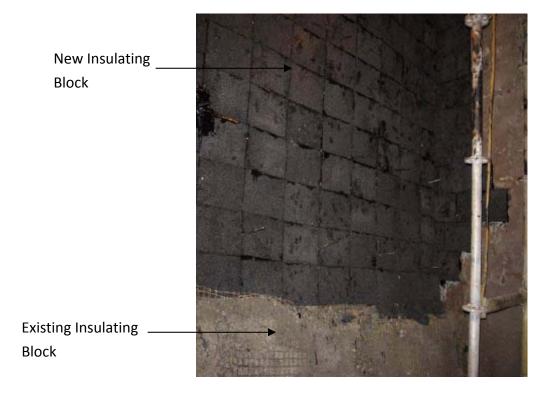
Figure 5 – Unit 1 Insulating Block Replacement

Also, failure of the internal insulation blocks is caused by the breakdown of the adhesive membrane that bond the blocks to the breeching plate. The temperature limit of the membrane is 200 degrees Fahrenheit. This limit is exceeded by the actual flue gas outlet temperature which is approximately 311 degrees Fahrenheit when Unit 1 is operated at full load.
