1 Q. Re: Production Life: Please provide a copy of any reports, memos, studies, etc.
2 during the past 10 years that discussed, identified, etc. future potential retirement
3 of any of the Company's generating facilities. If the reports, memos, studies, etc.
4 are only based on a mW (*sic*) level of generation to be retired without any specific
5 reference to a particular unit, then provide the information associated with the
6 generic retirement of production capacity by year.

ST. LEWIS DIESEL PLANT
CONDITION ASSESSMENT
AND
INVESTIGATION OF REPLACEMENT ALTERNATIVES

Prepared by: **G.W. Lundrigan, P. Eng.**
Engineering Design Department
Transmission & Rural Operations Division
June 17, 2005

Newfoundland and Labrador Hydro - Condition Assessment of Ten Diesel Plants
Condition Assessment Final Report - December 18, 2009

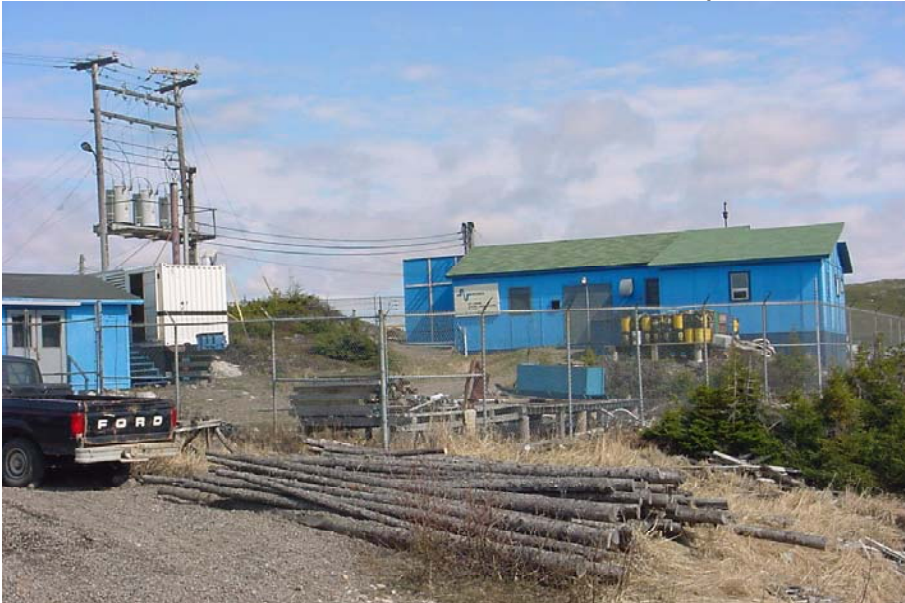
Photo #2---St Lewis Diesel Plant ---Note Extensions a) Office to the right and b) Storage Room to the left and rear.

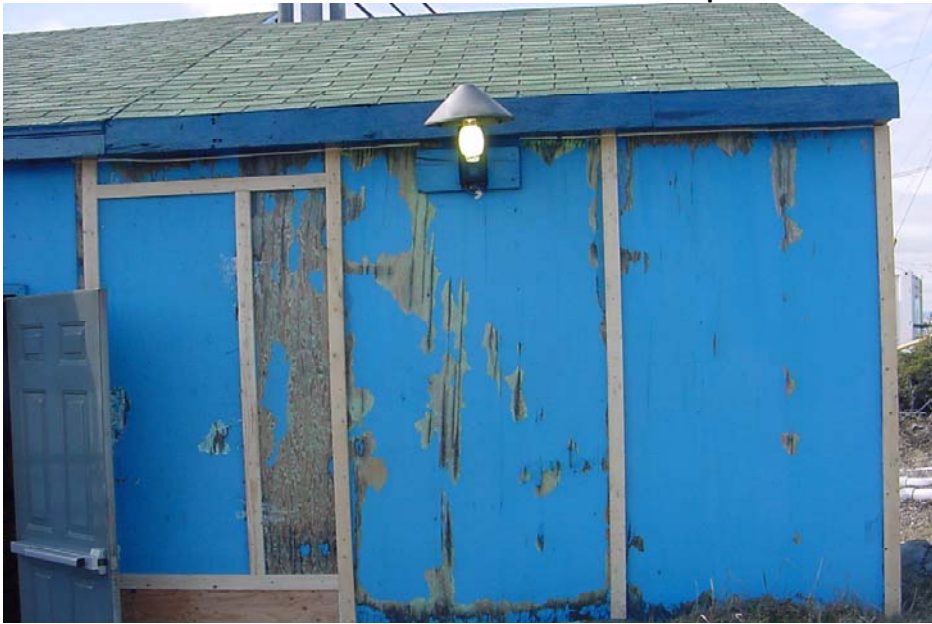
Although there are no major concerns with respect to the structural strength of the building, the plywood cladding is in a deteriorated condition and would need replacement or covering by metal siding. Doors and windows need to be replaced. The roof leaks. The walls and roof are penetrated in a number of areas to accommodate fuel piping, exhausts, ventilation fans and electrical wiring and it is very difficult to seal these areas against snow and rain. Other openings which were used in the past and which have since being abandoned are patched but are also difficult to seal.

Photo #4—St Lewis Plant—Rear View Showing Deterioration of Siding

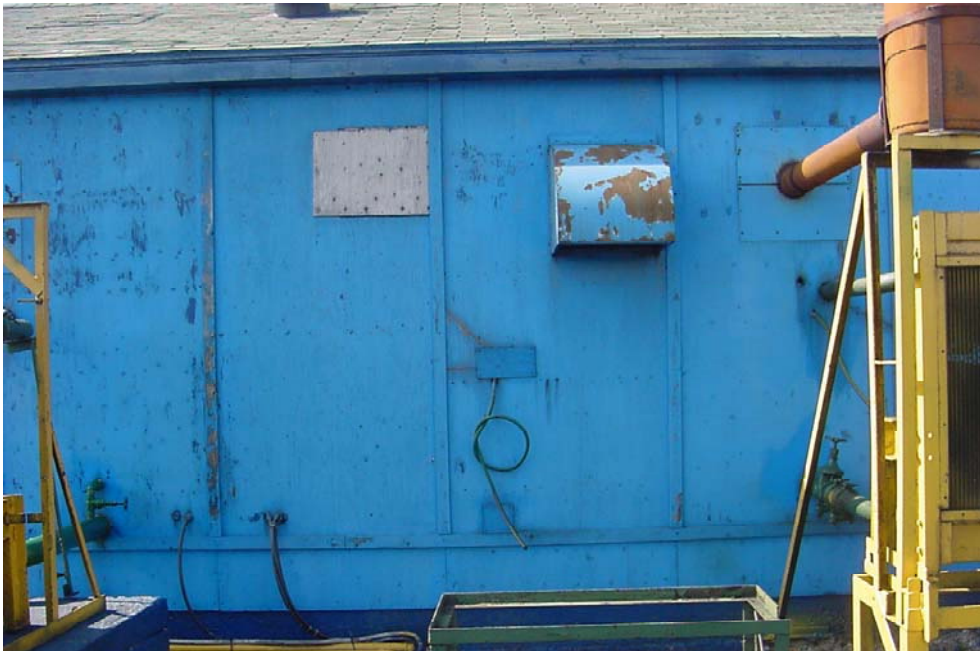
Photo #5—St Lewis Plant—Rear View Showing Wall Penetrations

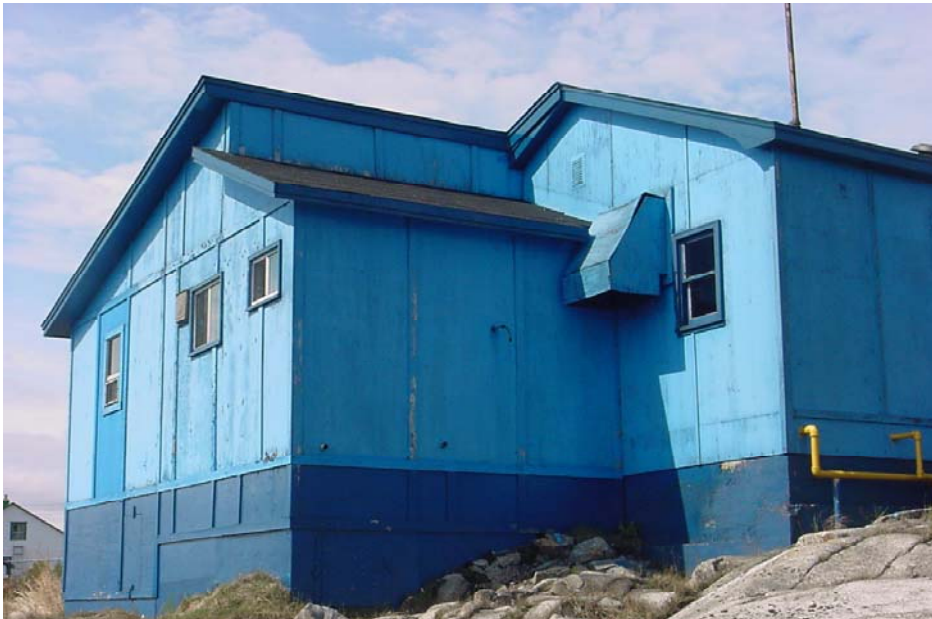
Photo #7—St Lewis Plant—Rear View Showing Office & Kitchen Extensions

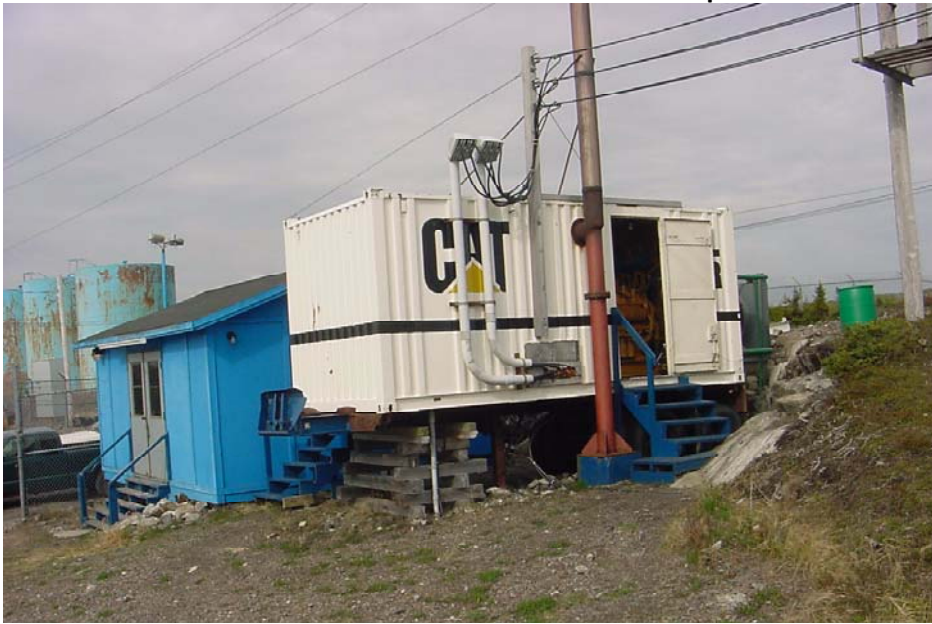
The existing plant has three diesel units installed inside the diesel hall and a mobile diesel unit installed outside the building. This mobile diesel was put in place in 1997 to meet growing power requirements and, due to inadequate space inside the building, was set up outside adjacent to the substation.

Photo #8—St Lewis Plant—Mobile Unit & Line Storage Building

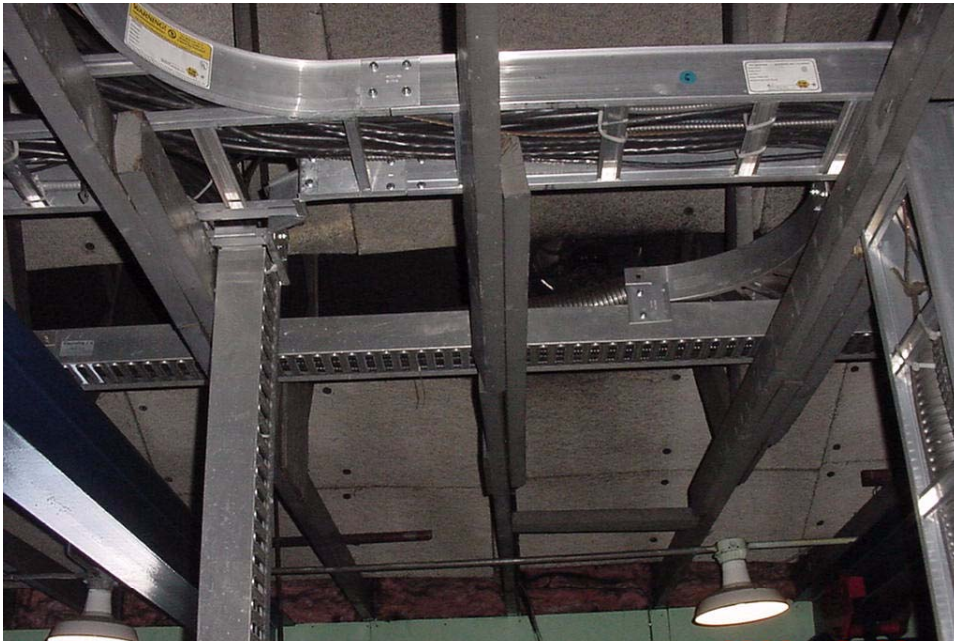
The plant's structural members and siding, have become tinder dry, due to excessive build up of heat in the engine hall, and this combined with the congestion of electrical equipment and inadequately spaced gensets operating at elevated temperatures results in conditions conducive to a catastrophic fire.

Photo #9—St Lewis Plant—Interior View Showing Wooden Trusses

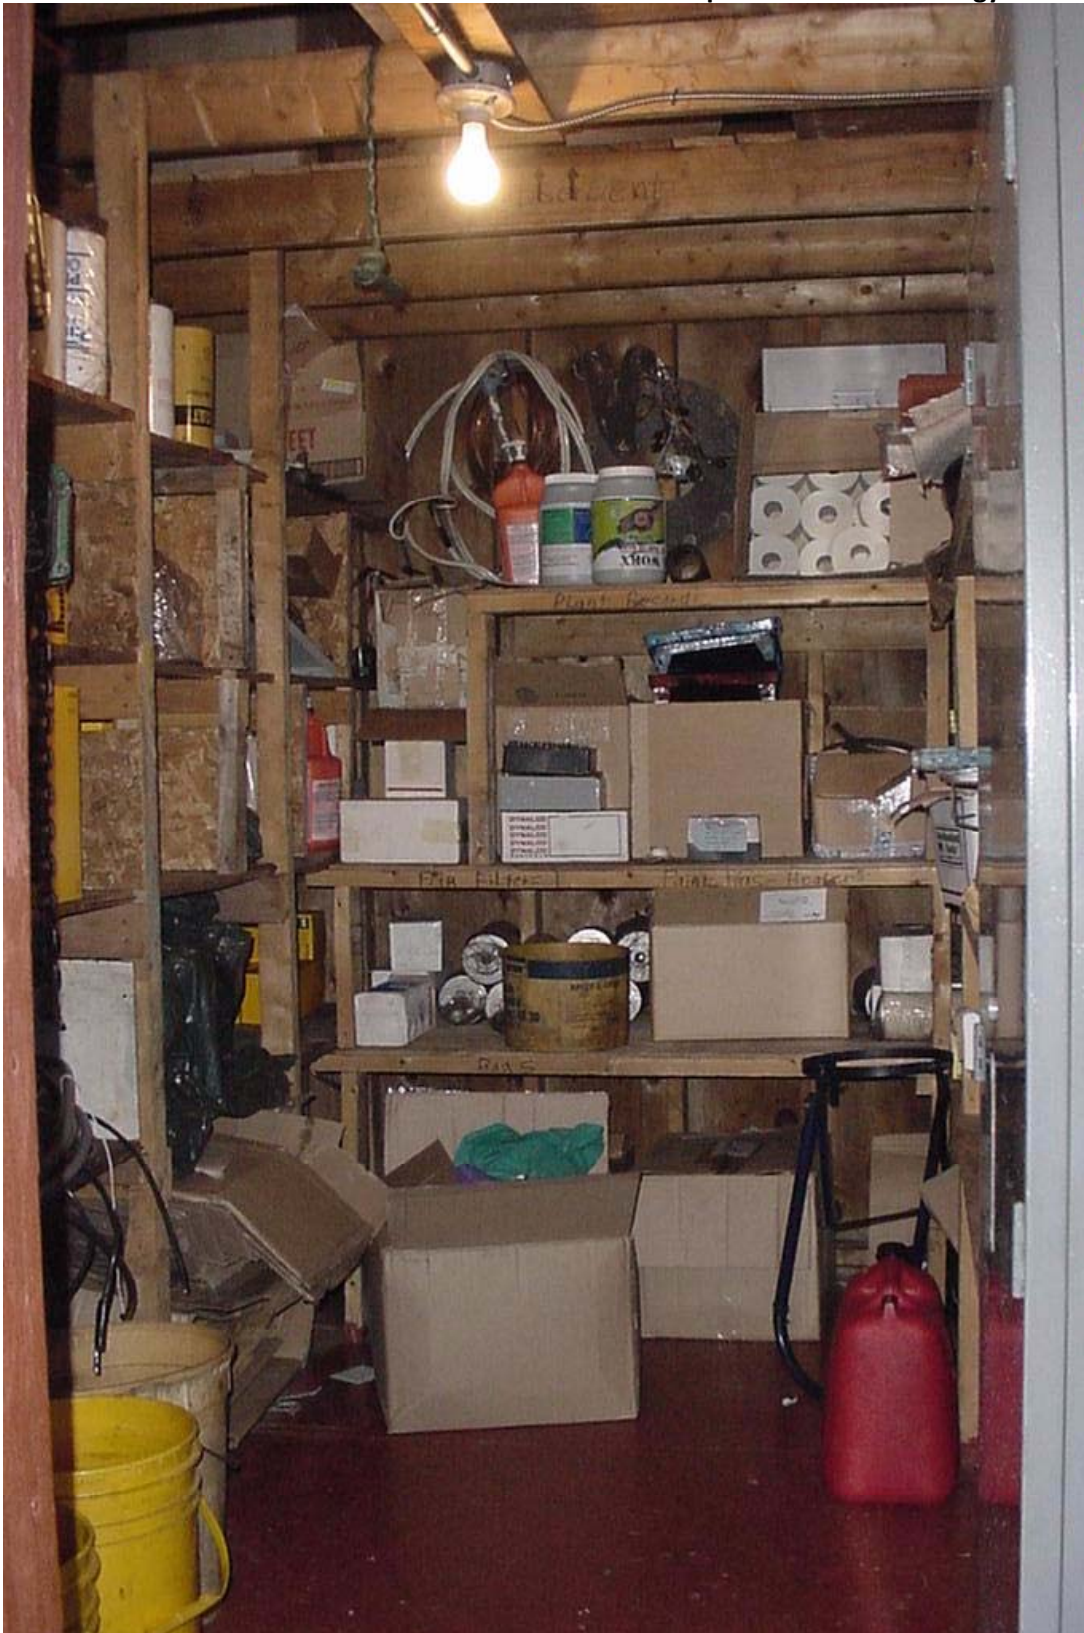
The storage room is too small to adequately store the plant supplies such as engine filters, etc. In addition, rain and snow infiltrates the structure and supplies get wet.

Photo #10—St Lewis Plant—Storage Room

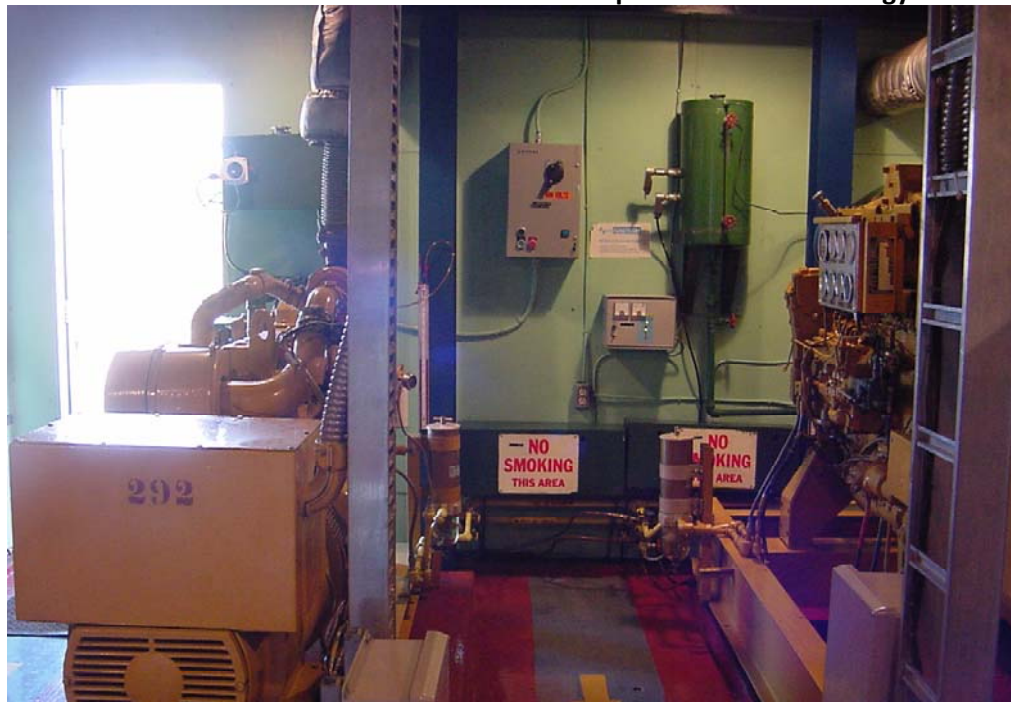
The floor area of the existing diesel hall is approximately 65 m² as compared to the current design criteria of 140 m² for a similar capacity plant. This has resulted in the units having inadequate spacing such that operational and maintenance tasks must be performed in close proximity to operating equipment giving rise to safety

Photo #11—St Lewis Plant—Interior View Showing Space Between Units

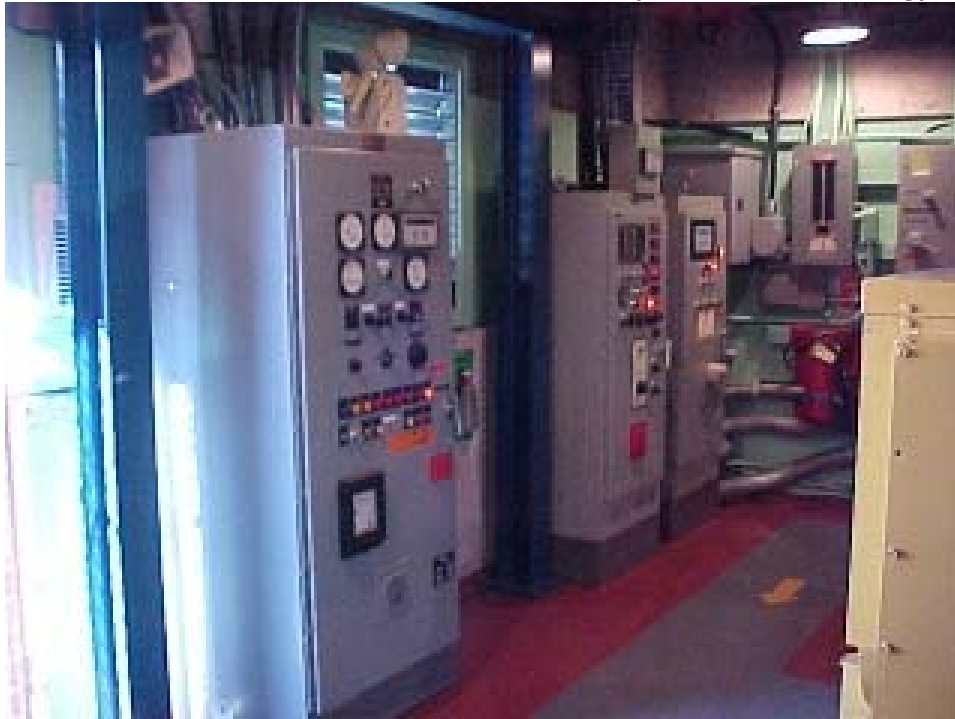
The lack of space results in operational and maintenance tasks being performed in close proximity to operating equipment which exposes workers to unsafe conditions. Noise and ventilation conditions are also substandard.

Photo #15—St Lewis Plant—Interior View Showing Congestion

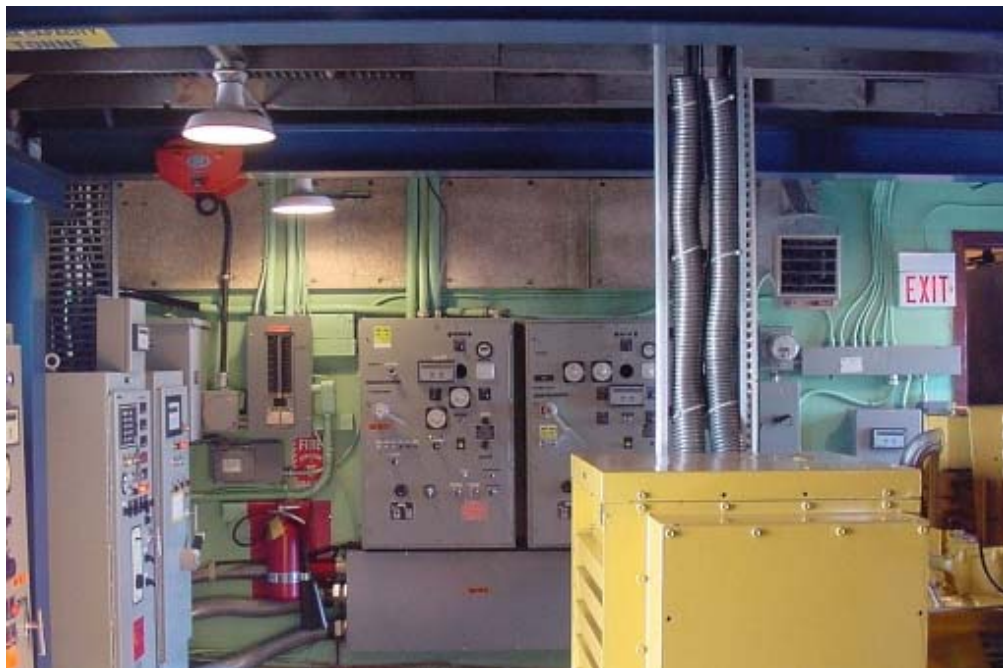
Photo #16—St Lewis Plant—Interior View Showing Congestion
