Project Title: Upgrade Access Road

Location: Cat Arm

Slope Stability Study (TF8310459)
Road to Powerhouse
Cat Arm Hydro Development, White Bay NL
Newfoundland and Labrador Hydro
March 2009

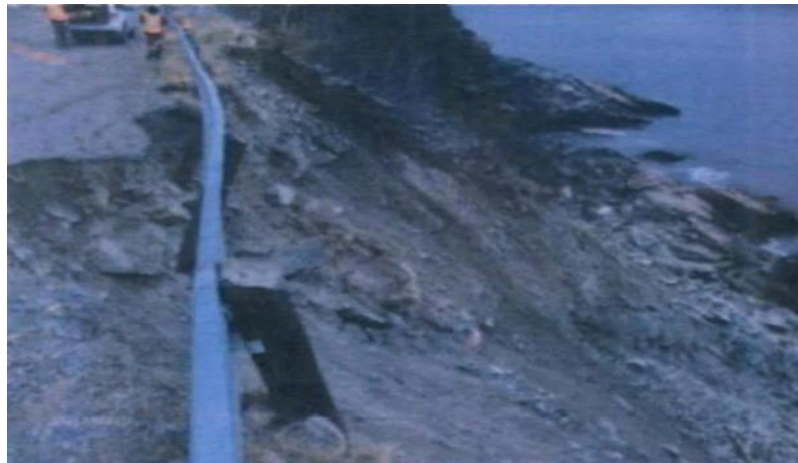
The roadway embankment near the powerhouse has been eroding since it was originally constructed in 1984, particularly following freeze and thaw cycles and runoff from coastal rainstorms. A number of recent rainstorms have progressed the erosion to a point whereby the existing guardrail is undermined and imminent failure of the roadway is a real concern (see Figure 1).

Figure 1: Embankment Erosion at Shoulder of Access Road

The eroded embankment areas require major rehabilitation work to ensure the long term performance and stability of the road. Failure to complete the recommended rehabilitation work will result in continued slope failure and probable road embankment collapse to a point where the road will be impassable or it will be unsafe for Hydro personnel to travel. This would result in loss of access to the powerhouse to address operational or maintenance problems, affecting plant reliability and power supply to Hydro's customers.

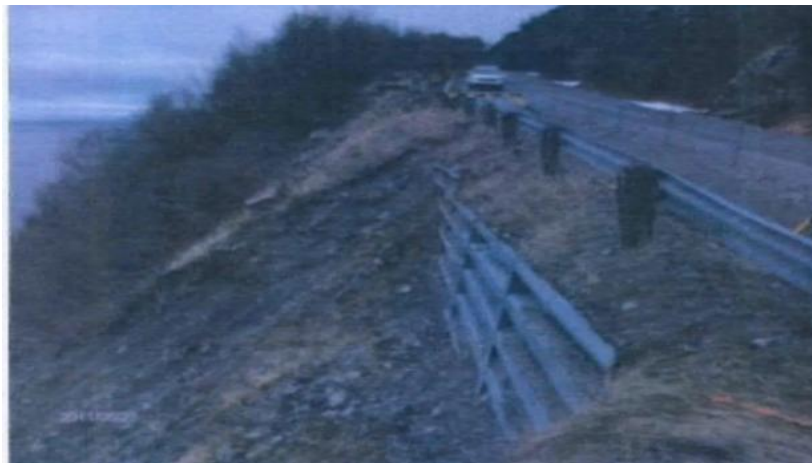
Previous upgrades to the access road consisted of bin-wall installation to reinforce failing roadway embankments. This work was completed in 1993 and was constructed at a cost of approximately \$50,000 (see Figure 2).

Figure 2: Bin-Wall Installation completed in 1993.

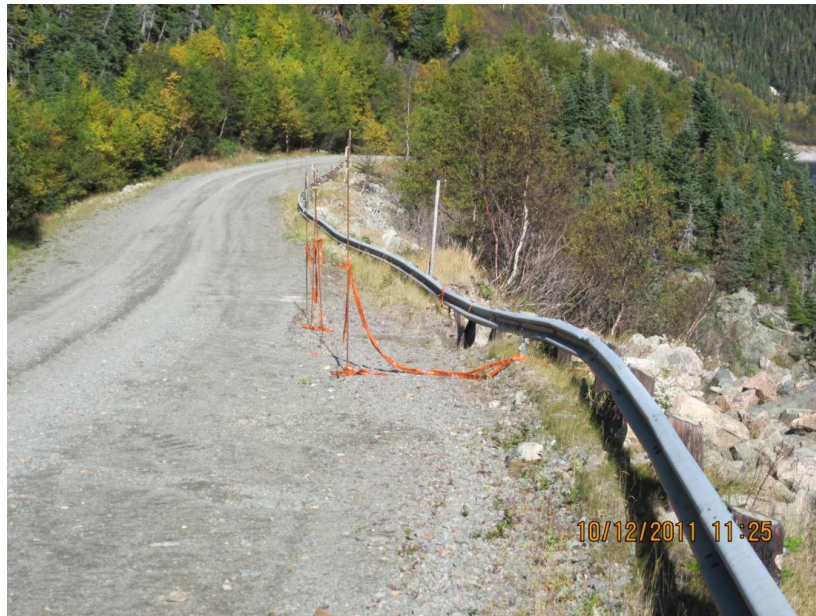
progressed to a point such that the existing guiderail is undermined, leading to concerns over the potential for imminent failure of the roadway. To maintain public safety, barricades have been placed to prevent vehicular traffic from driving too close to the shoulder of the road (See Figure 3).

Figure 3: Barricades Erected in Vicinity of Undermined Guardrail

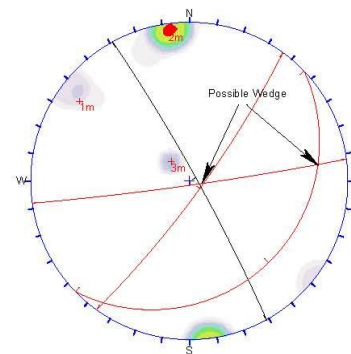
Potential wedges form where two planes intersect as shown in Figure 4.2-B below. Only wedges which could result in movement toward the free face of the slope are considered potential wedges.

Figure 4.2-B – Wedge Plot

Computer modeling has shown two potential wedge failure mechanisms (shown east side of the stereonet). The wedge identified furthest east of the centre of the stereonet poses no immediate concern as the computed factor of safety is greater than 2. The second wedge mechanism, nearest the centre of the stereonet, does pose a concern as its factor of safety has been computed to be less than 1. This wedge mechanism is small (possibly the origins of many of the smaller fallen rock fragments) and most have been removed either during construction or have subsequently fallen. Any of these rock fragments which may fall are anticipated to be small in size (cobble and small boulder size) and quantity and continue to fill

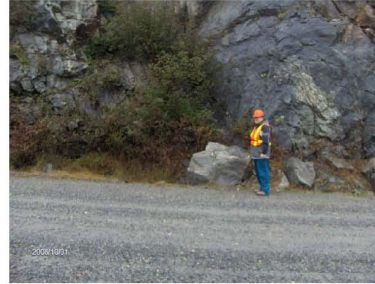
Location	Quantity	Remarks
Post 0 (South end of guide rail)	22 pieces of rock ranging in size from 2 m ³ to 0.25 m ³ .	Area of a fault, rocks most likely originated from a wedge feature formed by the fault and jointing. Fault surface is thin with slickensides and mylonite.
Post 5 to 15	Occasional fallen rock.	Rock face is set back from the road. Half barrels from the original blasting were observed throughout the area.
Post 17	-	Rock debris from possible previous cleanup dumped on embankment shoulder of road.
Post 20 to 21	Occasional fallen rock.	Large boulders observed high up on the slope. Small pieces of debris observed in the ditch and along the shoulder of the road that may have been graded off the road. Ditch is narrow in this area.
Post 30	Occasional fallen rock.	Several boulders in the ditch that appear to have originated from ~15 m height on the slope.
Post 41 to 54	Occasional fallen rock.	Wide ditch in good condition, with occasional small boulders originating from the lower slope.

Photo 2 – Fallen rock debris at Post 0, Guide Rail Section 1

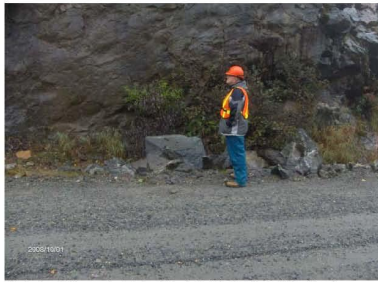
Photo 3 – Fallen rock debris at Post 20-21, Guide Rail Section 1

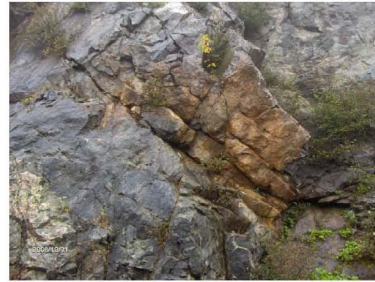
Photo 4 – Area where rock has recently fallen from the rock cut near Post 1, Guide Rail Section 1, as shown by the brown discolouration

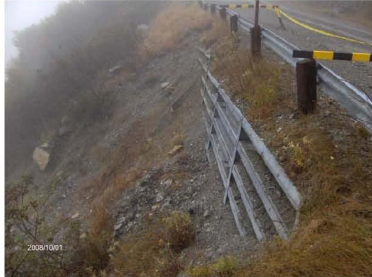
Location	Existing Infrastructure	Failure Mechanism	Recommendations to Increase Safety in the Area
Post 35 to 39	Bin wall supporting roadway. Bin wall is partially supported on bedrock. Traffic barrier up to keep traffic away from guide rail.	Erosion at toe of slope has caused over steep conditions.	Keep barrier up and reassess in May 2009 by qualified geotechnical personnel.
Post 70 to 73	Bin wall supporting roadway. Bin wall is partially supported on bedrock. Traffic barrier up to keep traffic away from guide rail.	Erosion at toe of slope has caused over steep conditions	Move guide rail in three metres. Reassess in May 2009 by qualified geotechnical personnel.

Photo 5 – Bin wall between Post 35-39, Guide Rail Section 1

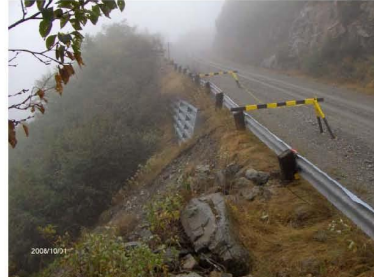
Photo 6 – Bin wall between Post 70-73, Guide Rail Section 1

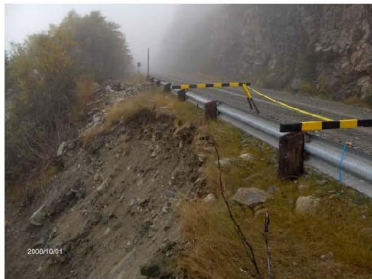
Location	Existing Infrastructure	Failure Mechanism	Recommendations to Increase Safety in the Area
Post 6 to 12	Guide rail only. No bin wall or other support mechanism.	Erosion at toe of slope has caused over steep conditions. Erosion has undermined one of the posts. Bedrock is visible on the slope at three metres below the crest of the slope.	Move guide rail in three metres. Reassess in May 2009 by qualified geotechnical personnel.
Post 16 to 21	Guide rail only. No bin wall or other support mechanism.	Erosion at toe of slope has caused over steep conditions. Erosion has reached one of the posts. Bedrock is visible on the slope at three metres below the crest of the slope.	Move guide rail in three metres. Reassess in May 2009 by qualified geotechnical personnel.
Post 43 to 45	Guide rail only. No bin wall or other support mechanism. Guide rail was previously moved in about 1.5 m.	Erosion at toe of slope has caused over steep conditions.	Move guide rail in three metres. Reassess in May 2009 by qualified geotechnical personnel.

Photo 7 – Embankment erosion between Post 6-12, Guide Rail Section 2

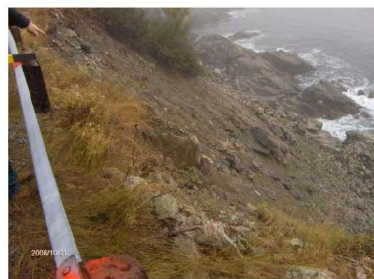
Photo 8 – Overview of embankment between Post 16-21, Guide Rail Section 2

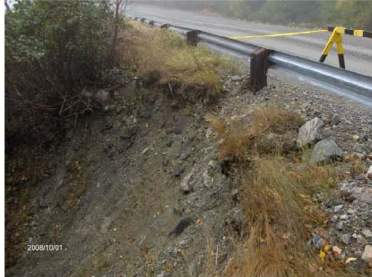
Photo 9 – Embankment erosion between Post 43-45, Guide Rail Section 2

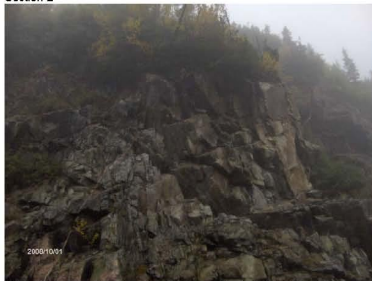
Location	Quantity	Remarks
Post 16 to 20	Occasional fallen rock.	Slope is highly fractured with some minor debris in the ditch. Bedrock appears to be undercut.
Post 20 to 45	-	Location of a small valley. Possible location for disposal of debris from cleanup operations.
Post 45 (North end of guide rail)	-	Post 45 is the north end of guide rail.

Photo 11 – Overview of rock cut between Post 16-20, Guide Rail Section 2

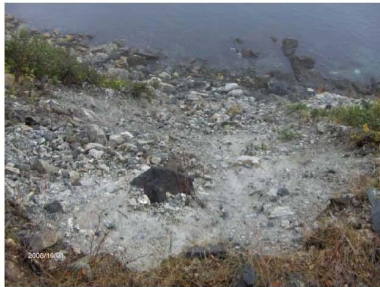
Photo 15 – Erosion gully in soil embankment, north of Guide Rail Section 3

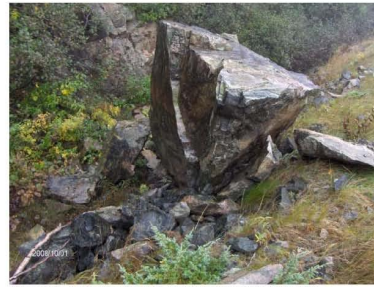
Photo 16 – Fallen rock debris, north of Guide Rail Section 3

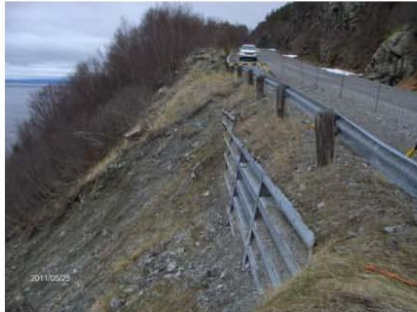
Location	Existing Conditions	Failure Mechanism	Recommendations to Increase Safety in the Area
Post 35 to 39 Section 1 Area 1	<p>Bin wall supporting roadway. Bin wall appears to be partially supported on bedrock. Upper structural members appear to be slightly bent outward on the south two sections. Observation of the beach from the roadway indicates that the shoreline appears to be mostly bedrock.</p> <p>Visually aligning the nearby bedrock exposures suggests that about ½ the width of the road in this area should be supported by bedrock.</p> <p>A traffic barrier is up to keep traffic away from guide rail.</p>	<p>Erosion at toe of slope has caused over steep conditions. The length of erosion has increased about 4 m to the south and working its way around the bin wall reaching the guiderail.</p>	<p>Add three sections of bin wall to the south end of existing wall. Repair existing bin wall. Clean ditch adjacent to hillside of fallen rocks. Move the guide rail in toward the hill four metres and continue to monitor annually or more frequently if conditions change.</p> <p>Additional geotechnical investigation is required to assist with design and construction of additional bin walls.</p>

Photo 1 – Section 1, Area 1 – Bin wall showing some erosion at the south end

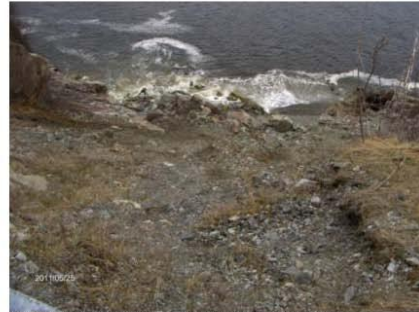
Photo 2 – Section 1, Area 1 – Erosion of the embankment

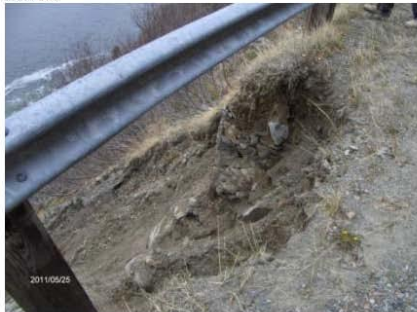
Location	Existing Conditions	Failure Mechanism	Recommendations to Increase Safety in the Area
Post 70 to 77 Section 1 Area 2	<p>Bin wall partially supporting roadway. In the 2008 report the bin wall appeared to be partially supported on bedrock. Subsequent erosion now shows what appeared to be bedrock was a large flat boulder. Bedrock is exposed further down the slope about 30 m below the bin wall.</p> <p>There are three gabions installed on the north end of the bin wall, which are showing loss of material at their bases. Erosion has encroached onto the roadway to about one metre inside the guiderail over a length of five metres. Two support posts are completely undermined.</p> <p>Curved tree trunks on adjacent slopes show that downward soil creep is very active in this area.</p> <p>A traffic barrier is up to keep traffic away from guide rail.</p>	<p>Severe erosion at toe of slope has caused over steep conditions. Water from roadway flows down over slope in this area causing erosion.</p>	<p>Add five to six sections of bin wall to the north end of existing wall. Clean ditch adjacent to hillside of fallen rocks. Move the guide rail in toward the hill four metres and continue to monitor annually or more frequently if conditions change.</p> <p>Additional geotechnical investigation is required to assist with design and construction of additional bin walls.</p>

Photo 3 – Section 1, Area 2 – Erosion progressing into the driving surface of the road. Existing gabions are starting to be undermined.

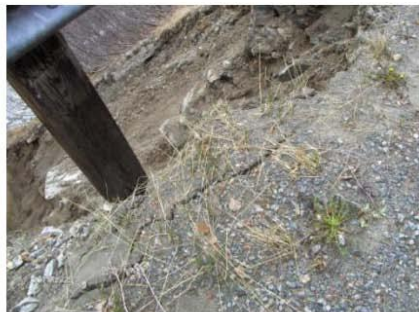
Photo 4 – Section 1, Area 2 – Tension cracks at edge of road and guiderail post suspended

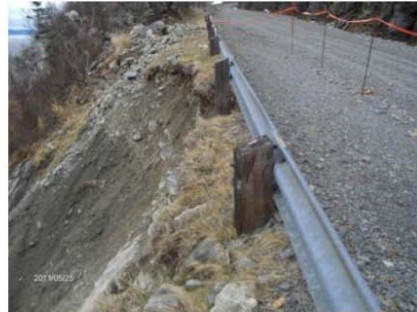
Photo 6 – Section 2, Area 1 – Continuing Erosion has Progressed to Undermining a Guiderail Post

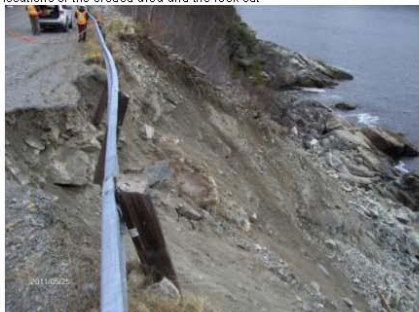
Photo 7 – Section 2, Area 2 – Erosion reaching driving surface and undermined four guiderail posts. Tension crack visible at crest of road

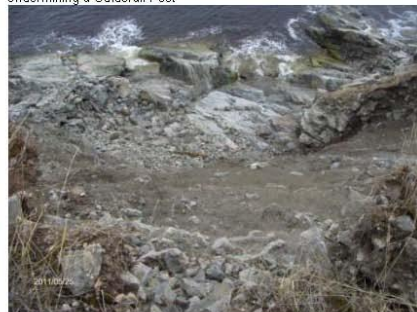
Photo 8 – Section 2, Area 2 – Beach conditions and rapidly eroding slope comprising a high proportion of sand and gravel

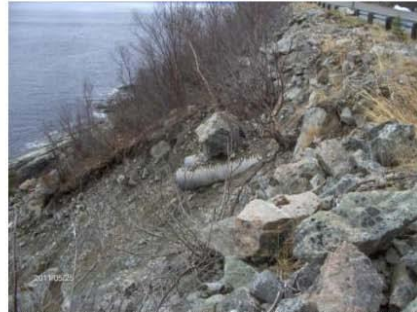
Photo 10 – Section 2, Area 3 – Eroding embankment and tilted culverts

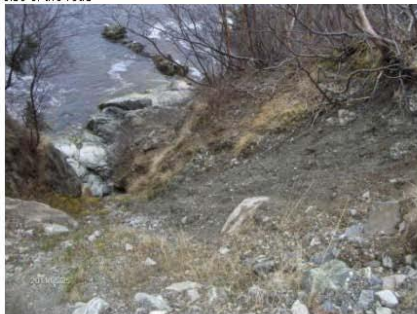
Photo 11 – Section 2, Area 4 – Moderately eroding slope
