**Review of the Newfoundland and Labrador Hydro  
March 4, 2015 Voltage Collapse**

**Newfoundland and Labrador  
Board of Commissioners of Public Utilities**

**The Liberty Consulting Group**

**October 22, 2015**

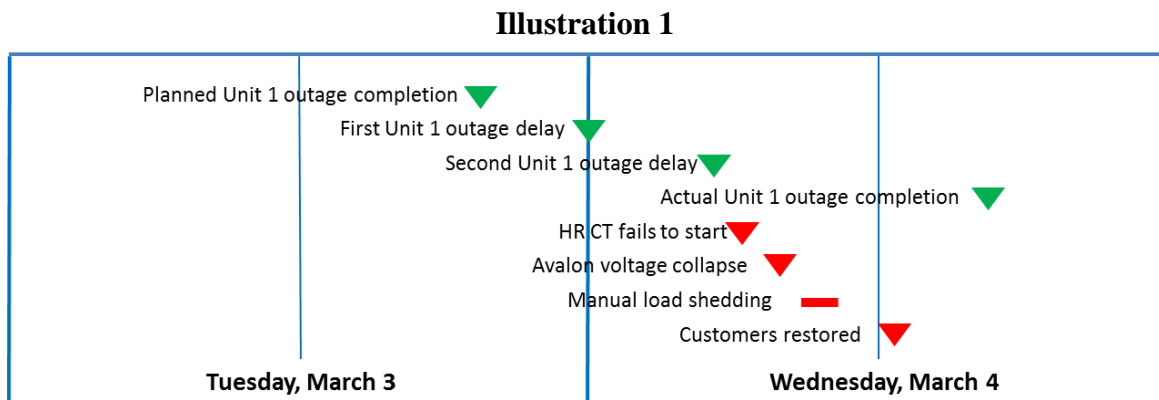
Illustration 1 summarizes the timeline of the March 4, 2015, events.

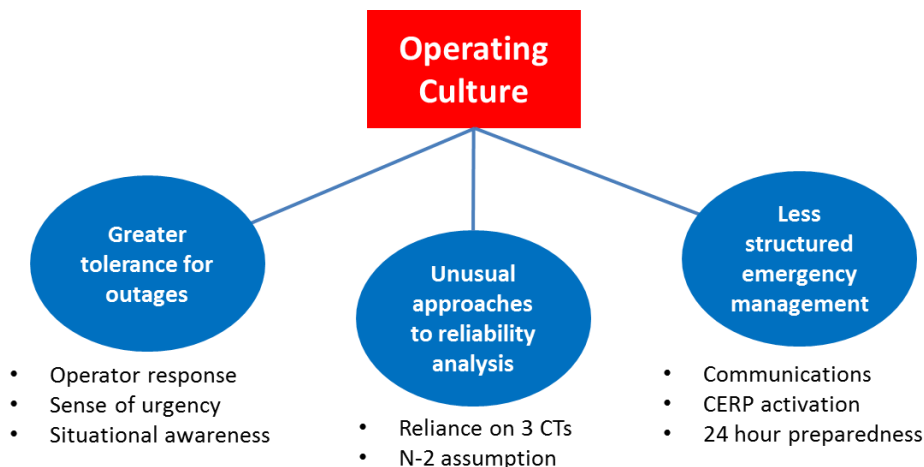
**Illustration 2**

A number of factors contributed to or exacerbated the events of March 4, 2015. The following illustration summarizes their relationship to Hydro's operating culture, which Liberty views as the root cause of the March 4<sup>th</sup> events.
