# **DESIGN STUDY AND FAILURE INVESTIGATION FOR AUTO TRANSFORMER**

**NALCOR**

**SERIAL # 289147**

**CANADIAN GENERAL ELECTRIC**

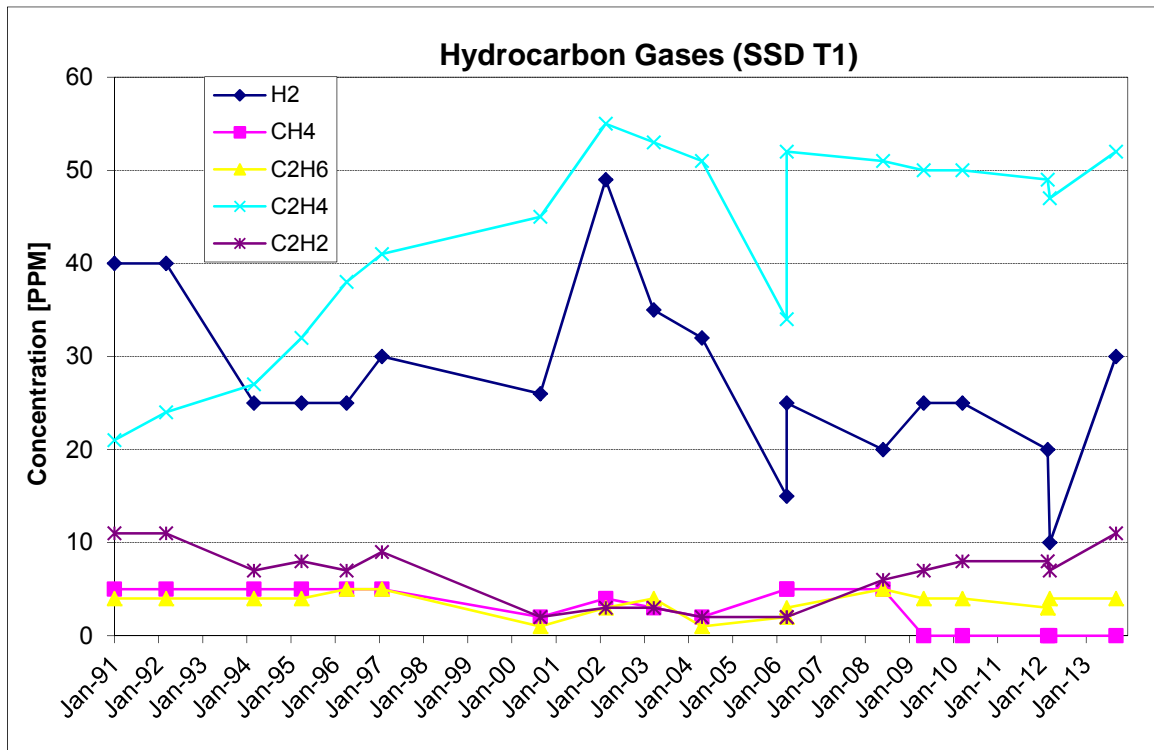
**Figure 2 - Hydrocarbon Gas Concentrations**

- The concentration of Hydrogen (H<sub>2</sub>) has been well below IEEE C57.104-2008 guide condition level 1 since 1991, the highest level was 49 ppm.

- The concentration of Methane (CH<sub>4</sub>) and Ethane (C<sub>2</sub>H<sub>6</sub>) have been steadily low for the period of the data provided. The Ethylene (C<sub>2</sub>H<sub>4</sub>) level is slightly above condition level one of the IEEE C57.104-2008 guide since 1991.

- The concentration of Acetylene (C<sub>2</sub>H<sub>2</sub>) has been above IEEE C57.104-2008 guide condition level 2 since 1991. The level went up and down since then but was almost stable around the 10ppm. This could be oil leaking from LTC diverter compartment.

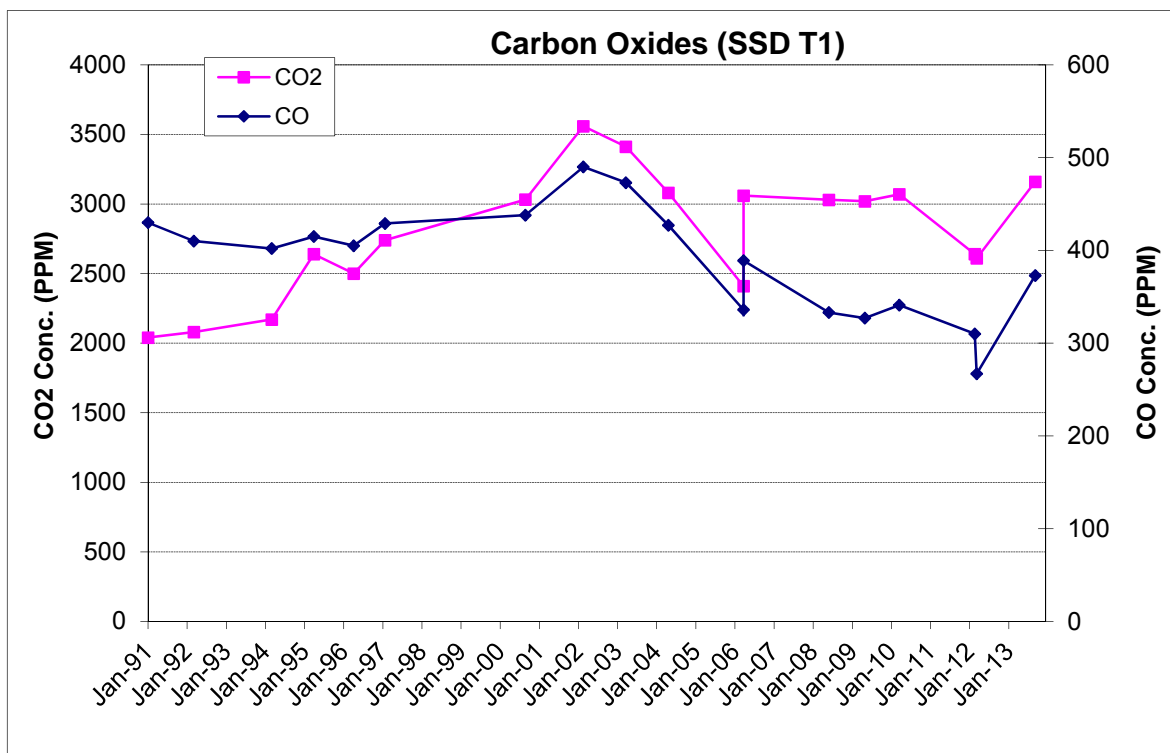
**Figure 3 - Carbon Oxides Gas Concentrations**

- The carbon dioxide level has been below the IEEE C57.104-2008 guide condition level 2 for the time period provided. The carbon monoxide level is slightly above the IEEE C57.104-2008 guide condition level 1 since 1991. However the ratio of CO<sub>2</sub>/CO is between 4 and 9. The

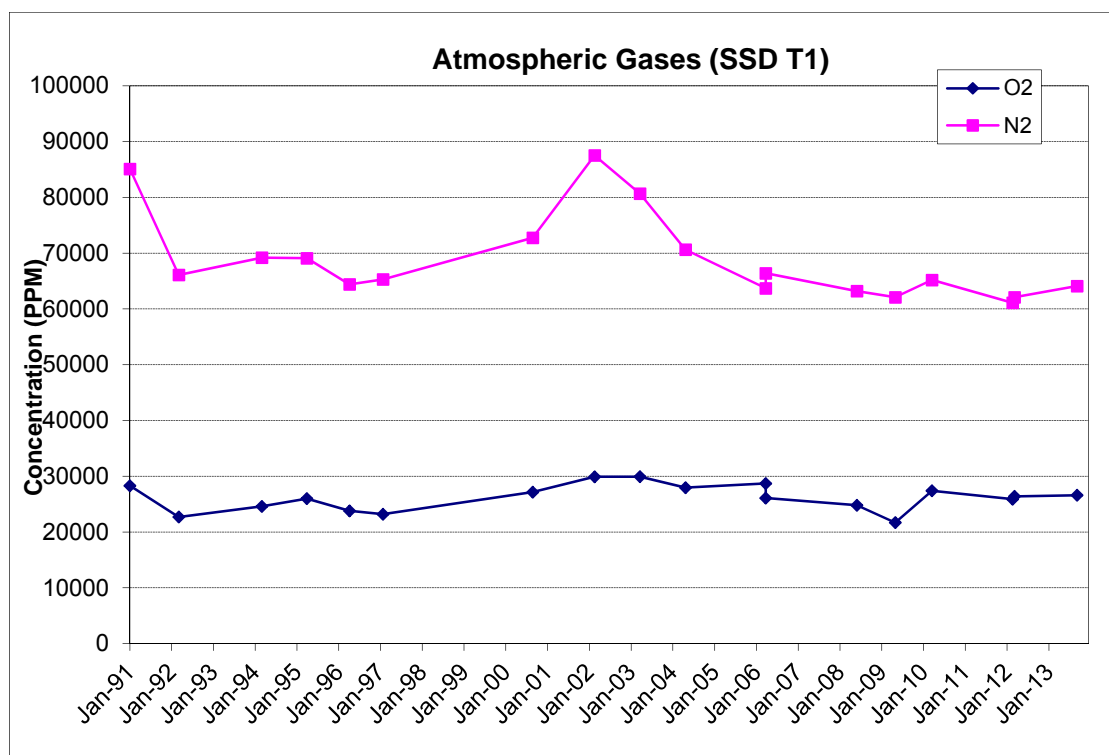
**Figure 4 – Atmospheric Gases Concentrations**

- The presence of large concentrations of oxygen in the oil can promote the formation of acids in the oil and cellulose and accelerate the aging rate of the cellulose insulation. It is recommended that the concentration of oxygen in the transformer be less than 2000 ppm (Refer to CIGRE report 323 – Aging of Cellulose in Mineral-Oil Insulated Transformers). The transformer maintenance record (09/21/2007) provided by the customer does not mention if the oil had ever been vacuum processed since 1991. The oil samples from this transformer have consistently shown very high oxygen concentrations (>20,000 ppm). The source of this high oxygen is the free-breathing oil conservator. To reduce the oxygen in the transformer oil and eliminate the uncertainty concerning the gas generation.

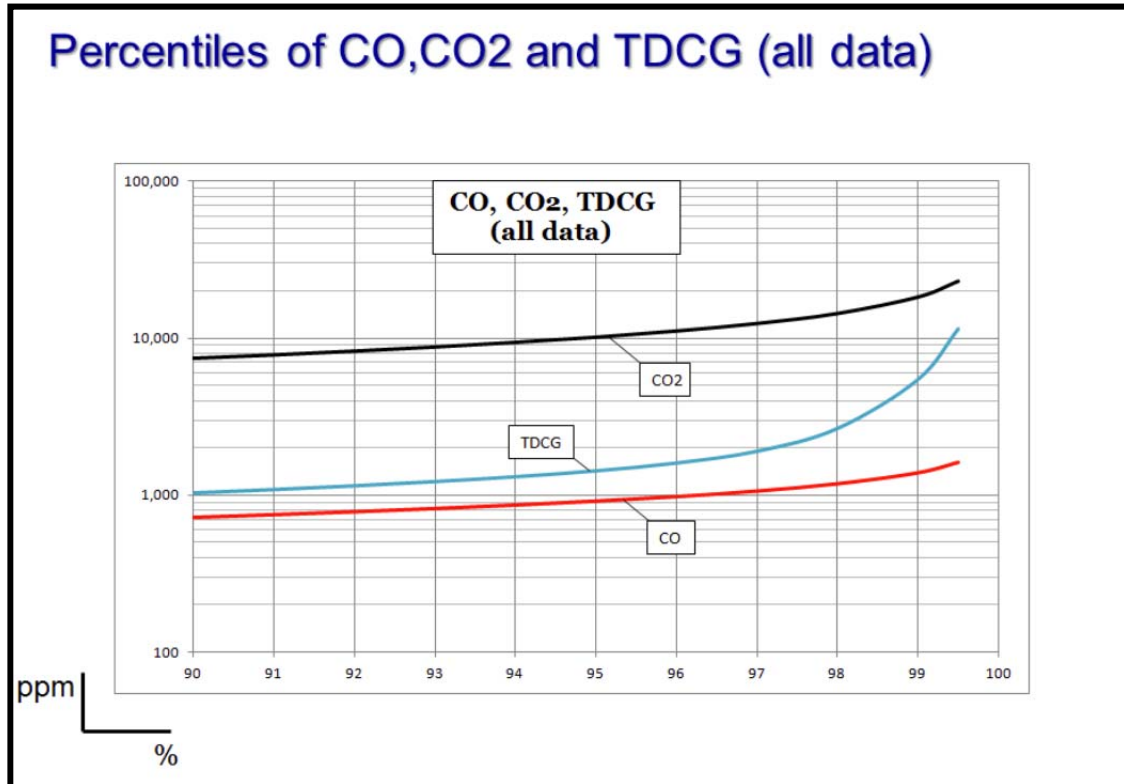
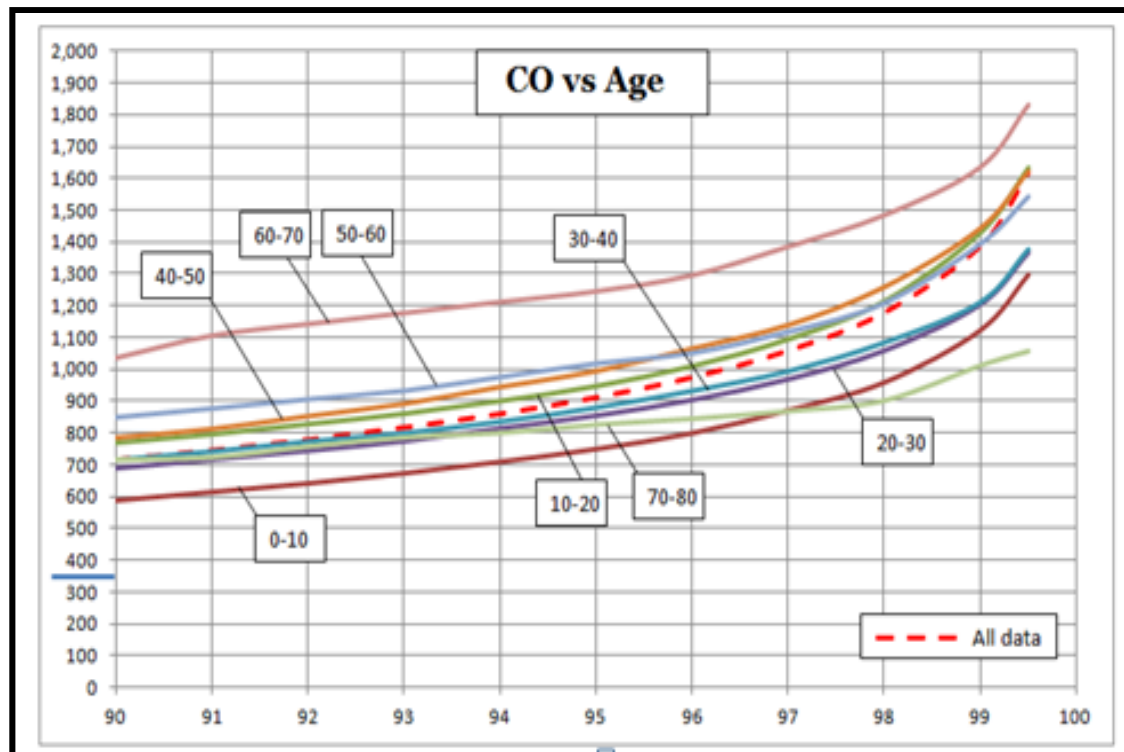
- Shown below in **Figure 5** is a distribution plot of carbon oxide gas levels taken from a survey by the IEEE Transformer Committee using > 520,000 data records of units in service. This very large quantity of data is being used to revise the gas level limits in C57.104 (the famous Table 1 with condition 1 – 4 levels) – note that the levels will be increased. As can be seen, the 90<sup>th</sup> percentile levels are 700 ppm and 7500 for CO and CO<sub>2</sub> respectively. **Figure 6** shows the CO distribution by age categories and for 30 – 40 years category, the 90<sup>th</sup> percentile is about 700 ppm. The history gassing on this transformer was around 500 ppm and 3600 ppm for CO and CO<sub>2</sub> respectively. Thus these levels are well below the 90<sup>th</sup> percentile of the IEEE data for the age of this unit.

**Figure 5** – IEEE Transformer Committee Carbon Oxide Survey Results

**Figure 6** - IEEE Transformer Committee Carbon Oxide Survey Results (CO vs age)

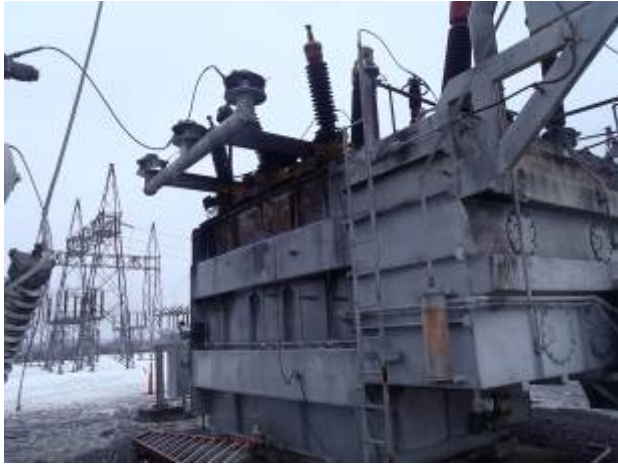
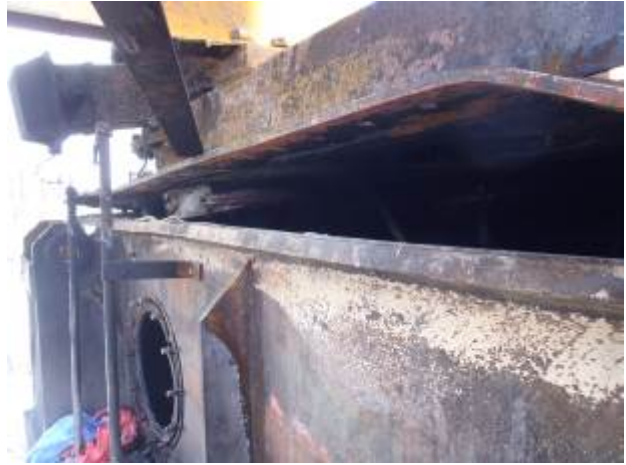
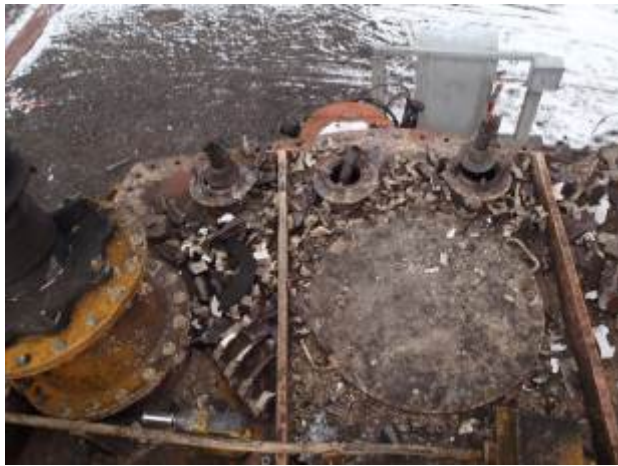
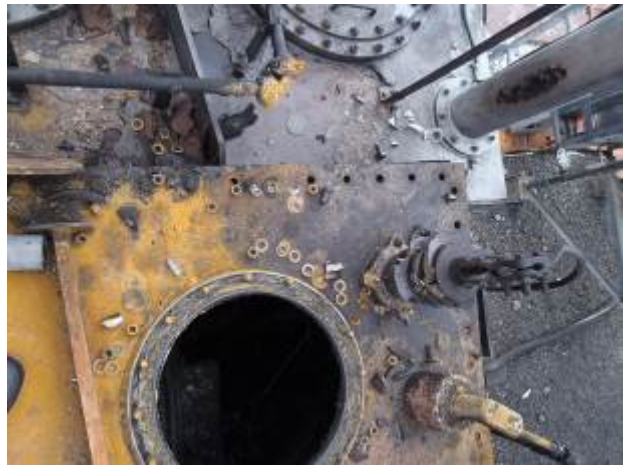
**Photo 1** – Cover Open & Broken Bolts

**Photo 2** – Cover Open & Broken Bolts

**Photo 3** – Cover Open & Broken Bolts

**Photo 4** – Cover Open & Broken Bolts

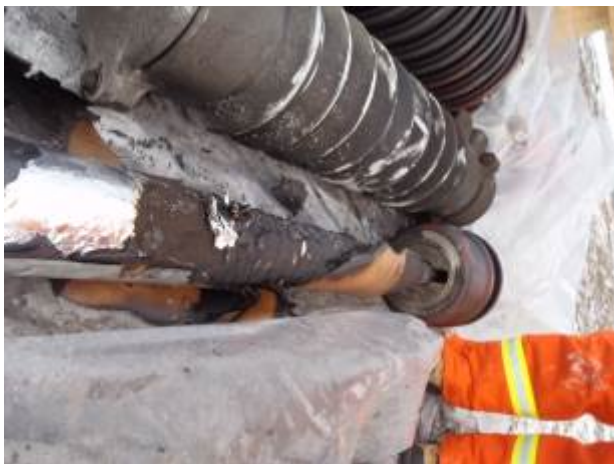
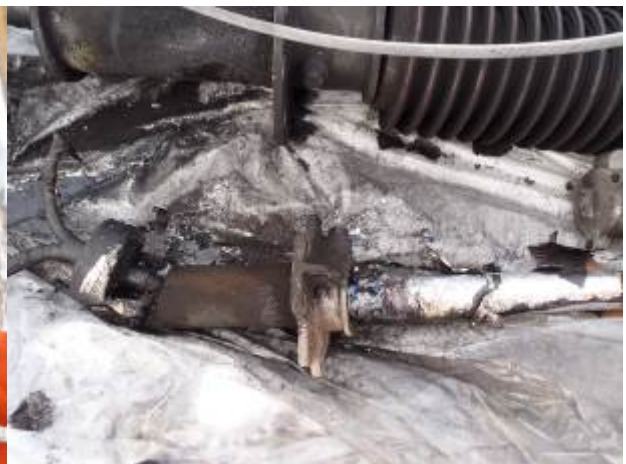
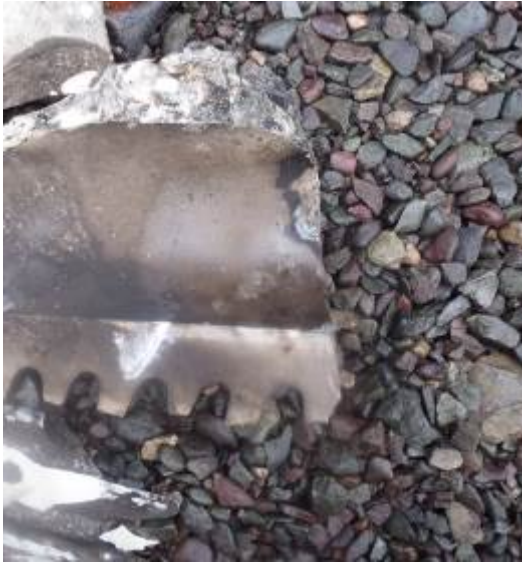
**Photo 5** – LV2 Bushing

**Photo 6** – LV2 Bushing

**Photo 7 – LV2 Bushing Porcelain**

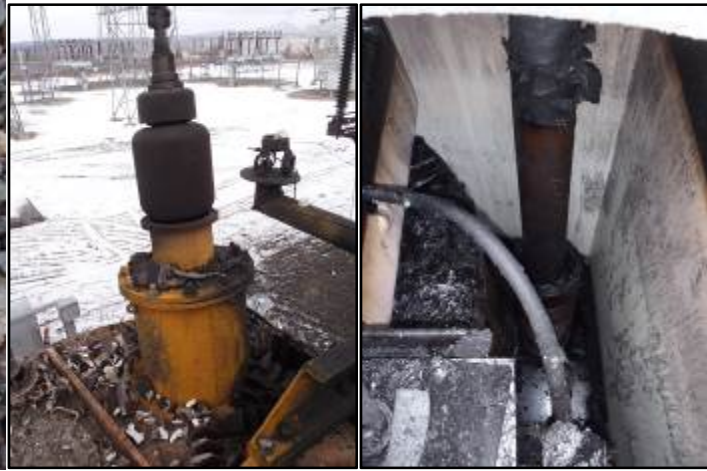
**Photo 8 – HV1 Bushing Porcelain**

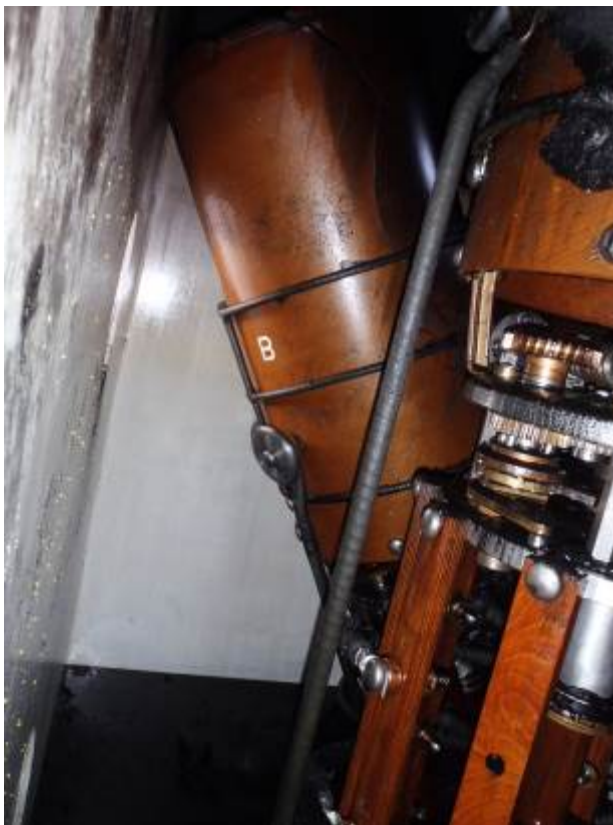
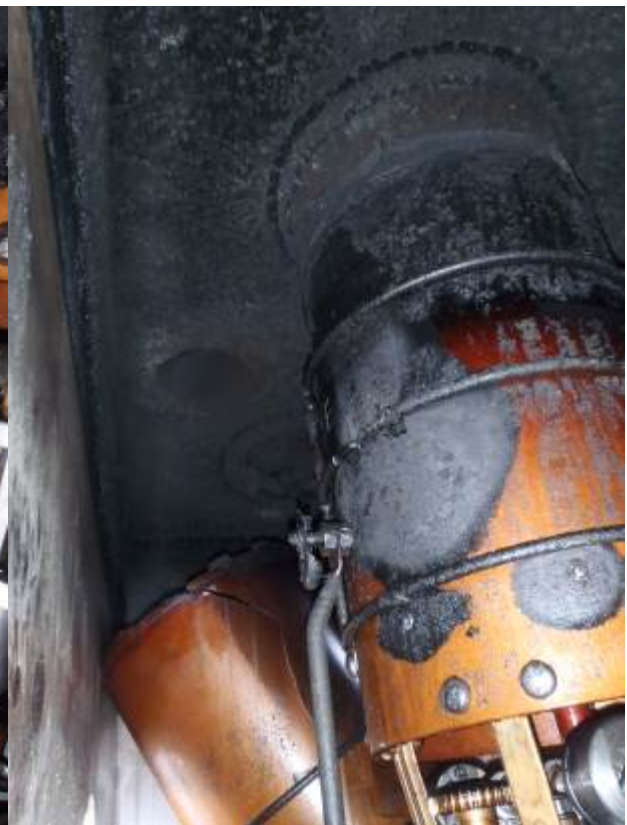
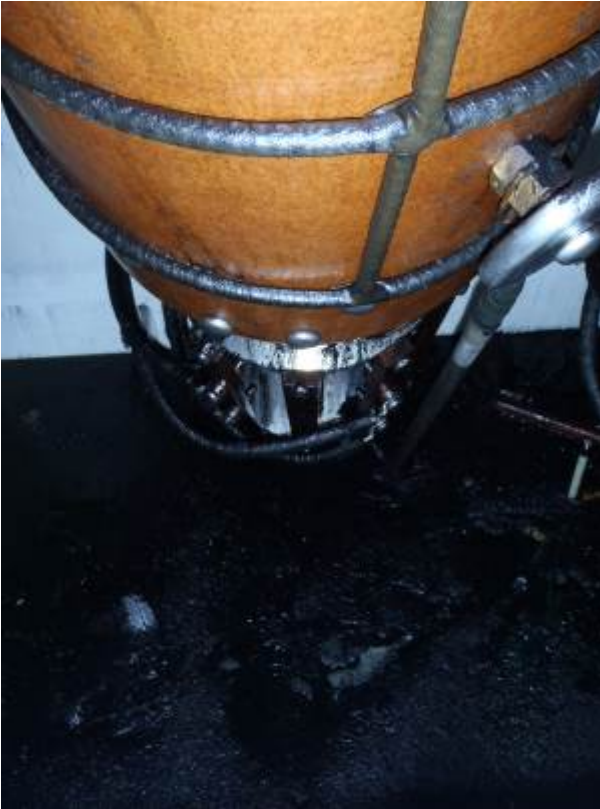
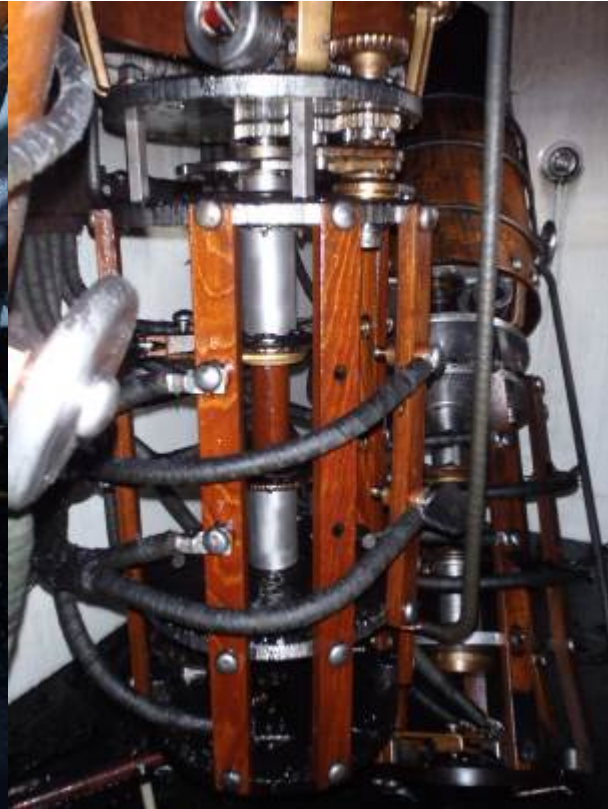
**Photo 9 – LTC Compartment (Phases 2 & 3)**

**Photo 10 – LTC Compartment (Phases 2 & 3)**

**Photo 11** – LTC Compartment (Phase 3)

**Photo 12** – LTC Compartment (Phases 2 & 1)

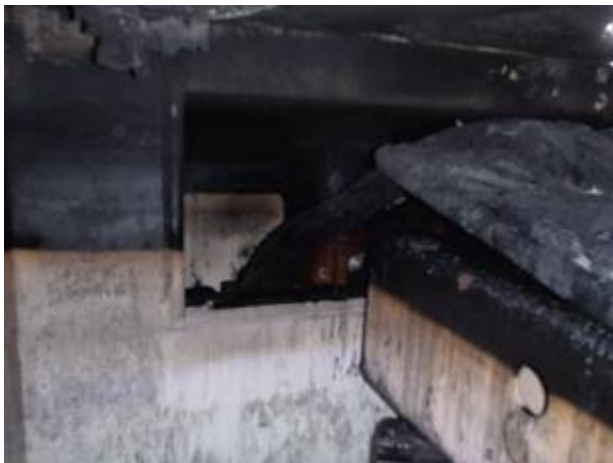
- No sign of phase to phase failure in the windings was found during the inspection.
- The L1 & L3 bushing's porcelain inside the transformer were shattered. Also marks of flashover were seen on core clamp just opposite to Phase 1 LV bushing.

**Photo 13** – Fire Line on Tank Wall & Core Clamp

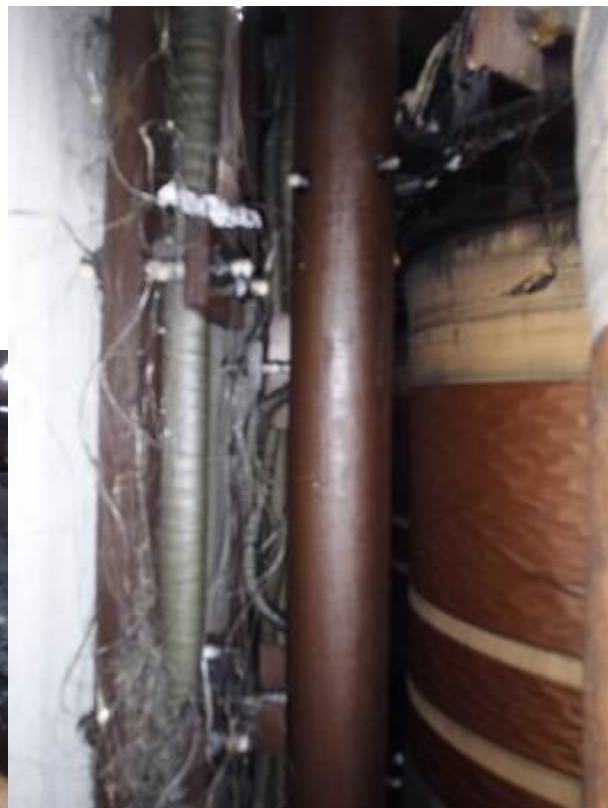
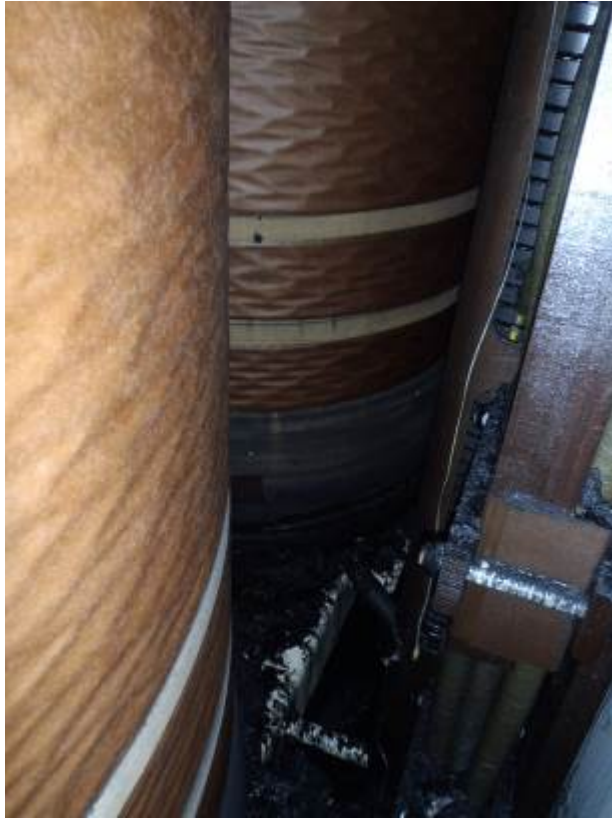
- No signs of flash over were seen in the cleats and leads including tap leads.
- All windings looked good with no signs of failure within the windings. It was not possible however to see the internal windings.

**Photo 14** – Windings

**Photo 15 – Windings**

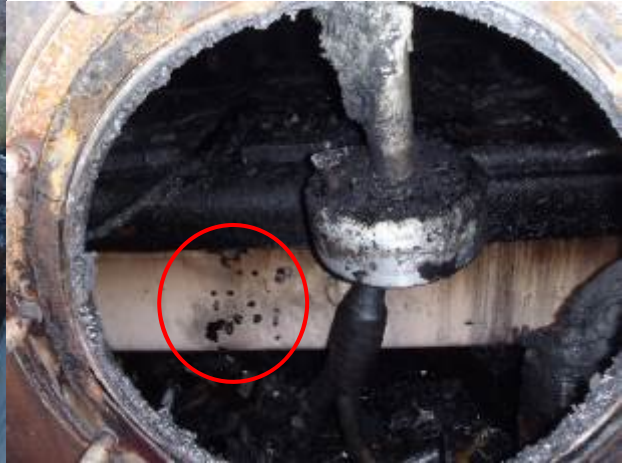
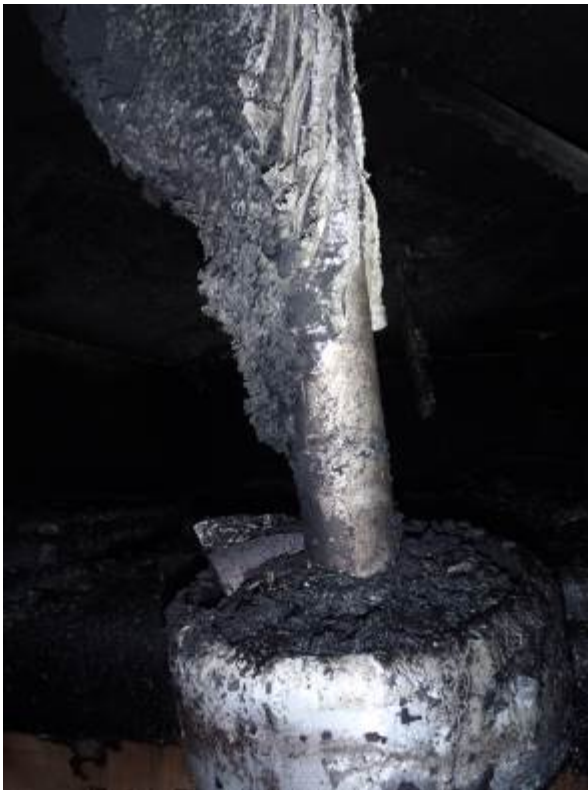
Based on the internal inspection observations, all the information available and the system analysis findings, it is concluded that most probably the LV1 or LV2 bushing failed first which initiated the failure and resulting fire.

**Photo 16 – LV1 Bushing & Flashover marks**

**Photo 17 – LV1 Bushing**

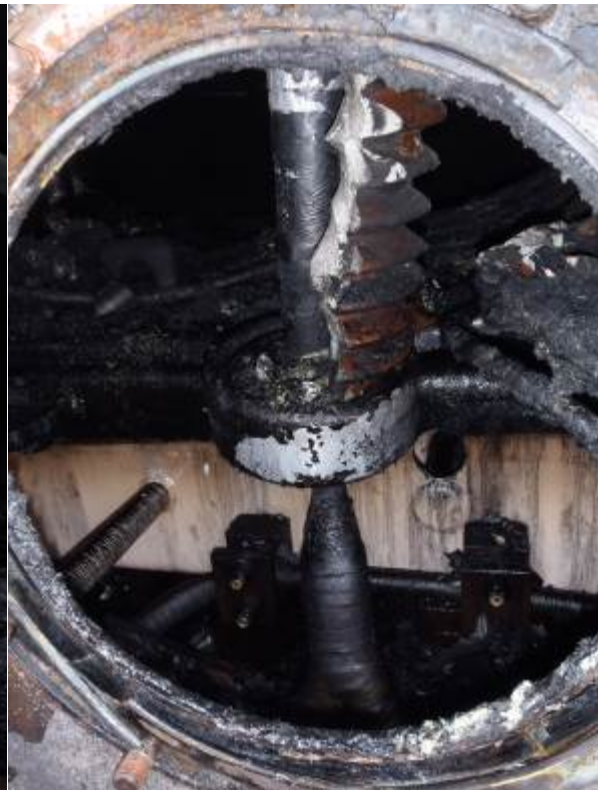
**Photo 18 – LV3 Bushing**

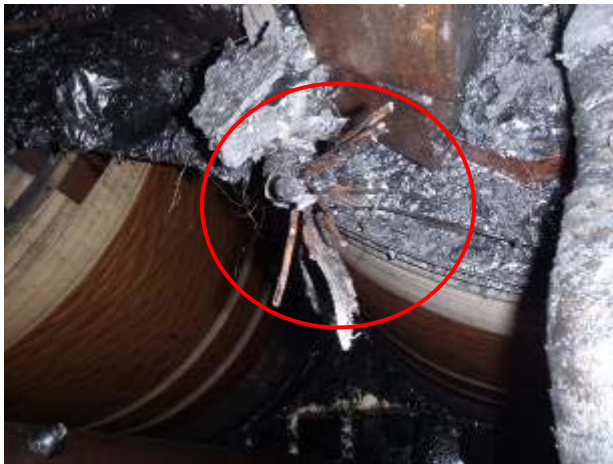
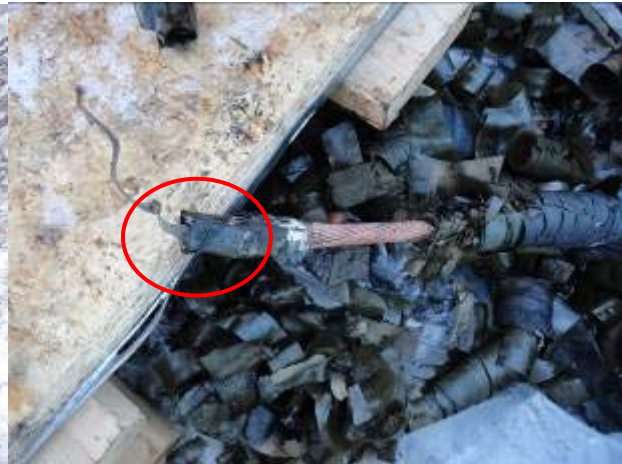
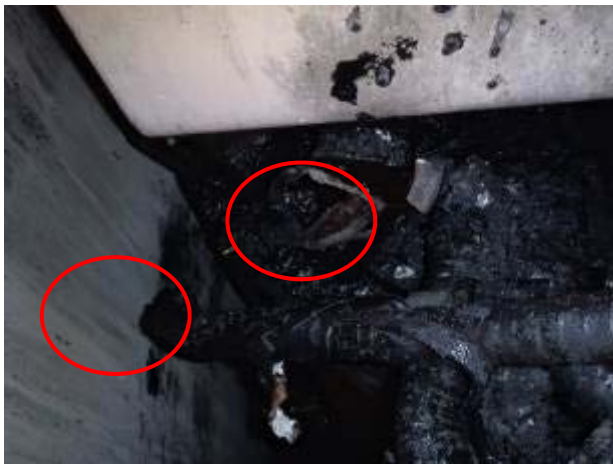
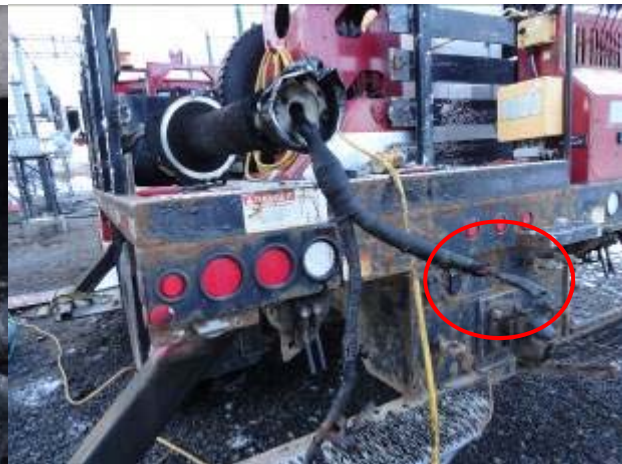
- For Phases 1 and 2 the leads connecting the LV bushings to the windings are disconnected. It seems the two leads were mechanically pulled and cut at the crimp during the fault when the cover opened up. The insulation of the leads looks intact with no signs of failure. **See Photos 19&20&21&22**

**Photo 19 – LV2 Winding Lead Broken**

**Photo 20 – LV2 Bushing Lead Broken at the Crimp**

**Photo 21 – LV1 Winding Lead Broken**

**Photo 22 – LV1 Bushing Lead Broken at the Crimp**

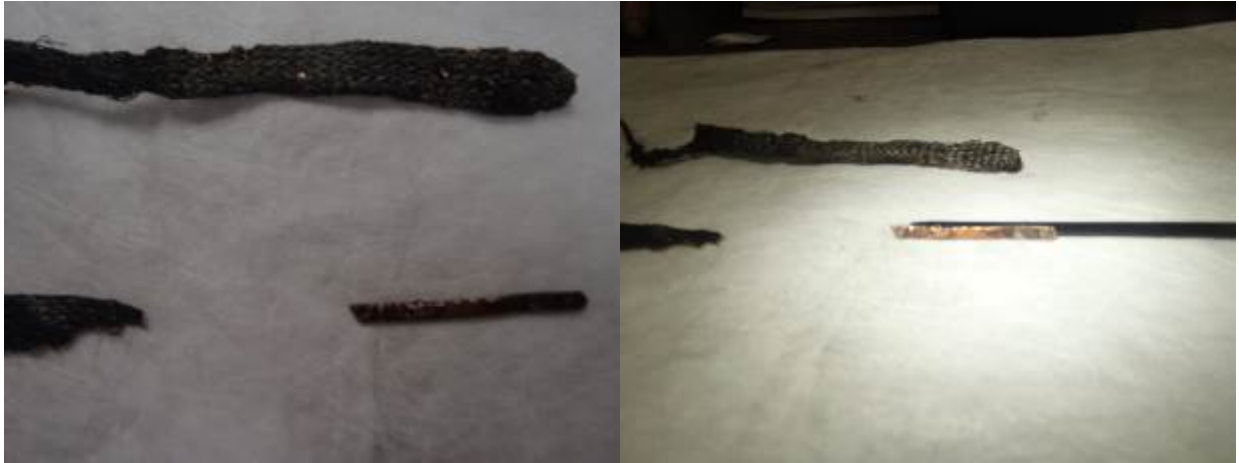
- Spitting and melting copper were seen on the LV windings conductor copper strands of phase one. **See Photo 23**

**Photo 23** – LV1 Winding Conductor Strand Copper Spitting
