**AND IN THE MATTER OF** an Application by Newfoundland and Labrador Hydro pursuant to Subsection 41(3) of the *Act*, for the approval of the replacement of the tap changer on transformer T5 at the Western Avalon Terminal Station.

## Replace T5 Tap Changer Western Avalon Terminal Station

**OEM (CG Power) Recommendation on Transformer T5**

**CONDITION ASSESSMENT OF  
FEDERAL PIONEER TRANSFORMER  
AT WESTERN AVALON STATION  
FOR NALCOR ENERGY**

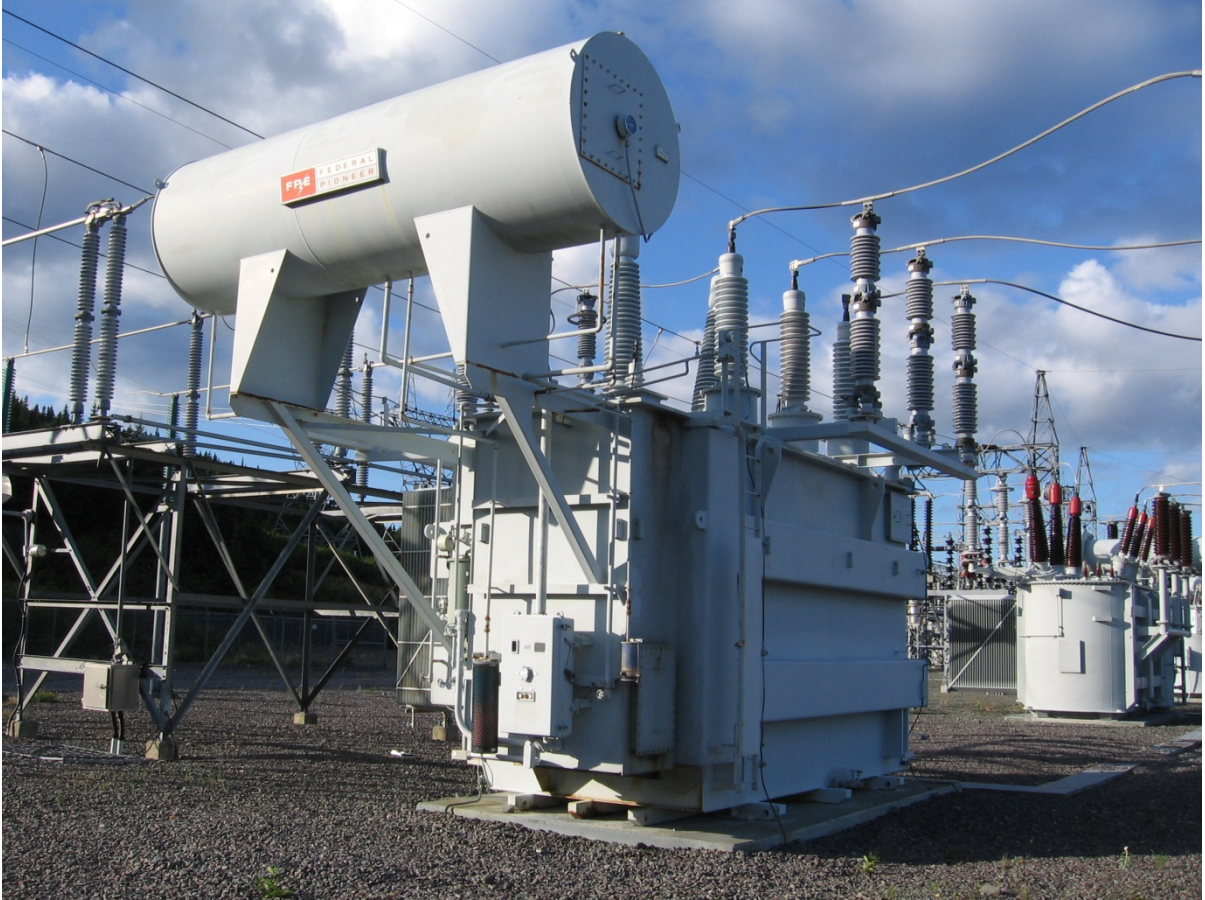
**Figure 3: Western Avalon T5 Transformer**

9  
 10 It is noted that the last preventative maintenance performed on the T5 transformer was in  
 11 2012. This included an overhaul of the on load tap changer. There were no issues with the  
 12 unit cited at that time. Figure 3 provides a picture of the Western Avalon T5 transformer.

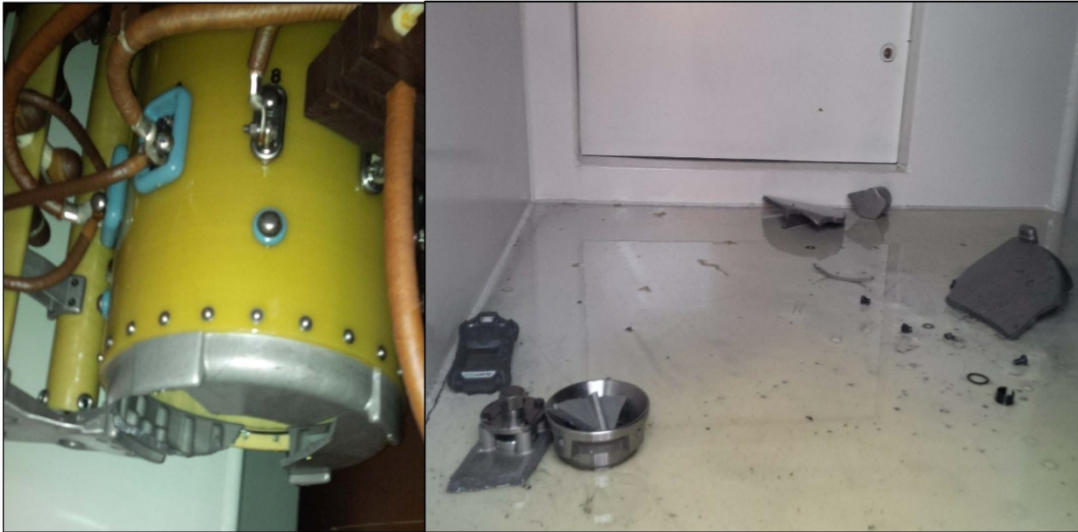
**Figure 5: Damaged Tap Changer**

1 recommendations by CG Power, i.e., the Western Avalon transformer T5 is in good  
2 condition and able to be returned to service once the tap changer is replaced. The ABB  
3 report is attached as Appendix B. Reinhausen reported that the failure of the tap changer  
4 was due to a phase to phase fault which resulted in an electrical arc in the unit. Figure 5  
5 shows pictures of the damaged T5 tap changer.

10 The damaged tap changer is a Type H and is obsolete. Reinhausen has recommended that  
11 Hydro replace the Type H tap changer with a Type VV unit. The work required to install a  
12 Type VV tap changer involves enlarging the existing hole in the transformer for the new tap  
13 changer, manufacturing the tap changer fitting flanges, and extending leads from the  
14 transformer windings to the new tap changer. Hydro plans to contract this work out to CG  
15 Power, as they manufactured the transformer and have the expertise to complete the work  
16 efficiently.

5 Reinhausen has internally inspected the tap changer and recommends that it be replaced  
6 with a new Type VV tap changer. The existing, damaged tap changer, Type H, is obsolete.

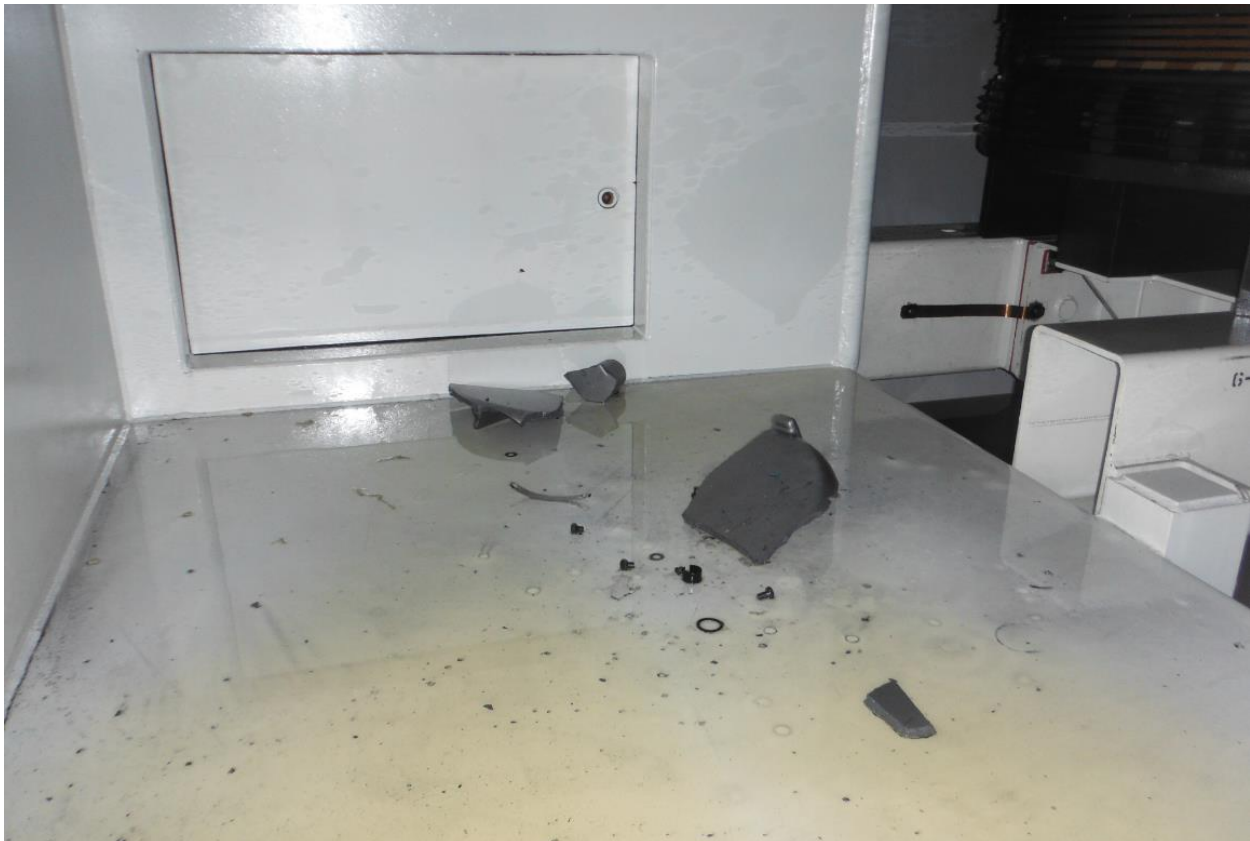
On opening the man hole cover at the tap changer end it was noticed that there were large amounts of metal and hardware from the bottom of the tap changer that was laying on the floor beneath the tap changer. Once inside CG removed all the parts from the unit and then proceeded with the inspection. CG checked all the tap connections and connections then worked around the active assembly looking for deformities or anything that may be damaged.

It was concluded that all lead work and connections were solid with no adverse effect to the active assembly. It is however my recommendation that the unit be flushed and the floor cleaned after the new tap changer is installed.

Picture – Below the Tap Changer on the shelf in the Transformer.

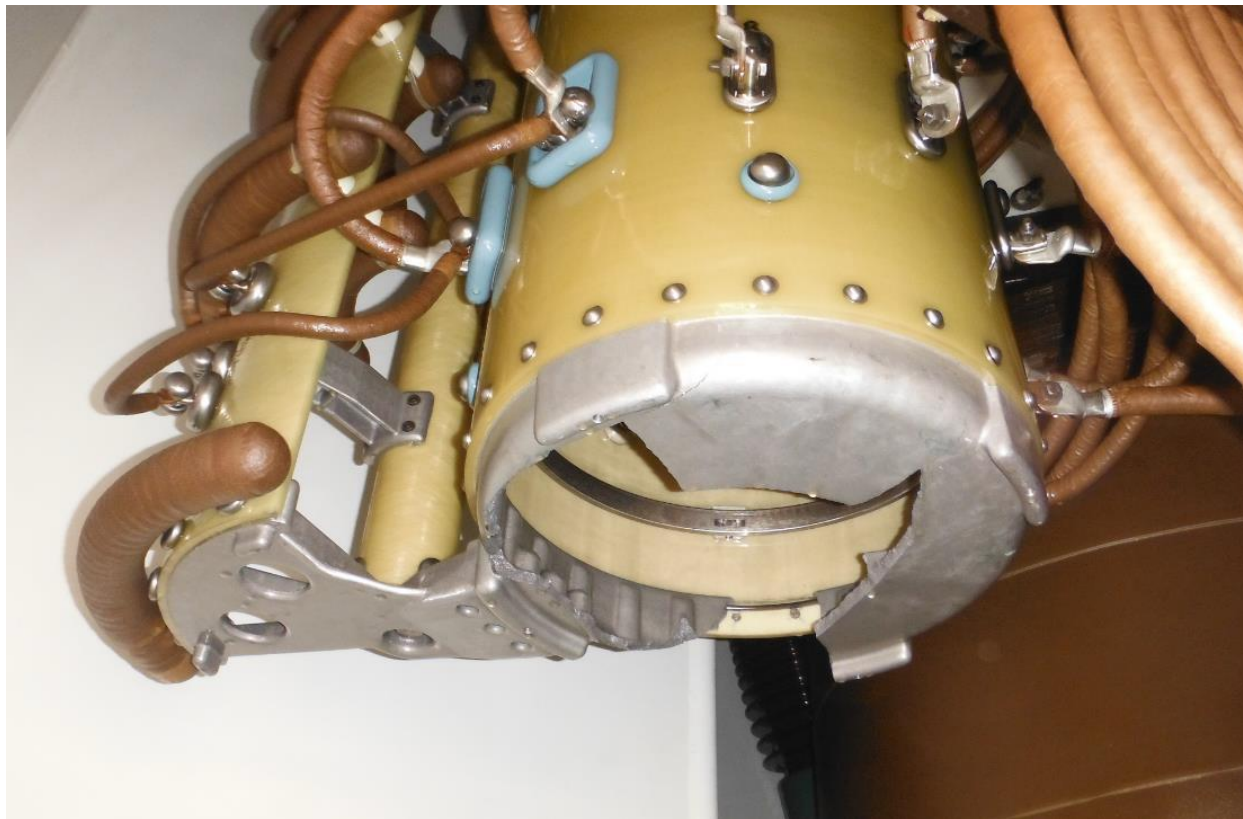
Picture – Bottom of the Tap Changer

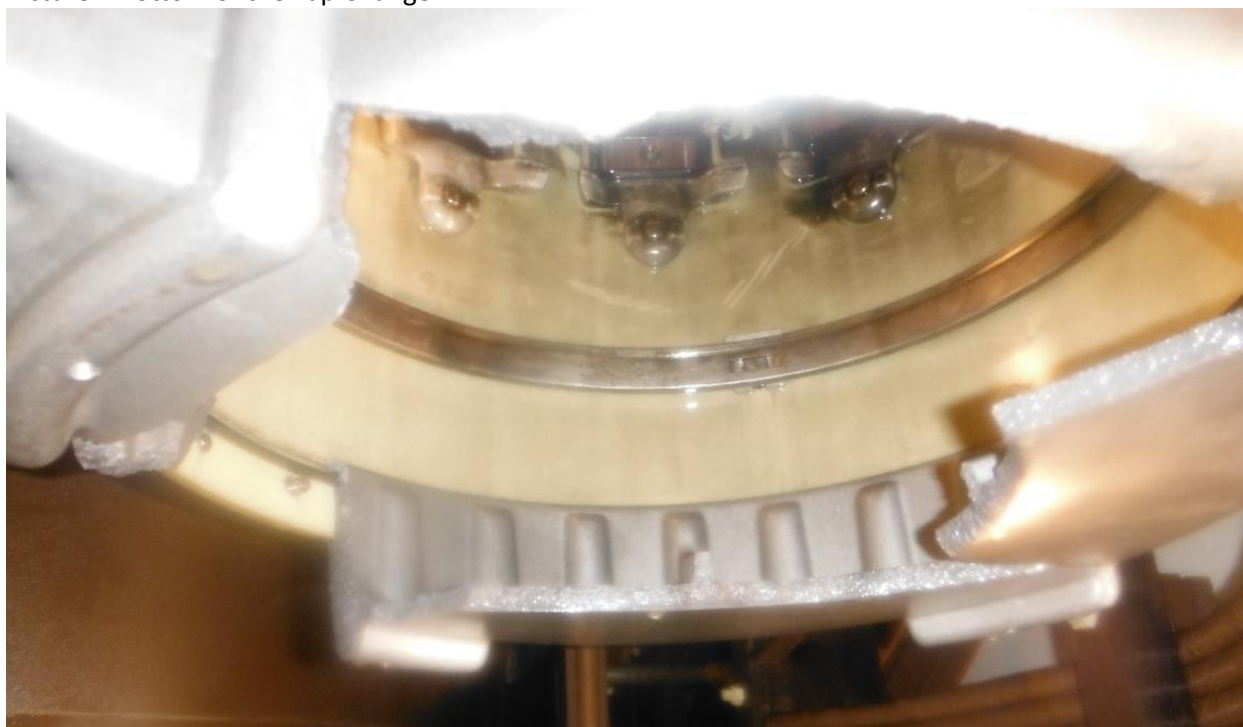
Picture – Bottom of the Tap Changer

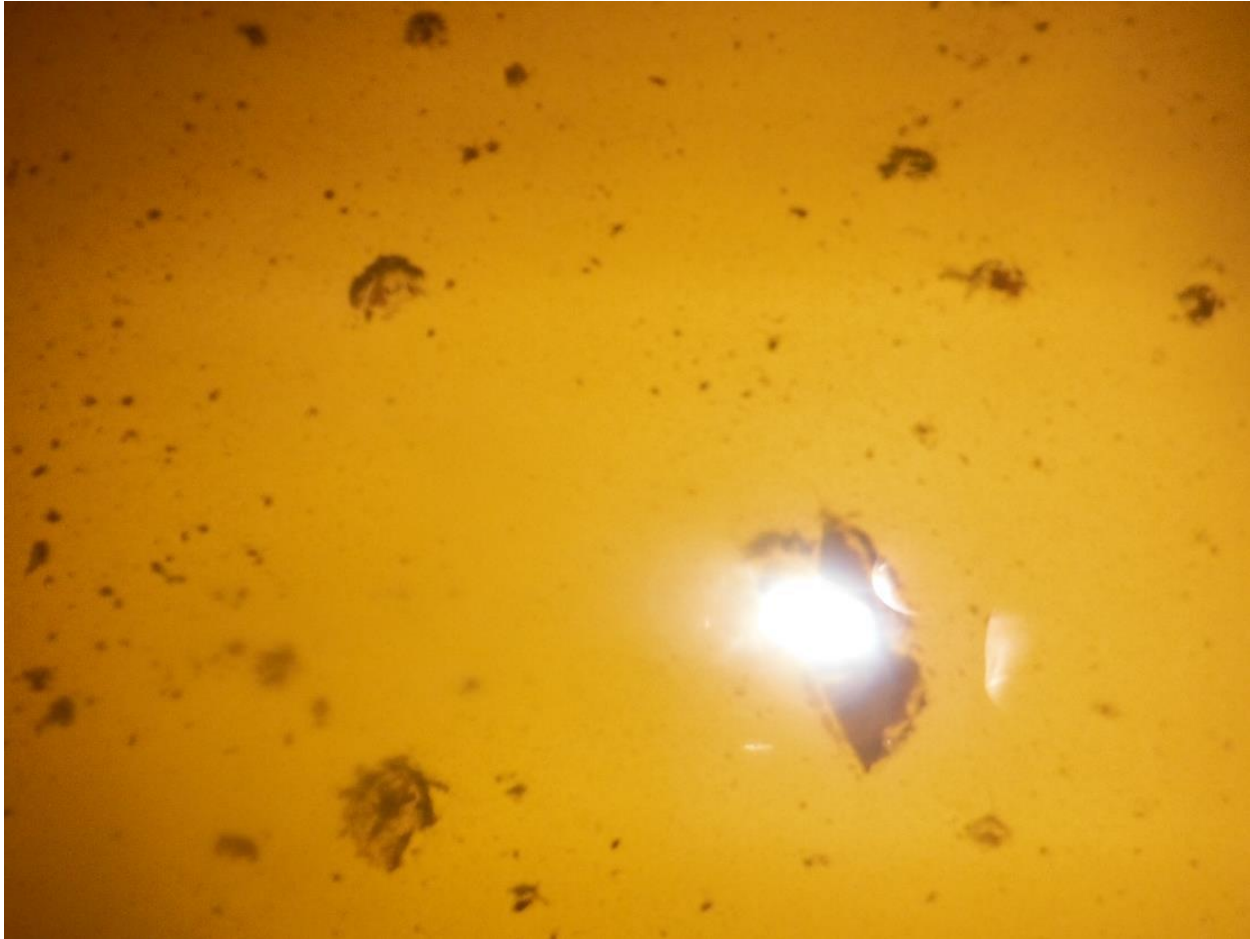
Picture – Bottom of the tank

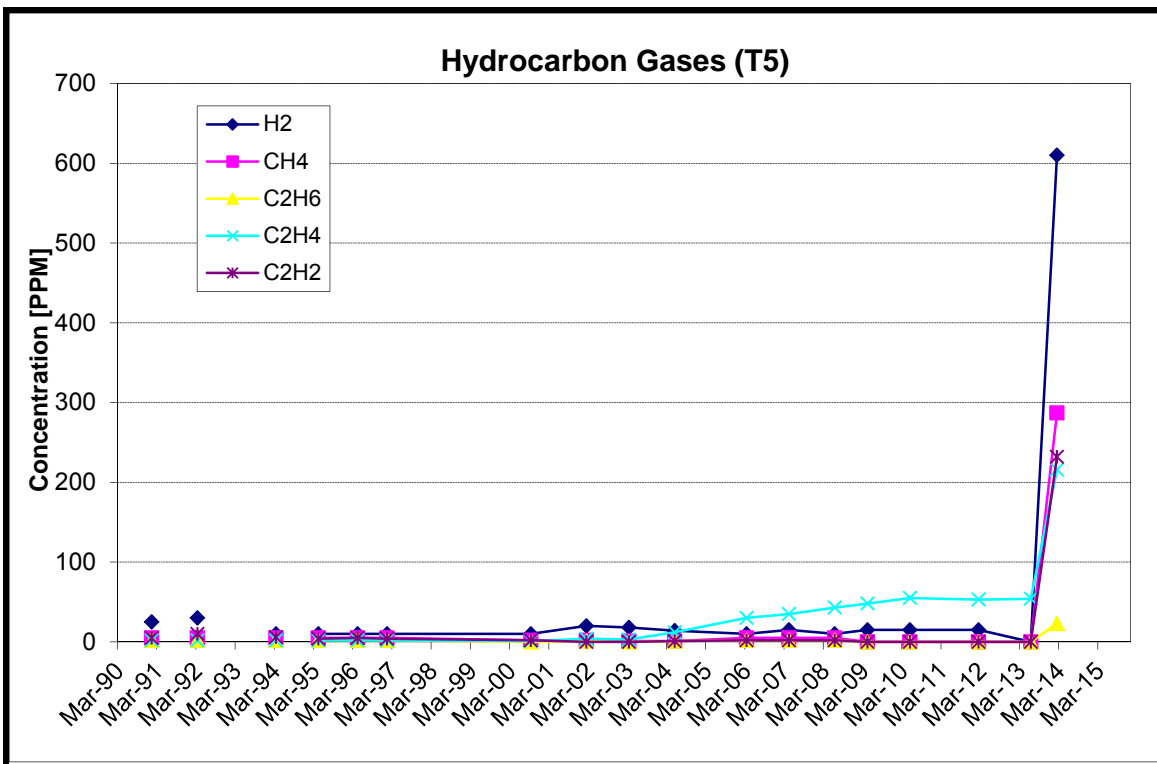
Figure 1 - Hydrocarbon Gas Concentrations

- The Ethylene (C<sub>2</sub>H<sub>4</sub>) level has been well below condition level one (50 ppm) of the IEEE C57.104-2008 guide before 2009. As can be seen from **Figure 1** below, the concentration of C<sub>2</sub>H<sub>4</sub> elevated after 2009, however the generation rate is very low at 0.0027 ppm/day until the LTC failure occurred in 2014.
