1 Q. On page 9 of Hydro's *Insulator Replacement TL-201 and TL-203* report, Hydro
2 states:
3 "The testing is currently ongoing and a report will be provided from Kinectrics by
4 the second quarter of 2014."

CONDITION ASSESSMENT TESTS OF PORCELAIN INSULATORS REMOVED FROM NALCOR'S CIRCUITS

Kinectrics Inc. Report No.: K-419614-RC-0001-R00

July 18, 2014

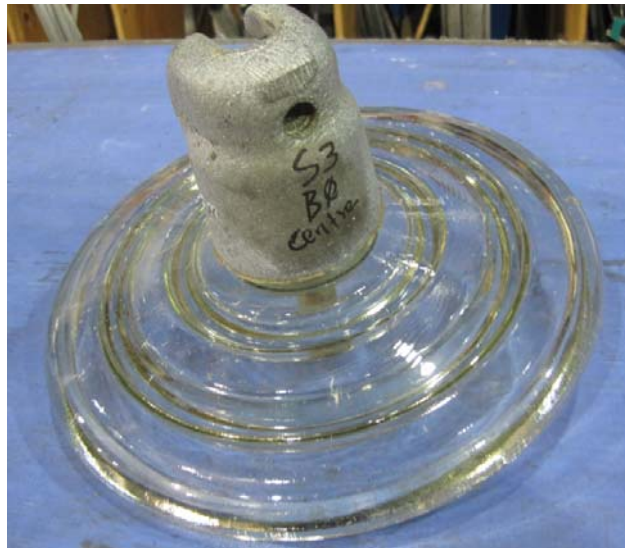
Figure 3 Typical Insulator Sample as received, Side View

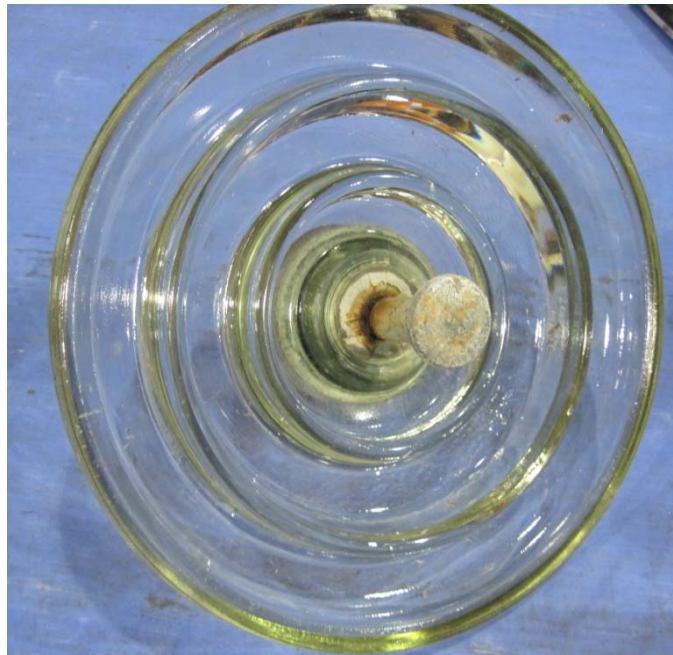
Figure 4 Typical Insulator Sample as received, Bottom View

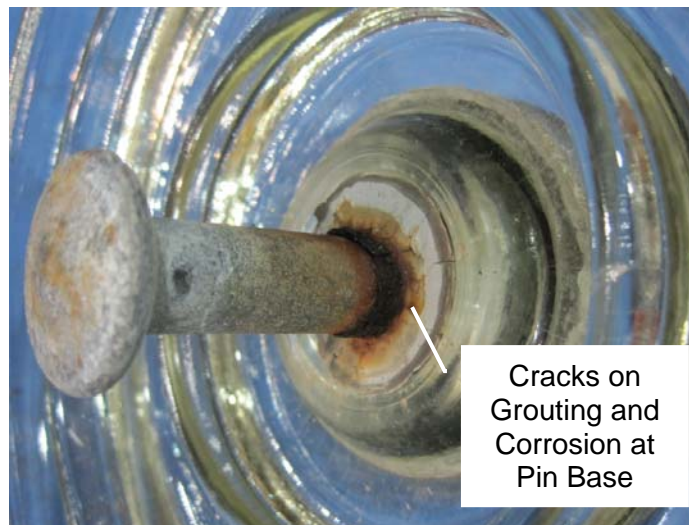
All test samples exhibited visible cracks in the surface of the grouting for the pin on the underside of the insulators (see Figure 5). The grouting surface cracks may be a result of thermal cycling and temperature excursions the insulators experience during their lifetime.

Figure 5 Typical Insulator Sample as received, Bottom View, Magnified View of Cement Grouting near Pin

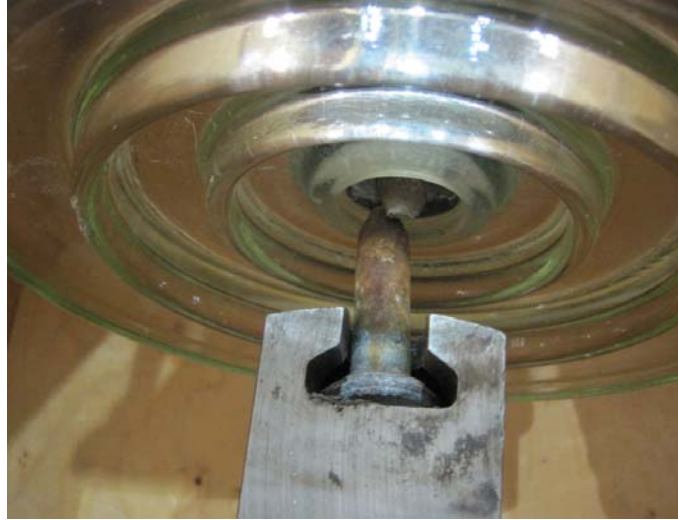
The results of the tests are shown in Table 1. Almost all 25,000 lbf insulators failed at a load below their rated strength of 25,000 lbf. Only one insulator (Sample # 28) failed at a tensile load exceeding its rating. The mode of failure for all tested insulators involved necking of the pin which lead to eventual failure of the pin. This is illustrated in Figure 6.

Figure 6 Typical Insulator Sample after Mechanical Test (failed at Pin Base)

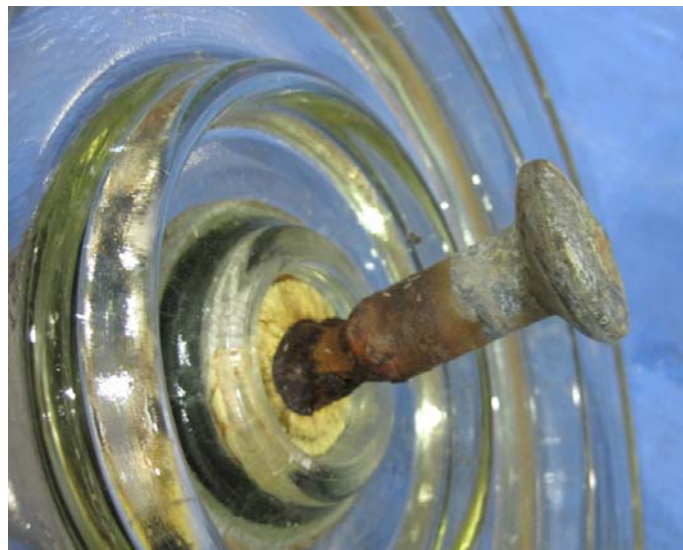
With varying degrees, all test samples showed advanced pin corrosion as shown in Figure 7. There is an obvious complete loss of Zinc (galvanizing) which normally protects the steel parts from the environment. Due to severe weathering and probable extended service life, the pin base in many samples experienced significant loss of material as a result of penetrating metal corrosion. The reduced cross-section de-rates the insulators' mechanical strength, which is evident from the mechanical test data.

- Only one of the tested insulators met the tensile strength requirement given in the standard specification. All of the remaining insulators failed to meet the standard tensile test requirements.
- The failure of the insulators to meet the standard tensile strength requirements is due to advanced corrosion of the pin which leads to significant reduction of the pin cross-section.
- Visible cracks on grouting surface of the insulator underside most likely display advanced weathering effects.

Figure 7 Typical Insulator Sample as received, Bottom View, Magnified View of Pin with Severe Corrosion

Based on the test results, we would strongly recommend that the insulators of which the tested units are representative be removed from service as soon as possible. Failure to do so will lead to a continually increasing probability of line drops due to mechanical failure of the insulator pins.

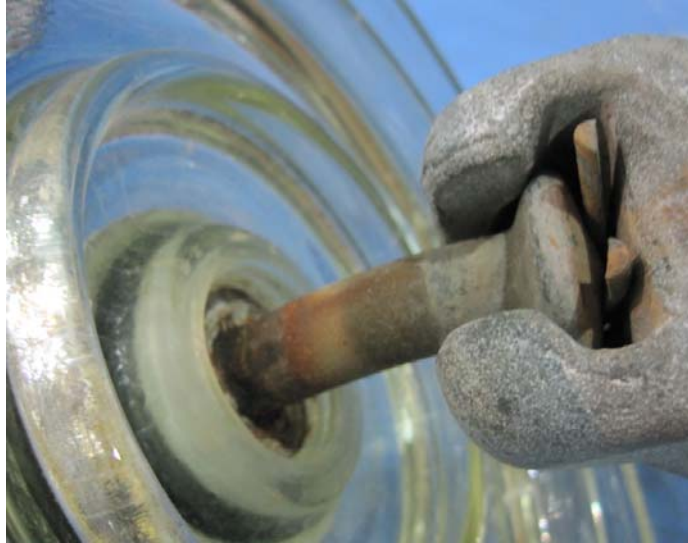
Figure 8 Typical Insulator Sample as received, Bottom View, with Bent Pin (not suitable for Mechanical Testing)
