B-7 Upgrade Cooling Water System Units No's 1 and 2, \$112,200

Q. Provide a listing of instances of fouled or leaking piping that have required remedial attention during the years 2004 to 2006F.

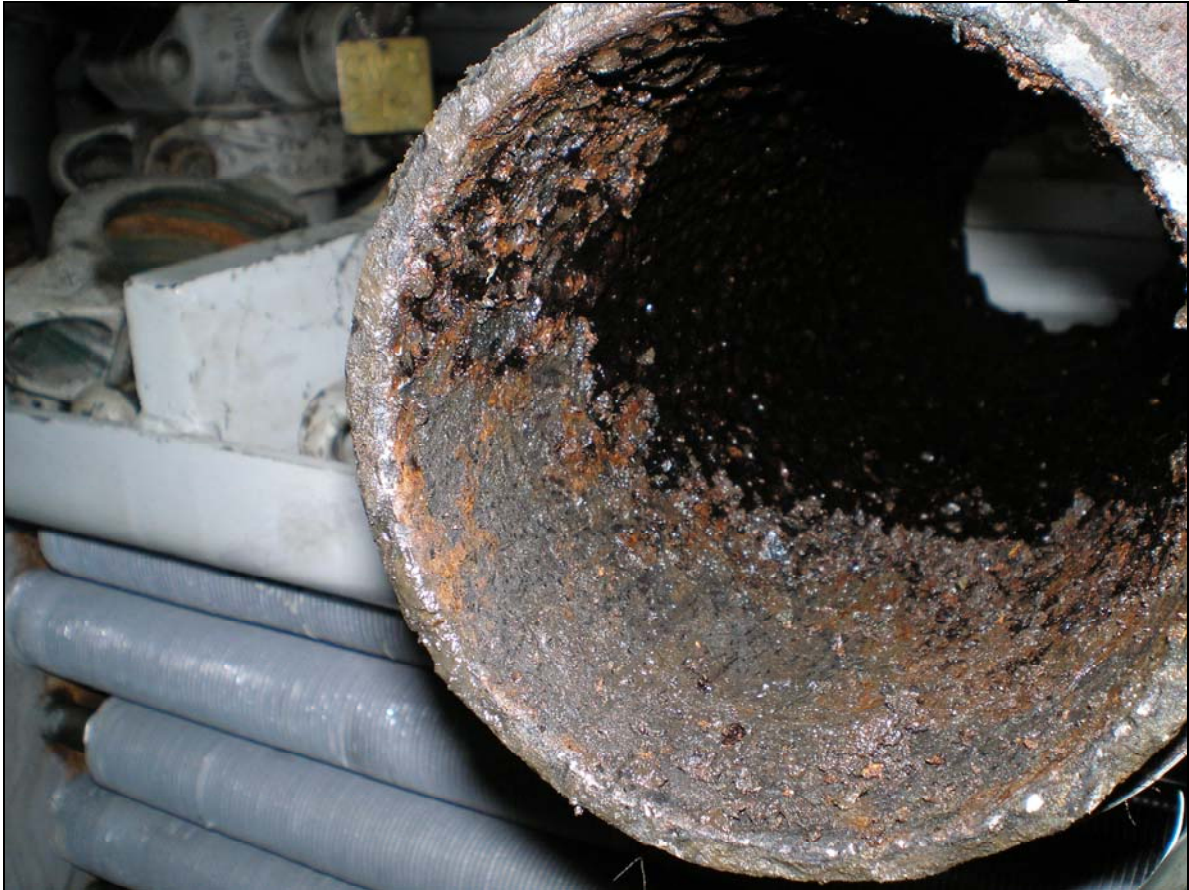
Picture 1

A fouled 4-inch section of surface air cooler piping, removed from service this year due to severe corrosion. Picture taken August 2006.

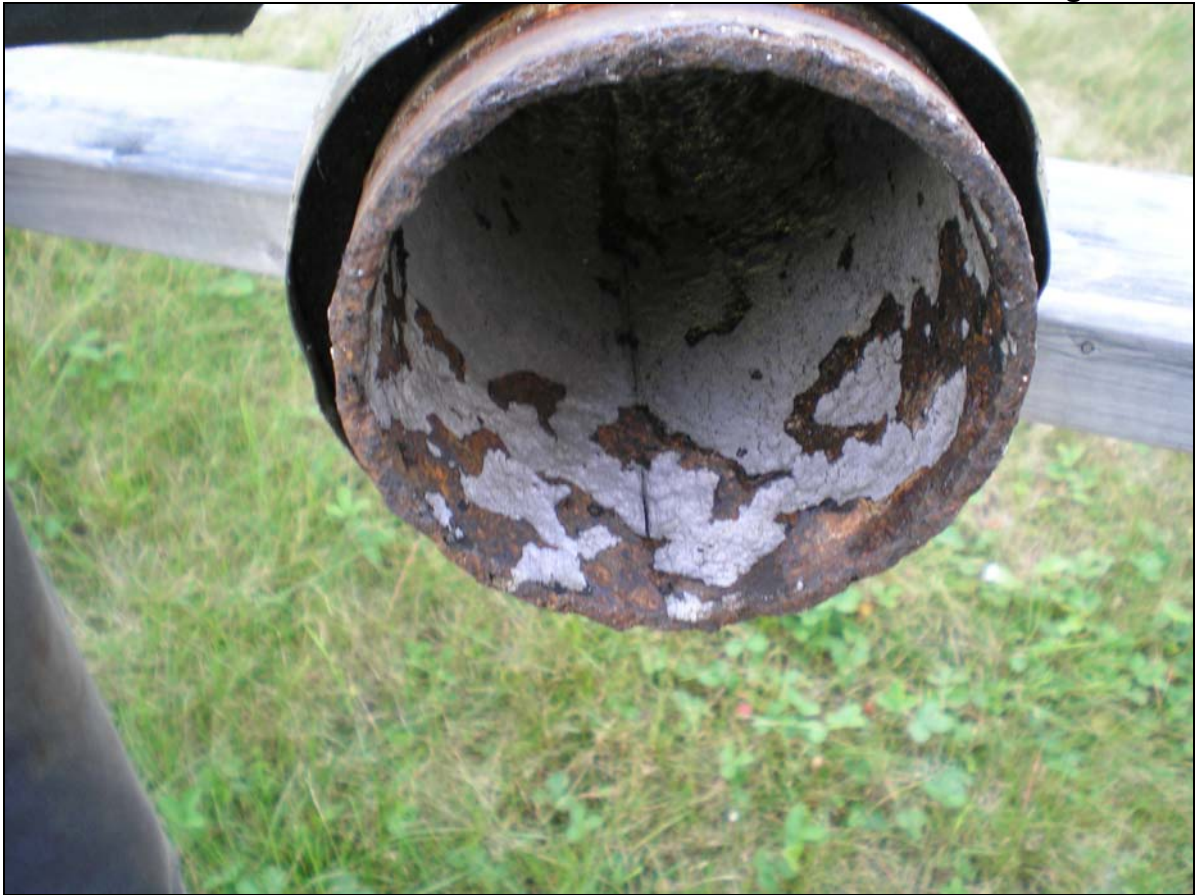
Picture 2

This is the same 4-inch section of pipe as in picture #1 after it has been cleaned. The corrosion pitting is on the order of 0.080-0.110 inch deep.

Picture taken August 2006.

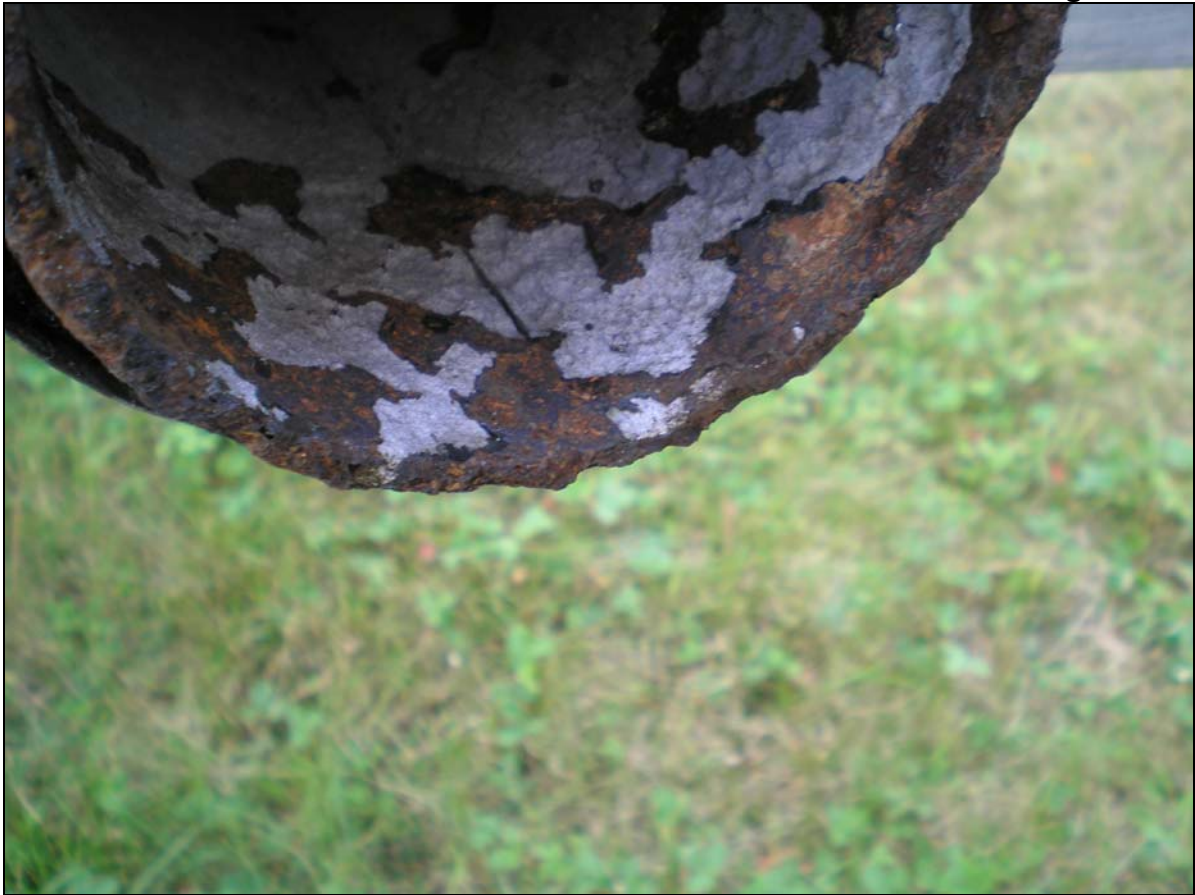
Picture 3

This is the same 4-inch section of pipe as in picture #2, showing the amount of corrosion on the end. Picture taken August 2006.

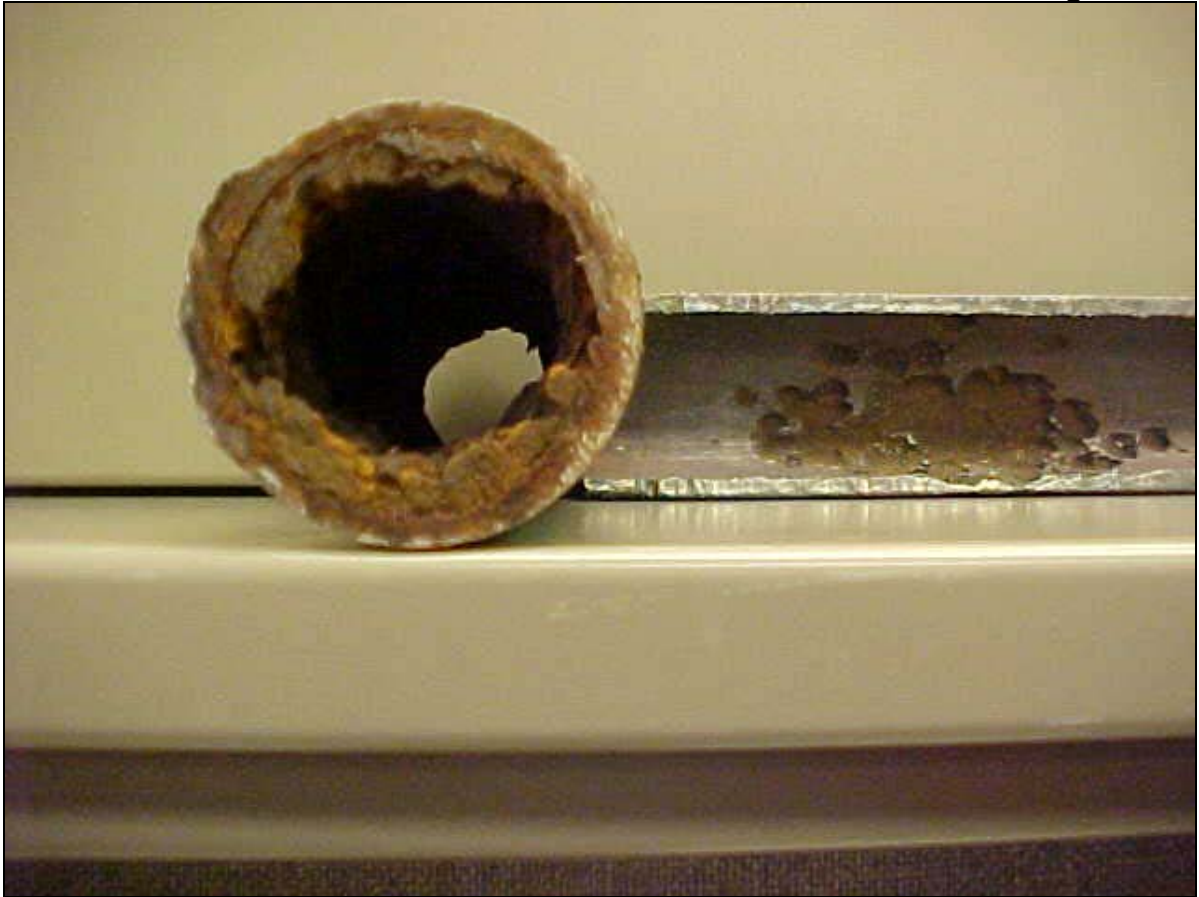
Picture 4

11
12 The average fouling thickness is measured to be around 1/4-inch, this can be
13 seen in picture 4 on a section of 2-inch schedule 40 pipe. This amount of
14 fouling reduces the flow rate through this pipe by approximately 45%.

This is a typical section of 2 inch cooling water pipe that shows the amount of fouling present and the severity of localized corrosion after the pipe was cleaned. Picture taken August 2006.

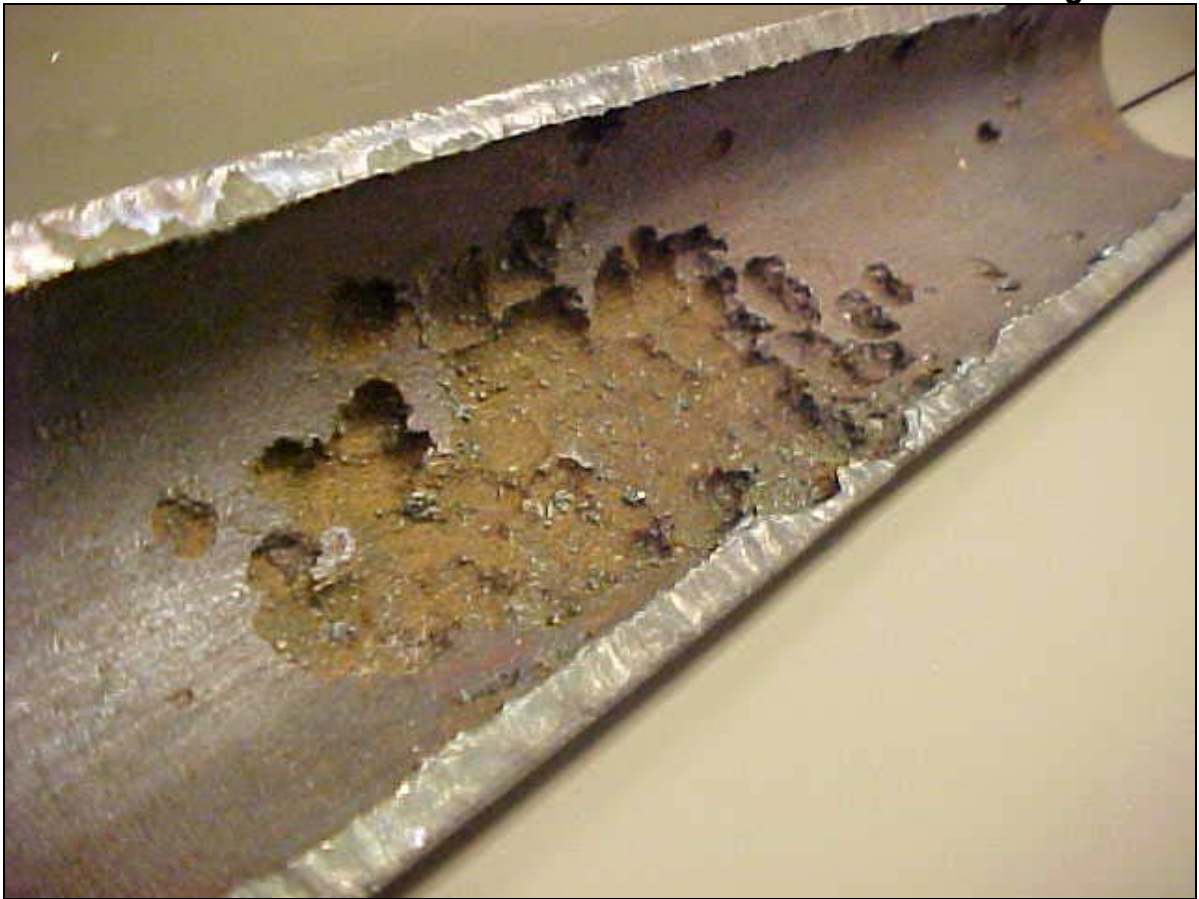
Picture 5

This is the same section of 2-inch cooling water pipe shown in picture #4, showing how deep the localized corrosion has gone, resulting in over 90% wall loss. Picture taken August 2006.

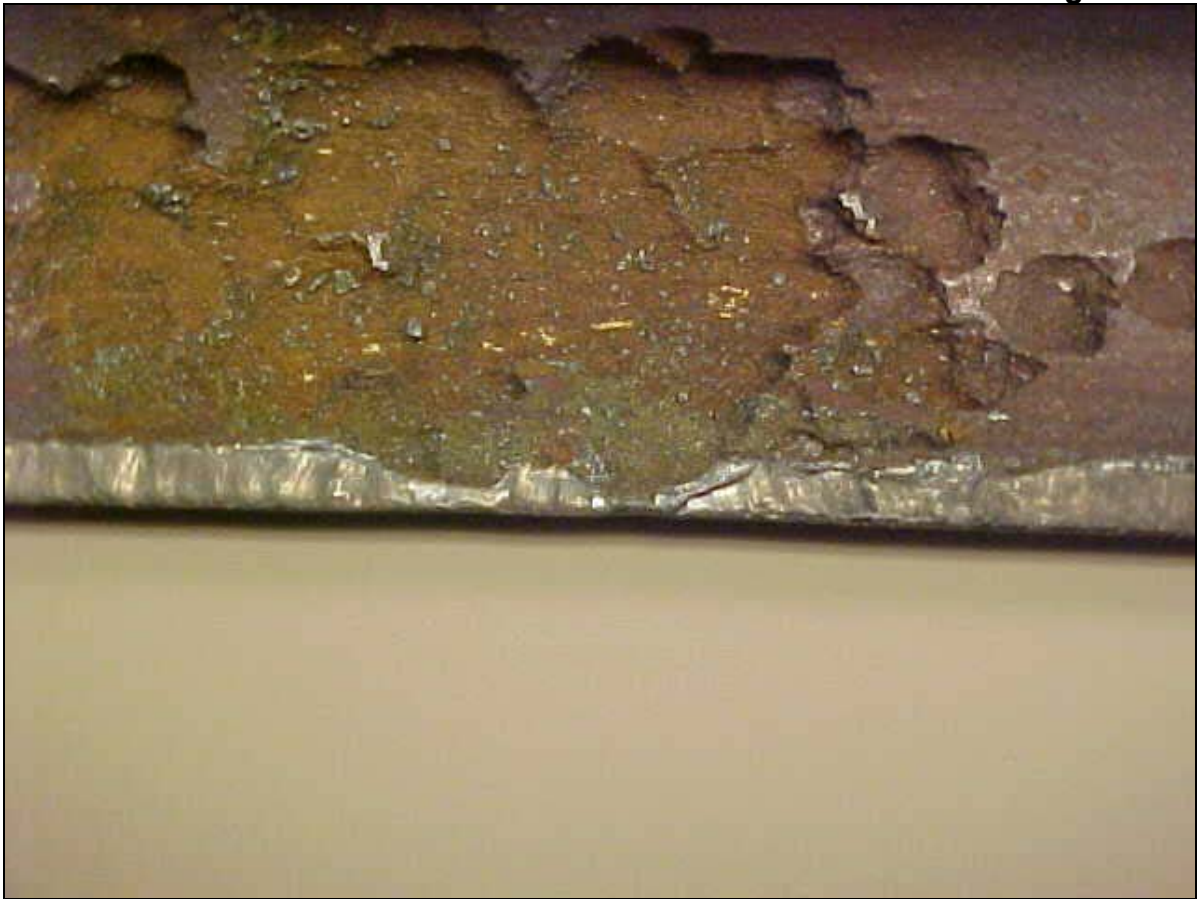
Picture 6

This is the same section of 2-inch cooling water pipe as in picture #5,

showing how deep the corrosion penetrates the wall. Picture taken August

2006.
