# **NEWFOUNDLAND AND LABRADOR HYDRO**

*January 11, 2013 Power System Outage Report*

December 2013

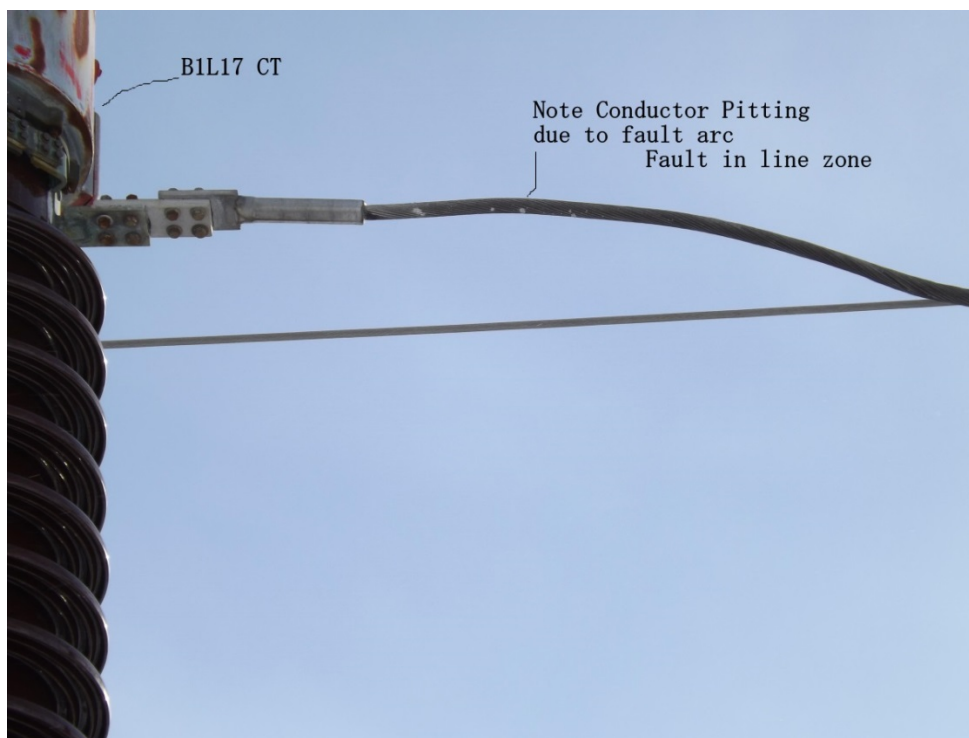
Figure 2-5c: Conductor Between Breaker B1L17 to B1L17 CT

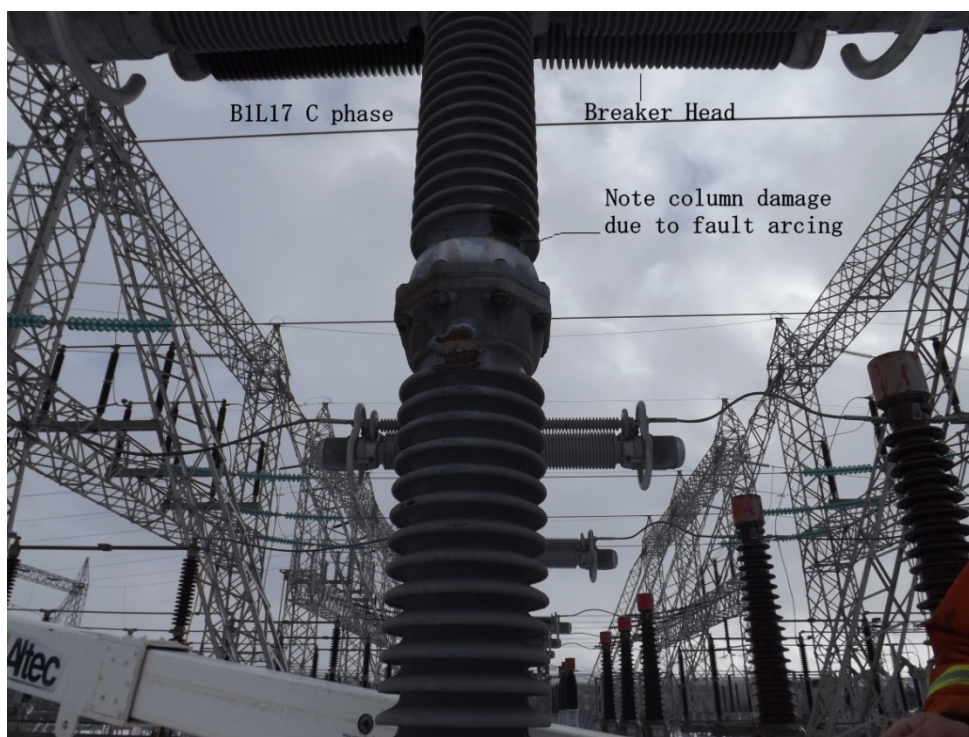
Figure 2-5d: B1L17 Vertical Column Arcing Damage
