**Re: Newfoundland and Labrador Hydro - The Board's Investigation and Hearing into  
Supply Issues and Power Outages on the Island Interconnected System – Rolling 12  
month performance of Hydro's generating units**

Quarterly Report on Performance of Generating Units  
For the Quarter ended September 30, 2017

October 30, 2017

*A Report to the Board of Commissioners of Public Utilities*

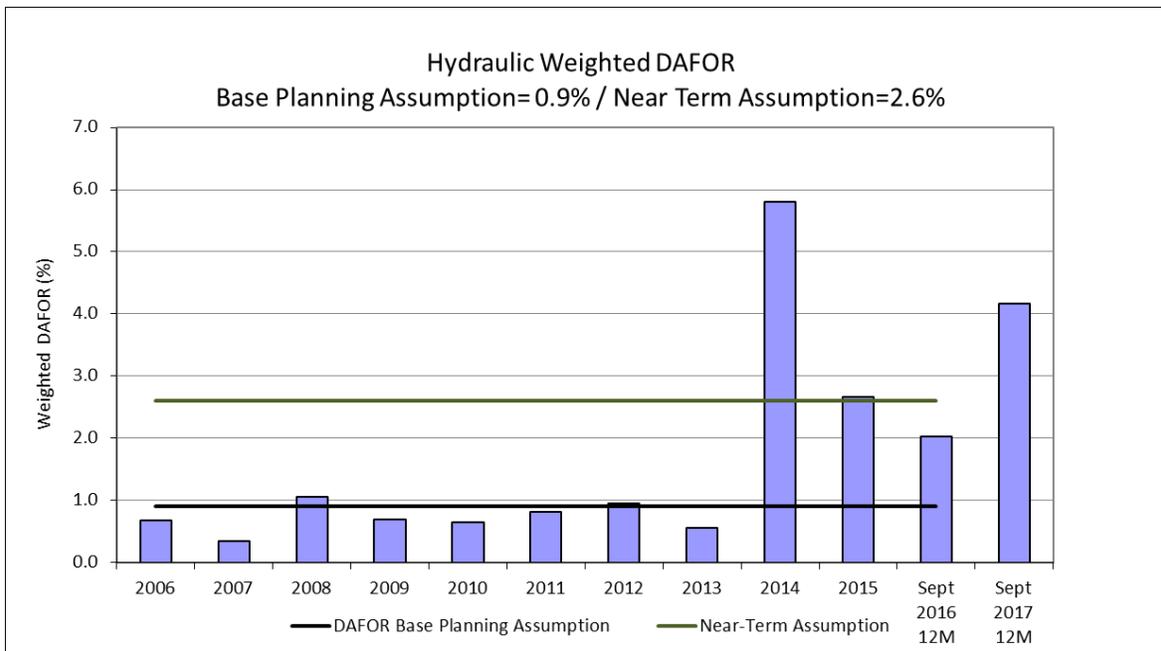
**Figure 1: Hydraulic Weighted DAFOR**

- 1 Considering the individual units' performance, the assumed Hydro generation base planning
- 2 DAFOR was materially exceeded for Bay d'Espoir Unit 1 and Bay d'Espoir Unit 2. Also, there
- 3 were exceedances compared to base planning assumption for Bay d'Espoir Unit 6, Bay d'Espoir
- 4 Unit 7, Cat Arm Unit 1, Hinds Lake and Paradise River for the current period.

2 The Bay d’Espoir Unit 1 DAFOR of 19.88% and Unit 2 DAFOR of 25.77%, exceeded the base  
3 planning assumption of 0.9% and the near-term assumption of 3.9%, due to the units being  
4 removed from service on two separate occasions as a result of a leak in Penstock 1, which  
5 provides water to both Unit 1 and Unit 2. These penstock issues contributed 99.9% of the  
6 DAFOR for this period.

15 The Bay d’Espoir Unit 6 DAFOR of 1.35% exceeded the base planning assumption of 0.9% and is  
16 less than the near-term assumption of 3.9%. This is a result of the unit being unavailable from  
17 February 22, 2017, to February 25, 2017, due to a high turbine bearing alarm, which caused the  
18 unit trip protection to operate and shut the unit down in a controlled fashion. An investigation  
19 was completed, and it was determined that the Babbitt bearing was damaged. The bearing was  
20 repaired and the unit was returned to service. The results of the investigation found no issues  
21 for long term bearing reliability.

23 The Bay d’Espoir Unit 7 DAFOR of 1.80% exceeded the base planning assumption of 0.9% and is  
24 less than the near-term assumption of 3.9%, as a result of the unit being unavailable from July  
25 3, 2017, to July 9, 2017, due to a failure in the collector assembly, which caused the unit  
26 protection to operate and isolate the unit from the system. An investigation was completed,  
27 and it was determined that there was a flash over between the positive and negative slip  
28 rings which was caused by excessive brush wear. The investigation resulted in improvements to  
29 the preventive maintenance (PM) program for brush gear inspections across the hydraulic

5  
6 The Cat Arm Unit 1 DAFOR of 1.06% exceeded the base planning assumption of 0.9% and the  
7 near-term assumption of 0.7%, as a result of the unit being unavailable from November 23,  
8 2016, to November 25, 2016, due to a governor oil pump trip. An investigation into the issue  
9 revealed that the internal seals in the pump had failed, preventing the pump from maintaining  
10 the governor oil pressure. The oil system was completely cleaned, flushed and replaced with  
11 new oil. A new oil pump was installed and the unit returned to service, and the issue has been  
12 resolved. An additional consideration to improving the system is with respect to changing how  
13 the plant alarms are grouped. This will permit minor anomalies to be initiated as such, and not  
14 as major anomalies, which have the potential to take the unit off line. Recommendations will  
15 be finalized by end of Q4.

16  
17 The Hinds Lake Unit DAFOR of 1.09% exceeded the base planning assumption of 0.9% and the  
18 near-term assumption of 0.7%, as a result of the unit being unavailable from April 19, 2017, to  
19 April 22, 2017, due to water in the generator bearing oil. An investigation revealed that the  
20 generator bearing oil cooler experienced a leak, which resulted in water getting into the  
21 bearing oil. Testing revealed that three of the six coolers were leaking. The damaged coolers  
22 were isolated from the system, with tests conducted to confirm adequacy of reduced cooling  
23 capacity. These tests confirmed that cooling with the three remaining coolers were adequate at  
24 ambient air and water temperatures. A planned maintenance outage was arranged from May  
25 24, 2017 to May 30, 2017, to repair the damaged coolers, as well as to conduct extensive  
26 testing of the three in-service coolers. All work was completed, with no further issues being

3  
4 The Paradise River unit DAFOR of 4.05% exceeded the base planning assumption of 0.9% and  
5 the near-term assumption of 0.7%, primarily as a result of a forced outage from September 23,  
6 2016, to September 30, 2016, which was related to a governor low oil level alarm. This alarm  
7 was caused when a seal broke on one of the governor servo motors, releasing oil from the  
8 governor oil sump into the powerhouse sump system. A new seal was installed and oil was  
9 added to the governor system. The results of the investigation found no issues regarding long  
10 term governor reliability.

8 The investigation identified a major weld refurbishment of the penstock, which was completed  
9 to provide a long term solution. The investigation into this outage identified two additional long  
10 term recommendations to extend the reliable life of Penstock 1. The first recommendation is to  
11 add structural backfill to the upper portion of the penstock, planned for 2018. The second is to  
12 replace the internal protective coating, which is currently being planned as part of the capital  
13 refurbishment program to coincide with the generation outage schedules.

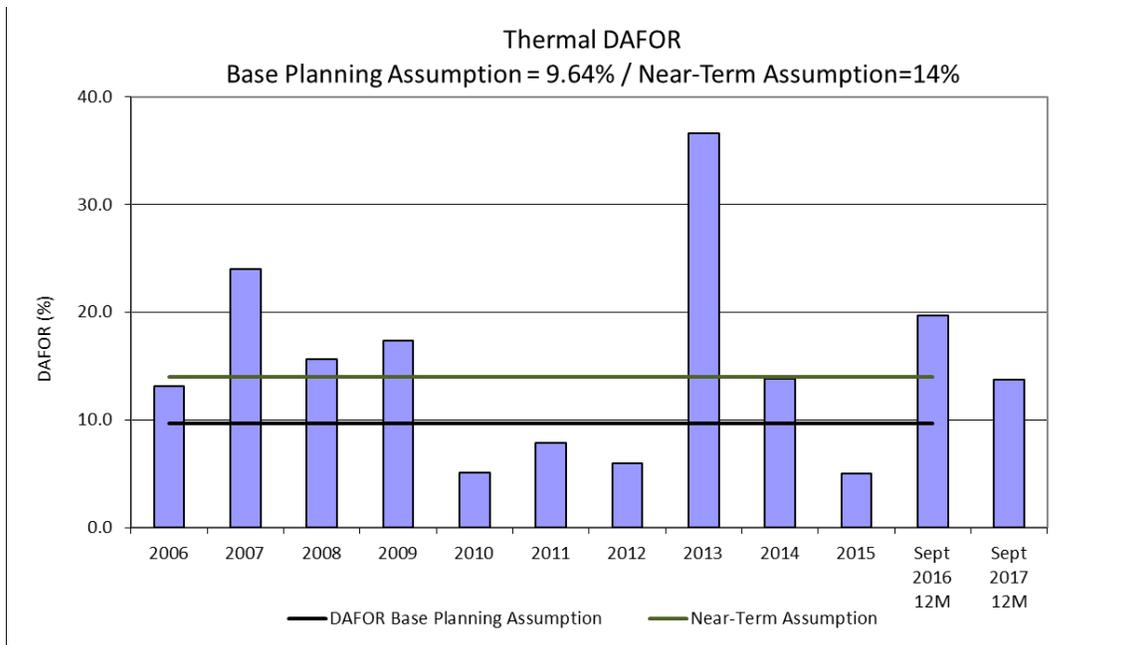
**Figure 2: Thermal DAFOR**

1 For the 12-month period ending September 30, 2017, the weighted DAFOR for all thermal units,  
 2 13.77%, was above the assumed Hydro generation base planning DAFOR value of 9.64%;  
 3 however, below the near-term assumption of 14.00%. Unit 1 DAFOR was 18.23% and Unit 2  
 4 DAFOR was 18.27%. The performance for both Units 1 and 2 was above the base planning  
 5 assumption of 9.64% and the near-term assumption of 15% (Unit 1) and 10% (Unit 2). Unit 3  
 6 DAFOR was 4.44%, which is better than the base planning assumption of 9.64% and near-term  
 7 assumption of 18.0%. The majority of the 13.77% DAFOR for the plant is due to deratings from  
 8 airflow issues in the 2016/2017 winter season on Unit 1 and Unit 2.

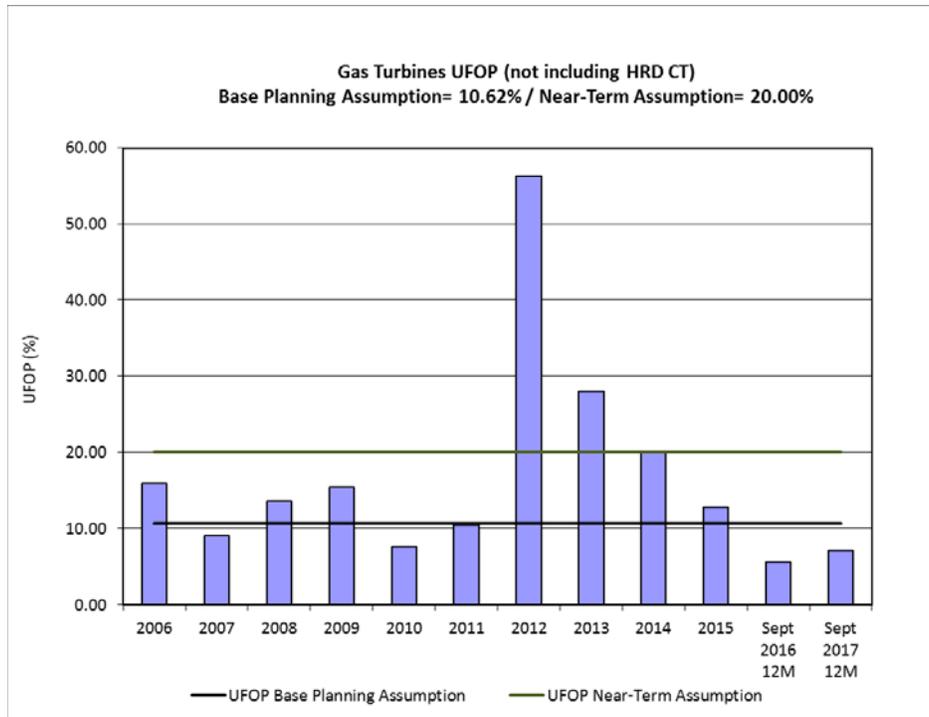
Figure 3: Gas Turbine UFOP – Hardwoods/Happy Valley/Stephenville Units

25 The combined UFOP for the Hardwoods, Happy Valley and Stephenville gas turbines was 7.06%  
26 for the 12-month period ending September 30, 2017 (see Table 6). This is below the base  
27 planning assumption of 10.62%, and the near-term assumption of 20.00%. The current period  
28 UFOP declined from the previous period UFOP of 5.54%. The Hardwoods UFOP for the current  
29 period is 6.47%, which is better than the base planning assumption of 10.62%. Happy Valley's

- 1 Hydro continues to mitigate extended outages to the Hardwoods and Stephenville gas turbines
- 2 by utilizing spare engines to allow for timely replacement of failed engines to return the units to
- 3 full or near-full capacity. During the winter 2017/2018, Hydro will have two spare engines
- 4 available for this purpose.

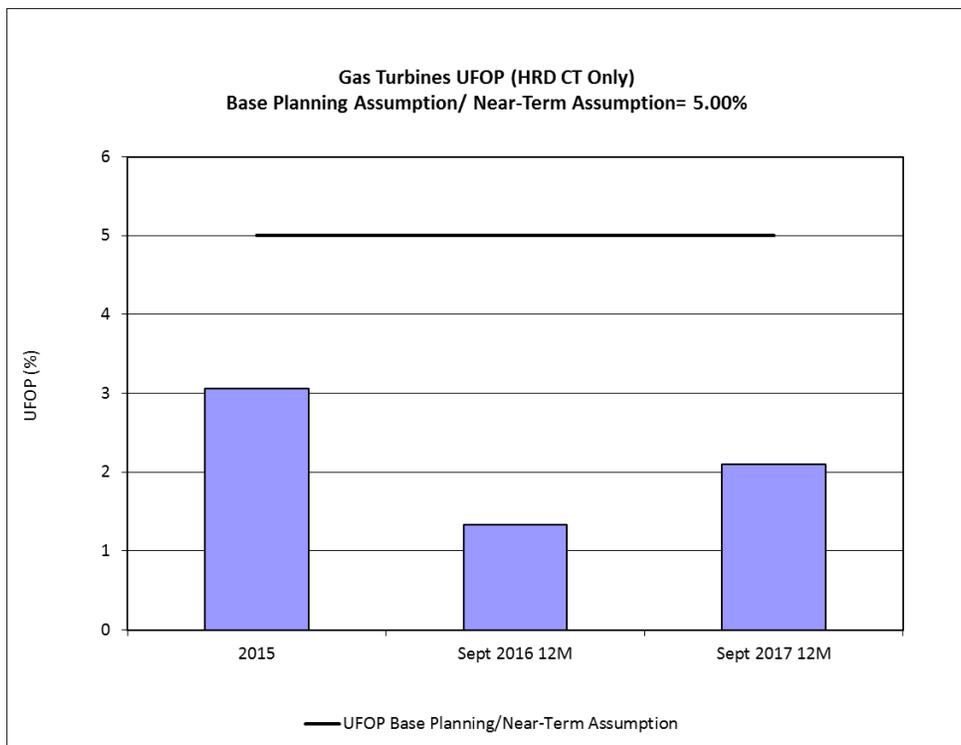
Figure 4: Gas Turbine UFOP – Holyrood Gat Turbine Only

7 The Holyrood gas turbine UFOP of 2.10% for the current period is better than the base planning  
 8 and near-term assumptions of 5.00% (see Table 7).
