**Supply Issues and
Power Outages Review
Island Interconnected System**

**Executive Summary of
Interim Report**

**The Board of Commissioners of Public Utilities
Newfoundland and Labrador**

The Liberty Consulting Group

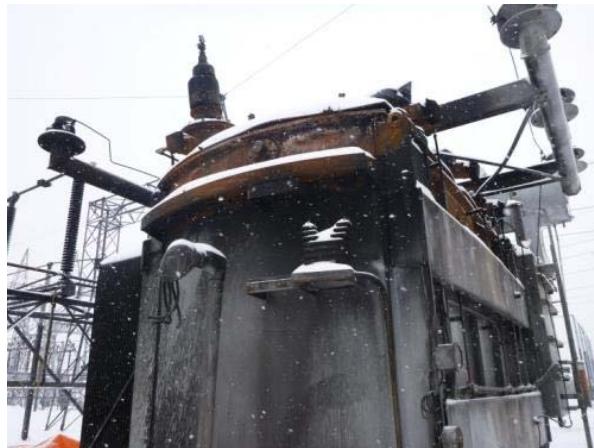
Illustration 3.1 Failed Sunnyside 125MVA T1 Transformer

At 9:05 a.m. on January 4th, Hydro experienced at its Sunnyside Terminal Station the first major event; *i.e.*, failure of the station's 125MVA T1 Transformer and a malfunction in an air-blast circuit breaker. A major power outage resulted from failure of one of five 230kV air-blast circuit breakers to open to interrupt the fault current produced by the T1 transformer fault, and because 230kV breaker failure protection had not been installed for a transformer fault.²⁹

The T1 transformer failure did not itself cause the major outage event. The Sunnyside terminal station has two 230/138kV 125MVA transformers (identified as T1 and T4). A fault in one of the transformers causes protective relays to sense the fault, and send "trip" signals to either the T1 or T4 "lockout relay." In order to clear (de-energize) a fault in either transformer, a fault detection

The long time required to clear the transformer fault resulted in the explosion and destruction of the T1 transformer. The oil expelled by the explosion ignited. The fire, the collateral damage caused, and ensuing system collapse most likely resulted from the two-second delay in clearing the transformer fault. The tripping of the transmission lines and long delay in clearing the transformer fault caused loss of supply, voltage depressions, and power frequency swings on the transmission system. A collapse of the transmission system and disconnection of the three Holyrood generating units (within three seconds of the transformer fault) ensued. The event caused power interruptions to about 187,500 customers on the Avalon Peninsula.

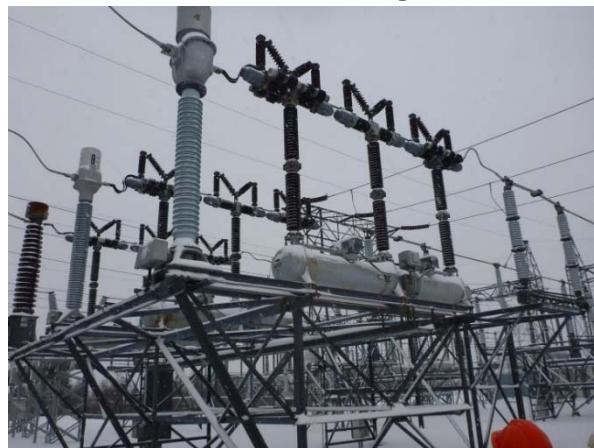
Illustration 3.2: Malfunctioning B1L03 Breaker

relay sends a trip signal to a lockout relay. This relay then sends trip signals to the two 230kV air-blast circuit breakers and to the three 138kV air-blast circuit breakers. These signals permit the rapid tripping (in less than 200 milliseconds) of all five circuit breakers, in order to isolate both transformers from the 230kV and the 138kV transmission systems. Correct operation of the equipment should have limited the consequences of transformer failure. Loads on each transformer at the time ran at less than 50 percent of capacity. Thus, the failure of one transformer should have permitted switching the 138kV load from that transformer to the other transformer within a short time.

The T1 transformer experienced an internal fault at 9:05 a.m. Breaker B1L03 malfunctioned. This breaker serves as one of the two 230kV air-blast circuit breakers connecting the transformers to the 230kV bus and to the four 230kV transmission lines. Breaker B1L03 “stuck,” and did not open. The line protection relays at the remote ends of the transmission lines exist primarily to protect the lines from faults. These relays therefore only provide time-delayed “back up” protection for a transformer/bus fault at Sunnyside. The last line to trip was the TL203 from the Western Avalon terminal station (where a transformer failed later in the day). The T1 transformer fault lasted a comparatively lengthy 2.0 seconds, because of the stuck breaker. The fault should have been cleared within the 200 millisecond standard.³⁰

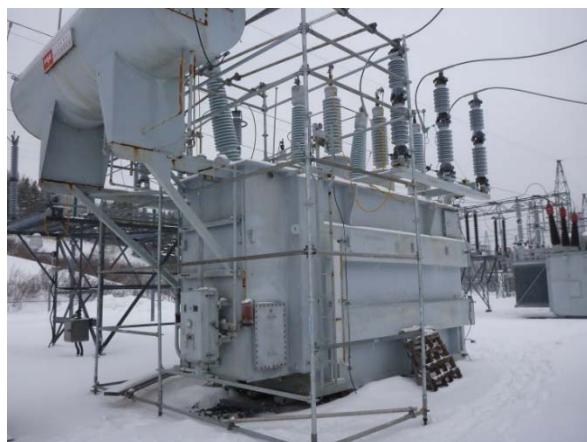
Illustration 3.3: Western Avalon Transformer T5

At 12:22 p.m. on January 4, 2014, Hydro's Western Avalon Terminal Station experienced an electrical fault in a transformer tap changer diverter switch and an air-blast circuit breaker malfunction. This event did not cause customer interruptions, but it did delay for several hours the restoration of service to customers already experiencing interruptions.⁴⁷

The Western Avalon terminal station has one 125MVA transformer (T5), two 41.7MVA 230/138kV transformers (T3 and T4) and two 25MVA 230/66kV transformers, connected on a straight bus. Hydro began attempting to restore the Western Avalon terminal station from the Come-by-Chance terminal station at about 9:30 a.m. on January 4th. Operators attempted to close Western Avalon air-blast circuit breaker B1L37 several times, in order to energize the bus and the transformers. The breaker, however, kept tripping shortly after each closing. The operators finally energized the terminal station by closing another breaker at 12:22 p.m. The 125MVA T5 transformer, however, faulted 12 seconds later. The 230kV bus tie breaker then tripped. This event cleared the T5 transformer fault, and also de-energized T3 and T4 (because they operate in parallel with T5, and connect to common 230kV and 138kV buses). Hydro later determined that the T5 transformer on-load tap changer faulted due to a flash over between the phases of the tap

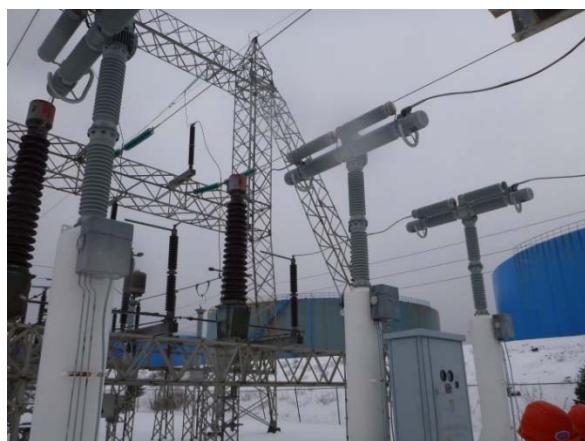
Illustration 3.4: Air-Blast Circuit Breaker B1L17

At 9:27 p.m. on January 5, 2014, a Holyrood Terminal Station air-blast circuit breaker failed to open. This third major customer interruption event affected 110,000 customers.

The arcing fault occurred because one phase of the 230kV air-blast circuit breaker B1L17 had been closed, even though the three position indicators (one for each phase) showed it as open on all three phases. The linkage to one of the indicators had also stuck. Because of the one stuck phase, single-phase current flowed back through the Unit 1 transformer. The disturbance caused the other two units, all transmission lines, and Holyrood station service to trip, and to disconnect from the system. The loss of the two other units at Holyrood generating station caused the interruption of about 110,000 customers.

For example, Hydro makes use of the now-dated technology of air-blast circuit breakers. Recent outage events on the IIS involved three of these devices. They should be, as has been recommended to Hydro in the past, operated (on a test basis) periodically to ensure that they will operate under extreme (but nevertheless predictable) environmental conditions. Our discussions with Hydro indicated that the company is now committed to doing so, but Hydro did not test them earlier. We also found that changes to Hydro's transformer examination and testing cycles and practices would better reflect the age and nature of its equipment.

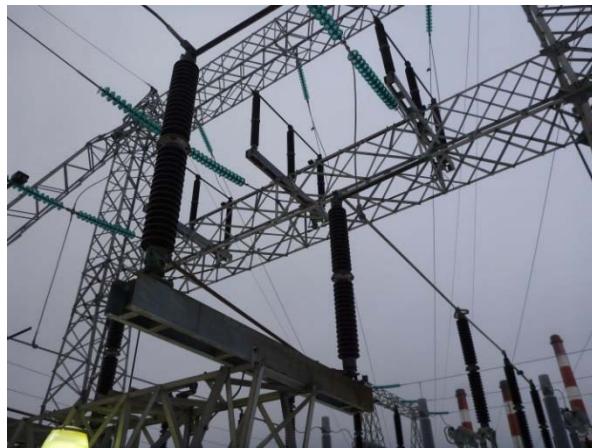
Illustration 3.5: Unit 1 Disconnect Switch

Hydro had restored Unit 2 and Unit 3 at Holyrood generating station. In preparing to bring Holyrood Generating Unit 1 on-line, operators had to close the Unit 1 switch between the line coming from the Unit 1 step up transformer and the presumably de-energized bus sections between the two breakers on the energized ring bus. The breaker open/close indicators on the control panel and on the breakers for the two air-blast circuit breakers showed both breakers to be in open status. When the operators closed the Unit 1 switch onto the supposedly de-energized bus section, an arcing fault occurred.⁶¹
