LOWER CHURCHILL PROJECT

SITE VISIT REPORT JULY 14 TO 23, 2014.

Prepared for: Natural Resources Canada and Nalcor Energy

Date: September 19, 2014

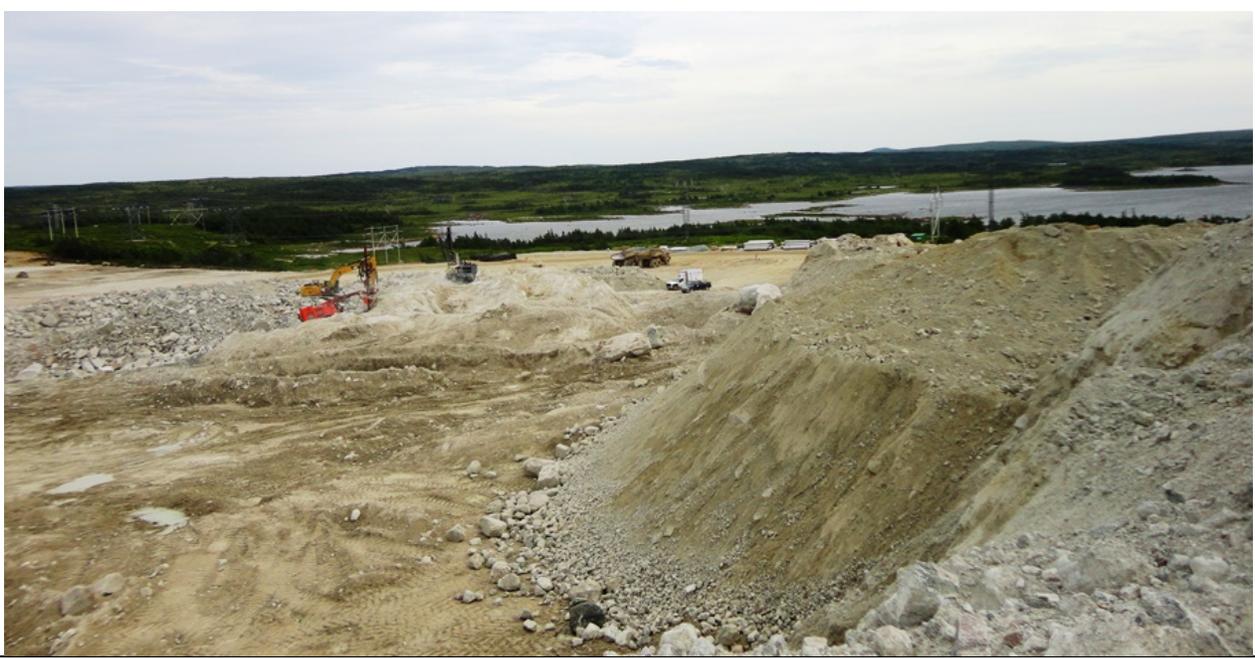
Photo 1.1: Soldier's Pond site; excavation work at the west end of the site. (July 14, 2014)

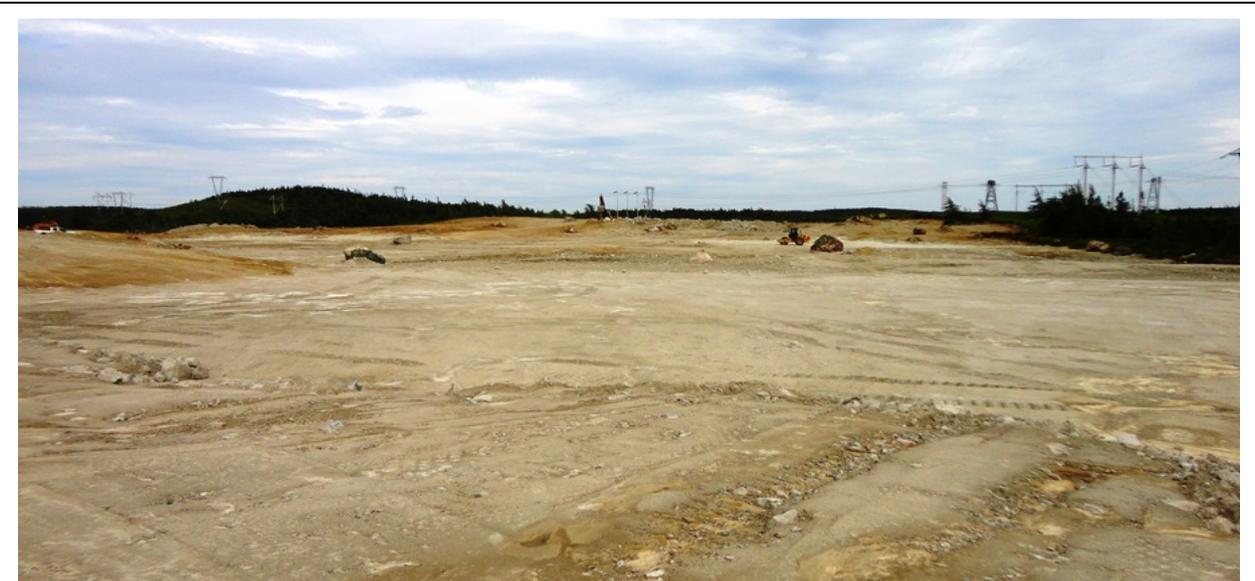
Photo 1.2: Soldier's Pond site; placing compacted fill to grade at east half of the site. (July 14, 2014)

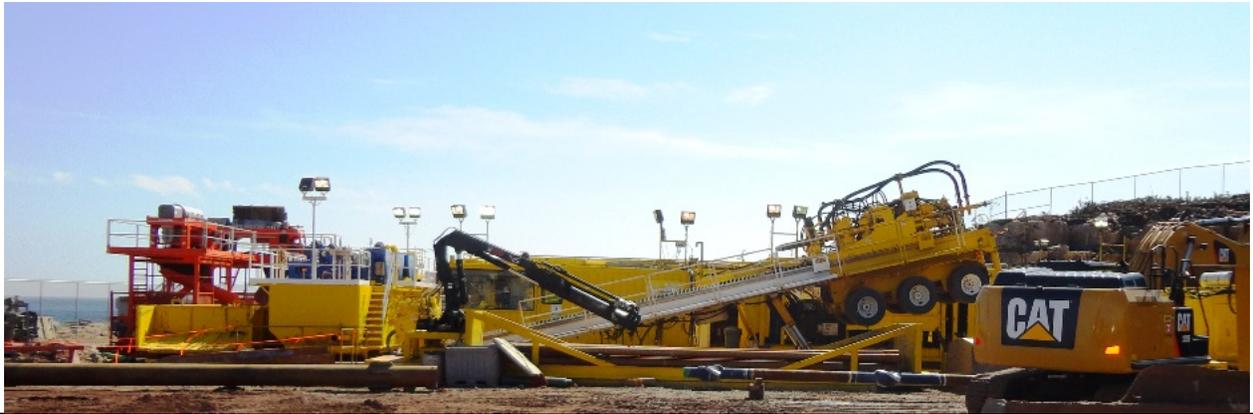
At the time of the site visit the directional drilling rig (Photo 2.1 in Appendix A), owned and operated by Direct Horizontal Drilling was set up on drill hole Forteau 2. The holes at this site are collared in competent, layered sandstone that has subhorizontal to gently inclined bedding (Photo 2.2 in Appendix A). As shown in Photo 2.3, the hole is collared near surface with 30 inch casing installed in a 36' boring. Inserts of 24" and 14" casing are telescoped into this and advanced in the hole as needed until sound bedrock is encountered. The main portion of the hole is drilled with a 14 3/4 " bit. The hole orientation and route are guided by a steerable bit that is oriented by compass guided instrumentation in non-magnetic rods (tool), 20 m behind the drill bit.

Photo 2.1: Forteau Directional Drilling. Inclined drill and equipment. (July 15, 2014)

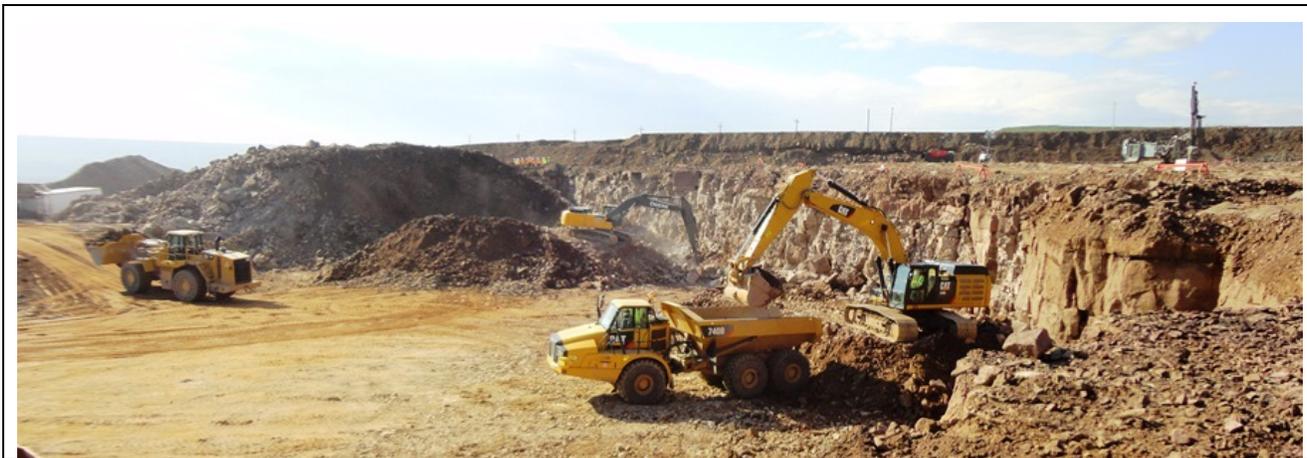
Work was progressing well at the time of the site visit. As can be seen on the photos in Appendix A, the quarrying operation has produced an 8 to 10 m high quarry face. The quality of blasting is good (Photo 4.1) and there is adequate equipment to blast, excavate and remove blasted rock from the face. The crushing and screening operation has produced a large stockpile of processed rockfill (Photos 4.2 and 4.3 Appendix A). The rock fill is made up of strong durable sandstone that is suitable for the intended use.

Photo 4.1: Forteau quarry. Principal quarry face on the right side of the photograph. Note stockpile of unprocessed rockfill in left background. (July 15, 2014)

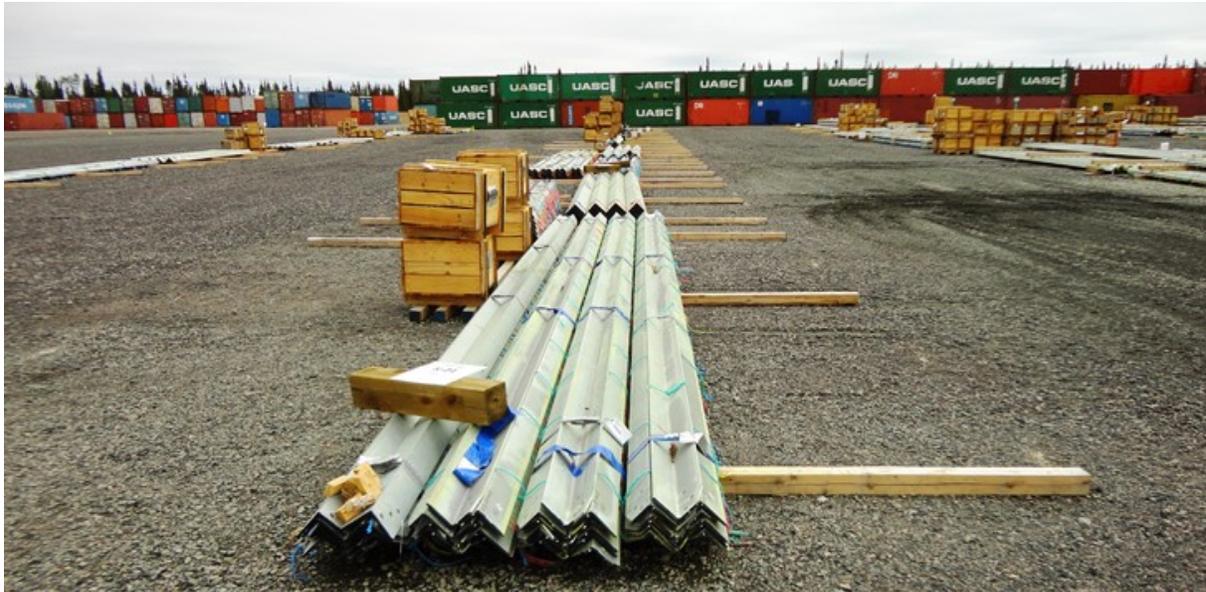
A main marshalling yard has been set up near Goose Bay (Photos 5.1 and 5.2). It is very well organized and has ample space for the planned quantities of construction materials for the various construction sites across Goose Bay, Muskrat Falls and the transmission lines.

Photo 5.1: Goose Bay Marshalling Yard (July 16, 2014)

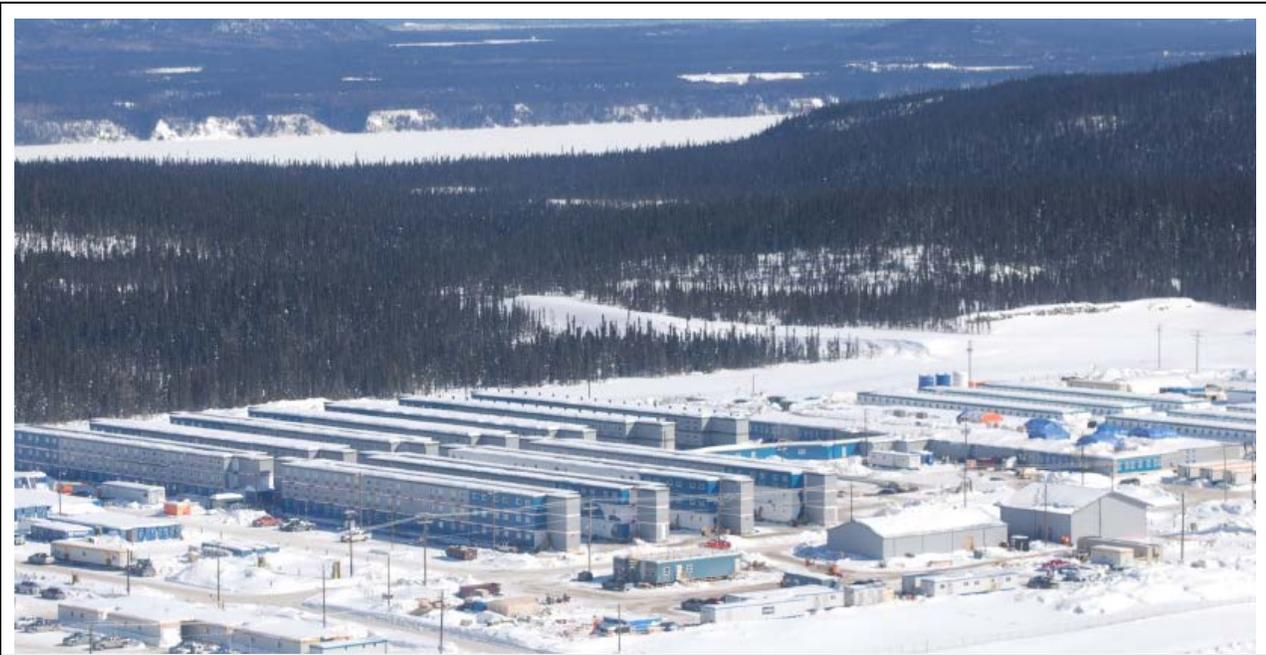
Nalcor is providing camp facilities for the various contractors. The new permanent camp is now completed (Photo 5.3 in Appendix A). Accommodations for approximately 1500 persons are available in the new permanent camp, supplemented by an additional 300 in the original "temporary" camp. The camps are of the accepted and even higher standard for northern work sites in Canada. The facility has adequate dining and recreation (a gym facility is still in construction) facilities for the residents. The main camp's kitchen and lounge for 500 single seating are very well organized and generally of a high standard. The kitchen layout accommodates a second (spare) serving bay that provides increased capacity during peak hours demand. The living quarters are with individual units, each one equipped with TV and wireless internet, individual toilet and shared (by two units) shower. Additional camps have been established at Churchill Falls and along the transmission line route, upstream of Muskrat Falls.

Photo 5.3: Muskrat Falls Camp, permanent and starter (Nalcor photo -Winter 2014)

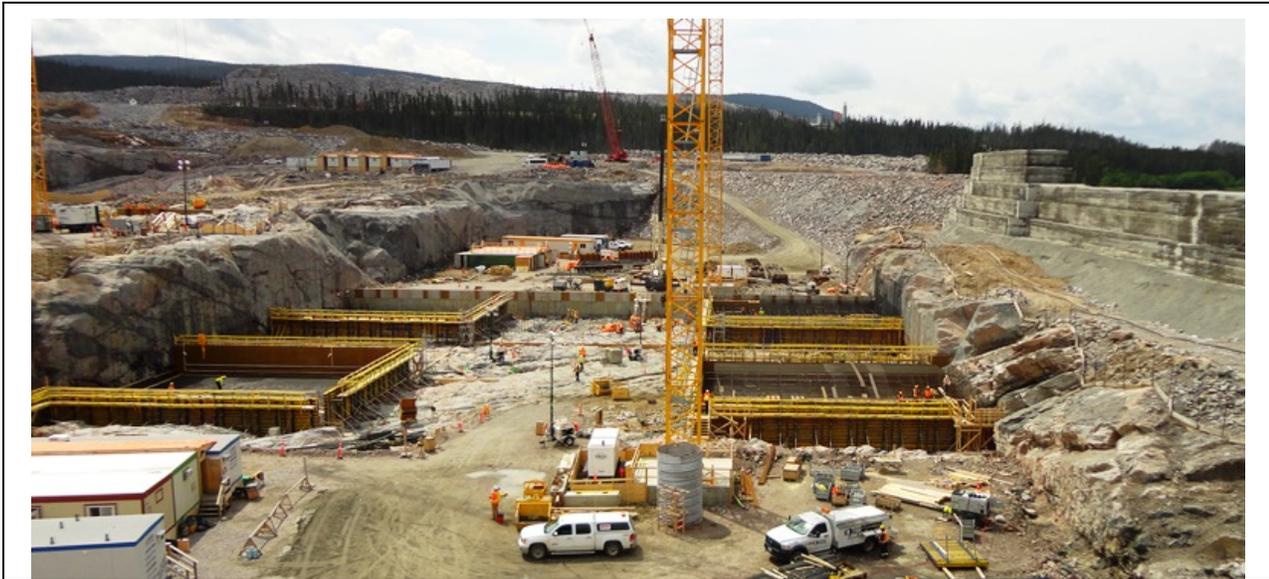
- During the IE site visit, work was underway at the first four base slabs of the spillway (Photo 6.2 in Appendix A). Foundation preparation had been completed, but could not be inspected by the IE on foot because of the limitations of the tour itinerary and heavy concentration of work at the foundation area.

Photo 6.2: Spillway base slab. Formwork for first four blocks of the base slab. (July 17, 2014)

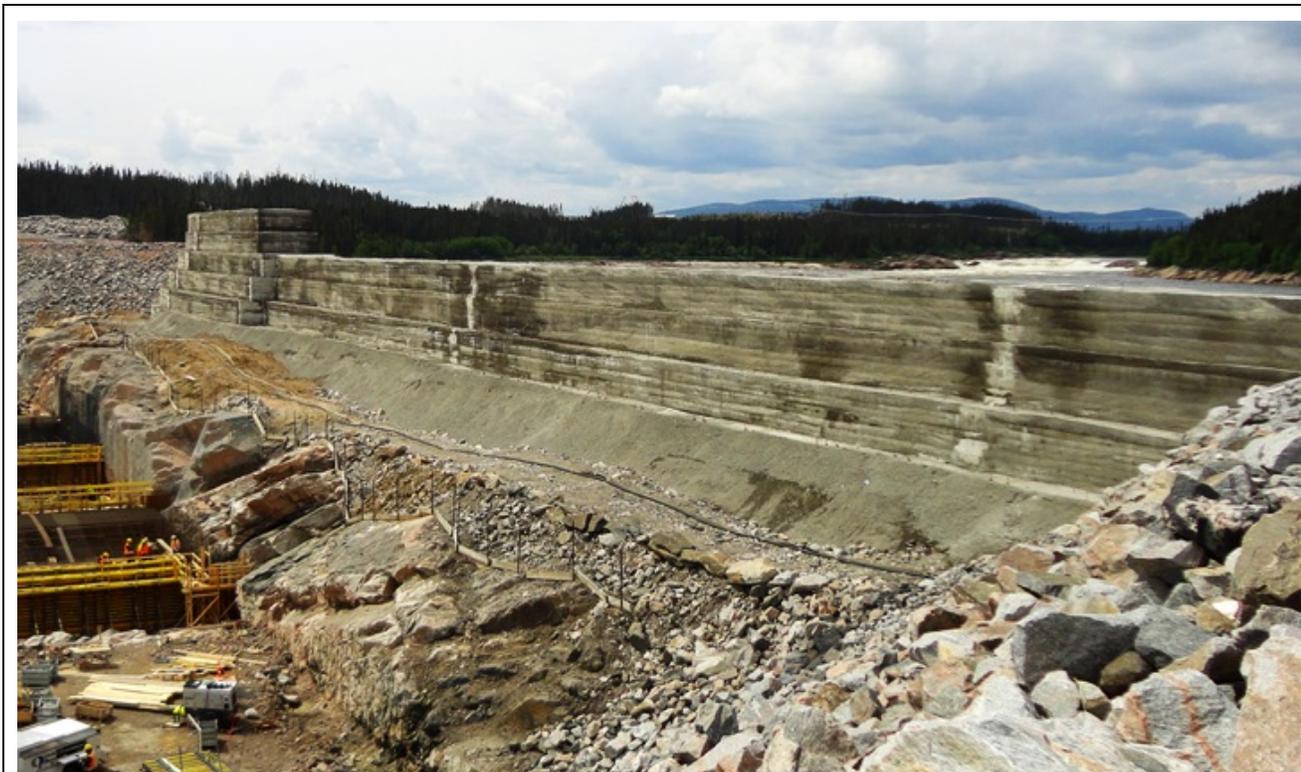
- The completed first stage cofferdams are shown on Photos 6.3 and 6.4 in Appendix A. These structures performed very well during the winter of 2013-2014 despite the unusual severity of the river ice conditions.

Photo 6.3: RCC cofferdam above the spillway left wall. Note the localized blasting overbreak of the spillway rock slope caused by block sliding along pervasive foliation planes. (July 17, 2014)

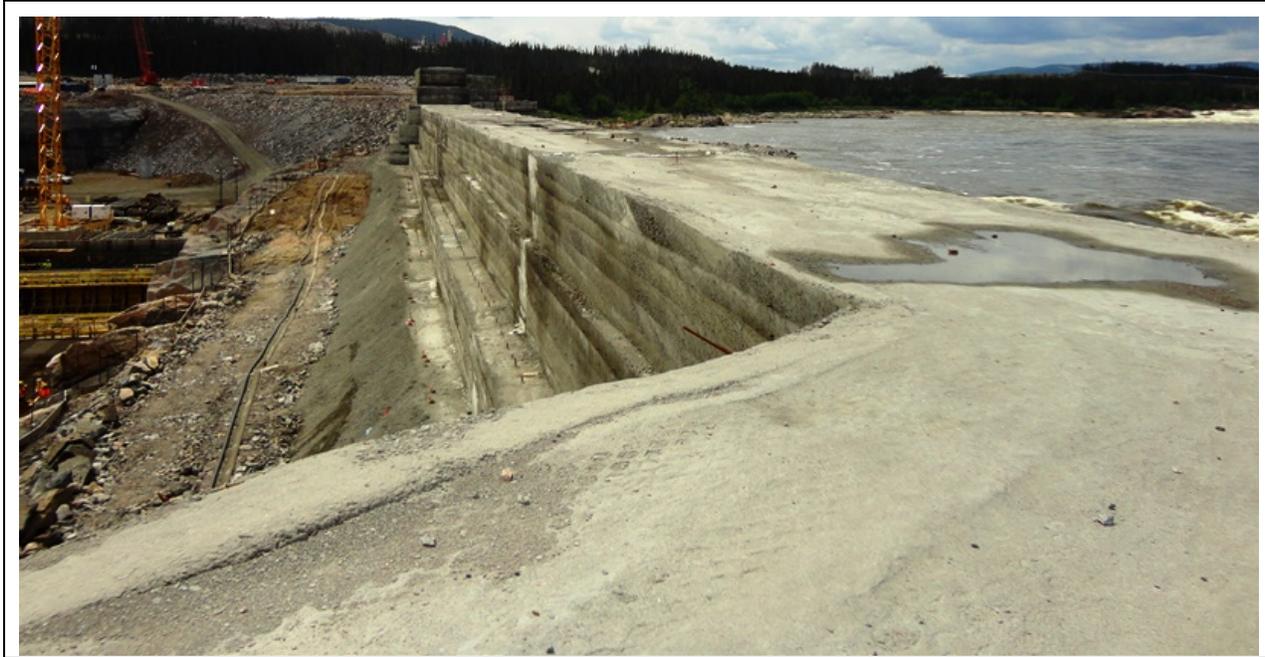
Photo 6.4: RCC cofferdam above spillway left wall. (July 17, 2014)

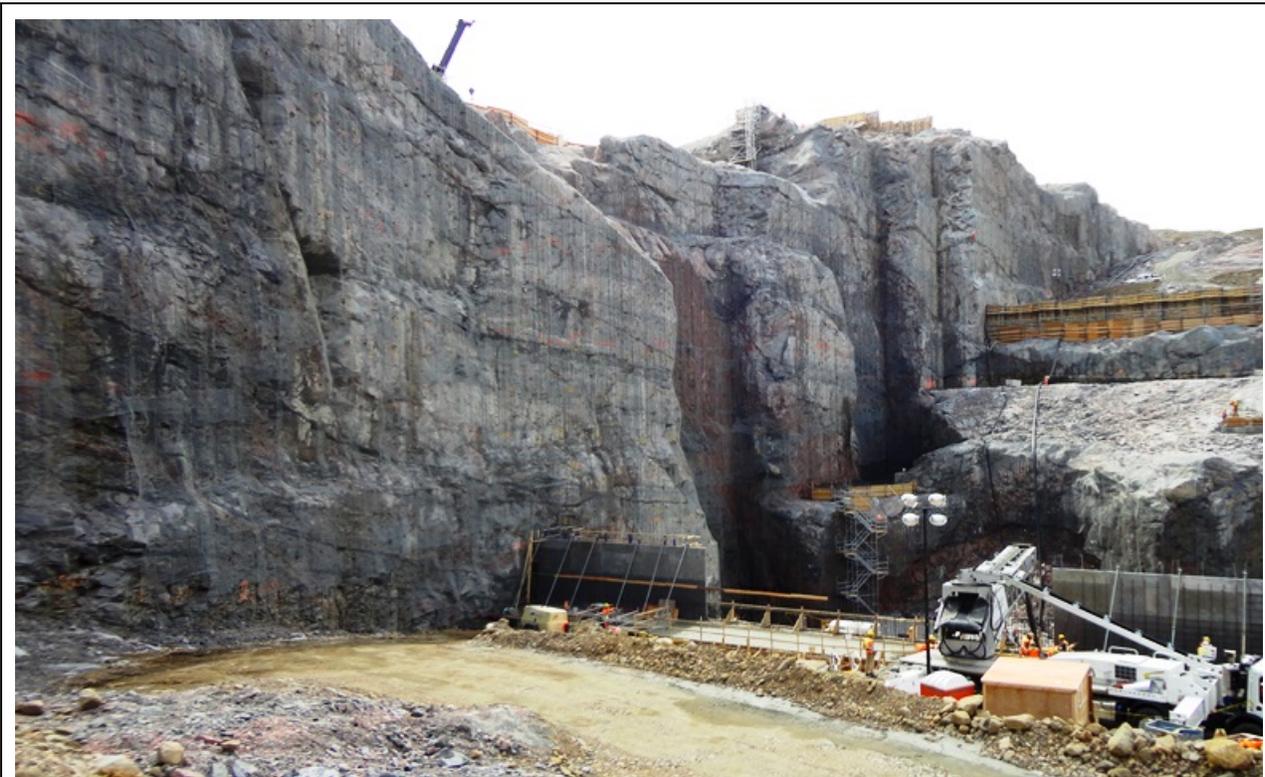
Photo 6.5: Right rock slope at powerhouse. Note the excellent quality of the line drilled excavated rock walls. A single fallout of a small wedges has caused a very localized overbreak feature. (July 17, 2014)

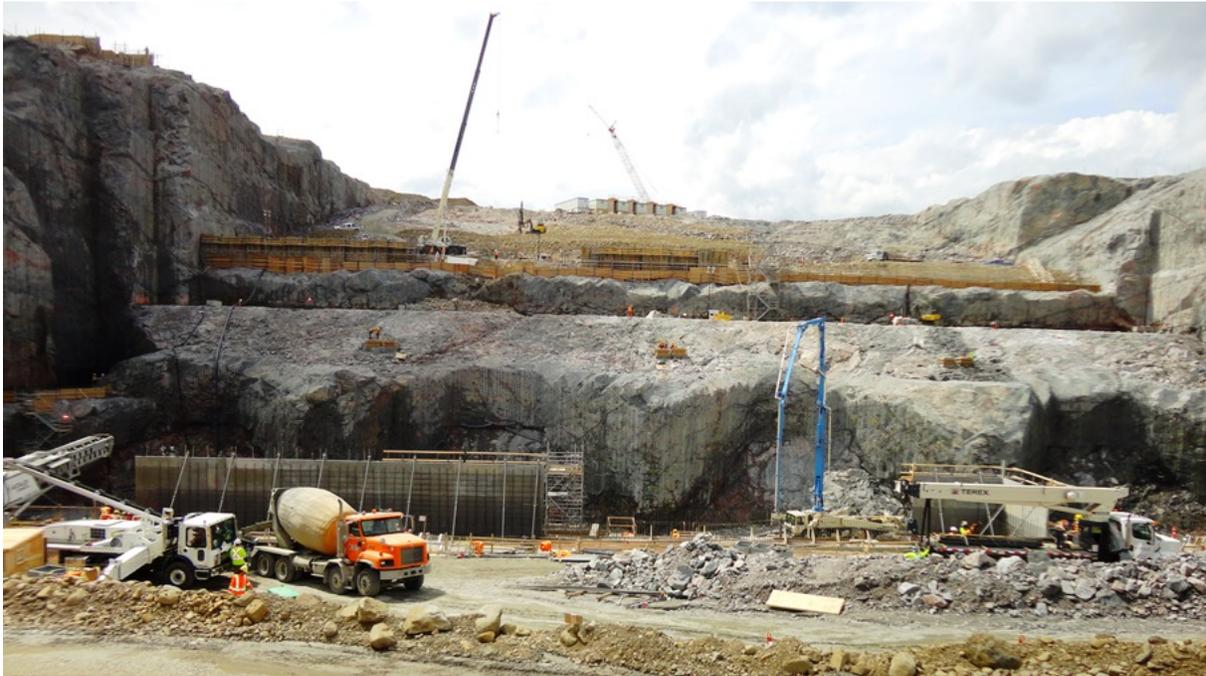
Photo 6.6: Powerhouse excavation, view looking upstream. The excellent control blasting results are visible in the rock noses between the unit cut-outs. (July 16, 2014)

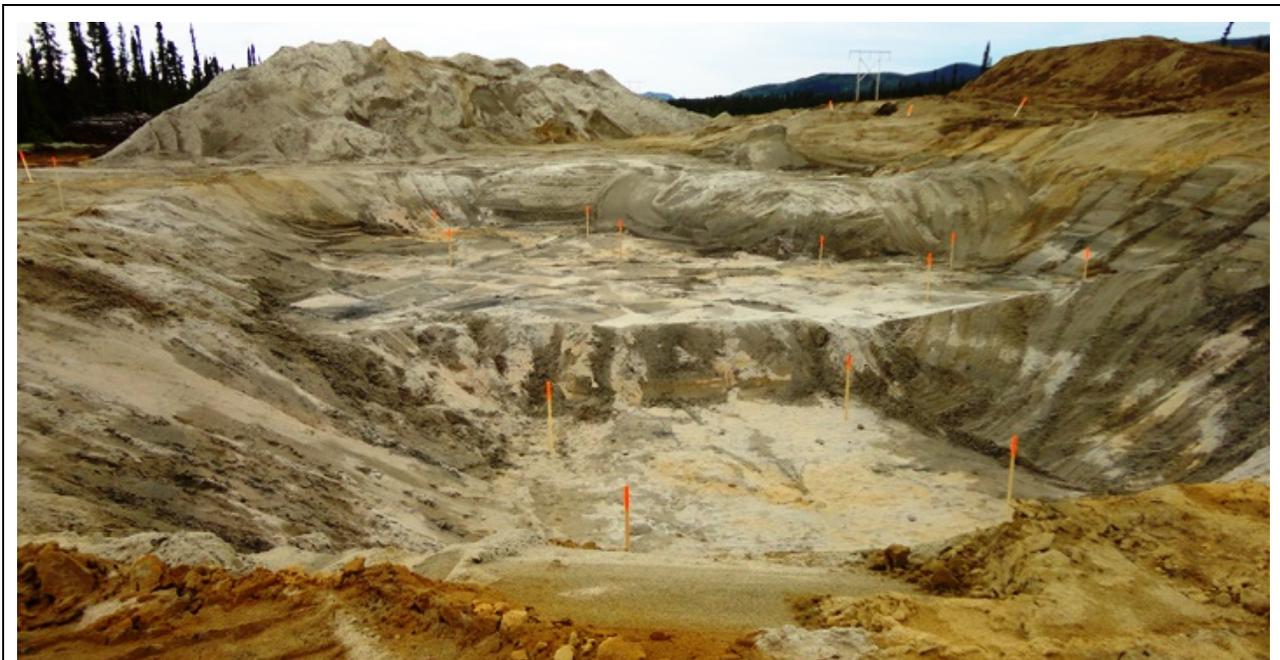
- Prepared foundations were viewed, as shown on Photo 8.2 in Appendix A. Work on the foundations examined has been carried out in accordance with good practice.

Photo 8.2: Transmission Tower Erection and Foundations. Excavated and prepared tower foundation (July 16, 2014)

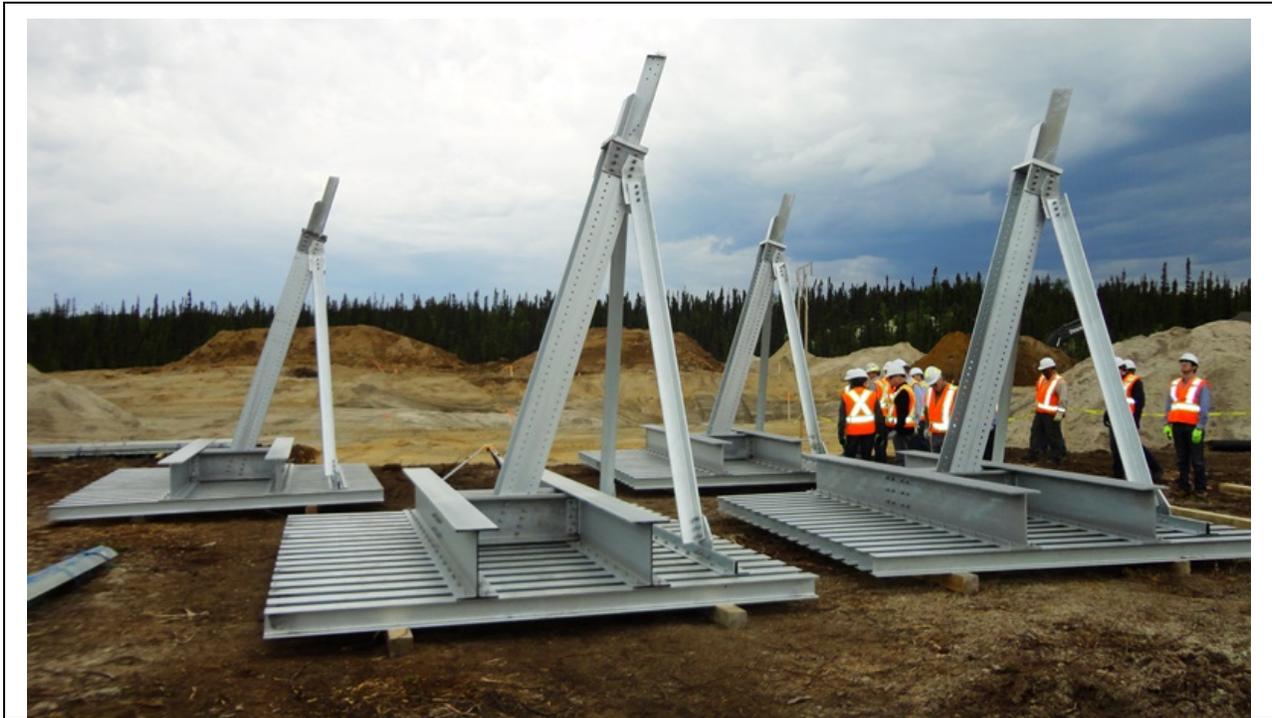
- Grillage footings (Photo 8.3 in Appendix A) are being used for overburden foundations. Two types of grillage footings were available for the HVac line; 100 kPa footing for loose to compact sandy foundations and 250 kPa footings for denser soils, including glacial till deposits. It is understood that there is a steel footing for competent bedrock foundations. Similar footings are used for the HVdc lines east of Muskrat Falls and on the island of Newfoundland. It is understood that footing types for various foundation conditions are chosen by qualified geotechnical personnel in accordance with a set of field guidelines prepared by the designers.

Photo 8.3: Transmission Tower Erection and Foundations. Assembled grillage footings. (July 16, 2014)

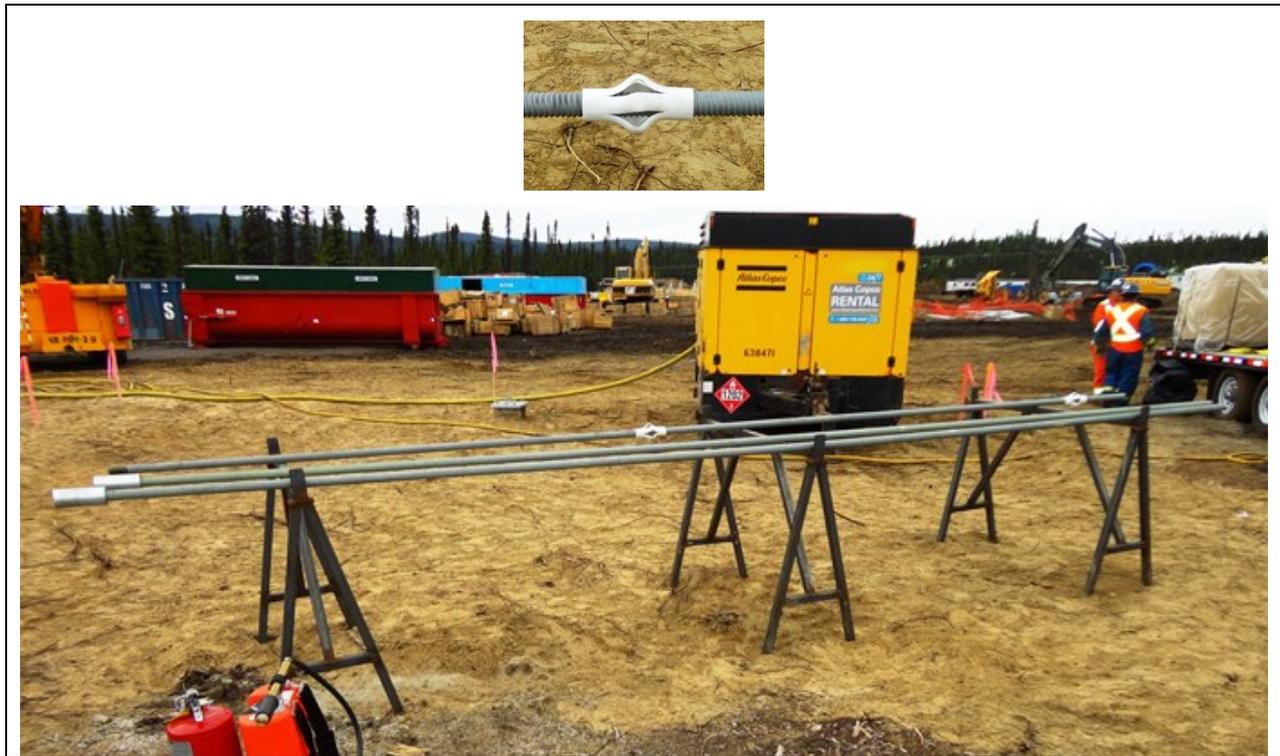
Photo 8.5: Transmission Tower Erection and Foundations. Ground anchorage assembly, complete with couplers. Inset shows a typical plastic centralizer (July 16, 2014)

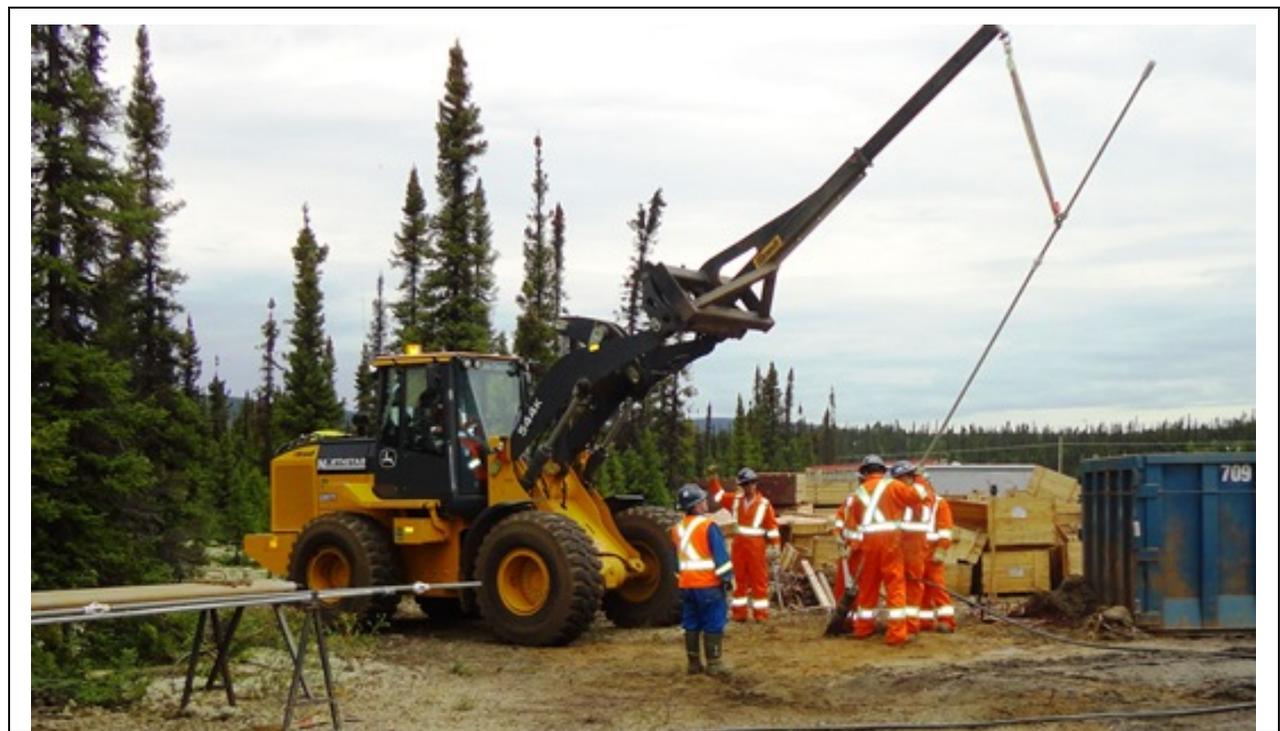
- Guy wires for towers are attached to fully grouted soil anchors. The IE team viewed installation work for one of these anchors on July 16, 2014 (Photos 8.5, 8.6 and 8.6 in Appendix A). The anchor details vary depending upon soil conditions and guy wire loadings. The following ground anchor design details apply:

Photo 8.6: Transmission Tower Erection and Foundations. Installing a ground anchor. (July 16, 2014)

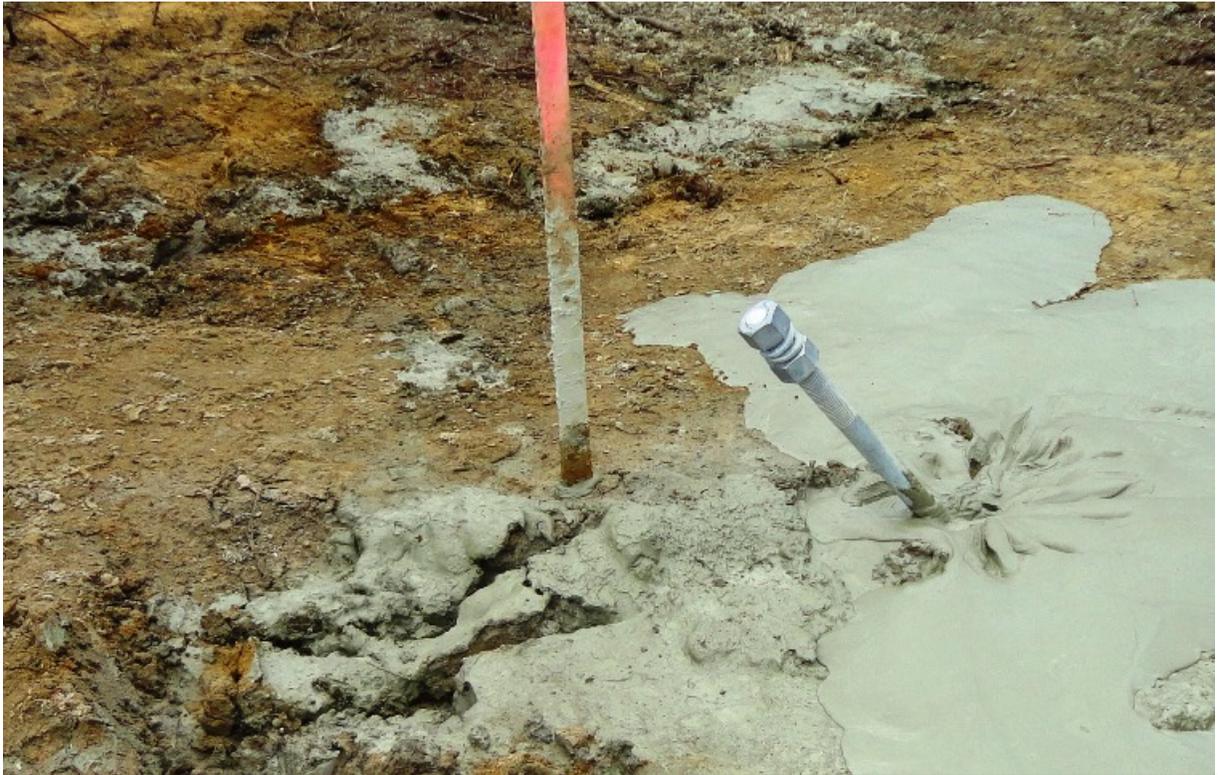
Photo 8.7: Transmission Tower Erection and Foundations. Installed, fully grouted ground anchor. (July 16, 2014)
