1 Q. Please provide a copy of the report referred to on page 22 of Volume 1 of Hydro's
2 Report to the Board dated March 24, 2014 that was completed by an external
3 consultant on the electricity system readiness for the 2013-2014 winter season.

Newfoundland and Labrador Hydro Facilities Winter Readiness Review

April 16, 2014

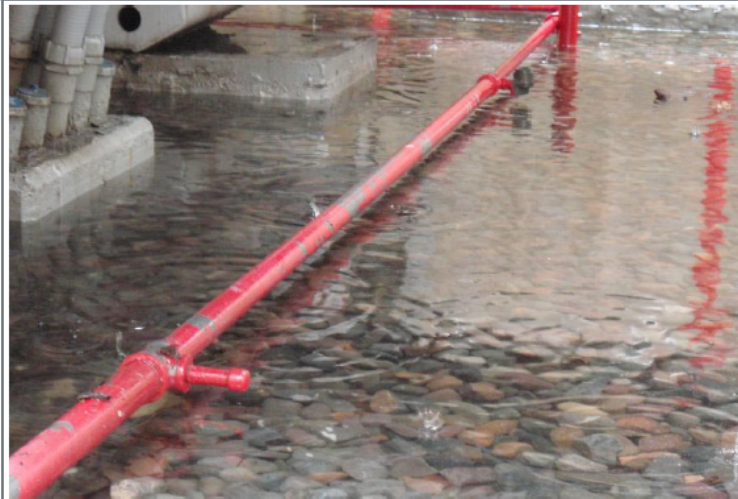
Reinstall the missing spray nozzle for the Transformer No. 1 deluge sprinkler system. The missing nozzle is located under the east side radiator.

Missing Spray Nozzle on Transformer No. 1

This work has not been completed, but the spray nozzles are on order and will be done in the new year.

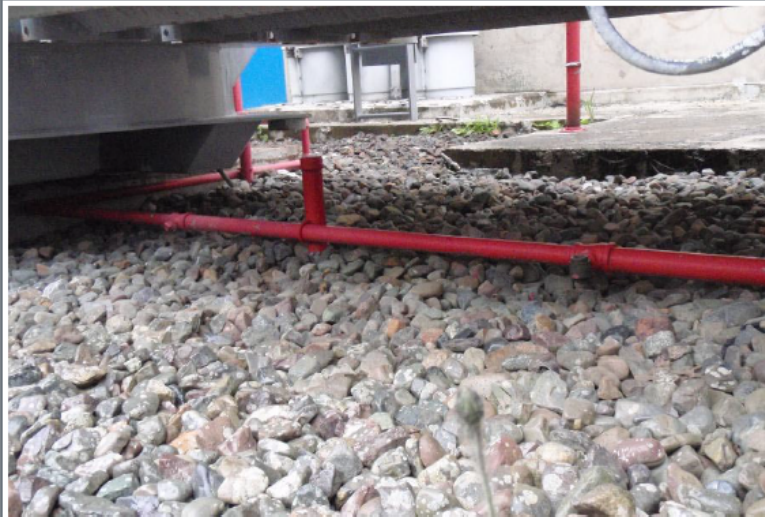
Reinstall the missing spray nozzle for the Transformer No. 4 deluge sprinkler system. The missing nozzle is located under the south-side radiator.

Missing Nozzle Transformer No. 4

Reinstall the missing nozzle for the Transformer No. 4 deluge system.
