1 **Q. Please describe how transmission line equipment repairs are prioritized and state**
2 **the time limits for each prioritization.**

Appendix C
Photographs of Transmission Lines
12L, 13L, 18L, 35L and 68L

**2013 Transmission Line Rebuild
June 2012**

**2010 Transmission Line Rebuild
June 2009**

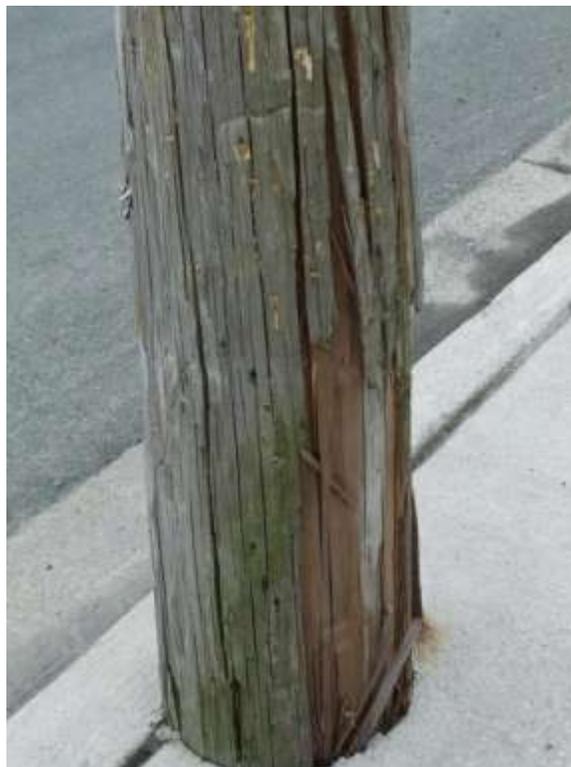
Figure 1 – 12L - Pole showing checking around bolts

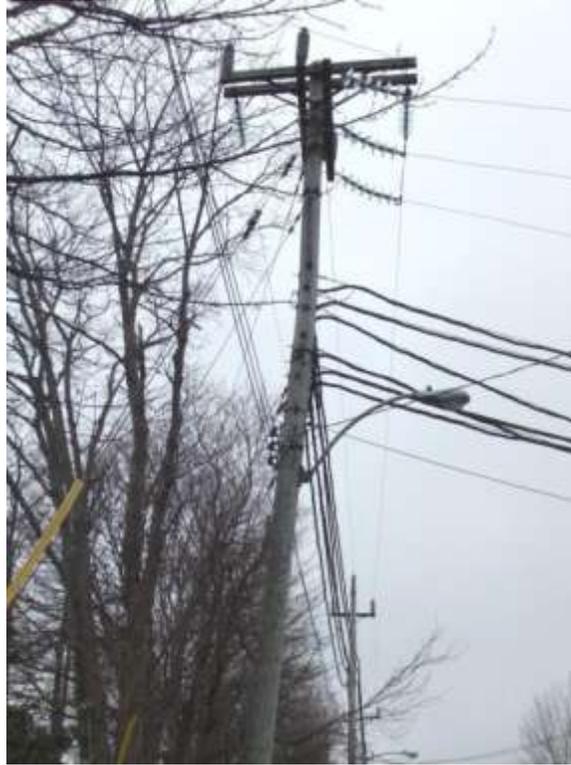
Figure 2 – 12L - Pole showing shell separation and damage

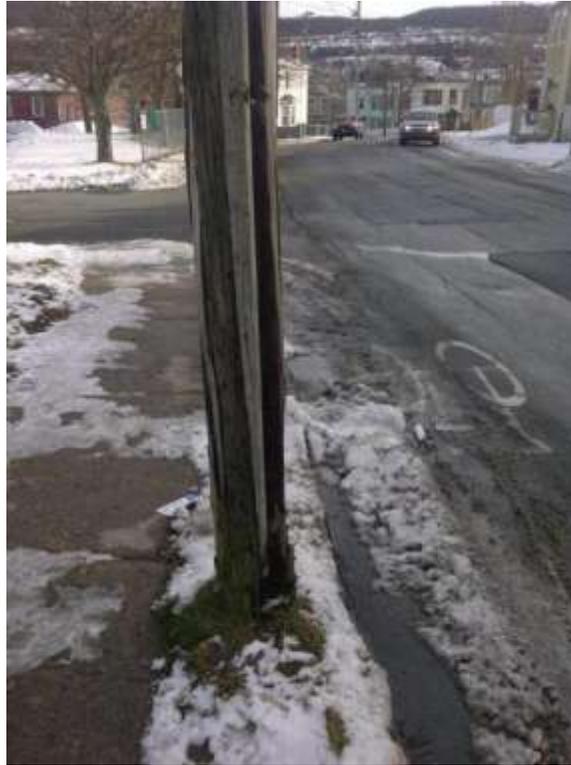
⁴ Most of the poles are located adjacent to city streets and are prone to damage by passing snowploughs and other vehicles. Where practical, new poles will be located behind the sidewalk to mitigate future damage.

Figure 6 – 13L - Pole showing vehicular or snow plough damage

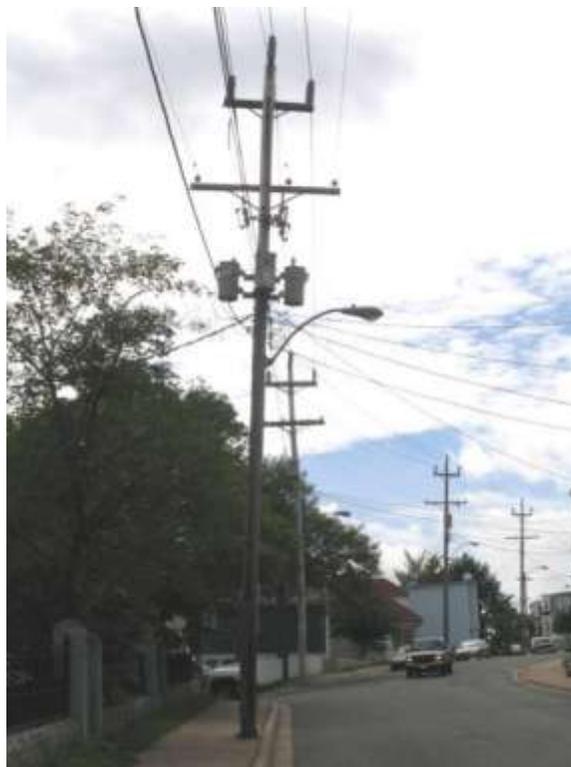
Figure 7 – 13L - Deteriorated pole showing shell separation

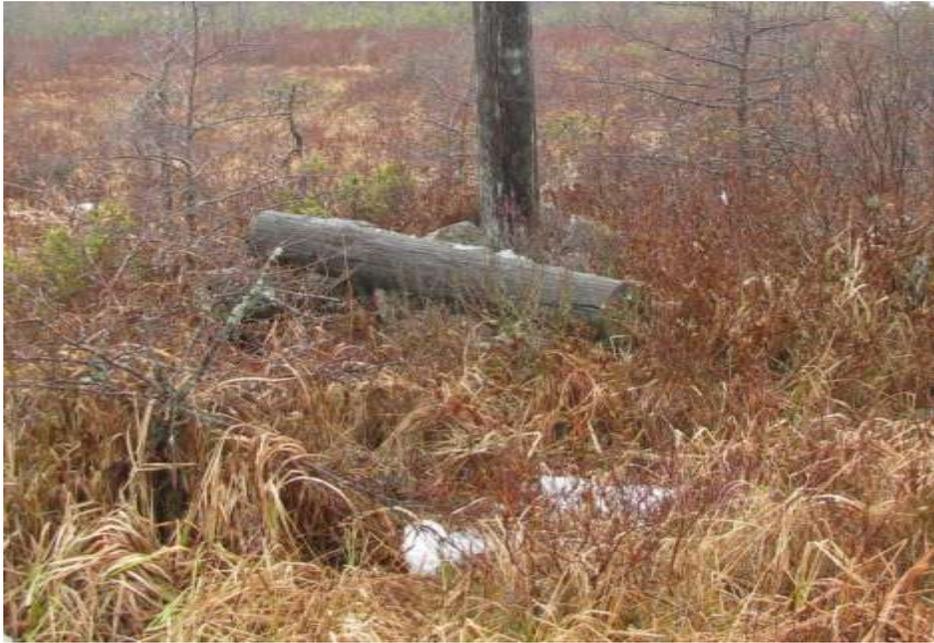
Figure 9 – 18L - Deteriorated Pole Crib

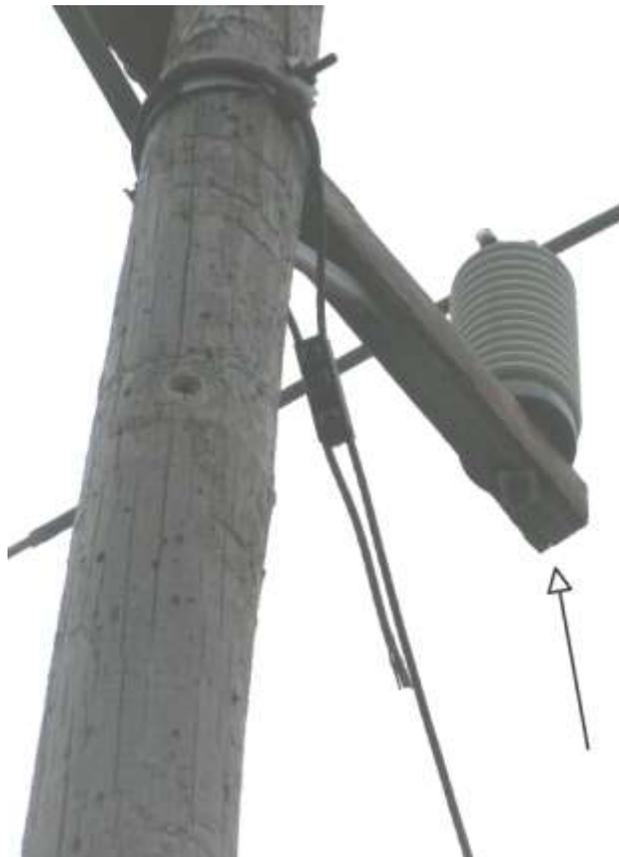
Figure 10 – 18L - Split crossarm and nonstandard guy wire

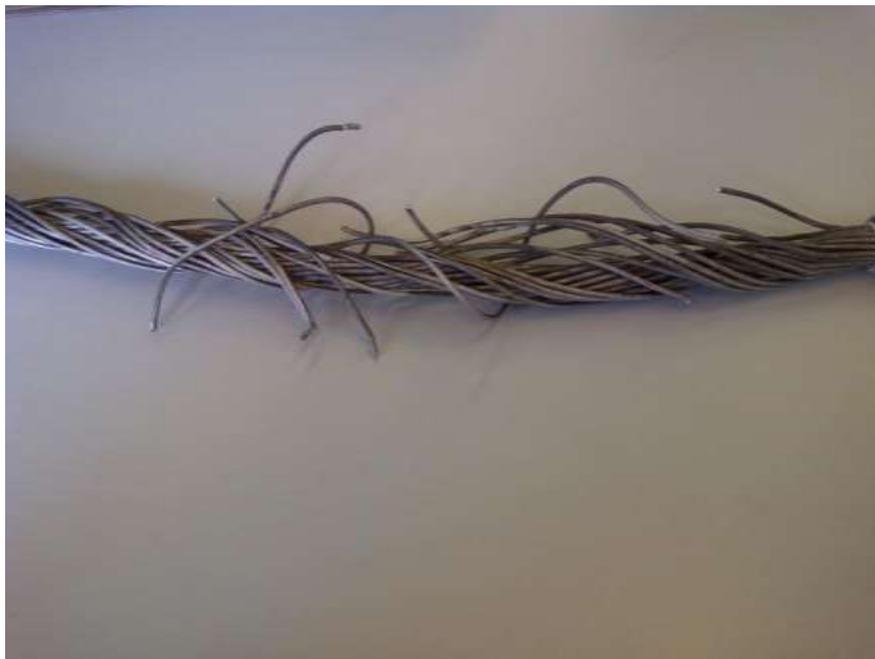
Figure 12 – 18L - Conductor damage removed in 2012

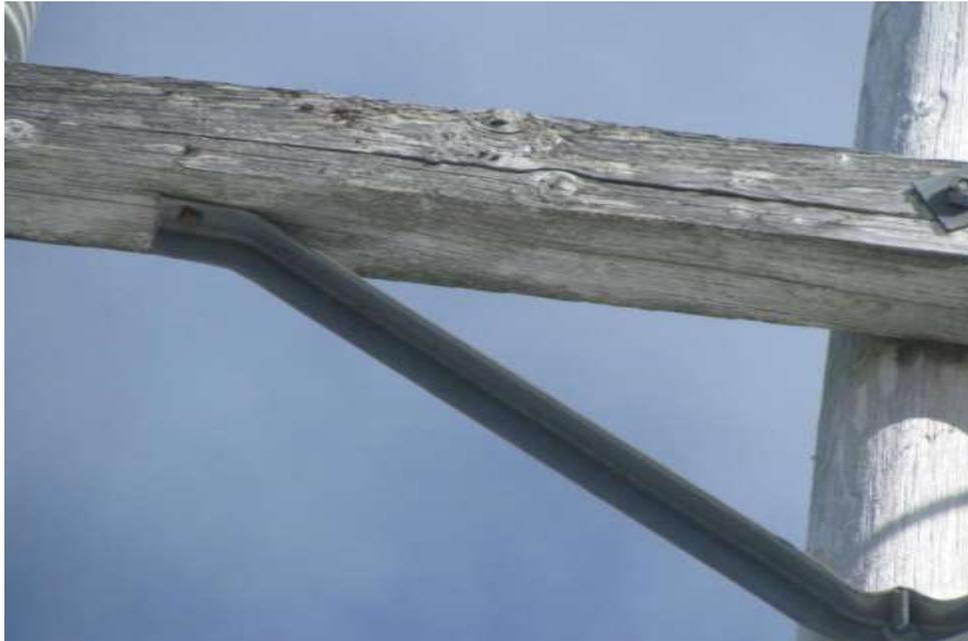
Figure 13 – 35L - Split crossarm

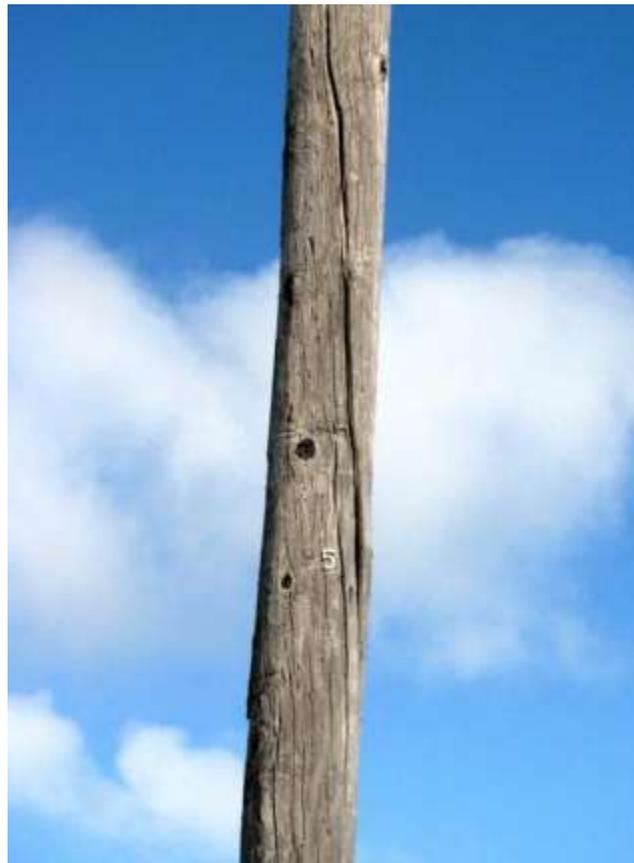
Figure 14 – 35L - Severely deteriorated pole

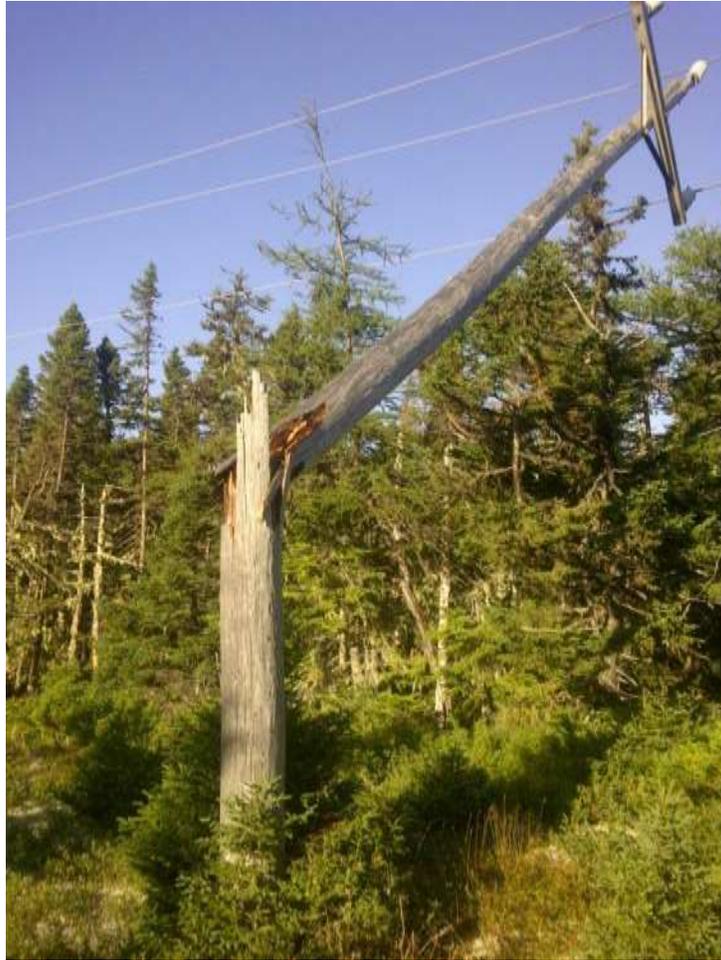
⁶ Most recently in 2012 three poles in this section failed due to heavy wind loading during Tropical Storm Leslie.

Figure 15 – 35L - Broken pole - Tropical Storm Leslie

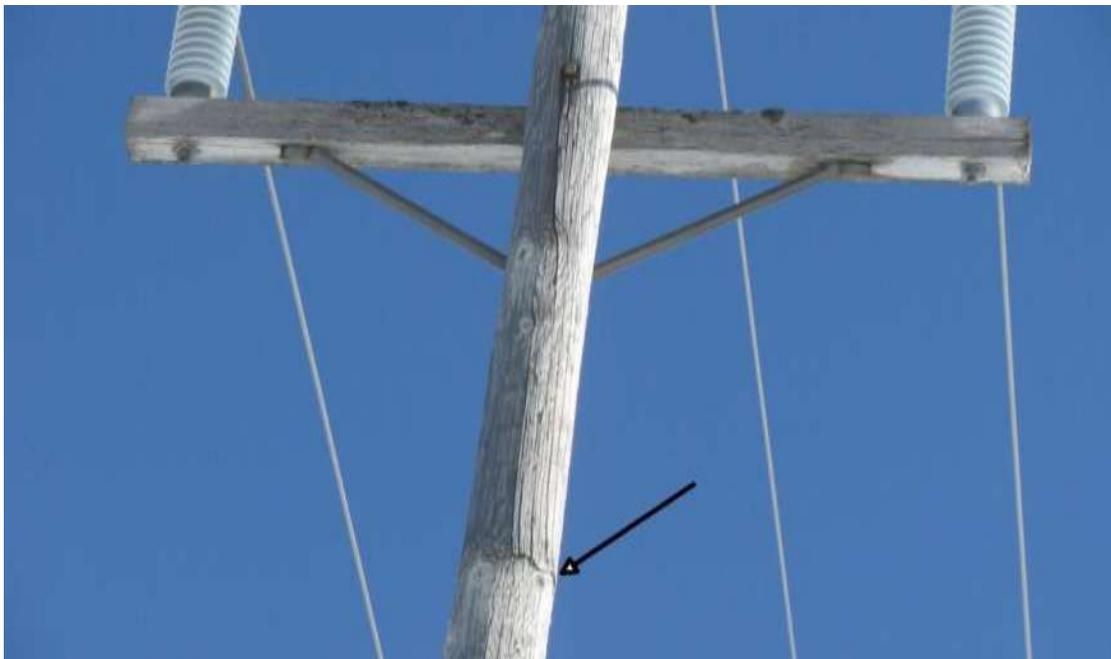
Figure 16 – 35L - Horizontal crack in pole

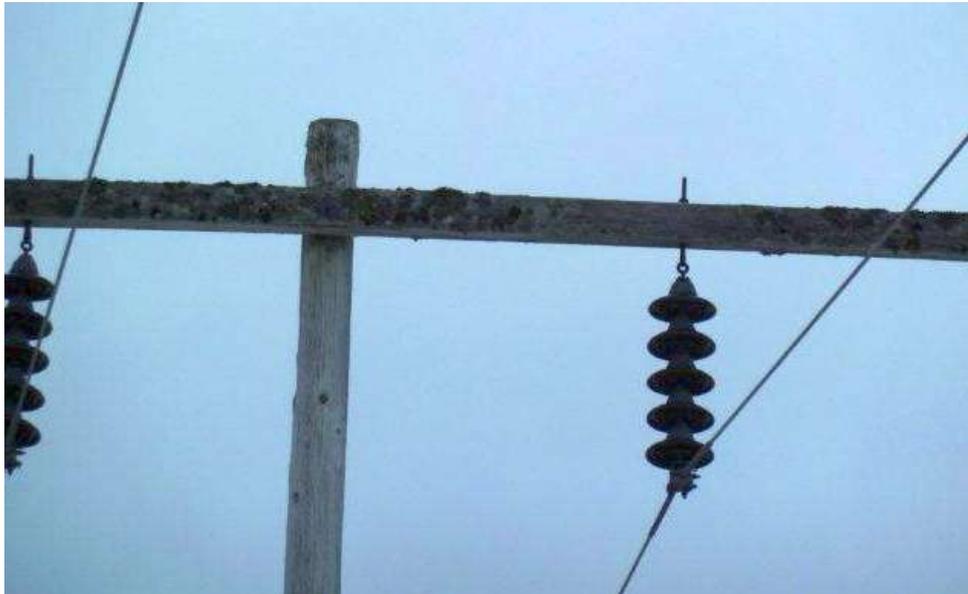
Figure 17 – 68L - Mossy/rotten crossarm

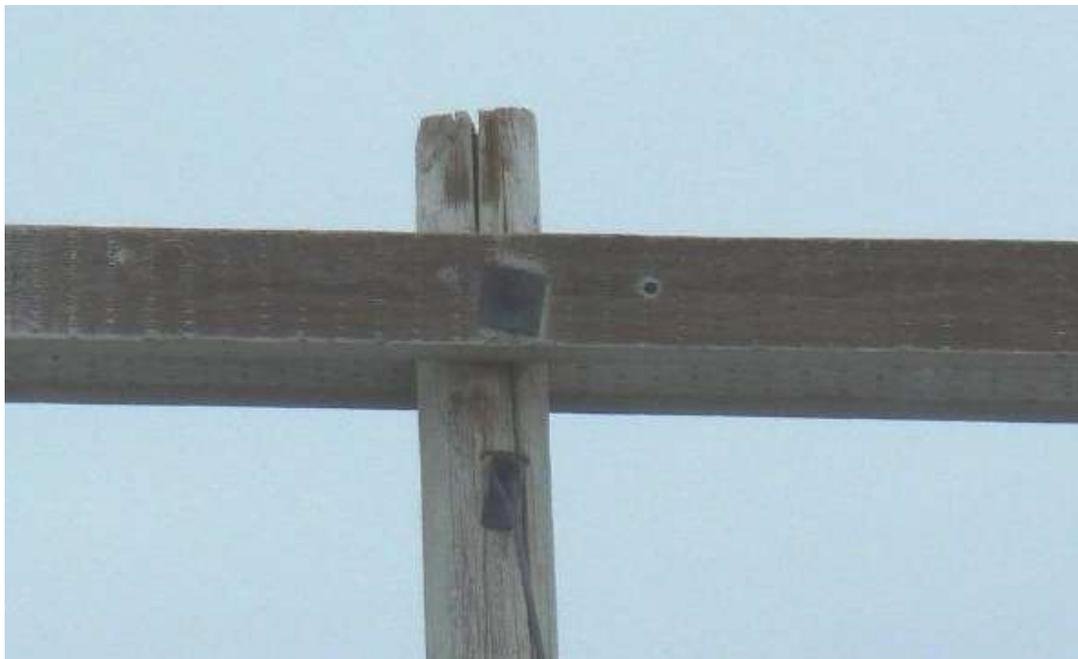
Figure 20 – 68L - Deteriorated pole and crossarm

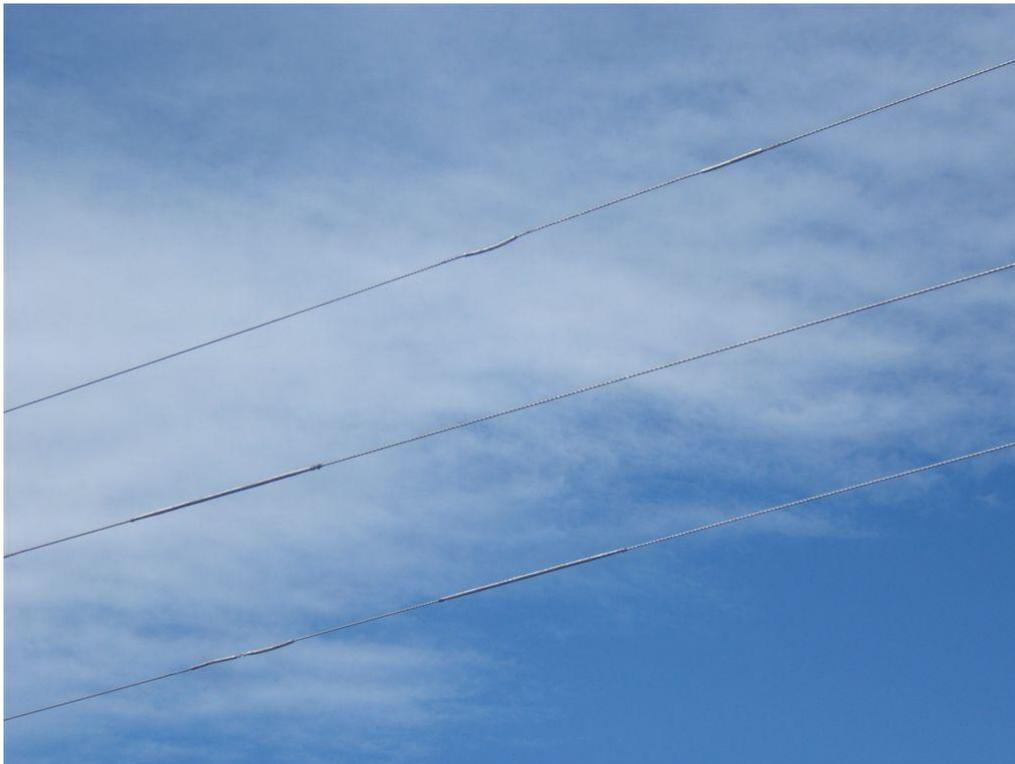
Figure 1 – 110L – Multiple sleeves to repair conductor damage

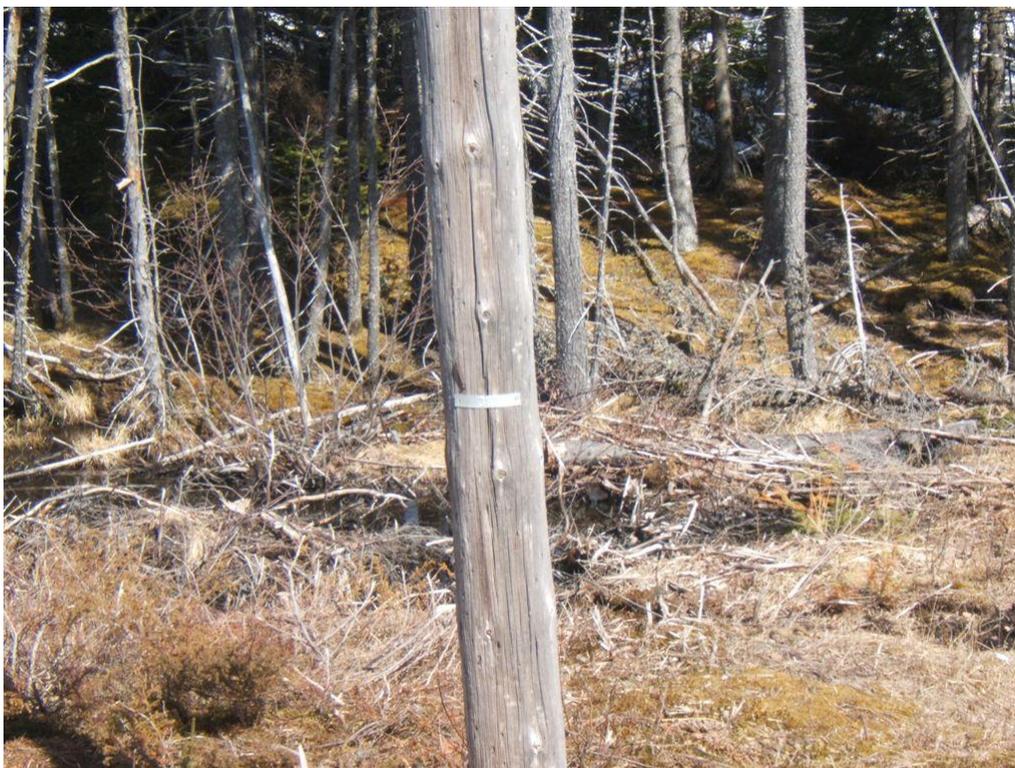
Figure 2 – 110L – Checks in pole

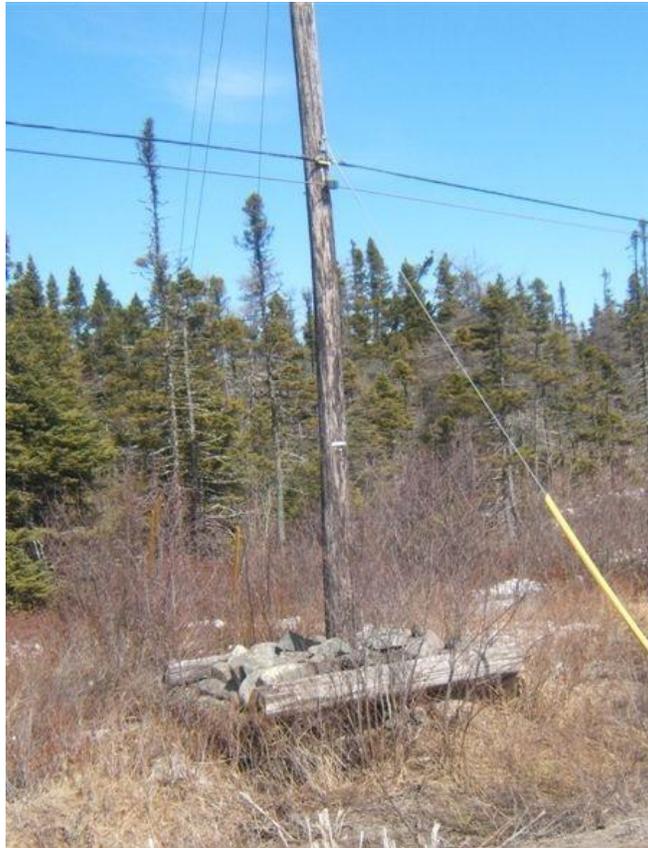
Figure 3 – 110L – Deteriorated pole and crib

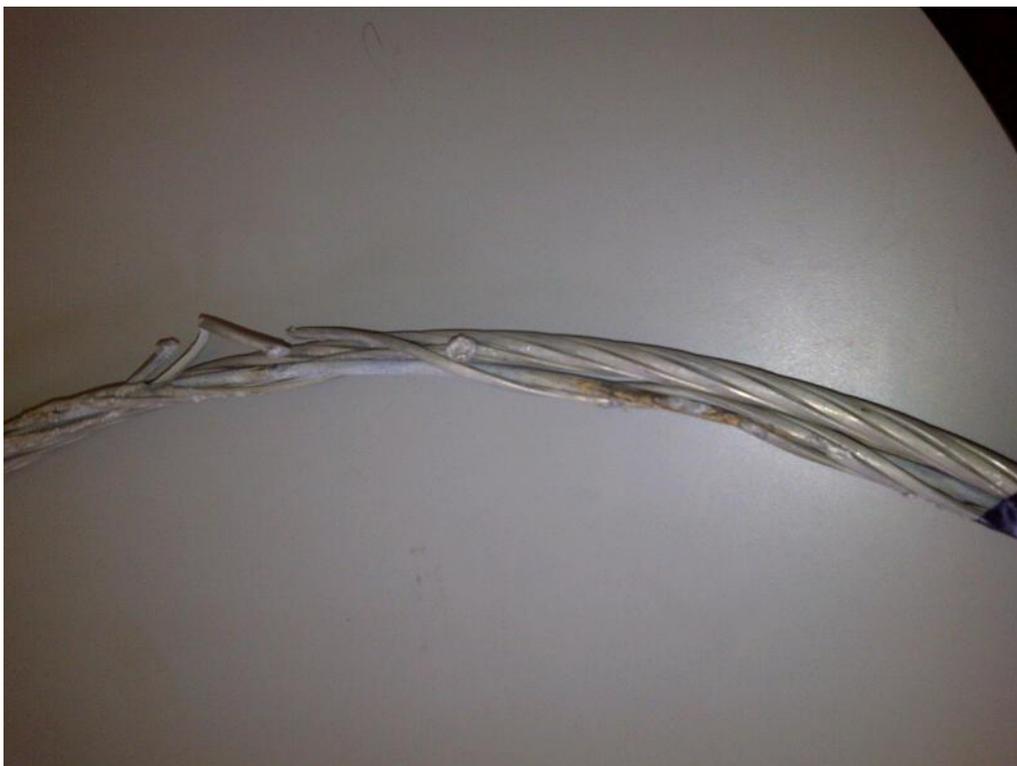
Figure 4 – 110L – Damaged conductor removed from 110L in December 2011

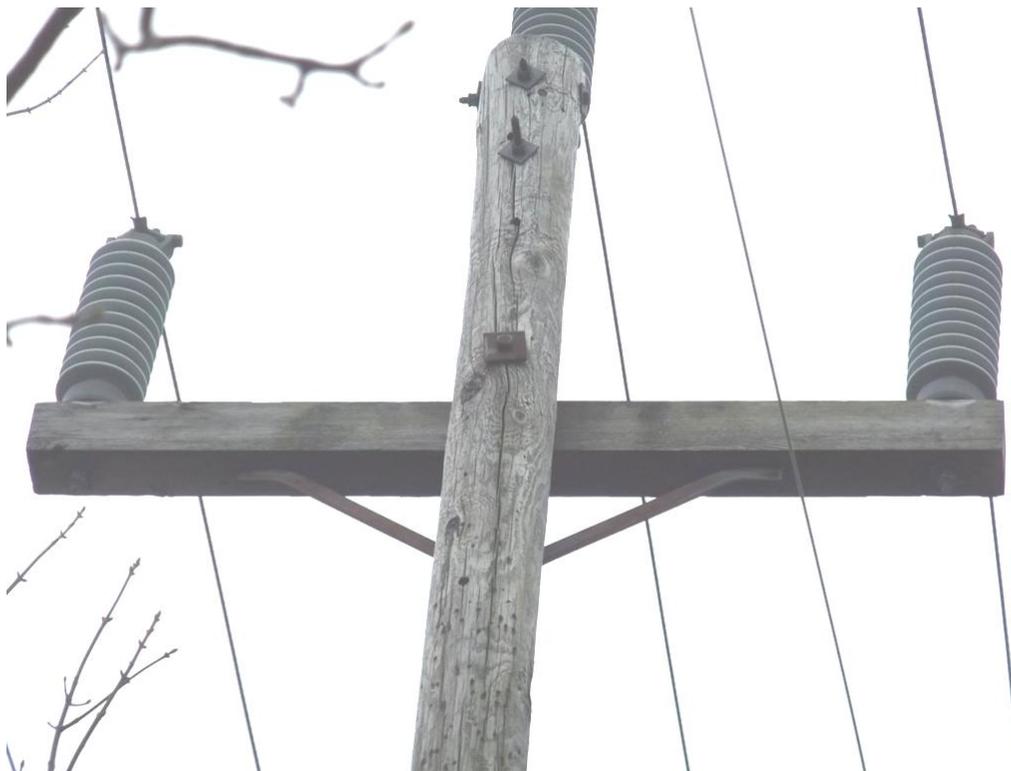
Figure 5 – 12L - Pole showing checking around bolts

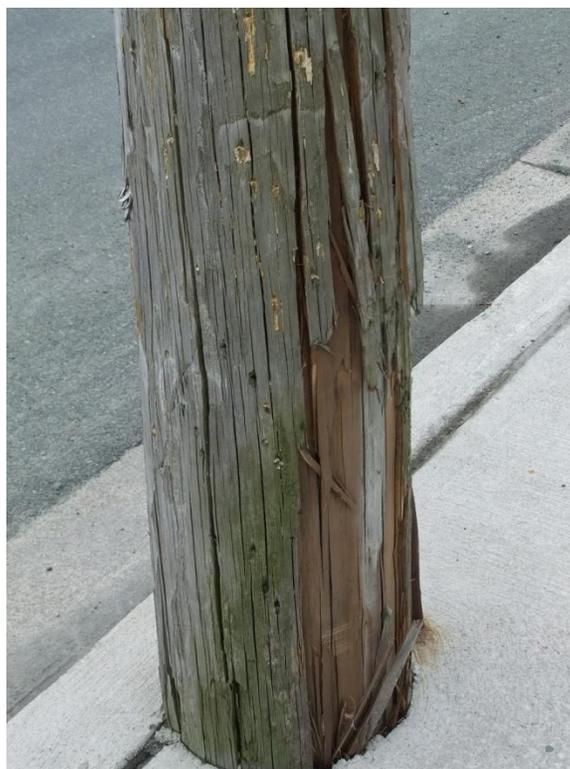
Figure 6 – 12L – Pole showing shell separation and damage

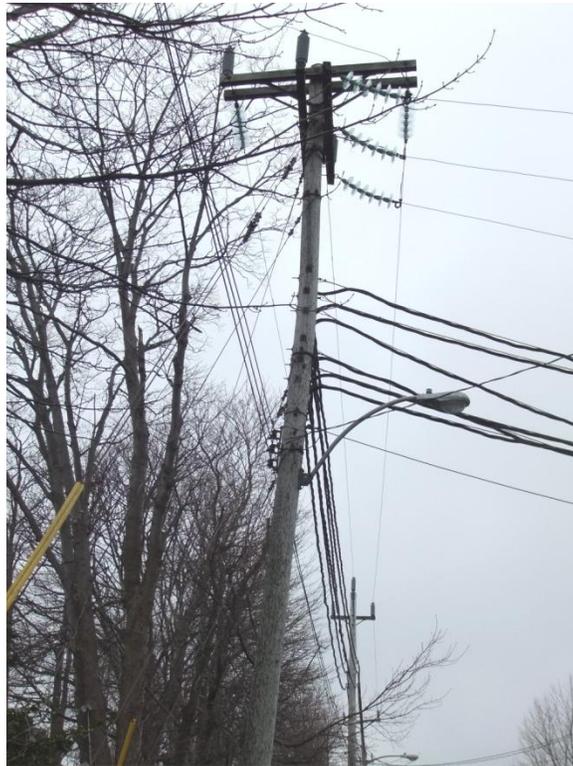
Figure 7 – 12L – Pole bent due to significant loading

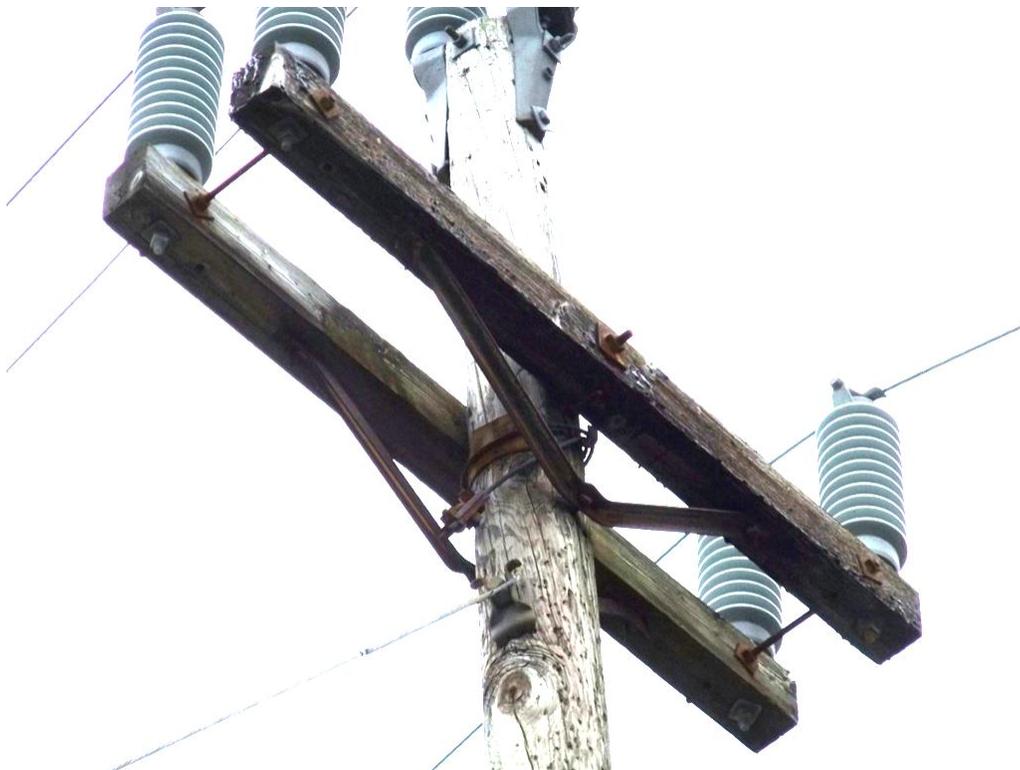
Figure 8 – 12L – Deteriorated crossarms

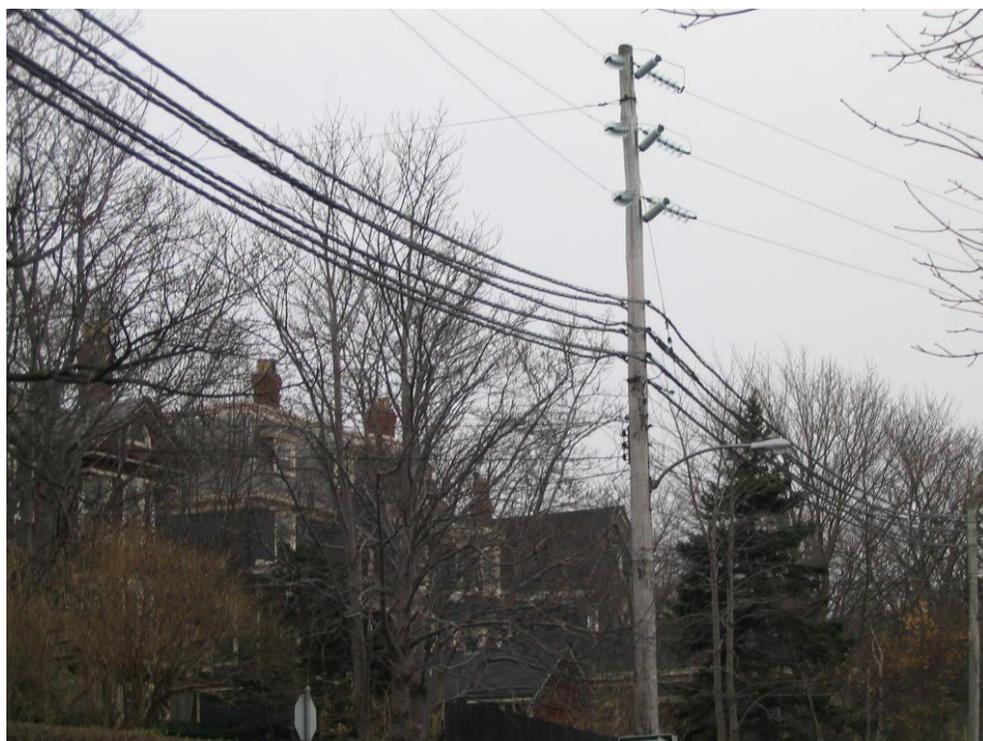
Figure 9 – 12L – Distribution aerial cable arrangement (1)

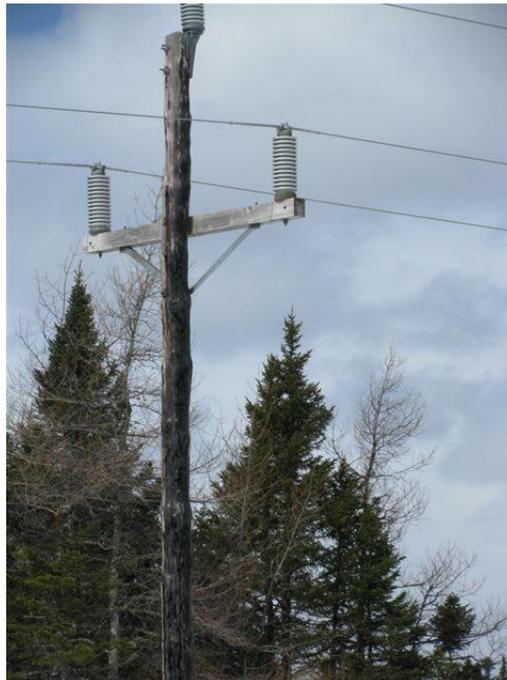
Figure 2 – Deteriorated Pole on 110L

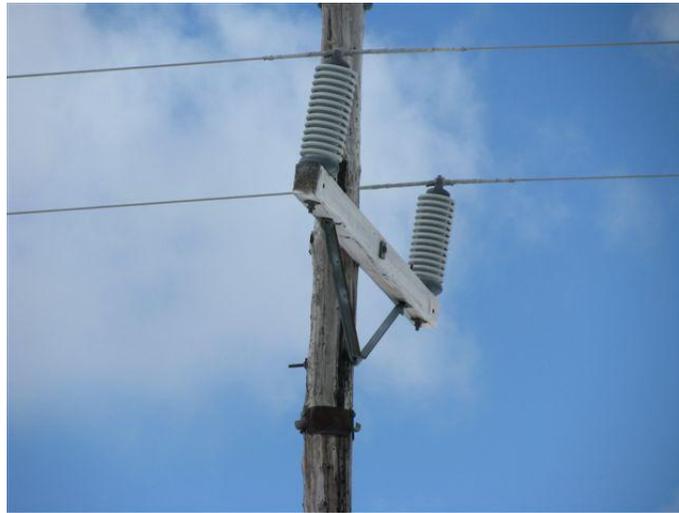
Figure 3 – Twisted Crossarm 110L

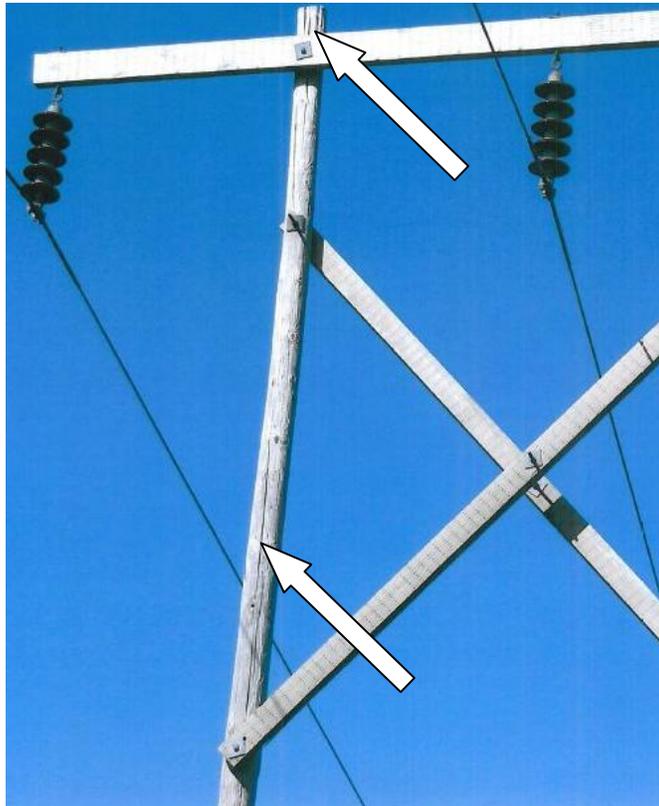
Figure 9 – Badly deteriorated pole 21L

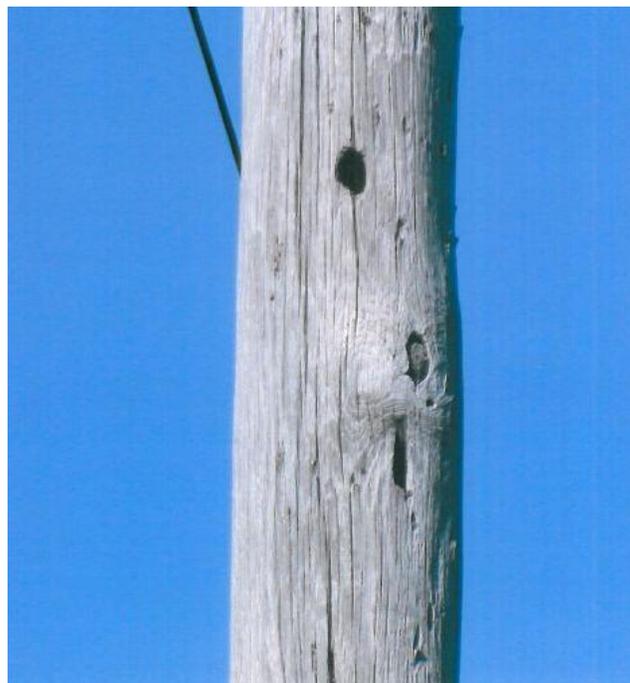
Figure 10 – Woodpecker Hole 21L

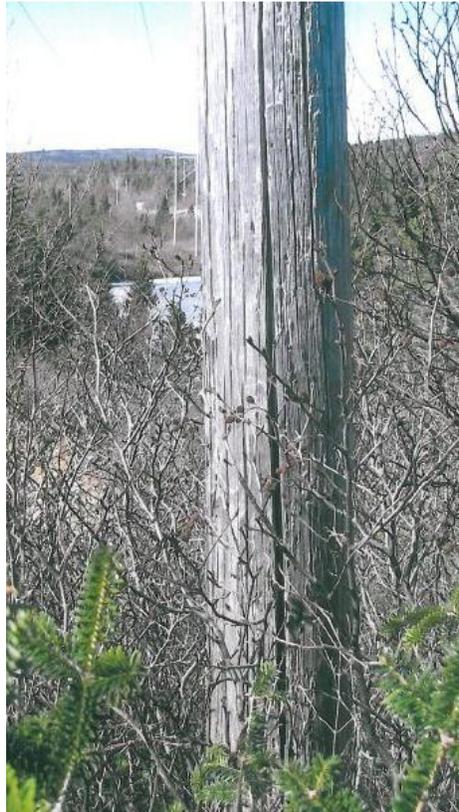
Figure 11 – Deteriorated pole 21L

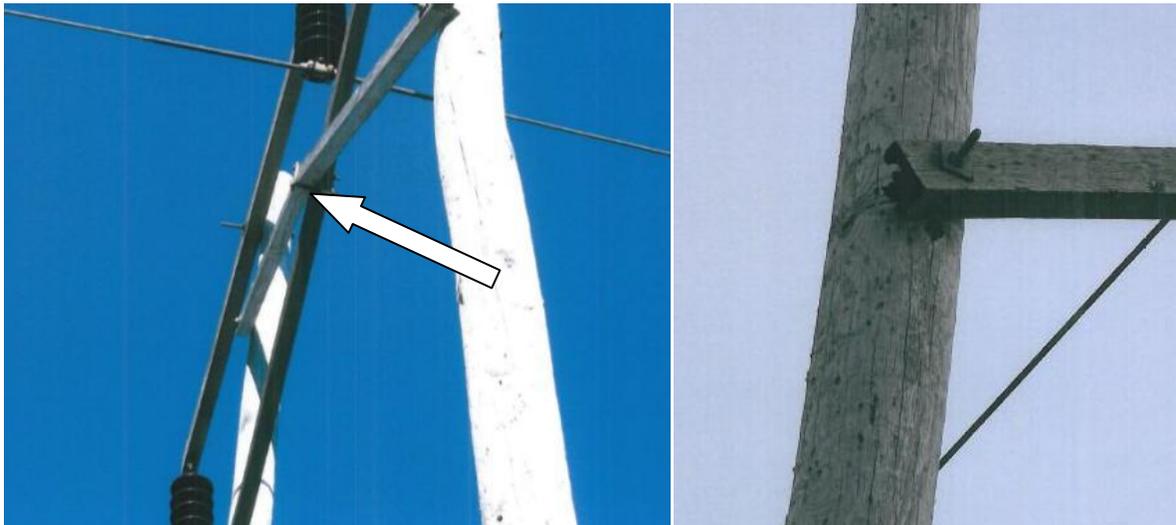
Figure 12 – Broken and Deteriorated Crossbraces 21L

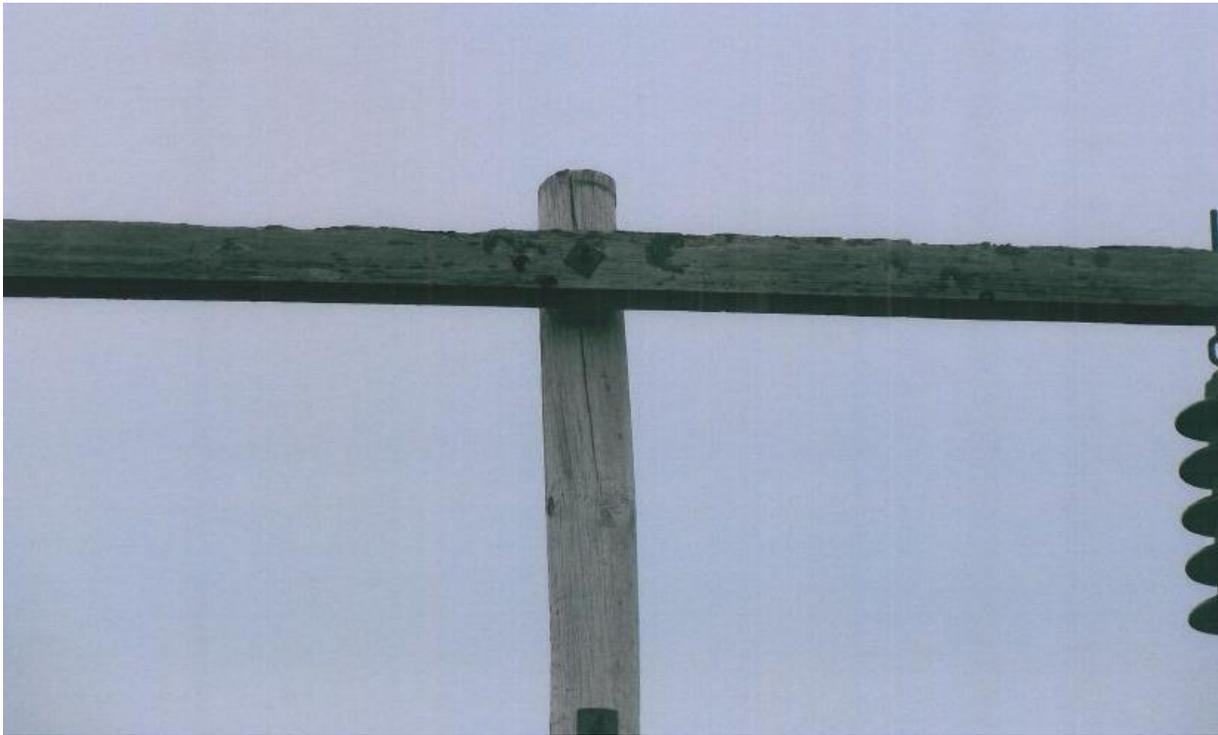
Figure 13 – Deteriorated Pole and Crossarm 21L

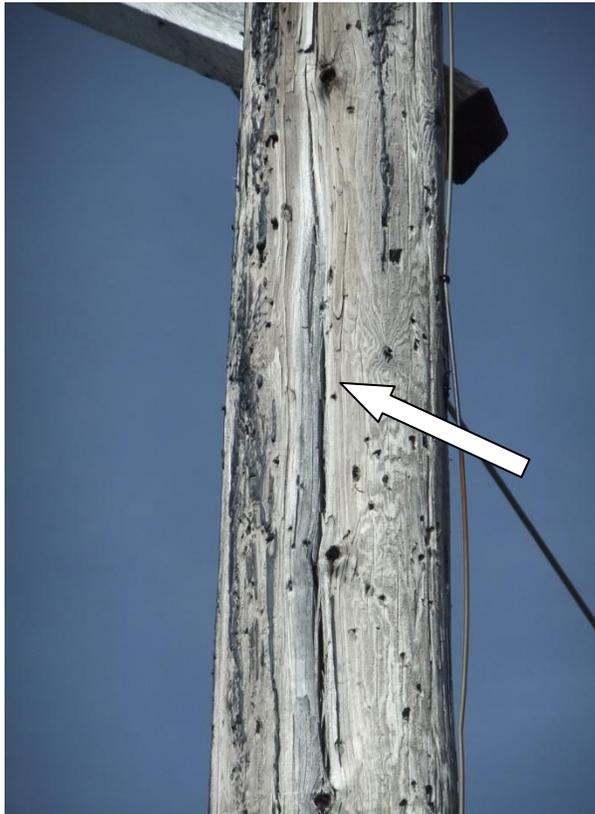
Figure 14 – Check in Pole 124L

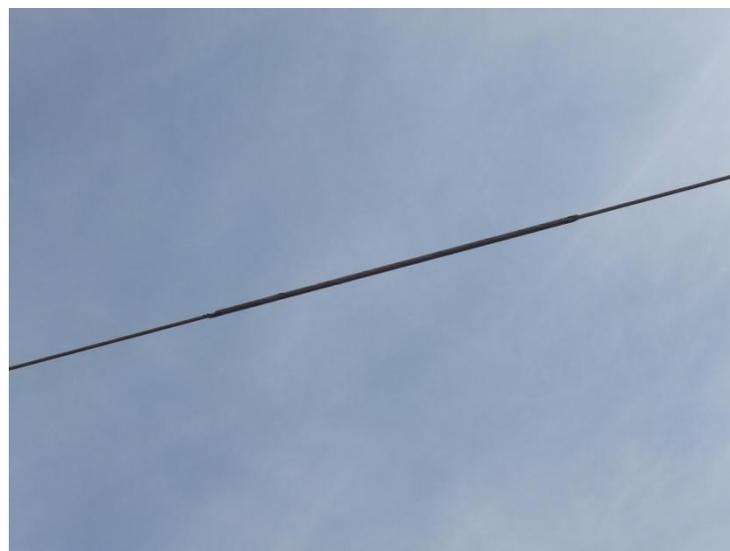
Figure 16 – Armour Rod to Repair Wire Damage 124L

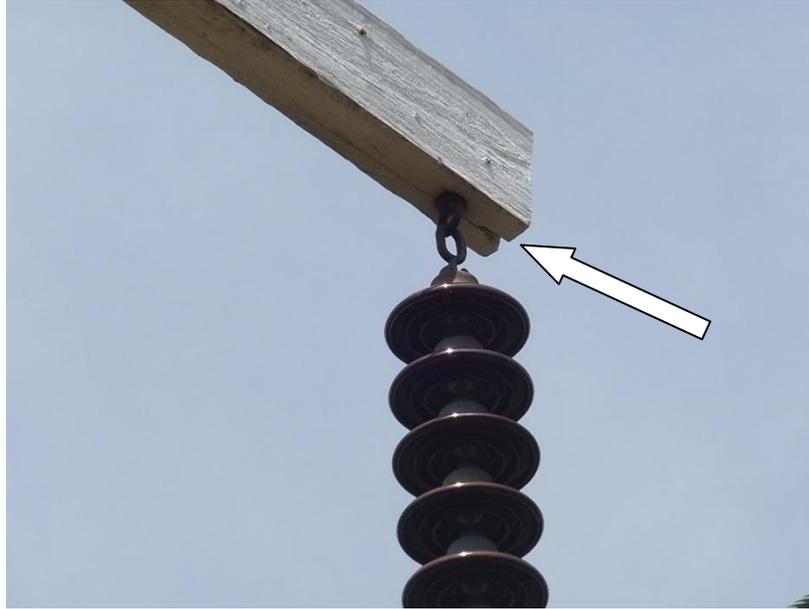
Figure 17 – Check in Crossarm 124L

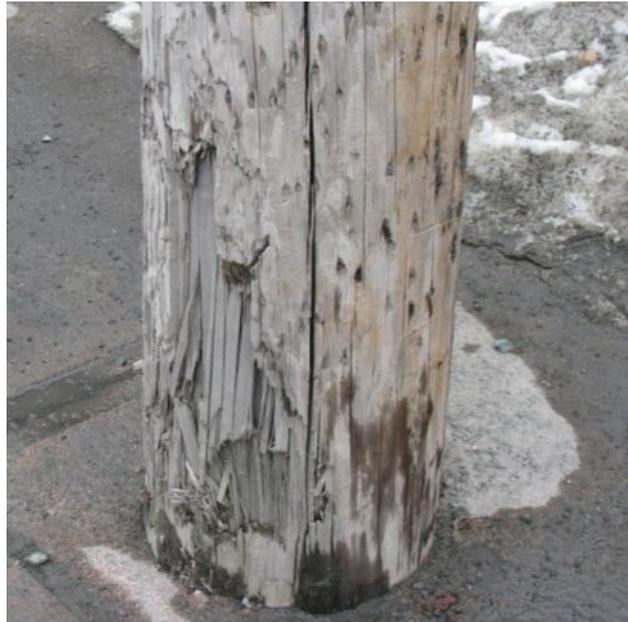
Figure 1 – Pole damaged by vehicle 16L

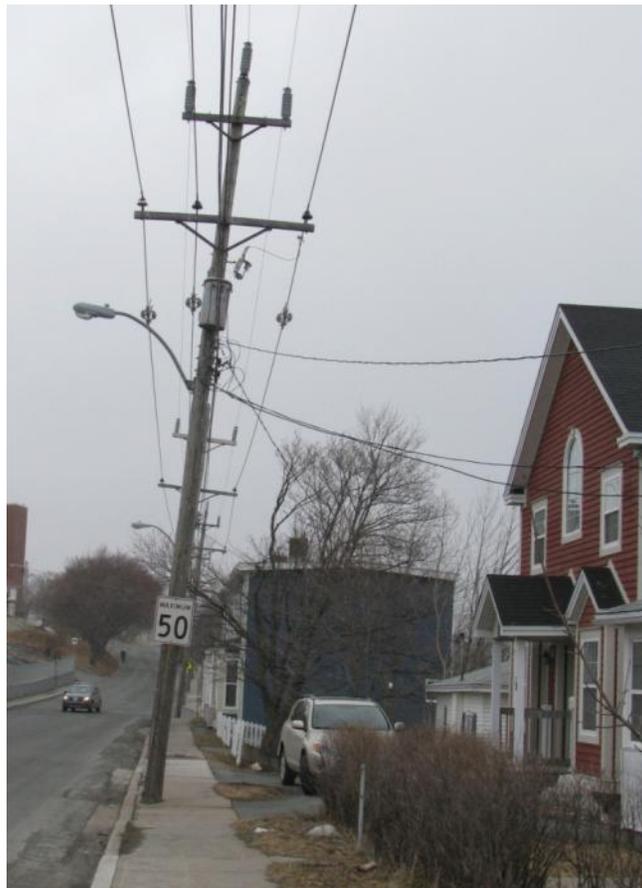
Figure 2 – Poles leaning along the Boulevard 16L

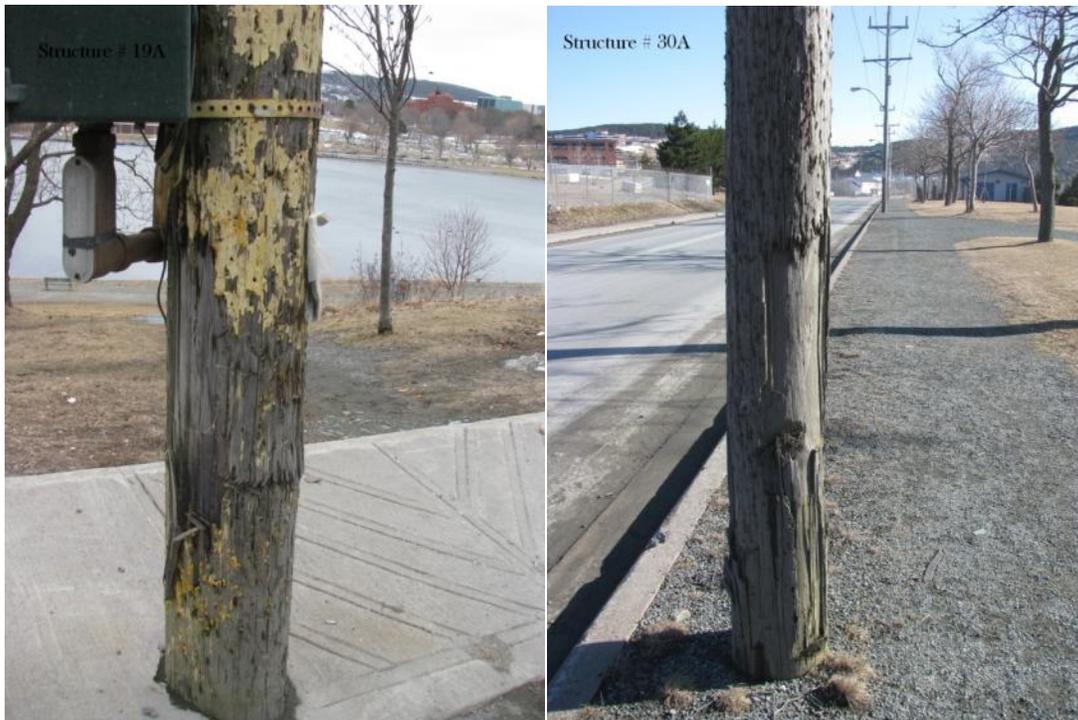
Figure 3 – Deteriorated poles 16L

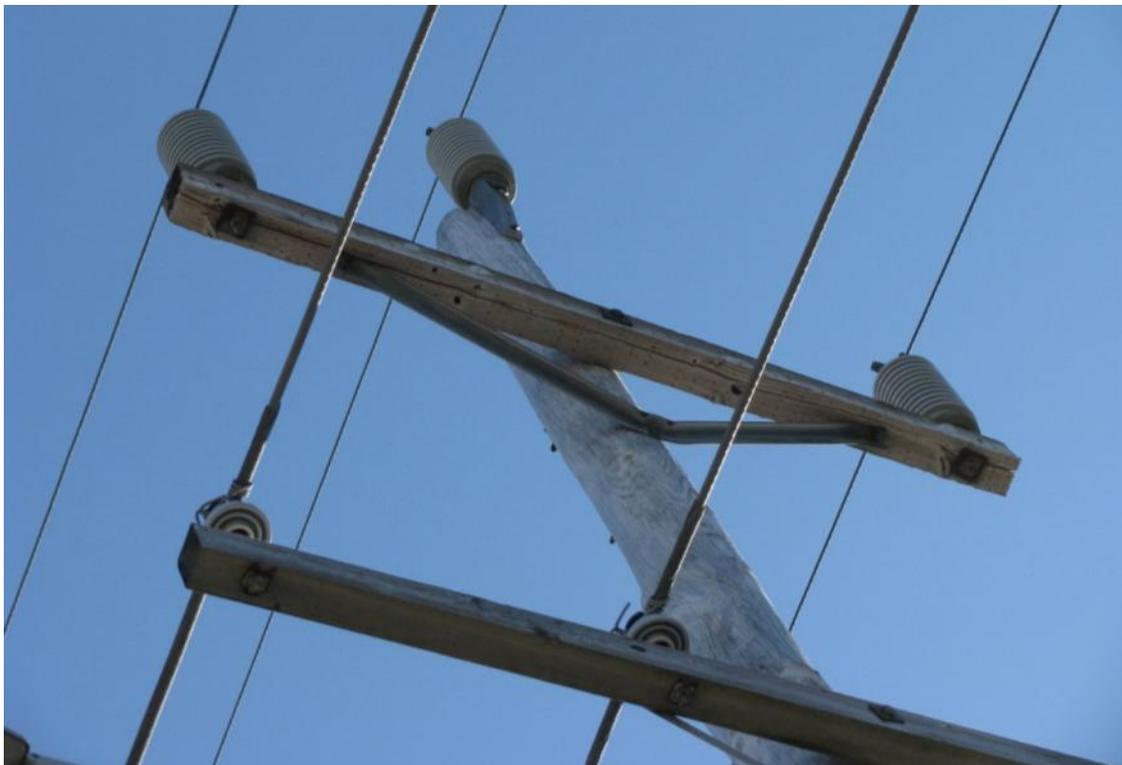
Figure 4 – Split Crossarm 16L

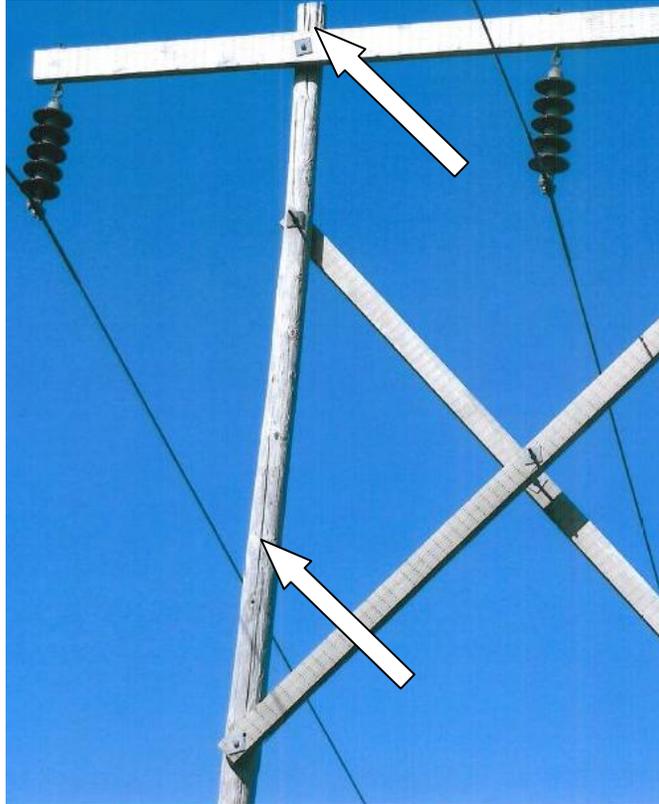
Figure 7 – Badly deteriorated pole 21L

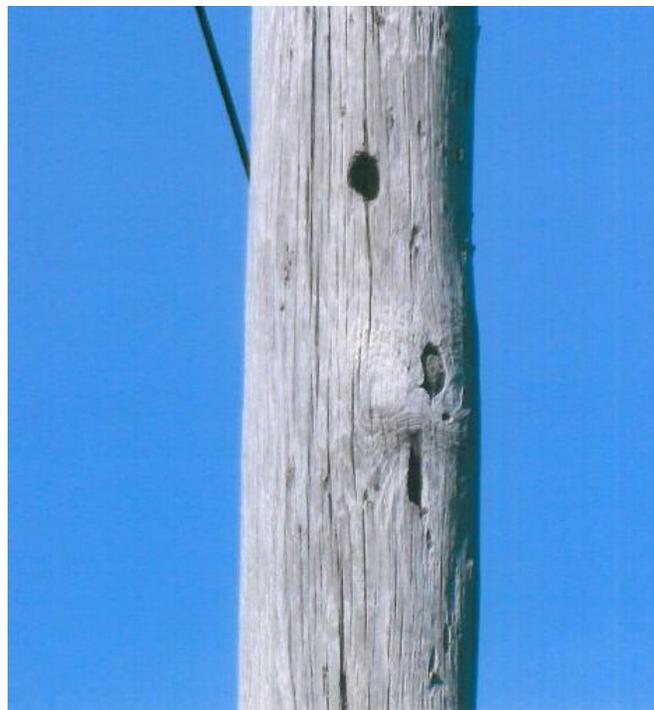
Figure 8 – Woodpecker hole 21L

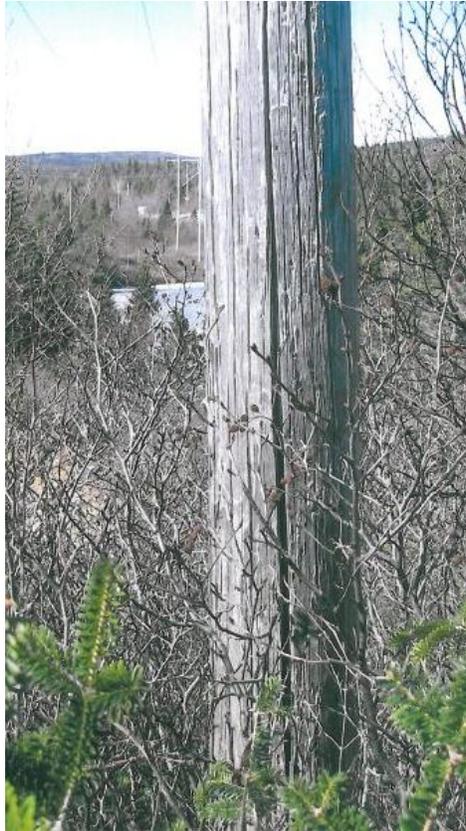
Figure 9 – Deteriorated pole 21L
