1 **Q. Please describe how transmission line equipment repairs are prioritized and state**
2 **the time limits for each prioritization.**

Appendix C
Photographs of Transmission Lines
12L, 13L, 18L, 35L and 68L

**2013 Transmission Line Rebuild
June 2012**

**2010 Transmission Line Rebuild
June 2009**

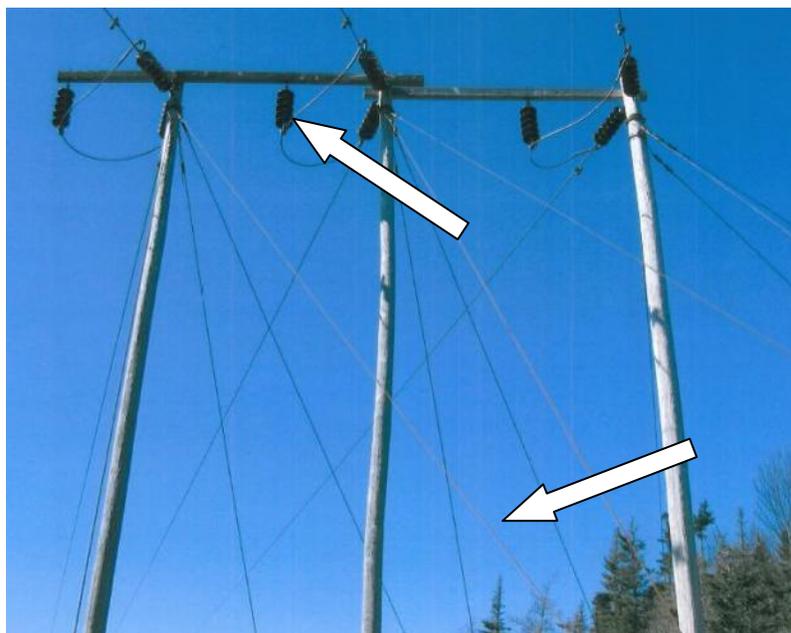
Figure 10 – Rusted guys and old vintage COB insulators 21L

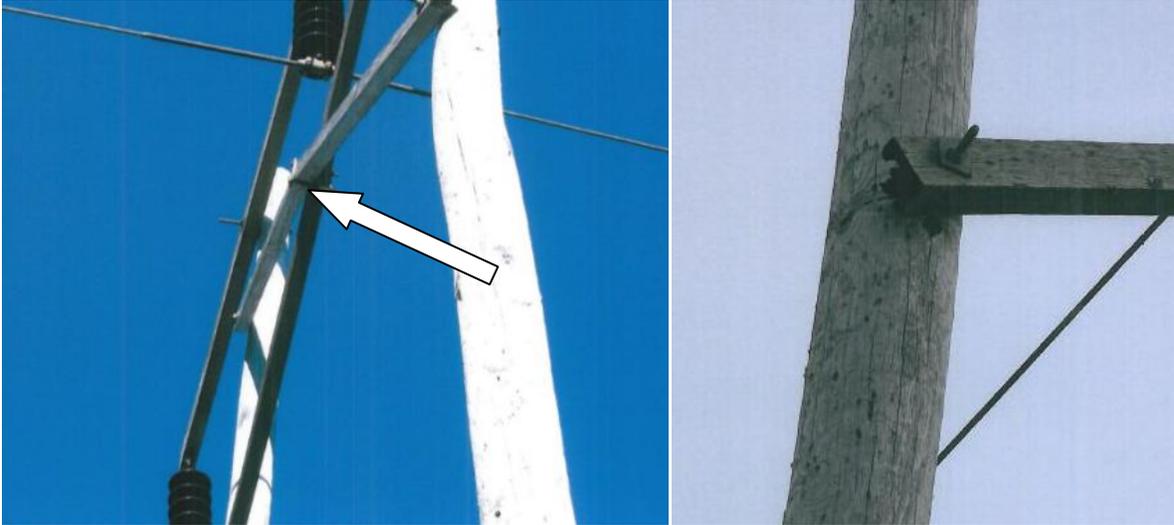
Figure 11 – Broken and deteriorated crossbraces 21L

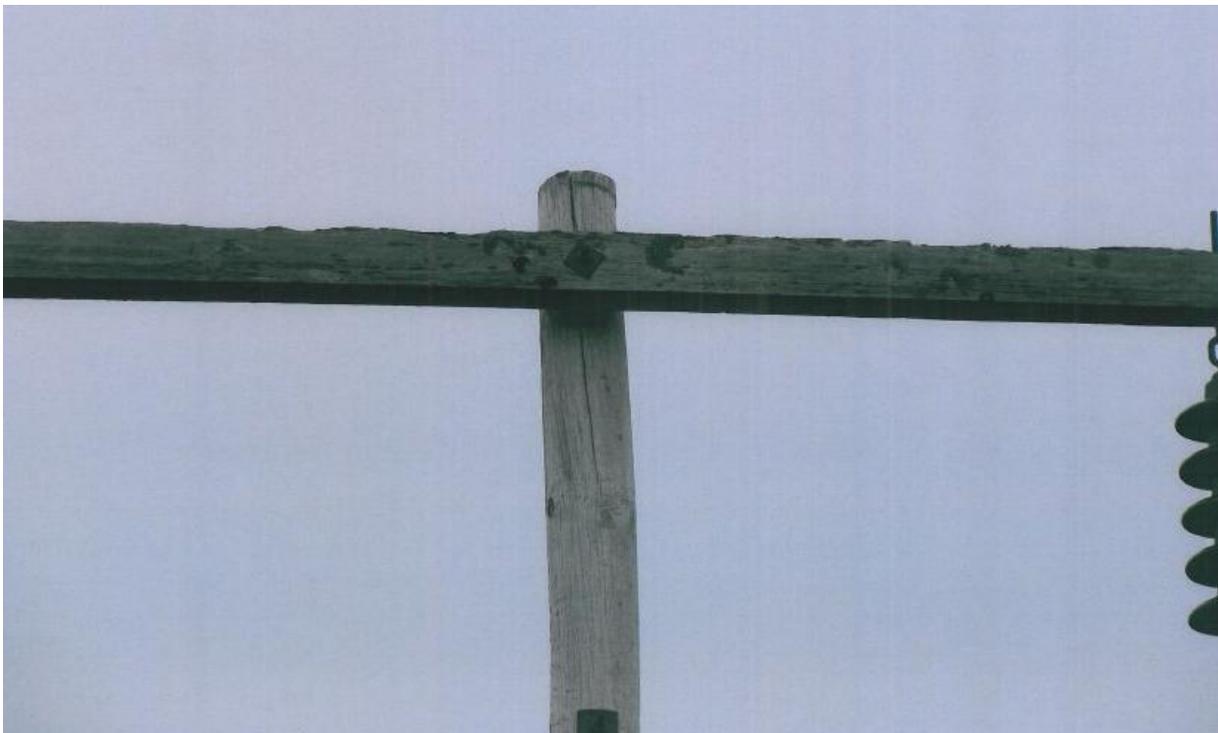
Figure 12 – Deteriorated pole and crossarm 21L

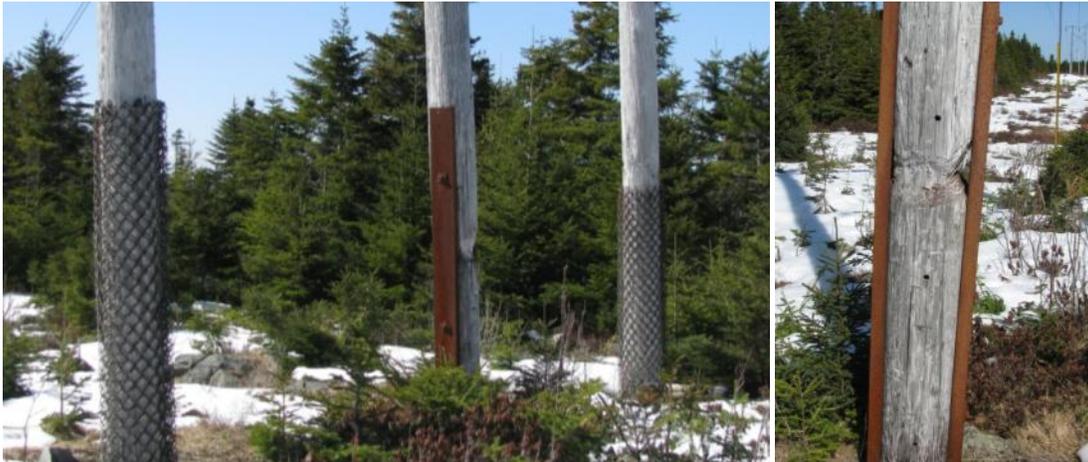
Figure 13 – Damaged pole requiring external support 25L

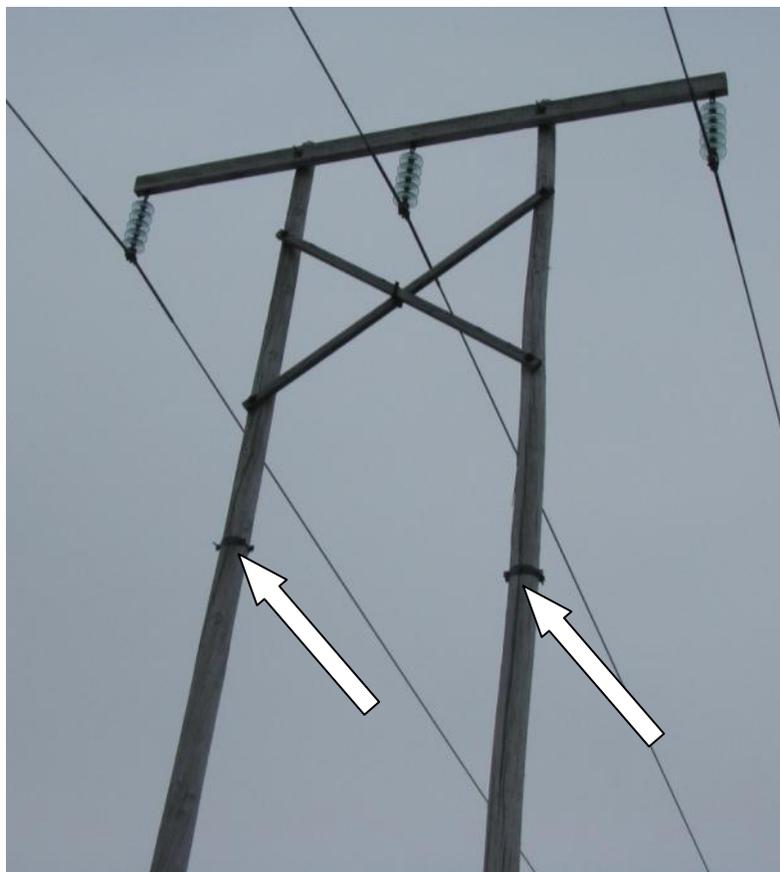
Figure 14 – Pole bands bracing damaged poles 25L

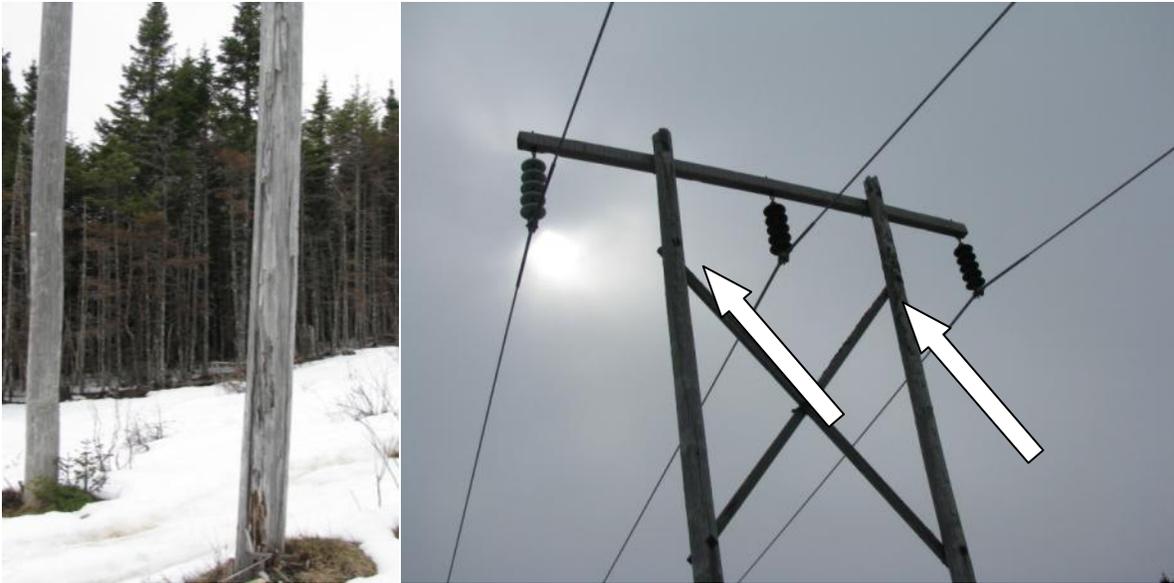
Figure 15 – Rotten poles 25L

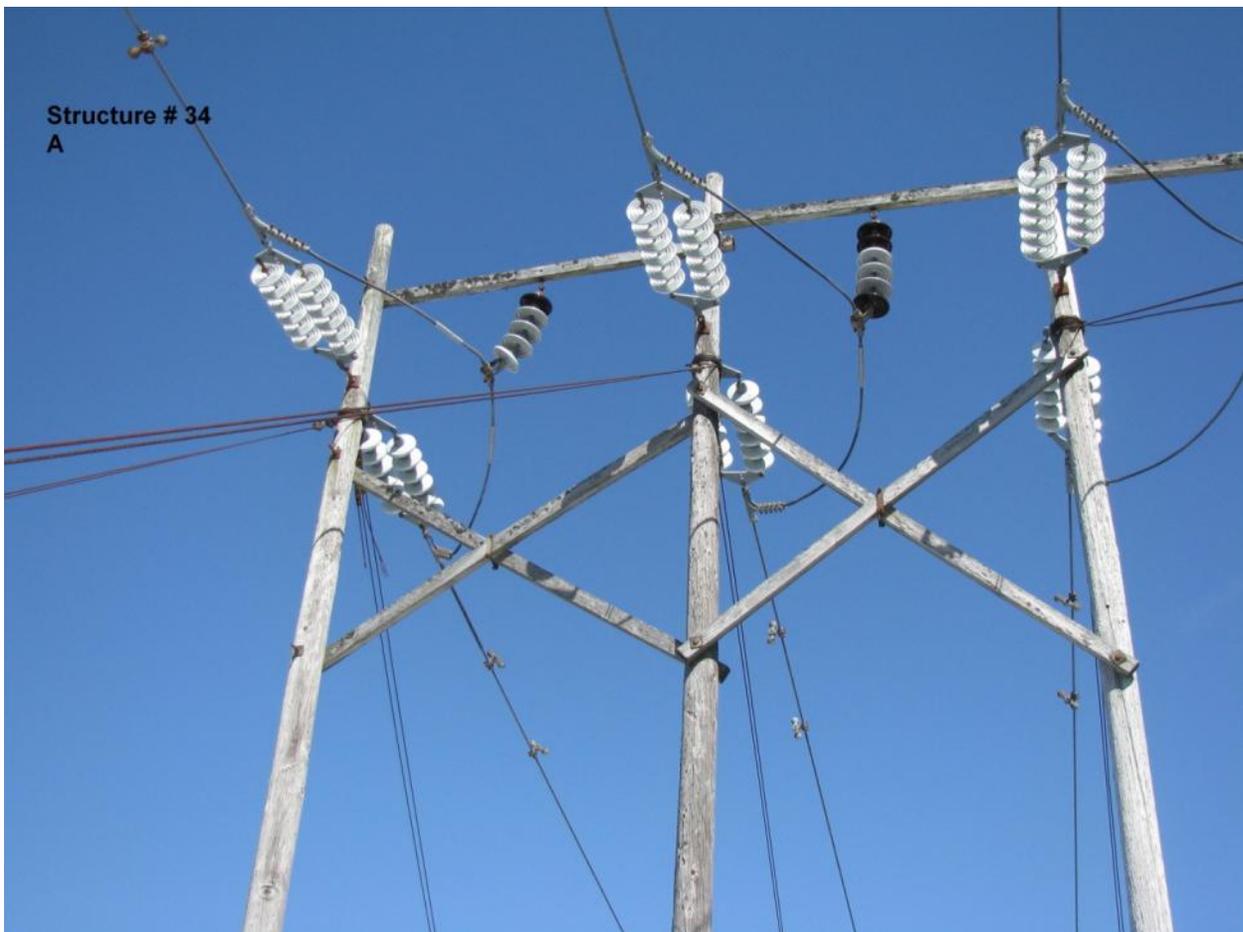
Figure 16 – Rusted guys and hardware 25L

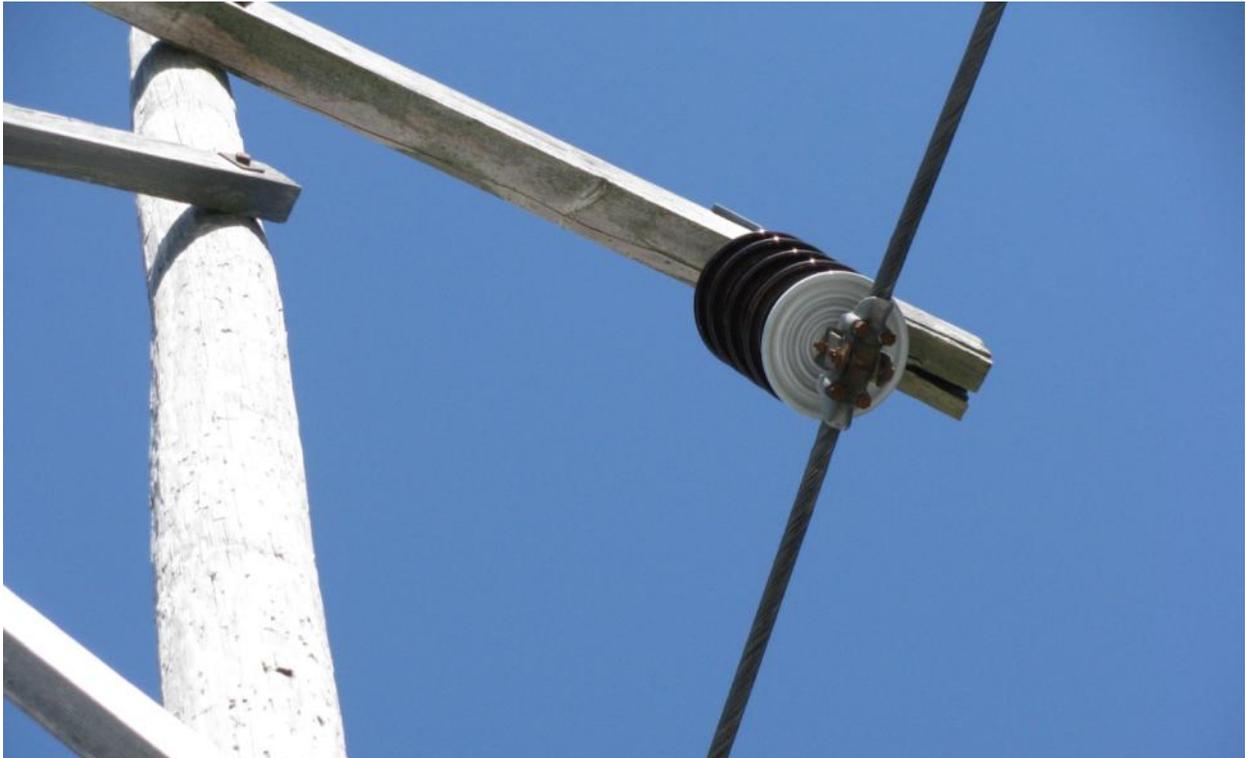
Figure 17 – Split crossarm 25L

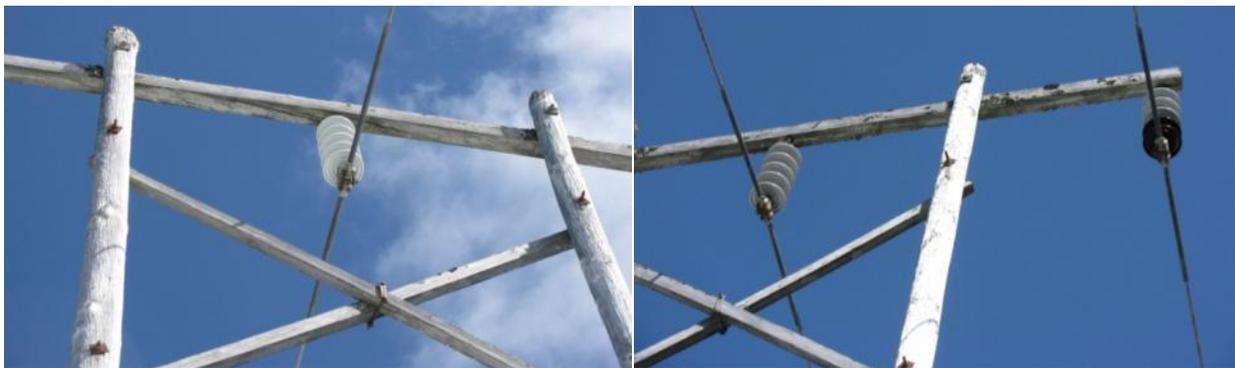
Figure 18 – Deteriorated poles, crossarms and hardware 25L

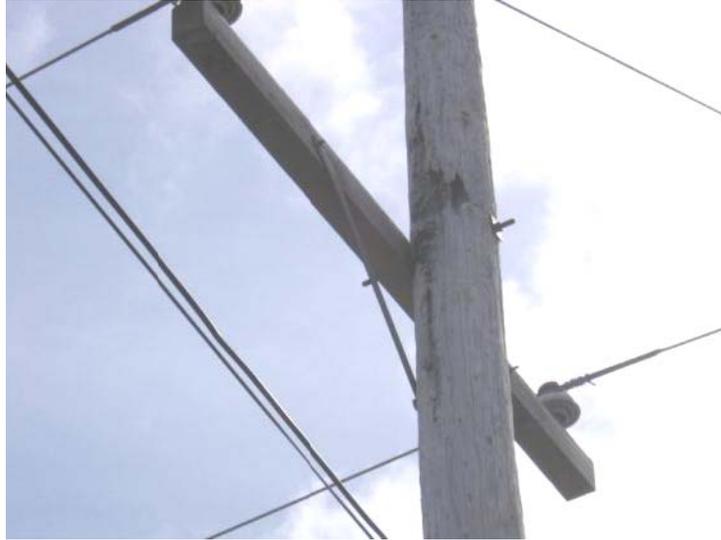
Burn Marks on Pole Caused by Flashover

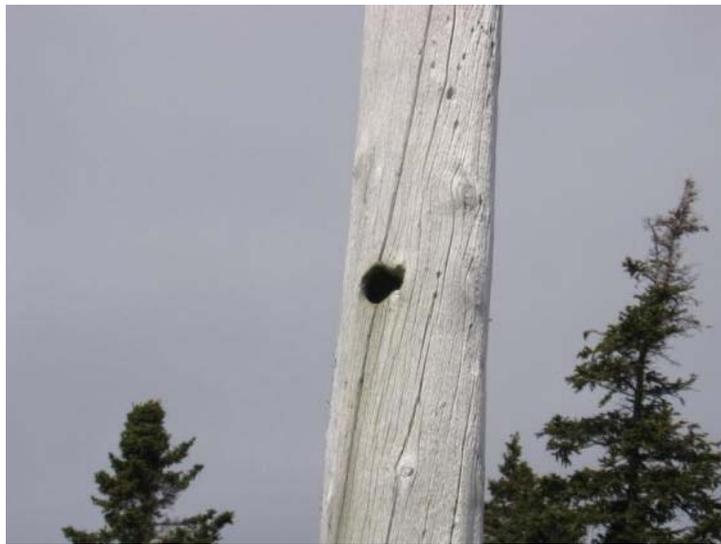
Woodpecker Hole in Pole

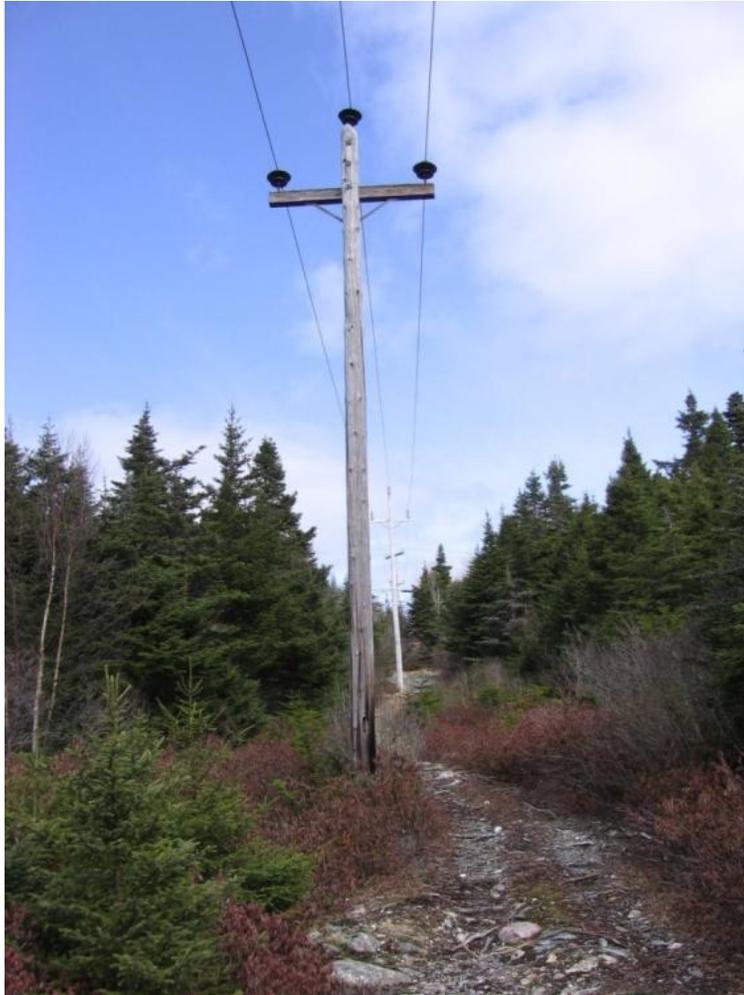
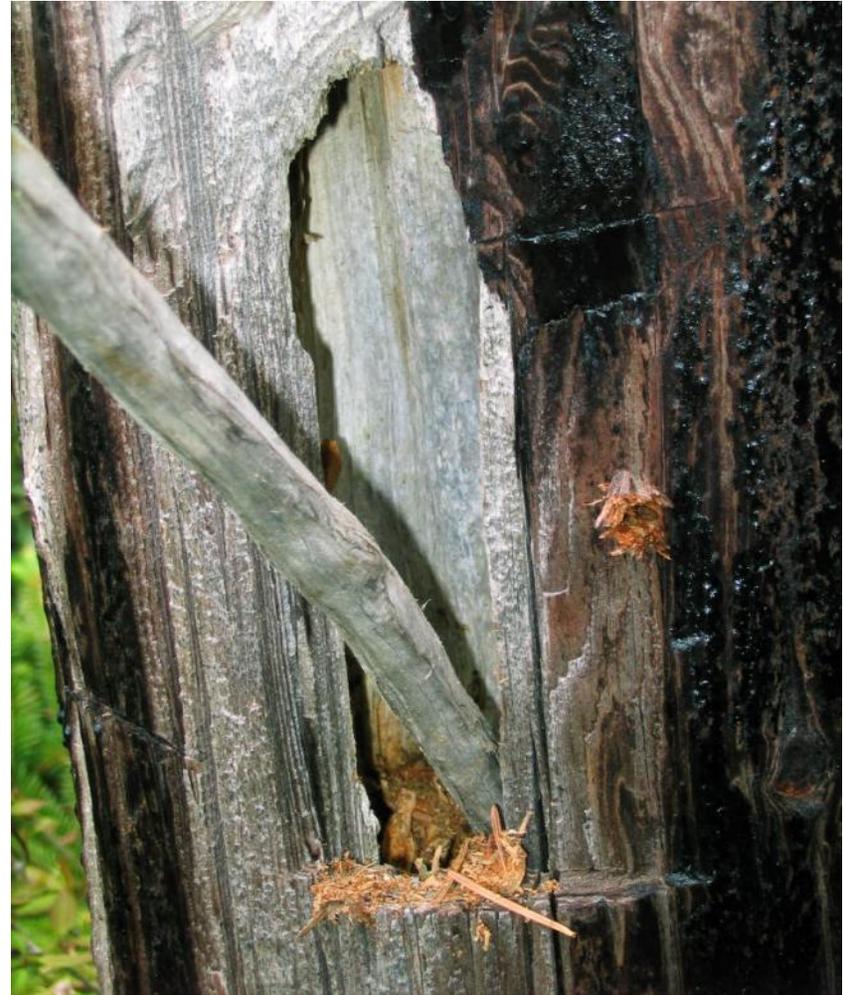
Hole and Rot in Pole

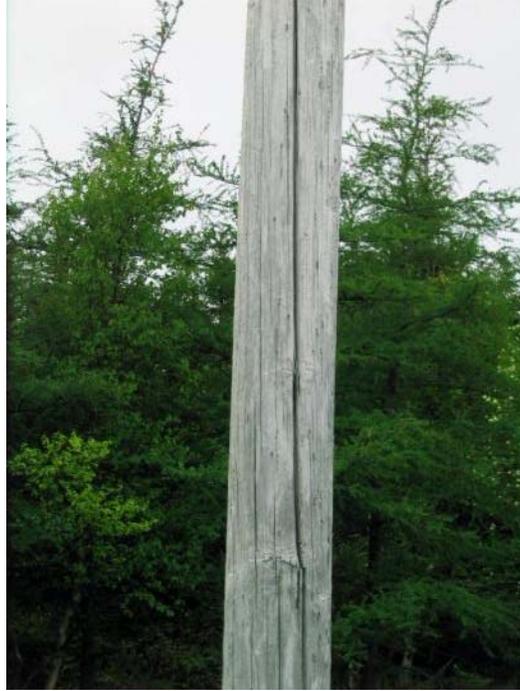
Deteriorated Pole

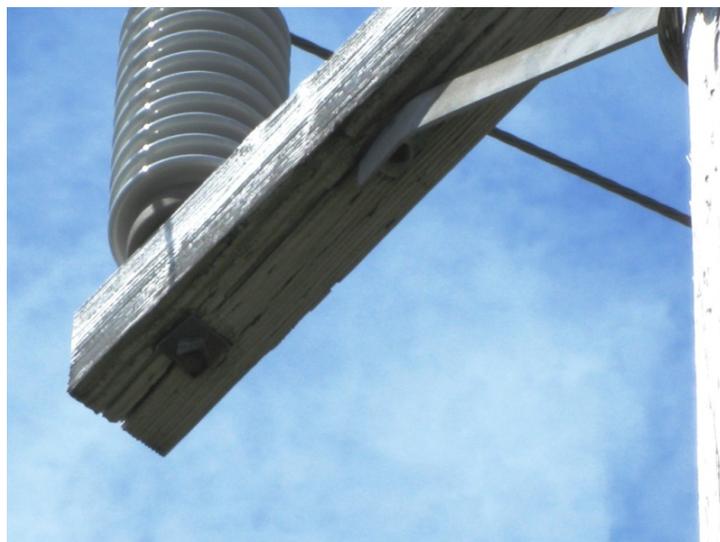
Deteriorated Crossarm

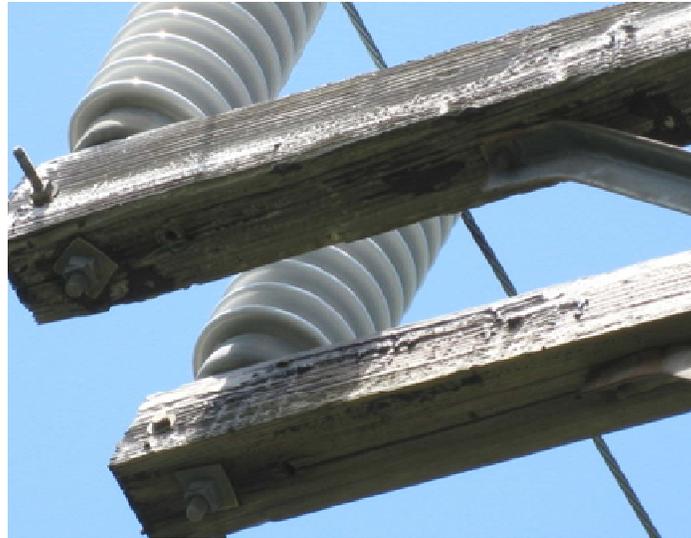
Deteriorated Crossarm

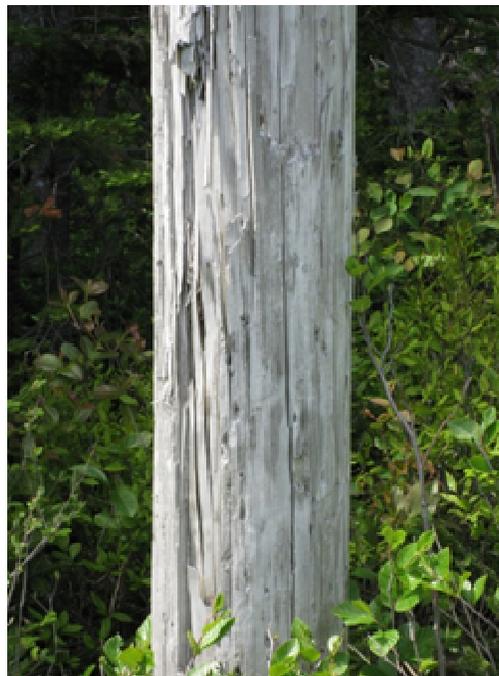
Deteriorated Pole

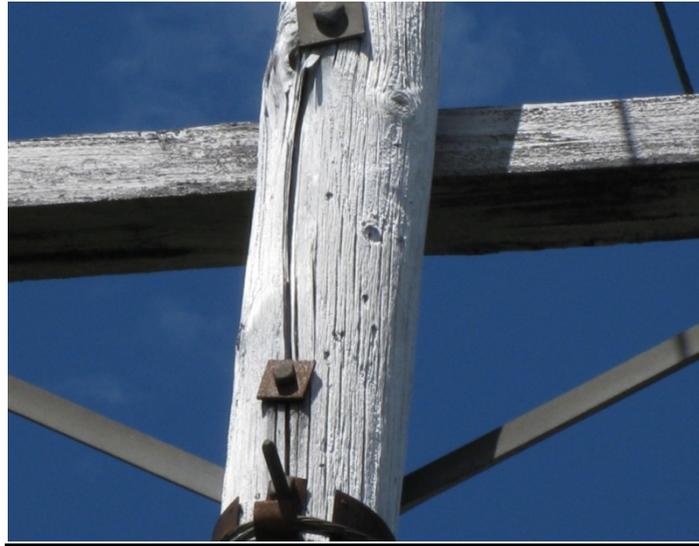
Pole Crack between Bolts

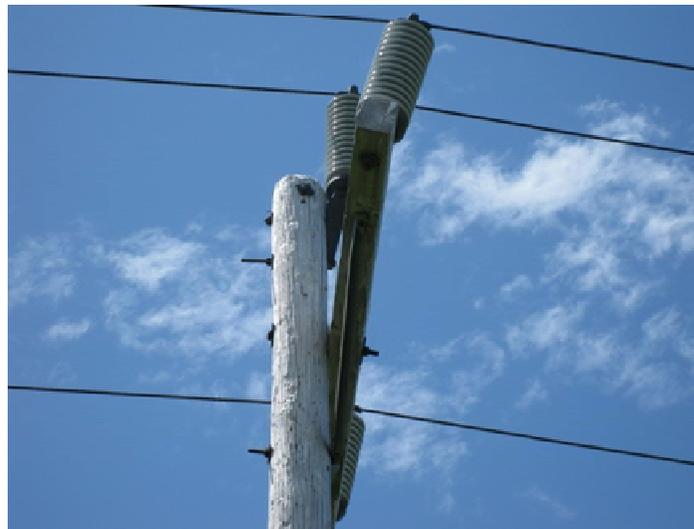
Leaning Insulator

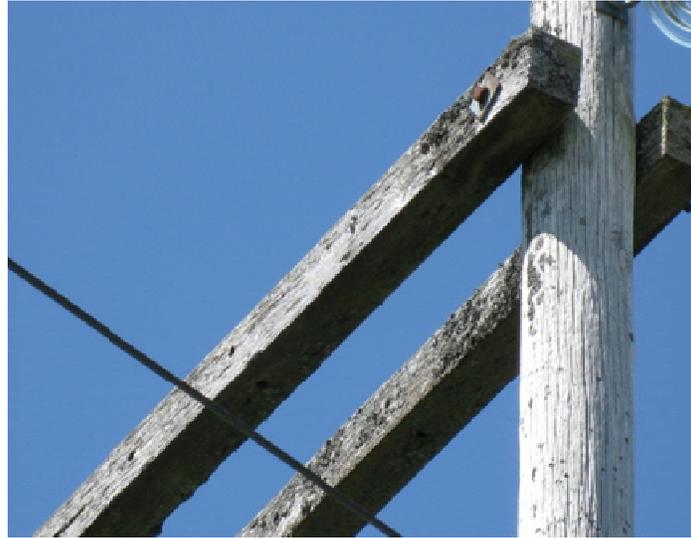
Deteriorated Crossarm

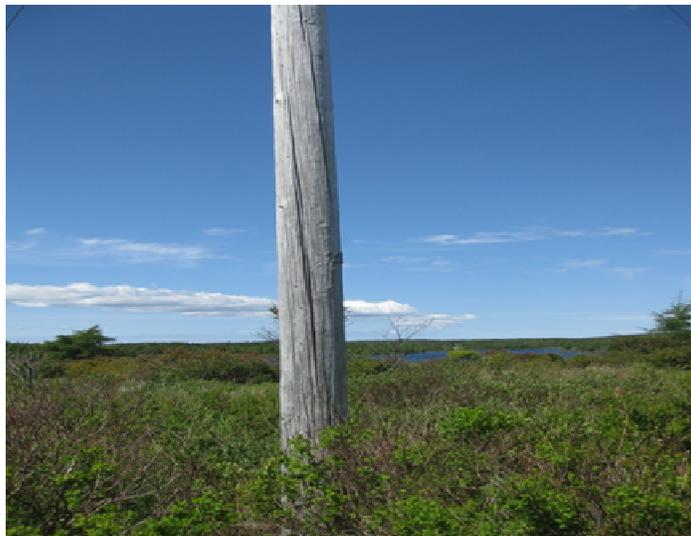
Split Pole

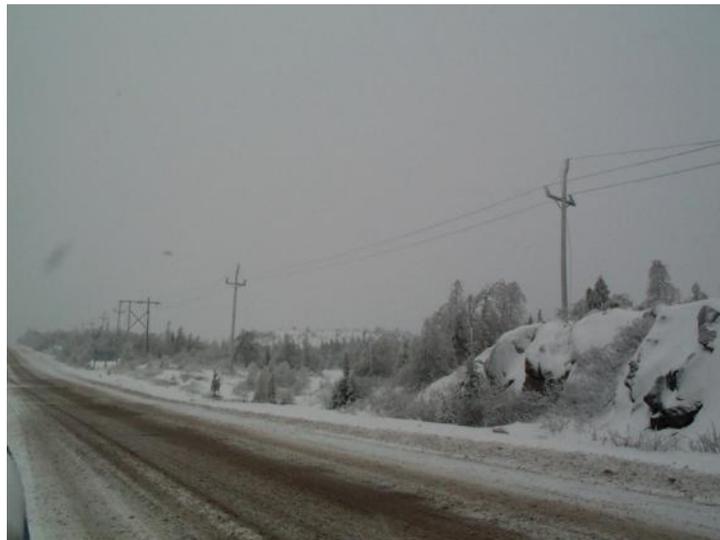
110L Ice Storm Damage December 2003

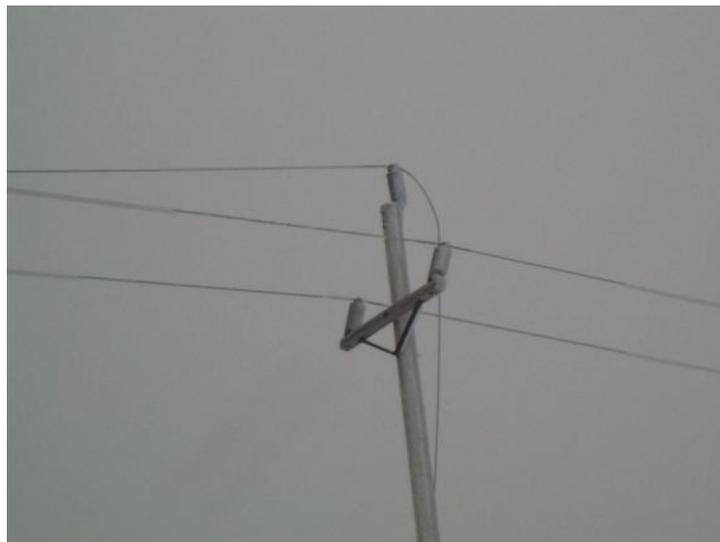
110L Broken Conductor - Ice Build Up December, 2003

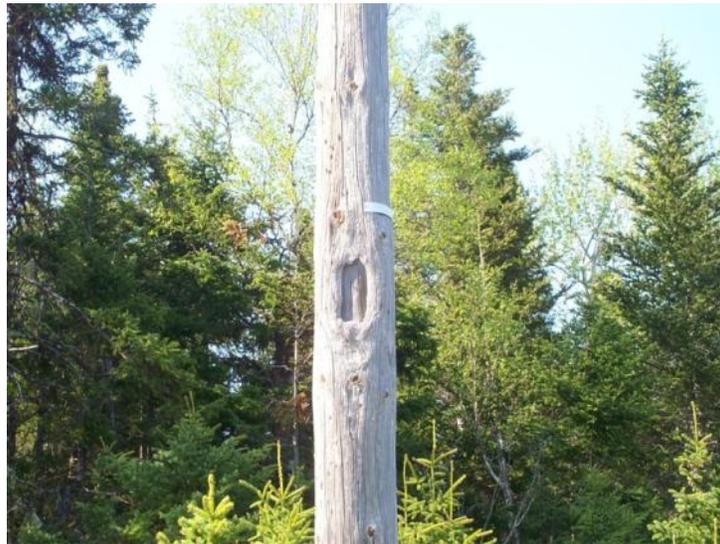
Deteriorated Pole 110L

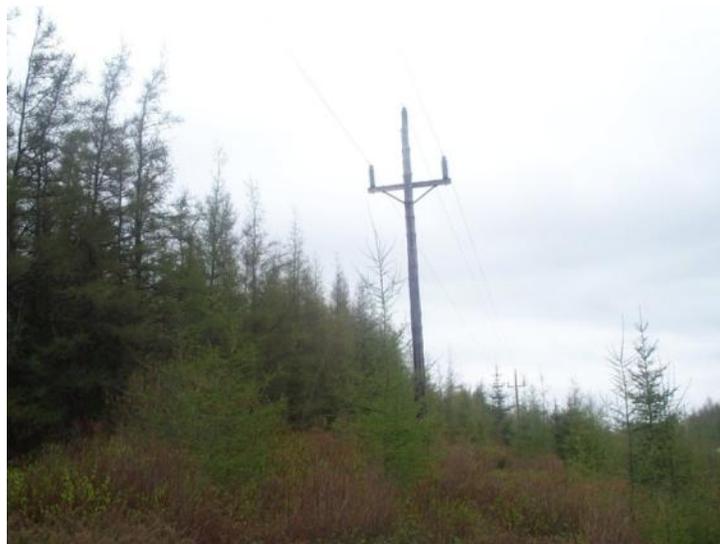
Deteriorated Pole 110L
