**Re: *Reliability and Resource Adequacy Study Review*  
Summary of Findings from L3501/2 Failure Investigations**

# Summary of Labrador-Island Link Failure Investigations

# Summary of Findings from L3501/2 Failure Investigation

Turnbuckle Failures

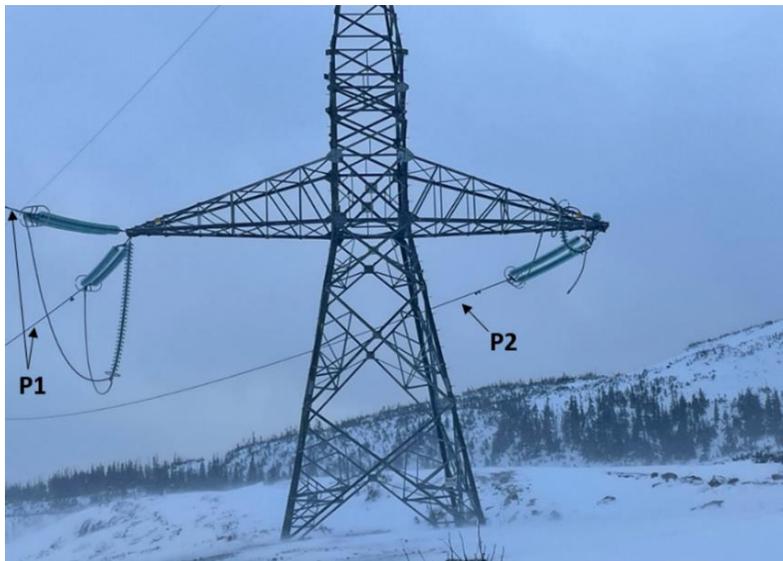
5       At approximately 2330 hours on December 1, 2022, a line trip was reported on L3502. The line tripped  
6       upon energization; however, as it had not been in service since November 24, 2022, the actual time of  
7       failure is unknown. On December 2, 2022, the failure was identified at Structure 1872. As Figure 3  
8       shows, the back span<sup>9</sup> of pole conductor Pole 2 (“P2”) was on the ground. The point of failure was the  
9       turnbuckle, which was located on the tower side of the dead-end assembly. The break was located in  
10      the threaded portion of the turnbuckle just below the eye, as shown in Figure 4 and Figure 5.

**Figure 3: Structure 1872 with Failed Dead-End Assembly**

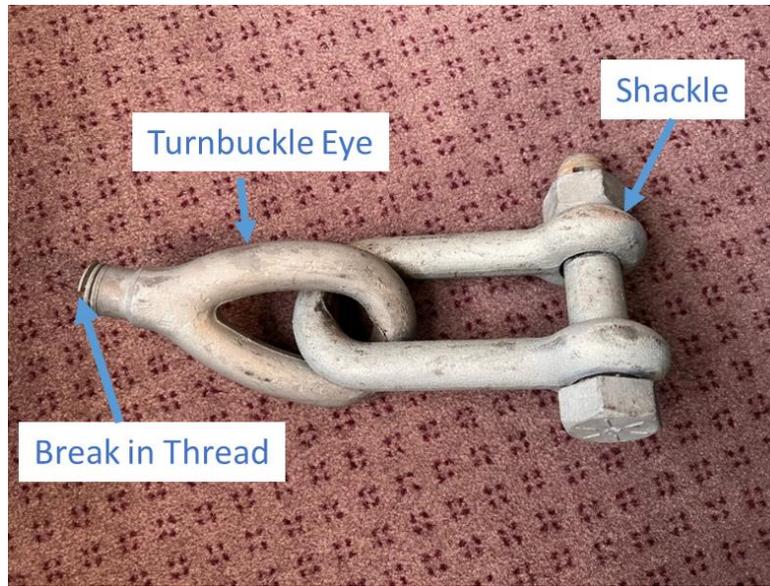
**Figure 4: Failed Turnbuckle and Shackle**

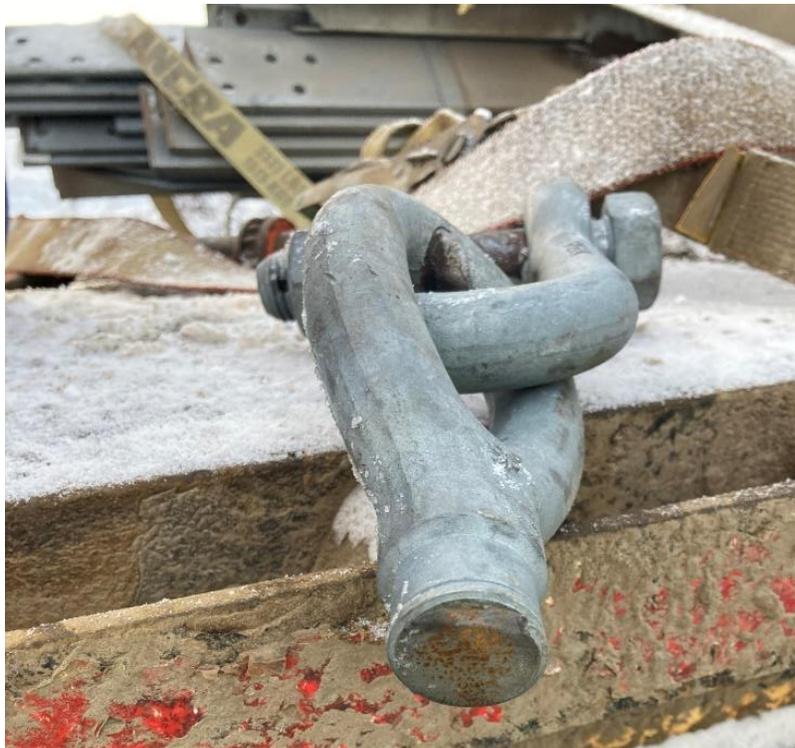
**Figure 5: Failed Turnbuckle Eye and Shackle**

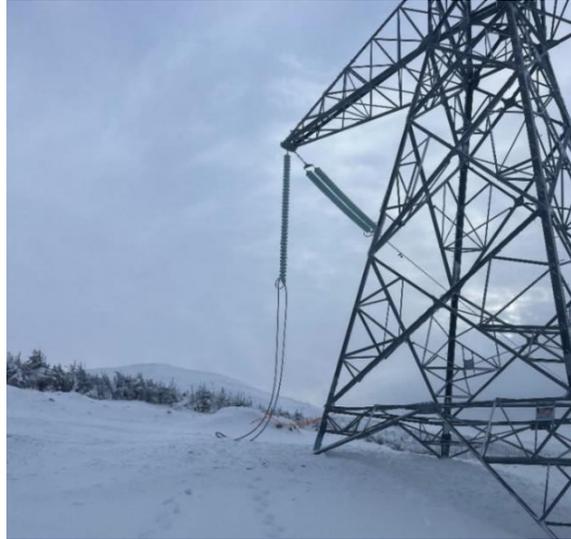
- 1 (“P1”) was on the ground, as shown in Figure 6 and Figure 7. Similar to Structure 1872, the failure was
- 2 located on the turnbuckle of the pole conductor assembly. Once the failure was identified, the necessary
- 3 repairs were made and the line was put back into service.

**Figure 6: Failed Dead-End Assembly at Structure 1806**

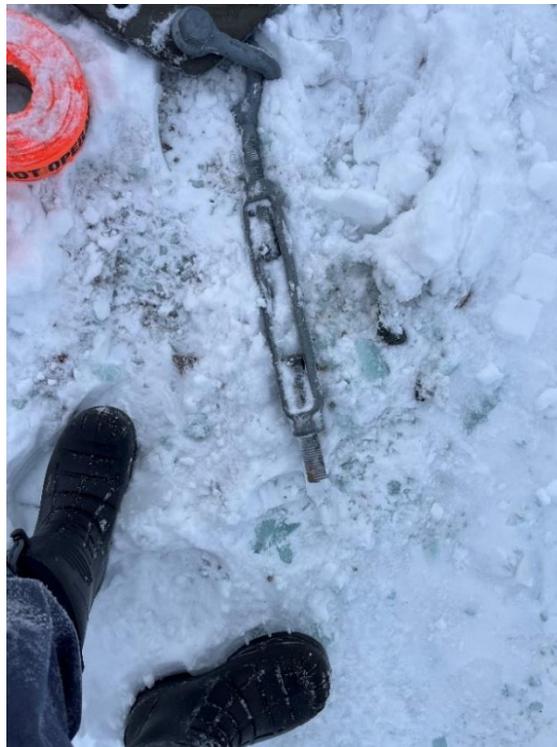
**Figure 7: Failed Turnbuckle on the Ground at Structure 1806**

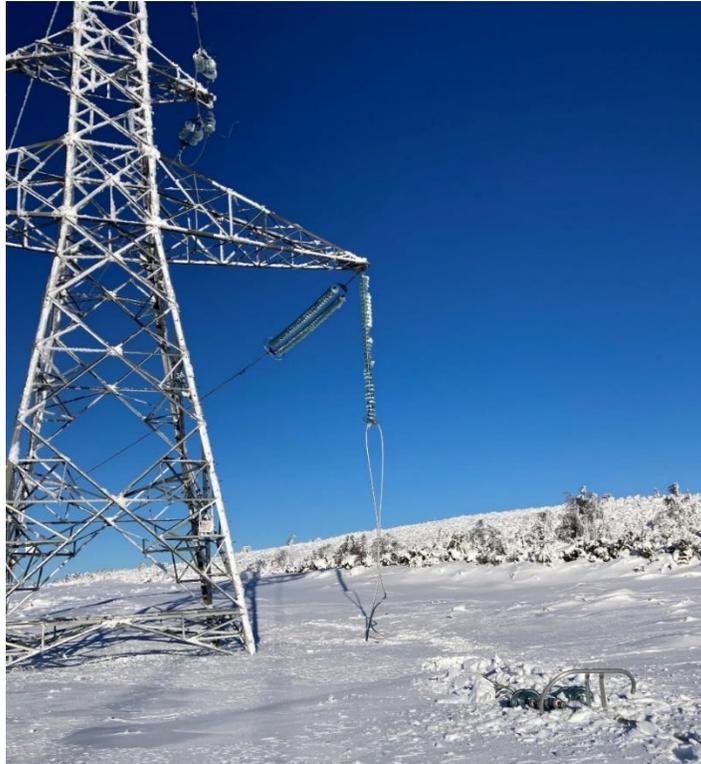
1 At approximately 1645 hours on December 29, 2022, the line tripped in the Labrador section of L3501.  
2 Later that same day, the failure was identified at Structure 1014. The ahead span of the pole conductor  
3 was on the ground, as shown in Figure 8. Similar to Structures 1872 and 1806, the failure was located on  
4 the turnbuckle of the pole conductor assembly. Once the failure was identified, the necessary repairs  
5 were made and the line was put back into service.

**Figure 8: Failed Dead-End Assembly at Structure 1014**

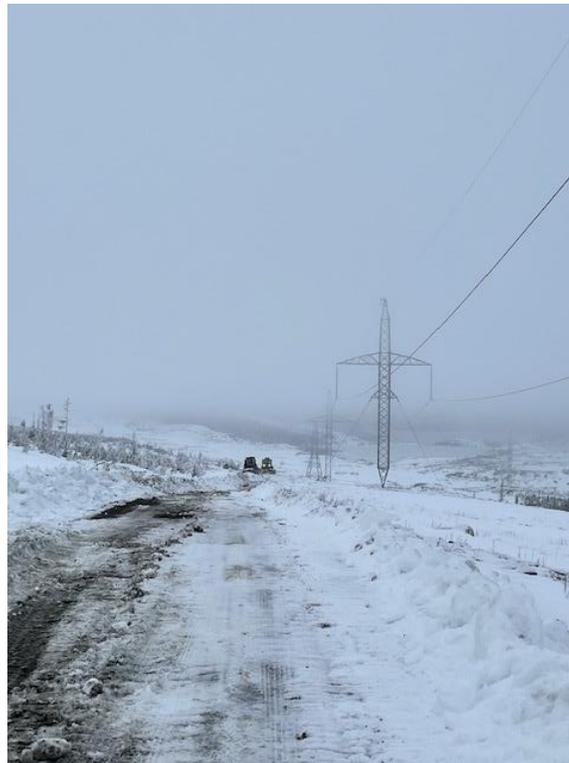
There was snow on the ground in the area of Structure 1872 at the time of failure. As Figure 11 shows, snow clearing was required to access the structure. There was some ice on the lines in the vicinity of the failure; however, the quantities observed were far less than the design thickness of 115 mm of radial rime ice for this section of the line.

**Figure 11: Snow Conditions at Structure 1872**

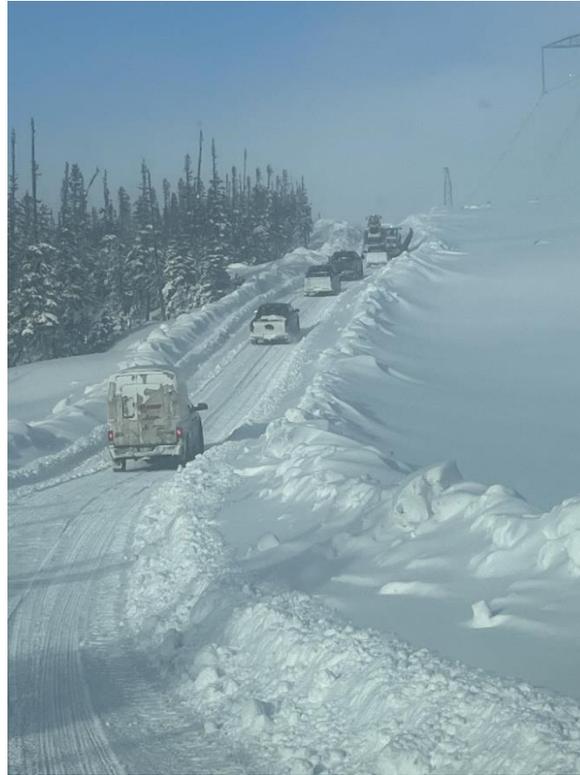
3 There was significant snow on the ground in the area of Structure 1806, as shown in Figure 12. Snow  
 4 clearing to access the structure took several days and continued effort was required to keep the access  
 5 road open. There was a small amount of ice on the lines in the vicinity of the failure; however, the  
 6 quantities observed were far less than the design thickness of 135 mm of radial rime ice for this location.

**Figure 12: Snow Conditions at Site near Structure 1806**

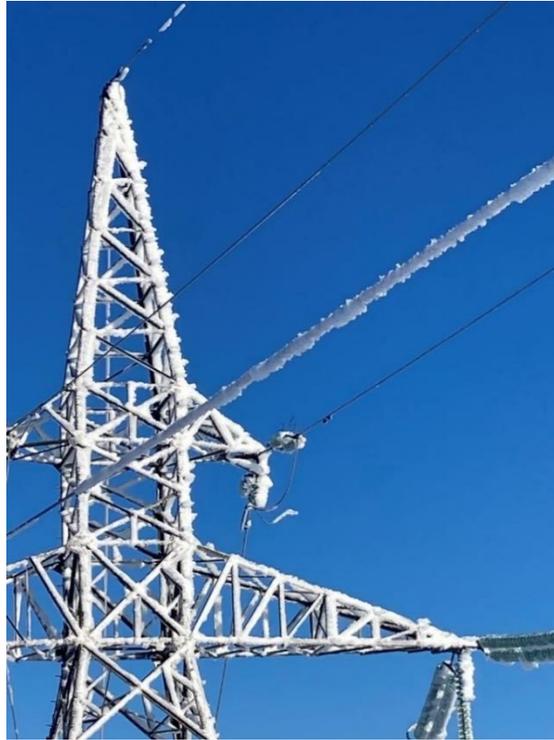
- 4 There was significant snow and ice in the area of Structure 1014 at the time of failure, as shown in
- 5 Figure 13 and Figure 14. The ice on the lines was observed to be nearing but not in exceedance of the
- 6 design thickness of 135 mm of radial rime ice.

**Figure 13: Ice on Lines near Structure 1014 Failure**

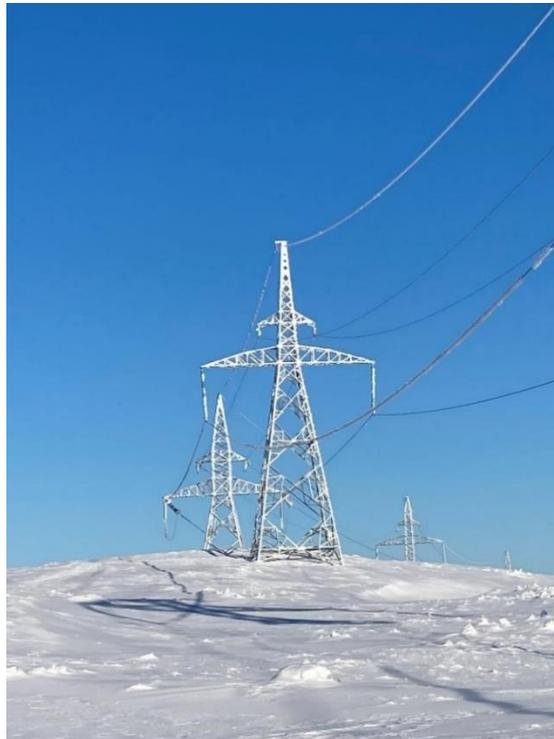
**Figure 14: Snow at Site near Structure 1014 Failure**

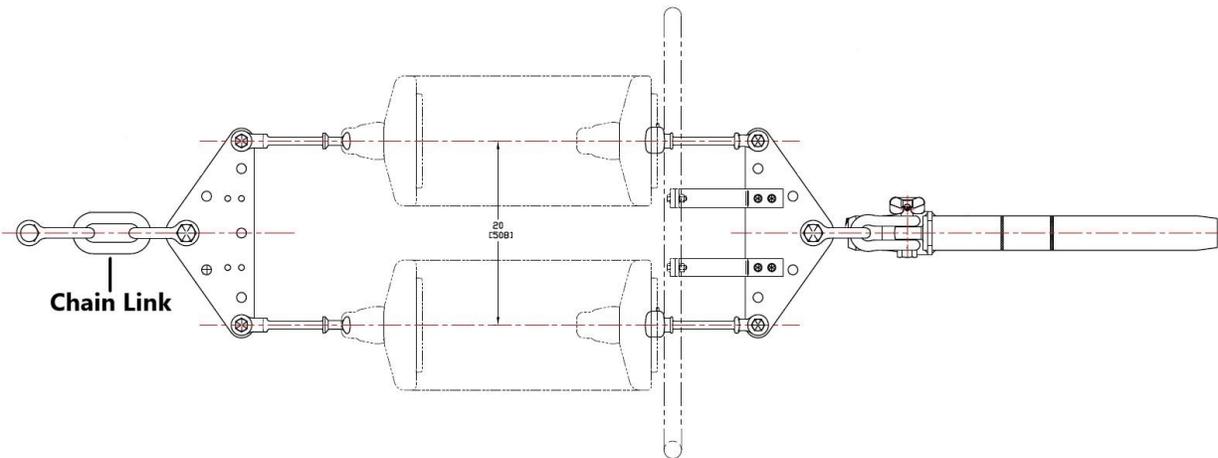
Figure 15: Pole Conductor Dead-End Assembly with Chain Link

The recommendation for repairs for failed dead-end structures was to replace the turnbuckle in the assembly with a chain link. The chain link is much shorter than the turnbuckle and is in one piece, so it would be less likely to fail under bending. A chain link was part of the original design of the pole dead-end assembly, as shown in Figure 15; however, the assembly design was revised to include the turnbuckle; this would allow adjustability to the initial sag of the line and better control over the vertical clearance between the conductors and the ground.

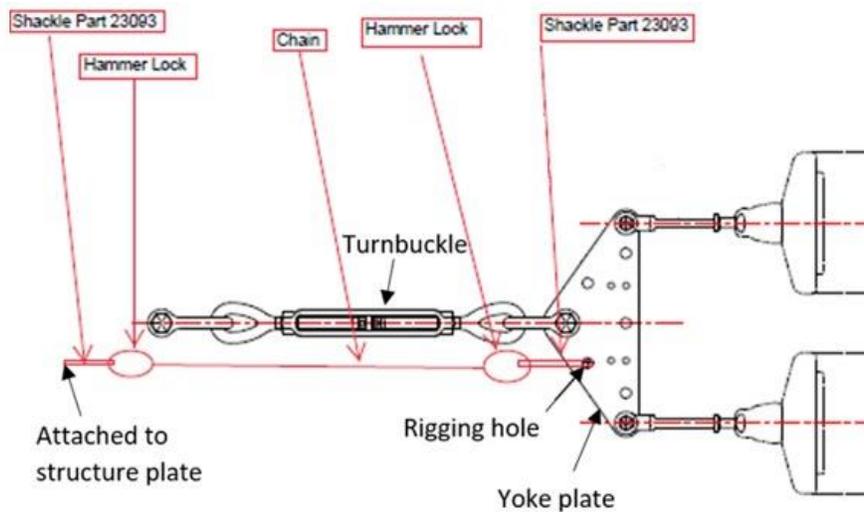
**Figure 16: Sketch for Installation of Shackles, Locks, and Chains**

- 1 In addition, it was recommended that airflow spoilers be installed on the front and back spans of the  
2 structures with failures to help control galloping. Galloping was identified as a primary contributing  
3 factor to the fatigue failures in February 2021.
- 4 For other structures in the area of the failures, it was further recommended to add shackles to the holes  
5 adjacent to the turnbuckle attachment on the tower plate and yoke plate, as shown in Figure 16. Locks  
6 and chains were attached to the shackles as a safety feature. If the turnbuckle were to break, the  
7 shackle, lock, and chain mechanism would catch the pole conductor and prevent it from falling to the  
8 ground.

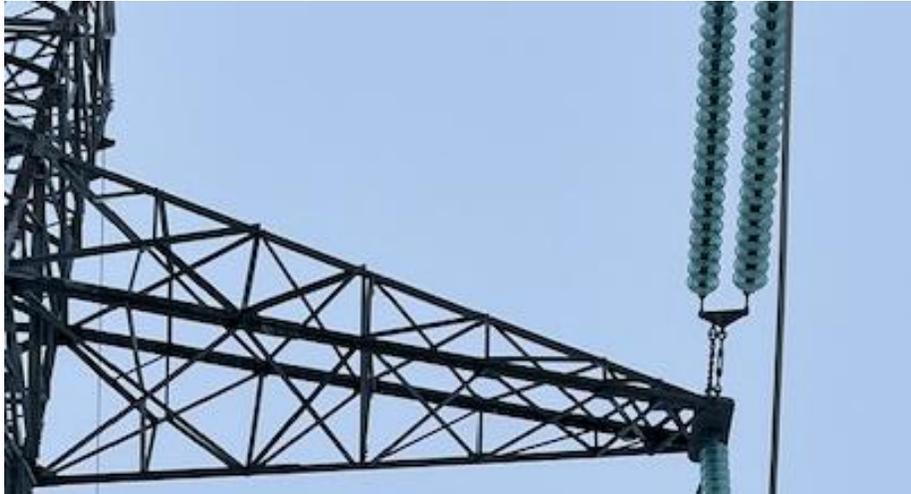
**Figure 17: Dead-End Assembly with Newly Installed Safety Chain**

- 10 The recommended repairs to Structures 1872, 1806, and 1014 were primarily completed as  
11 recommended due to equipment and time constraints. Some alternative strengthening options were  
12 used, such as replacing a turnbuckle with a new turnbuckle instead of a chain link or leaving the original  
13 turnbuckle in place and adding safety chains. Figure 17 shows an assembly with a safety chain installed.

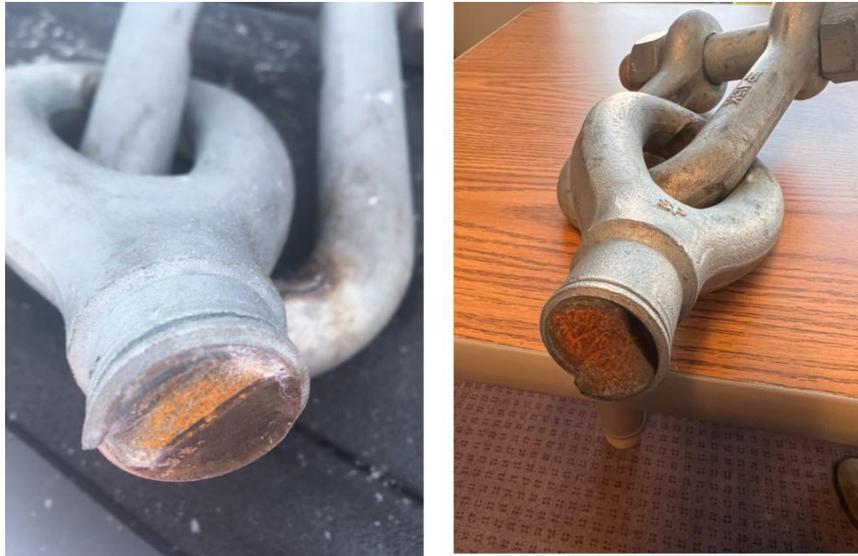
The failures in 2021 occurred under similar conditions to the most recent failures, with some wind and little-to-no ice. The failed face of the turnbuckle was similar in appearance to the current failures, occurring close to the eye on the tower side of the turnbuckle within the threaded portion. As Figure 18 shows, in both the February 2021 and December 2022 failures, there was considerable wear on the shackle and turnbuckle eye next to the break, suggesting excessive movement.

Figure 18: Failed Turnbuckle Faces from February 2021 (left) and December 2022 (right)

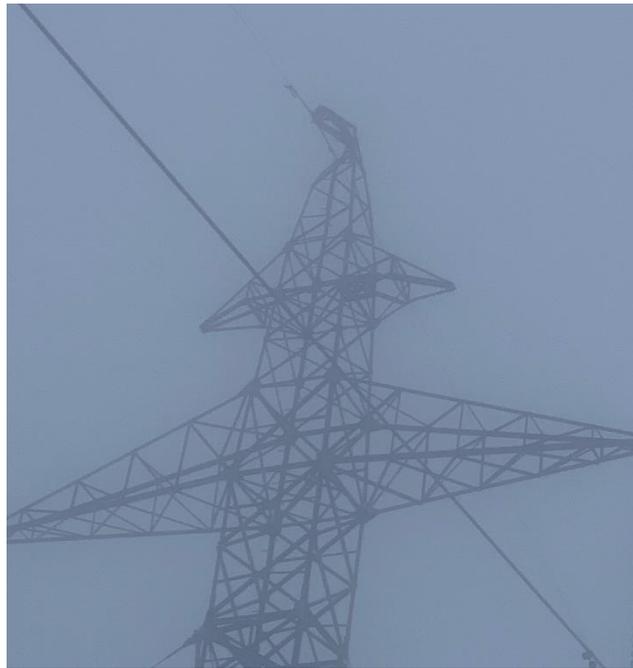
6       At approximately 1000 hours on December 14, 2022, there was a line trip reported in the Labrador  
7       section of L3502. Later that same day, failures were identified at Structures 1230 and 1231. Both peaks  
8       had failed toward the Pole 2 side of the tower. The OPGW was still intact and connected to the towers;  
9       however, as Figure 3 and Figure 4 show, the steel had bent significantly. The line trip was likely a result  
10      of contact between the OPGW and the pole conductor during the failure of the peaks,<sup>5</sup> which resulted in  
11      minimal damage to the internal fibre optics but did not affect the overall performance of  
12      communications systems.

**Figure 3: Failed OPGW Peak at Structure 1230**

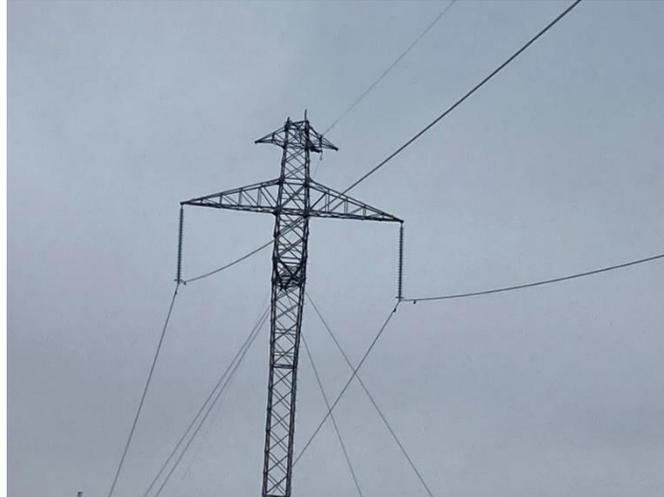
<sup>5</sup> The bending of the tower peak reduced the clearance between the OPGW and pole conductor. Additionally, there was likely significant vertical movement of the OPGW during the failure, which could cause the wires to make contact.

**Figure 4: Failed OPGW Peak at Structure 1231**

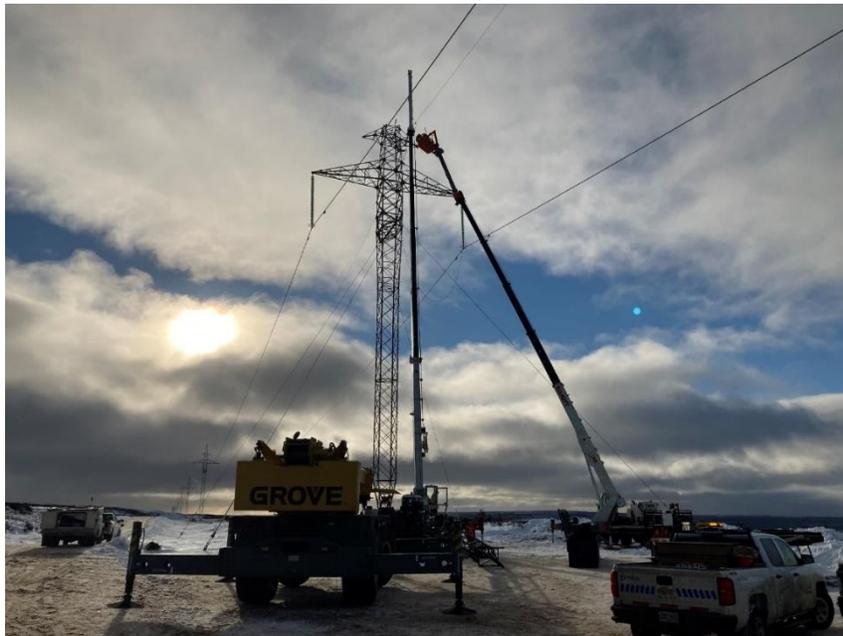
Figure 11: Repair work to OPGW Peak

9 The OPGW tower peaks were replaced at Structures 1230 and 1231 and the existing OPGW wire was  
10 reconnected to the towers. Crews later returned to this area to further troubleshoot the damaged fibre  
11 signal and verify if a section of OPGW should be replaced when the weather is more favourable. Pictures  
12 of the repairs are provided as Figure 11 and Figure 12.

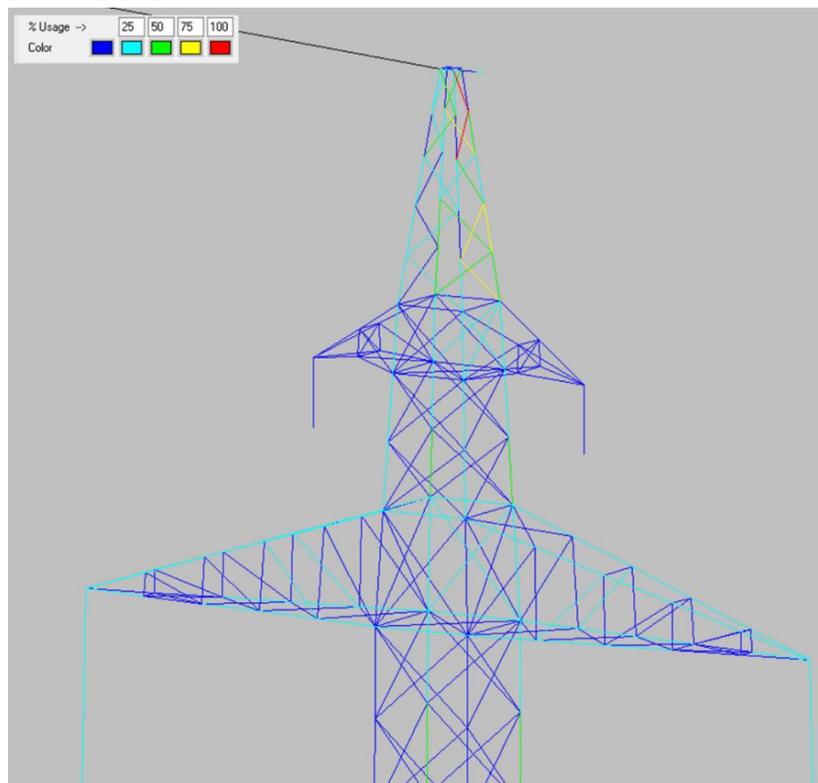
- 3 In addition, the way in which the structures failed in the model is similar to the failures experienced in
- 4 the field. As seen in Figure 13, Figure 14, and Figure 15, the failed members are contained to the OPGW
- 5 peak while the crossarms and tower body members have lower utilization. The failed members are also
- 6 located on the side of the tower, which would lead to the peak crumbling to the side, as seen in the
- 7 pictures of the failed structures in Figure 3 and Figure 4.

**Figure 13: Model of Structure 1230 Failure under OPGW 100/0% of 30 mm Load Case**

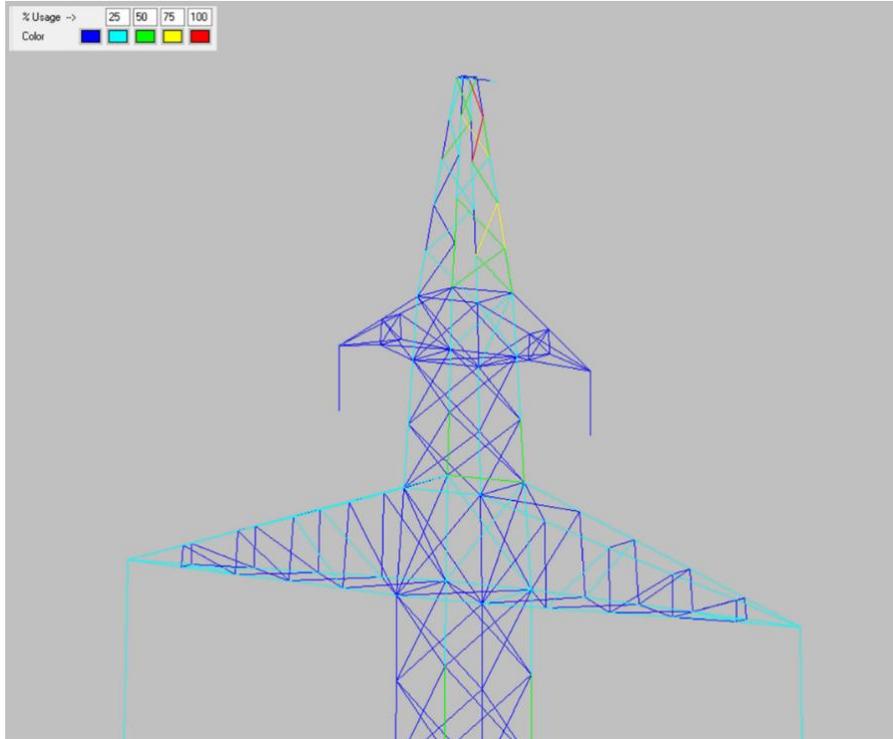
**Figure 14: Model of Structure 1230 Failure under OPGW 100/30% of 35 mm Load Case**

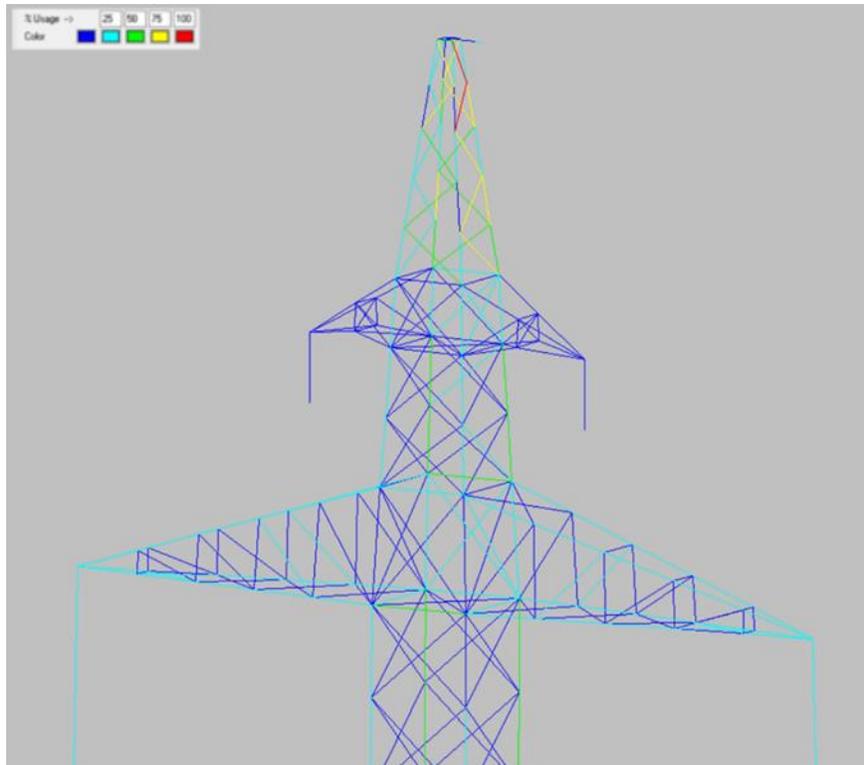
**Figure 15: Model of Structure 1230 Failure under OPGW 100/0% of 35 mm Load Case**

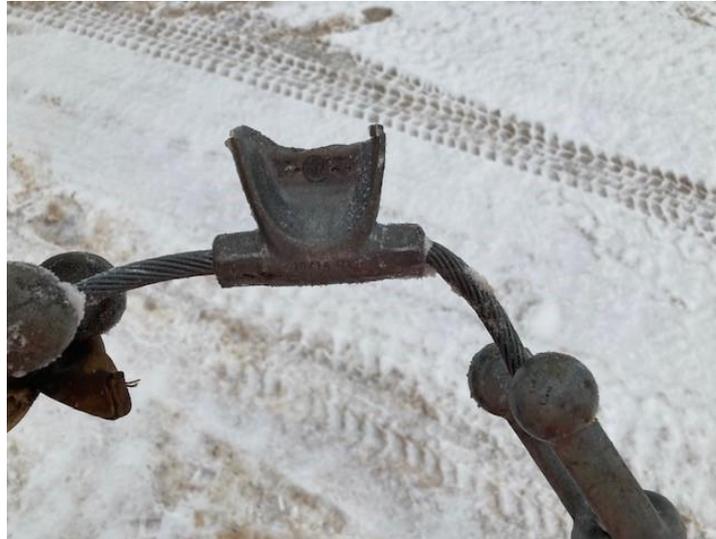
7 The line has also experienced issues with the Stockbridge damper, as shown in Figure 16, which is  
8 installed on the line to control Aeolian vibration.<sup>20</sup> Damper failures, which do not cause an outage to the  
9 line, could be caused by inadequate damping, ice loads, or galloping and have been identified  
10 throughout the line during routine inspections. Through testing of the dampers and vibration monitoring  
11 of the line, it was determined the dampers currently installed on the electrode conductors and OPGW  
12 are not adequately controlling the vibration. There is a capital project proposed for 2024 to specify new  
13 damper requirements and purchase new dampers for the line. Damper failures were found near the  
14 failed Structures 1230 and 1231, exhibiting significant damage to the clamp of the damper and bending  
15 in the messenger wire as shown in Figure 17 and Figure 18.

**Figure 17: OPGW Stockbridge Damper Failure**

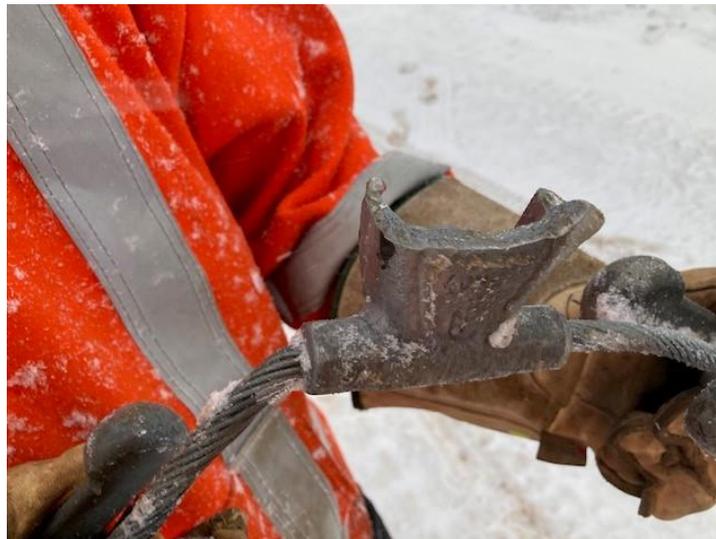
**Figure 18: OPGW Stockbridge Damper Failure**

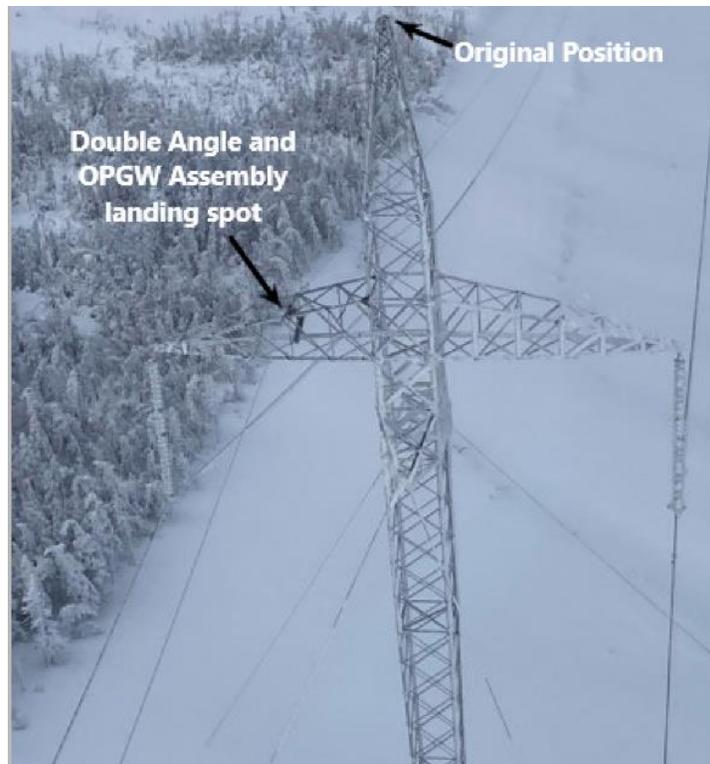
**Figure 3: Structure 2135 OPGW Connection Failure**

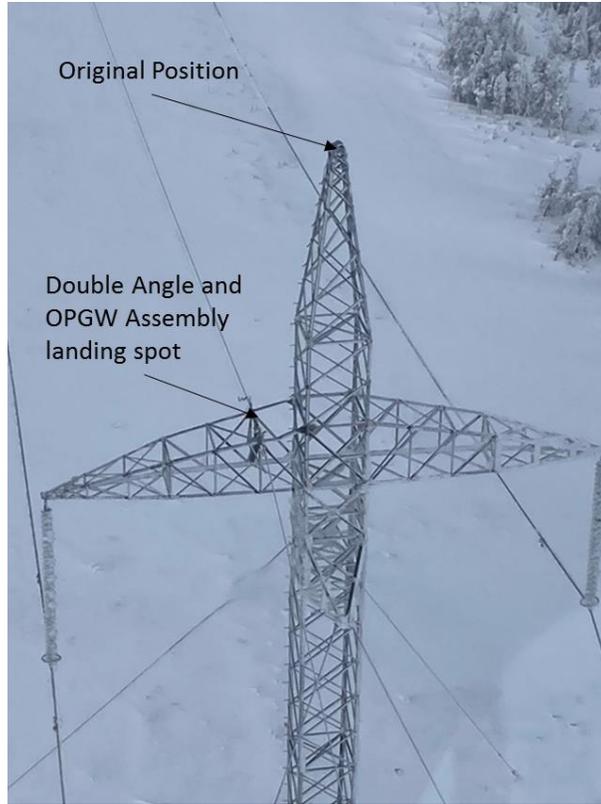
**Figure 4: Structure 2136 OPGW Top Plate Failure**

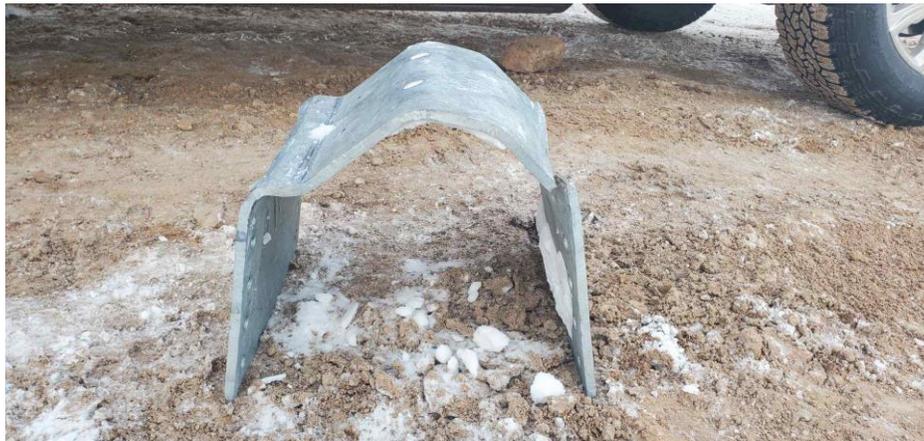
**Figure 5: Bent Top Plate after Removal from Tower**

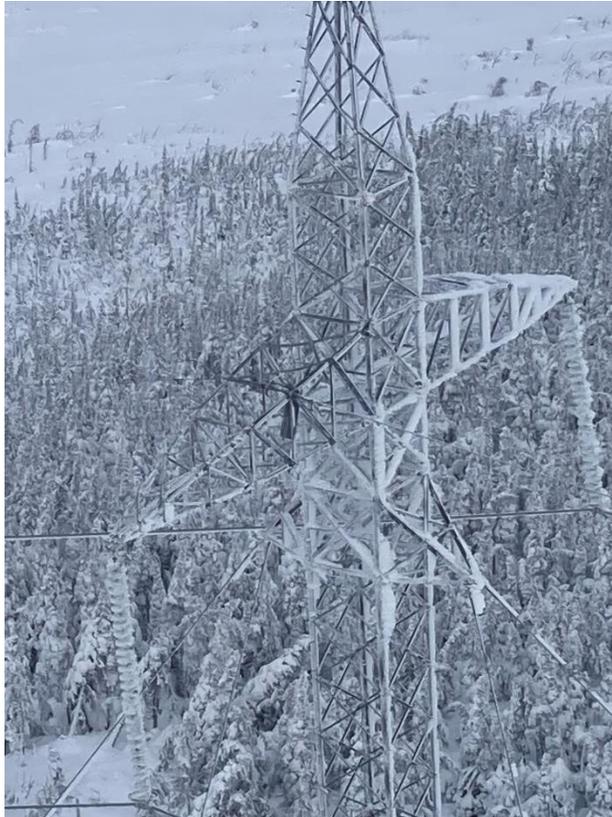
**Figure 8: Ice on Structure 2135**

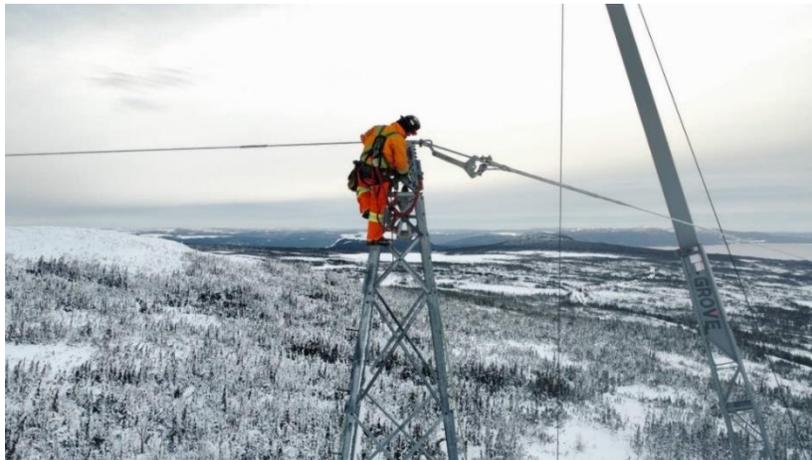
**Figure 9: Repair Work to OPGW Peak**

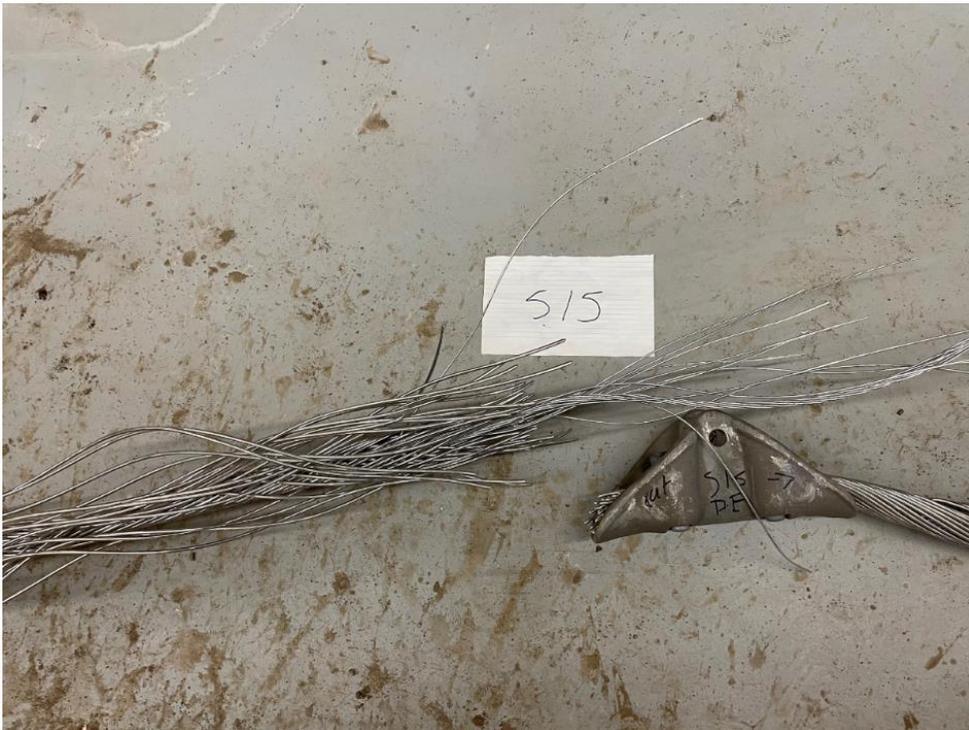
Figure 3: Broken EL2 at Structure 515

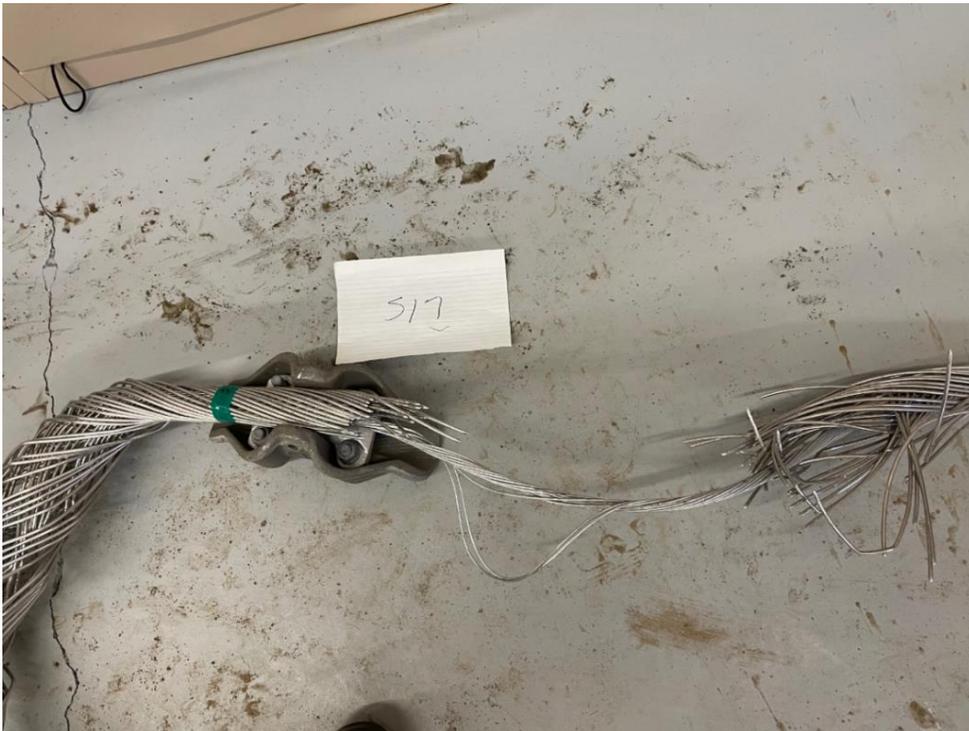
**Figure 7: Structure 517 Broken Aluminum Strands**

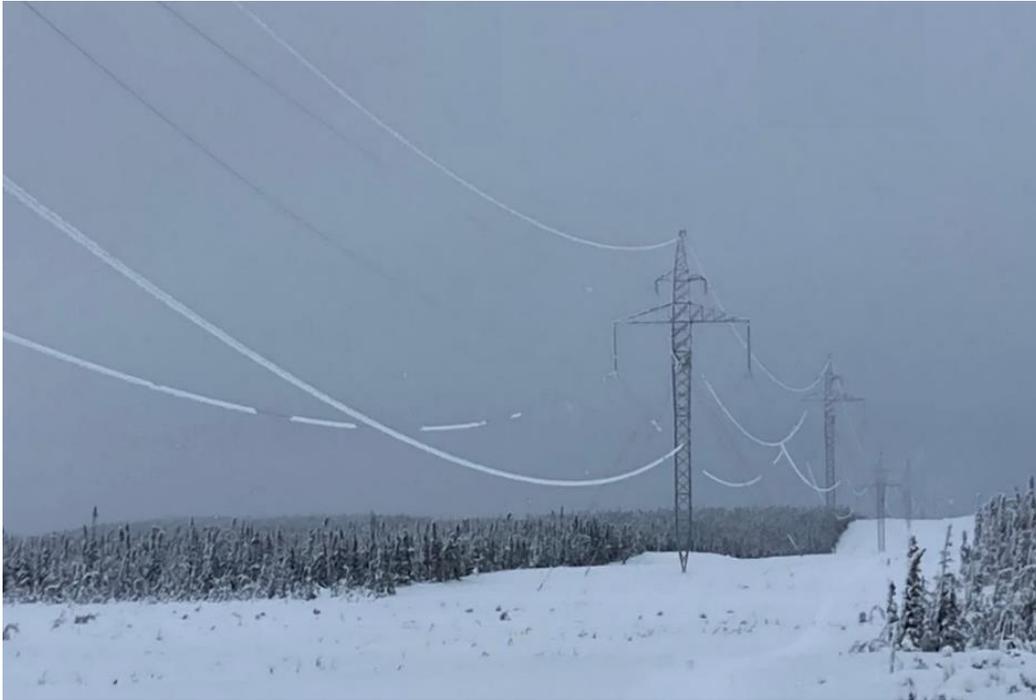
**Figure 12: Ice Accumulation on Cables Immediately After Failure**

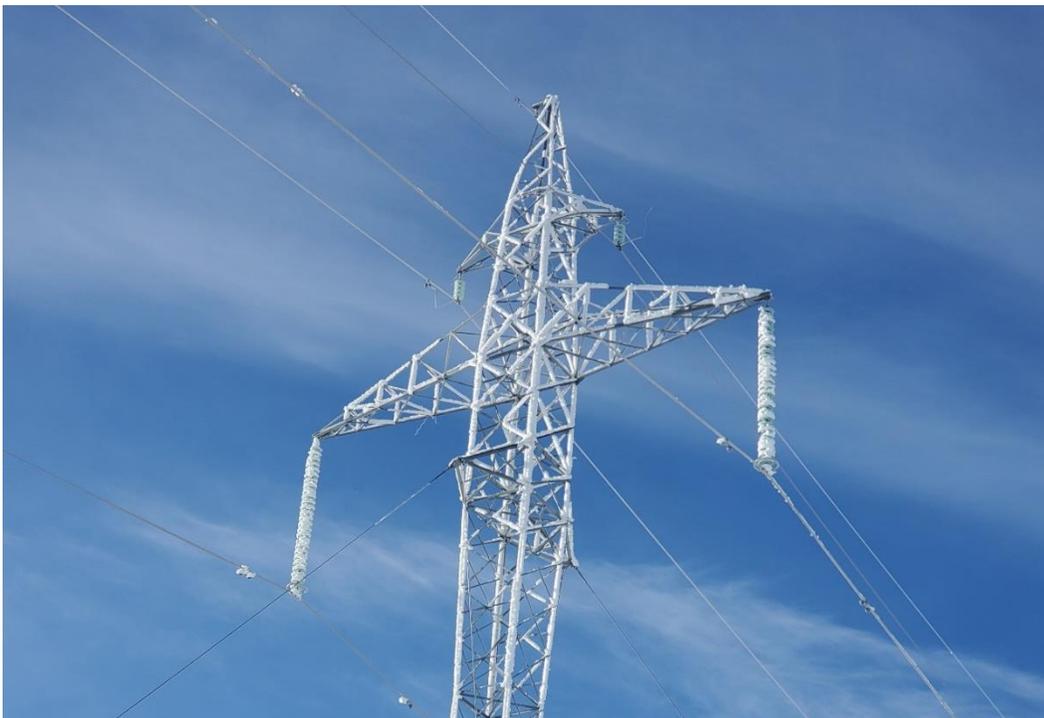
**Figure 13: Ice Accumulation on Towers/Insulators (Mixture of Snow/Ice)**

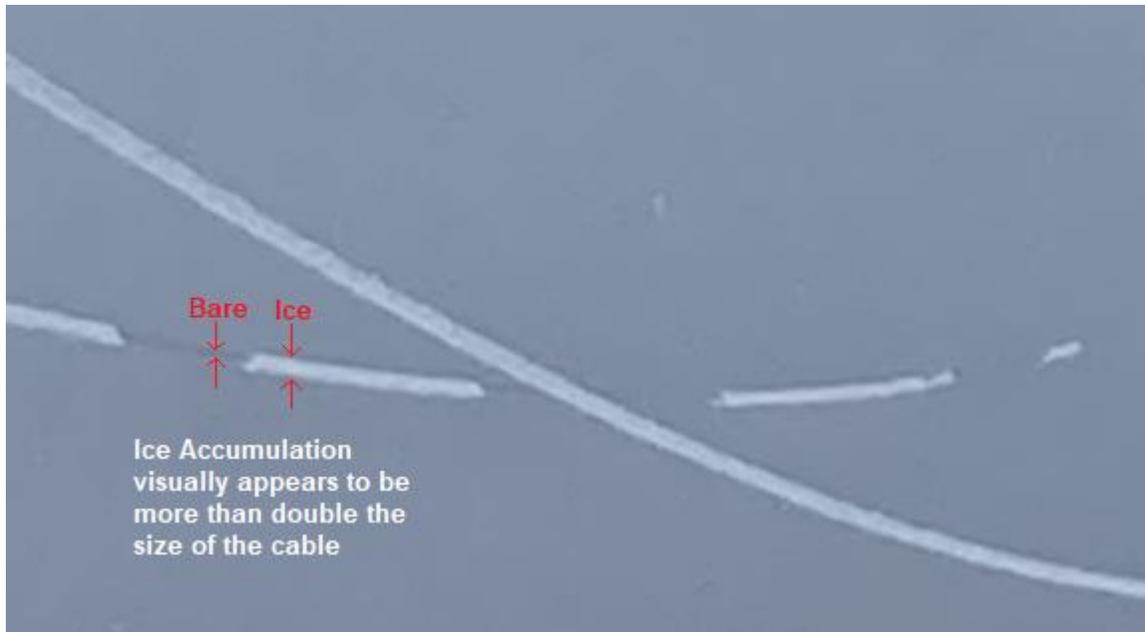
**Figure 16: Ice Accumulation/Partial Shedding on Cables**

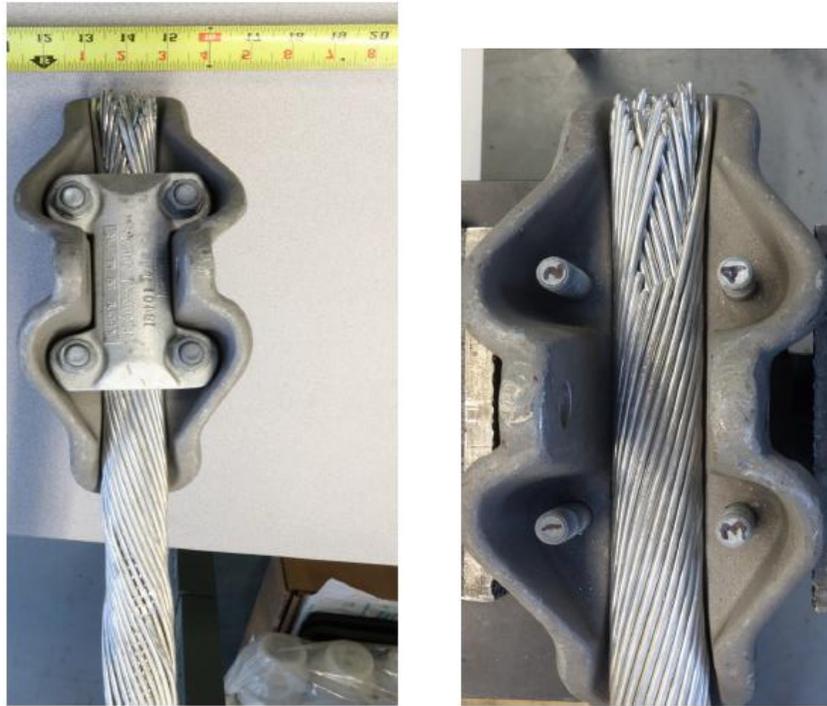
**Figure 22: Cable Damage at Clamp at Structure 515**

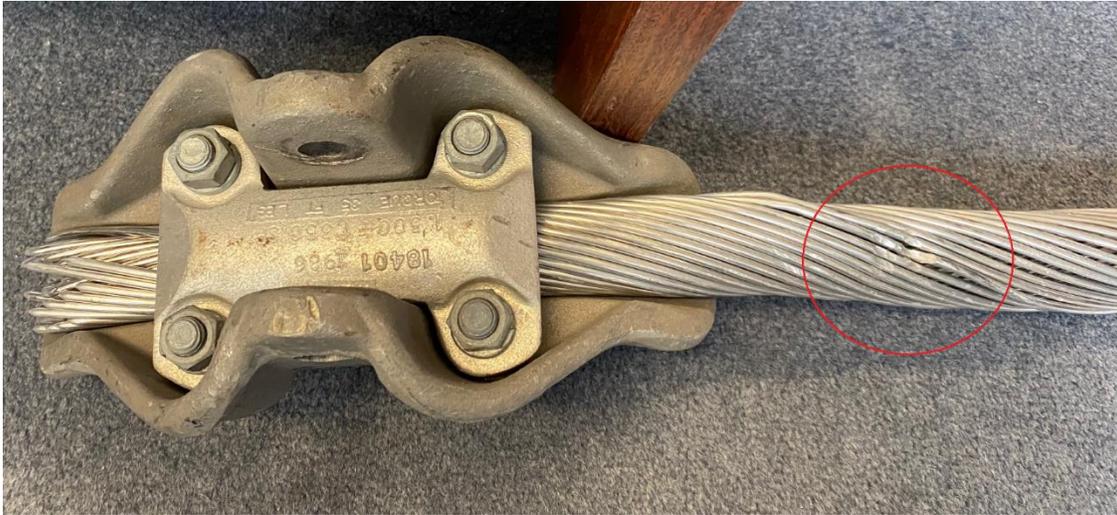
**Figure 23: Dent in the Conductor near the Tangent Assembly from Structure 515**
