**Re: *Reliability and Resource Adequacy Study Review – Updated Project Schedule for L'Anse au Diable Grounding Station and Wave Study for Dowden's Point Grounding Station***

## Design Check Report

Dowden's Point Breakwater

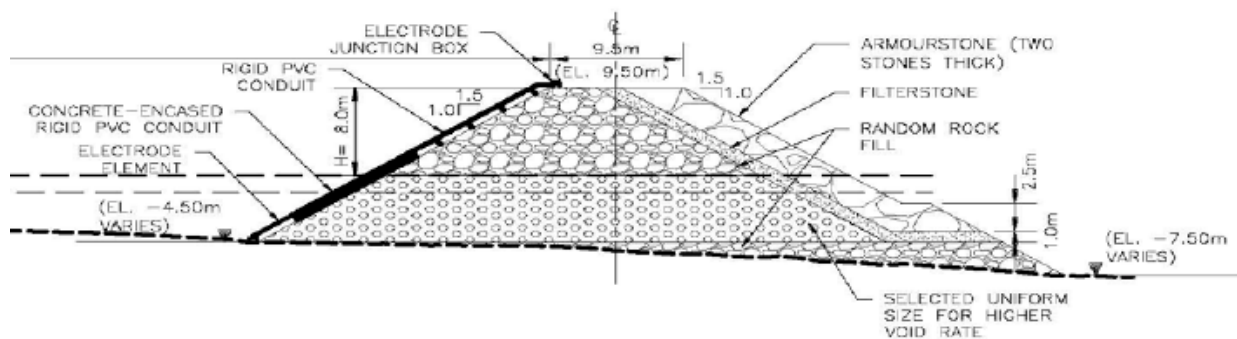
**Figure 1 – 2010 Preliminary Breakwater Design**

2010 preliminary Dowden's Point Breakwater Designs detail a crest height of 9.50m. It is assumed that this is referenced to chart datum which would equate to 8.75m geodetic. A 2010 cross section is shown below:

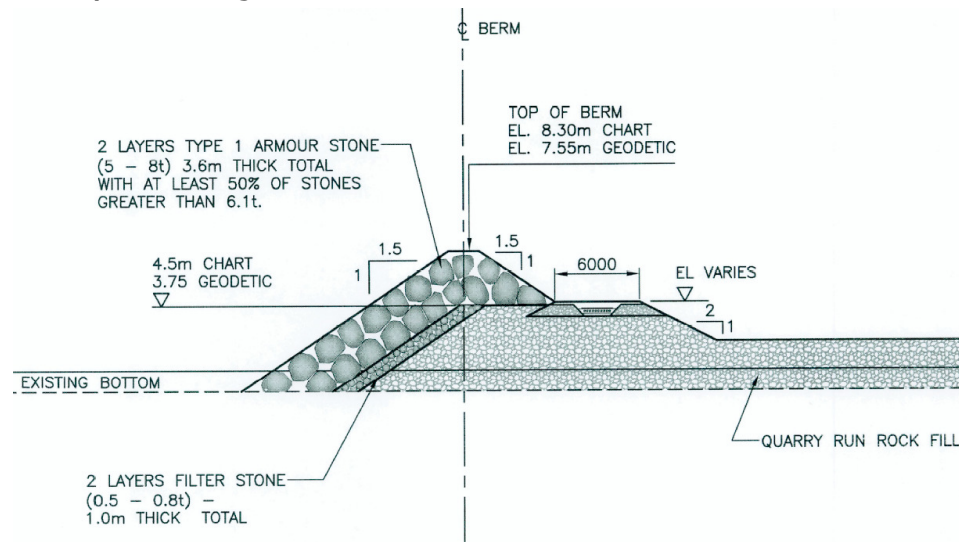
**Figure 2 – 2015 Issued for Construction Breakwater Design**

Based on the 2012 Design Criteria, the 2015 Issued for Construction Design defines a 7.55m (geodetic) crest height as can be seen below:
