1	Q.	Please	provide copies of reports or other documentation that describe the latest condition			
2		of the following assets and any work completed to date addressing the following issues:				
3						
4		a.	Bay d'Espoir penstocks;			
5						
6		b.	Hinds Lake rotor resistance;			
7						
8		С.	Granite Canal control system;			
9						
LO		d.	Upper Salmon rotor rim cracking;			
11						
12		e.	Hinds Lake bearing coolers;			
13						
<b>L</b> 4		f.	Cat Arm spherical control valves;			
15						
16		g.	Hardwoods combustion can failures;			
<b>L</b> 7						
18		h.	Hardwoods bellows failures/cracking;			
19						
20		i.	Holyrood boiler tube issue, variable frequency drive issues, air flow limitations,			
21			hydraulic fluid issues;			
22						
23		j.	Stephenville vibration issues;			
24						
25		k.	Hardwoods combustion can failures;			
26						
27		l.	Hardwoods bellows cracking issue;			
28						
29		m.	All Holyrood boiler tube failure studies;

1		n. All "Quarterly Report on Performance of Generating Units" reports; and
2		
3		o. Exploits frazil ice issues.
4		
5		
6	A.	The reports referenced below provide an overview of the latest condition of the asset(s)
7		and any work completed to

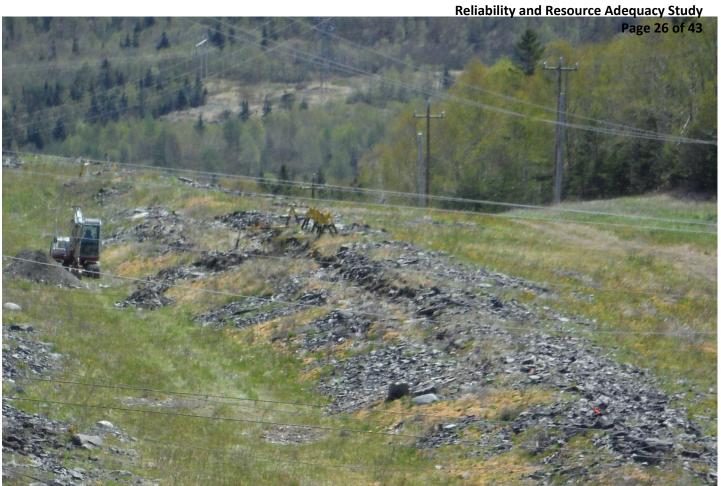
Photo 1-Looking downstream from the intake area at the damaged area of penstock no. 1

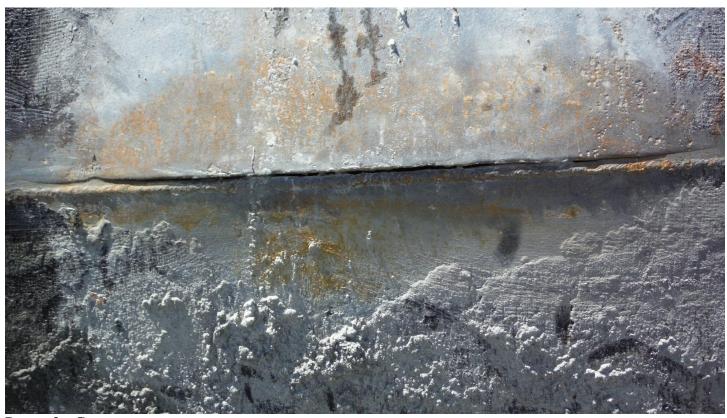
Photo 2-C rack in Penstock plate along longitudinal weld

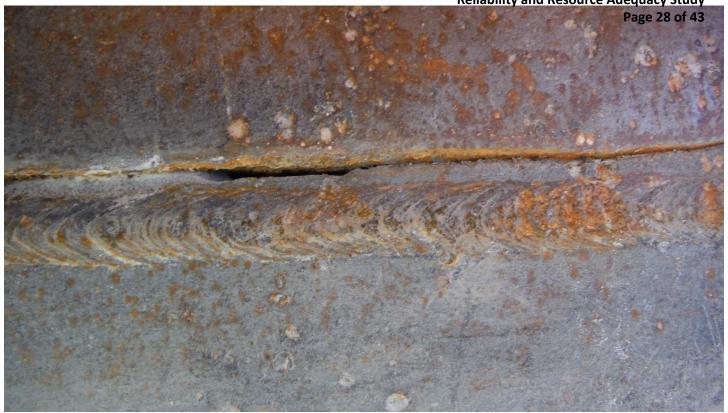
PHOTO 5 – CLOSE-UP OF CRACK. NOTE CORROSION IN CRACK THAT APPEARS OLDER THAN ONE WEEK.

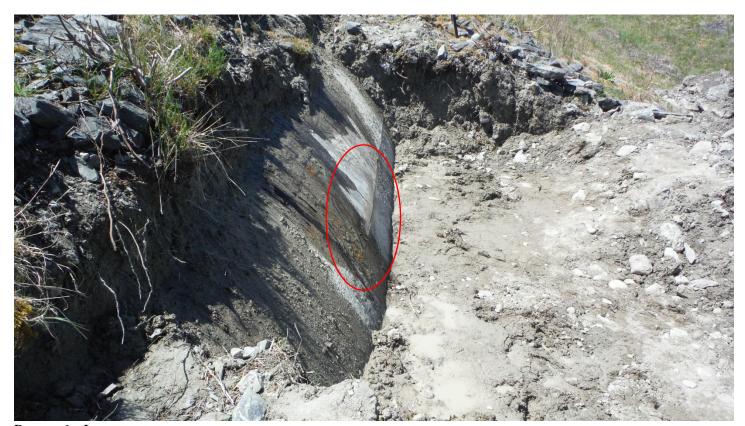
PHOTO 6 – LOOKING UPSTREAM ALONG CRACK LOCATION WITH BACKFILL REMOVED

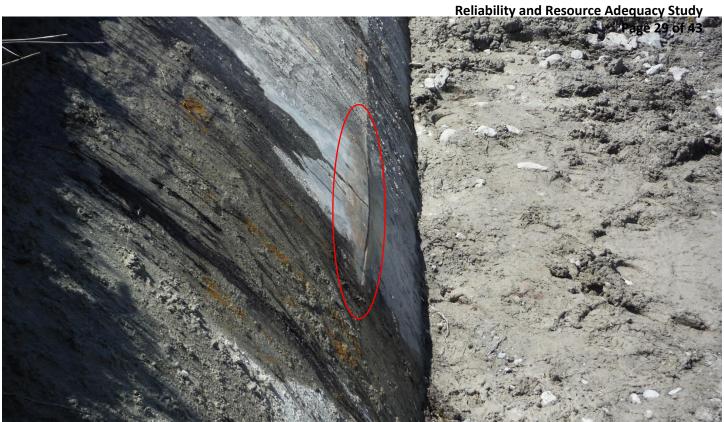
PHOTO 7 – LOOKING UPSTREAM FOR SIDE VIEW OF CRACK AND BULGE

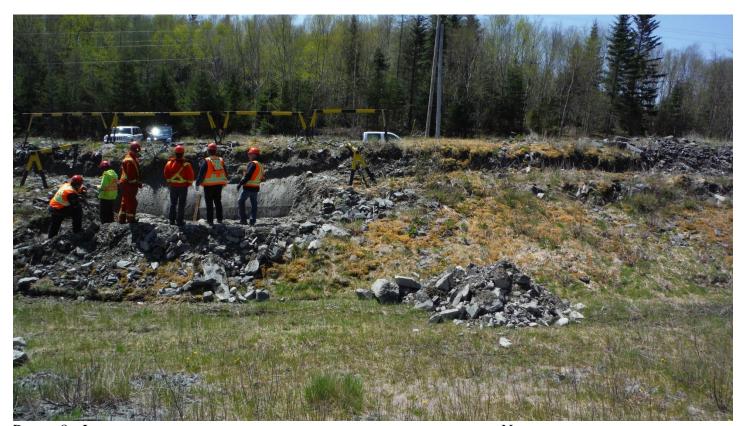
Photo 8 – Looking at the left side of the penstock in area of crack. Note slumped backfill

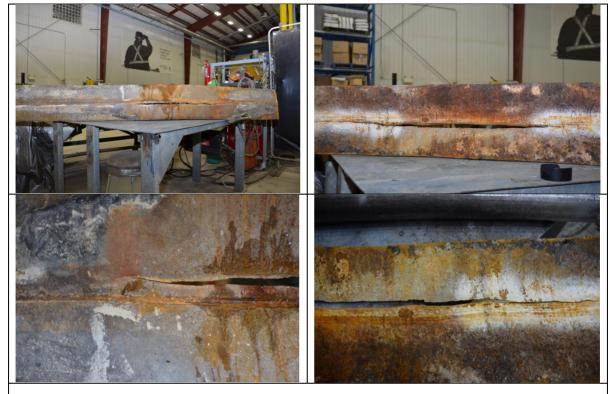
Figure 4-1: Close-up View of the Rupture in Can 35 (in the Laboratory for Material Tests)

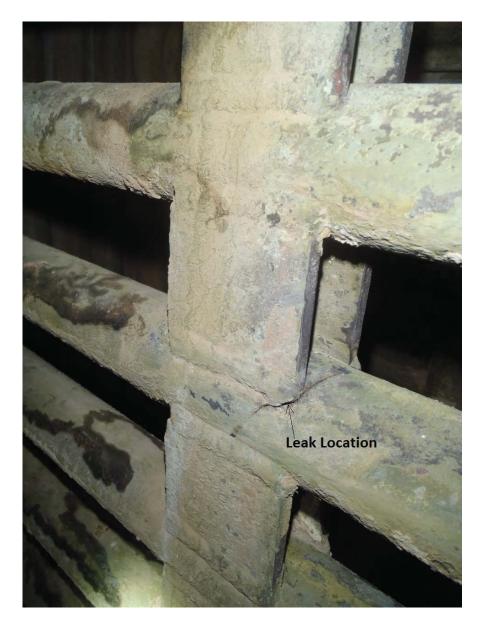
**Figure 2.** Shown is the failure site as it appeared prior to sample removal from the boiler.

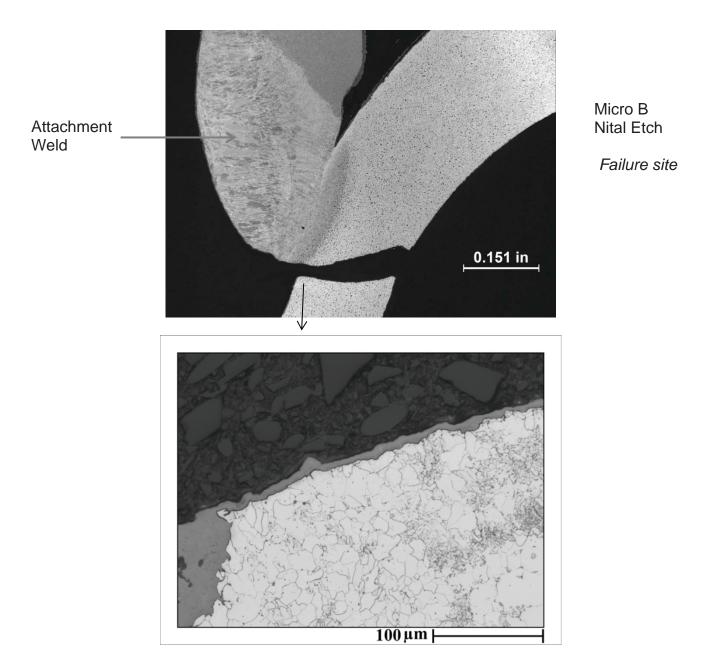
**Figure 5.** The condition of the macrostructure and microstructure at the failure site is shown.

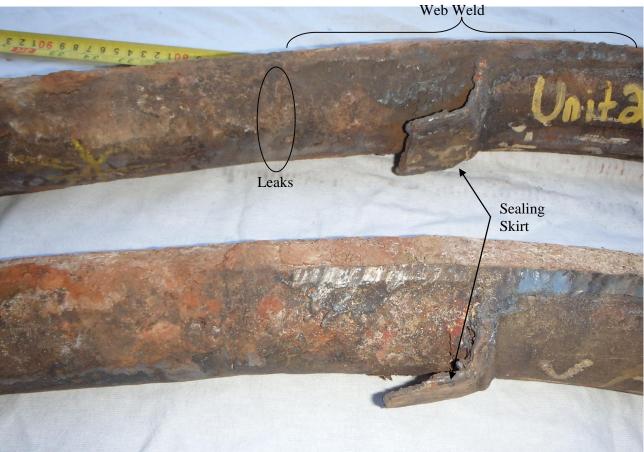
Figure 1: Tubes #111 & #114 In the As-Received Condition. Lower View Highlights Relationship Between Through Wall Perforations and Web Weld & Sealing Skirt.

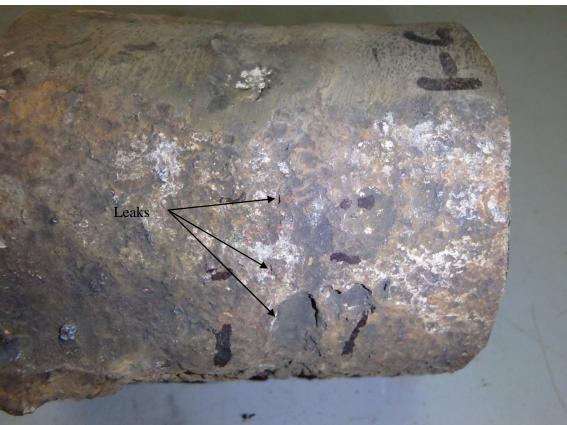
Figure 2: Close Up External Views of Through Wall Perforations on Tube #114

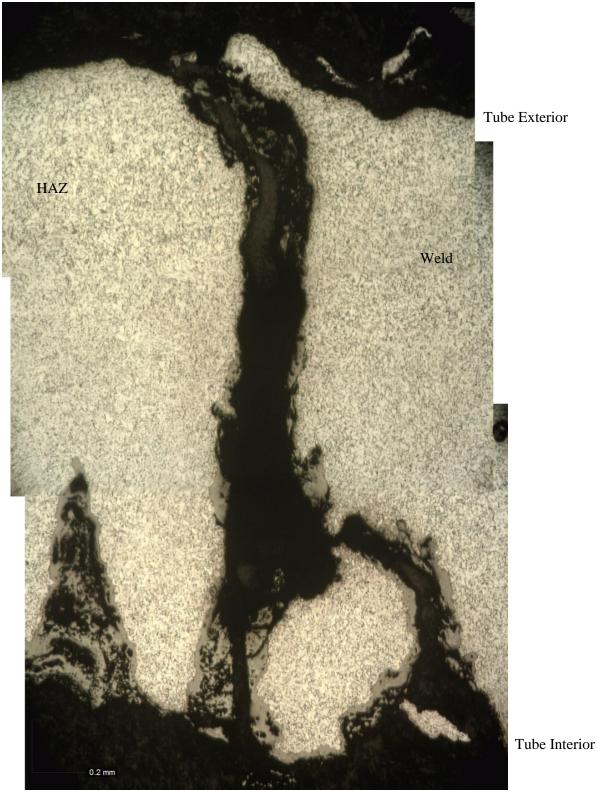
Figure 6: Cross Sectional View of Through Wall Perforation. Crack Appears to originate at Internal Surface and Propagate Through to the Exterior. There is An Appreciable Layer of Corrosion Along the Length of the Crack Fracture Face.

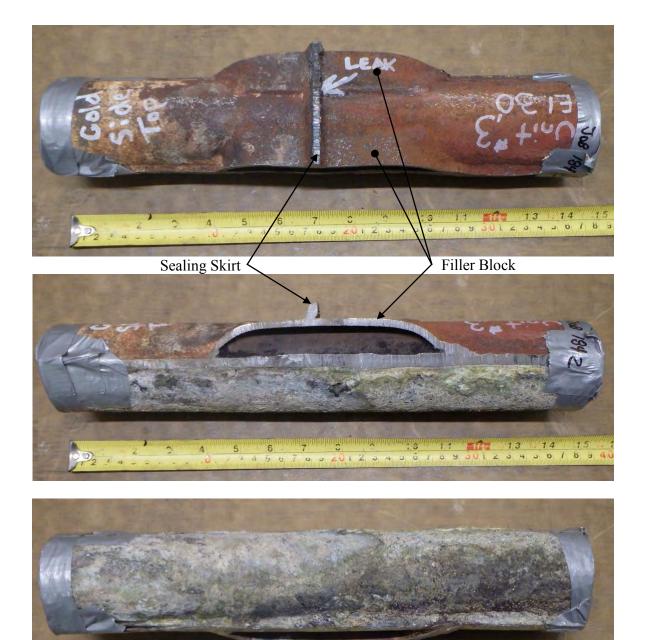
Figure 1: East Wall Tube #1 In the As-Received Condition. Views Highlight Relationship Between Leak, Filler Block & Sealing Skirt.

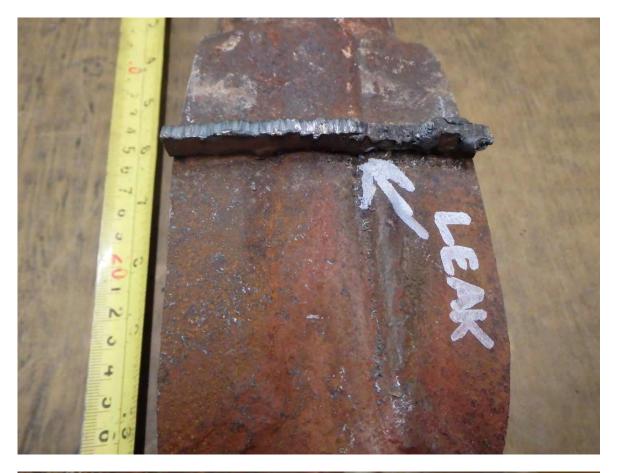
Figure 2: Close Up External View of Leak on Tube #1.
