1 Q. **Reference: Reliability and Resource Adequacy Study 2022 Update, Volume III, page 25.**

2019 HOLYROOD THERMAL GENERATING STATION CONDITION ASSESSMENT UPDATE REPORT

REPORT
 FOR
**2019 HRD TGS CONDITION ASSESSMENT
 UPDATE REPORT**
HOLYROOD THERMAL GENERATING STATION
 FOR
NEWFOUNDLAND AND LABRADOR HYDRO

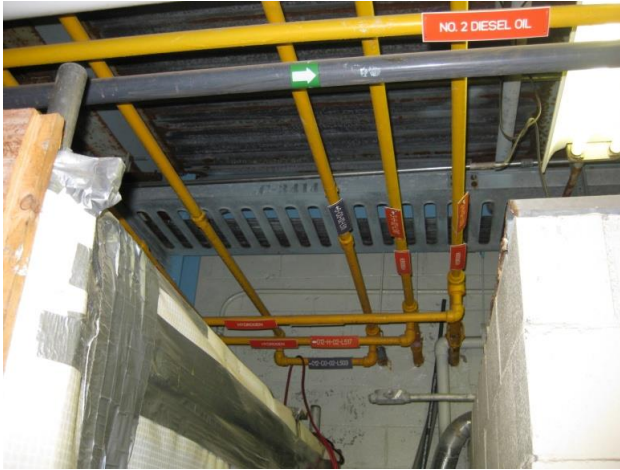
Figure 11-5 Hydrogen Lines in Powerhouse

One issue with the hydrogen was that there was no other major Newfoundland user and hence no Newfoundland based supplier. It must be shipped from off-island. This led to the installation of a site-based hydrogen production facility. Issues with the system led to the installation of a bulk hydrogen storage system.

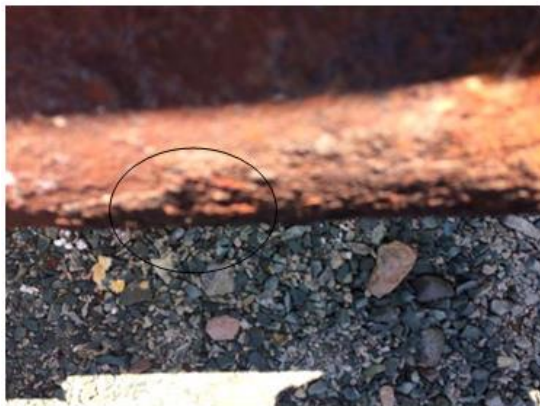
Most areas inspected with guided wave indicate that corrosion under insulation is present. Data indicated that multiple areas of corrosion pitting were observed throughout the test lengths inspected. Visual inspections indicated rust bloom and pitting at each collar attachment point. General external corrosion was noted along the entire pipeline with the worst cases being up in the tank farm. Data collected from TL-9 through TL-29 illustrate this condition. The worst pitting noted was found in the expansion loop between tank 3 and 4. Here external corrosion pitting measured up to .040". Guided wave data also indicated corrosion pitting worse than at the collar attachment point. TL-7 noted on the expansion joint between the power plant and the tank farm is excluded to this rule. Piping noted at TL-7 expansion loop was found to be severely corroded. Due to the corrosion, radiography is recommended at the lower elbow and the piping to the east.

Pit depth of .030"

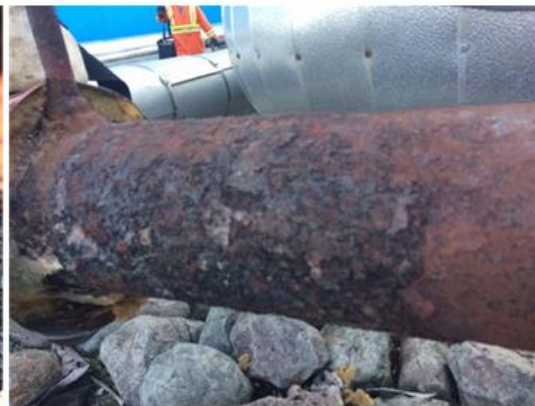
General corrosion noted prior to pre-cleaning
