1 Q. **Reference: Application, Schedule 1: Upgrade Report – Penstock 1 Life Extension – Bay**
2 **d'Espoir, Appendix J, Page 26 of 51..**

PENSTOCK NO. 1 INSPECTION AND EVALUATION

BAY D'ESPOIR HYDROELECTRIC DEVELOPMENT PENSTOCKS 1-3 INSPECTION PROJECT

2670021_003RP
April 2020

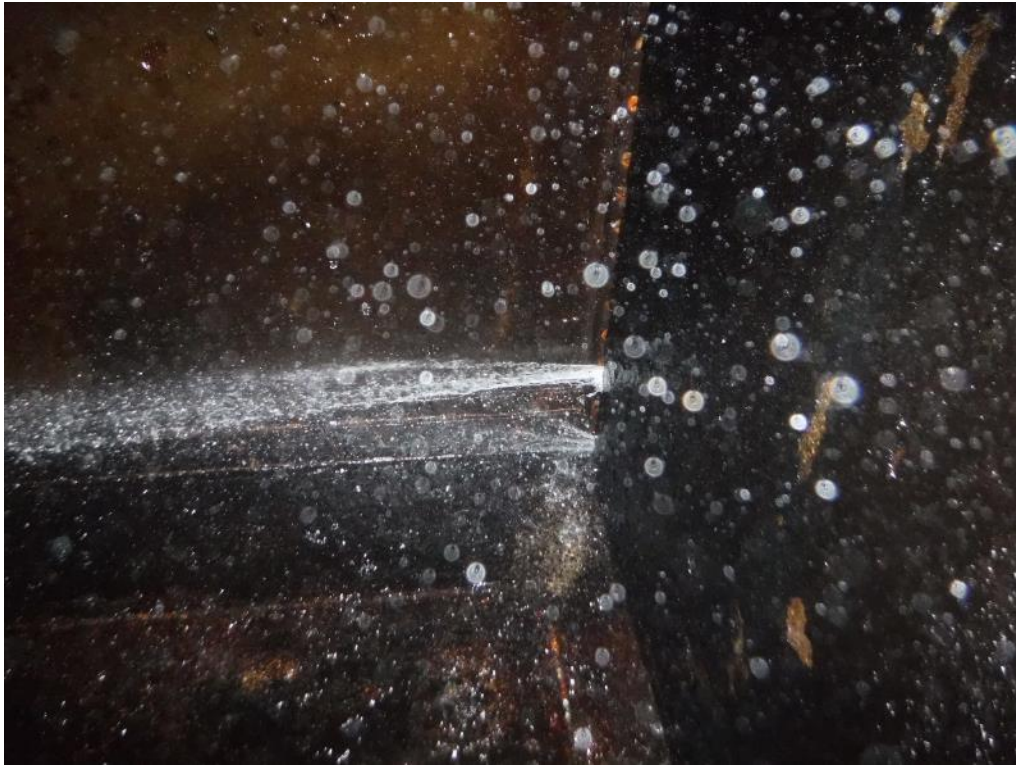
The inspection started at the headgate. Leakage around the gate was mainly from the left bottom corner as seen in Photo 1, Appendix B. Concrete deterioration at the concrete to steel transition (Photo 2), notably more extensive than at other Bay d’Espoir penstocks, has resulted in the leading edge of steel exposed all the way around but worse in the lower left area. The interior surface of the penstock was fairly wet as the penstock was dewatered two days prior and had not dried out. Much of the organics had been cleaned away during the previous penstock repairs, which facilitated the inspection.

PHOTO 1 LEAK IN BOTTOM LEFT CORNER OF GATE

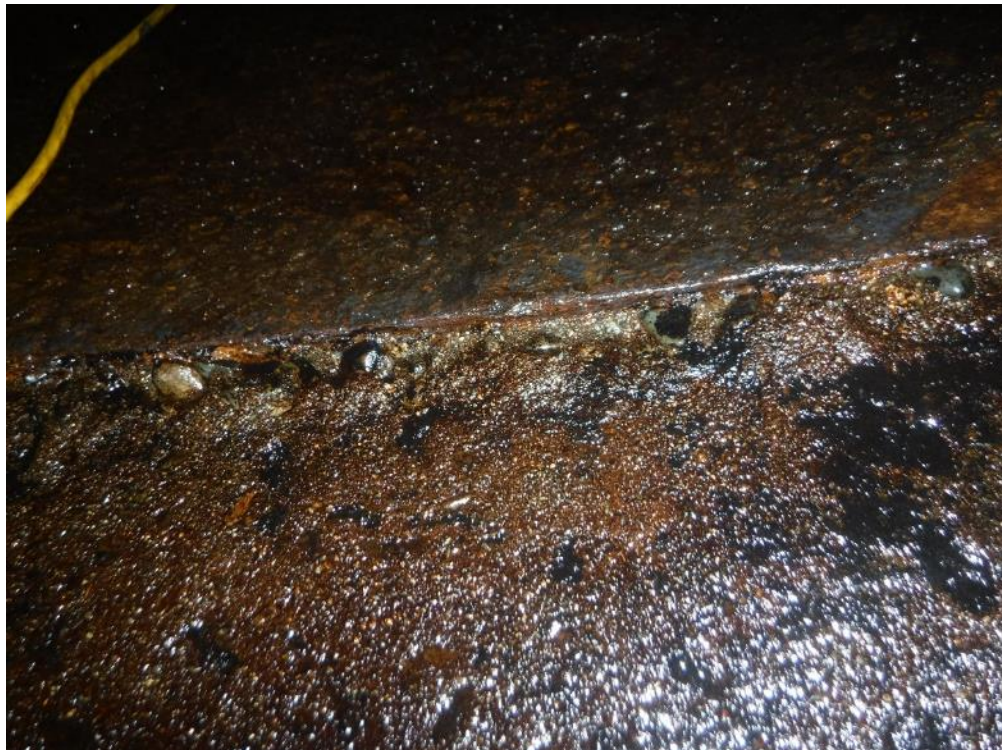
The concrete of the intake structure was in fair condition with no significant deterioration or wear, except the transition from the concrete to steel penstock showed significant deterioration all around and especially the lower left side area (Photo 2). The headgate seals appeared to be in good condition with only minor leakage of the headgate apparent from the bottom left corner of the headgate when looking upstream (Photo 1). The headgate skin plate also appeared to be in good condition. A full inspection of the gate members and gate embedments was not performed and was outside the scope of work.

PHOTO 2 CONCRETE DETERIORATION AT CONCRETE TO STEEL TRANSITION

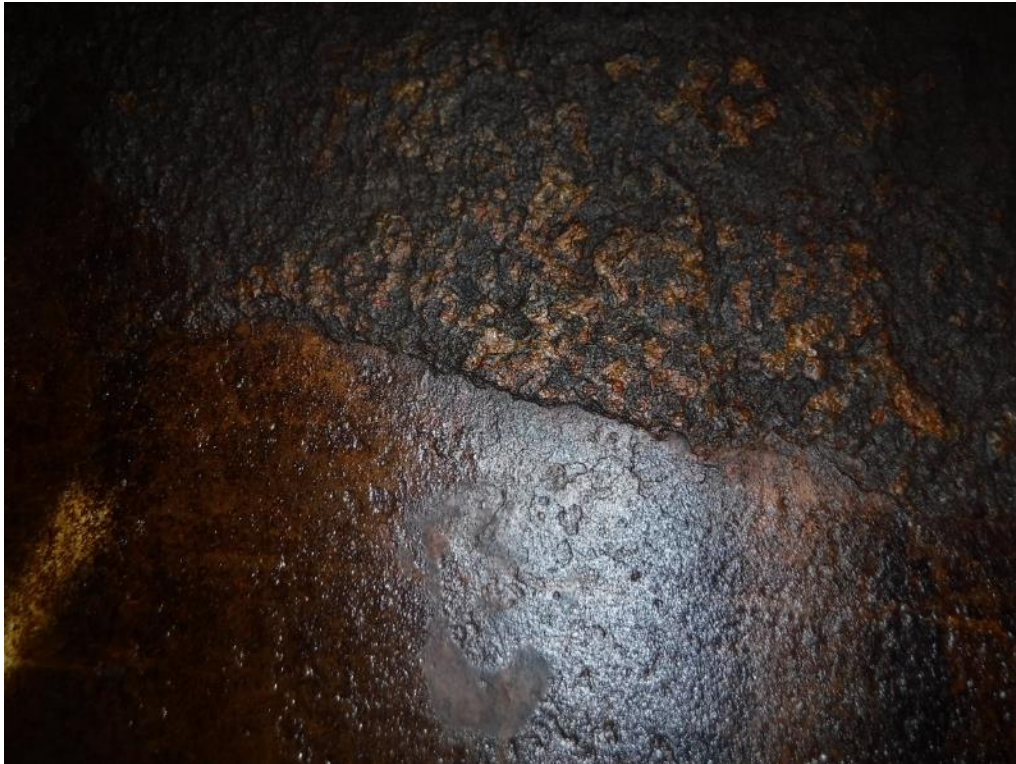
PHOTO 3 OLD ORGANIC GROWTH ON INSIDE OF PENSTOCK

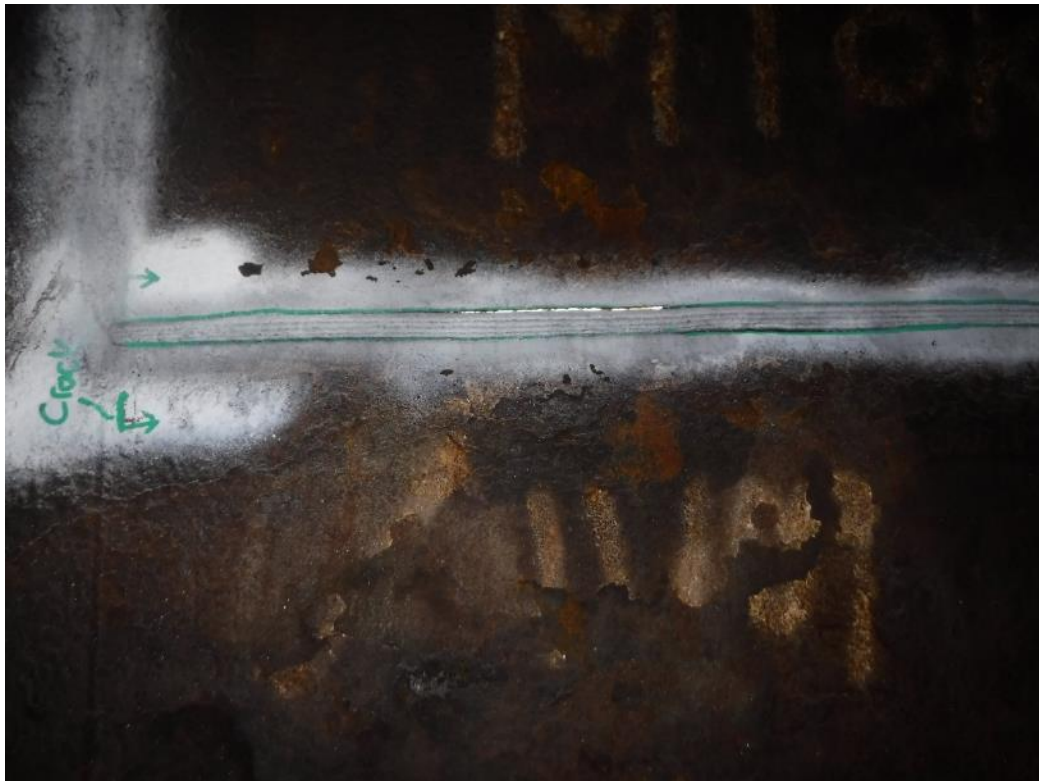
PHOTO 6 CRACKED WELD RIGHT SIDE OF CAN 106 NEAR SPRING LINE

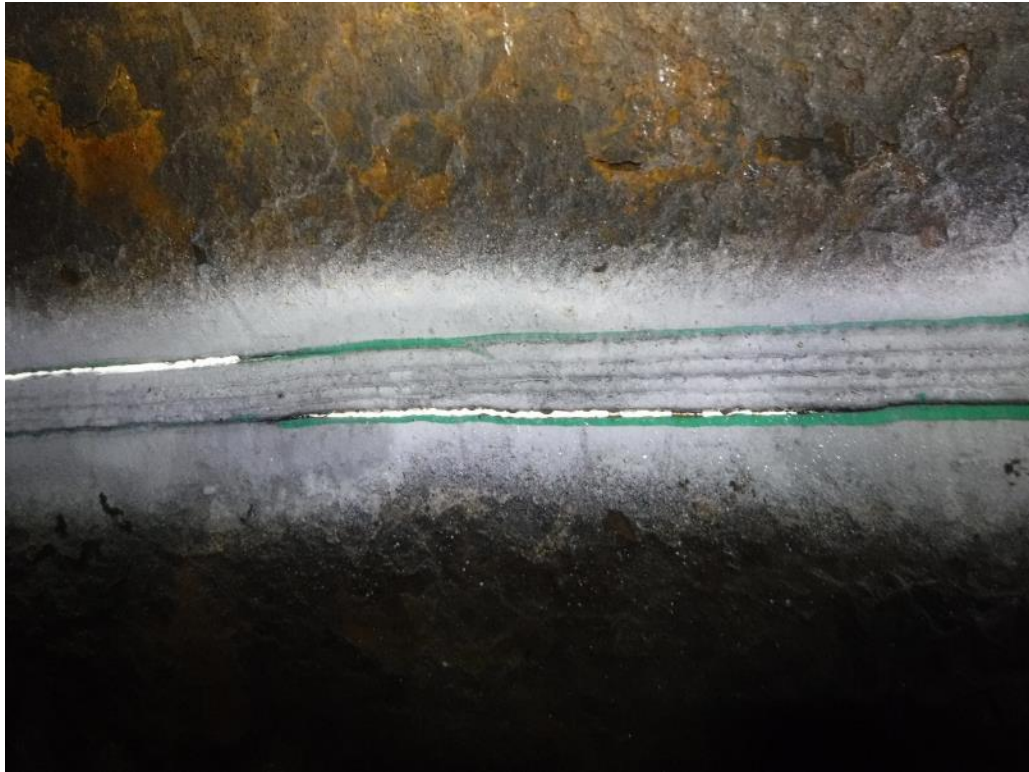
PHOTO 7 **CRACKED WELD RIGHT SIDE OF CAN 106 NEAR SPRING LINE**

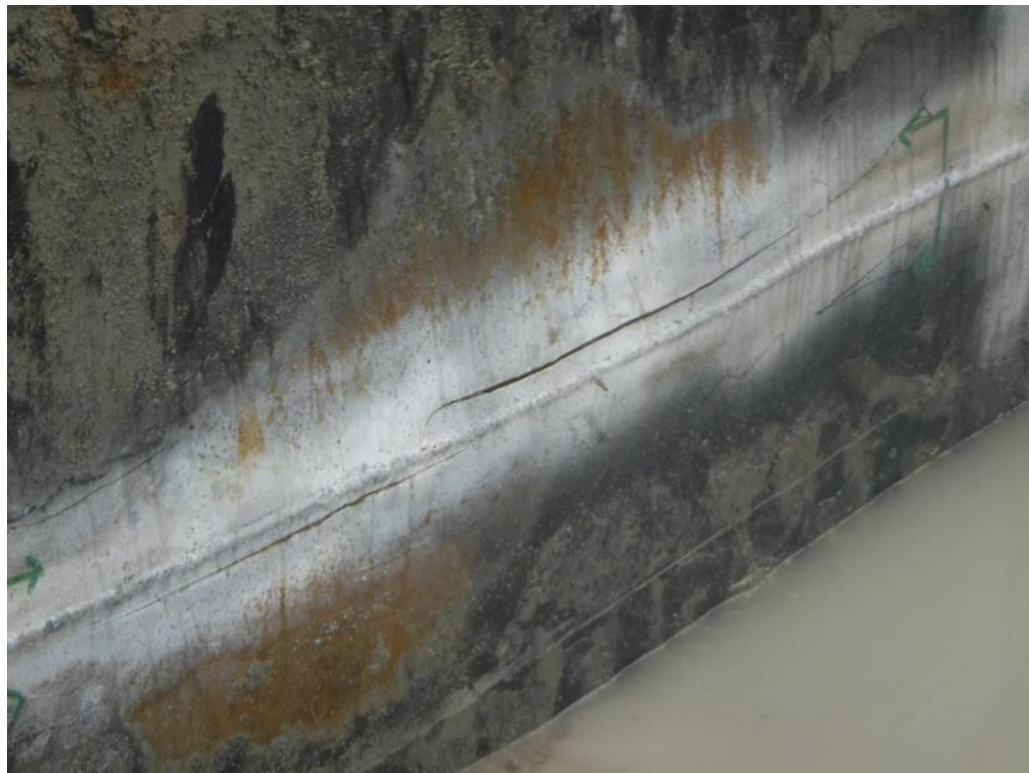
PHOTO 8 **CRACKED WELD FROM OUTSIDE RIGHT SIDE OF CAN 106**

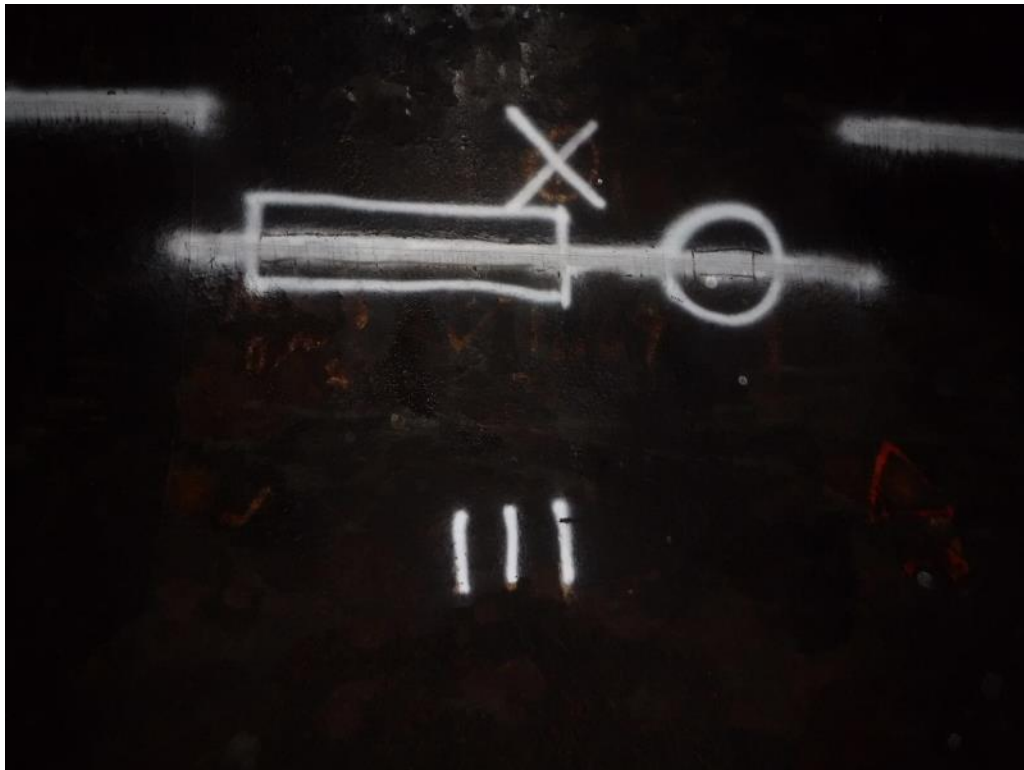
PHOTO 10 MT TEST SHOWED INDICATION OF ISSUE LEFT SIDE CAN 111 NEAR SPRING LINE

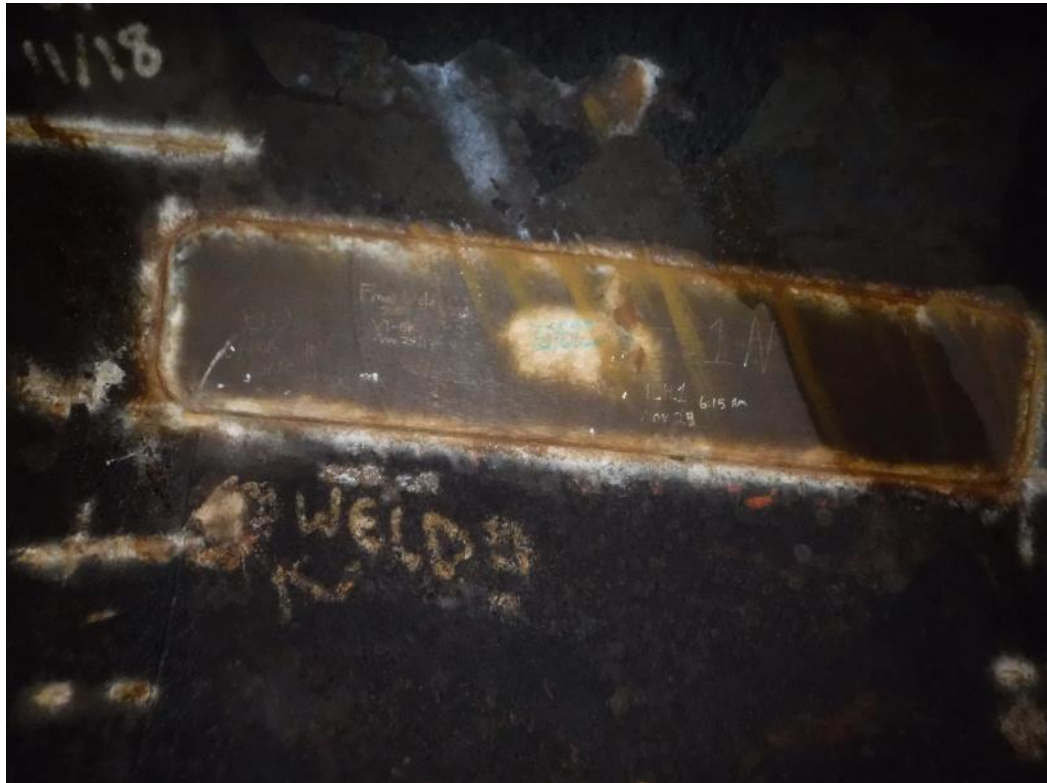
PHOTO 12 DOUBLER PLATE REPAIR

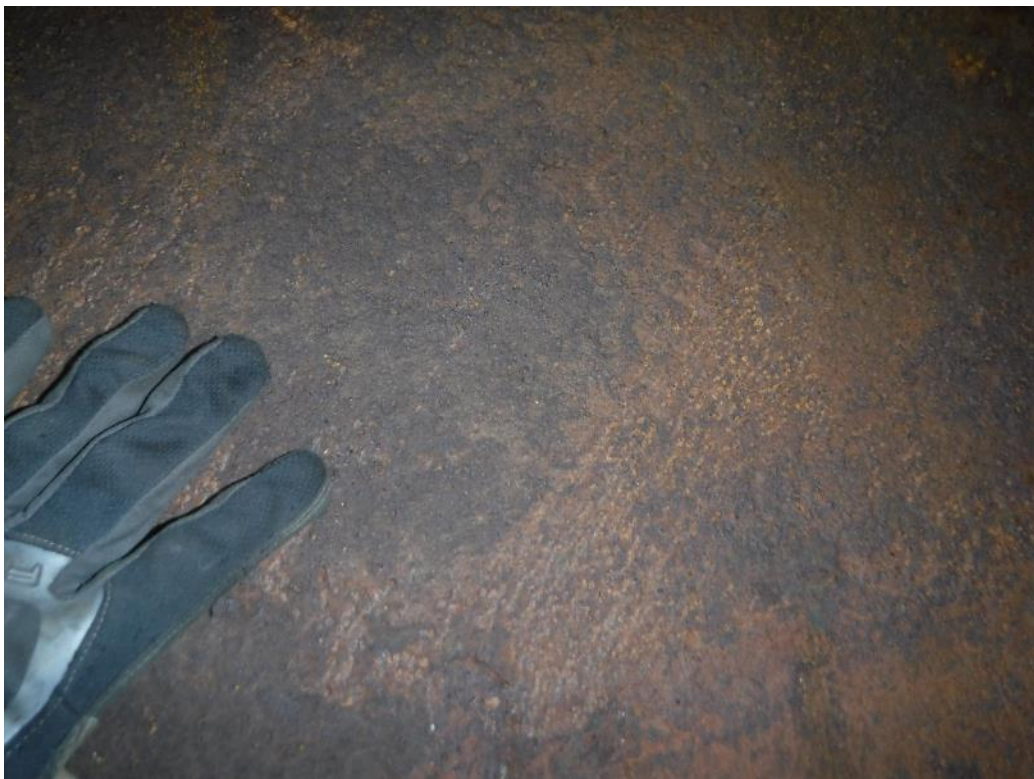
The interior of the penstock is generally in fair condition with scattered moderate corrosion and pitting with tubercles and growth (Photos 18 to 20). Pitting was minor to moderate, relative to the plate thickness, and detailed pit measurements were not taken.

PHOTO 18 SURFACE CORROSION CAN 320 – LESS PITTING THAN HIGHER IN PENSTOCK

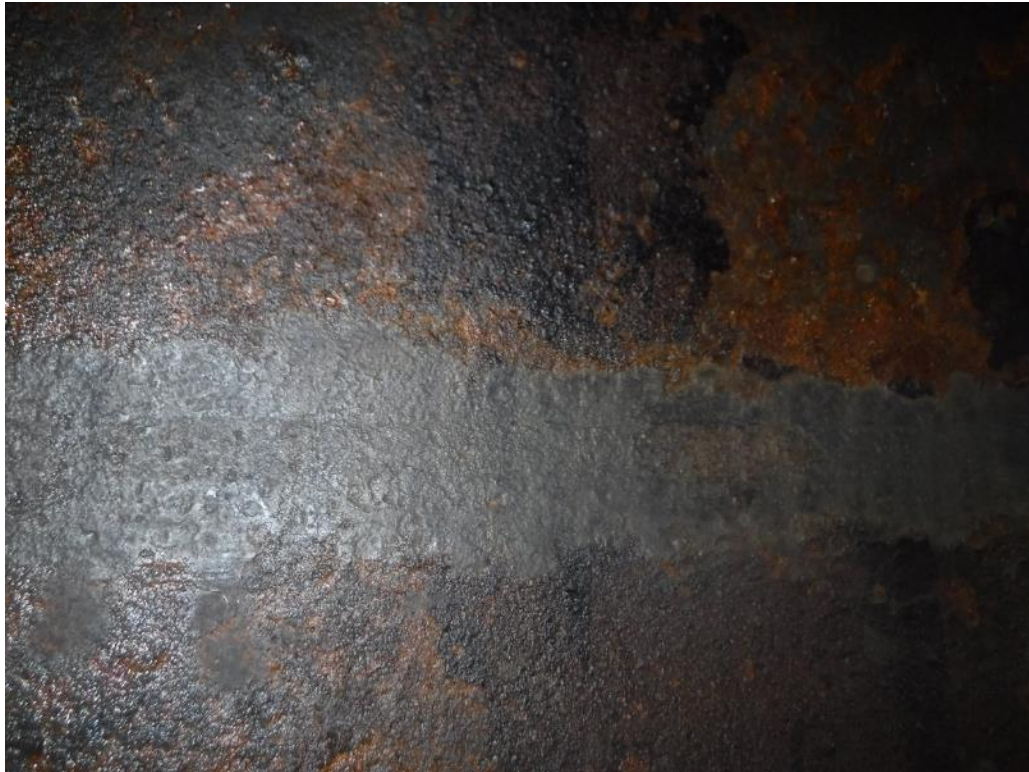
PHOTO 19 SURFACE SCRAPED DOWN TO SHOW LIGHT PITTING

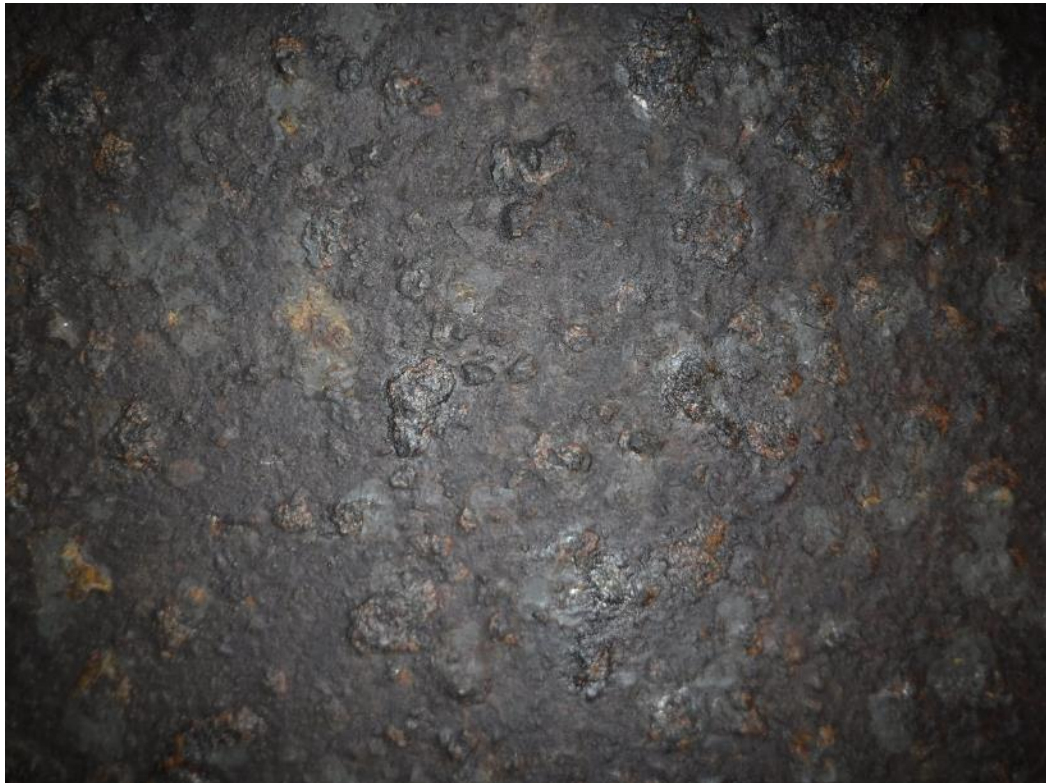
PHOTO 20 SURFACE CORROSION AND FLAKING CAN 200

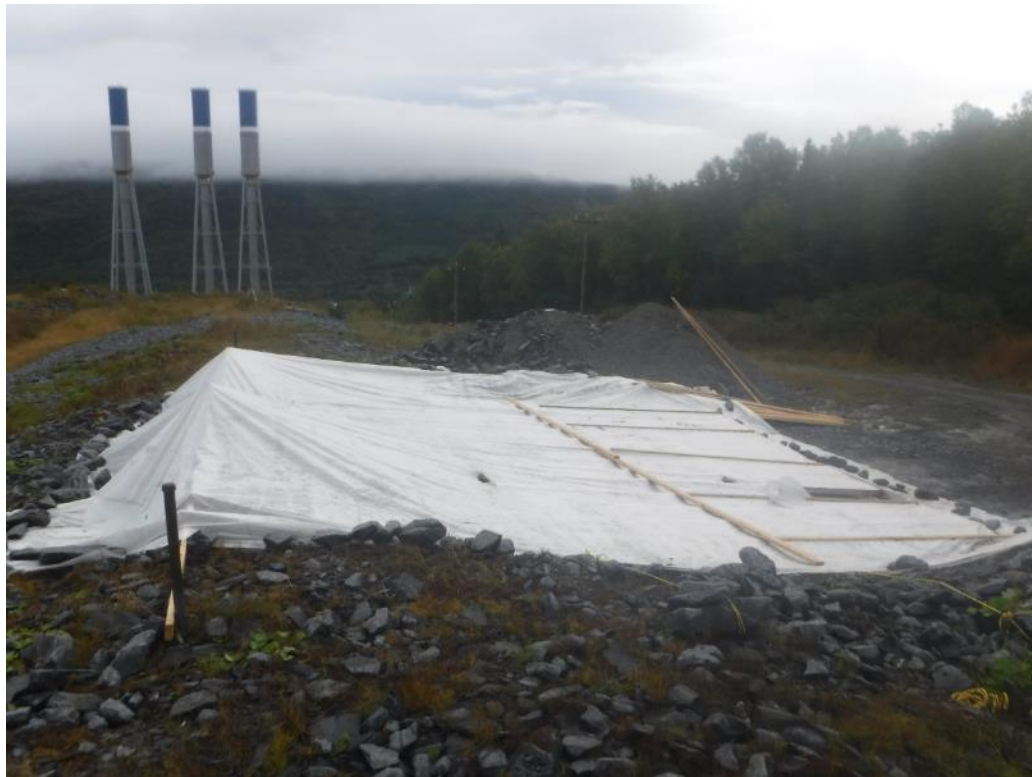
The crack location that resulted in the leak was covered with a tarp (Photo 28). Other features noted along the penstock route included open Manhole No. 1 (Photo 25), a piezometer just upstream of the crack location (Photo 27), and a pressure monitor (Photo 32) and closed Manhole No. 3 (Photo 33) that all appeared to be in good condition. No drainage wells were observed. It is recommended that bushes and alders growing in a few locations on the upper end of the penstock should be removed.

PHOTO 28 **LOOKING DOWNSTREAM AT CRACK LOCATION COVERED IN TARP**

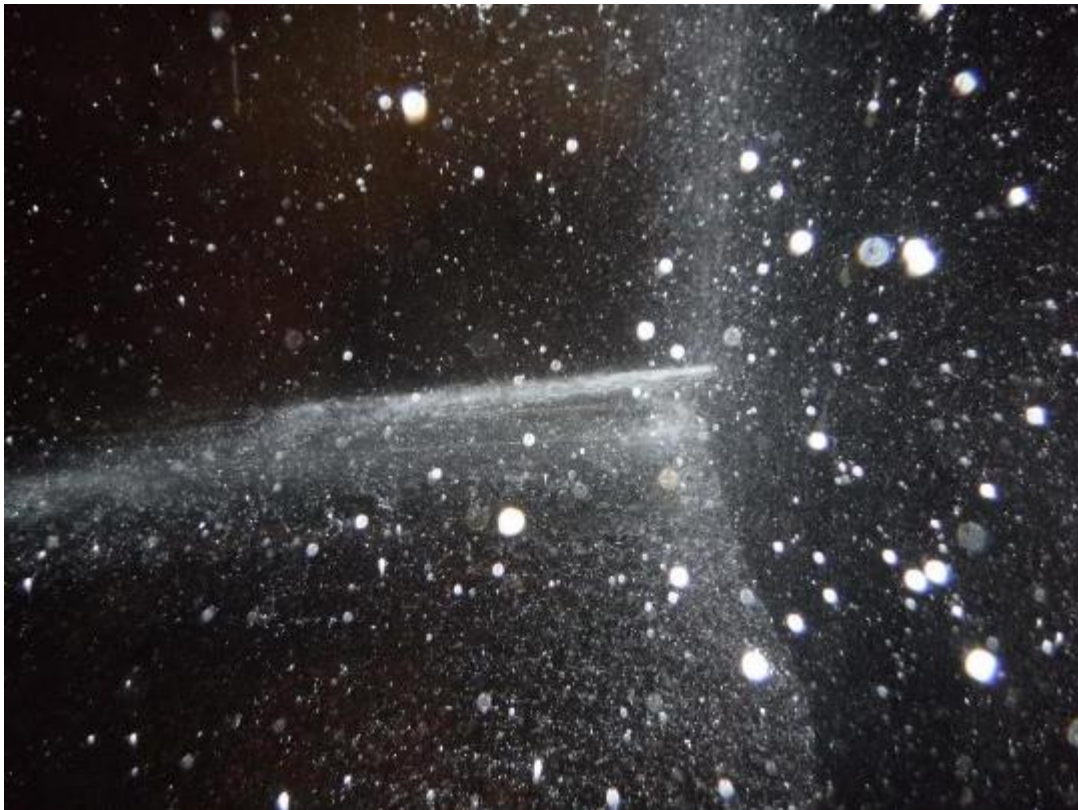
Photo 1 **Leakage Bottom Left Corner of Gate**

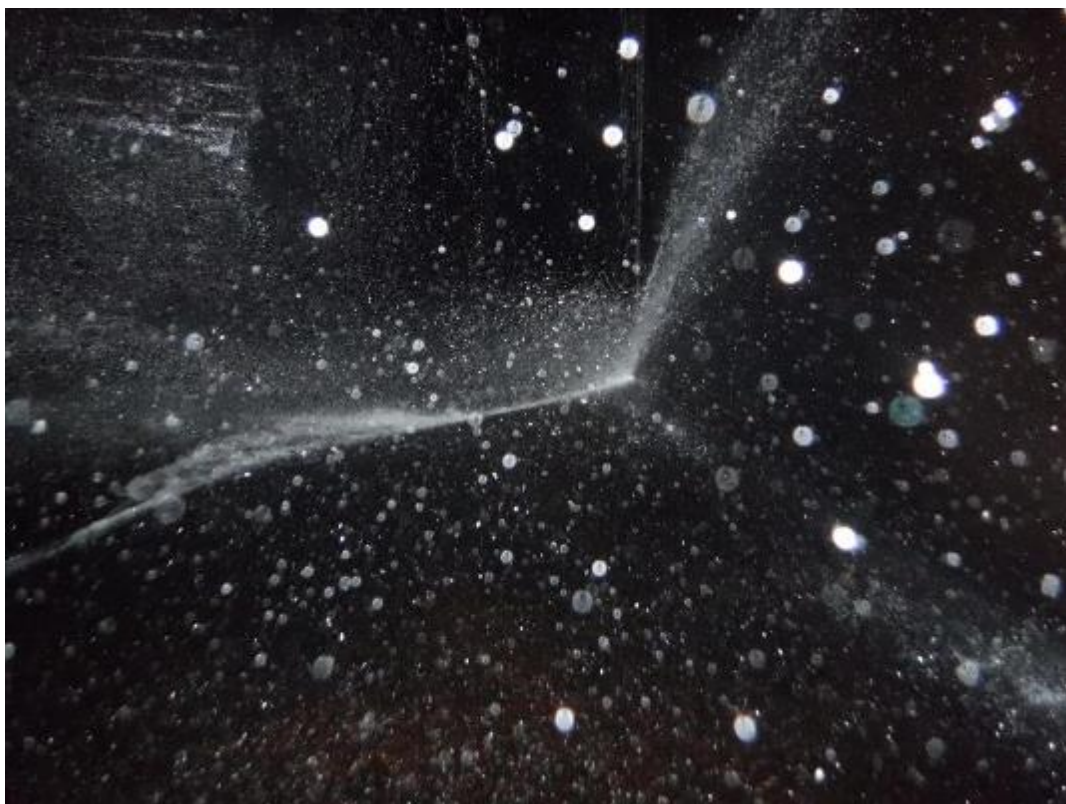
Photo 2 **Leakage Bottom Right Corner of Gate**

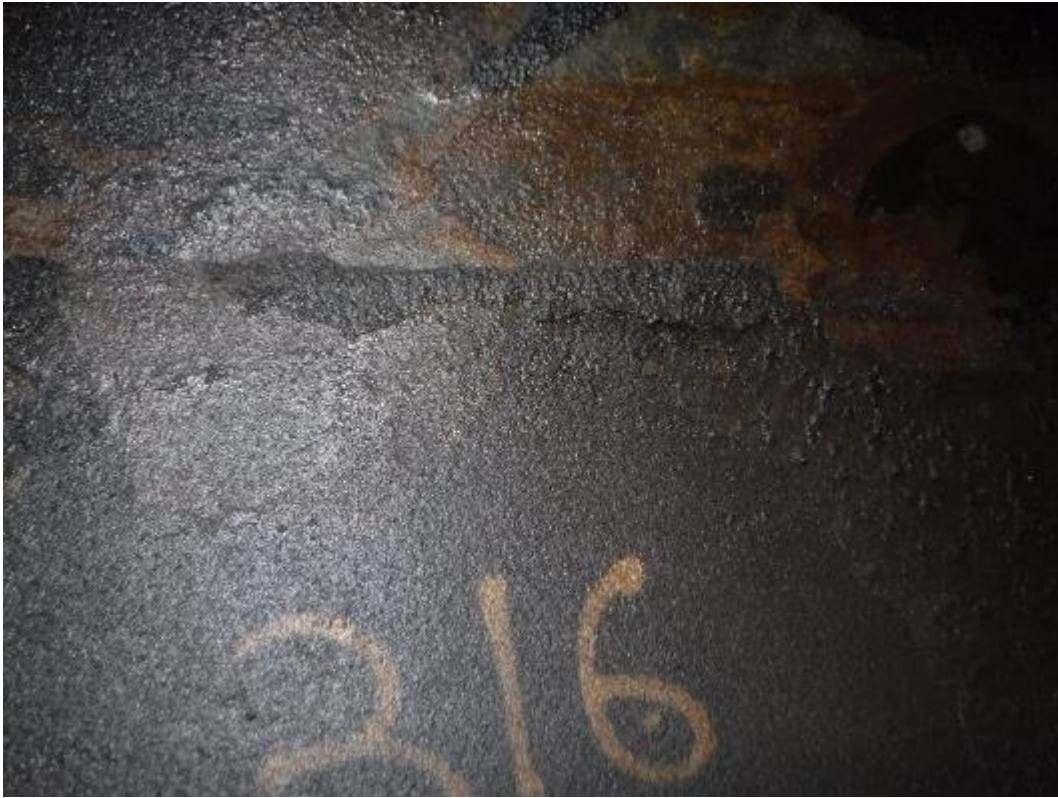
Photo 23 Surface conditions and original weld covered in organics Can 316

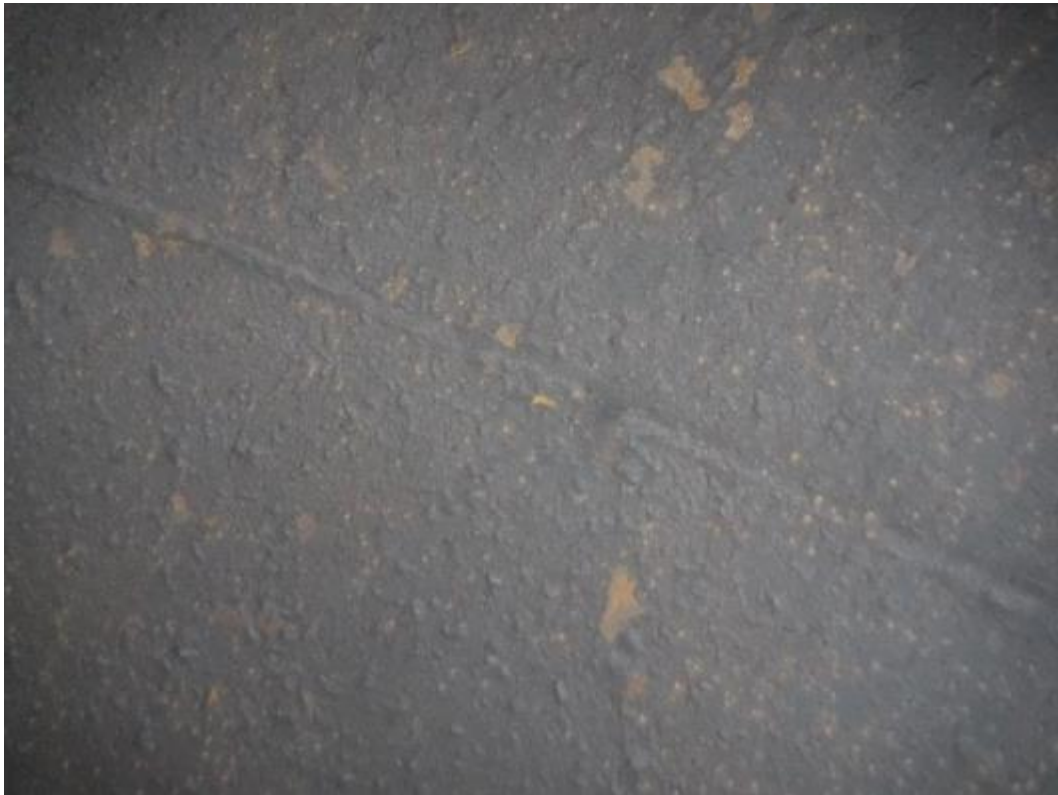
Photo 24 Surface conditions and original weld covered in organics Can 352

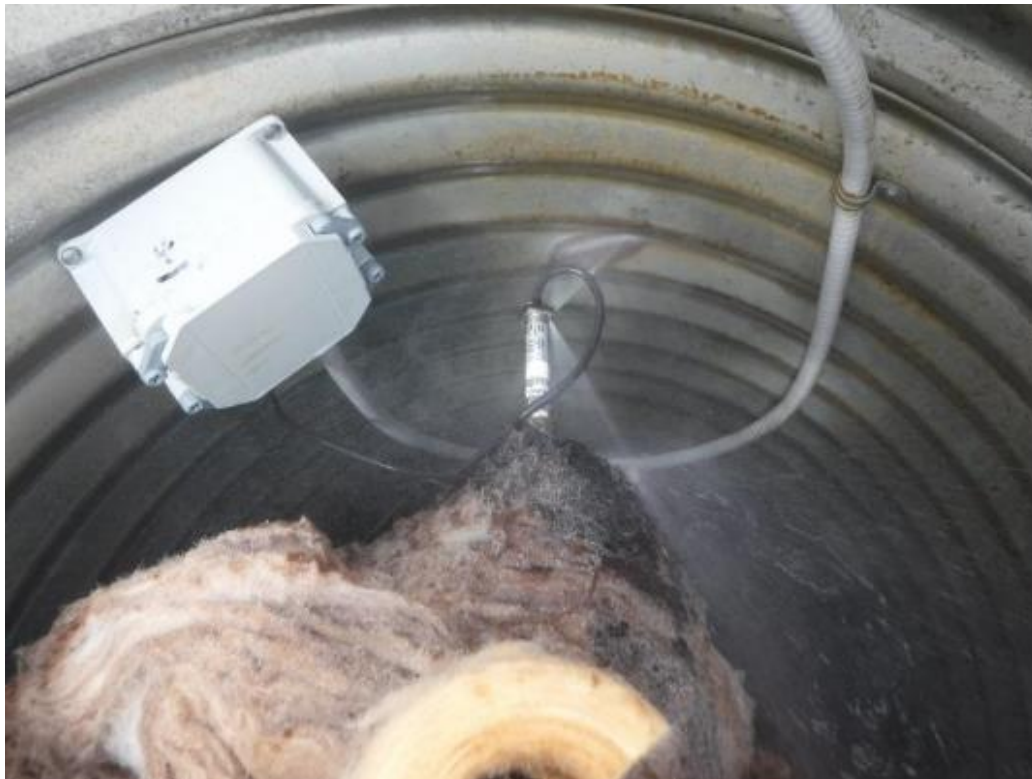
Photo 39 Leaking pressure transducer Penstock 2 upstream Station 900m

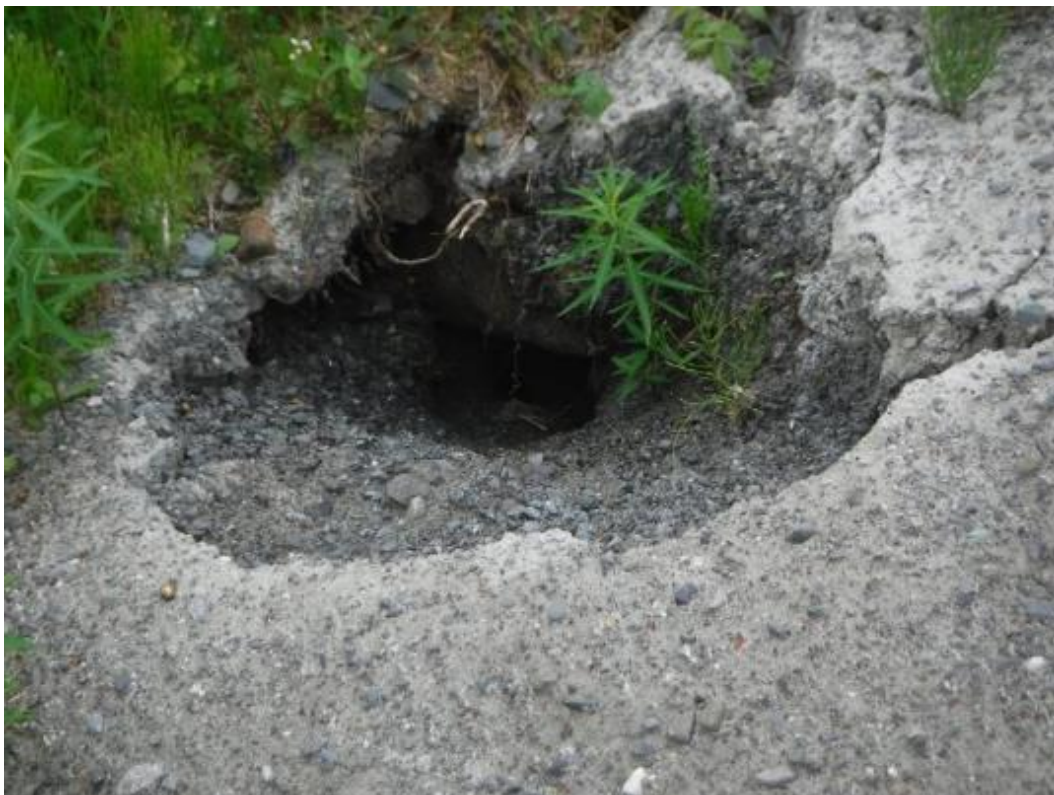
Photo 40 Sink hole downstream of penstock 3 surge tank

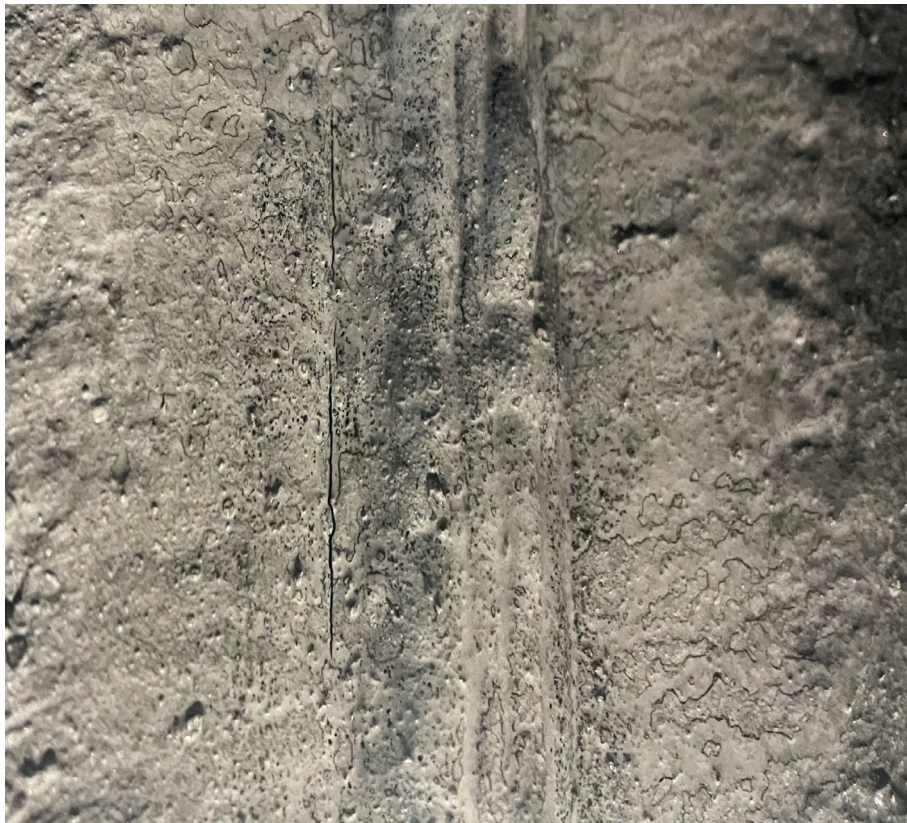
PHOTO 4 CRACK ABOVE LONGITUDINAL WELD NORTH SIDE CAN 126

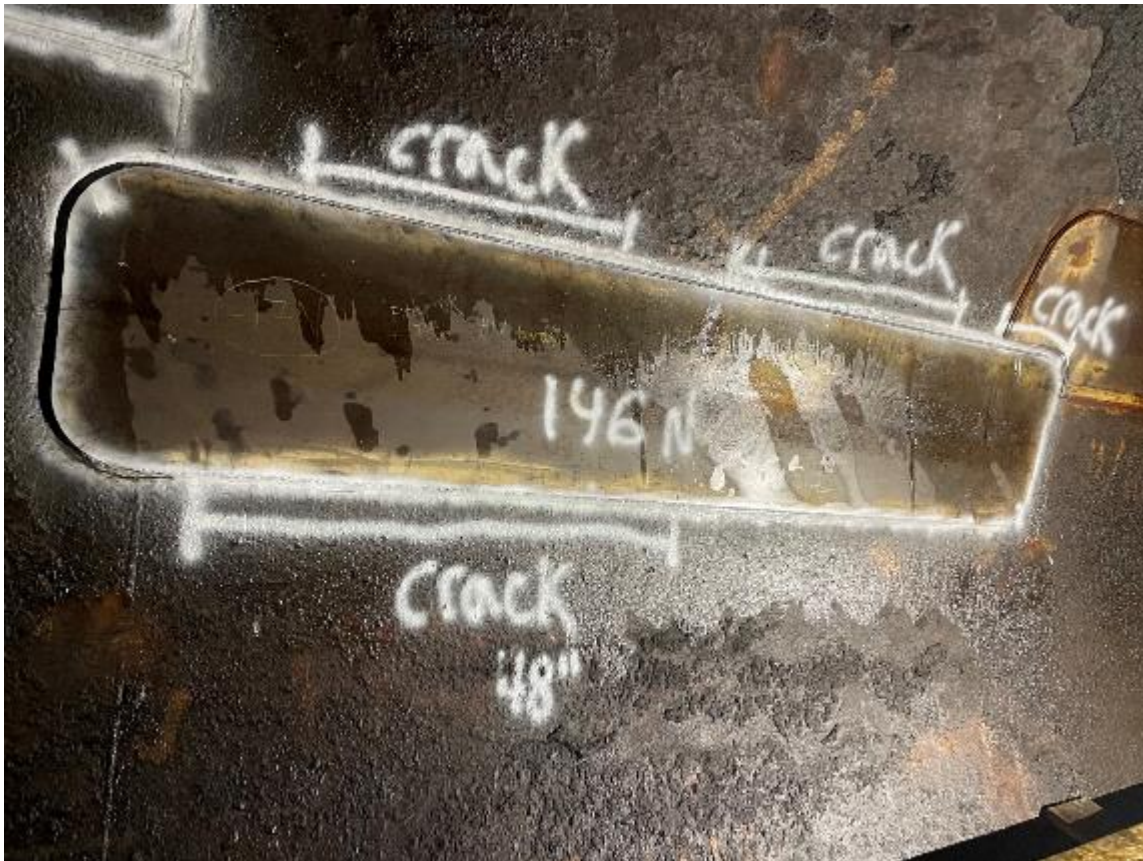
PHOTO 5 CRACKING AROUND WELD REINFORCING PLATE, CAN 146 NORTH SIDE

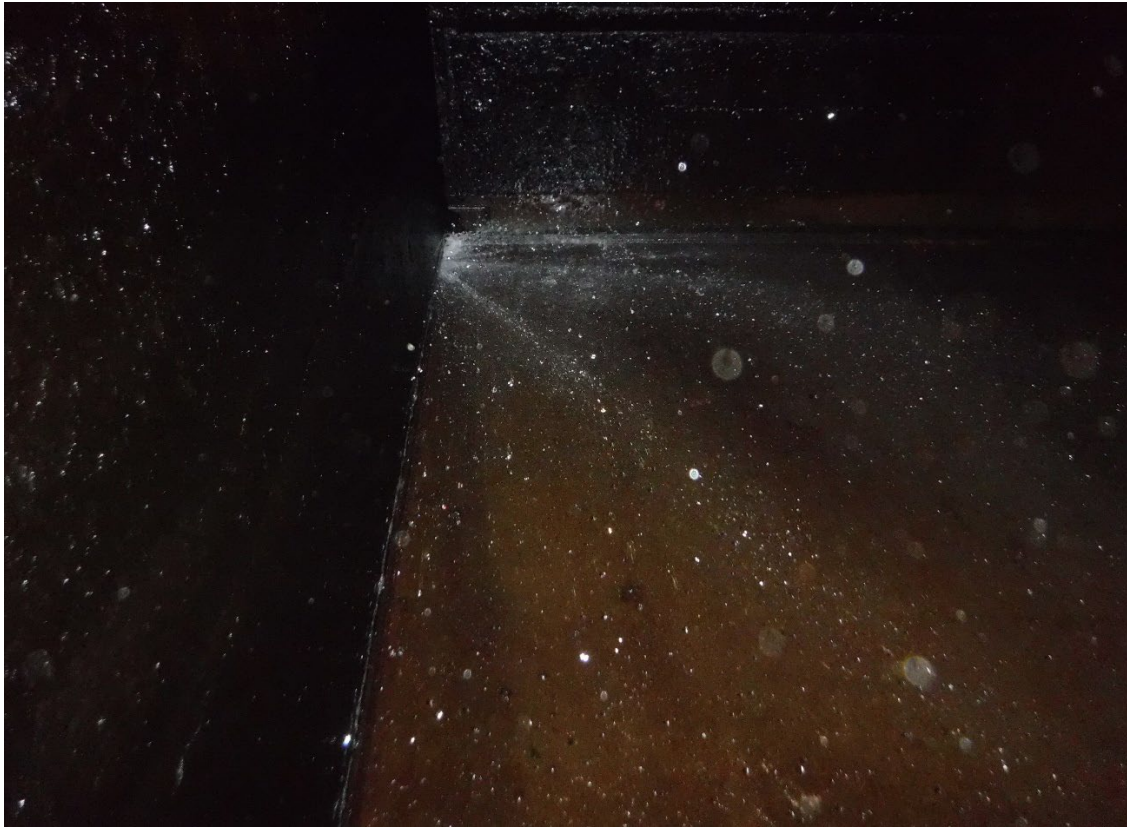
Photo 1 **Leakage from Right Top Corner of gate**

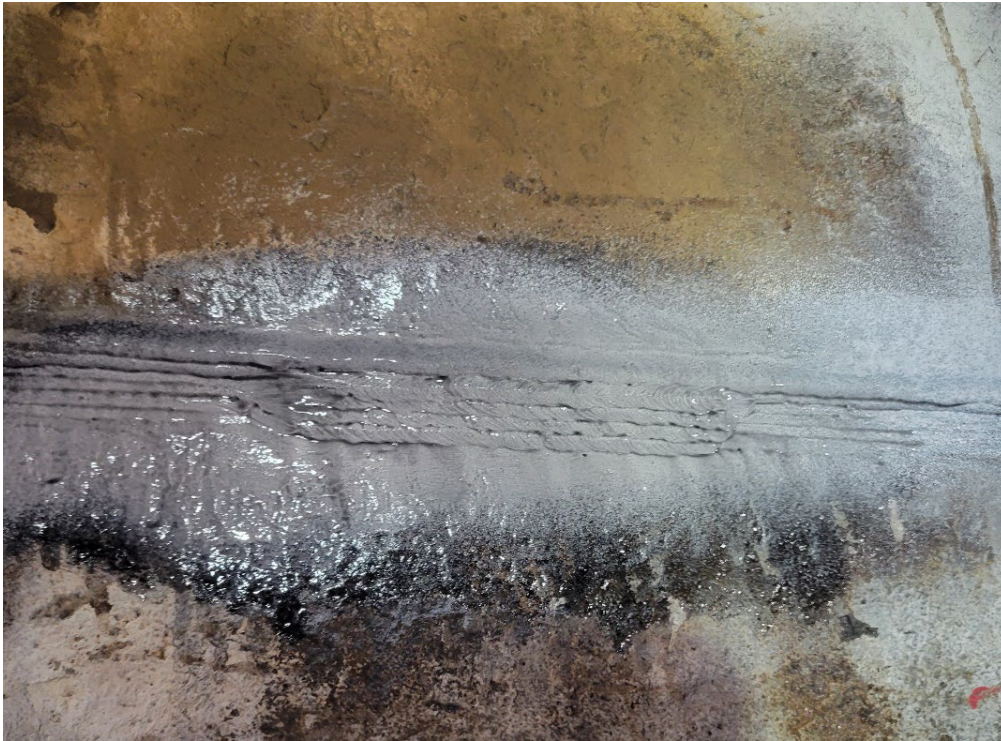
Photo 15 Weld repaired; Can 145

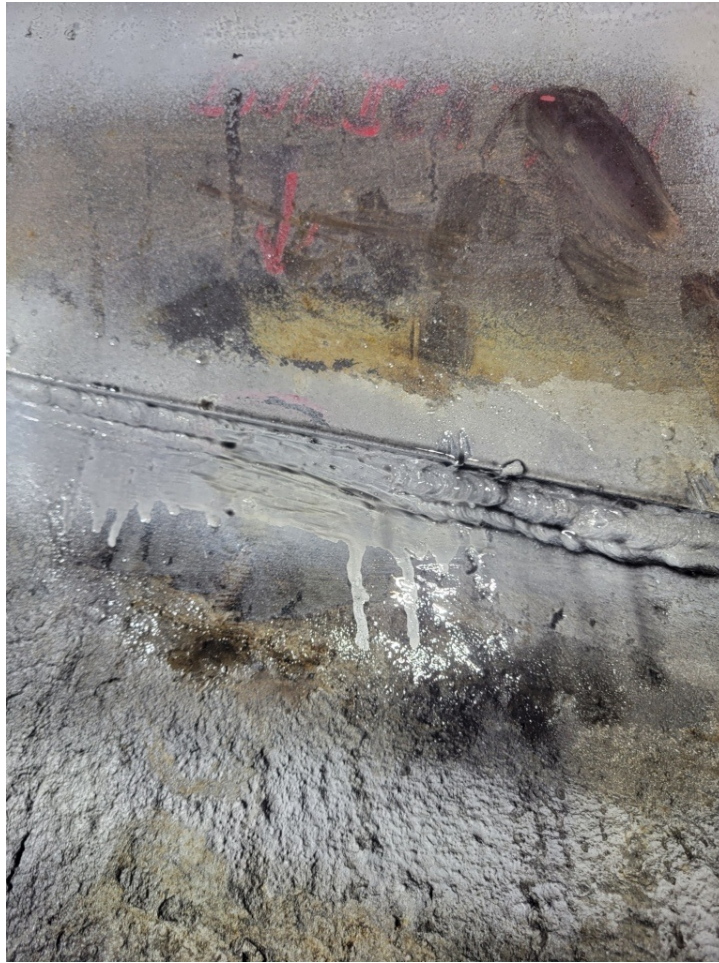
Figure 7. Can 146N - Indication Removed With Grinding - No Welding Needed
