PENSTOCK 3 INSPECTION AND EVALUATION

BAY D'ESPOIR HYDROELECTRIC DEVELOPMENT
PENSTOCKS 1-3 INSPECTION PROJECT

May 2026

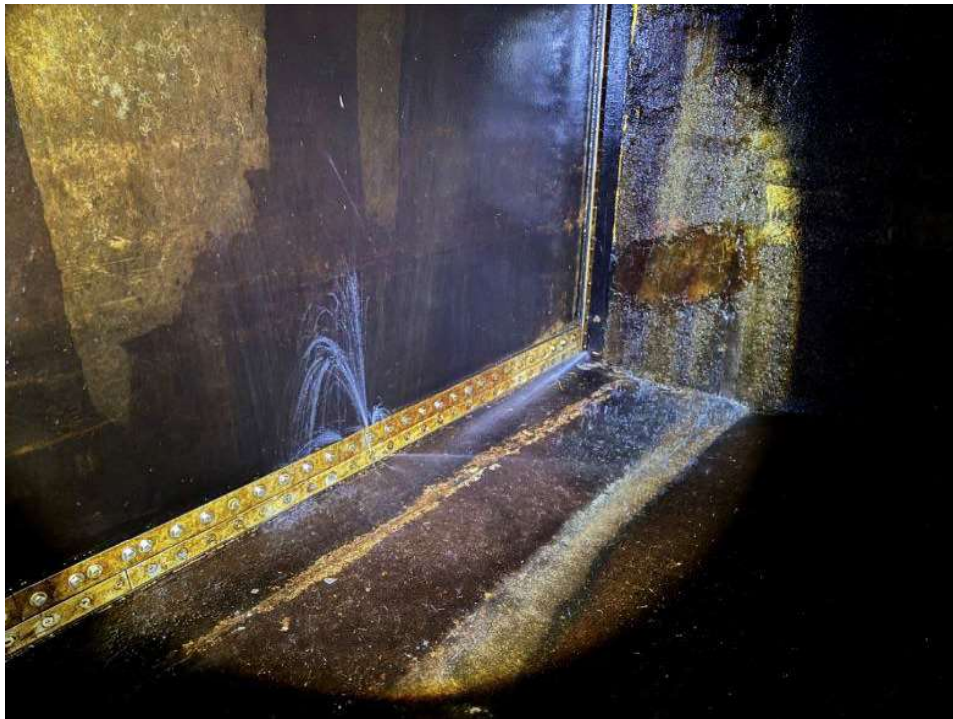
Photo 3 Leakage through bolts on left side of gate

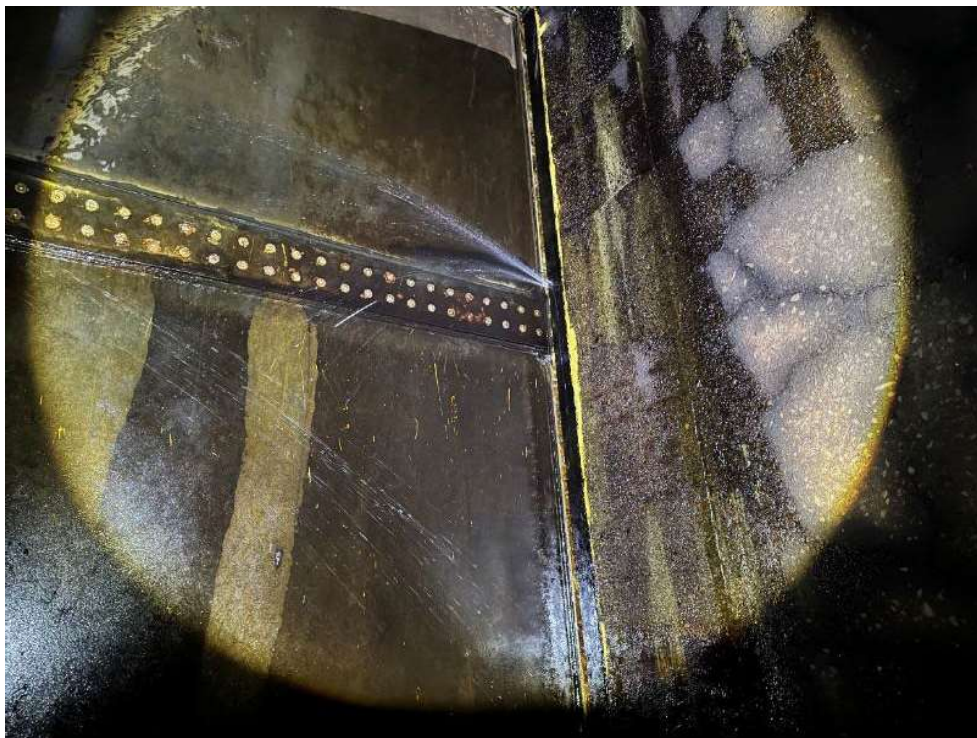
Photo 4 Leakage through seal on left side of gate

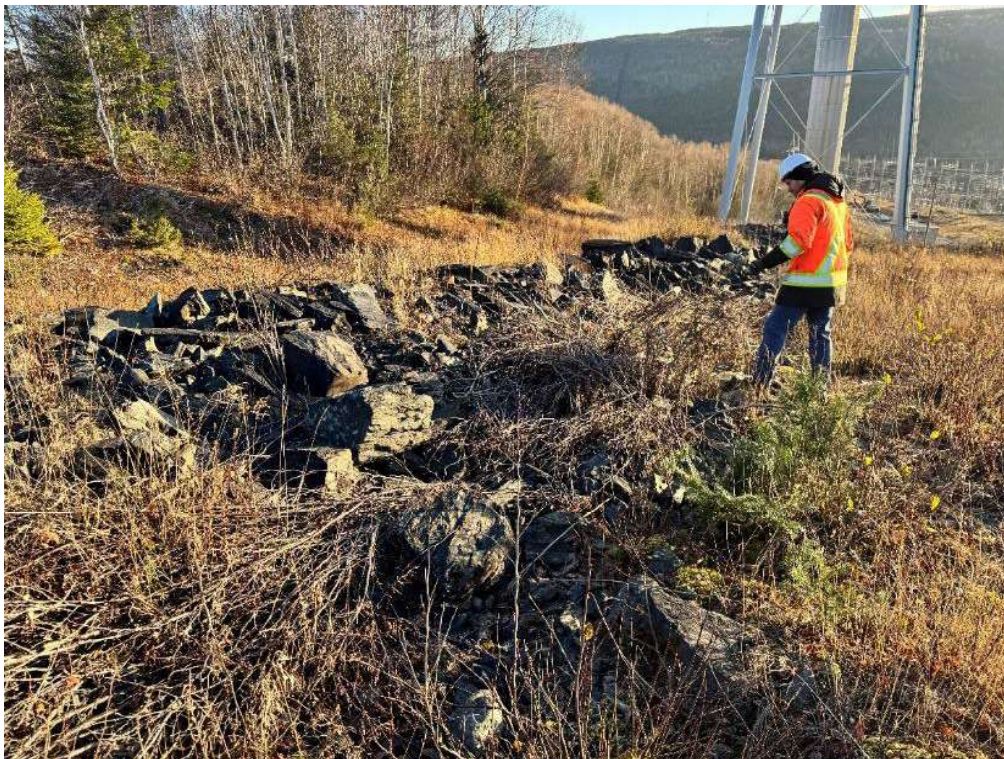
Photo 6 Brush impeding access to exterior of penstock

Vegetation was observed growing in proximity to the penstock alignment. Trees should not be allowed to establish on or immediately adjacent to the penstock, and the birch tree observed should be cut/mowed and routinely controlled. When clearing brush, cut material should not be piled or stored on the penstock to avoid impediments to future inspection access.

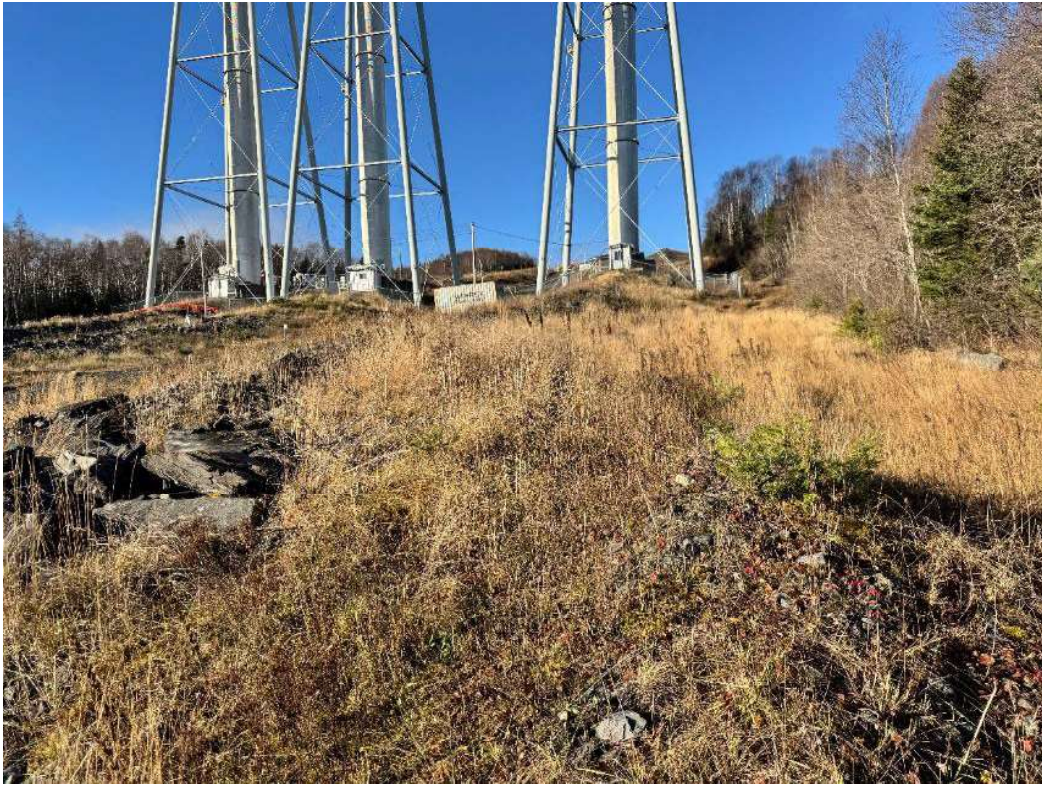
Photo 7 **Vegetation impeding visual access to exterior of penstock**

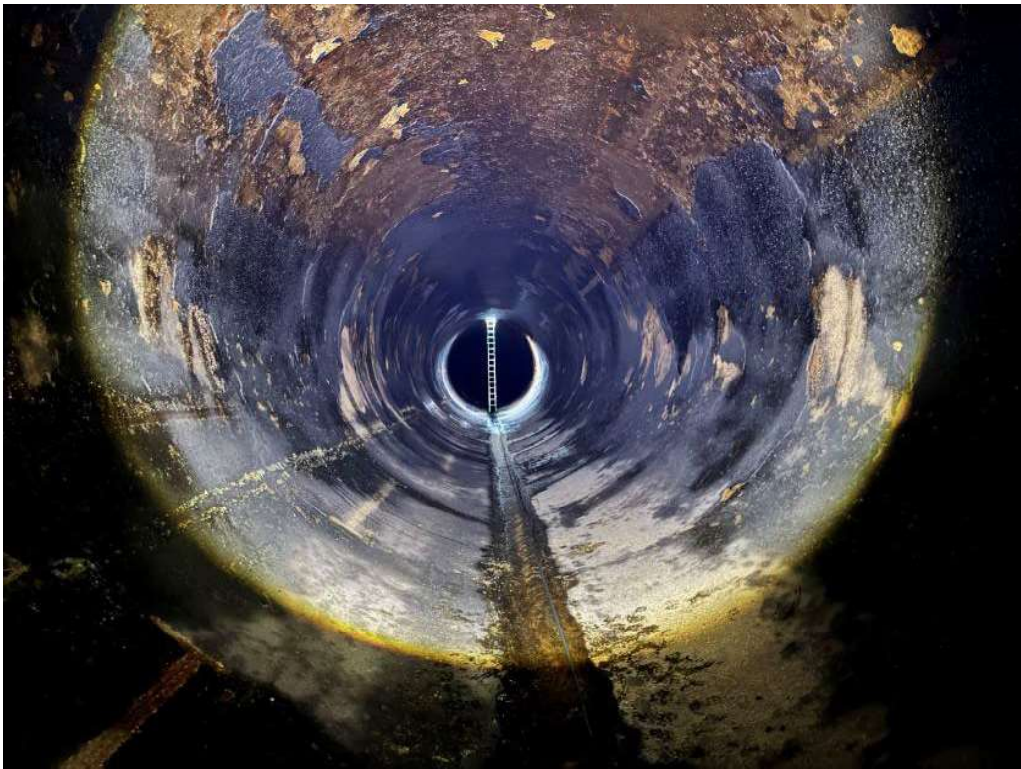
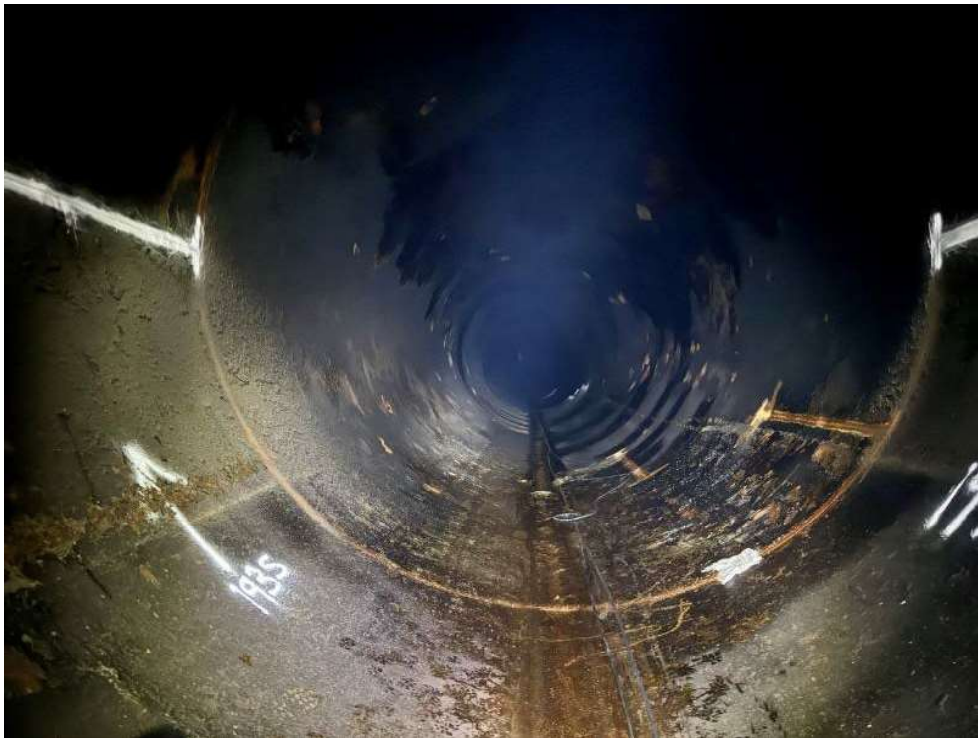
The interior of the penstock is generally in fair condition with consistent moderate corrosion and pitting with tubercles and growth (Photos 8 and 9). Pitting was moderate, relative to the plate thickness, and got more significant and deeper further downstream. A significant number of weld repairs were observed, and the previous weld repair work made this inspection a little easier as much of the organic build-up had been previously removed (Photos 10 and 11). Sporadic areas within the 17 ft diameter portion of the

Photo 8 **Interior surface condition of penstock by Manhole 3**

Photo 9 Interior surface condition of penstock by Can 193

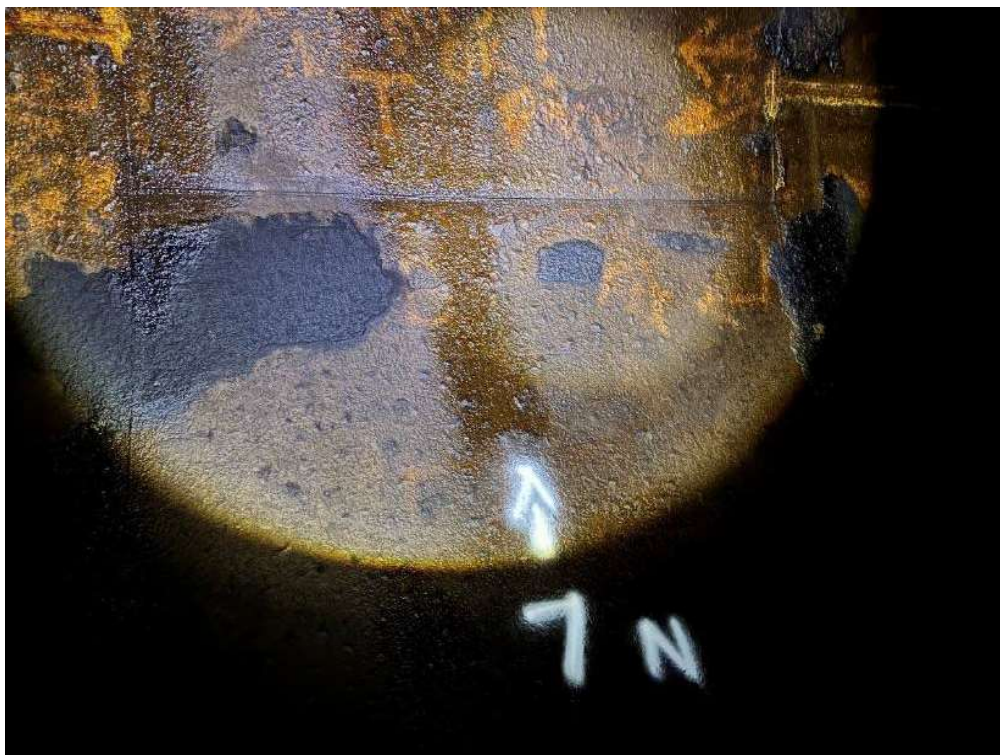
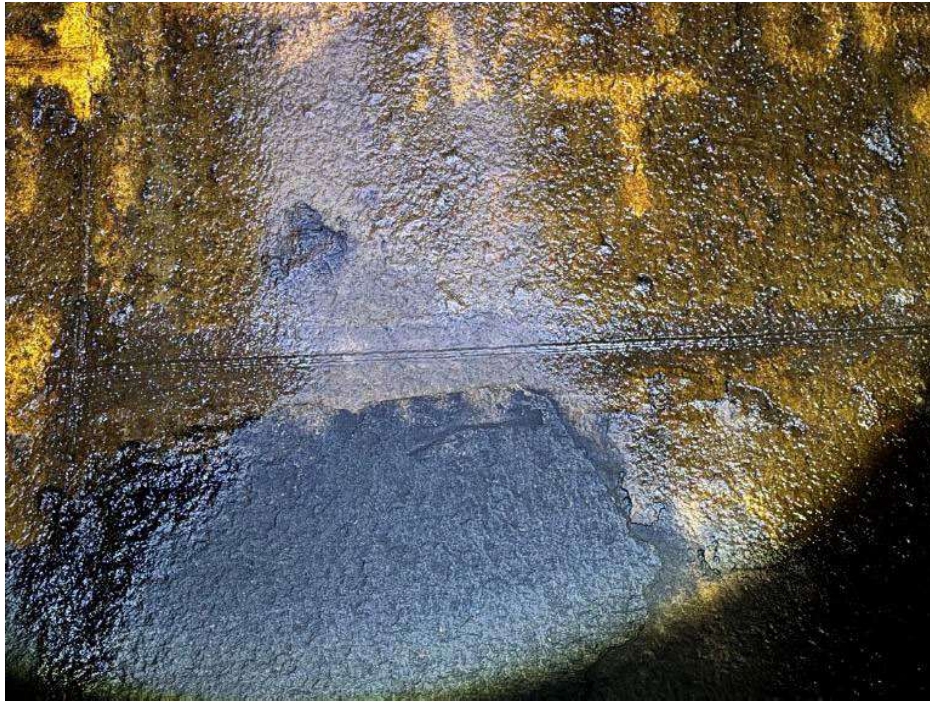
Photo 10 Weld 7N prior to being cleaned and tested

Photo 11 Close-up of Weld 7N prior to being cleaned and tested

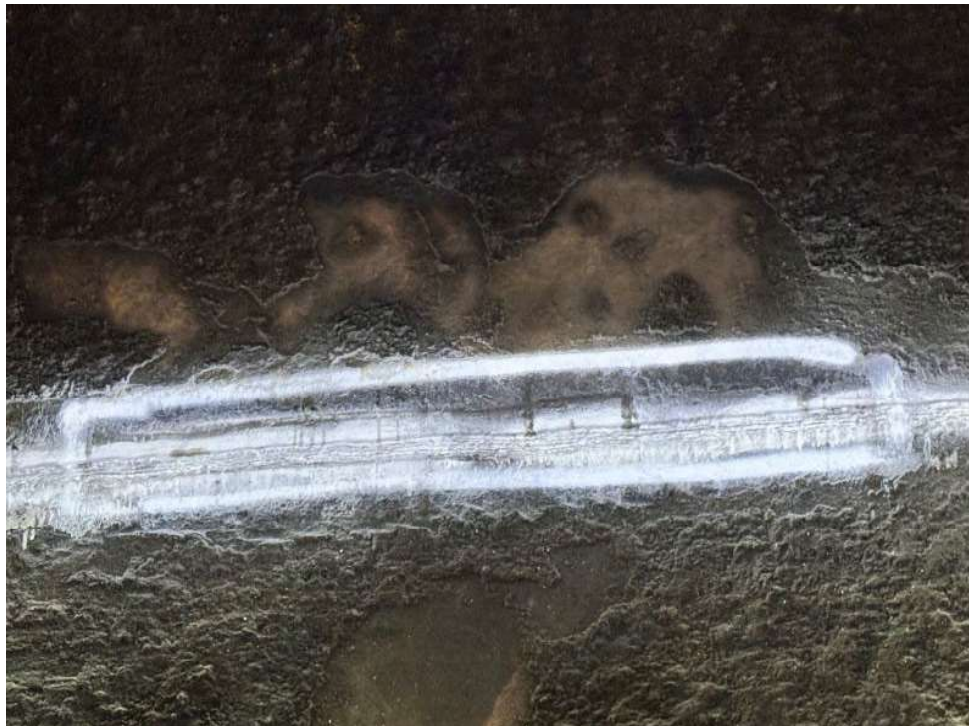
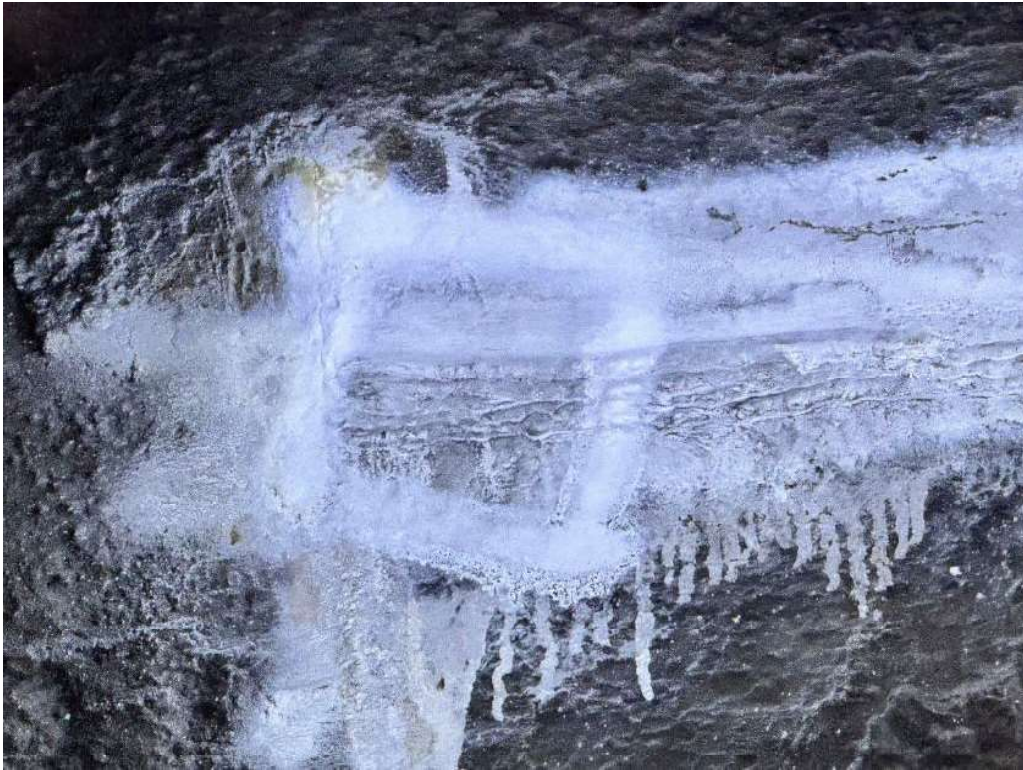
- Can 17 South – Two Indications noted toe of longitudinal weld; one intermittent over 70 mm and one localized, approximately 19 mm long. Repair recommended.
- Can 35 North – Indication noted toe of longitudinal weld, intermittent over approximately 65 mm. Repair recommended.
- Can 67 South - Indication noted toe of longitudinal weld, intermittent over approximately 195 mm. Repair recommended.
- Can 77 South - Indication noted toe of longitudinal weld, intermittent over approximately 150 mm. Repair recommended.
- Can 79 South - Indication noted toe of longitudinal weld, intermittent over approximately 75 mm. Repair recommended.
- Can 102 South - Indication noted toe of longitudinal weld, intermittent over approximately 40 mm. Repair recommended.

Photo 14 Close-up of intermittent weld indication at Can 17S

Photo 15 Close-up of weld indication at Can 17S

The repairs recommended above for six Cans 17, 35, 67, 77, 79, 102, should be completed in 2026.

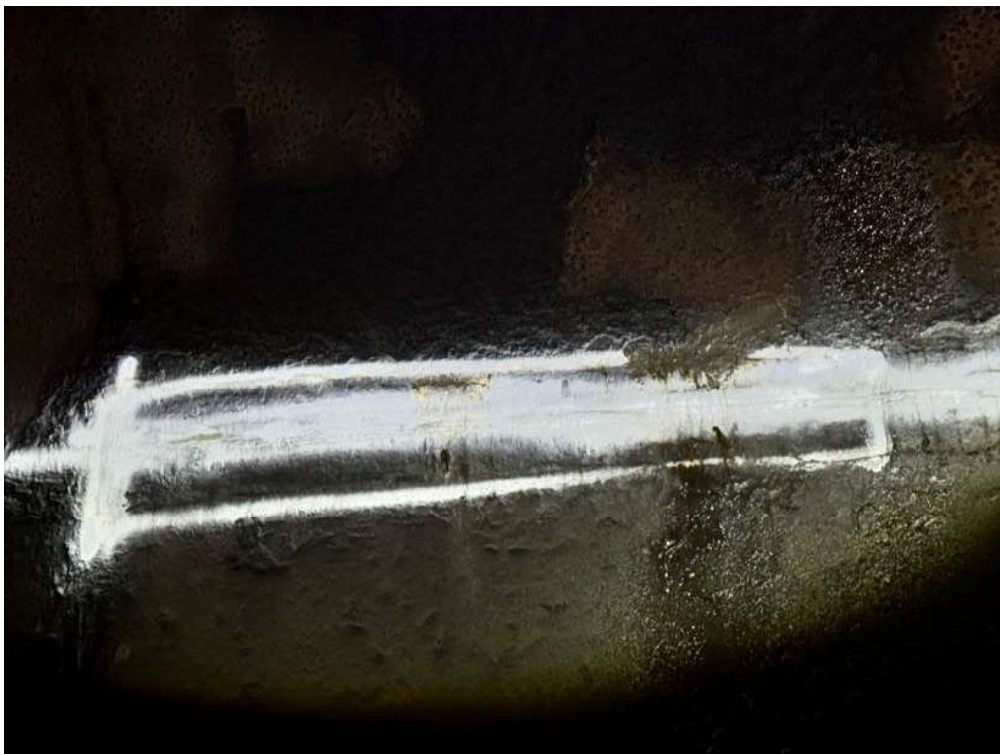
Photo 16 Close-up of intermittent weld indication at Can 35N

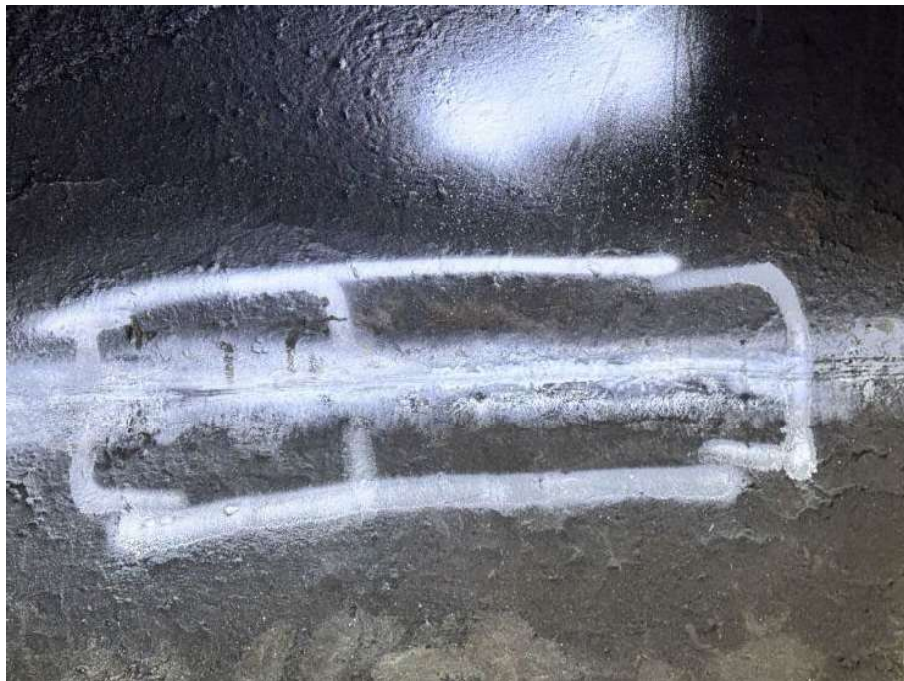
Photo 18 Close-up of intermittent weld indication at Can 67S

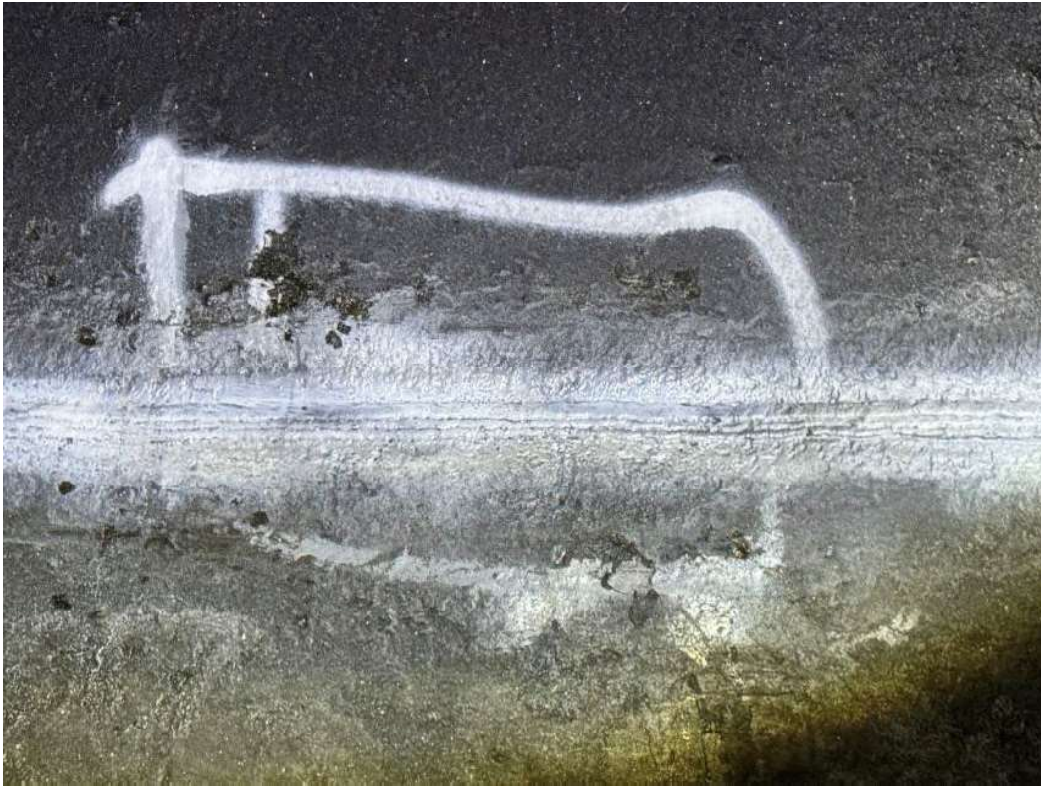
Photo 19 Close-up of intermittent weld indication at Can 79S

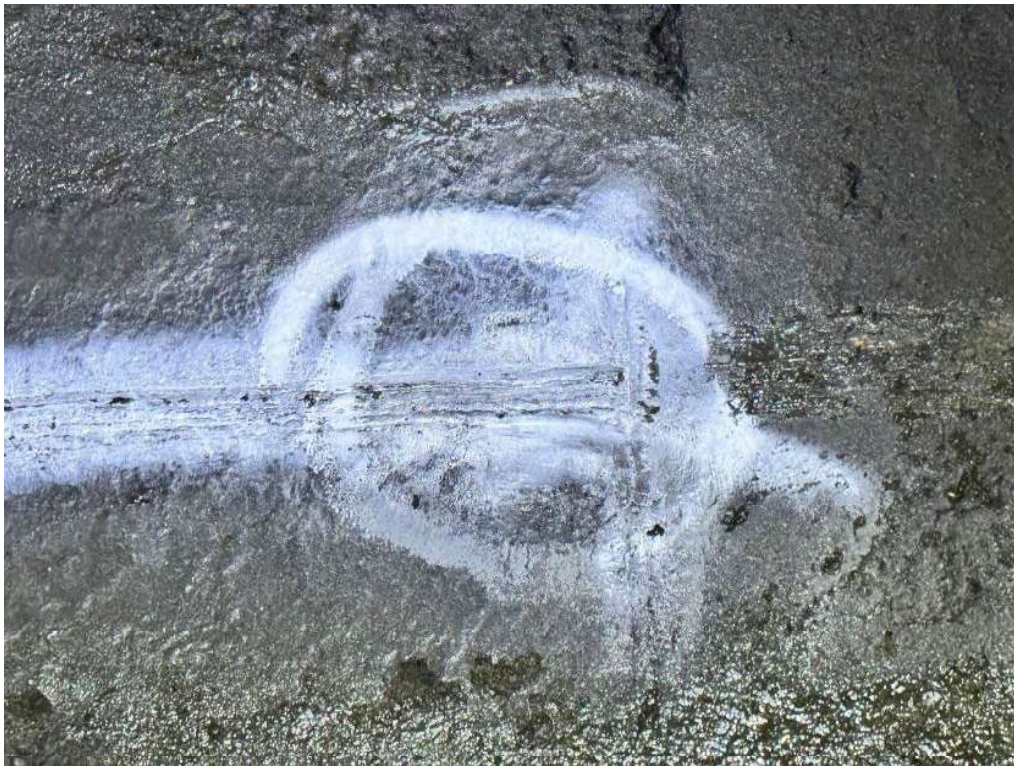
Photo 20 Close-up of intermittent weld indication at Can 102S

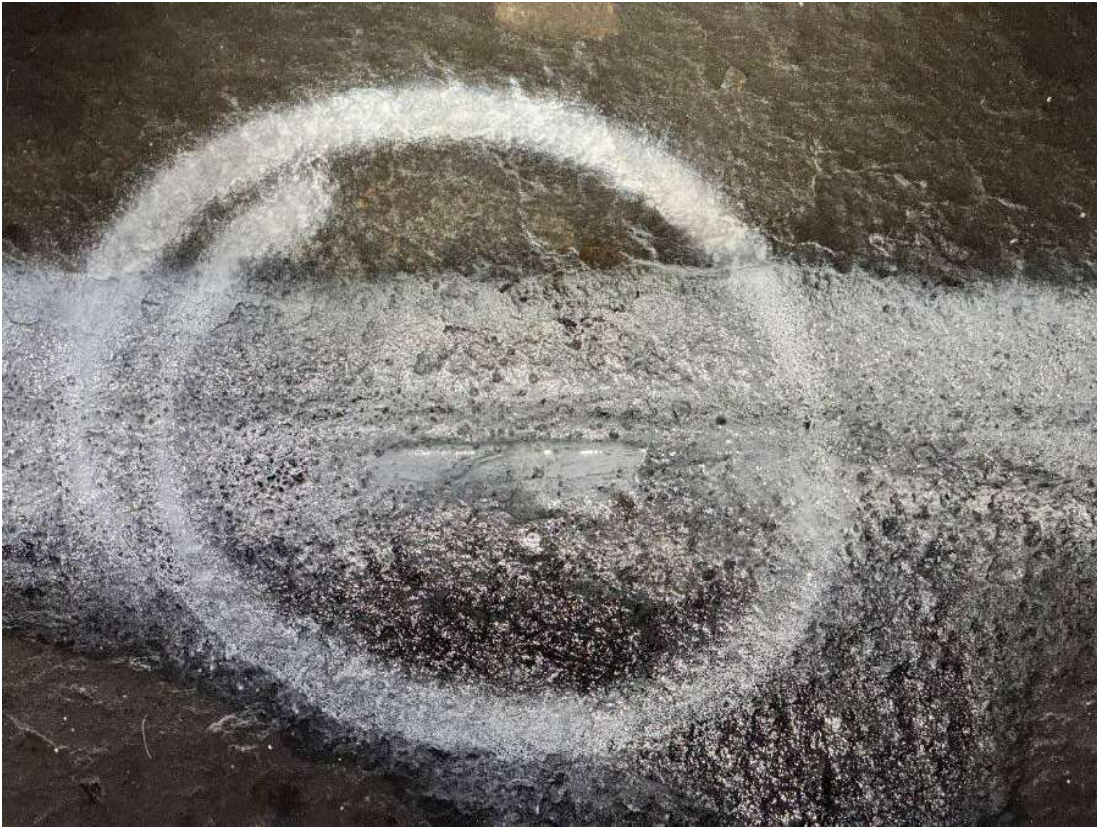
- Can 254 North - Indication noted toe of longitudinal weld, over approximately 25 mm. Indication is visible and deemed acceptable by Kleinschmidt. No further repair required.
- Can 263 South - Indication noted toe of longitudinal weld, over approximately 20 mm. Indication is visible and deemed acceptable by Kleinschmidt. No further repair required.
- Can 273 North - Indication noted; removed with grinding. No further repair required.
- Can 303 North - Indication noted; removed with grinding. No further repair required.
- Can 322 North - Indication noted; removed with grinding. No further repair required.
- Can 332 North - Indication noted toe of longitudinal weld, over approximately 10 mm. Indication is visible and deemed acceptable by Kleinschmidt. No further repair required.
- Can 353 North - Indication noted; removed with grinding. No further repair required.

Photo 21 Close-up of weld indication at Can 254N

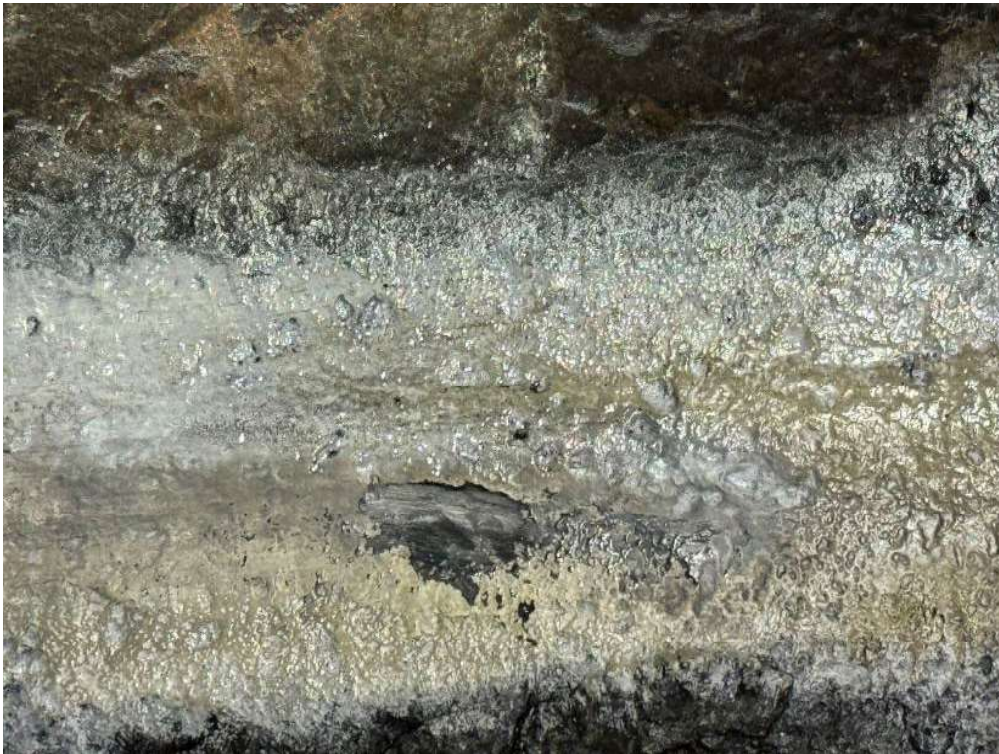
Photo 22 Close-up of weld indication at Can 263S

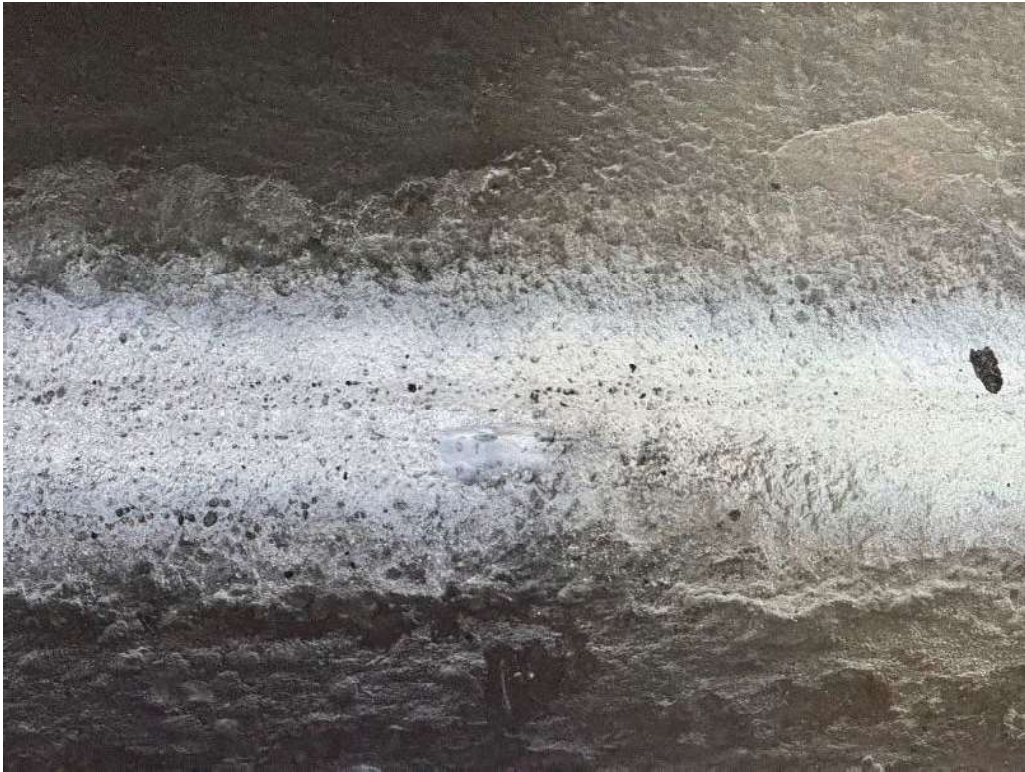
Photo 23 Close-up of weld indication removed with grinding at Can 273N

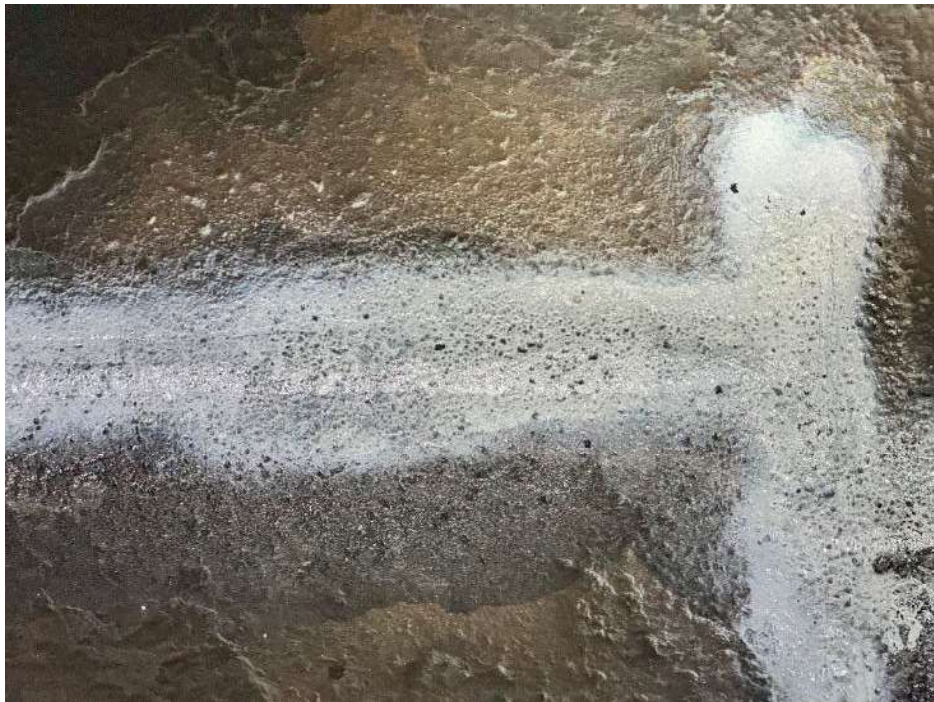
Photo 24 Close-up of weld indication removed with grinding at Can 303N

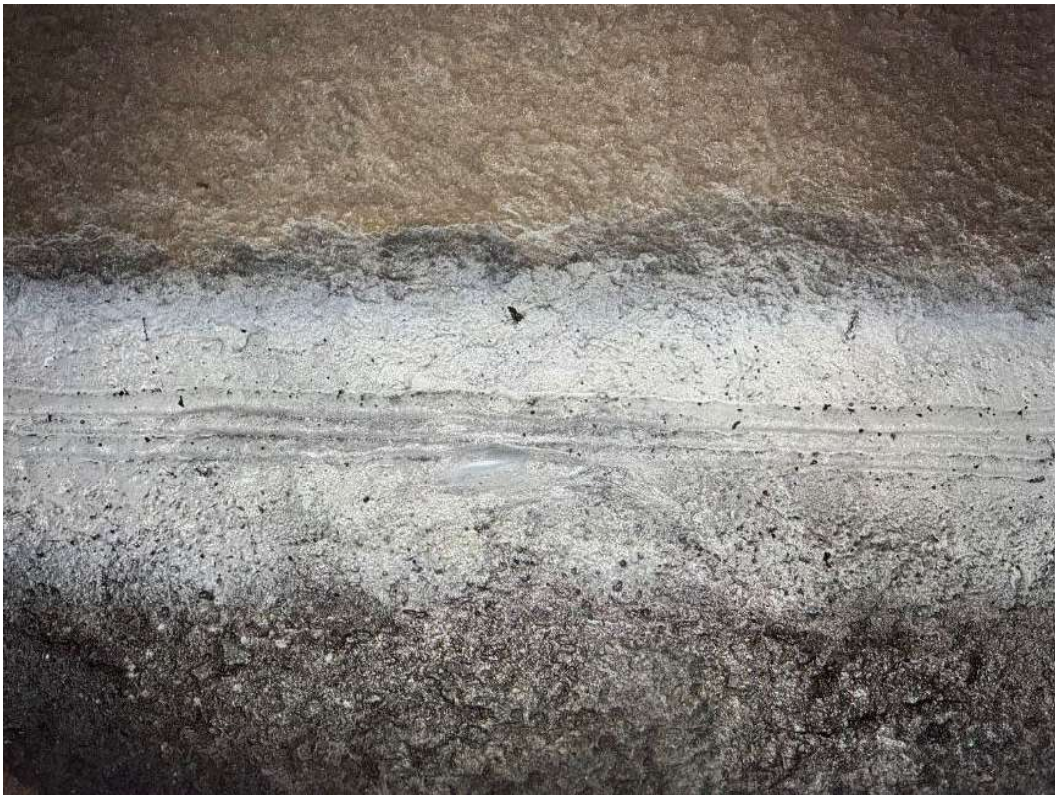
Photo 25 Close-up of weld indication removed with grinding at Can 322N

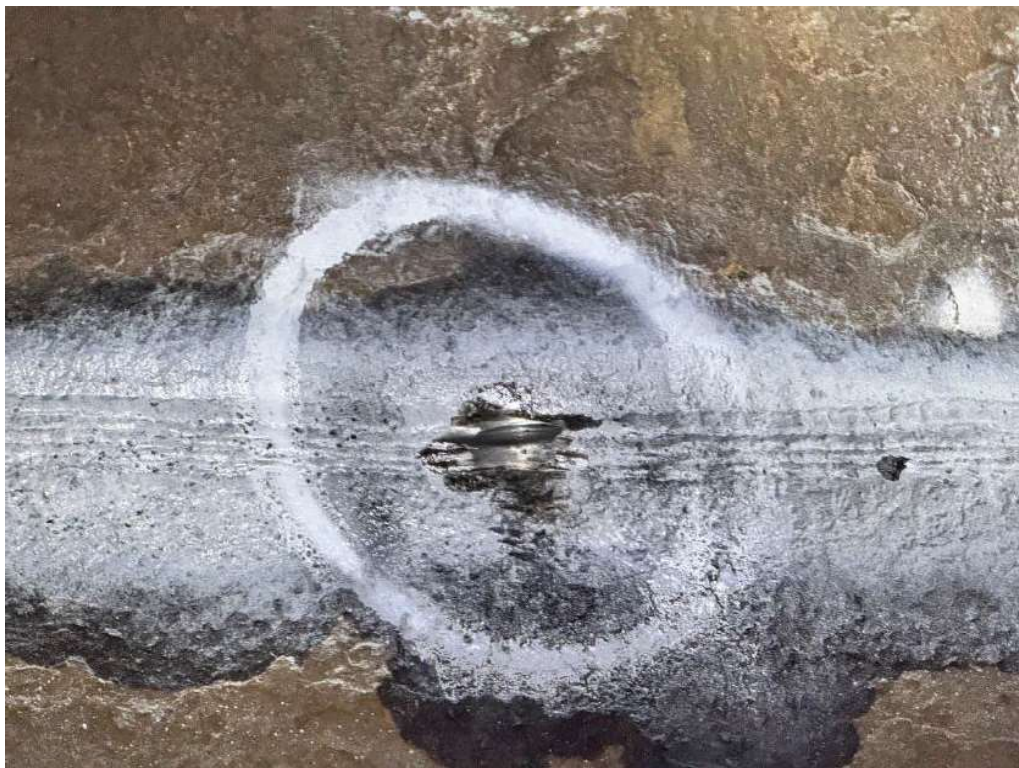
Photo 26 Close-up of weld indication at Can 332N

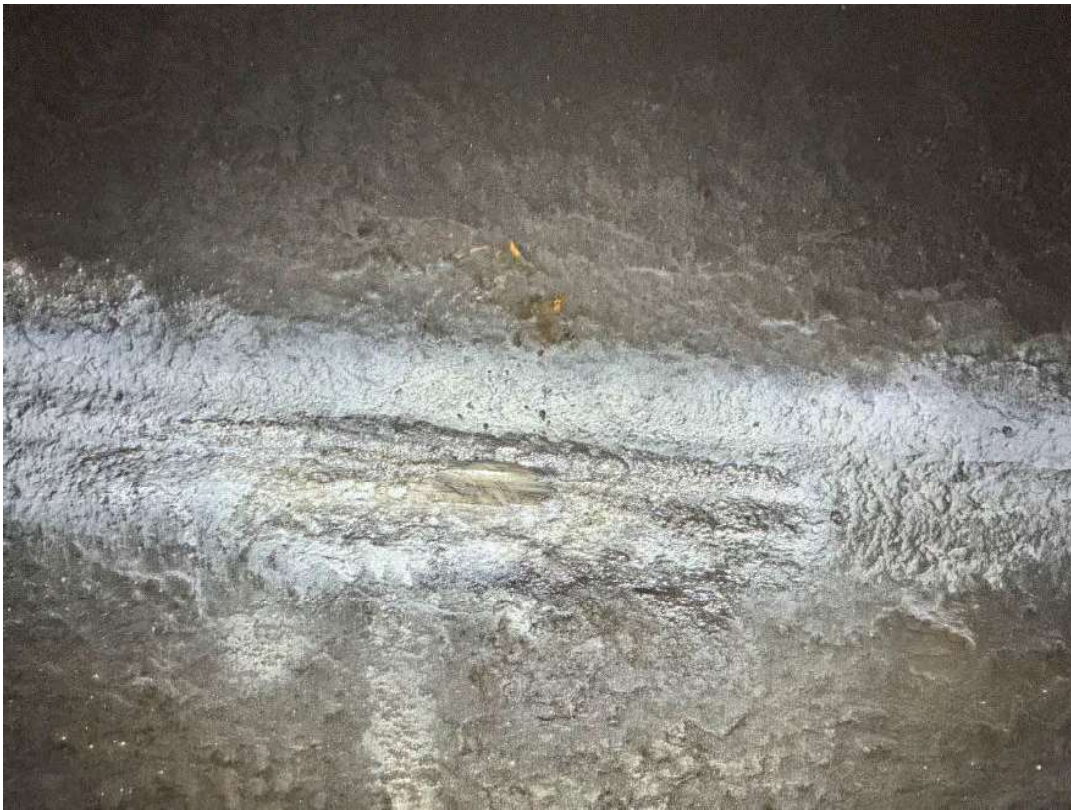
Photo 27 Close-up of weld indication removed with grinding at Can 353N

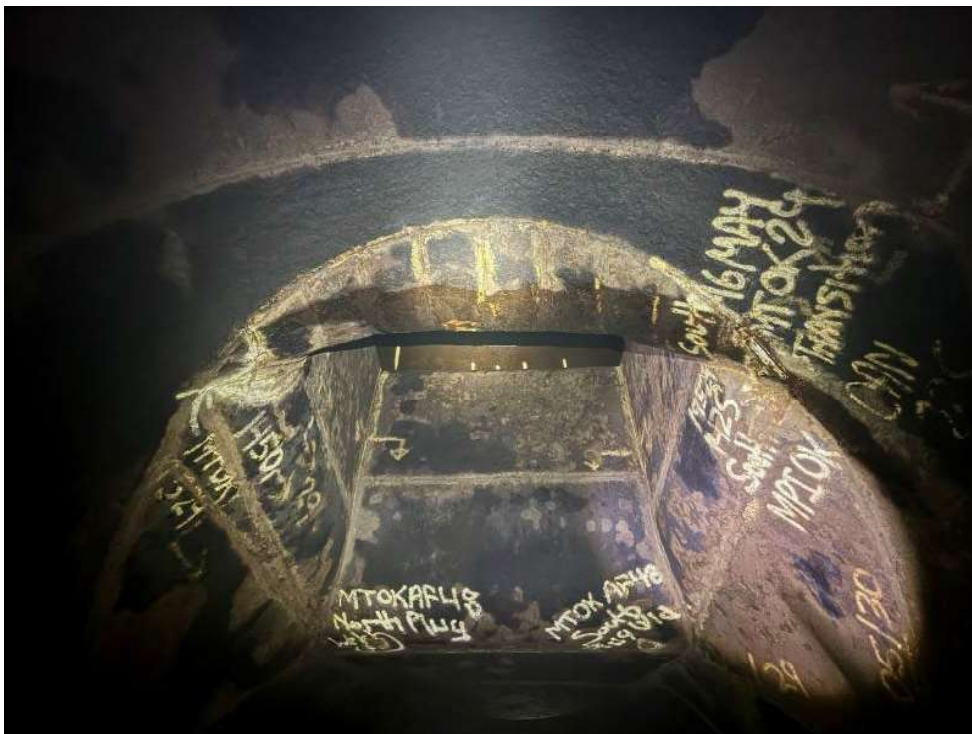
During the previous inspection in 2024, the surge tank transition welds were being tested and repaired following leakage found after the 2023 surge tank transition repairs. During the 2025 inspection, leakage was observed on the upstream side of the transition (Photos 28 and 29). No seepage or leakage was observed on the downstream side at the time of inspection (Photo 30). This condition should be monitored during future inspections.

Photo 28 Leakage observed at upstream side of surge tank transition

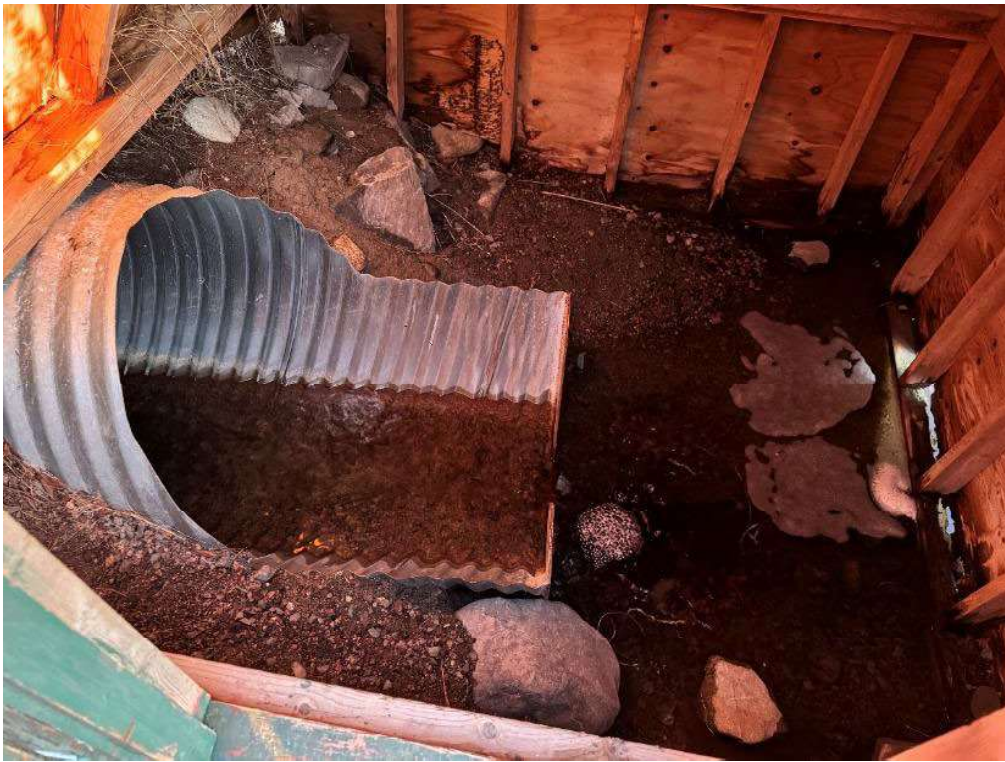
wooden shack, was in fair condition and had a small amount of drainage flowing through the weir. Vegetation surrounding the shack has been cut back allowing for easier inspection and rock and debris has been cleaned from the intake.

Photo 31 Condition of monitoring weir at N-1

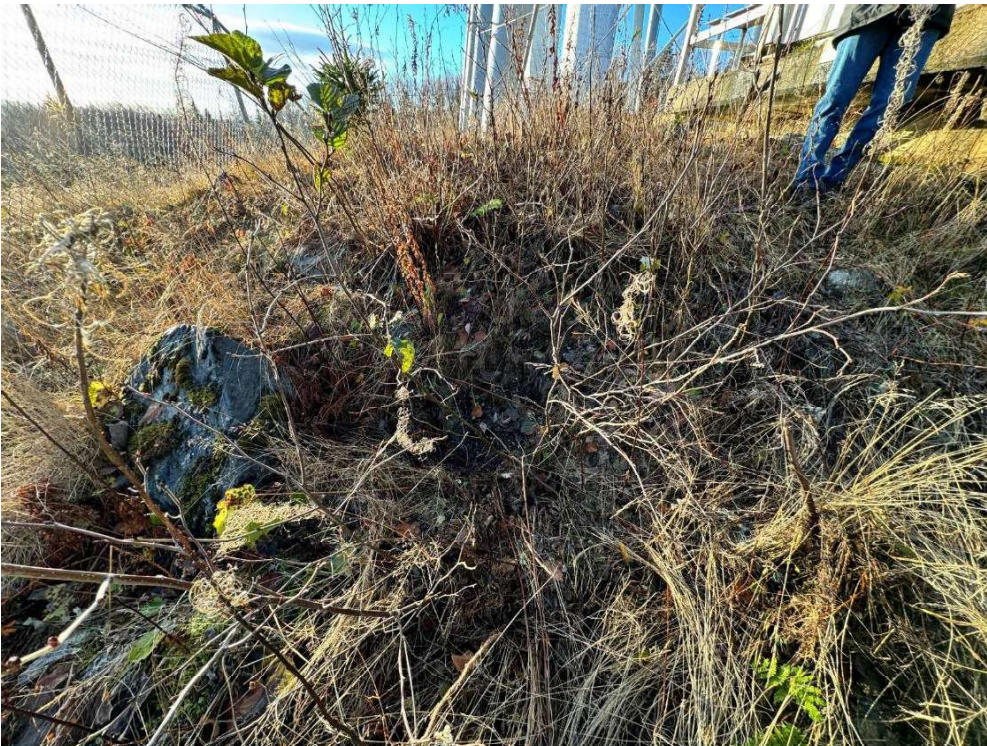
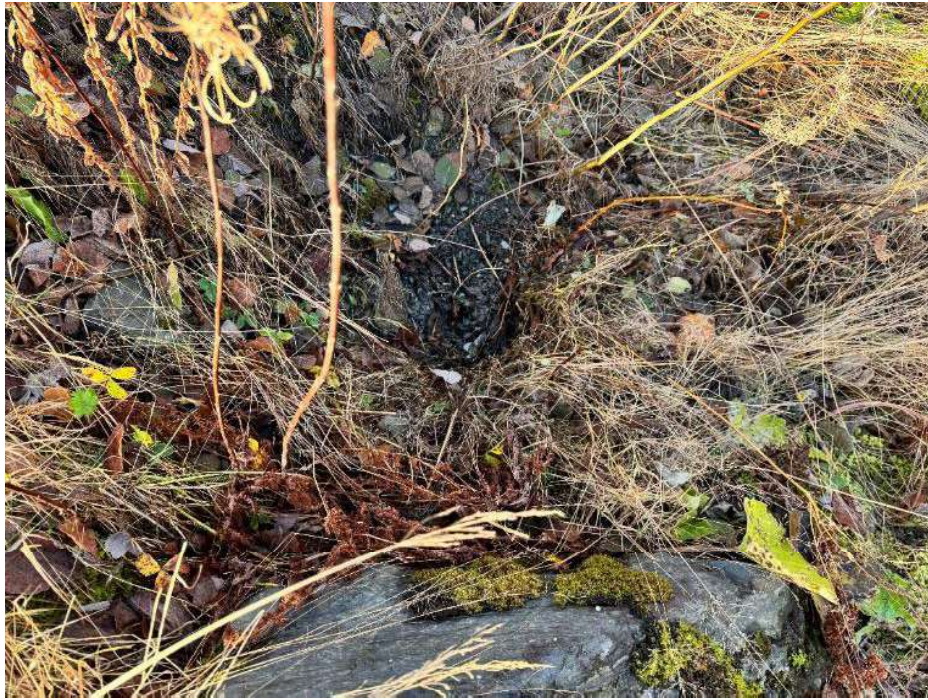
During the 2019 exterior inspection of the penstock, a sink hole was discovered 9 ft downstream of the surge tank concrete encasement, located on the left side of the penstock. The hole was about 4 ft in diameter and 4 ft deep and was repaired and maintained in following years. The 2025 inspection had once again found the repair of the sink hole holding with no further settlement observed (Photos 38 to 41).

Photo 40 Sinkhole downstream of surge tank concrete base

Photo 41 Sinkhole downstream of surge tank concrete base

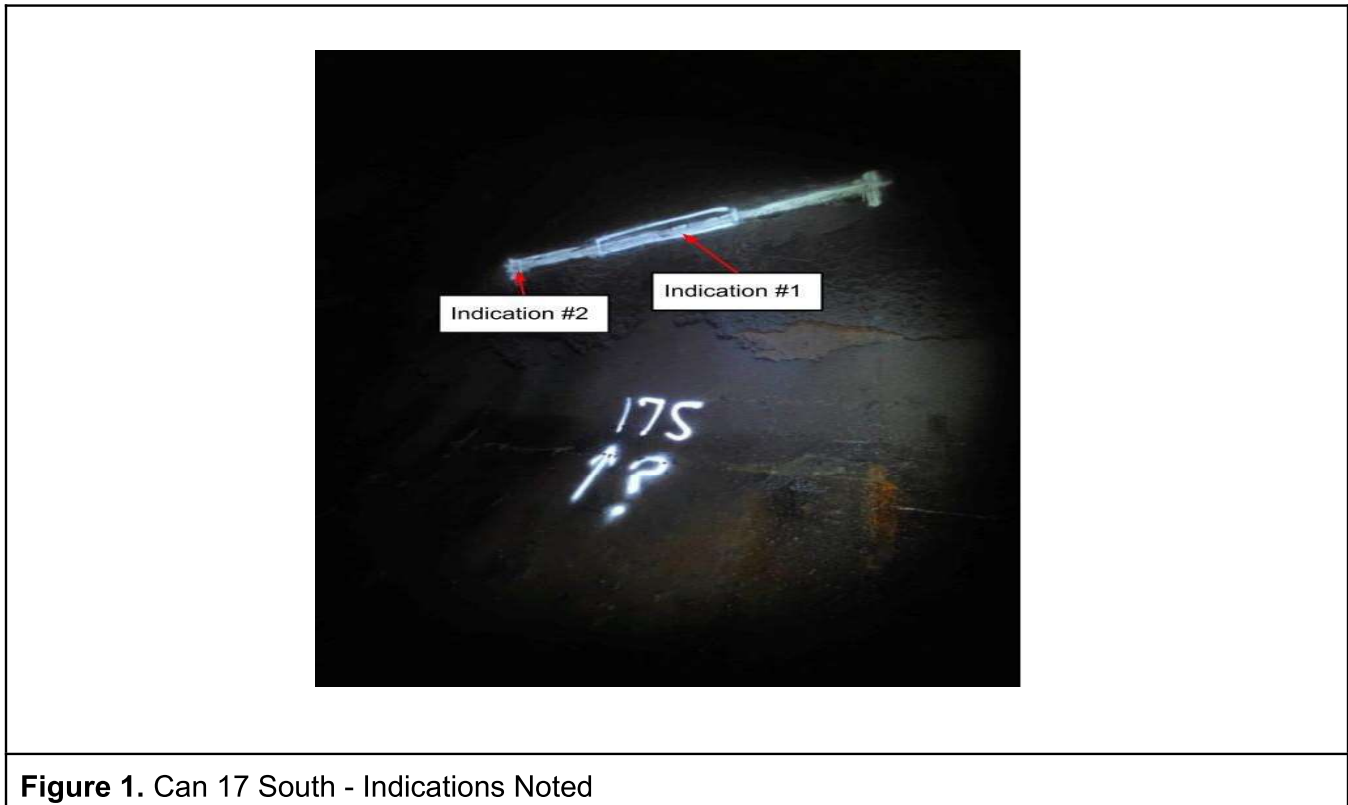
Figure 1. Can 17 South - Indications Noted

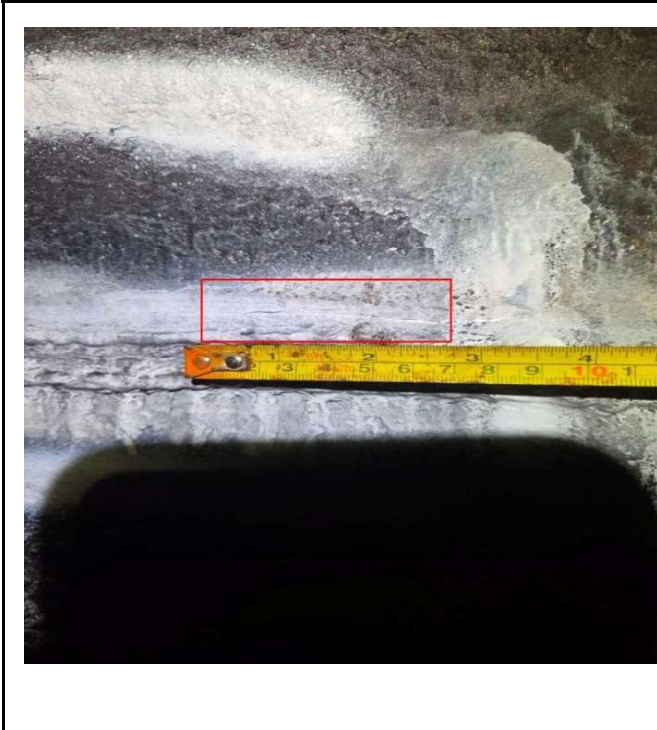
Figure 2. Can 17 South - Indication #1 - Intermittent Indication Noted

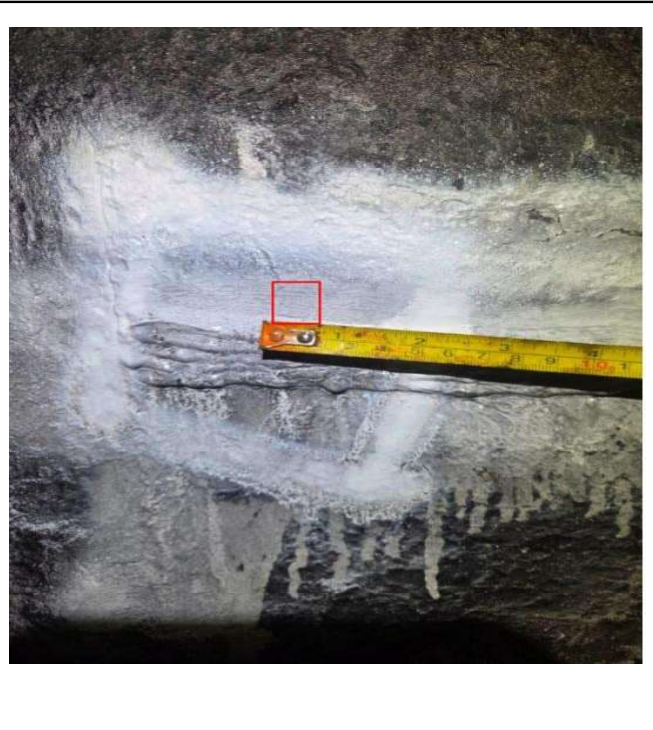
Figure 3. Can 17 South - Indication #2
