PENSTOCK 3 INSPECTION AND EVALUATION

BAY D'ESPOIR HYDROELECTRIC DEVELOPMENT
PENSTOCKS 1-3 INSPECTION PROJECT

May 2026

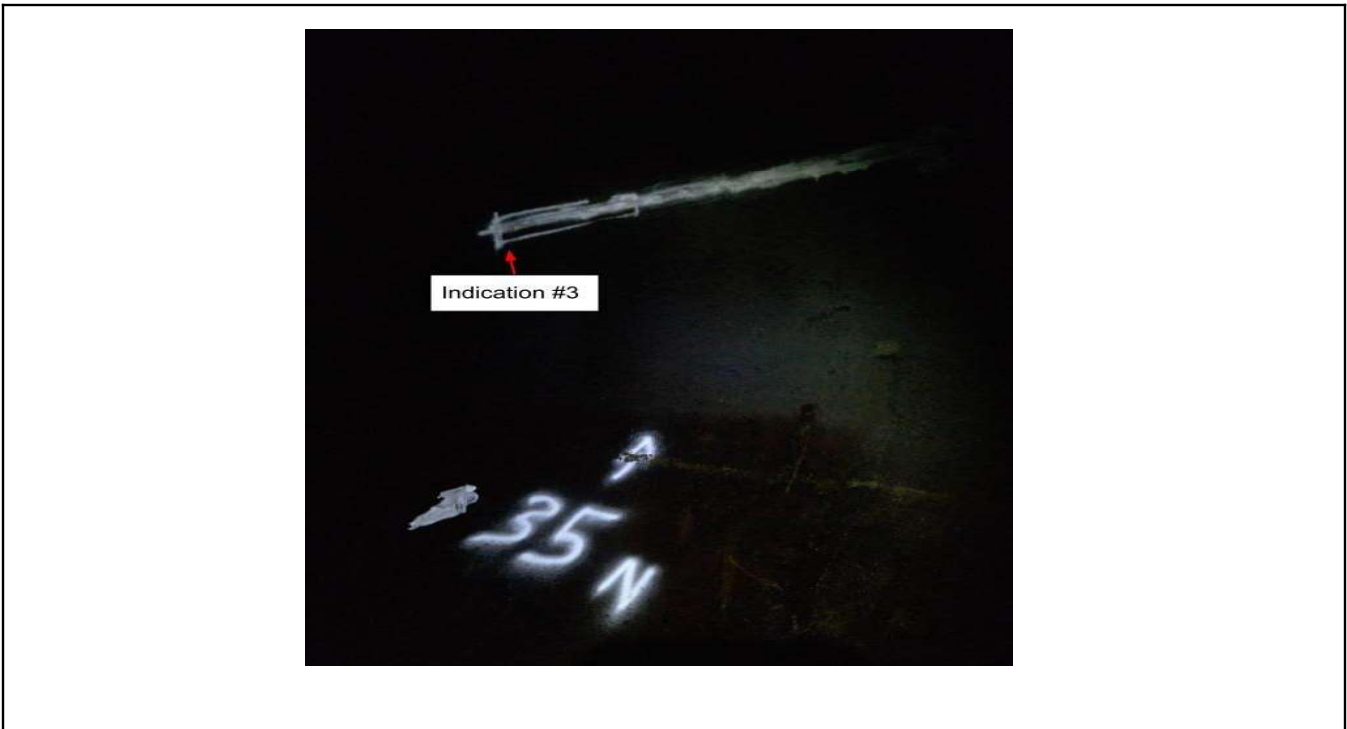
Figure 4. Can 35 North - Indication Noted

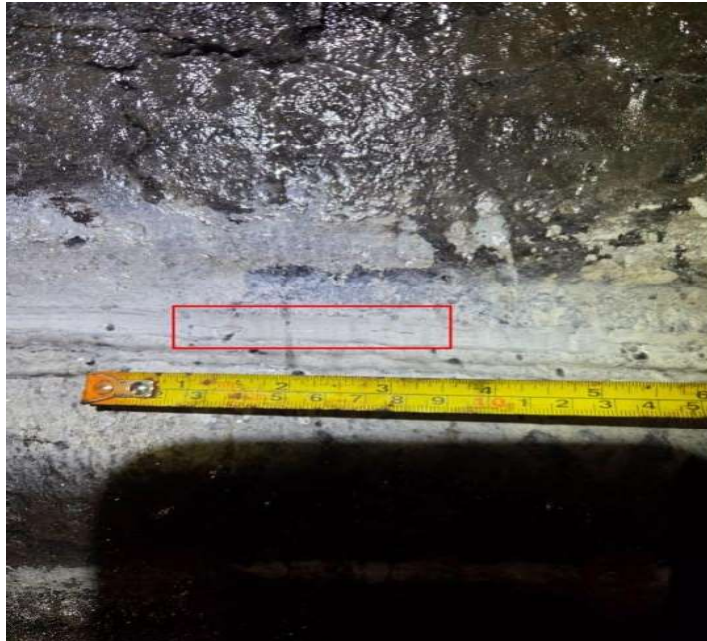
Figure 5. Can 35 North - Indication #3 - Intermittent Indication Noted

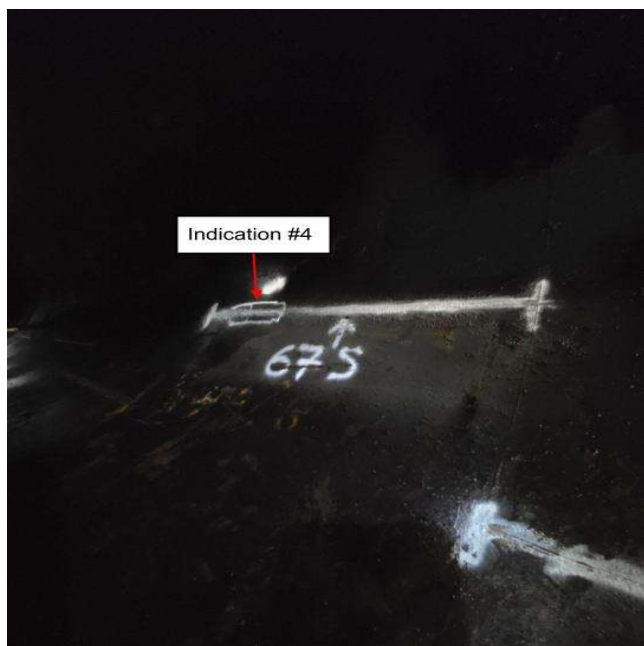
Figure 6. Can 67 South - Indication Noted

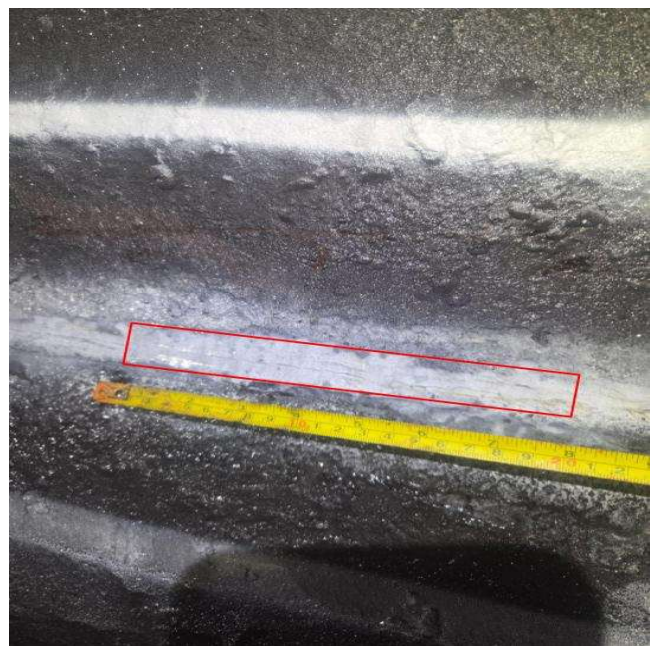
Figure 7. Can 67 South - Indication #4
Intermittent Indication Noted

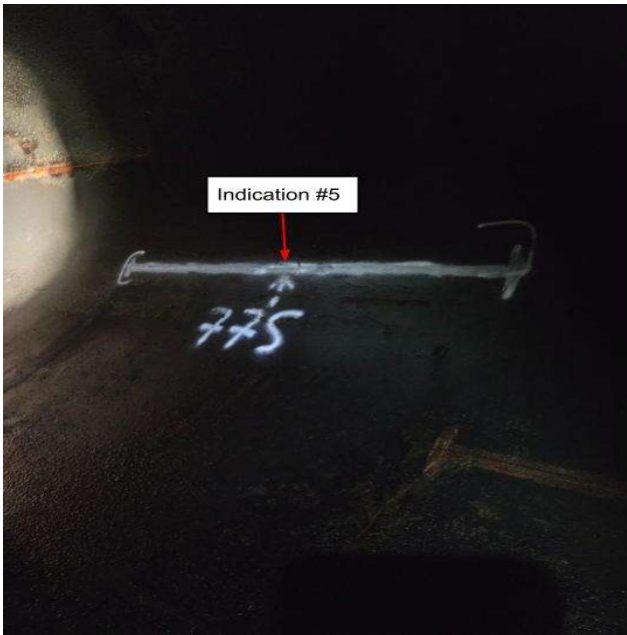
Figure 8. Can 77 South - Indication Noted

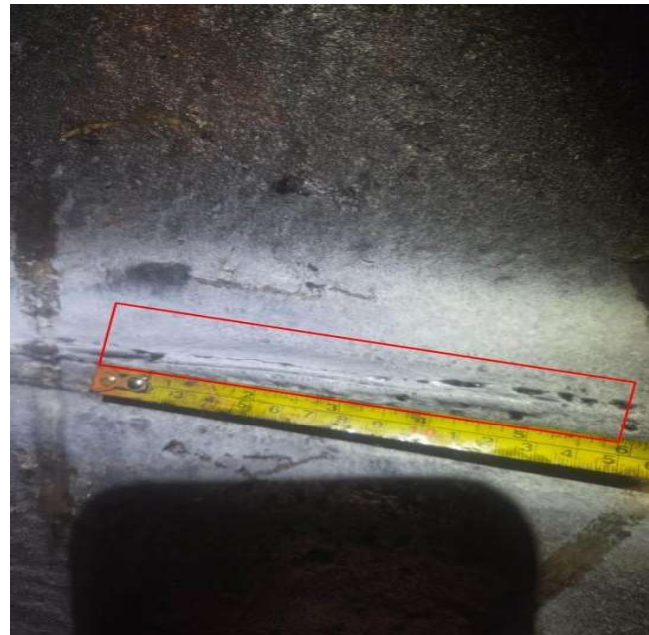
Figure 9. Can 77 South - Indication #5 Intermittent Indication Noted

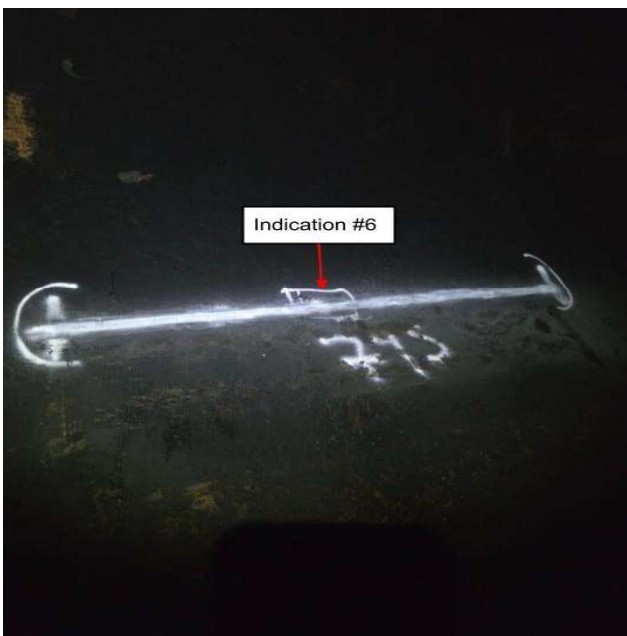
Figure 10. Can 79 South - Indication Noted

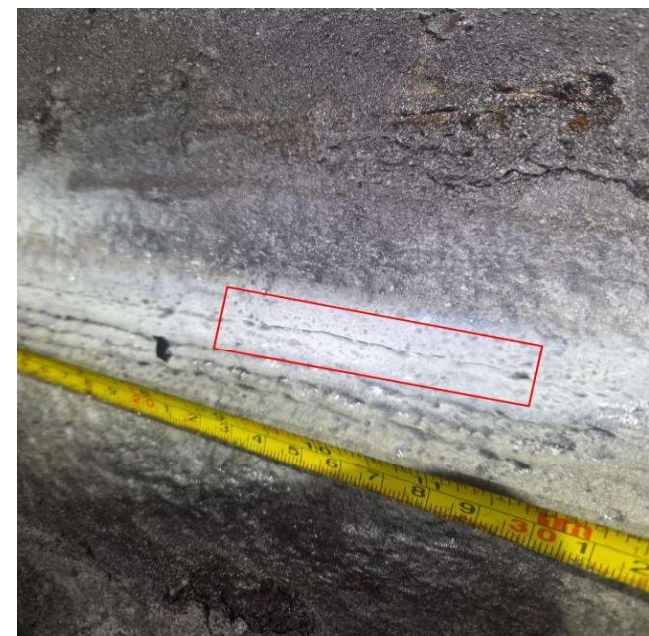
Figure 11. Can 79 South - Indication #6 Intermittent Indication Noted

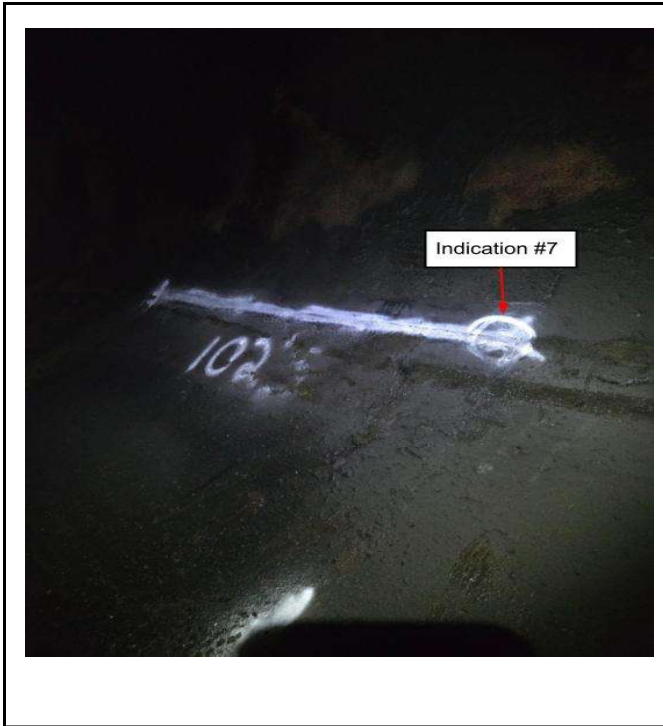
Figure 12. Can 102 South - Indication Noted

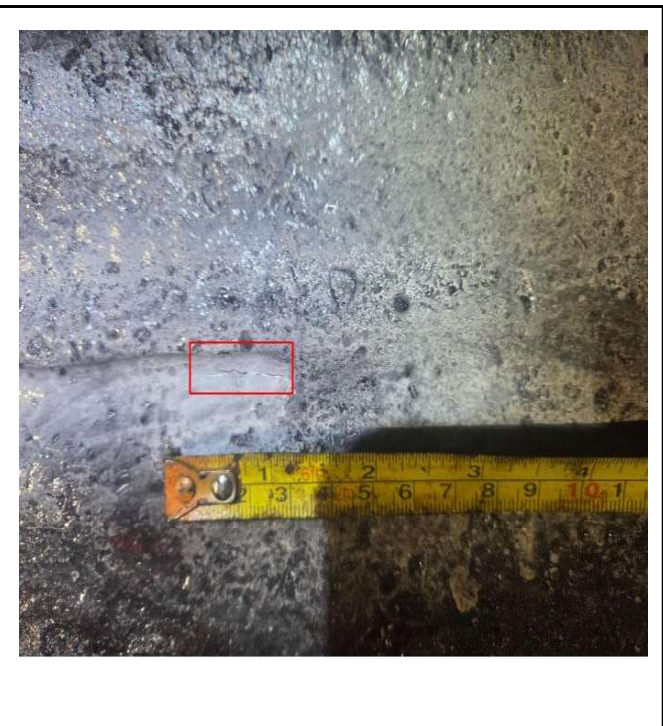
Figure 14. Can 254 South - Indication Noted - Post Grinding

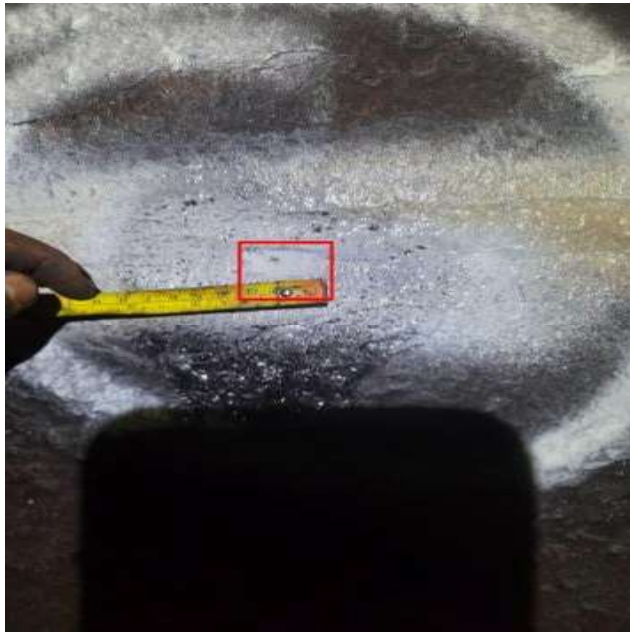
Figure 16. Can 263 South - Indication Noted - Post Grinding

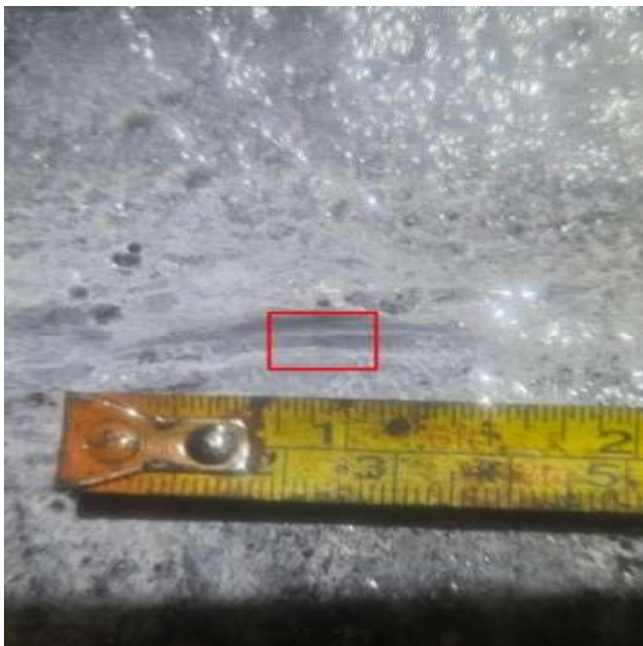
Figure 21. Can 332 North - Indication Noted - Post Grinding
